## Structure C 302/127A

Location: Between Tain and Ardgay Stations

ELR: WCK 54.1035

## Inspection

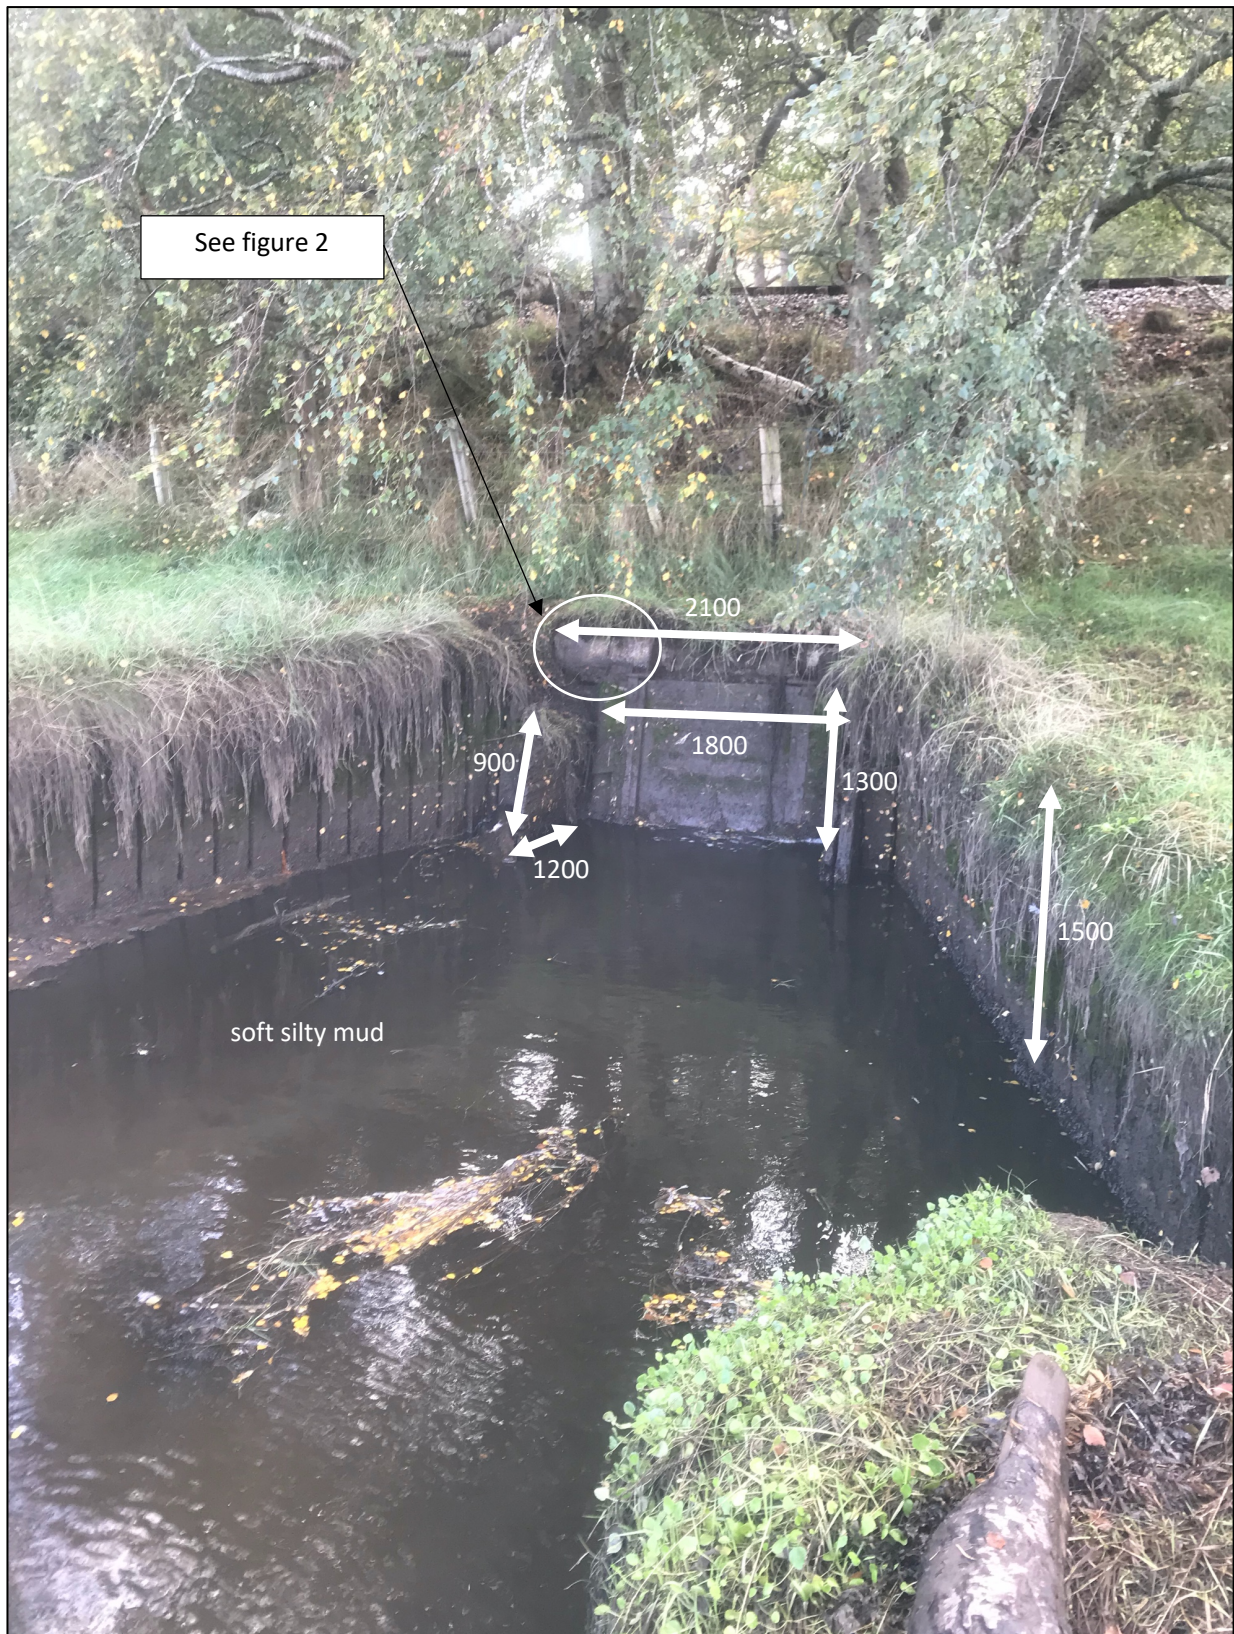
Figure 1 - Outlet

The rectangular tidal flap is constructed from timber and measures approximately 1800mm wide by 1300mm high as shown in Figure 1. It is fixed to a hinge joint that is bolted onto a concrete headwall. The face of the timber flap has been covered with a soft foam material presumably to create a seal around the inlet when operating properly.

It was not possible to open the flap during the site visit as it requires more than 2 people or the use of machinery which was not available and therefore the internal dimensions at the outlet are not known. It was however possible to insert a camera for a photograph which shows the culvert to comprise timber sleepers and side walls similar to the inlet which was more easily accessible.

1. Remove the existing flap and associated brackets and replace with a modern GRP flap valve which would fix onto the existing headwall. Other minor repairs to be carried out as required.
2. Replace the existing headwall with a new concrete (or similar) headwall with flap valve. This provides assurance that the connection between the flap valve and the headwall is good and will achieve a 50-year design life.
3. As option 2 but extend the scope to also improve the outlet training walls as well as the headwall
4. As option 3 but extend the scope to also include remediations at the inlet – albeit it looks to have had attention recently
5. Complete replacement of the culvert with a NR compliant structure.
6. Any of the previous options with the addition of reinstating the upstream water retention structure as an alternative/additional way of controlling water levels in the loch.

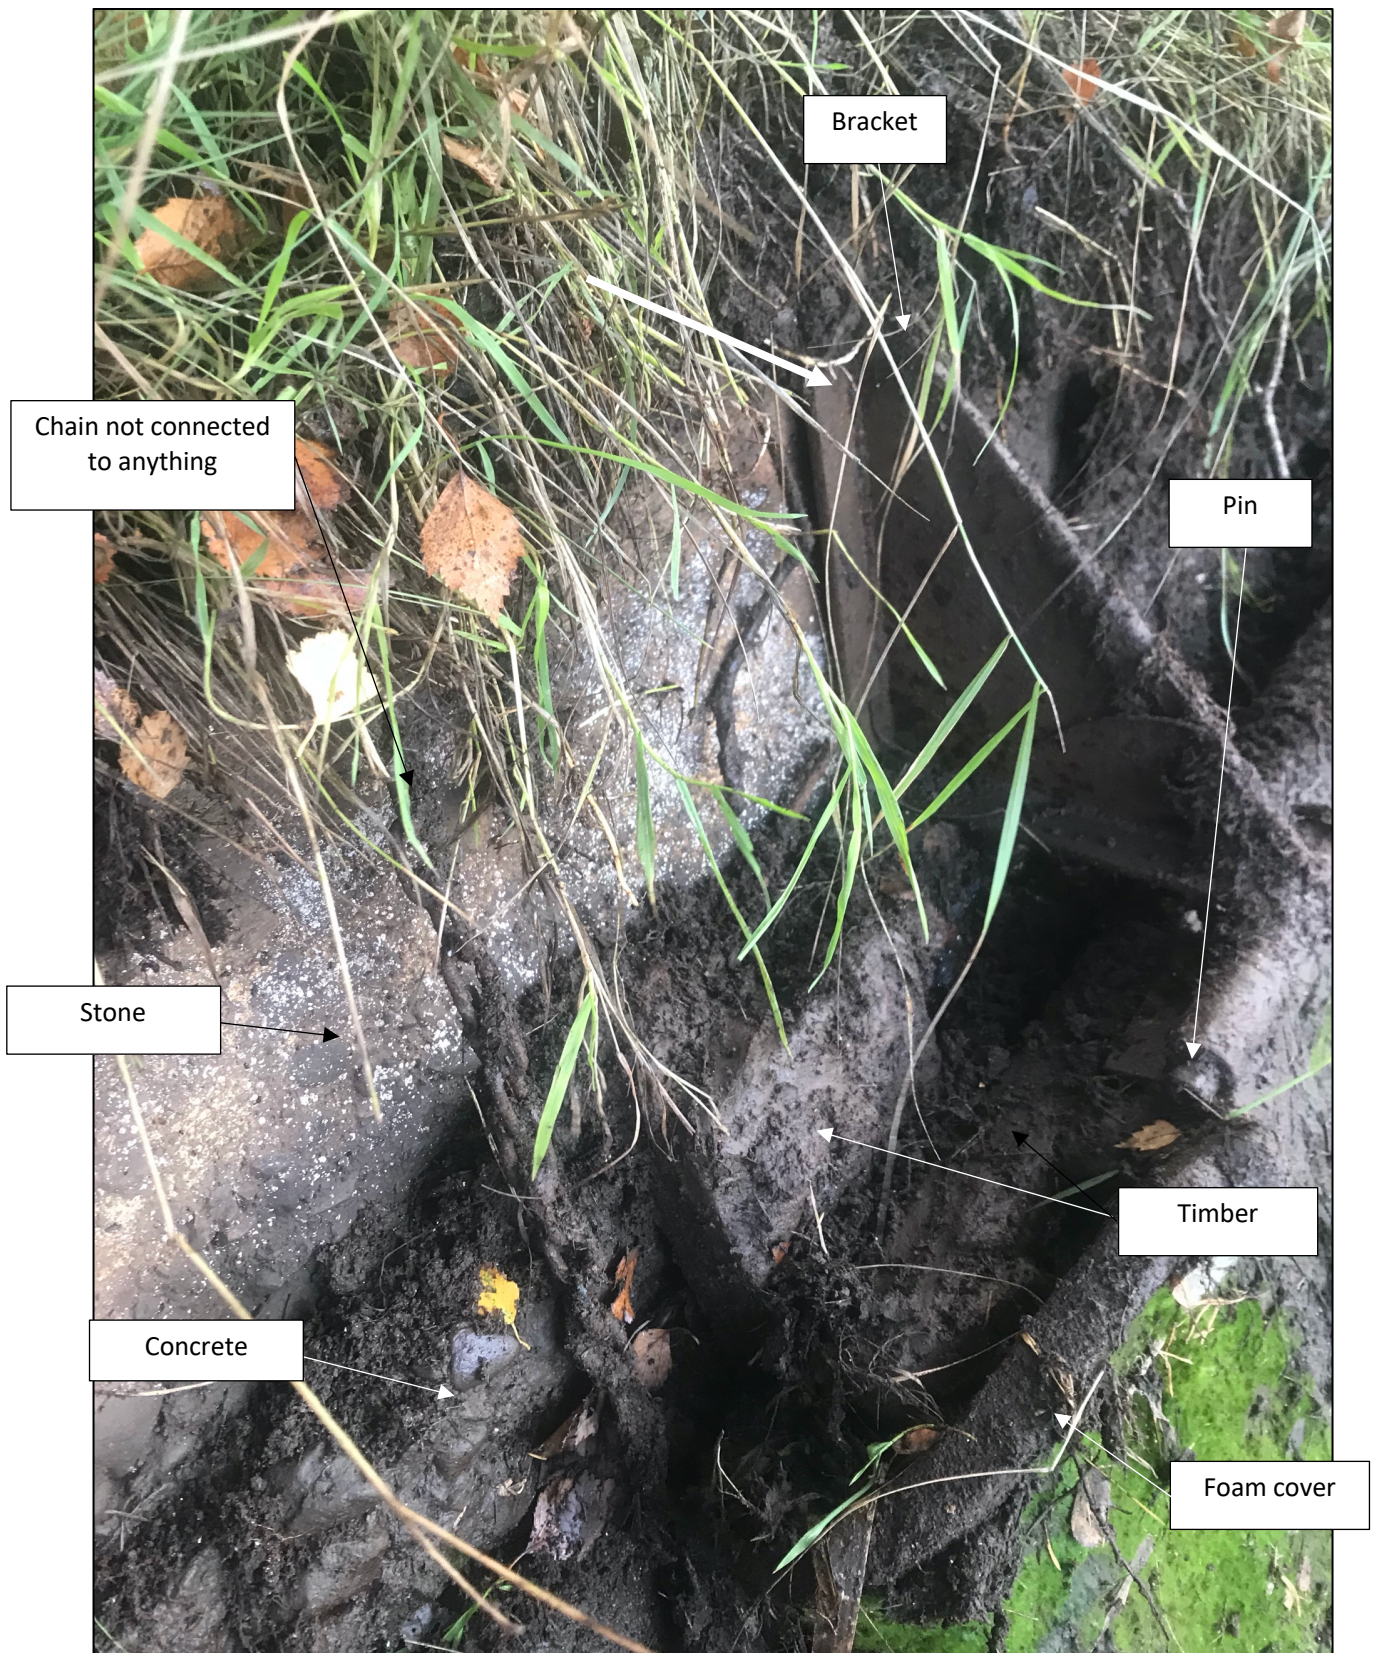
Figure 2 – Flap Bracket

The steel bracket connecting the flap to the concrete is approximately 300 long x 200 high by 20mm thick.

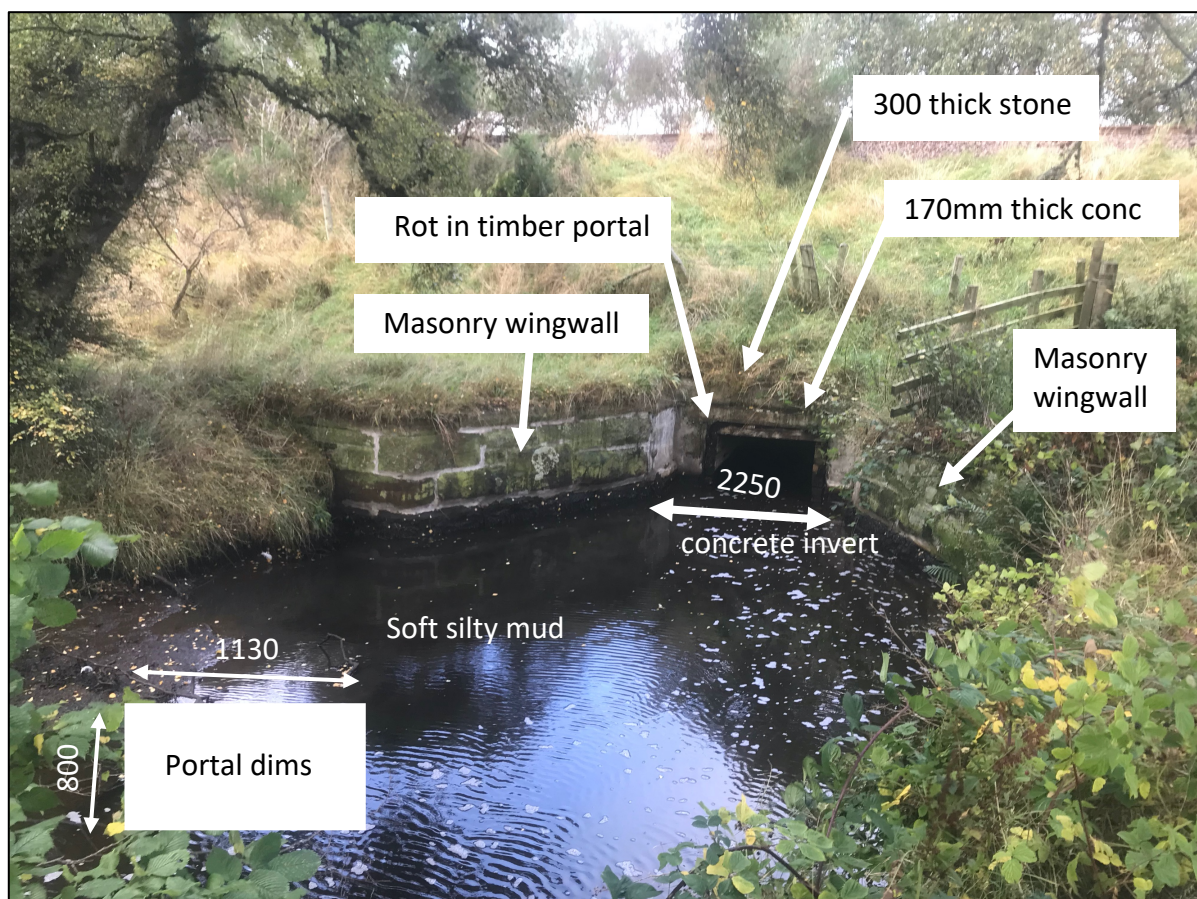
Figure 4 – Inlet

The bed at the inlet comprises soft silty mud. A concrete invert is present 900mm from the inlet portal. There is a 100mm step from the natural bed up to the concrete invert. The concrete is of an older construction comprising large stone aggregates which has been eroded and broken up over time leaving a rough stony finish to the invert.

The culvert comprises a timber box of sleepers and sidewalls 800mm high by 1130mm span. Above the timber portal is 170mm thick concrete and 300mm thick stonework. Internally, the masonry is in good condition with some rot apparent on the left corner of the culvert portal.

The clear width from one wingwall to the other is approximately 2250mm. Masonry repairs have been undertaken to the wingwalls which are in good condition.

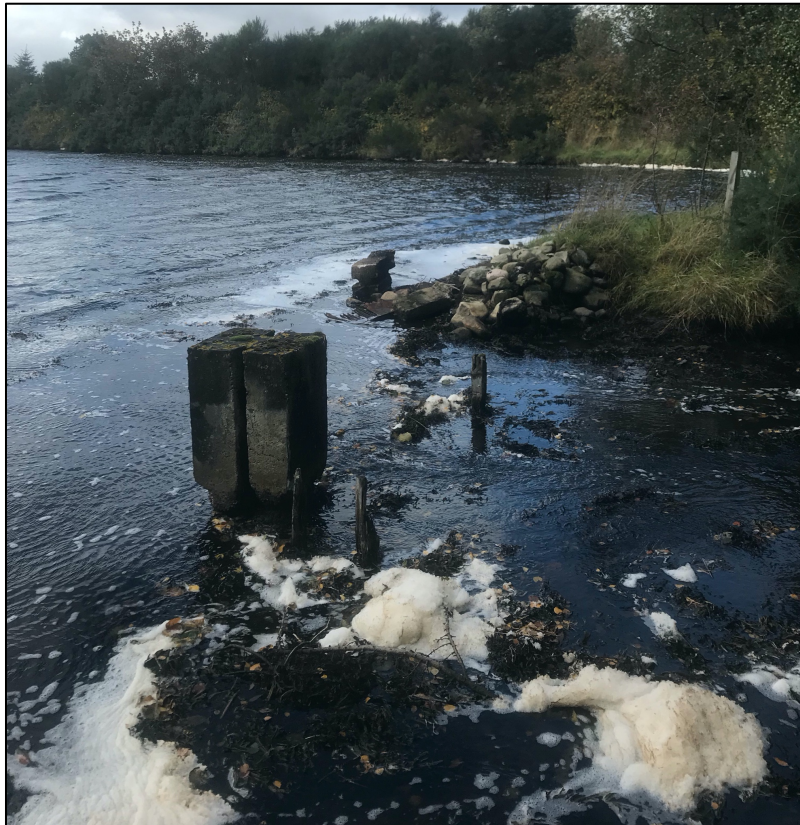
Figure 5 - Upstream

Water at the point of this picture was shallow at the time of the inspection (low tide). It is understood that a structure used to exist here. Timber or metal plates used to fit into the slits of the concrete blocks to maintain high water at low tide. It is unknown when this was deconstructed however a review of Routeview shows the structure to be in place in April 2019.
