## Retaining Wall Detailed Examination Report

ELR: KNE1

Struc. Ref: 200/561

ELR: KNE1		Contract Mileage: 004m 0240yds 10.91chs			Struc. Ref: 200/561	
Struc. Type	WCE RD	NR ID	11009030	Rpt ID	8909	OS Ref NS92858723
		Exam ID	2940107			
Dimensions	Max Height 4.00m Max Length 2500.00m					Exam Date 19/04/19
Side of Line						Last Detailed 17/05/18
Min dist. from Track	2.30					Last Visual
Line	Kincardine Power Stn - Charlestown Jn (Goods Line)					
Name:	Kincardine on Forth

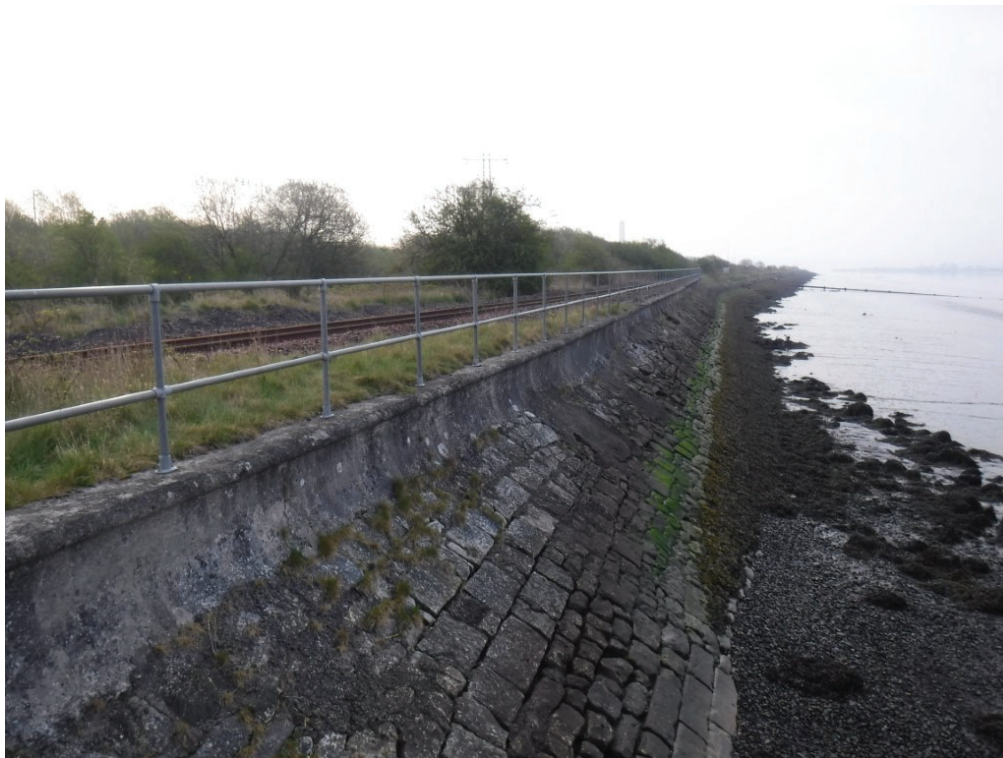
Photograph 1 - Section 1 - General view from start of defence - 19.04.19

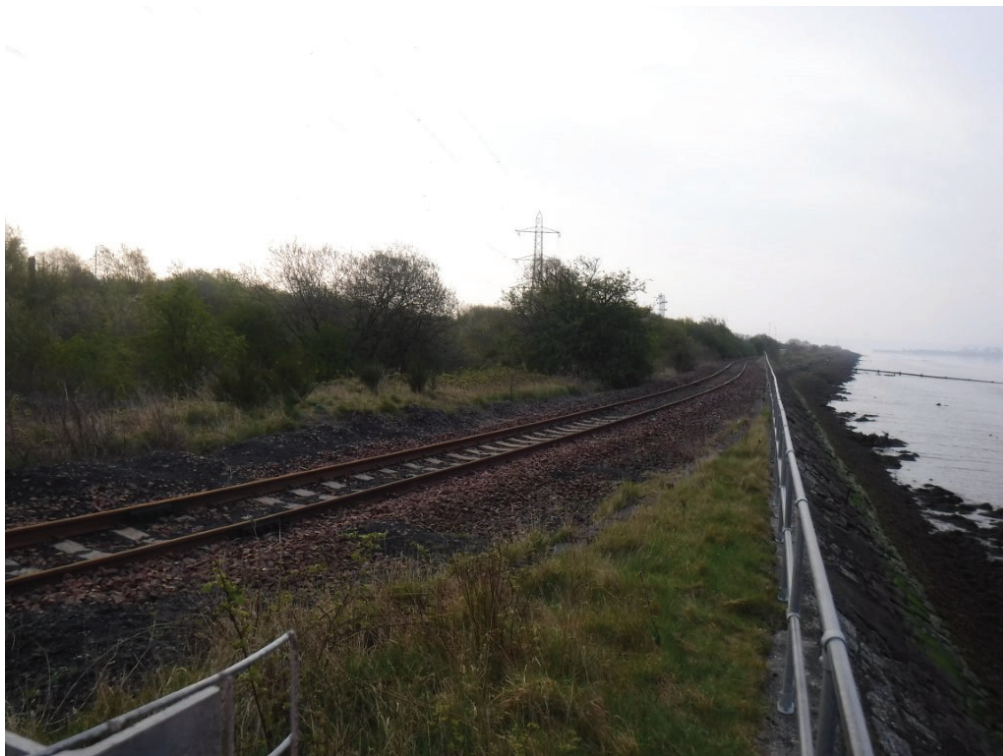
Photograph 2 - Section 1 - Track view from start of defence to high miles - 19.04.19

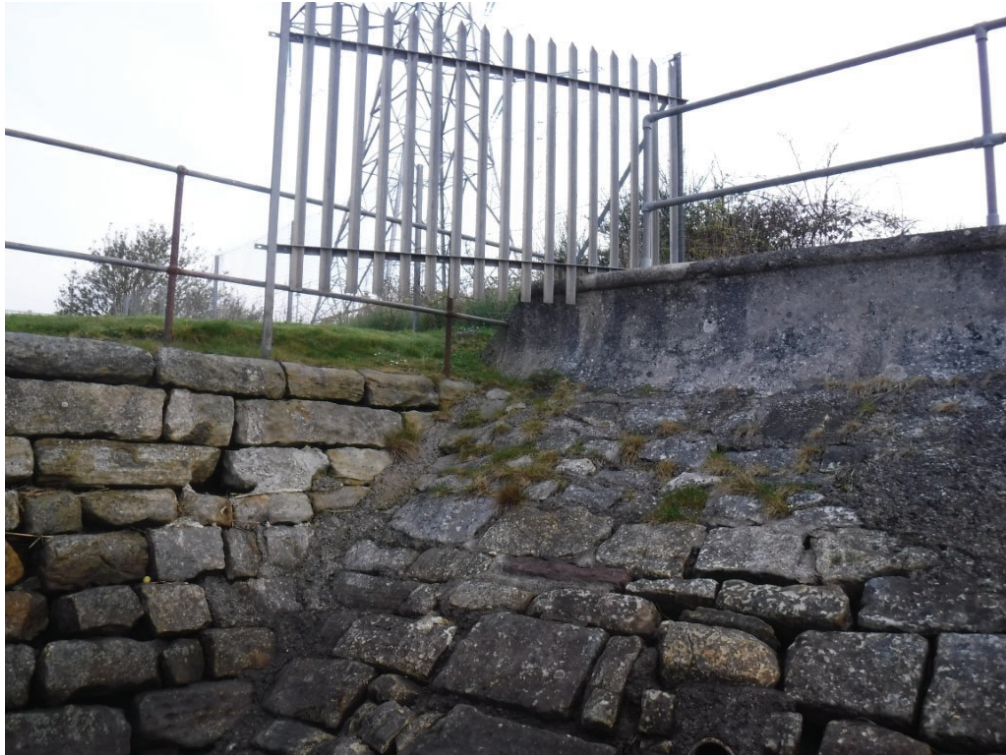
A clay pipe outfall approximately 150mm in diameter was noted at the start of this section 4M 242Y (see Photograph 3), although no flow was noted during the time of this examination.

Photograph 3 - Section 1-General view from start of defence -19.04.19

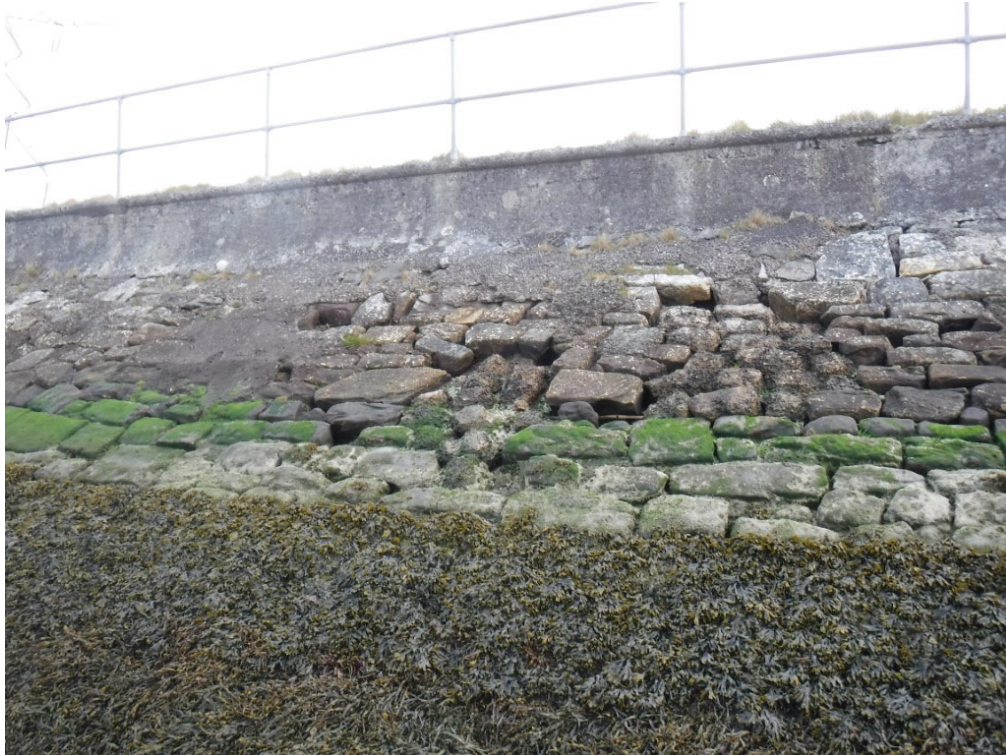
Areas of washout noted at 4M 260Y and 4M 280Y, between the revetment and the wave return wall do not appear to have deteriorated since last year's examination (see Photographs 4 and 5 respectively).

Photograph 5 - Section 1- 4M 280Y- Washout of bagwork -19.04.19

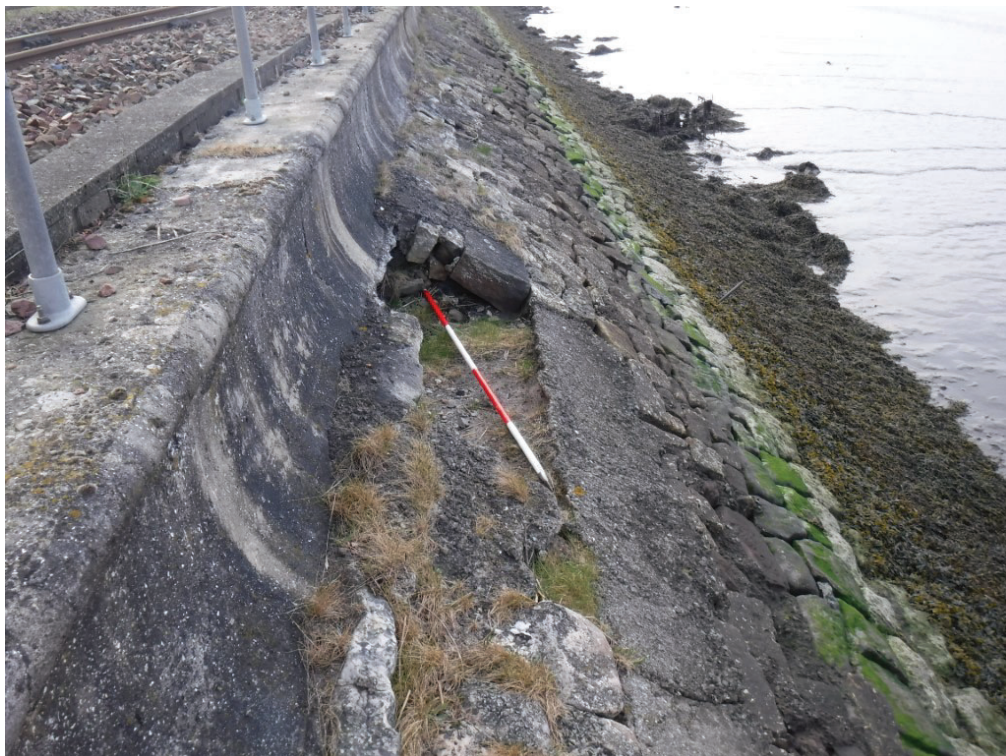
Photograph 6 shows an area of washout at 4M 280Y (2 x 0.8 x 1.6m). This defect is approximately 2m from the rail.

Photograph 6 - Section 1- 4M 280Y- Washout 2m from rail, deterioration (2x0.8x1.6m) -19.04.19

- a – Repair all voids noted throughout section.
- b – Repair all washed out areas noted throughout section.
- c – Repair eroded coping stone at the crest of the wave return wall at 4M 0295Y.
- d – Repair washout at 4M 280Y

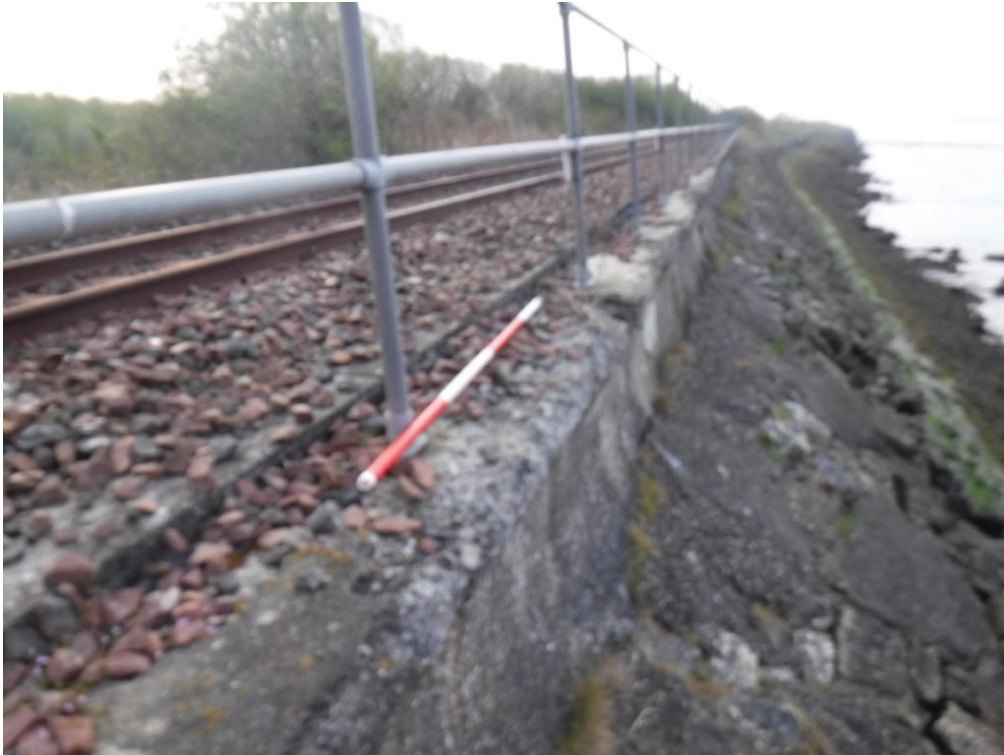
The eroded coping stone along the crest of the wave return wall around 4M 295Y has not deteriorated since last year's examination (see Photograph 7).

Photograph 7 - Section 1- 4M 295Y- Eroded cope - 19.04.19

c – Repair washed out section of the cope on the wave return wall at 4M 0280Y and 4M 0295Y.

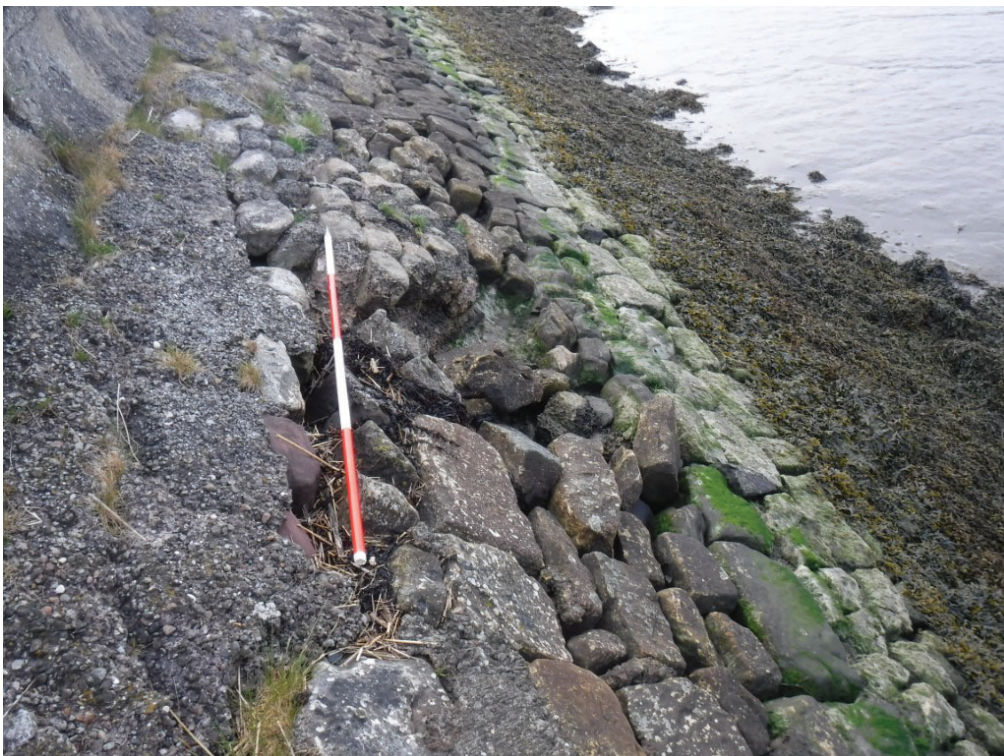
Areas of washout recorded at 4M 300Y and 4M 325Y have not deteriorated since last year's examination, as shown in Photograph 8 and 9.

Photograph 8 - Section 1- 4M 300Y- Washout 2x 1.5x0.5m deep -19.04.19

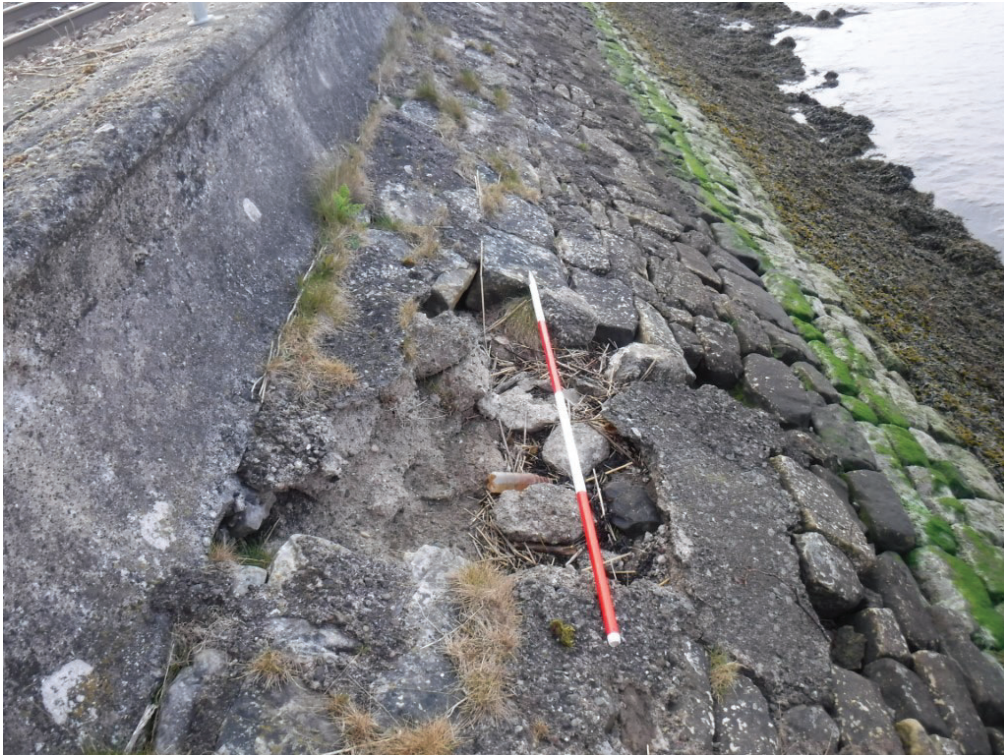
Photograph 9 - Section 1- 4M 325Y- Washout 1.7x0.25x0.75m -19.04.19

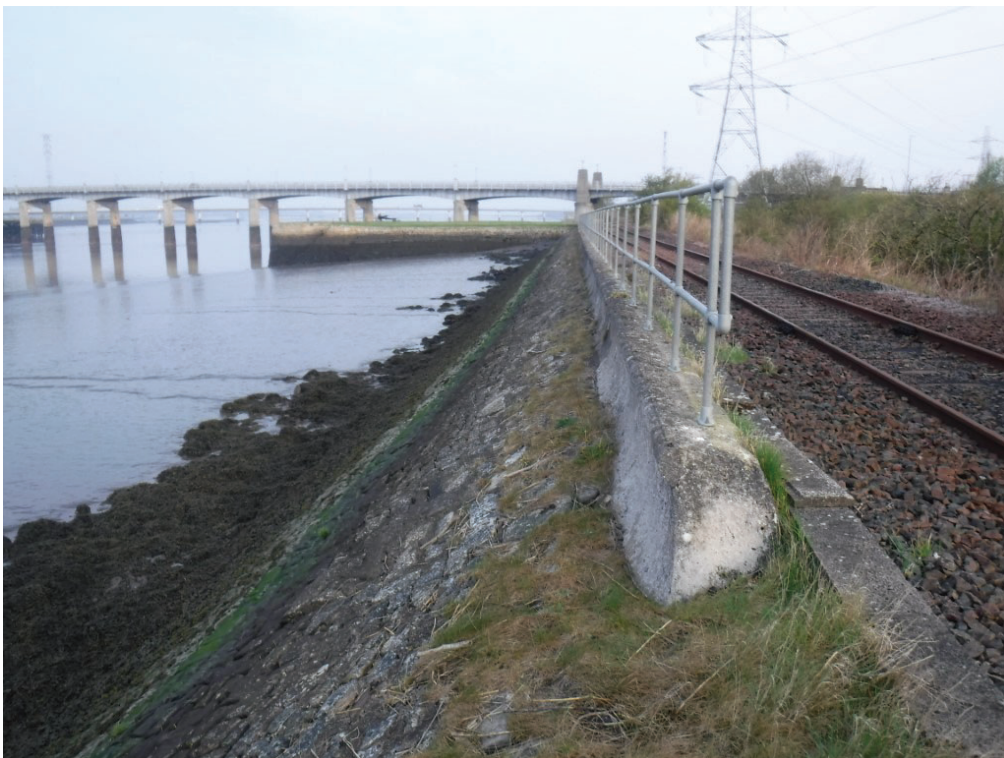
Photograph 10 - Section 1- End of section water draining mud along toe to low miles -19.04.19

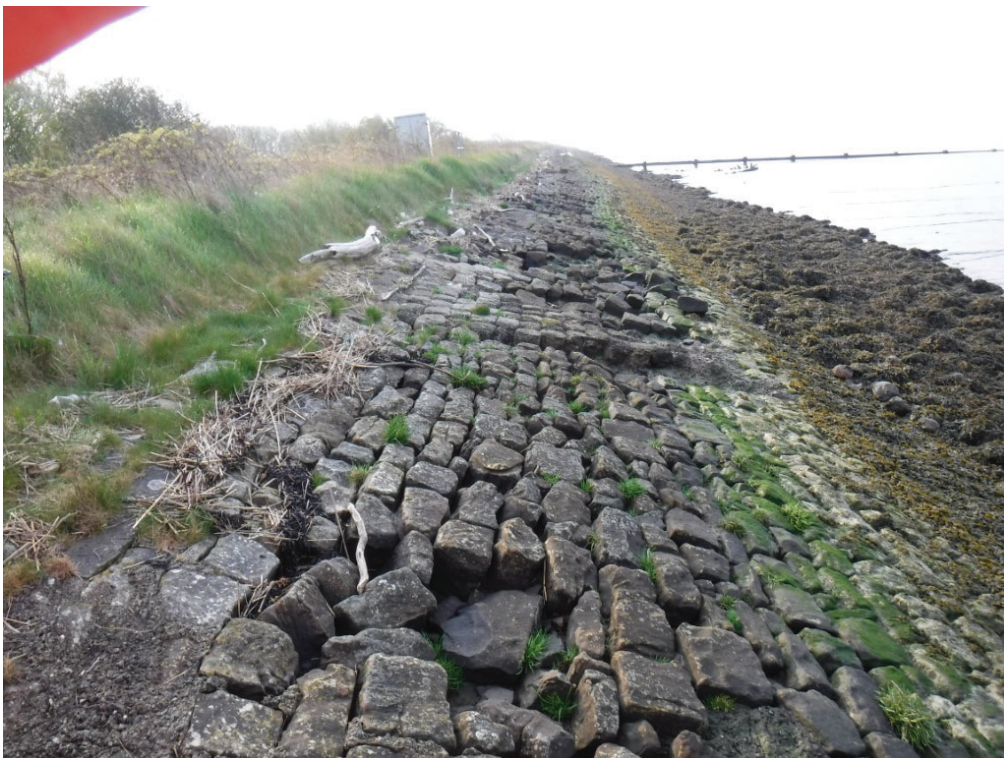
Several voids were noted in the revetment between 4M 385Y and 4M 490Y which can be seen in Photographs 12 (to high miles) and 18 (to high miles). These voids have not significantly deteriorated since last year's examination. These voids are approximately 5m from the running rail.

Photograph 12 - Section 2- 4M 385Y- Typical view of poor condition revetment -19.04.19

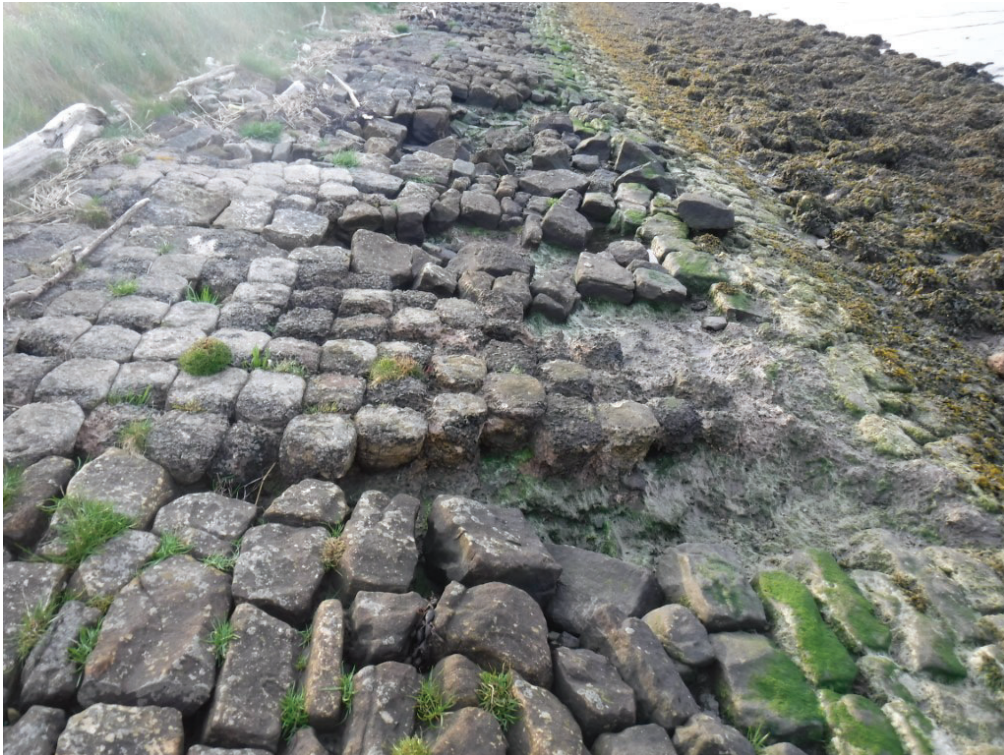
A view from 4M 393Y showing the typical condition of washout present across the revetment can be seen in Photograph 13. Deterioration of washout was noted at 4M 430Y and 4M 475Y and can be seen in Photographs 14 and 15.

Photograph 13 - Section 2- 4M 393Y- Washout of sandbags (2x1x0.5m) -19.04.19

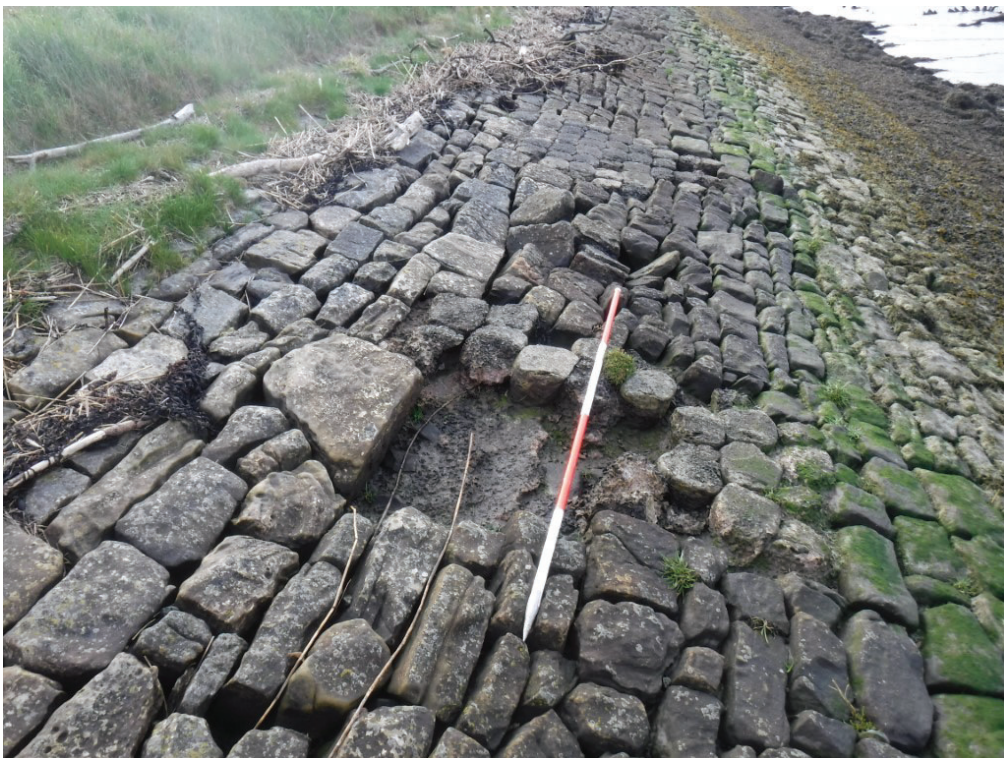
Photograph 14 - Section 2- 4M 430Y- Slight deterioration of washout (1x0.5x0.2m) -19.04.19

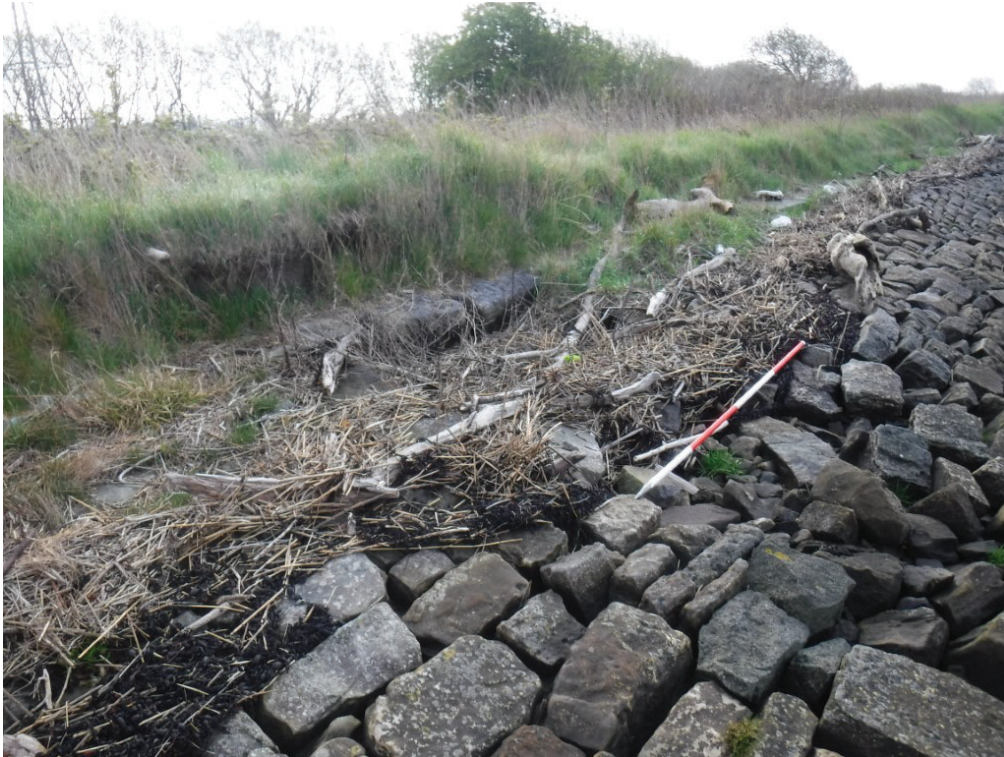
Photograph 15 - Section 2- 4M 475Y- Slight deterioration to washout (2x0.5x0.25m) -19.04.19

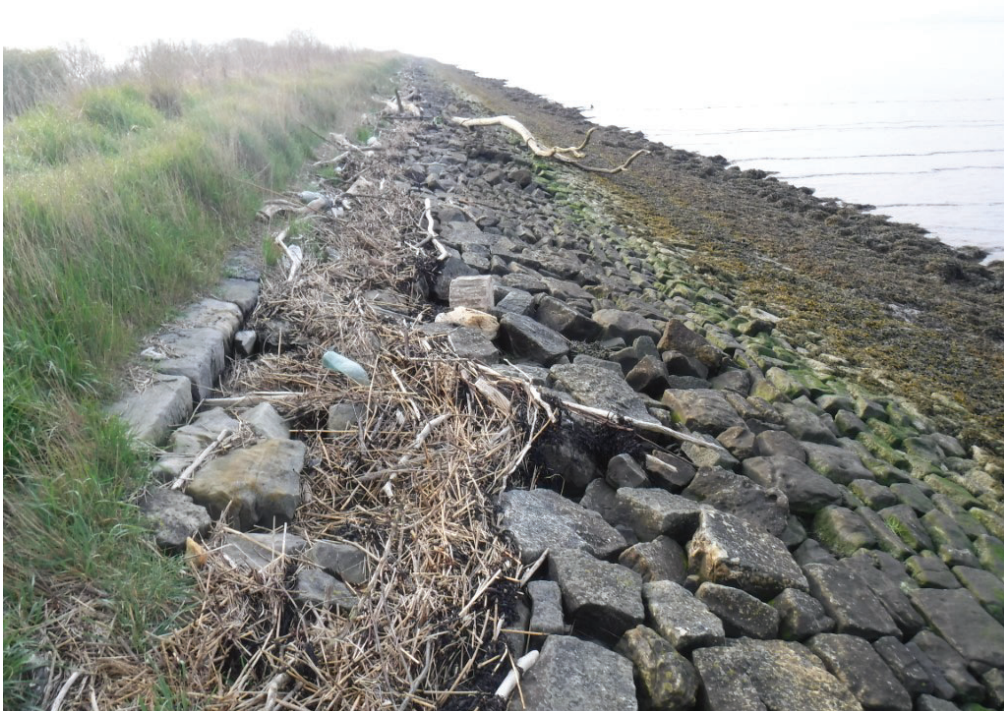
Photograph 18 - Section 2- 4M 490Y- Typical condition of revetment high miles -19.04.19

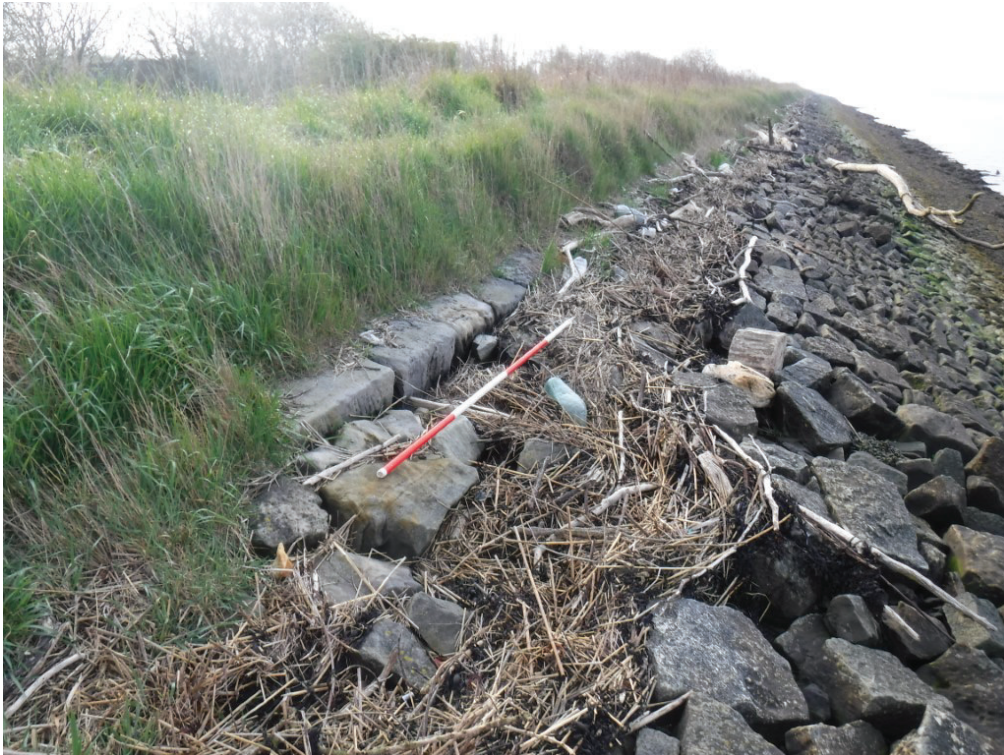
A large void (3m x 2m) noted at 4M 491Y (approx. 6m from running rail) has not deteriorated since last year's examination (Photograph 19).

Photograph 19 - Section 2- 4M 491Y- Void at crest of revetment -19.04.19

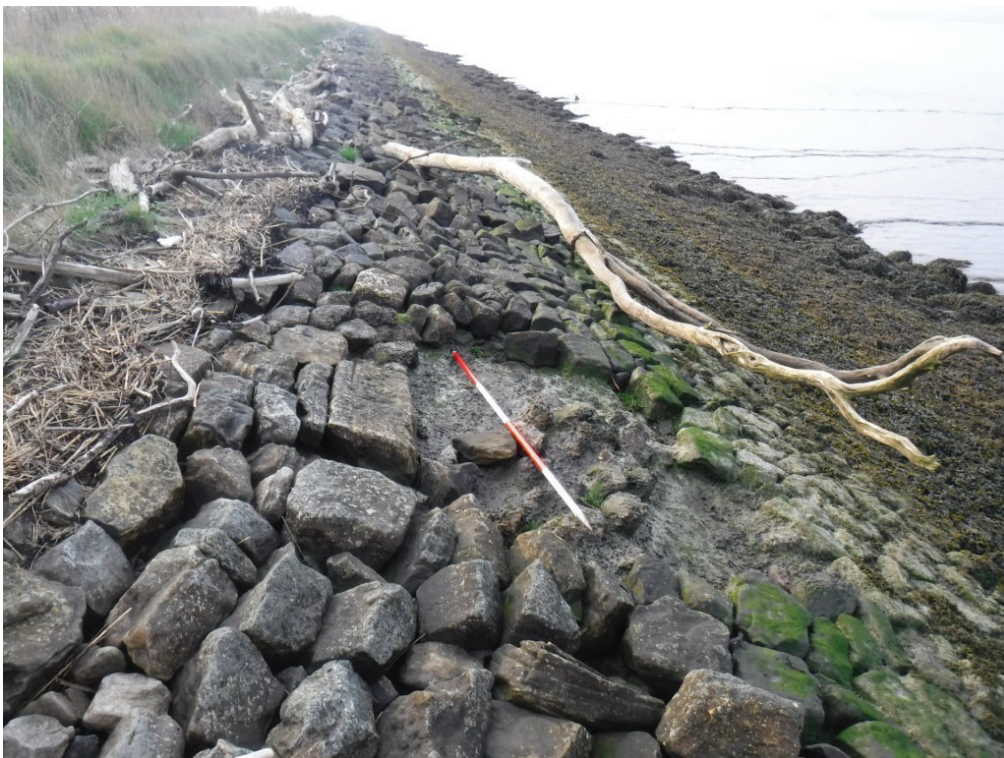
Washout to previous areas of concrete bagwork repair show signs of deterioration and was noted at 4M 500Y (now 3m wide) and 4M 545Y is shown in Photographs 20 and 21, respectively.

Photograph 20 - Section 2- 4M 500Y- Failing bag repair, slight deterioration -19.04.19

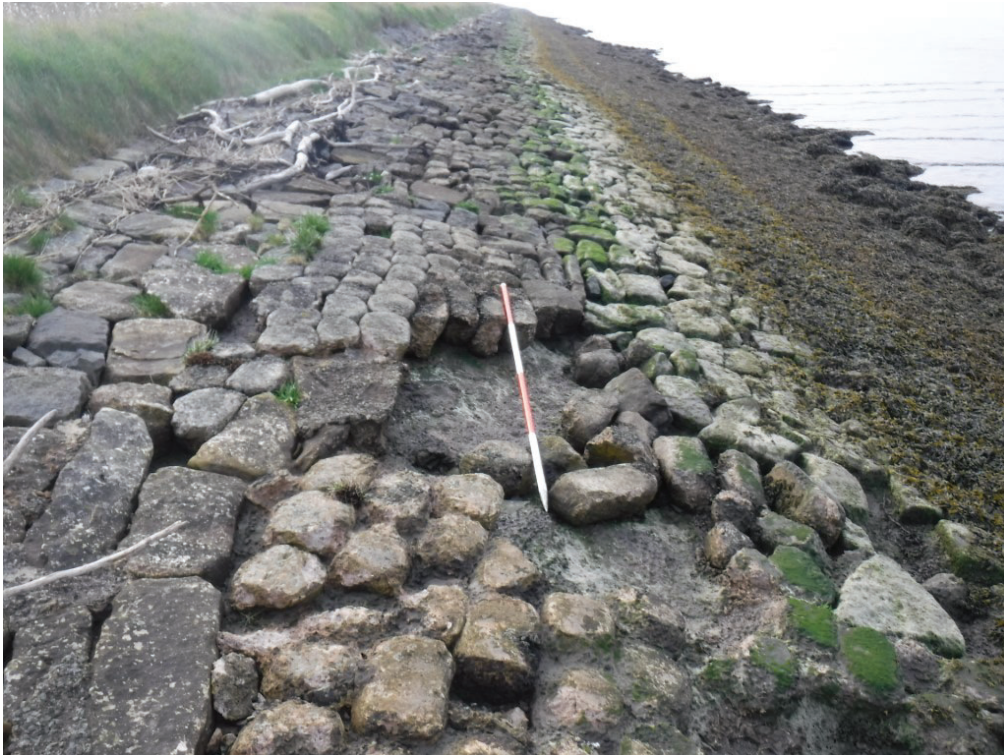
Photograph 21 - Section 2- 4M 545Y- Failure of concrete bag work, slight deterioration -19.04.19

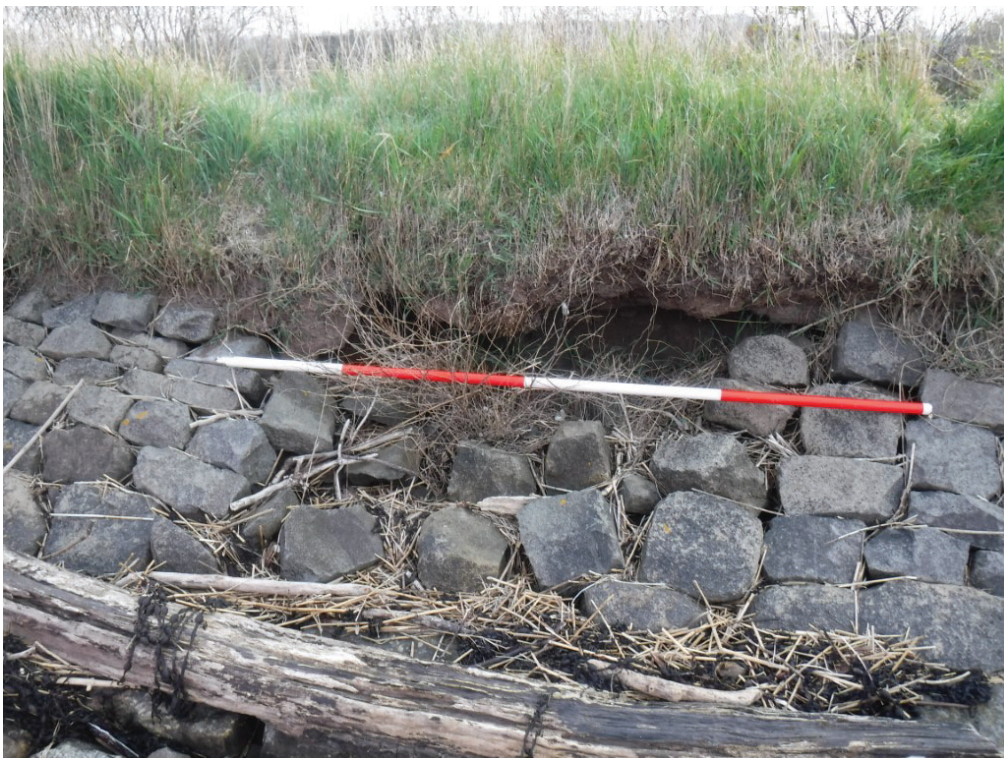
An area of typical erosion (1.5m x 0.6m) noted at the crest of the defence at 4M 570Y (approx. 6m from running rail) has deteriorated since last year's examination as seen in Photograph 22.

Photograph 22 - Section 2- 4M 570Y- Typical erosion of grass at crest -19.04.19

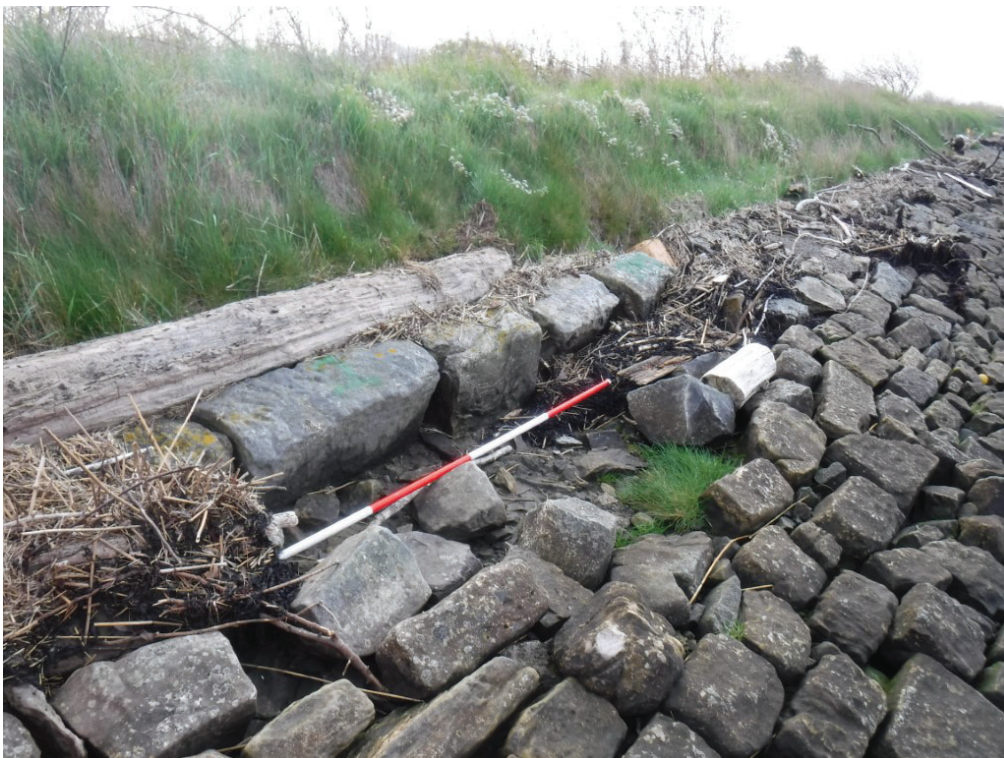
A view of typical voids, missing masonry and erosion to the revetment and crest of the defence from 4M 730Y, 760Y and 770Y can be seen in Photographs 24, 25 and 26. There has been no obvious deterioration since the previous examination.

Photograph 24 - Section 2- 4M 710Y- View of poor condition of revetment -19.04.19

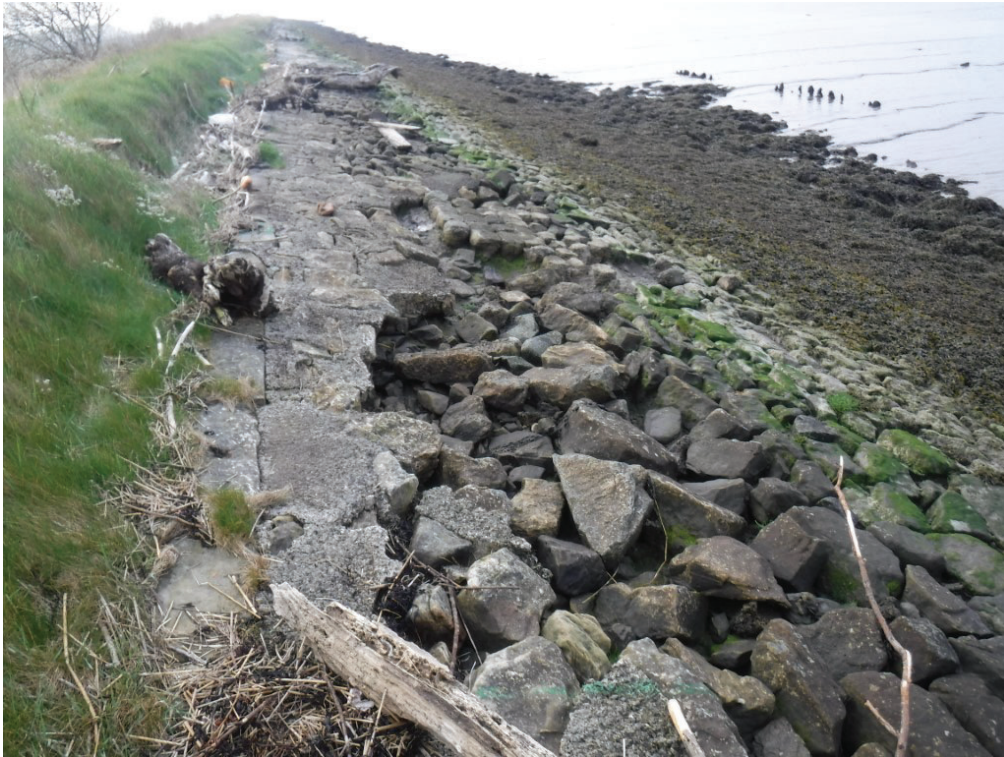
Photograph 25 - Section 2- 4M 730Y- Void and washout 0.5x1.5x1m -19.04.19

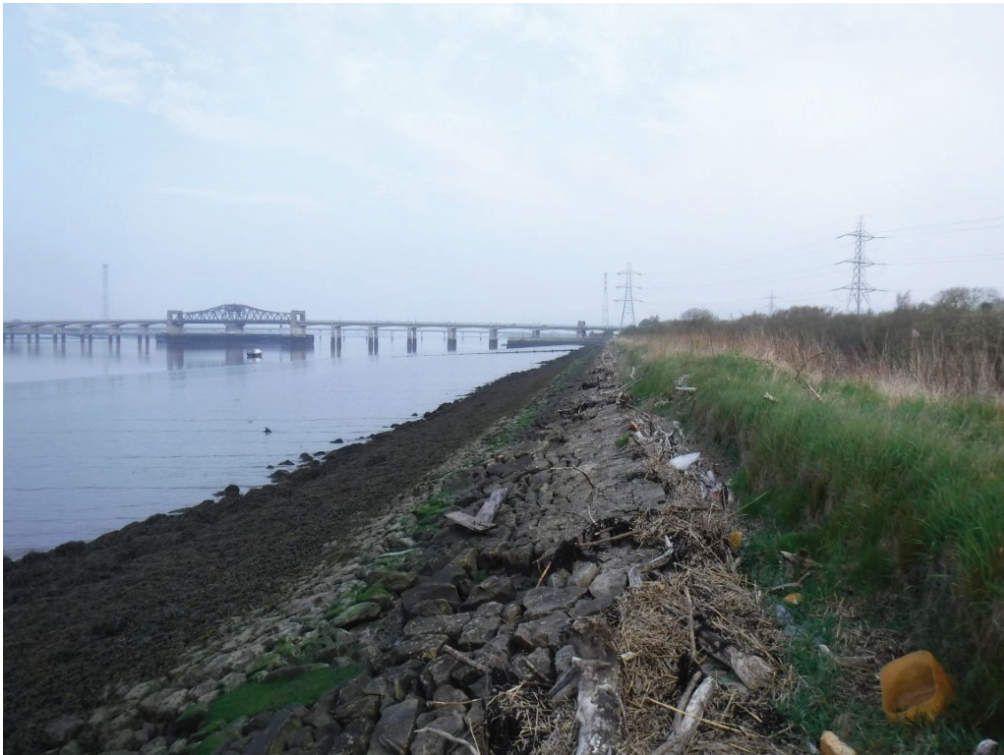
Photograph 26 - Section 2- General poor condition to low miles-19.04.19

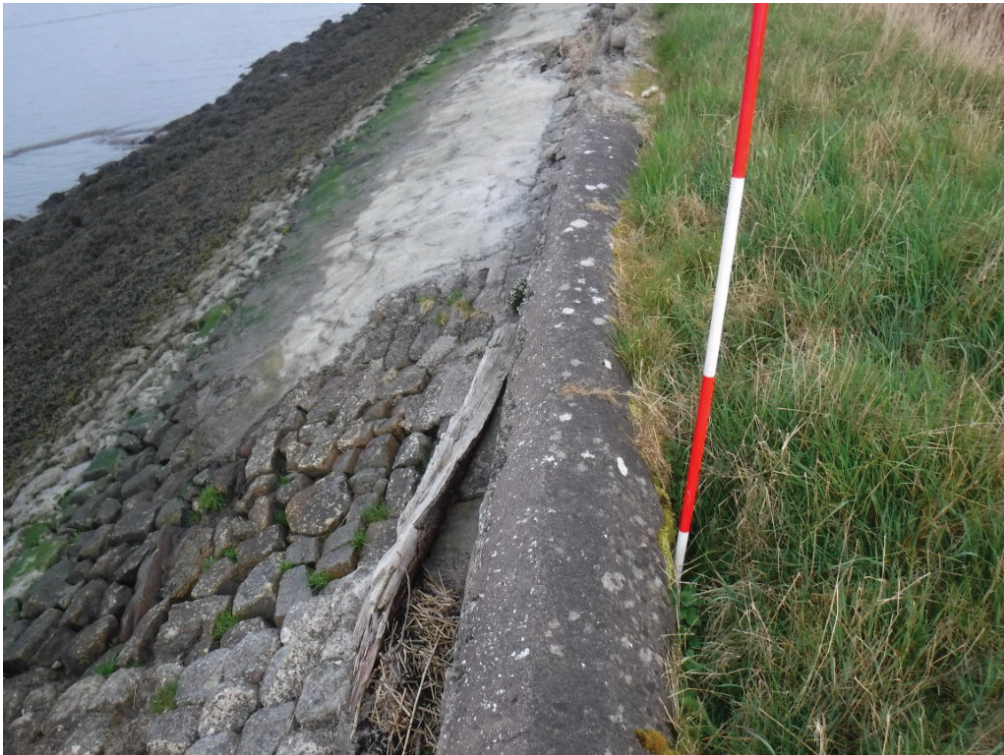
Photograph 30 - Section 3- Washout of embankment behind retaining wall to low miles -19.04.19

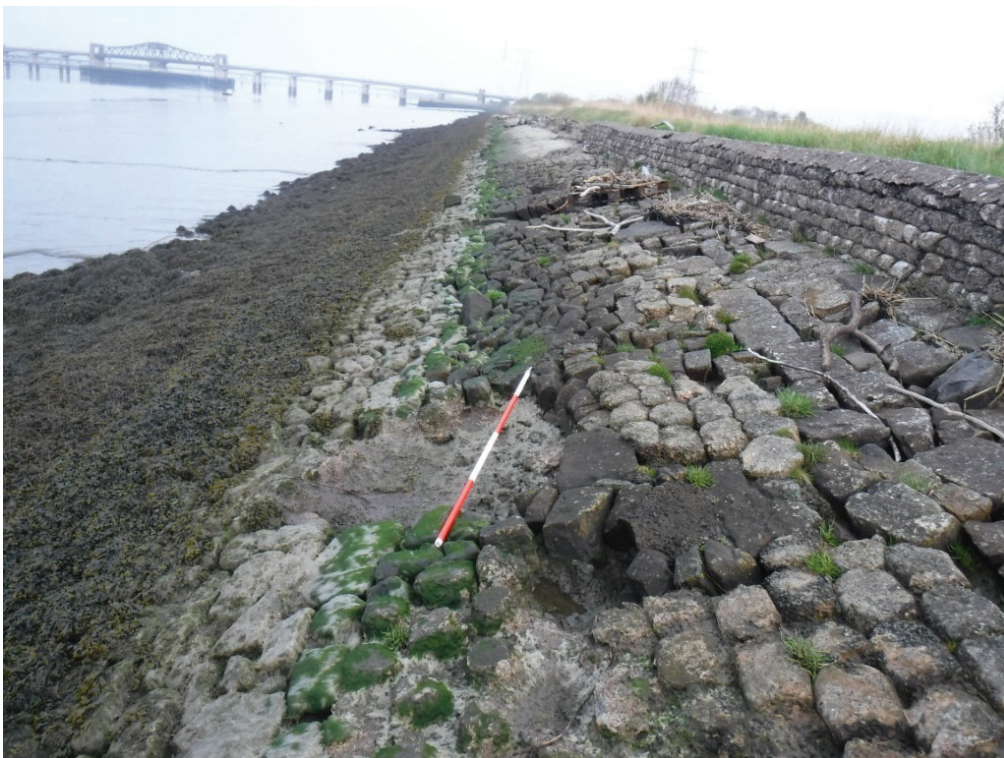
Several voids (approx. 4m width) were noted along the top section of the revetment between 4M 940Y and 4M 951Y (7.2m from running rail) as shown in Photographs 32 and 34.

Photograph 32- Section 3- 4M 940Y- 951Y-View to LM washed out revetment and voids -19.04.19

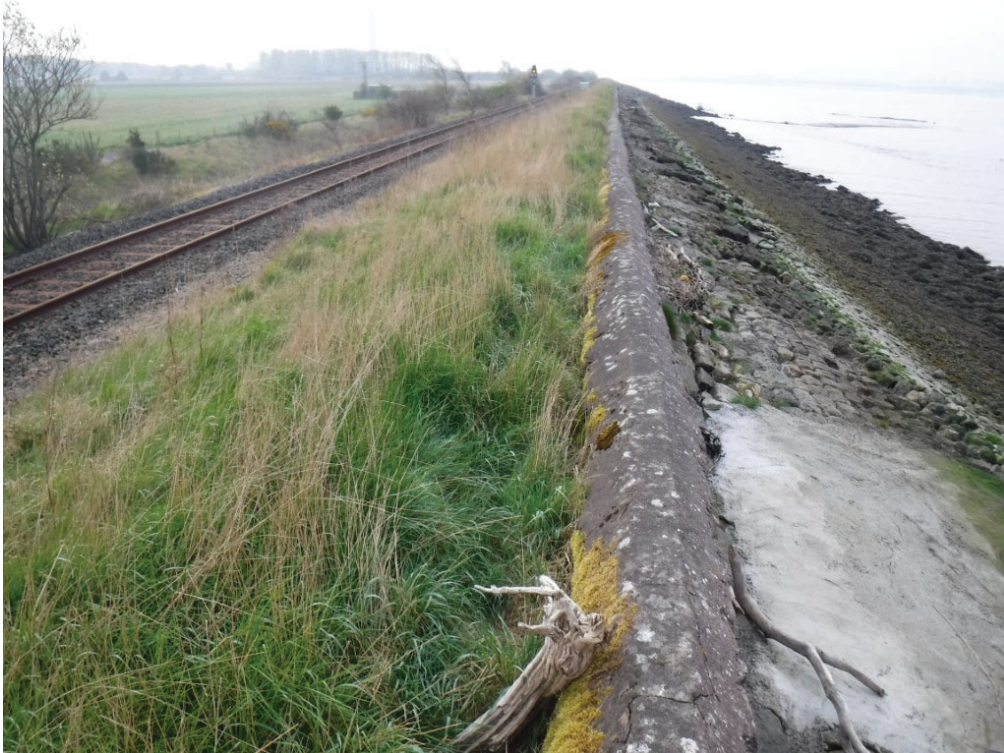
The depression behind the wave return wall noted at 4M 947Y has not deteriorated since last year's examination, as seen in Photograph 33.

Photograph 33 - Section 3- 4M 947Y - Depression behind wall 900mm deep -19.04.19

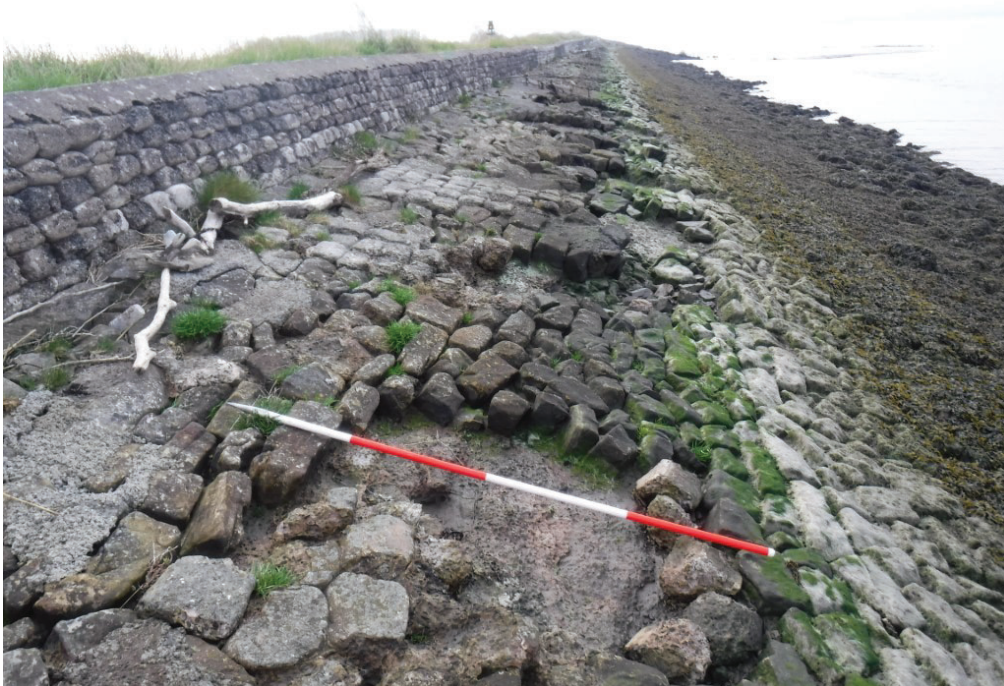
Photograph 34 highlights the revetment at 4M 960Y is showing significant deterioration from washout since last years examination (4 x 2m).

Photograph 34 - Section 3- 4M 960Y - 970Y- Washout of revetment 4x2m deterioration -19.04.19

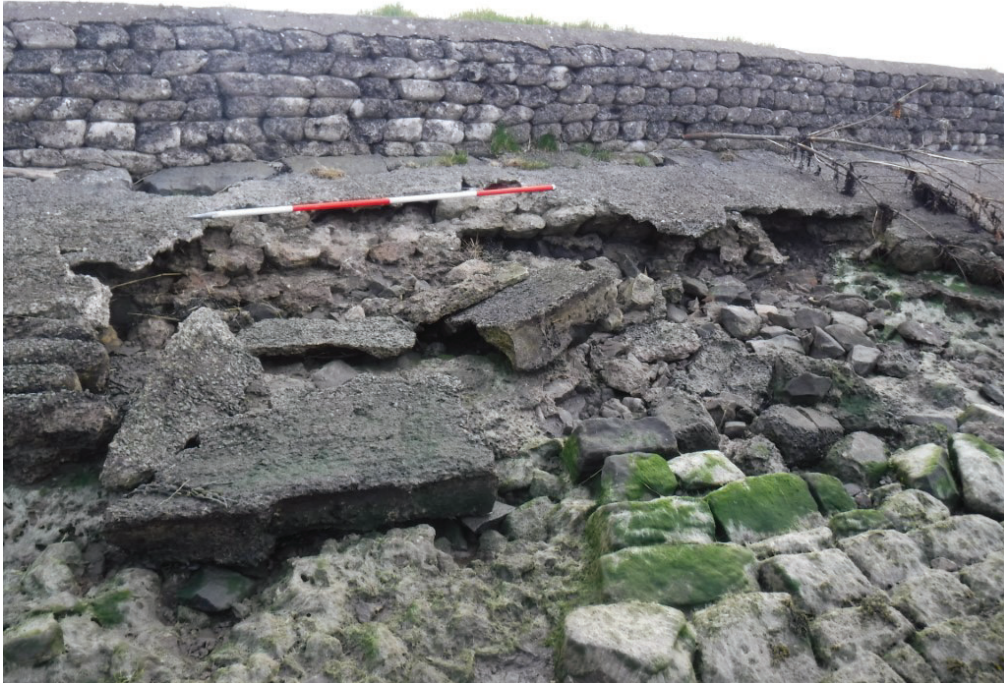
A large area of washout (9.3m x 1.5m x 0.45m) was noted with undercutting from 4M 980Y to 4M 1000Y (approx. 6m from running rail). This washout does not appear to have deteriorated since last year's examination as seen in Photographs 35.

Photograph 35 - Section 3- 4M 980Y - Deteriorated revetment washout -19.04.19

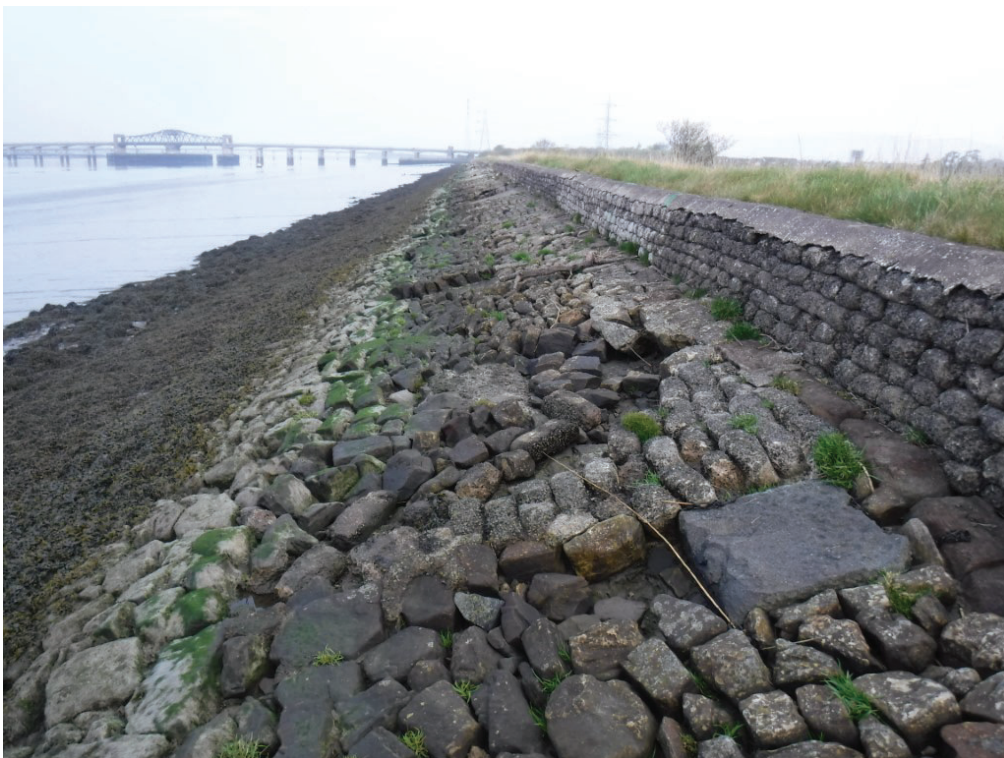
The concrete bag work wave return wall is showing signs of further erosion between 4M 980Y since last year's examination. Photograph 36 shows the typical worsening condition of the concrete bag work and wave return wall to low miles.

Photograph 36 - Section 3- 4M 980Y - Poor condition of revetment washout to low miles -19.04.19

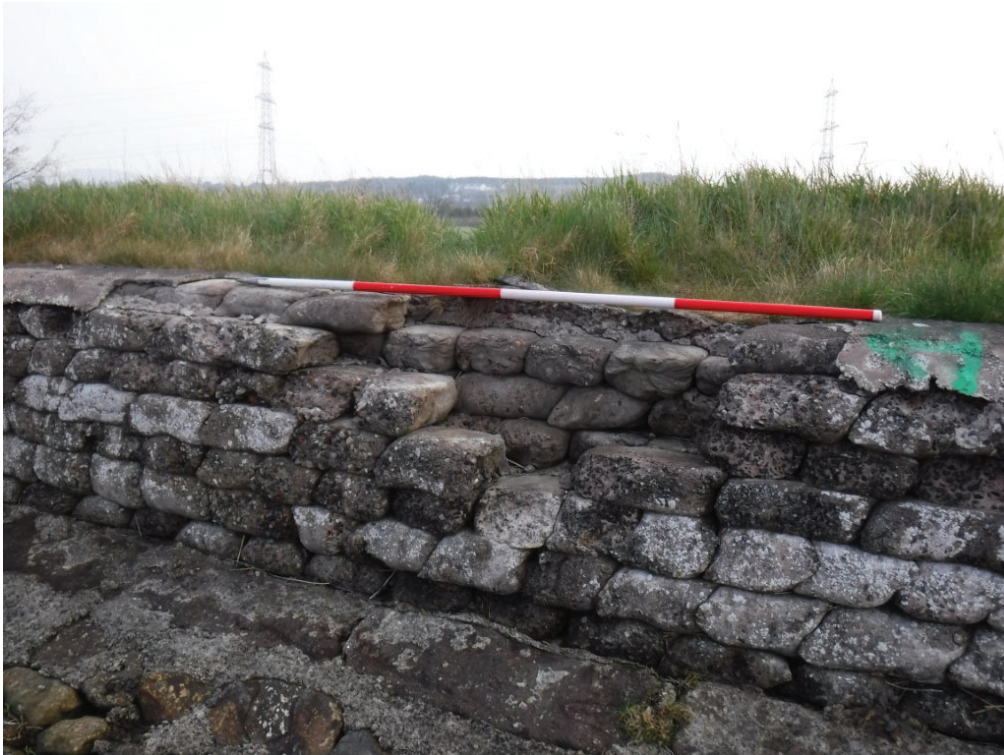
Photograph 37 - Section 3- 4M 1010Y - Washout of sandbag wall, slight deterioration - 19.04.19
