## Retaining Wall Detailed Examination Report

ELR: KNE1

Struc. Ref: 200/561

ELR: KNE1		Contract Mileage: 004m 0240yds 10.91chs			Struc. Ref: 200/561	
Struc. Type	WCE RD	NR ID	11009030	Rpt ID	8909	OS Ref NS92858723
		Exam ID	2940107			
Dimensions	Max Height 4.00m Max Length 2500.00m					Exam Date 19/04/19
Side of Line						Last Detailed 17/05/18
Min dist. from Track	2.30					Last Visual
Line	Kincardine Power Stn - Charlestown Jn (Goods Line)					
Name:	Kincardine on Forth

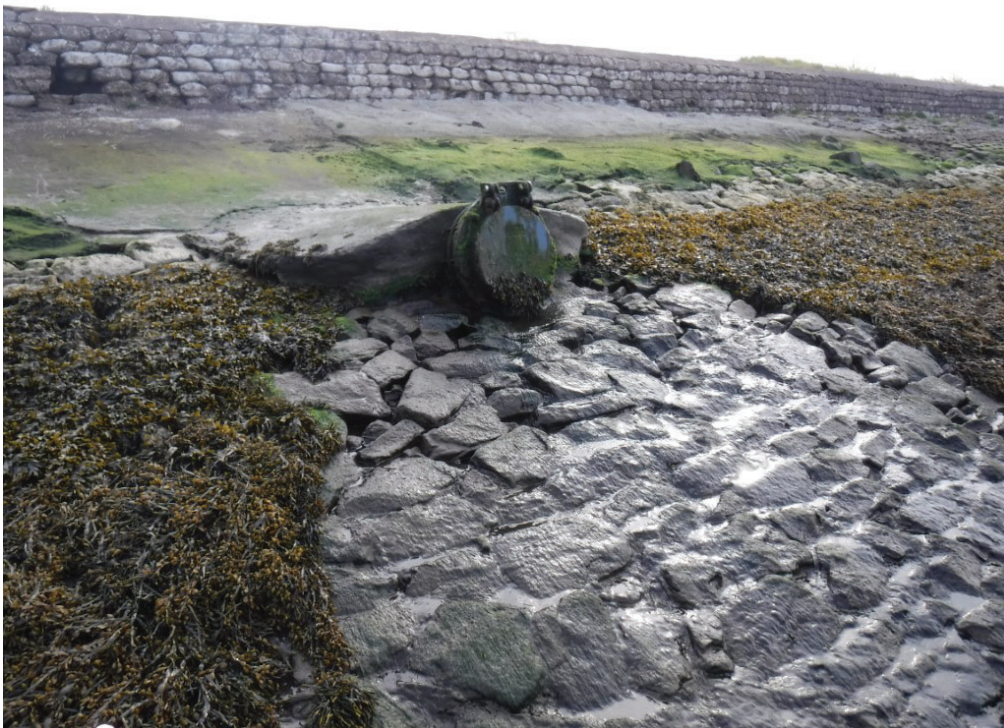
Another culvert was noted at 4M 1114Y. The wave return valve was found to be in good condition as seen in Photograph 40. There is also a large void in the revetment at this mileage (Photograph 41). The void has not deteriorated since last year's examination and the manhole cover is now repaired.

Photograph 40 - Section 3- 4M 1114Y- Wave return valve -19.04.19

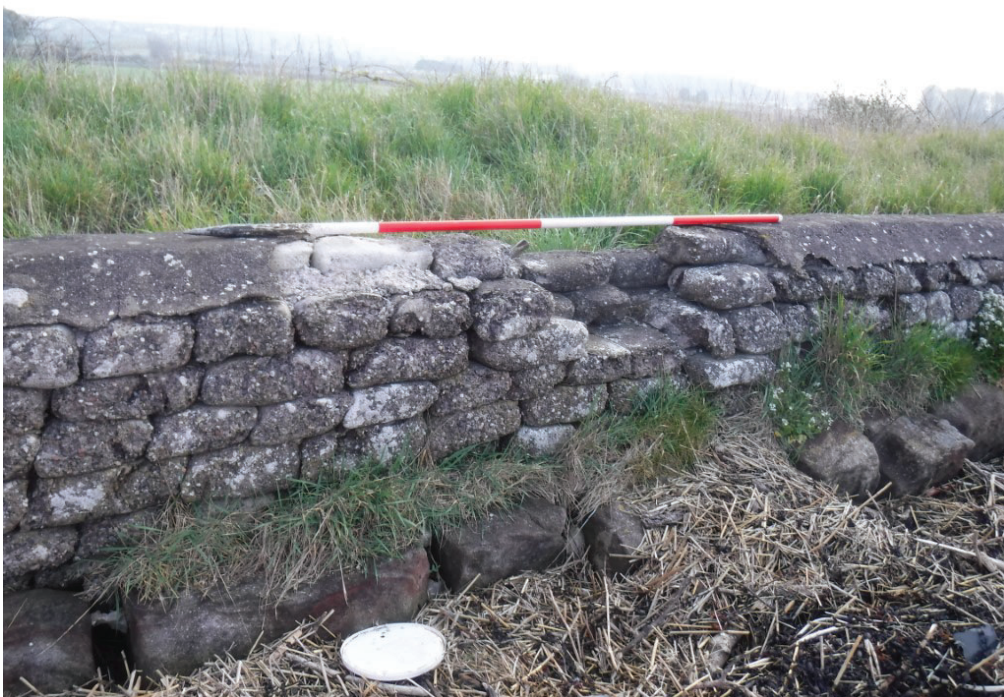
A void was noted in the wave return wall at the crest of the revetment at 4M 1185Y as shown in Photograph 42.

Photograph 42 - Section 3- 4M 1185Y- Void in wave return wall -19.04.19

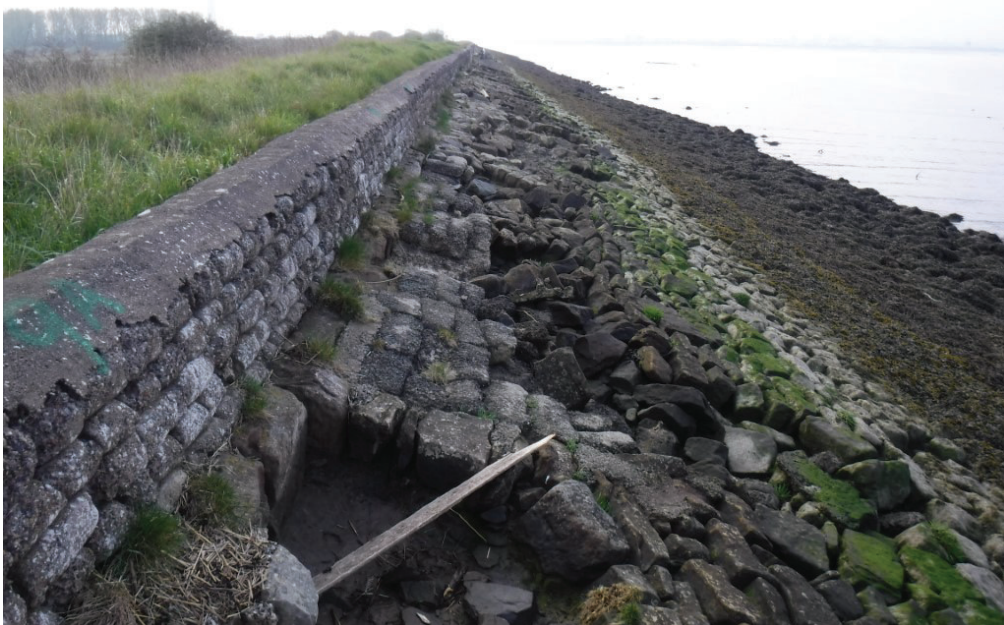
A void (1.9m x 0.8m) noted at 4M 1217Y along the crest of the revetment has deteriorated since last year's examination. Masonry revetment has been washed out as shown in Photograph 44.

Photograph 44 - Section 3 - 4M 1217Y- Missing revetment, no change -19.04.19

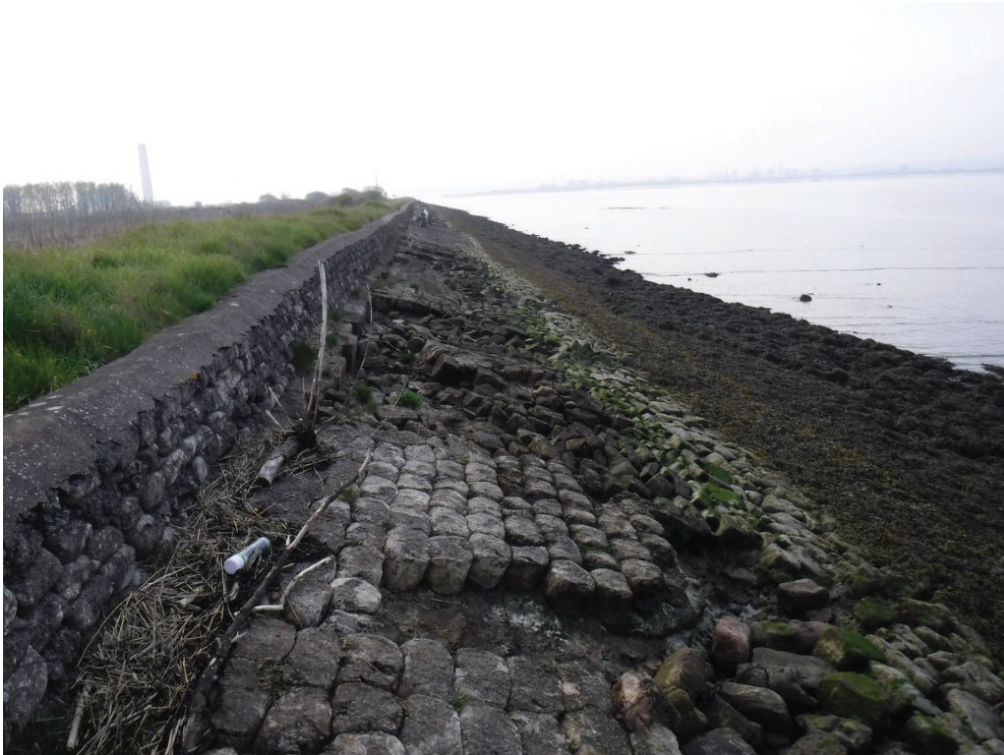
Photograph 45 - Section 3- 4M 1245Y - General view of voids (2) to low miles -19.04.19

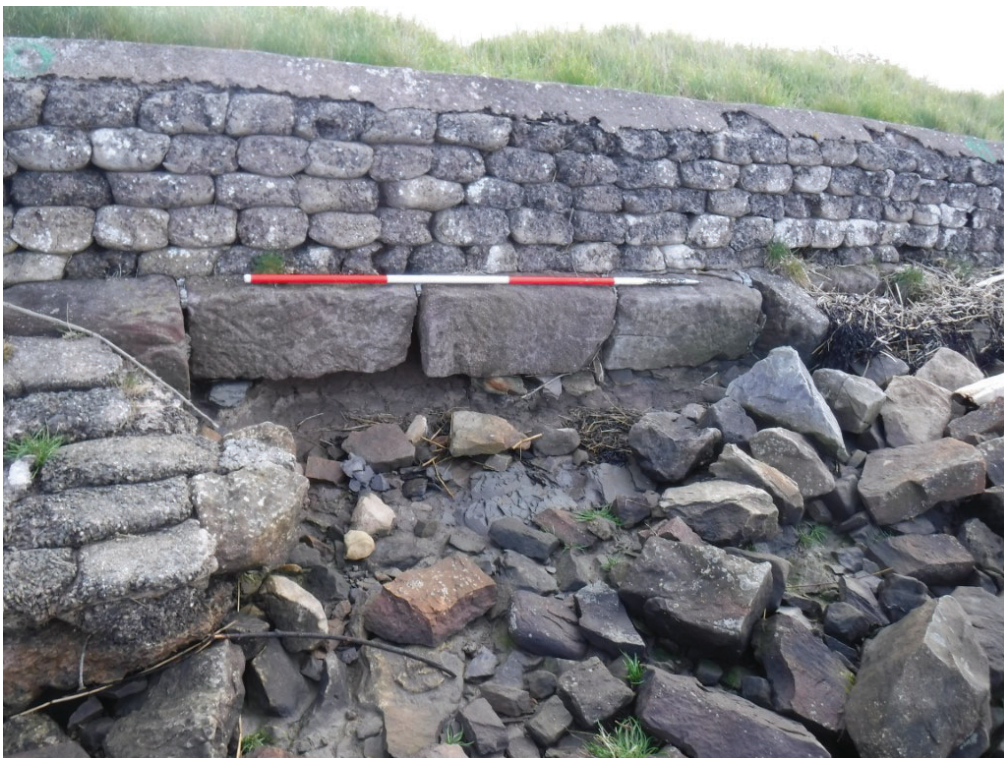
Photograph 46 - Section 3 - 4M 1230Y - General view of void at crest -19.04.19

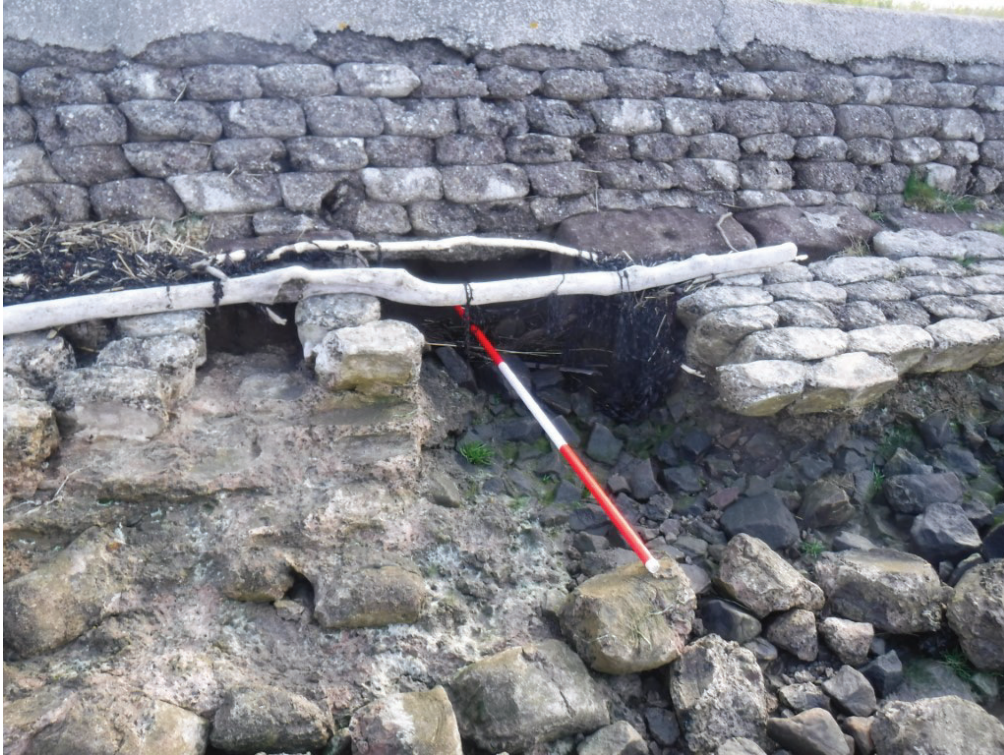
A large void (4m x 5m x 0.5m) noted at 4M 1330Y (6.6m from running rail) does not appear to have deteriorated since last year's examination as shown in Photograph 49.

Photograph 49 - Section 3- 4M 1330Y- Poor condition of revetment 0.5m deep -19.04.19

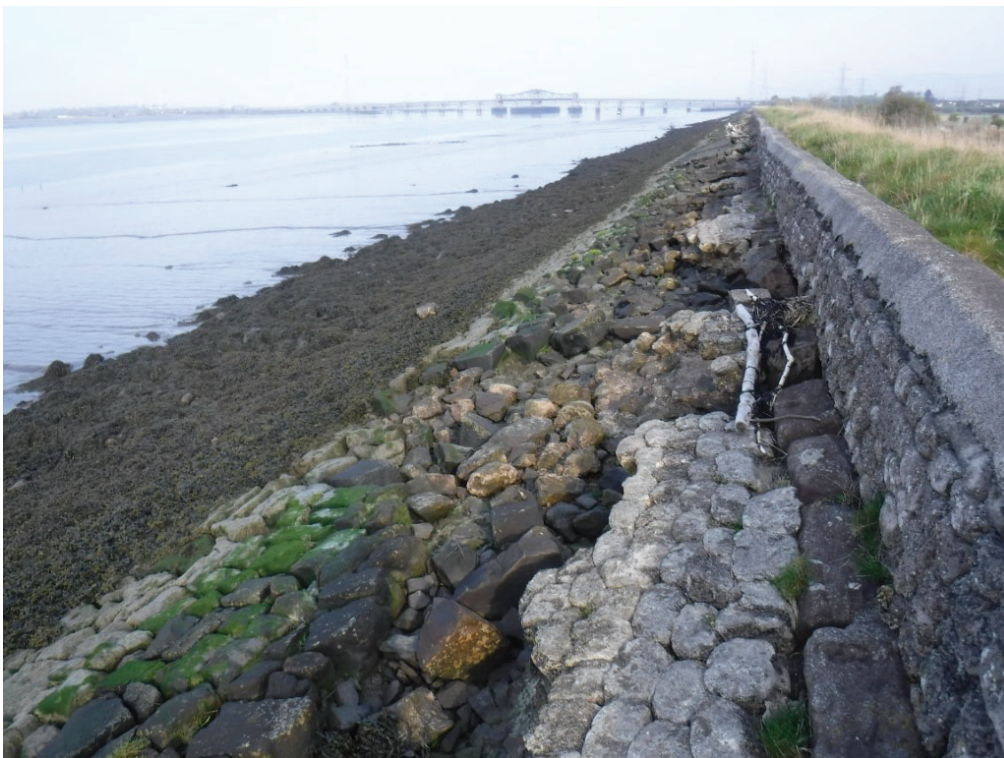
Several voids and areas of washout (approx. 6.6m from running rail) were noted in the revetment between 4M 1295Y and 4M 1367Y. These areas appear to have deteriorated slightly with further bag work and masonry being washed out. The typical condition can be seen in Photographs 50.

Photograph 50 - Section 3- 4M 1295Y to 1367Y- Poor condition of revetment to low miles - 19.04.19

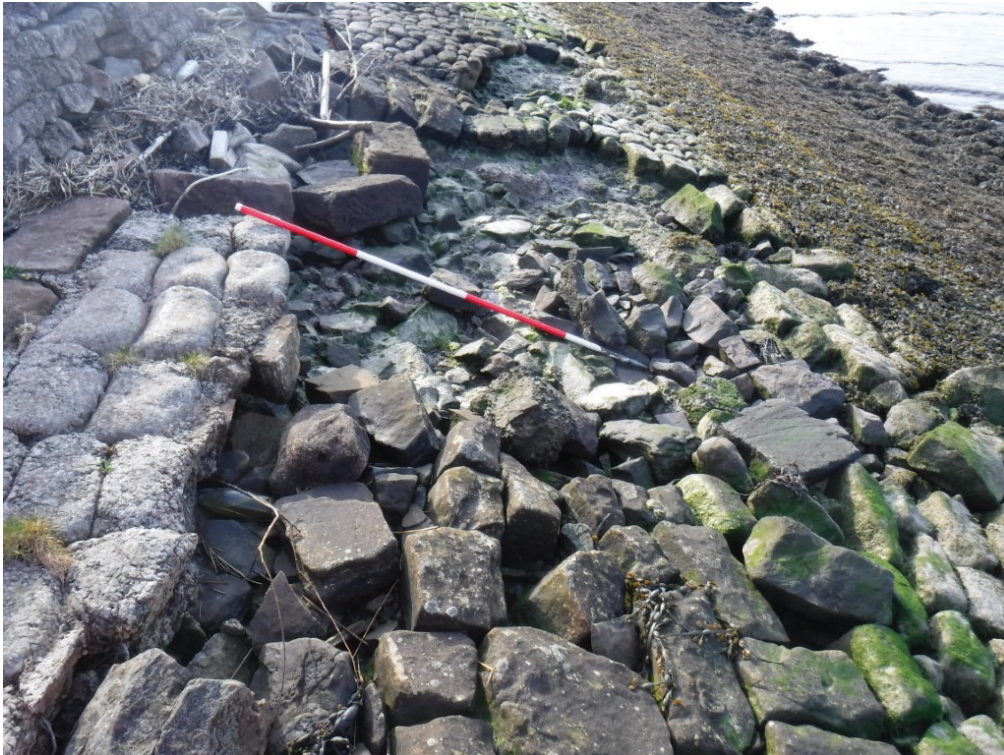
A large void (3.5m x 3.5m x 0.5m) noted at 4M 1425Y (approx. 6.4m from running rail) appears to have deteriorated slightly since last year's examination as seen in Photograph 51. Masonry revetment stones have

Photograph 51 - Section 3- 4M 1425Y- Void and undermining of wave return wall-19.04.19

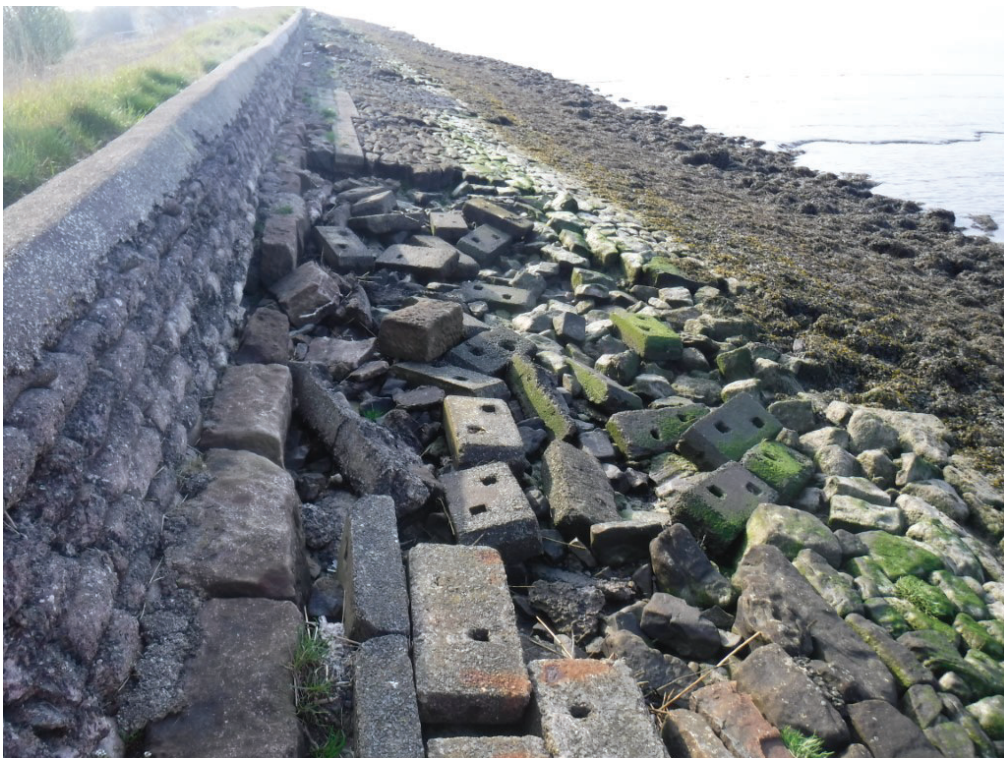
A large void (8.4m x 4.2m x 0.5m) noted at 4M 1465Y (approx. 6.4m from running rail) does not appear to have deteriorated since last year's examination as seen in Photograph 52.

Photograph 52 - Section 3- 4M 1465Y- Missing masonry -19.04.19

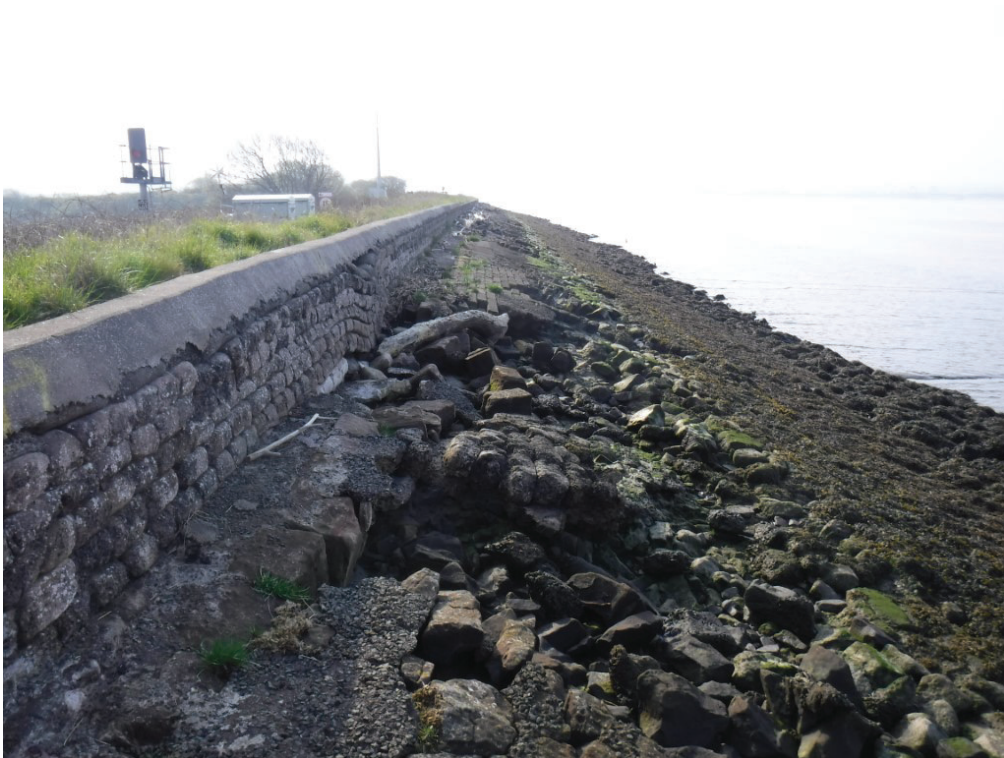
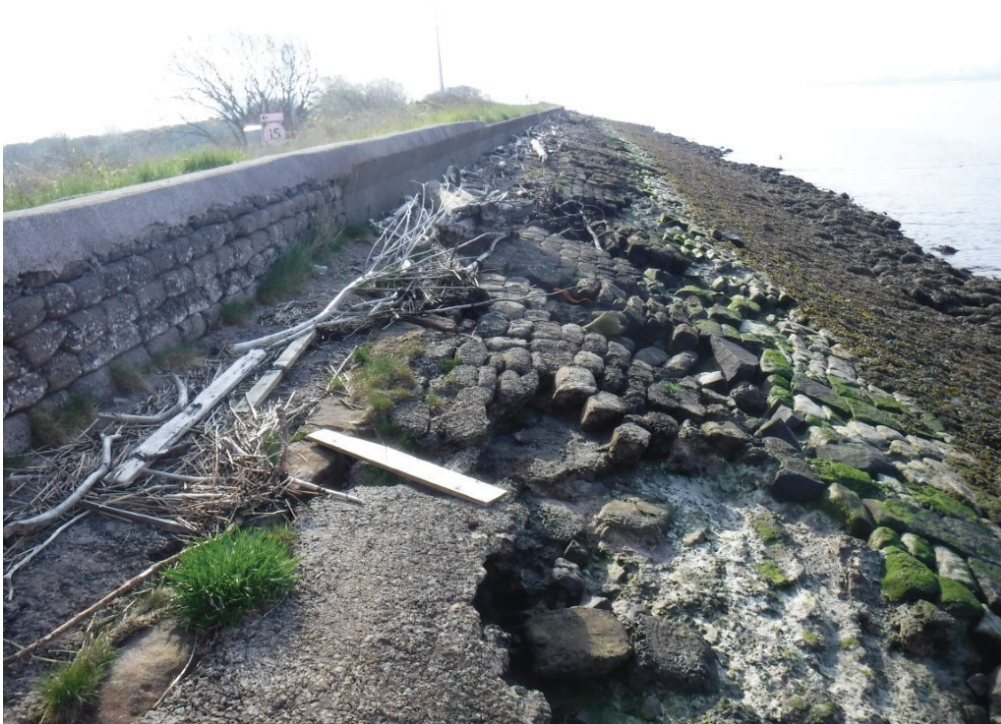
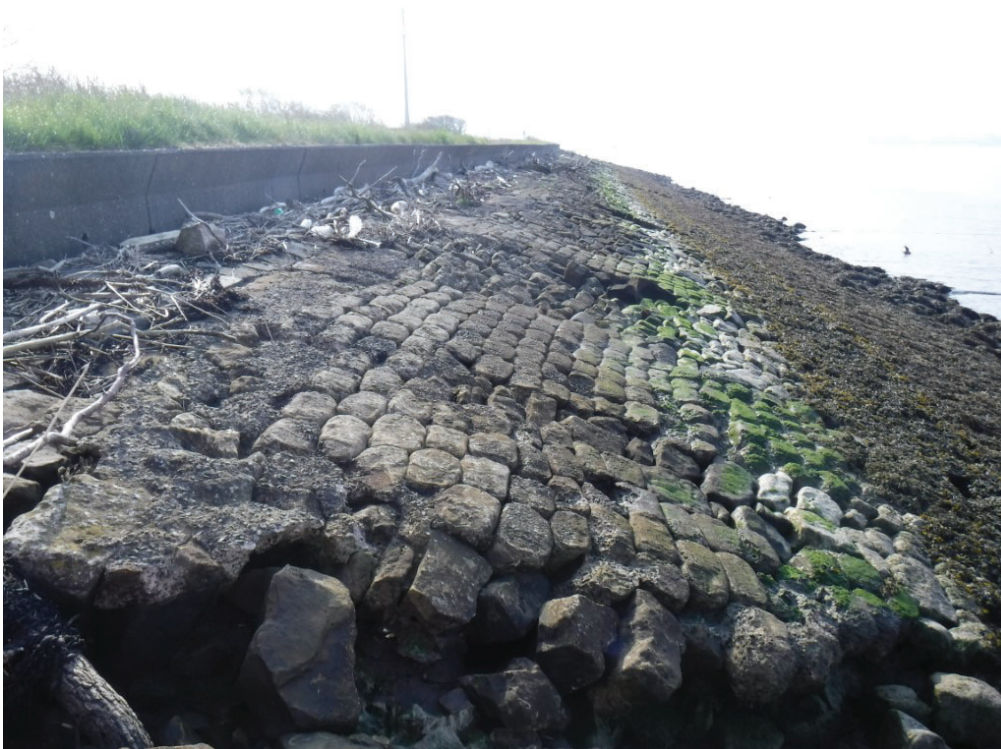
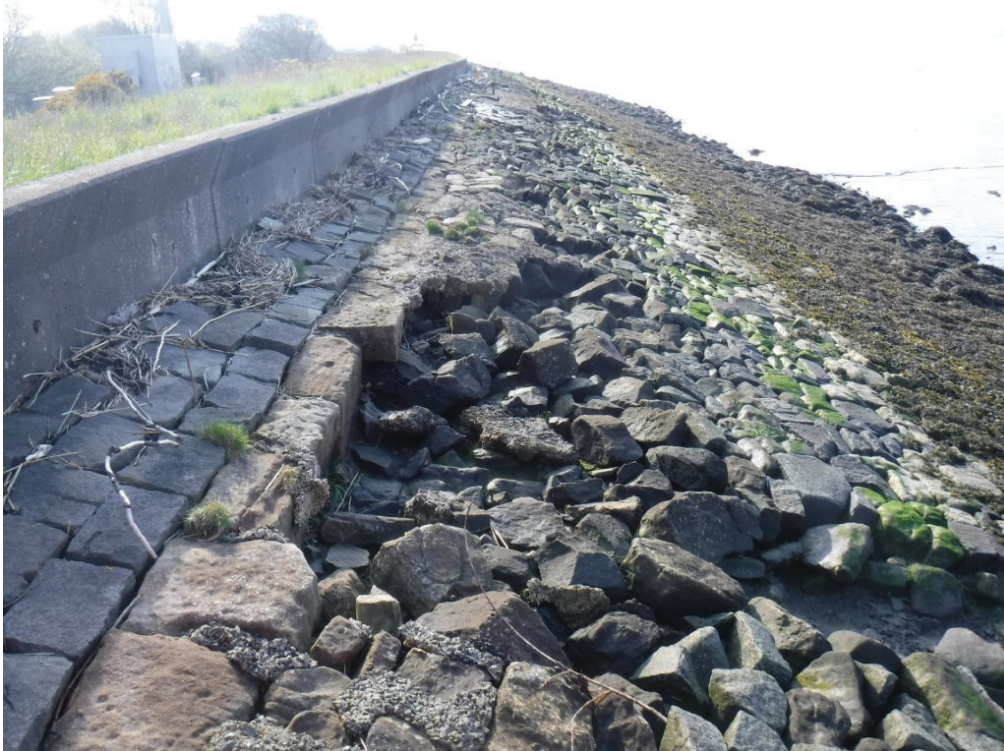
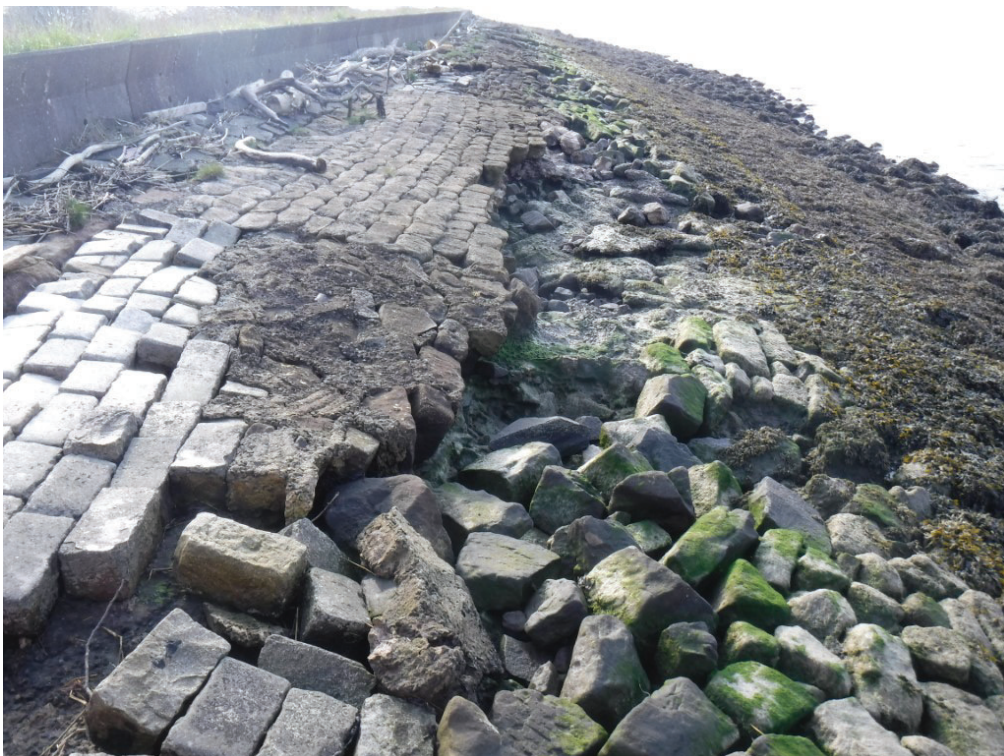
The revetment between mileage 4M 1510Y and 4M 1720Y is showing signs of widespread deterioration to voids and washout which can be seen in Photographs 53 to 58.

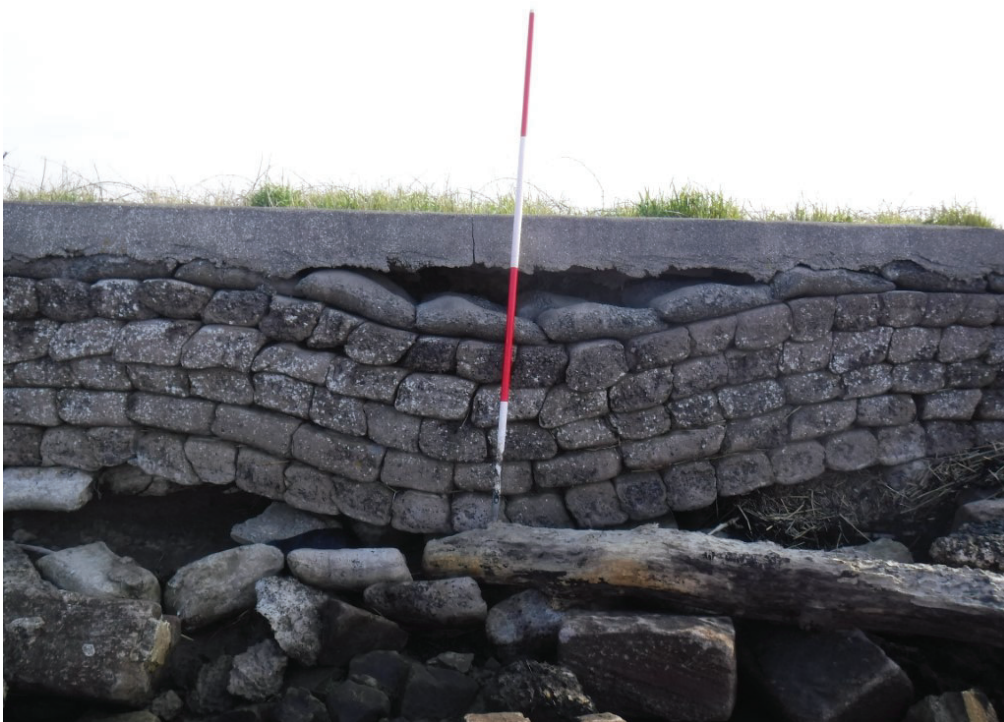
Photograph 54 - Section 3- 4M 1520Y- Undermined retaining wall & collapse of sand bags -19.04.19

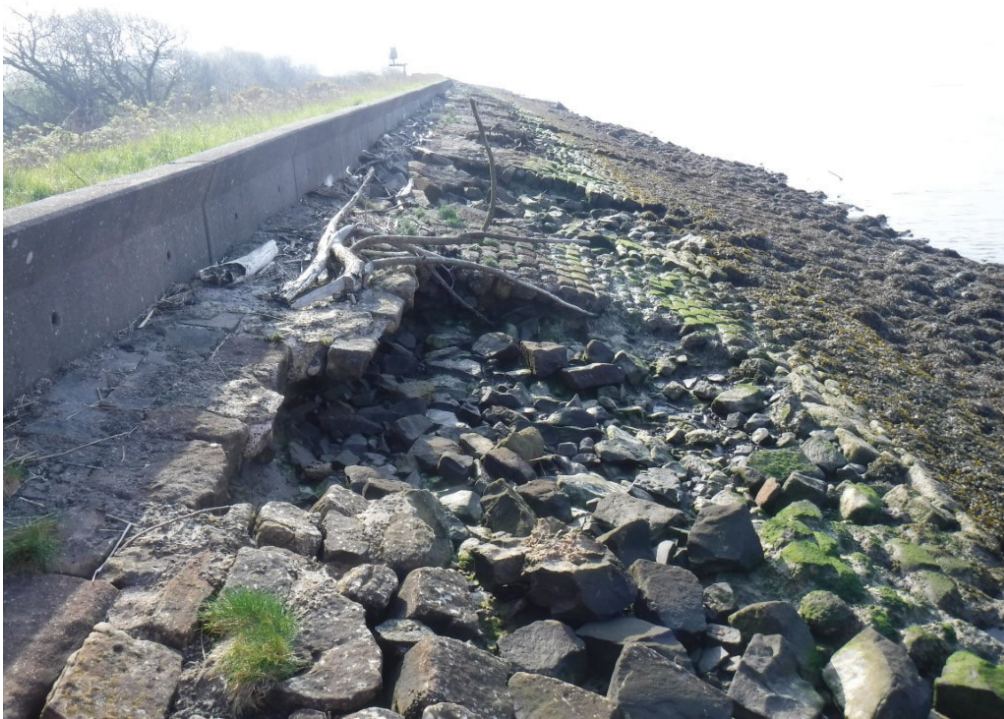
A large void (10m x 4m x 0.5m) noted at 5M 0005Y has not deteriorated since last year's examination as shown in Photograph 59.

Photograph 59 - Section 3- 5M 05Y- Large void in revetment -19.04.19

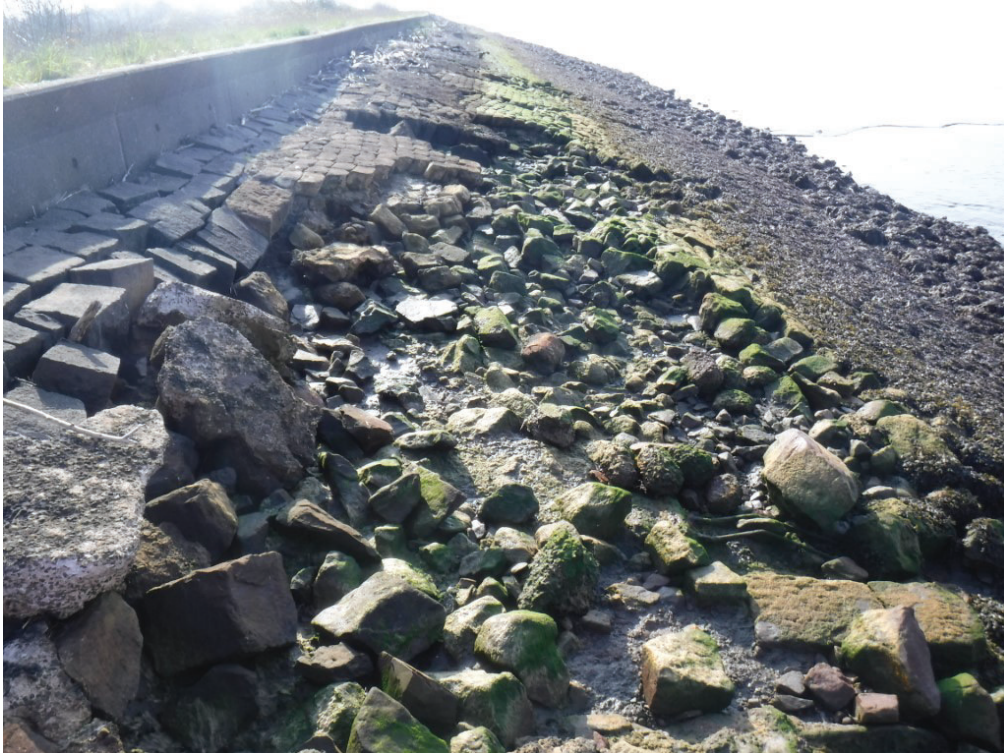
A large void (12m x 6.5m x 0.5m) noted at 5M 65Y (5m from running rail) has deteriorated since last year's examination (Photograph 61).

Photograph 61 - Section 3- 5M 65Y- Void at crest of pipe -19.04.19

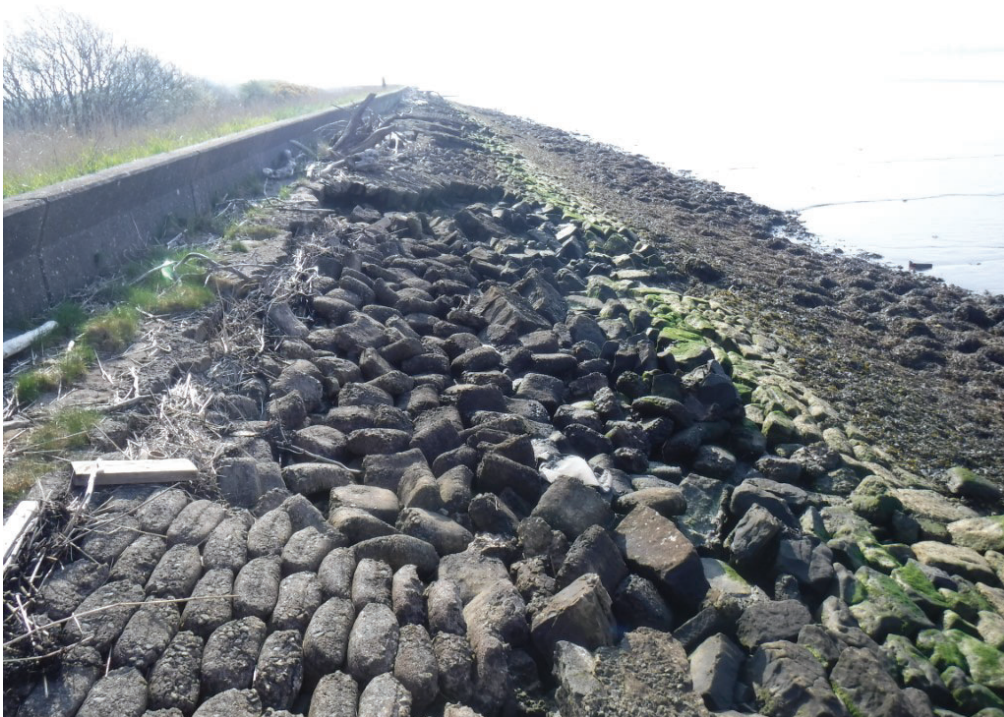
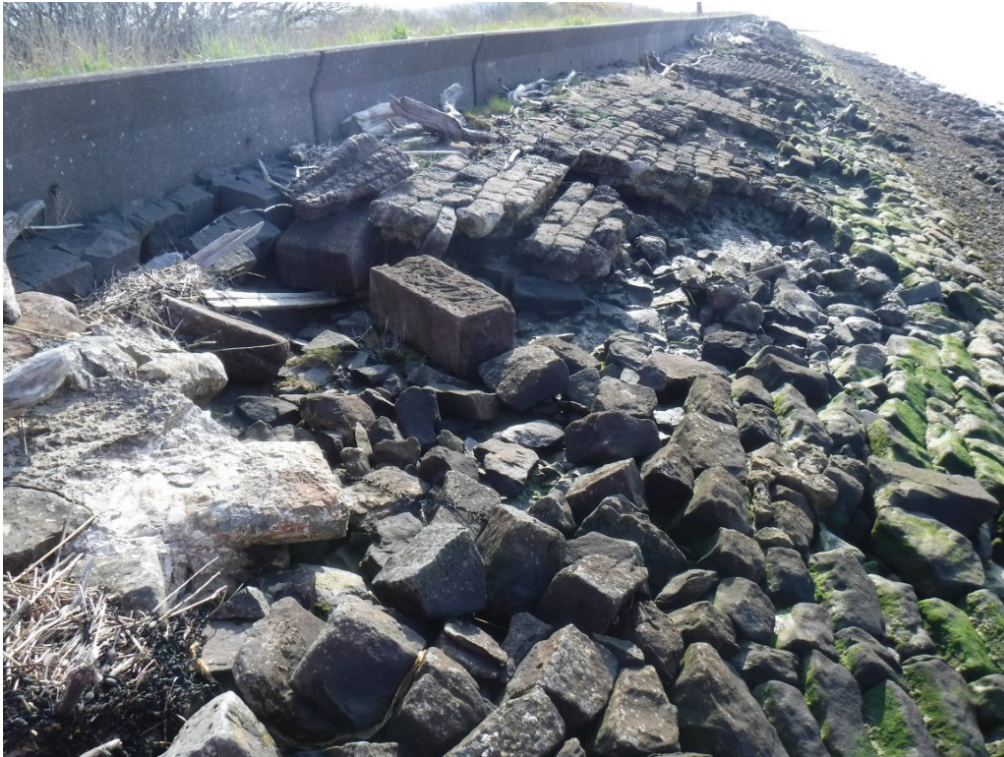
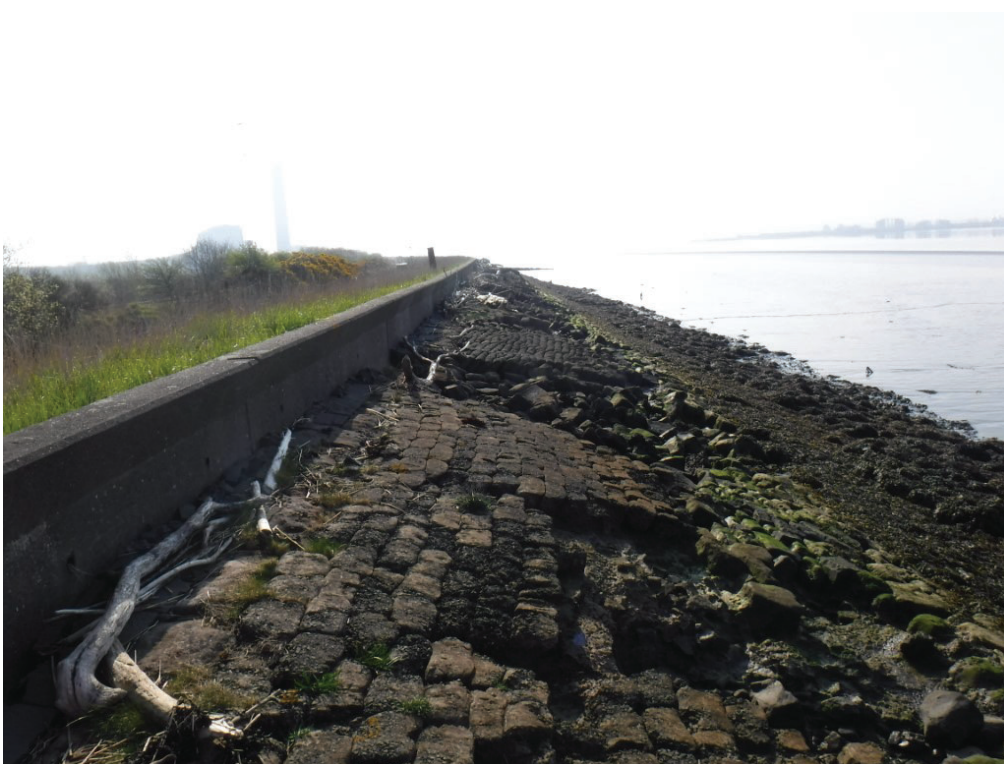
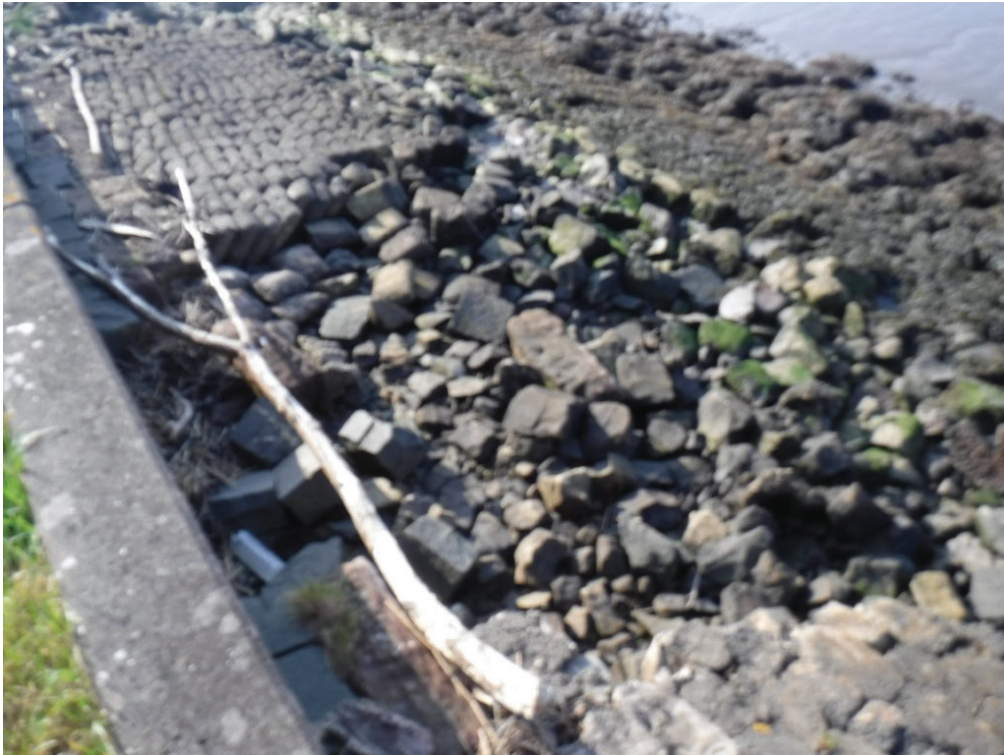
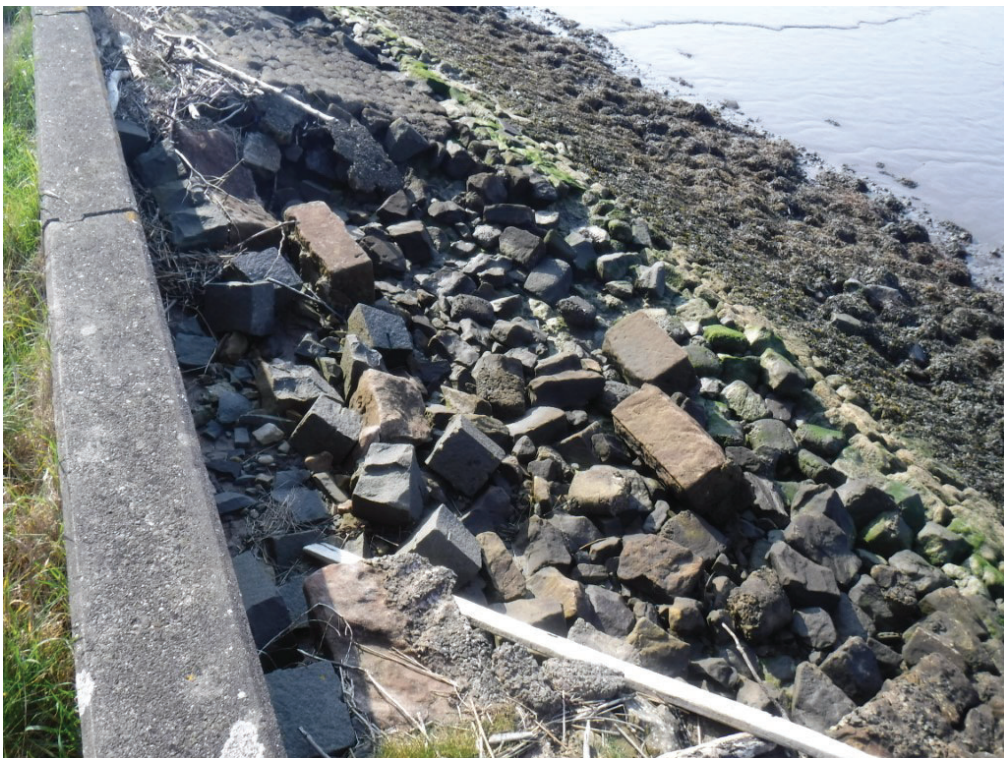
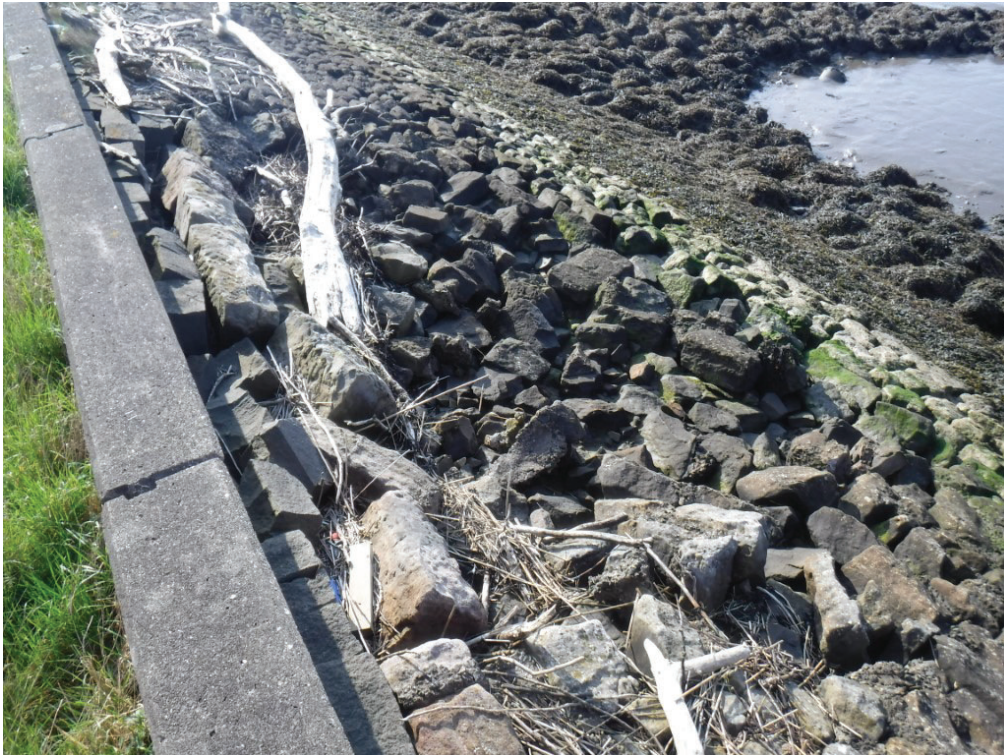
The revetment between mileage 5M 0300Y and 5M 0415Y includes areas of widespread voiding and washout. The typical condition of the revetment is shown in Photographs 62 to 67.

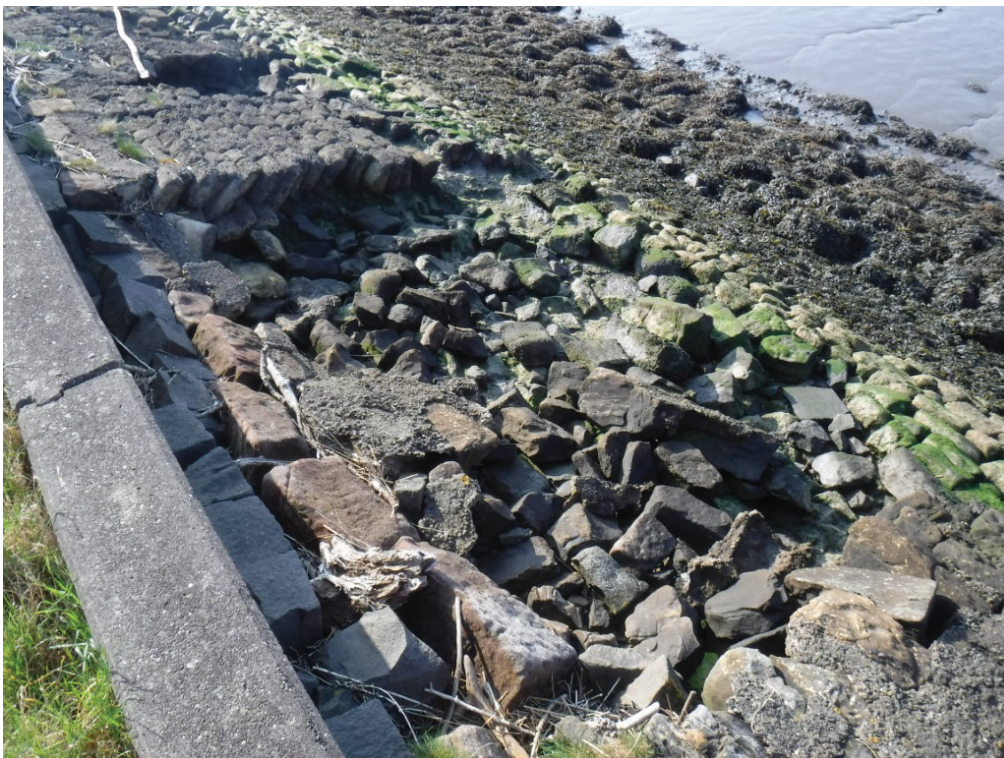
Photograph 68 - Section 3- 5M 403Y - Washout -19.04.19

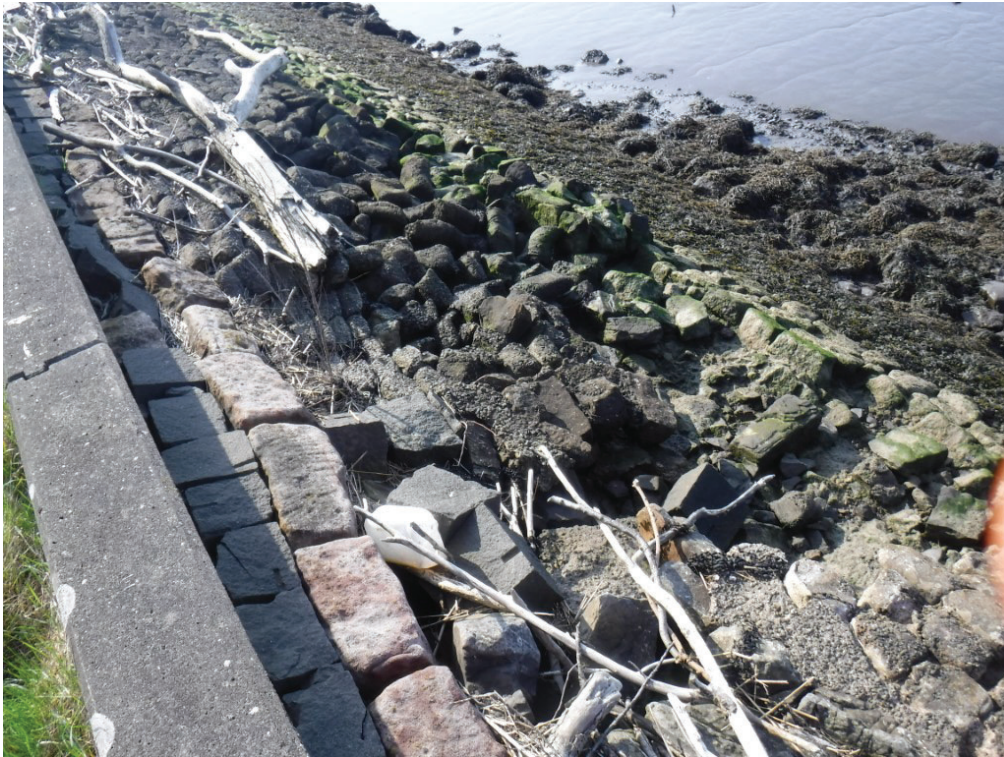
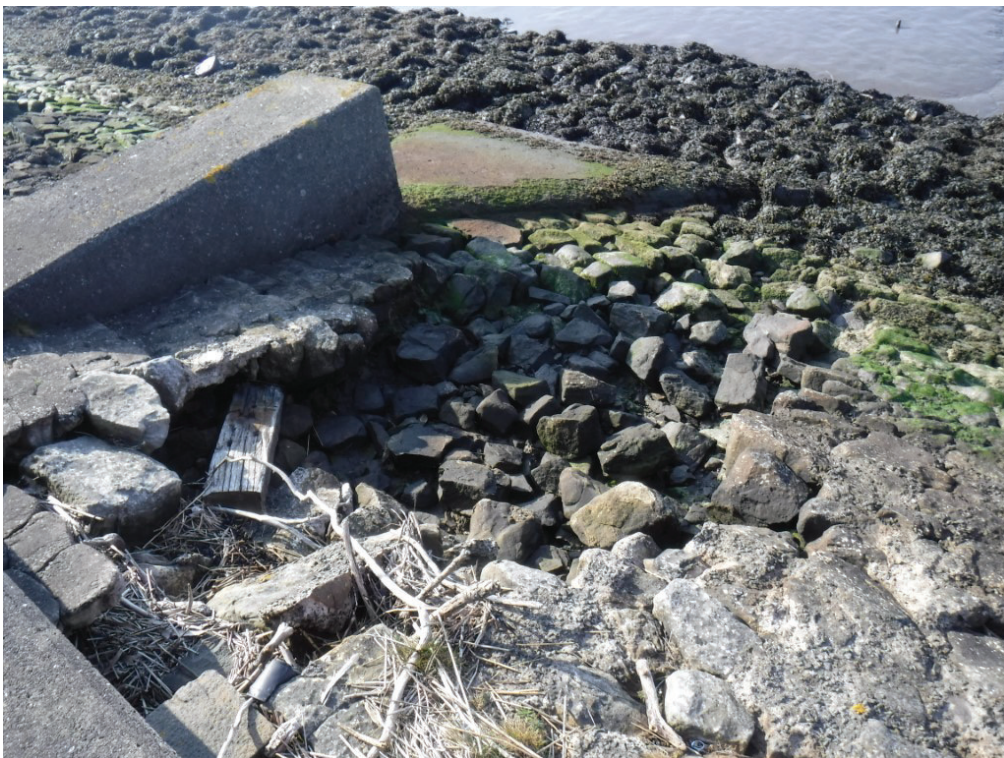
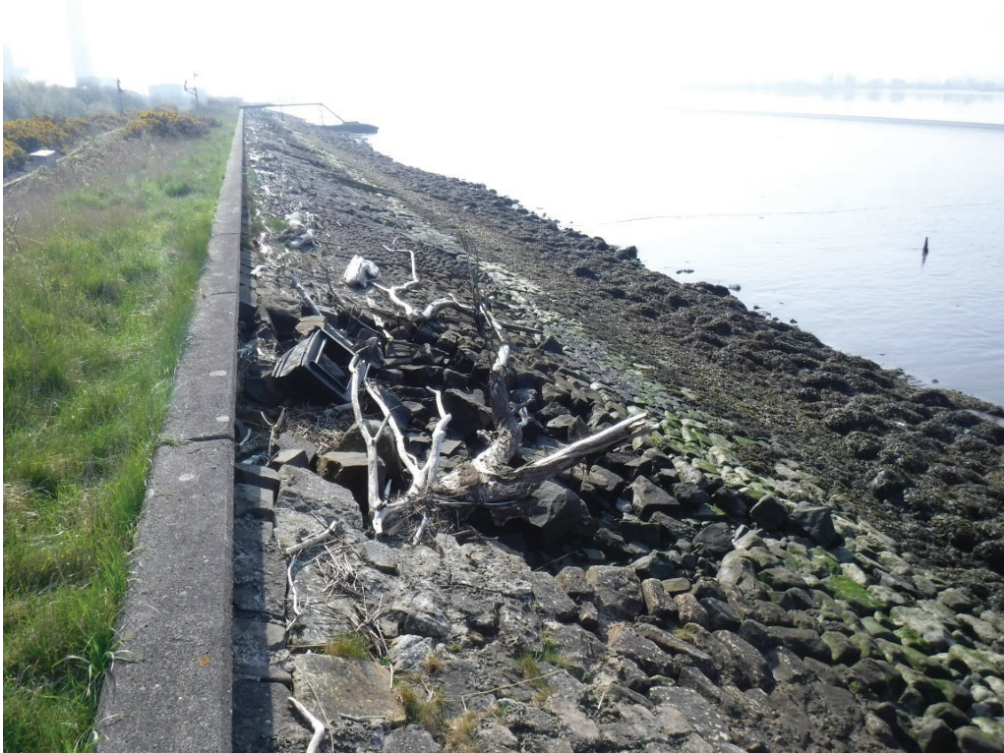
The revetment between mileage 5M 0675Y and 5M 0875Y showed widespread voids and washout. Generally, the voids have not visibly worsened since the previous year's examination. The typical poor condition of the revetment is shown in Photographs 69 to 72.

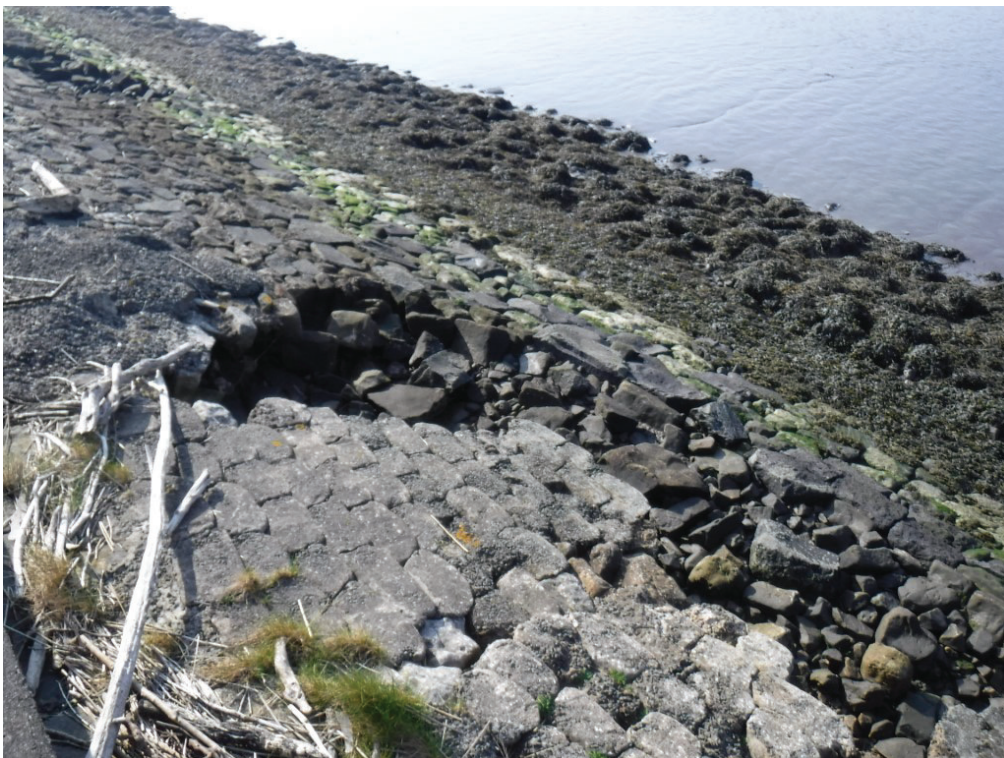
On the low mileage side of the culvert at 5M 675Y there is a large void in the revetment (Photograph 72). There has been a slight deterioration since the previous examination.

Photograph 72 - Section 3- 5M 675Y to 875Y- Poor condition of section (2)-19.04.19

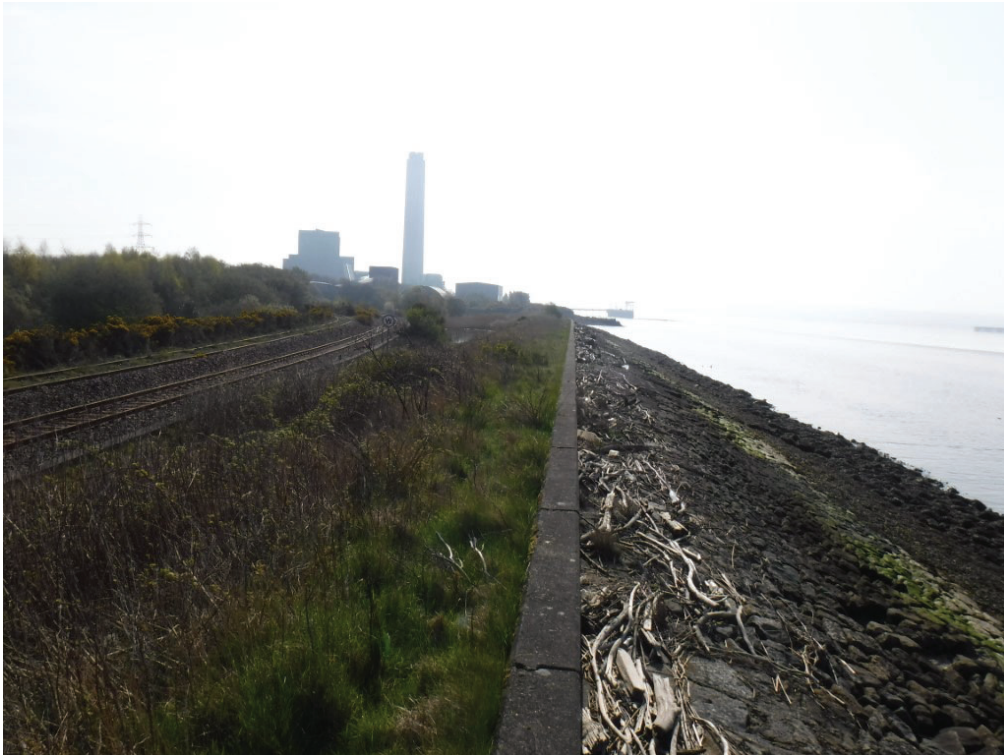
Photograph 73 - Section 3- 5M 1000Y- Water on the landward side of the defence -19.04.19
