## NETWORK RAIL BRIDGE & STRUCTURE UNDERWATER EXAMINATION REPORT

ELR:	GSW	Structure No. 161/343	Mileage: 106 M	1481 YDS	67.32 CH
Exam Date:	14/09/20	Route:	Gretna - Glasgow Central (Via Beatock)		
Group:	BU	OS Ref:	NY1870 6632	N° of Spans:	7
Structure Name:	Annan Viaduct

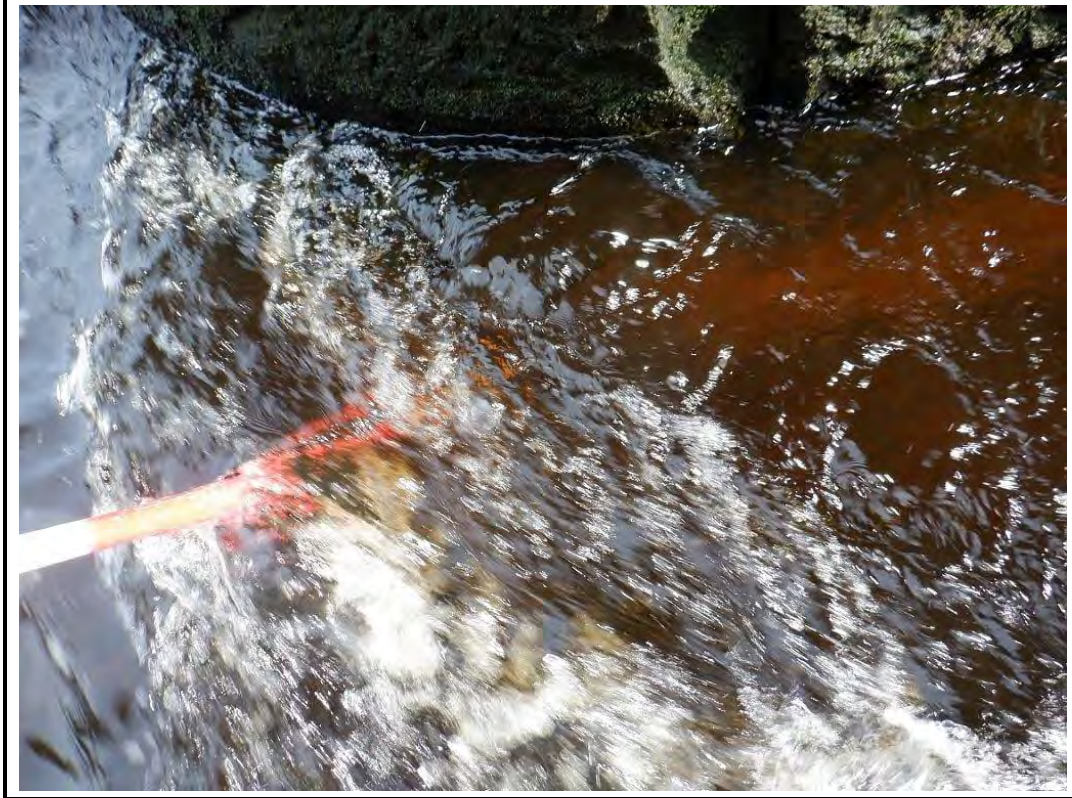
**PHOTO 5: P5 - DAMAGED GABIONS 14/09/20**

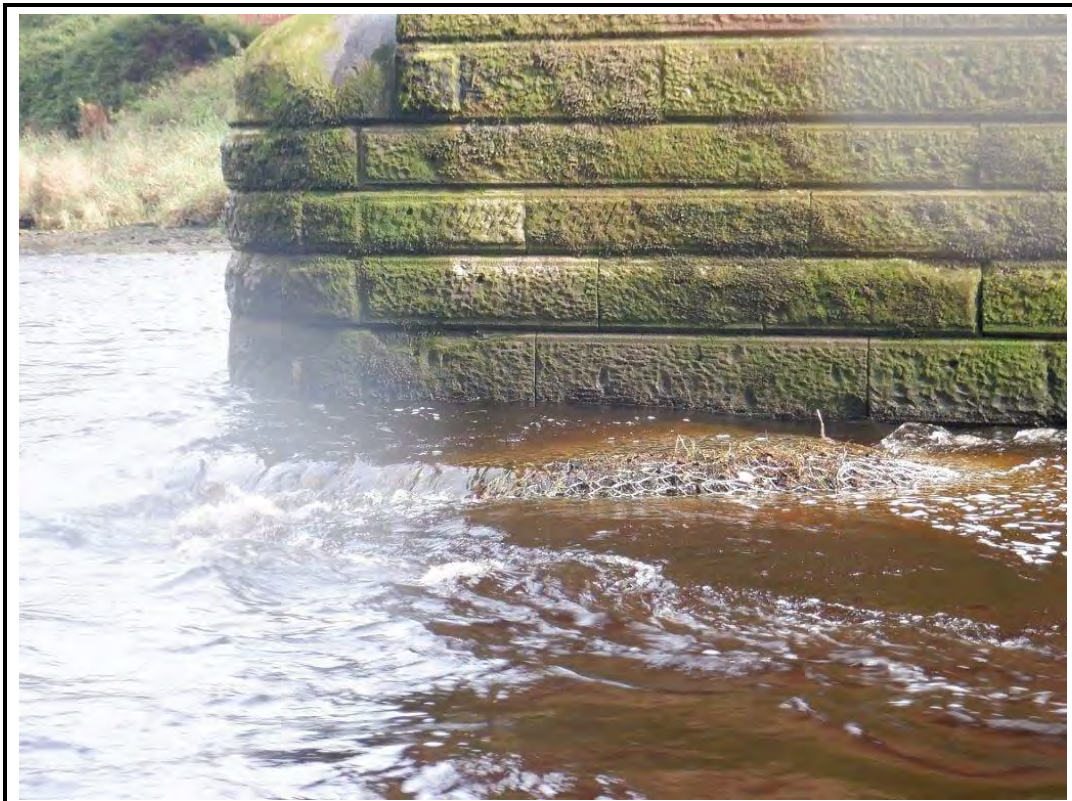
**PHOTO 6: P6- PIER 3 DAMAGED GABIONS 14/09/20**

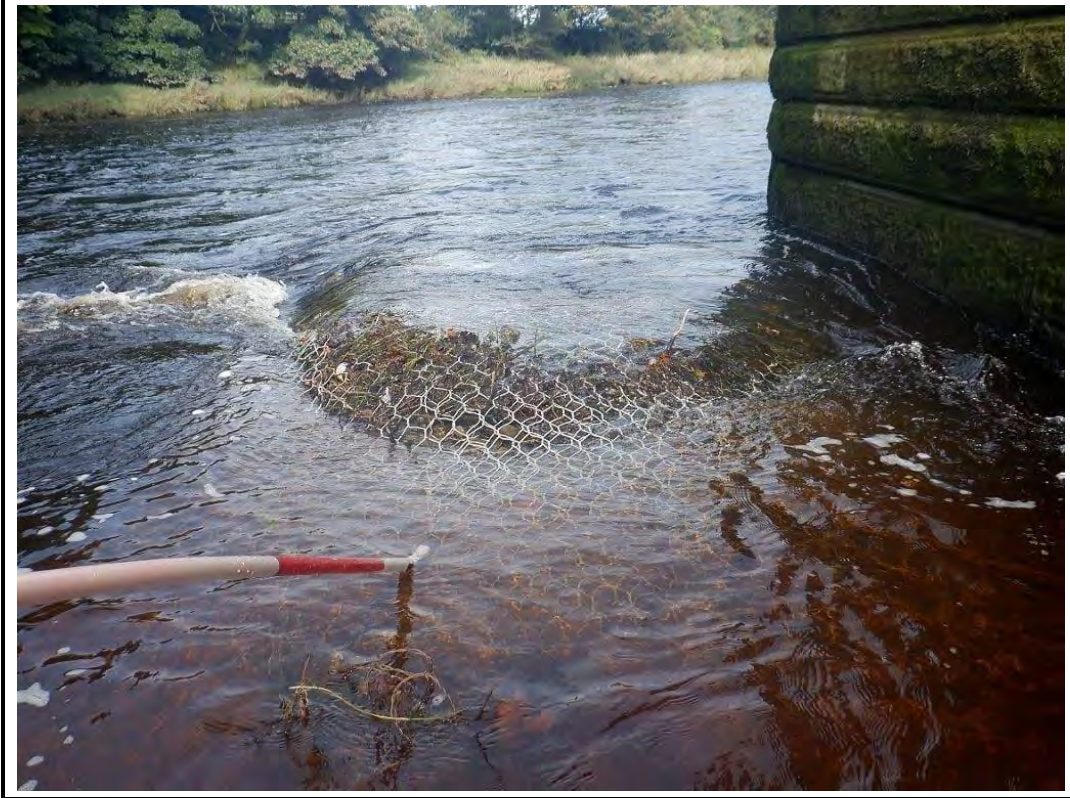
**PHOTO 7: P7- PIER 3 DAMAGED GABIONS 14/09/20**

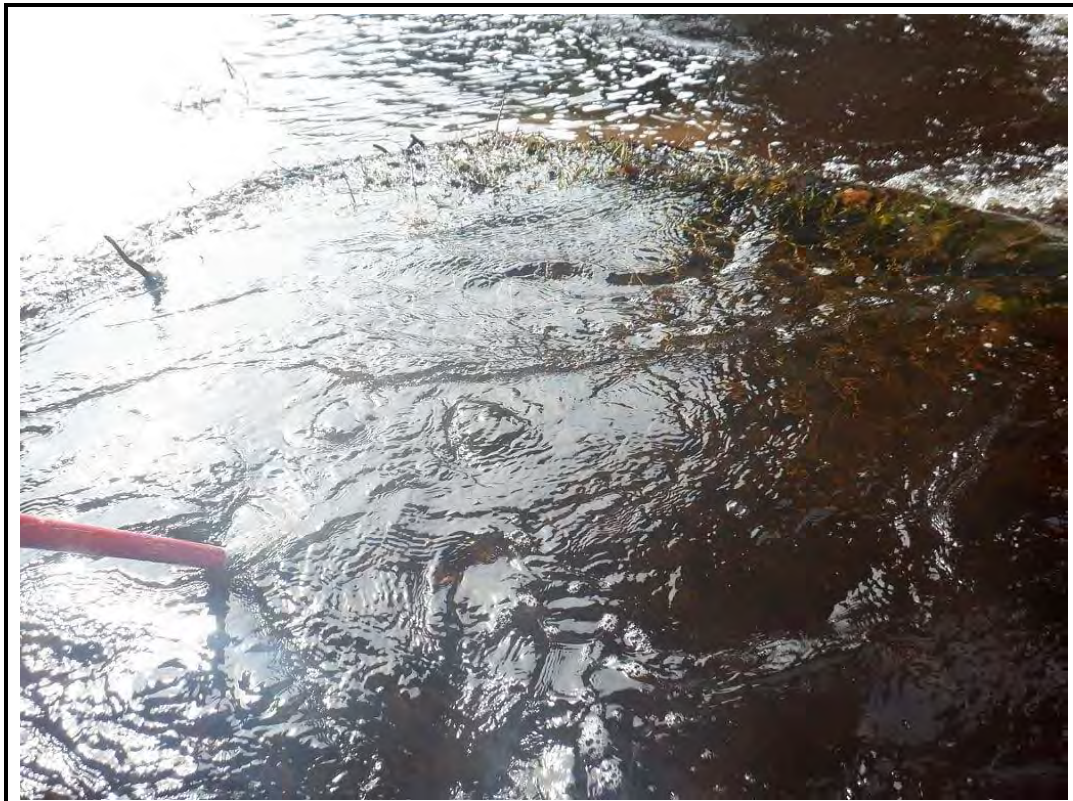
**PHOTO 8: P8- PIER 3 DAMAGED GABIONS 14/09/20**

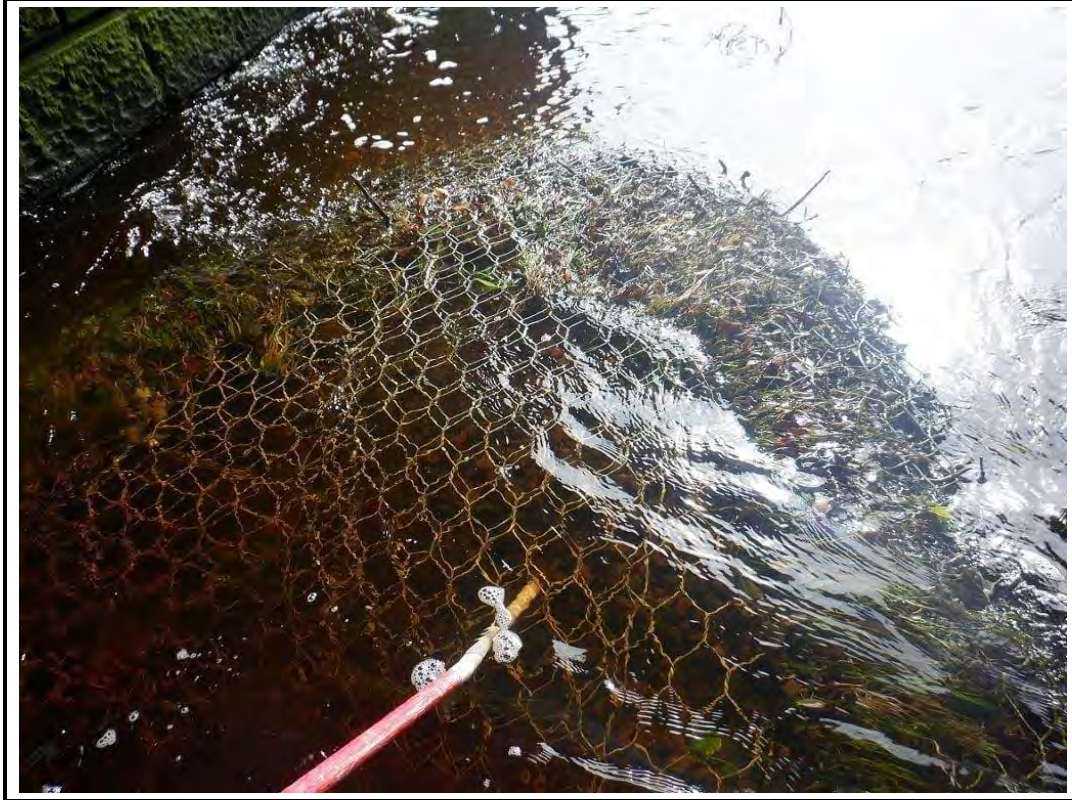
**PHOTO 9:** P9- PIER 3 DAMAGED GABIONS 14/09/20

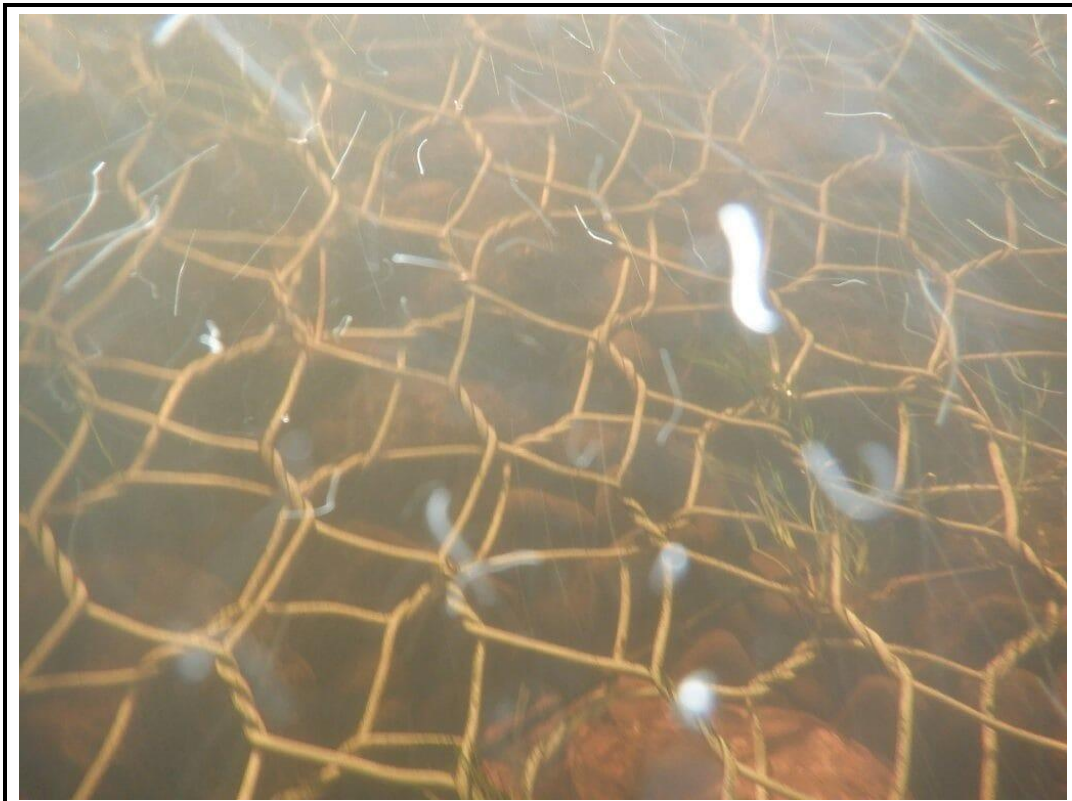
**PHOTO 10:** P10- PIER 3 DAMAGED GABIONS 14/09/20

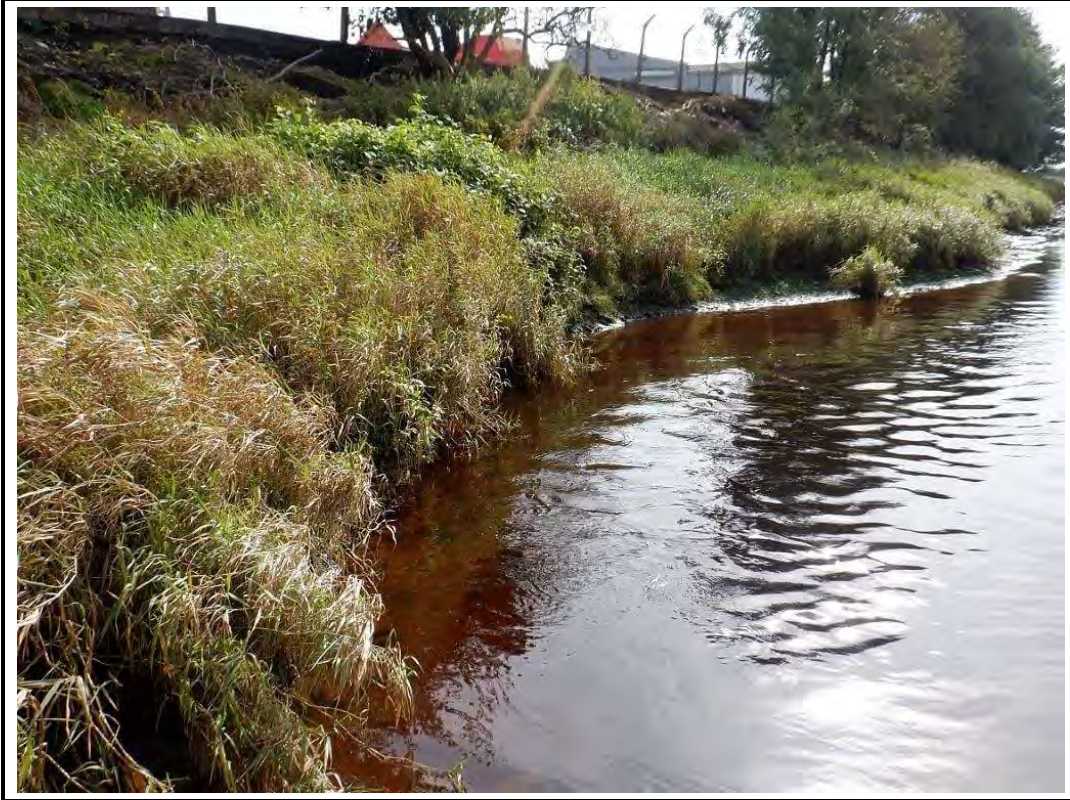
**PHOTO 11:** P11 - EROSION DOWNSTREAM HIGH MILEAGE 14/09/20

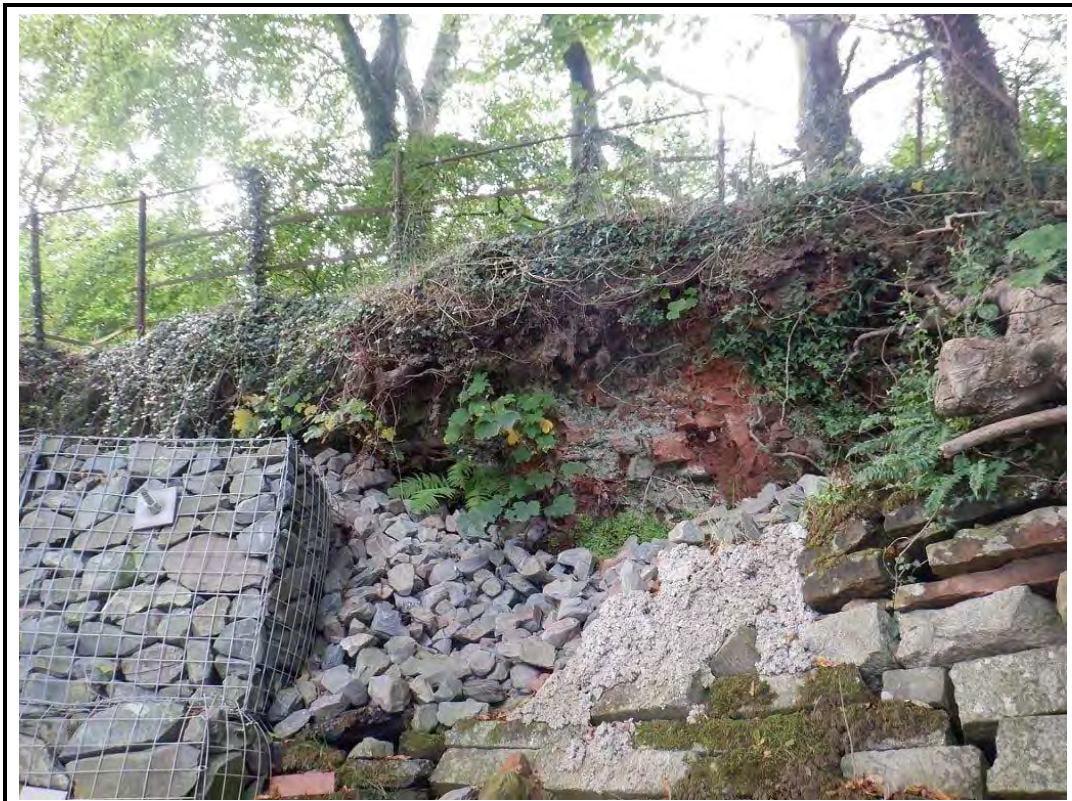
**PHOTO 12:** P12 - EROSION UPSTREAM LOW MILEAGE AFTER THE GABION BASKETS 14/09/20

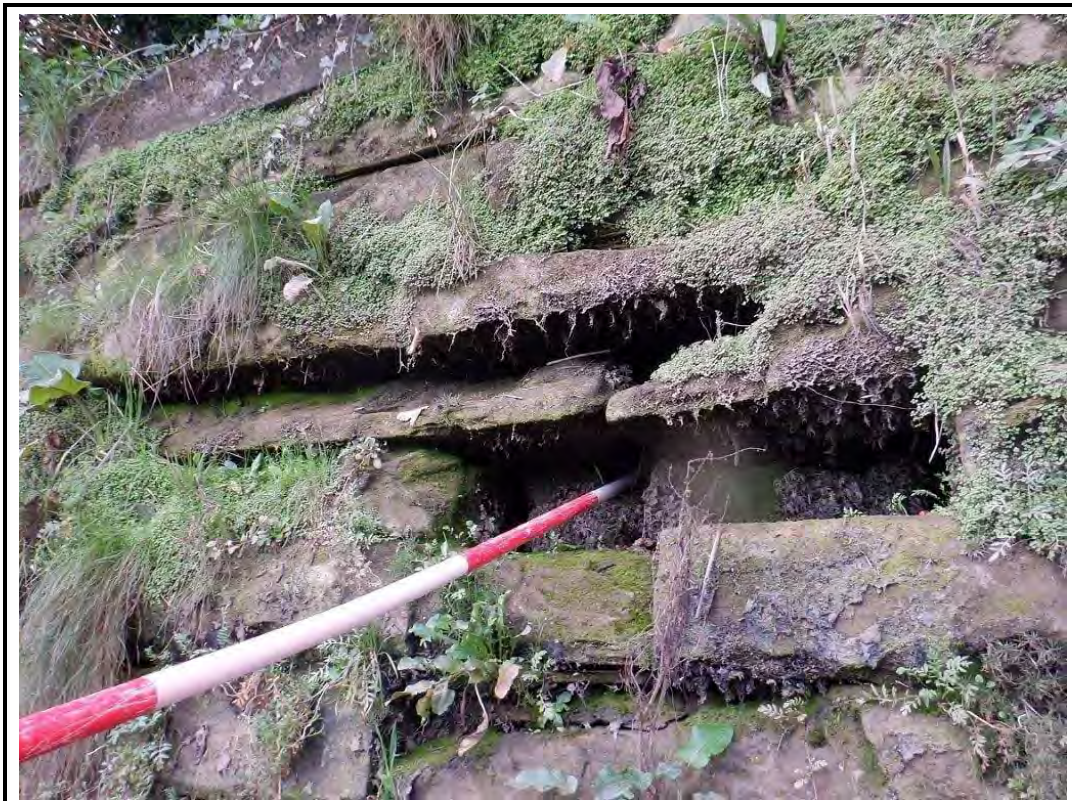
**PHOTO 14:** P14 - AREAS OF VOIDING AND SPALLING LOCATED THROUGHOUT 14/09/20

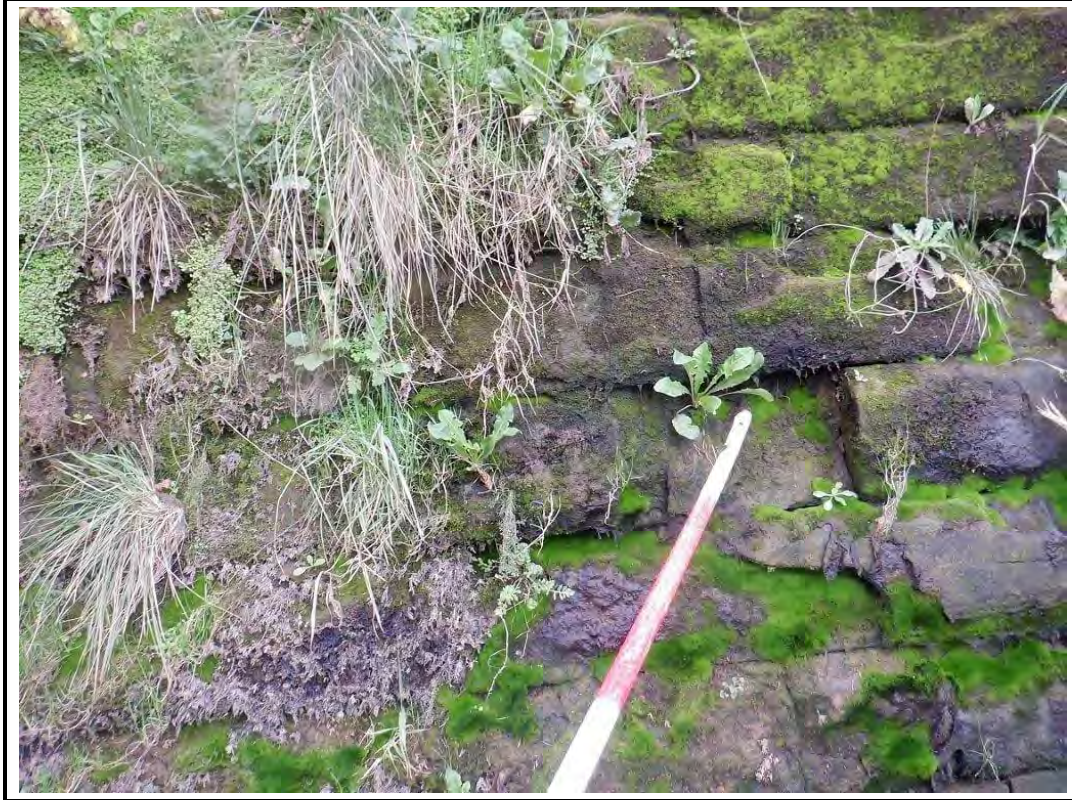
**PHOTO 17:** P17 - 8M FROM THE ABUTMENT 4M2 SPALLING 14/09/20

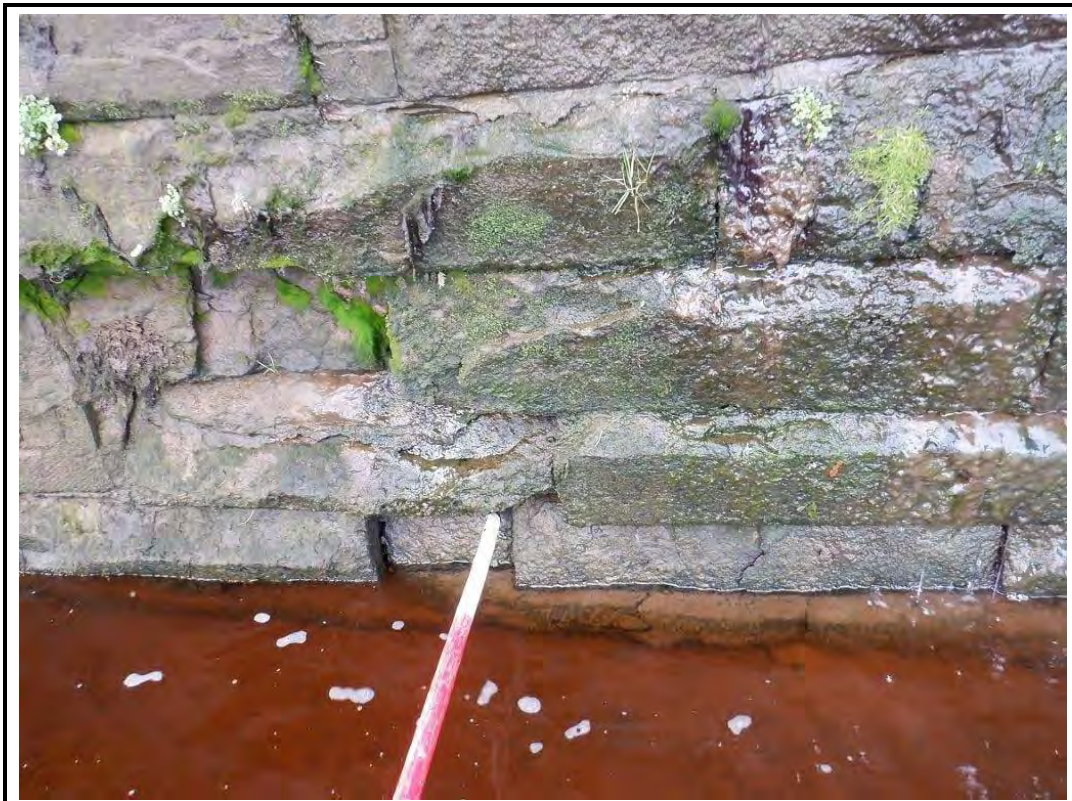
**PHOTO 18:** P18 - AT 9M FROM THE ABUTMENT SPALLING AT WATER LEVEL, 14/09/20

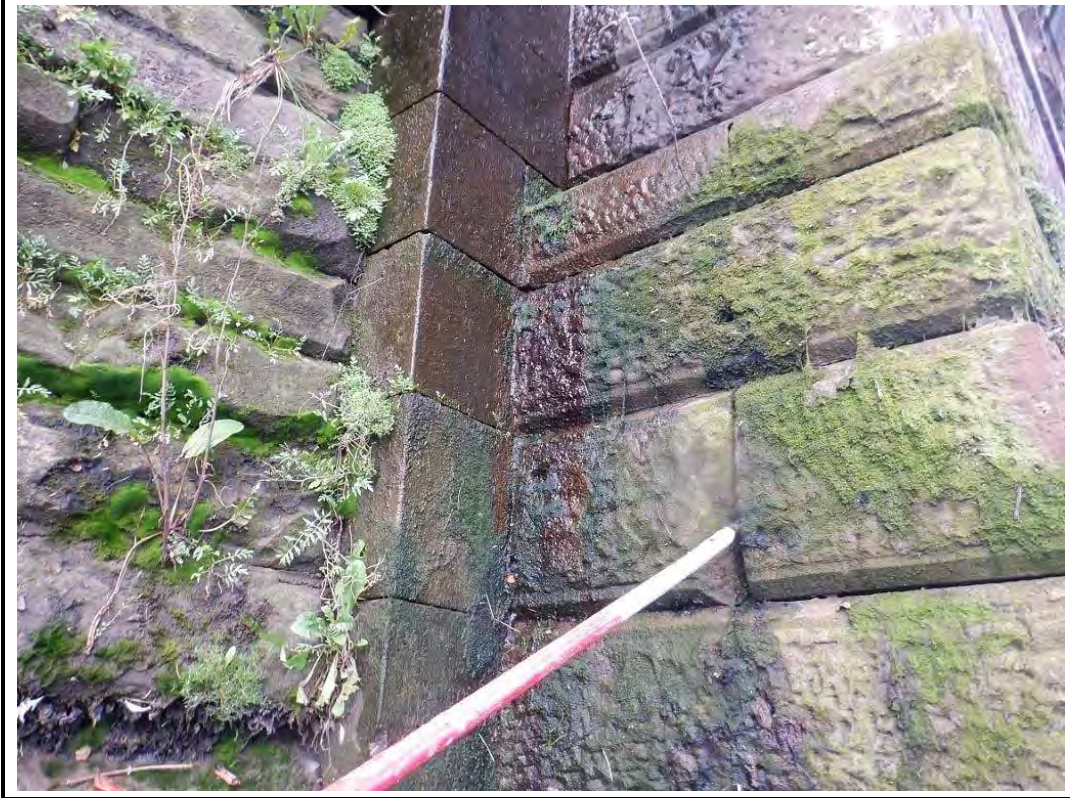
**PHOTO 21:** P21 - DOWNSTREAM RETURN - FRACTURE 14/09/20

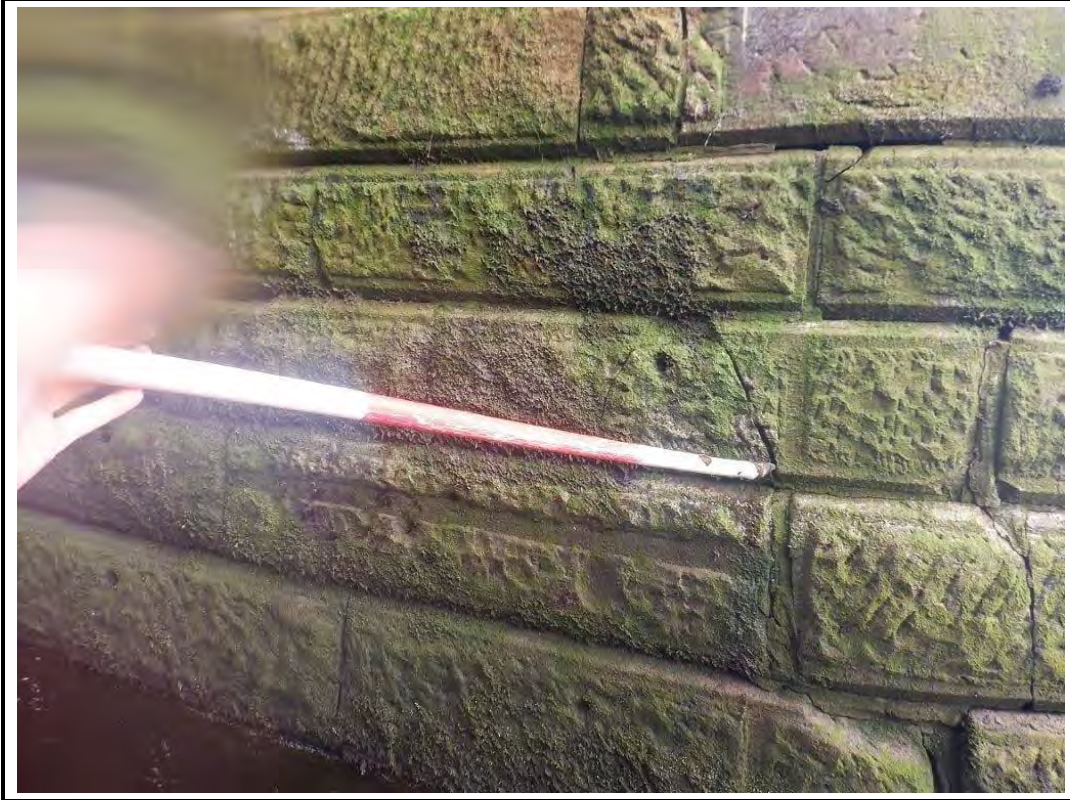
**PHOTO 29:** P29 - 2NO VERTICAL FRACTURES 14/09/20
