### Photo Schedule - A83 North of Inveraray Sea Wall

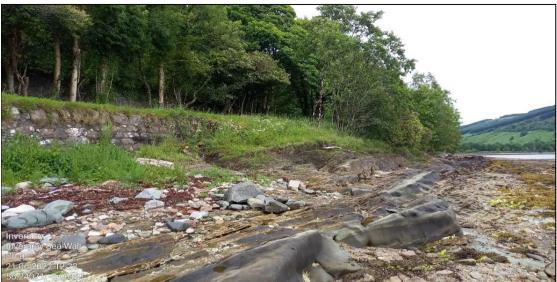
Ch.0 Looking North (away from scheme extents)

Ch.0 Looking South (towards scheme extents)

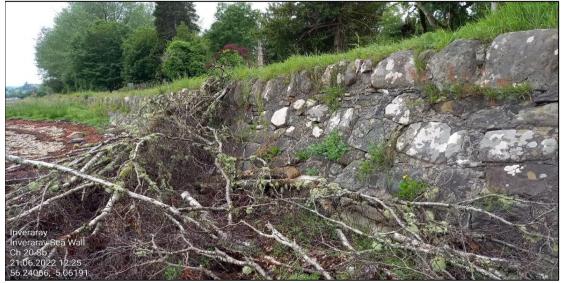
# Ch.20 Looking North

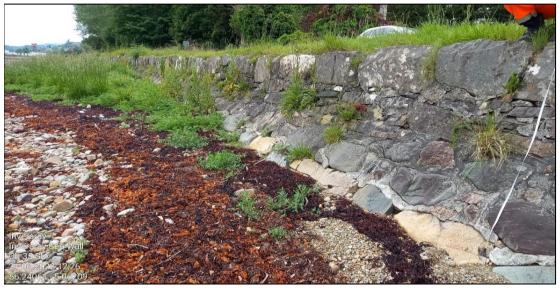
### Ch.35 Looking North

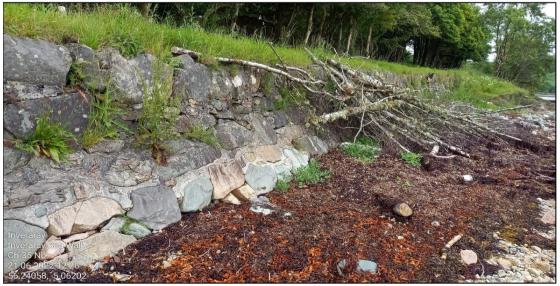
### Ch.46 to Ch.80 - Potential access spoint

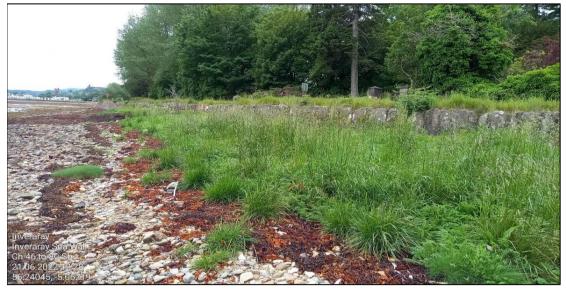
Ch.46 to Ch.80 Looking North - Potential access spoint

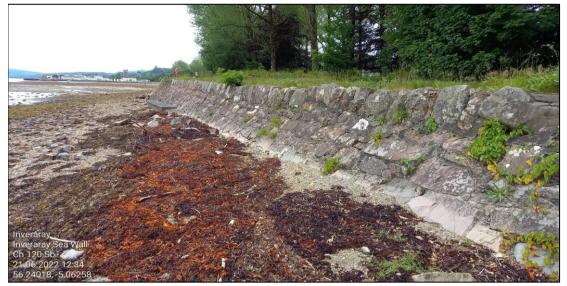
Ch.120 Looking North

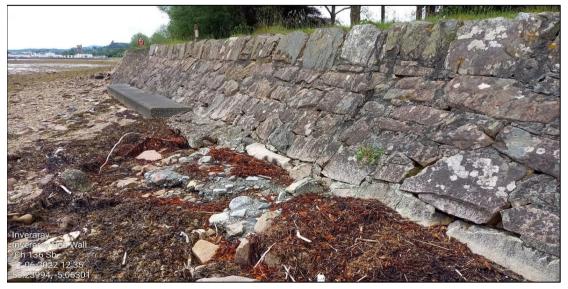
### Ch.144 - Minor voiding and start of concrete toe

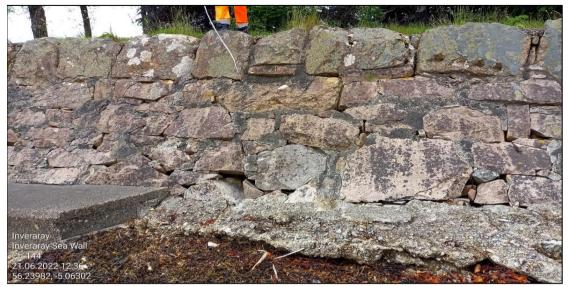
Ch.144 - Start of concrete toe

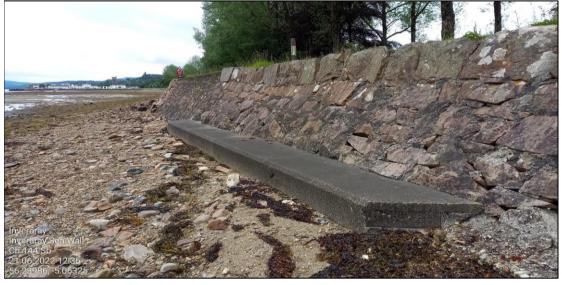
Ch.150 - Minor voiding above concrete toe

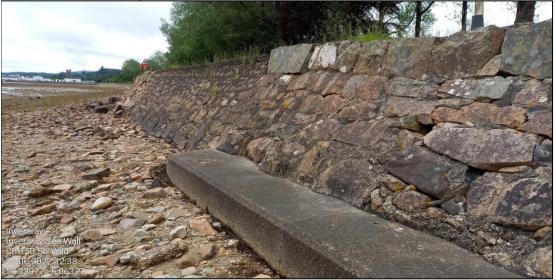
### Ch.150 Looking North - minor voiding

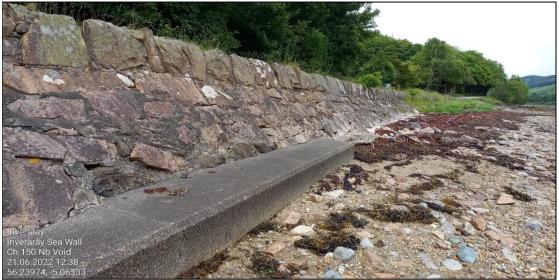
#### Ch.155 - End of concrete toe

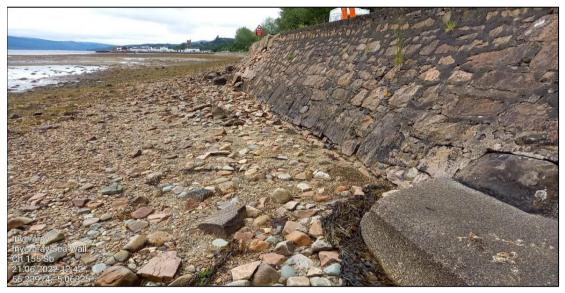
Ch.170 - Showing three localised areas where wall has collapsed

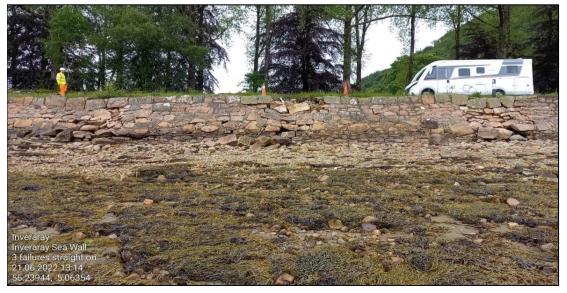
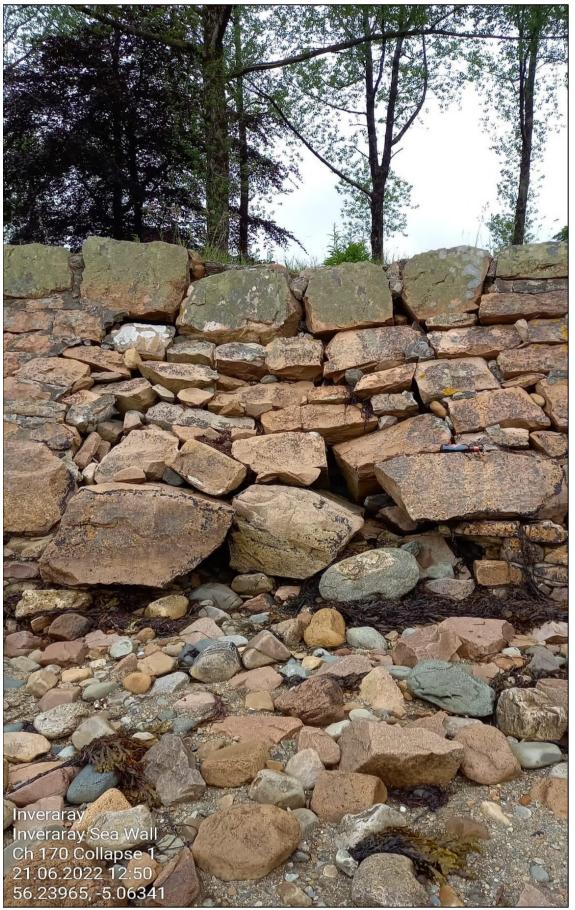
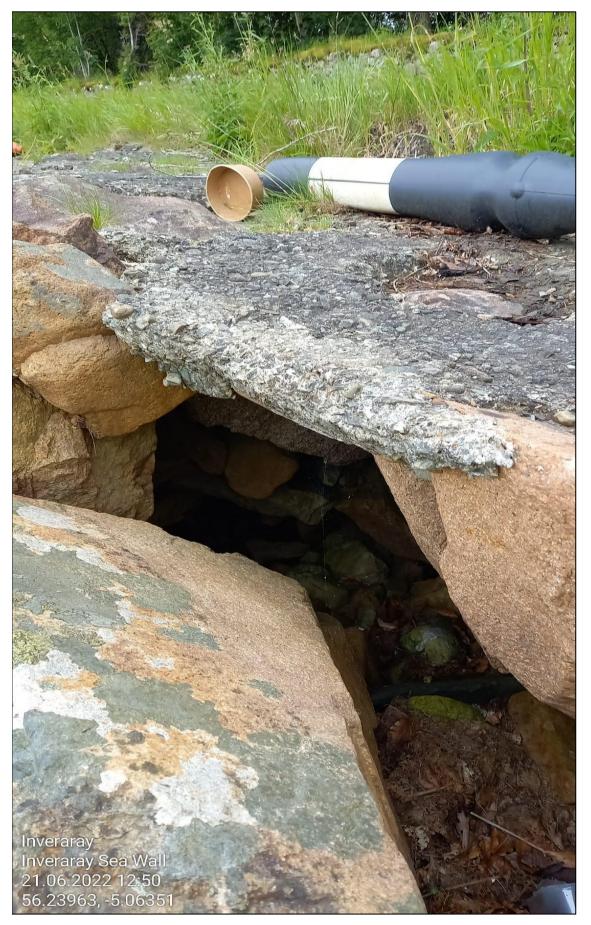
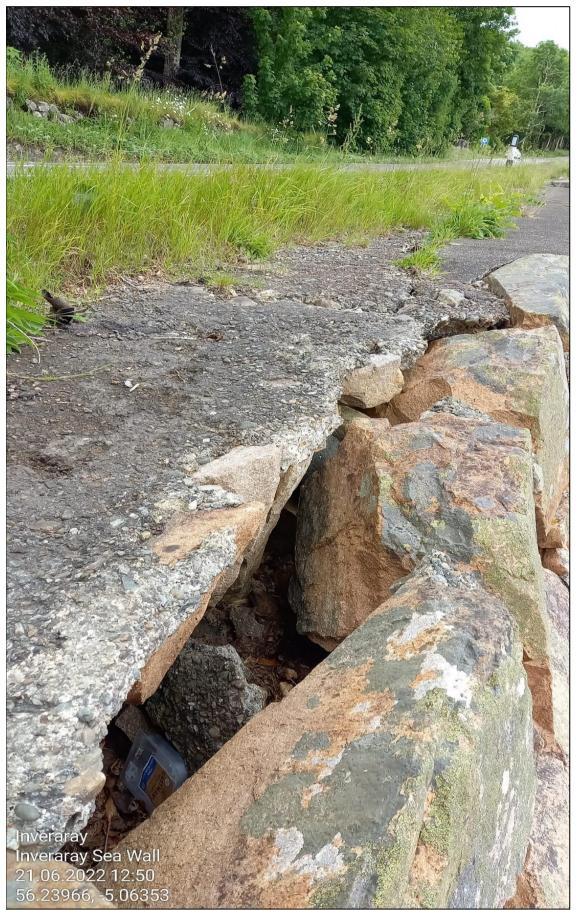
Ch.170 - Wall collapse (No.1)

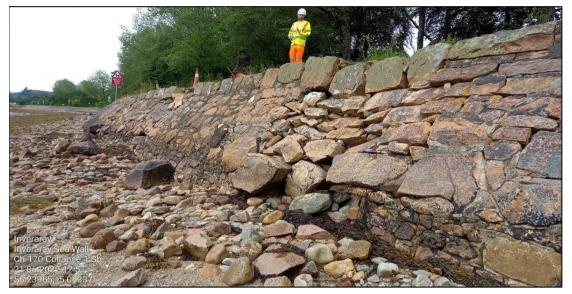
Ch.170 Wall collapse (No.1) - Looking North

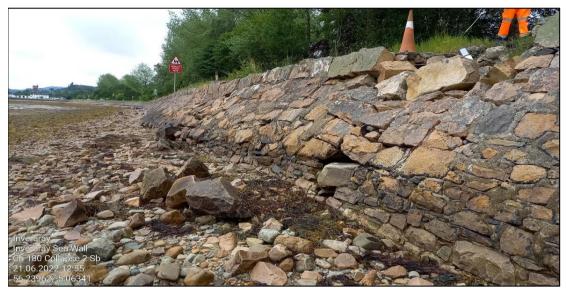
Ch.180 Wall collapse (No.2) - Looking North

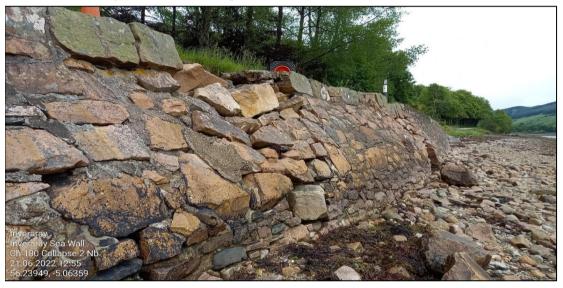
Ch.180 Wall collapse (No.2) - View from Verge

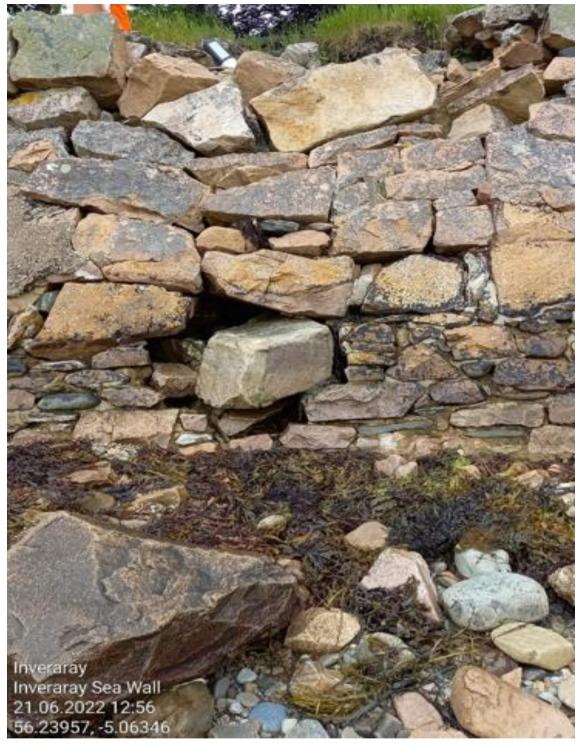
Ch.180 Wall collapse (No.2) - Looking North (collapse 1 also shown)

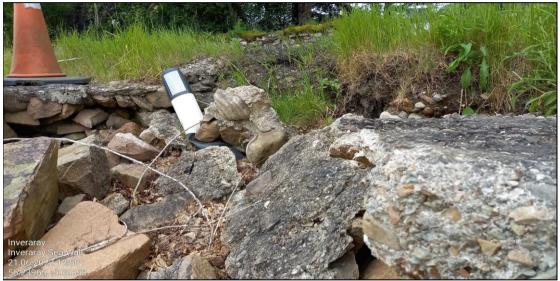
Ch.180 Wall collapse (No.3) - looking North

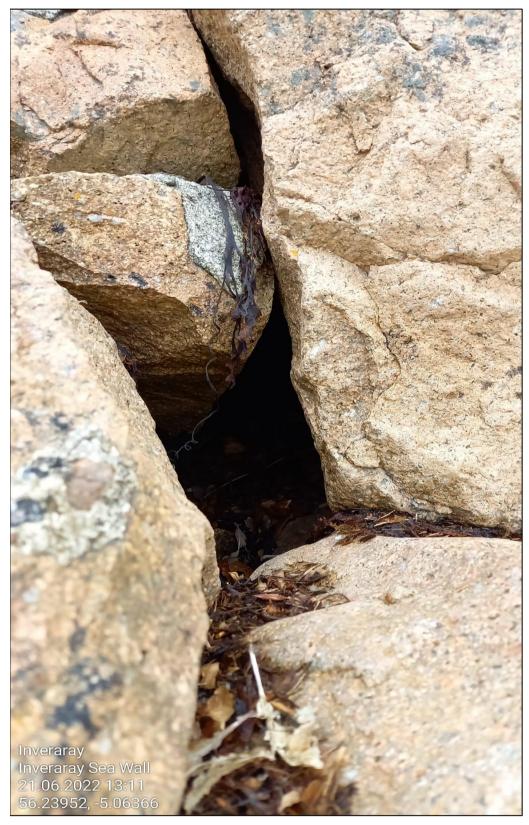
## Ch.185 Minor voiding

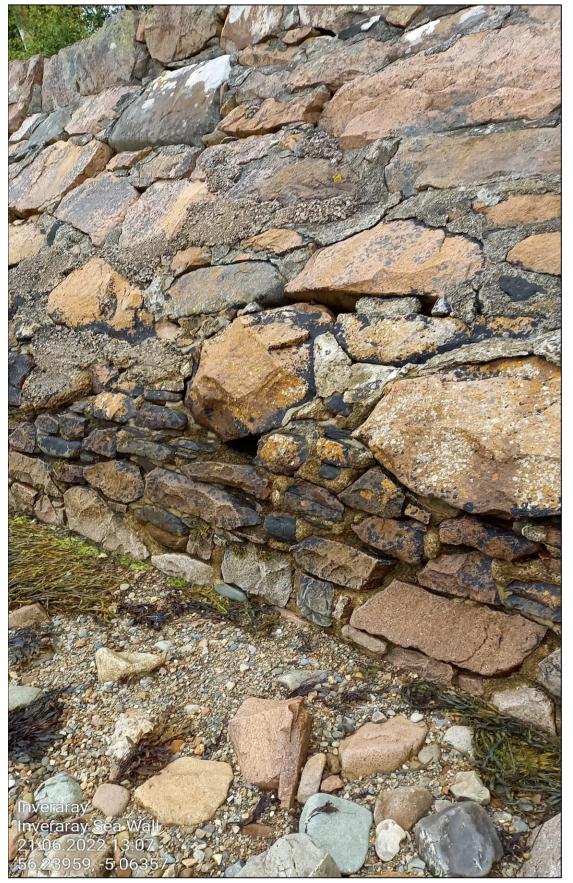
### Ch.185 Minor voiding
