BRIDGE DETAILED & HCE EXAMINATION REPORT

ELR: WCM2	Contract Mileage: 102 m 0088 yds 4.00 ch			Struc. Ref 031/082A	
Examination Type:	Additional Assess HCE	NR ID:	11016334	Exam Date:	14-Feb-2012
Area:	Scotland West	BRS:	0	OS Ref:	NS58716475
Structure Name:	NEW CLYDE BRIDGE	Type:	BU	Exam ID	305231
Route:	Gretna - Glasgow Central (via Beattock)	Complete Examination:		N/A

OS Ref: NS58716475 BRS: Name: NEW CLYDE BRIDGE

The remit was to examine structural elements affected by HCE code MJA in accordance with document HCE – Codes v1.5.

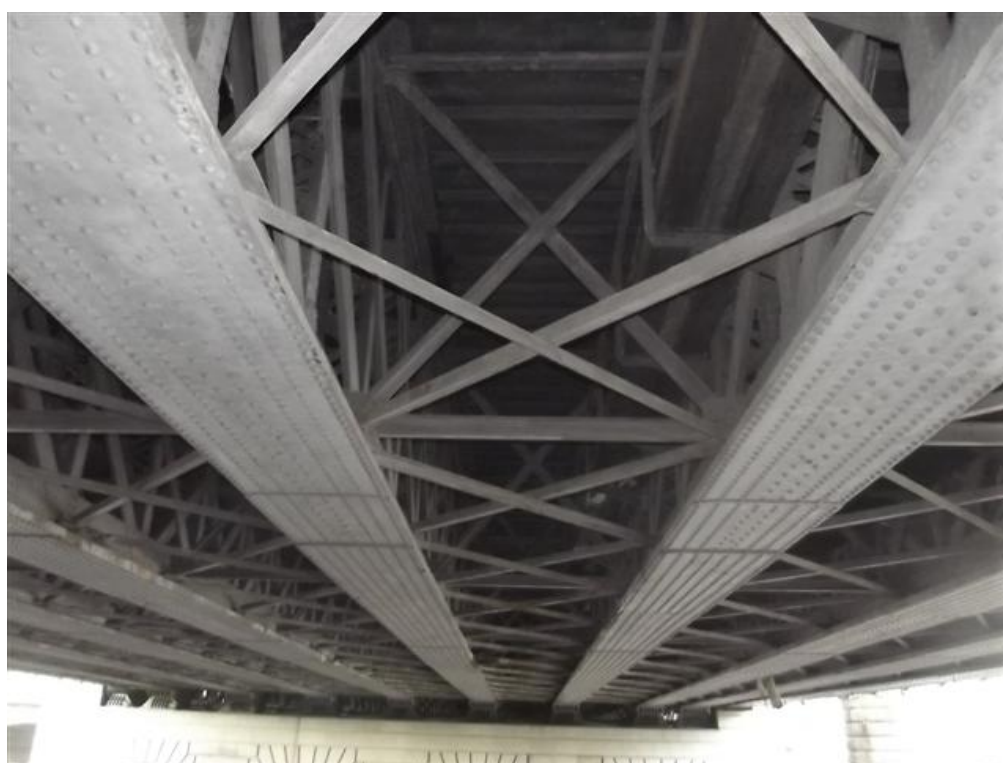
Photograph 2 – Typical view of the underside. Note the fair to good condition of the structure. The paint system is largely intact and the underside is dry. The structure owes its condition to the deck which is shielding the truss beams from the elements (14/02/2012).

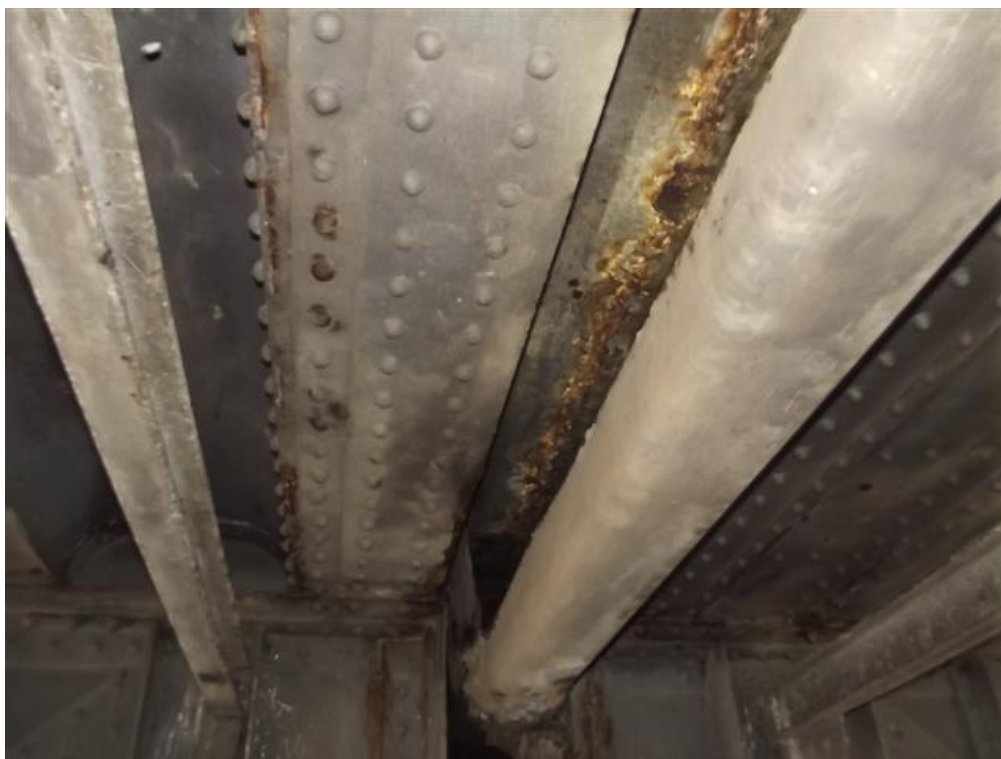
The structure is in fair to good condition and owes its longevity largely to the deck arrangement which shields the structure from the elements. The paint system is largely intact and there was only moderate localised water penetration through the deck above the piers.

Photograph 3 – Localised water penetration and associated rusting over the abutments (14/02/2012).

5	Consider rectification of deck waterproofing where defective	Isolated areas of seepage observed	0.00		1.00 unit	2	3	E6	Water Control
6	Consider repair/renewal of bird control netting to deter bird.	Generally to bridge.	0.00		1.00 unit	2	3	E6	Other
7	carry out suitable steelwork repairs to areas where loss of section has occurred.	throughout superstructure and substructure	0.00		1.00 unit	2	3	E6	Steelwork Repairs
8	Replace bolts and rivets by appropriate fasteners where defective or missing. Where fasteners have sheared establish cause and rectify.	Isolated locations including tie plates between main booms and to bracing.	0.00		1.00 unit	2	3	E6	Steelwork Repairs
9	Grit blast and apply protective paint system to areas of defective paint, light corrosion or where repaired.	throughout structure as required	0.00		1.00 unit	2	3	E6	Painting
Signed Redacted <small>For Employer</small>		Name Redacted			Date 9-May-2012

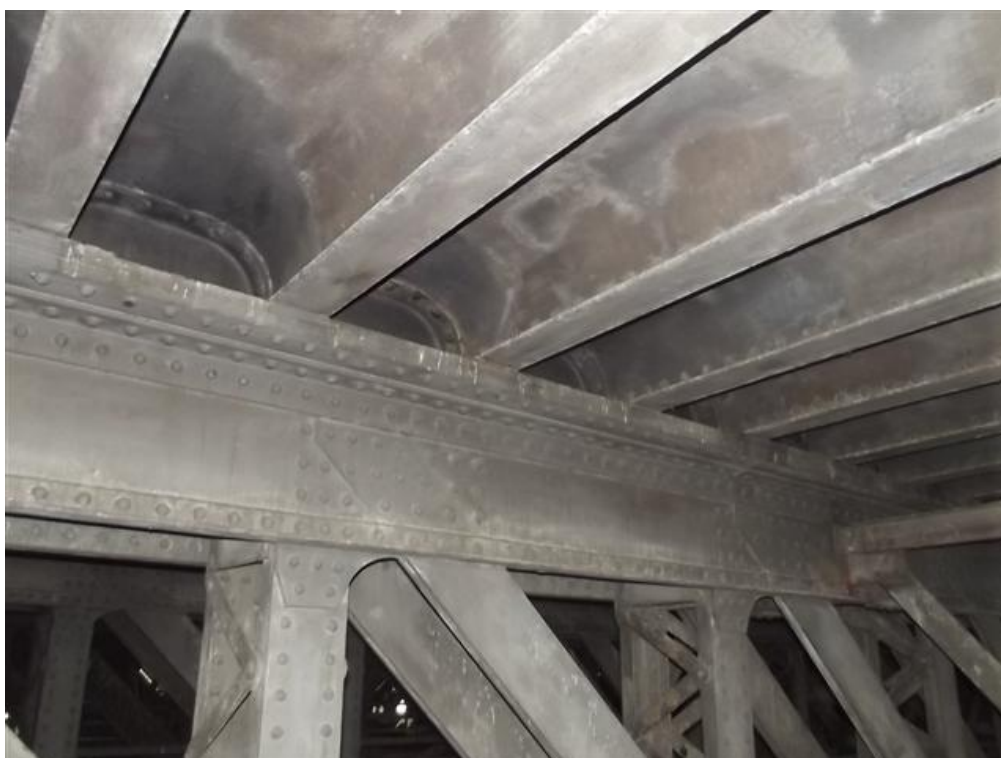
Photograph 4 – Detail of the MJA. The deck is comprised of Hobsons flooring (14/02/2012).

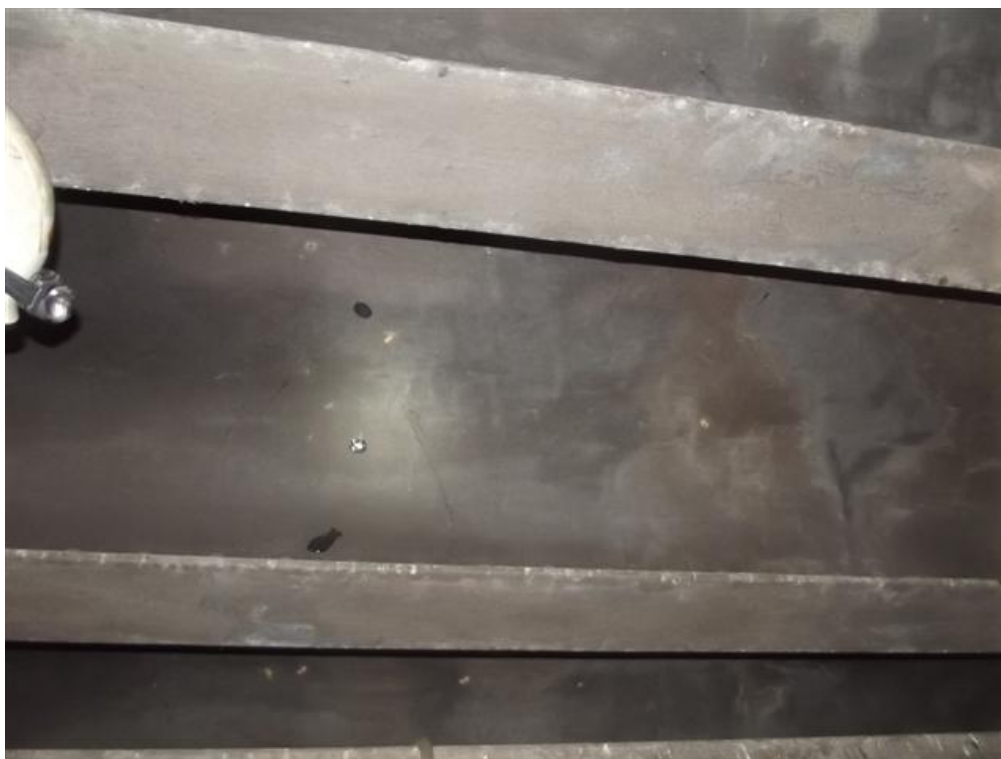
The deck is comprised of Hobsons type flooring which was found to be in good condition throughout. Ultrasonic thickness gauging suggests a thickness of ½" with less than 1mm section loss.

Photograph 5 – Thickness gauging suggests a thickness of ½” with less than 1mm loss of section (14/02/2012).

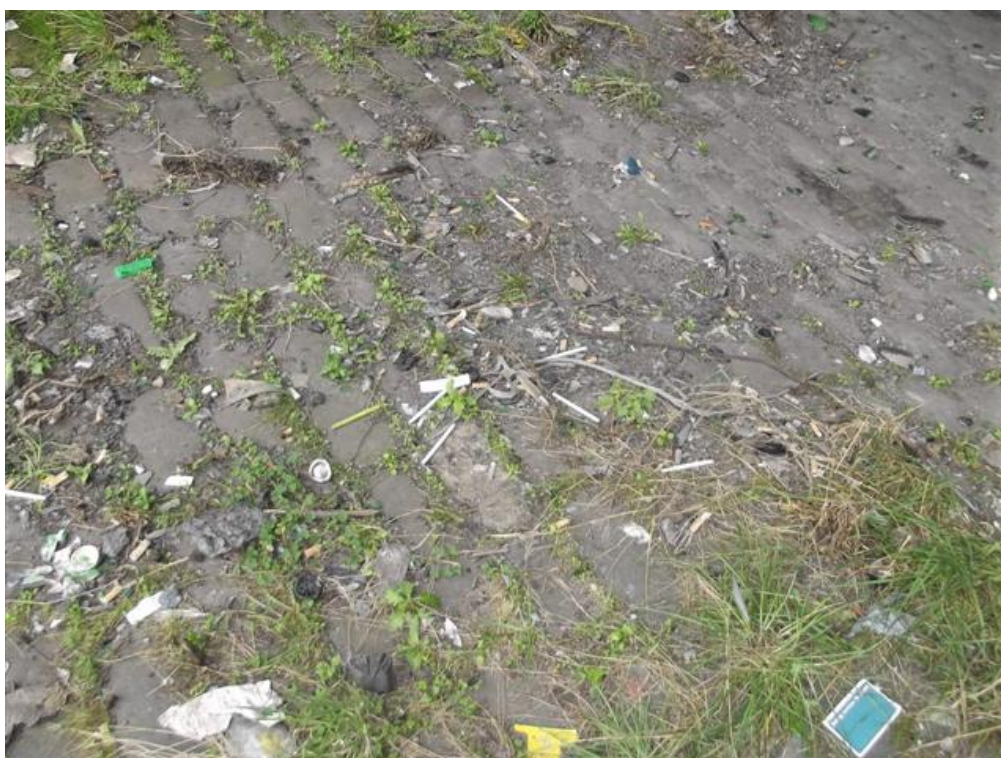
Photograph 6 – The south end of the structure had a significant number of hypodermic needles (14/02/2012).

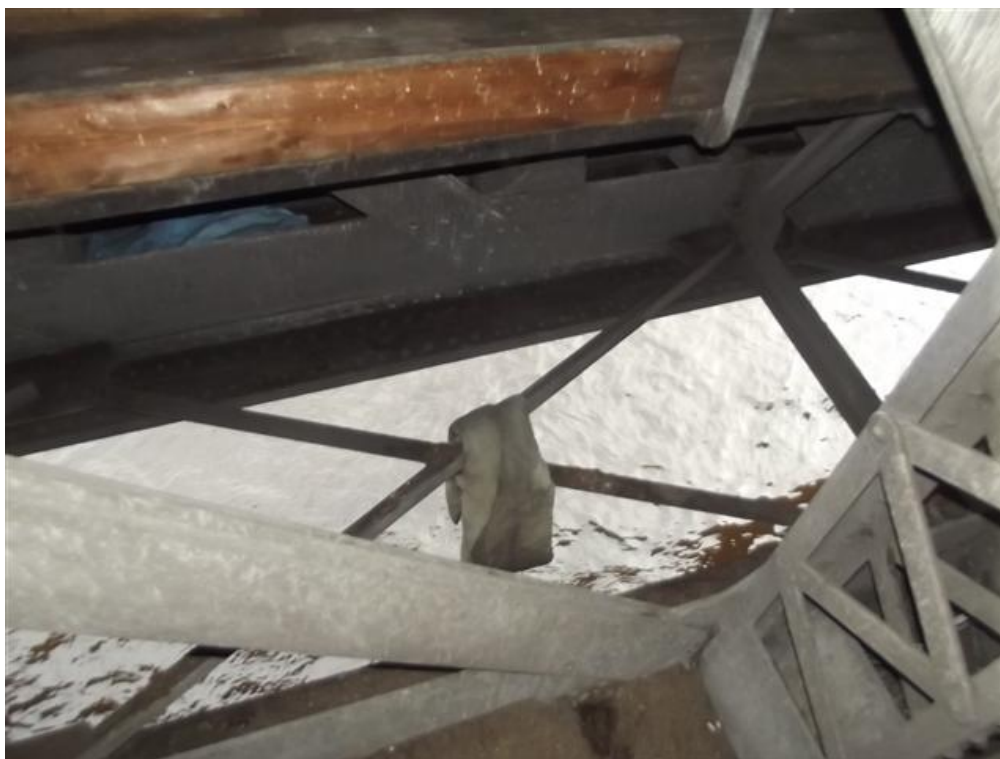
Photograph 7 – disused sleeping bags were noted throughout the span suggesting it is used by the homeless. Access to the structure is particularly easy from the southside (14/02/2012).

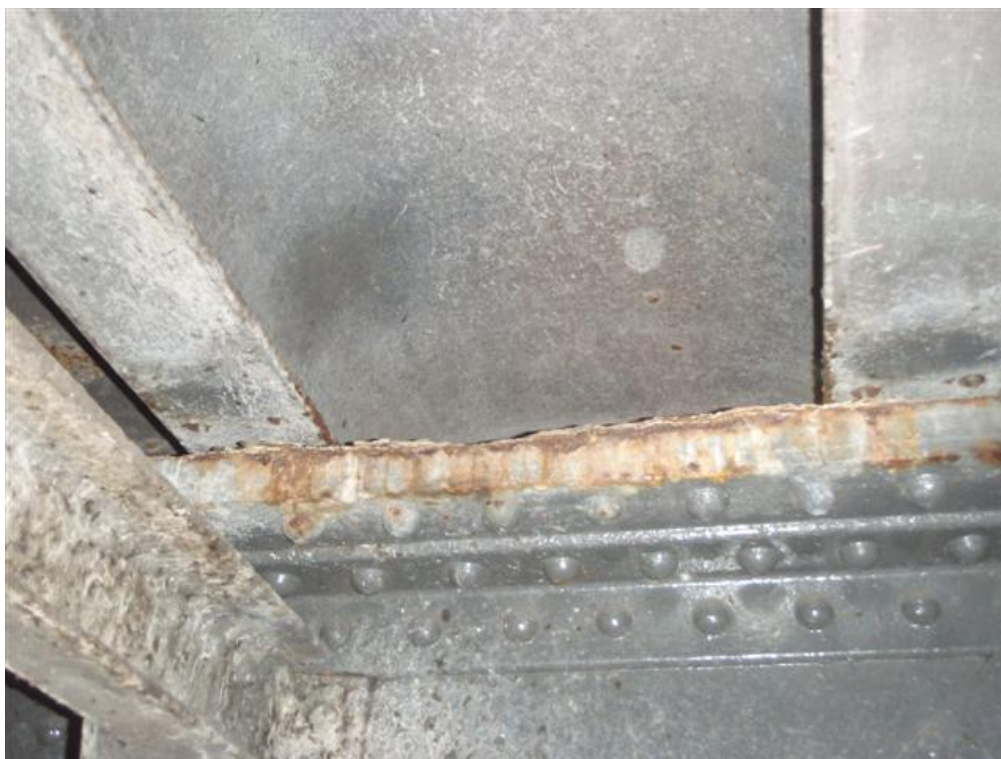
P9 - MGE1-TB upside-Thin/lamin between VP20&21 - 20/04/11

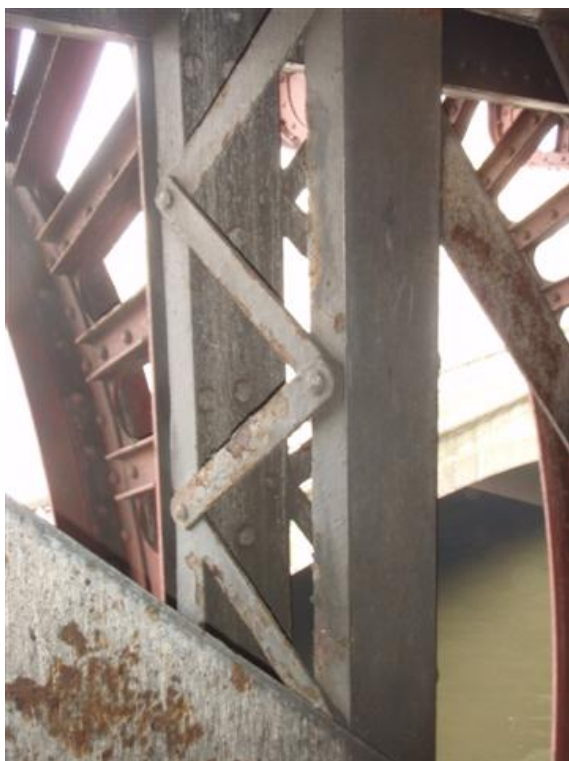
Vertical Lattice Posts - Generally VP show areas of minor LOP and corrosion, Max 1mm, covers <5%, Photo No. 11 shows typical.

P11 - MGE1-VP-Typical LOP & corrosion - 20/04/11

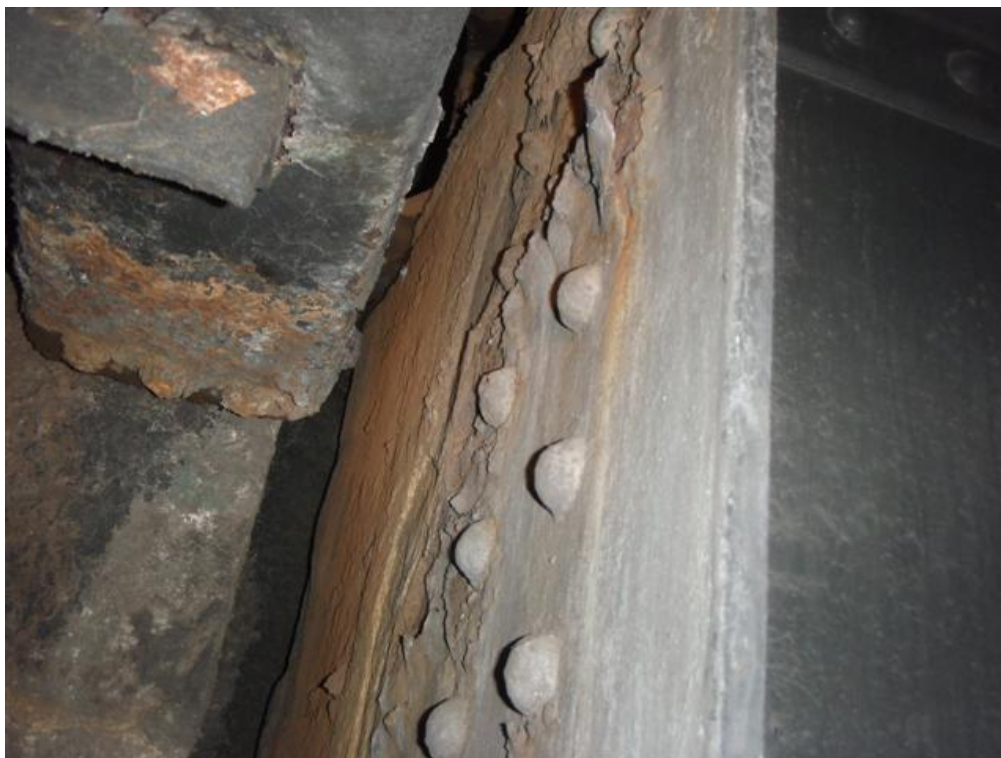
End Plates - LM - EP shows widespread areas of LOP with moderate corrosion and lamination from downside edge, 600mm wide x full height x 10mm Max deep. Rivets are pin head at same location. Fault due to seepage from adjacent box gutter, Photo No. 12 shows top and Photo No. 13 shows bottom.

P12 - MGE1-EP-Thin/lamination at downside top - 20/04/11

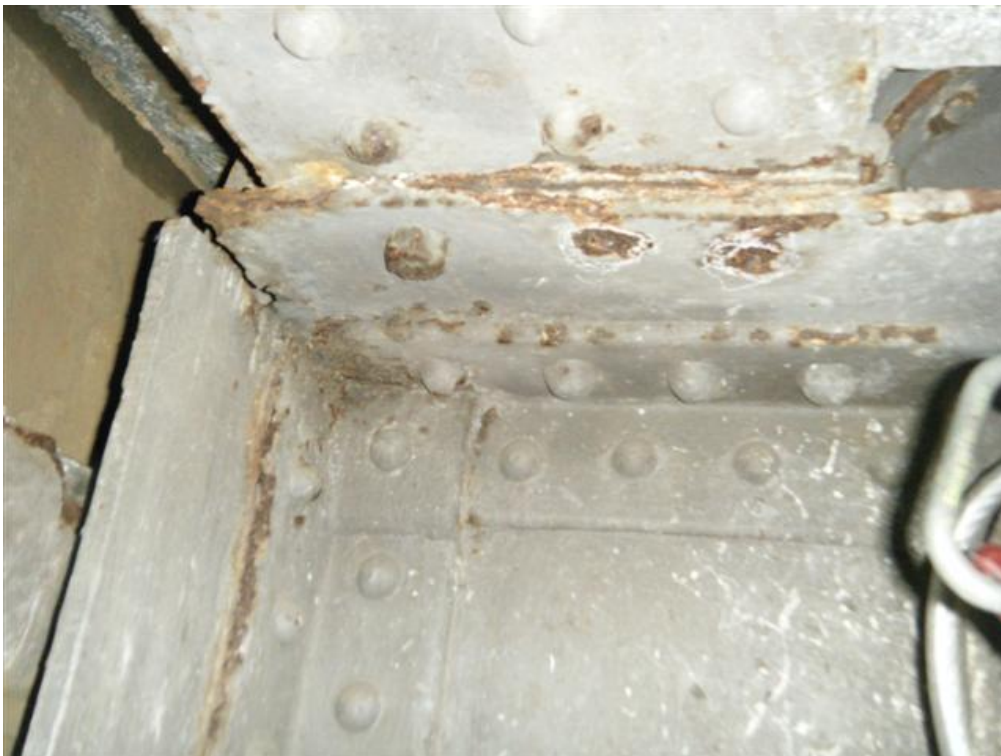
2 No rivets missing from downside of top flange at high mileage end, Photo No. 16.

P16 - MGI2 - HM end downside top flange- 2 rivets missing - 20/04/11

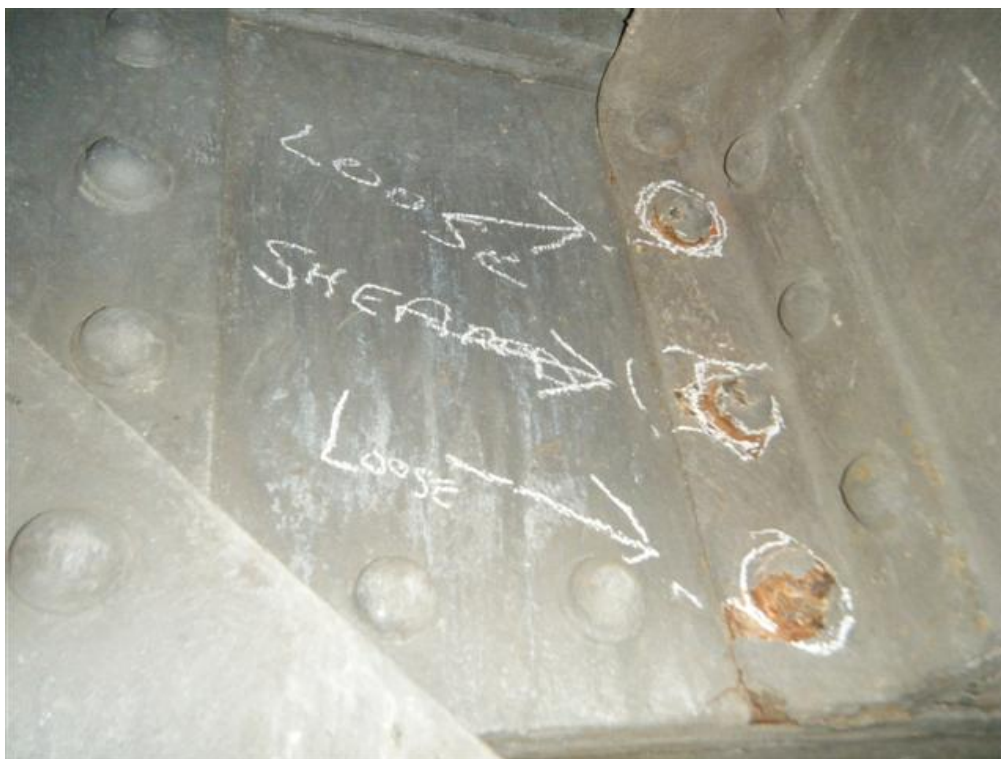
Tie plate on TB between VP2&3 has 2 loose and 1 sheared rivets at HM downside, Photo No. 17.

P17 - MGI2 - Loose and sheared rivets at tie plate - 20/04/11

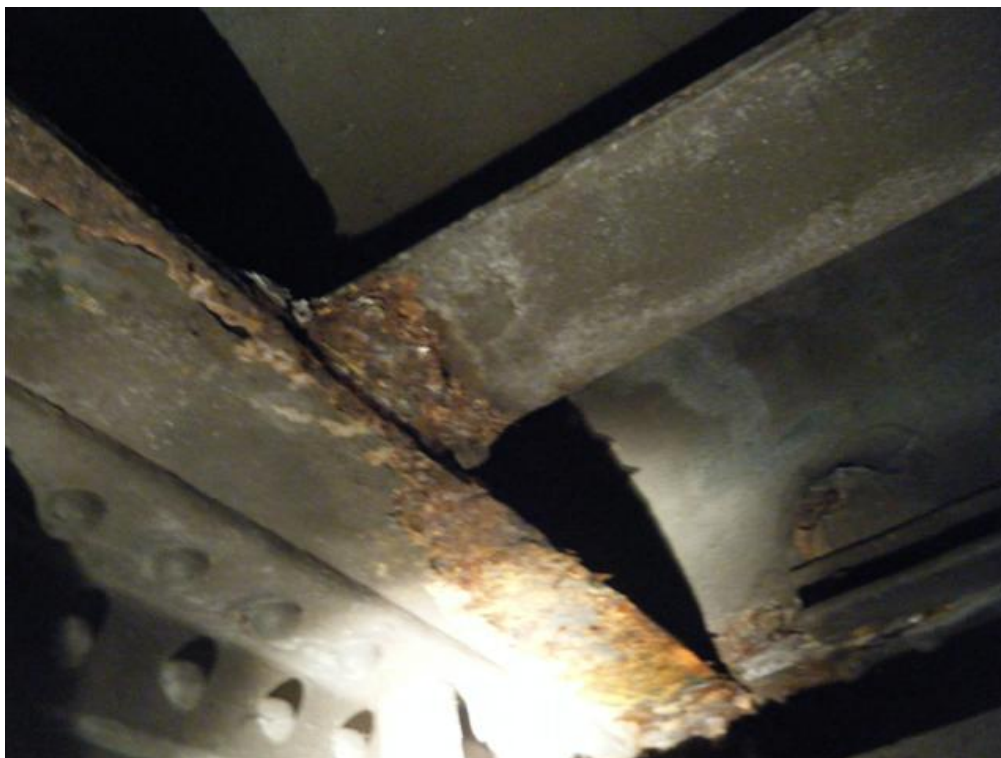
Top boom - areas of moderate to severe corrosion and lamination at low mileage up and downside and 1m x 100mm x 10mm, Photo No. 18.

P18 - MGI3 - LM downside top flange - Corrosion&thinning - 20/04/11

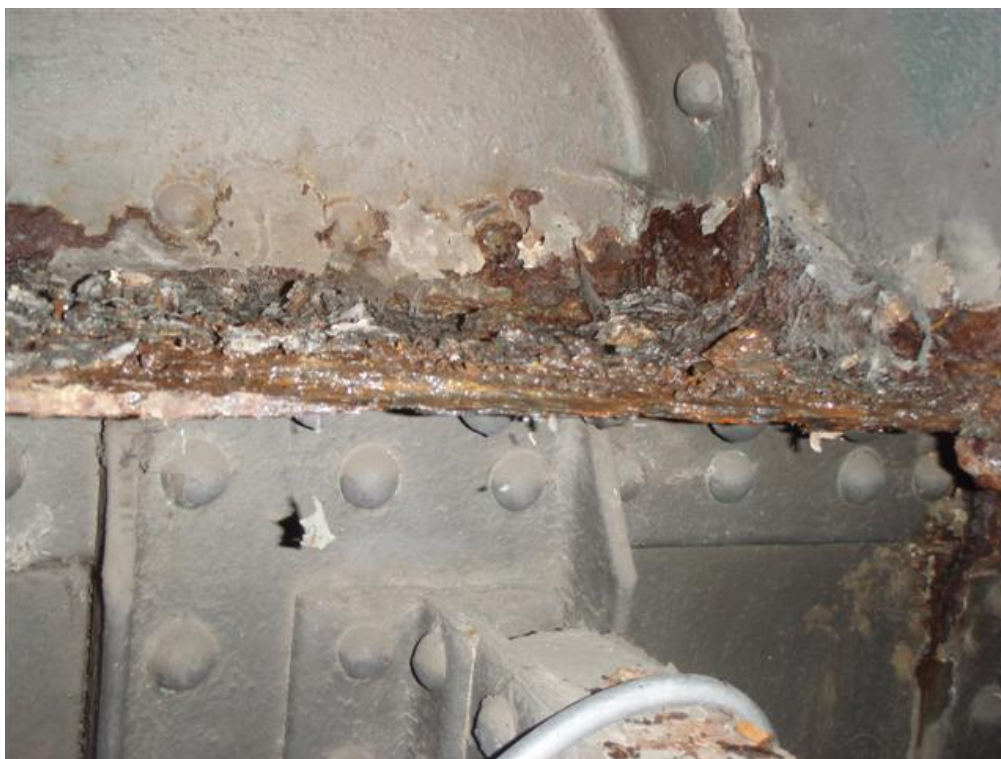
P19 - MG14-TB upside-Thin to KE at LM - 19/04/11

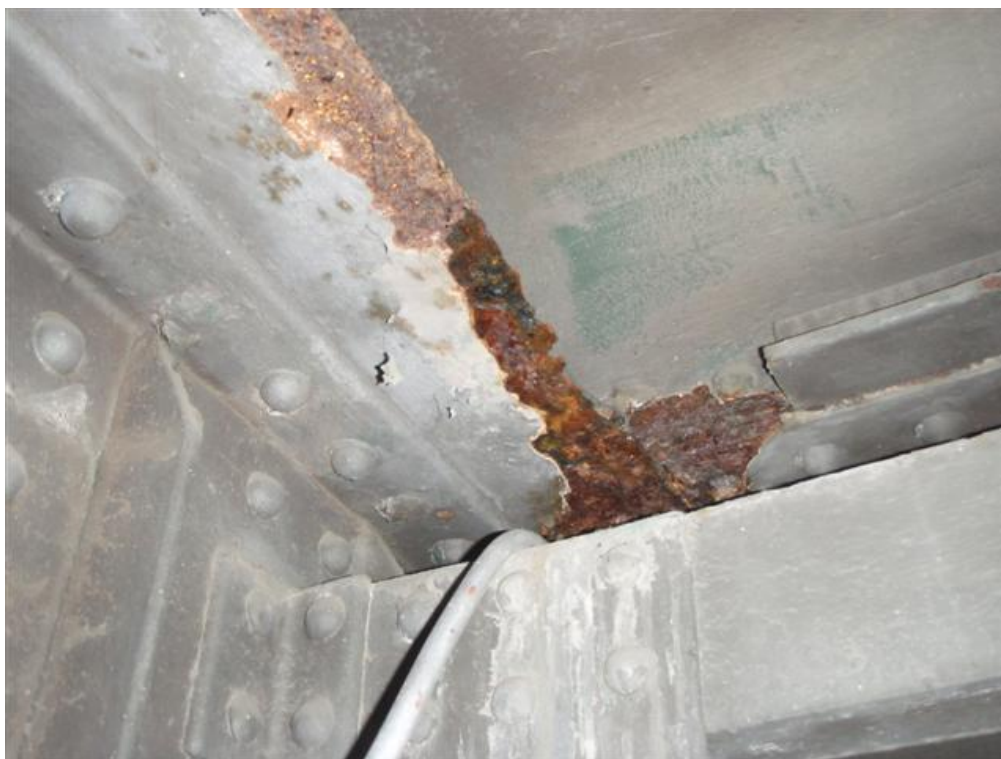
P21 - MG14-TB upside-LOS at LM - 19/04/11

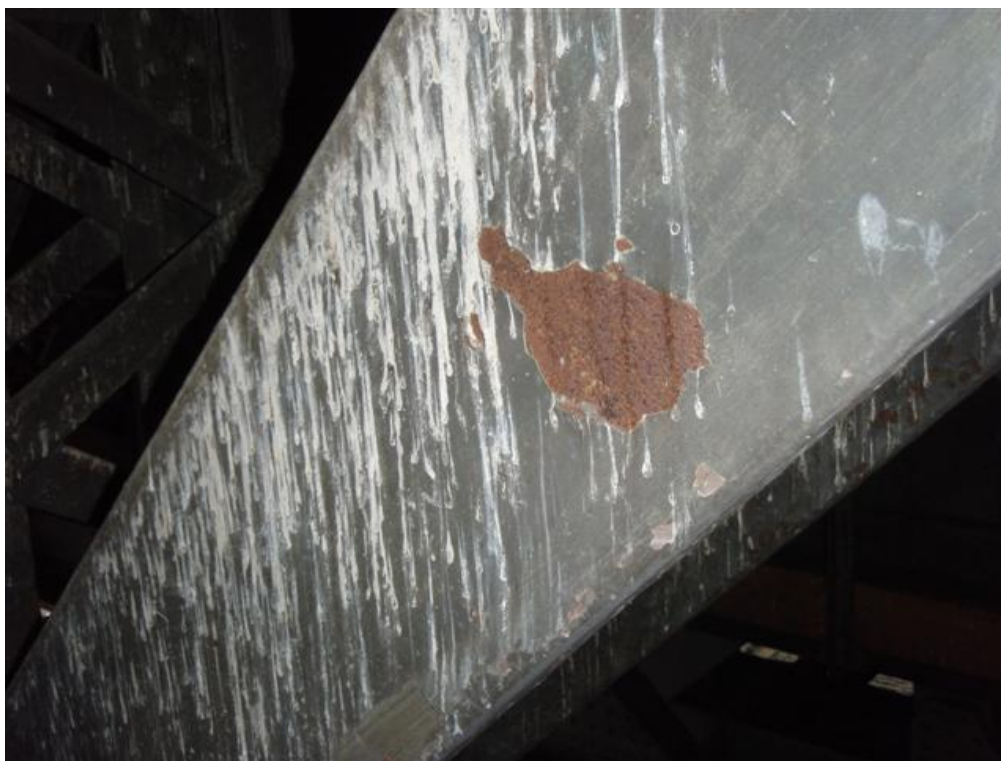
Web Diagonals - Generally WD show areas of minor LOP and corrosion, Max 1mm, covers <5%, Photo No. 23 shows typical.

P23 - MGI4-Typical corrosion to WD - 19/04/11

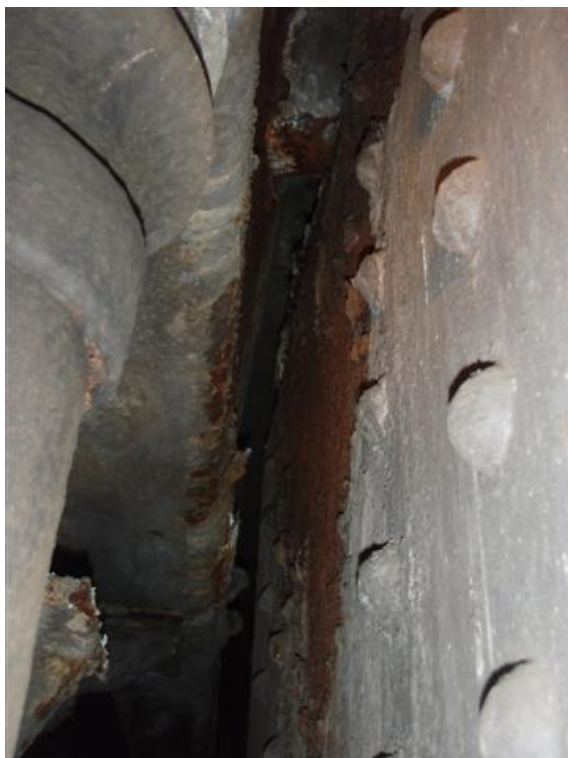
HM – EP shows area of LOP with moderate corrosion and lamination at middle, 500mm x full height x 10mm Max deep. Rivets are pin head at same location, Photo No. 24 shows top.

P24 - MGI4-HM EP-Thin/lamination at top middle - 19/04/11

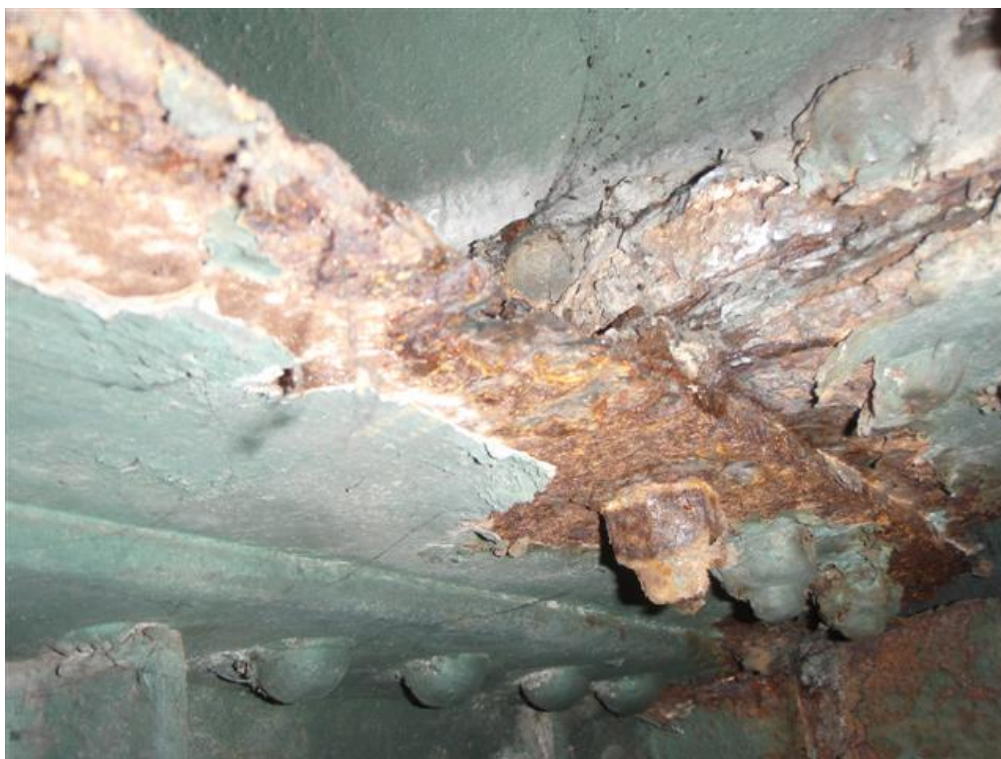
P25 - MG15-TB downside-Thin/lamin/LOS at LM - 18/04/11

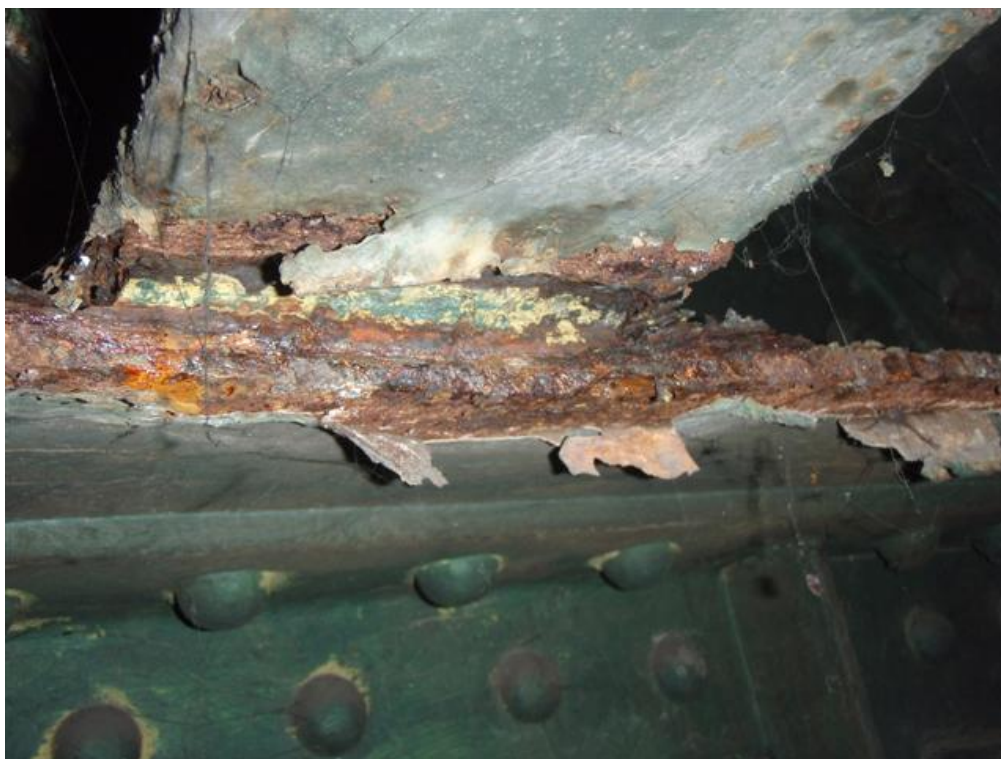
P27 - MG15-TB downside-RJ&lamin at joins to trough deck - 18/04/11

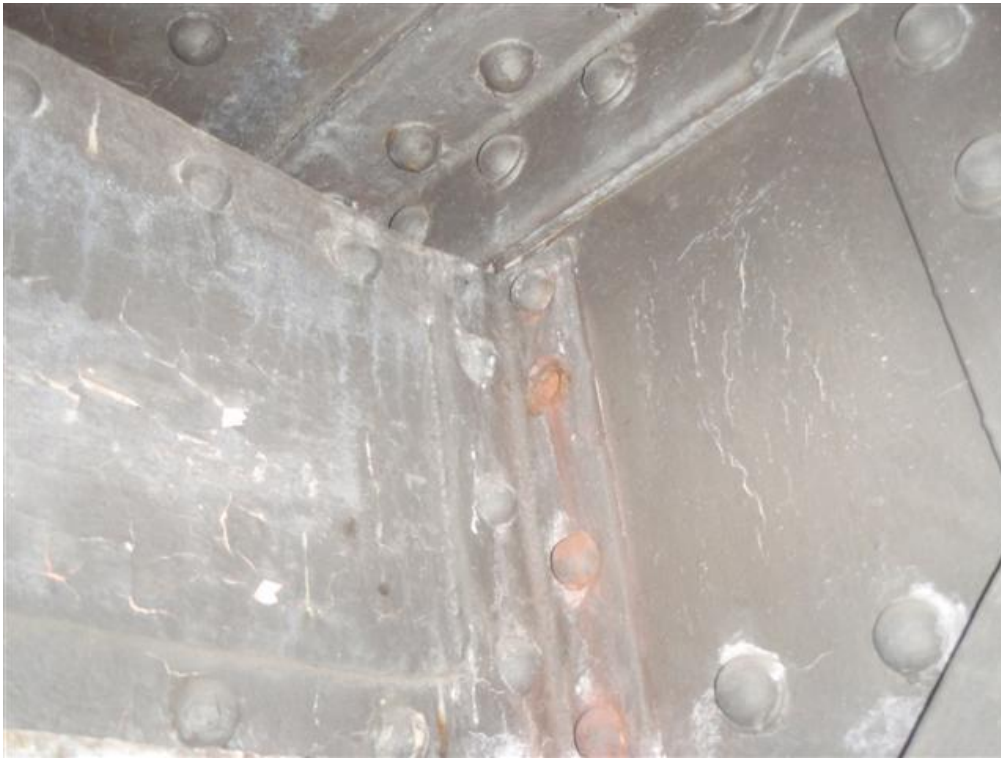
Tie plate on TB between VP5&6 has missing rivet at LM upside, Photo No. 31.

P31 - MGI5-TB-Tie plate-Missing rivet at LM upside - 18/04/11

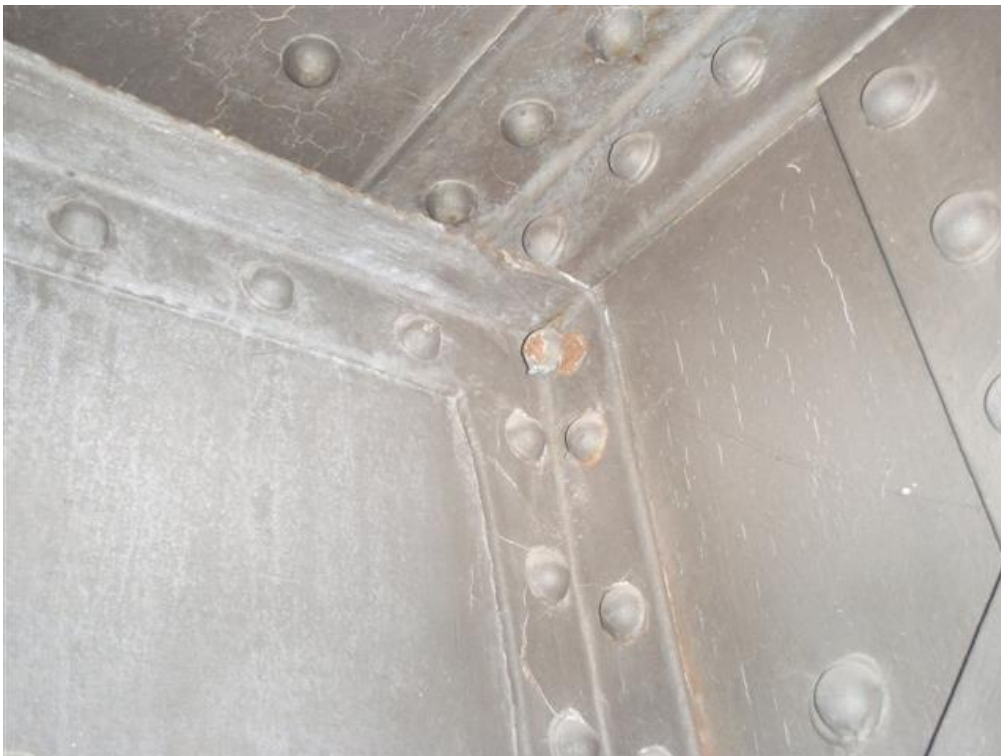
Tie plate on TB between VP8&9 has loose/projecting rivet at LM upside, Photo No. 32.

P32 - MGI5-TB-Tie plate-Loose rivet at HM upside - 18/04/11

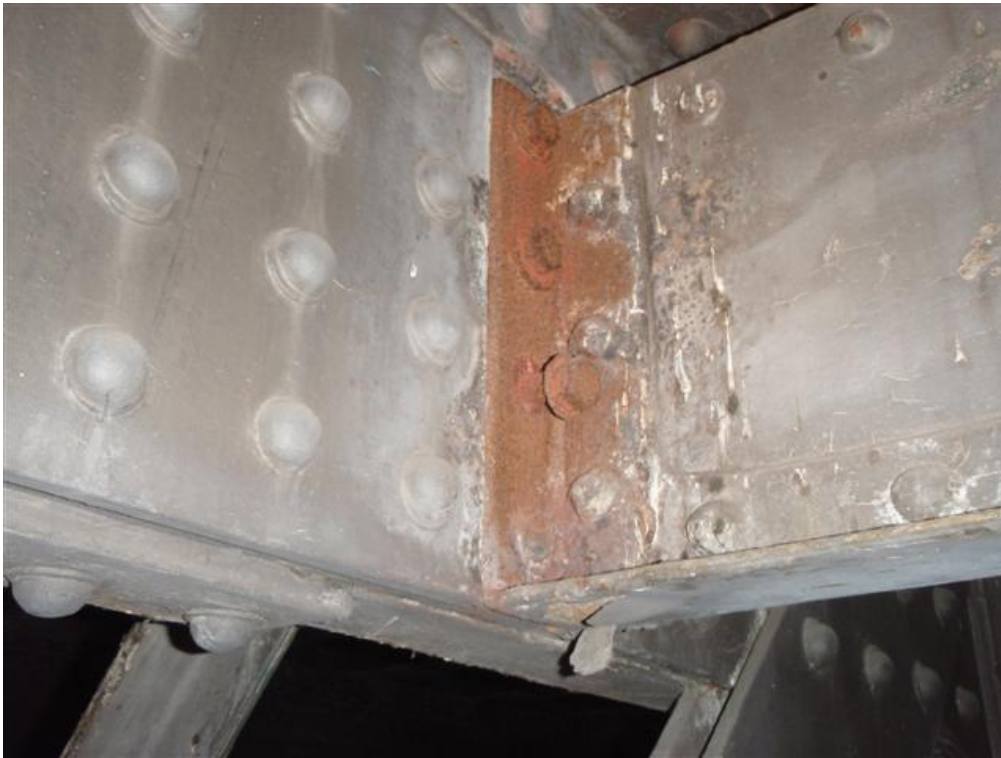
Tie plate on TB between VP8&9 has loose/projecting bolt at HM upside, Photo No. 33.

P33 - MGI5-TB-Tie plate-Loose bolt at HM upside - 18/04/11

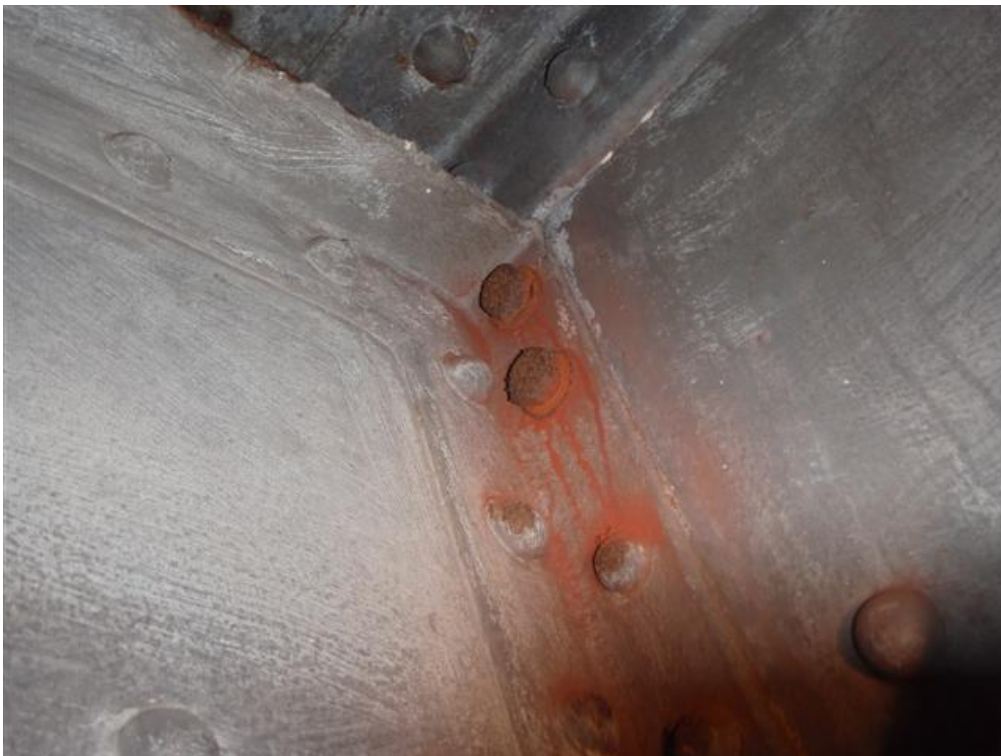
Tie plate on TB between VP8&9 has two loose bolts at LM upside, Photo No. 34.

P34 - MGI5-TB-Tie plate-Loose bolts at LM upside - 18/04/11

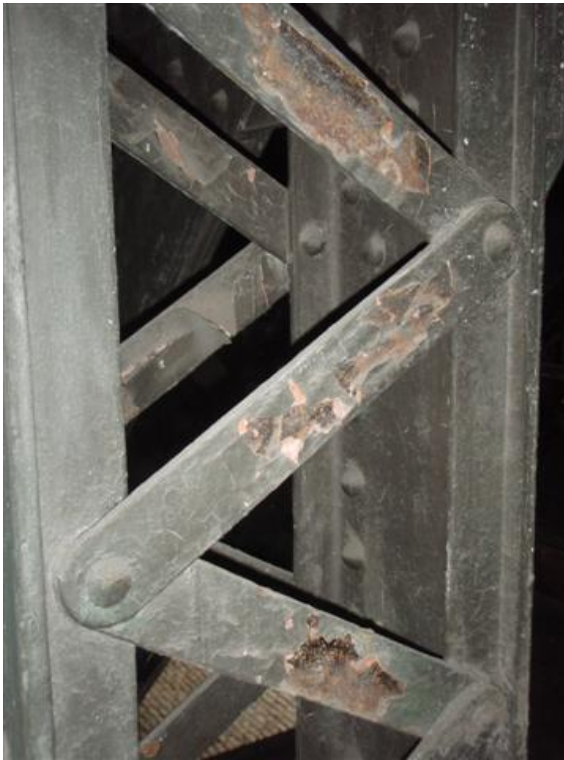
Vertical Lattice Posts – Generally VP show areas of minor LOP and corrosion, Max 1mm, covers <5%, Photo No. 35 shows typical.

P35 - MGI5-VP-Typical LOP & corrosion - 18/04/11

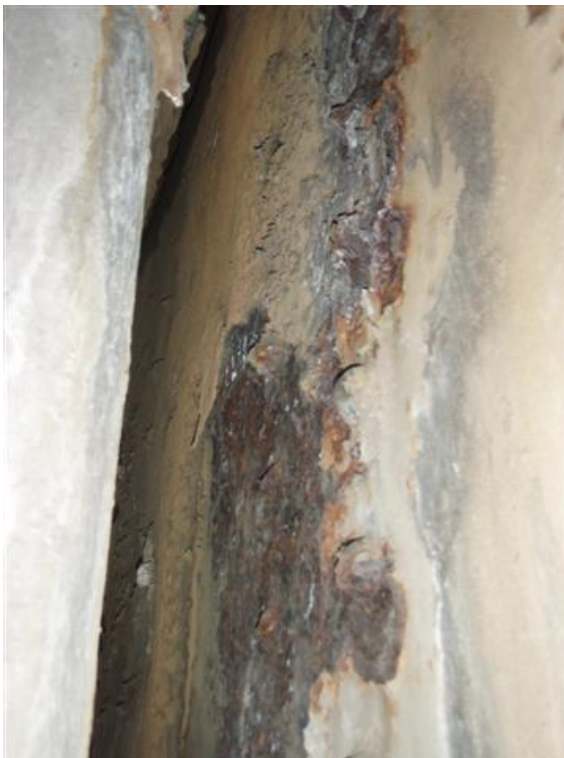
HM – EP shows area of LOP with moderate corrosion and lamination at top, 2000mm x full width x 10mm Max deep. Rivets are pin head at same location, Photo No. 36 shows top.

P36 - MGI5-HM EP-Thin/lamination at top - 21/04/11

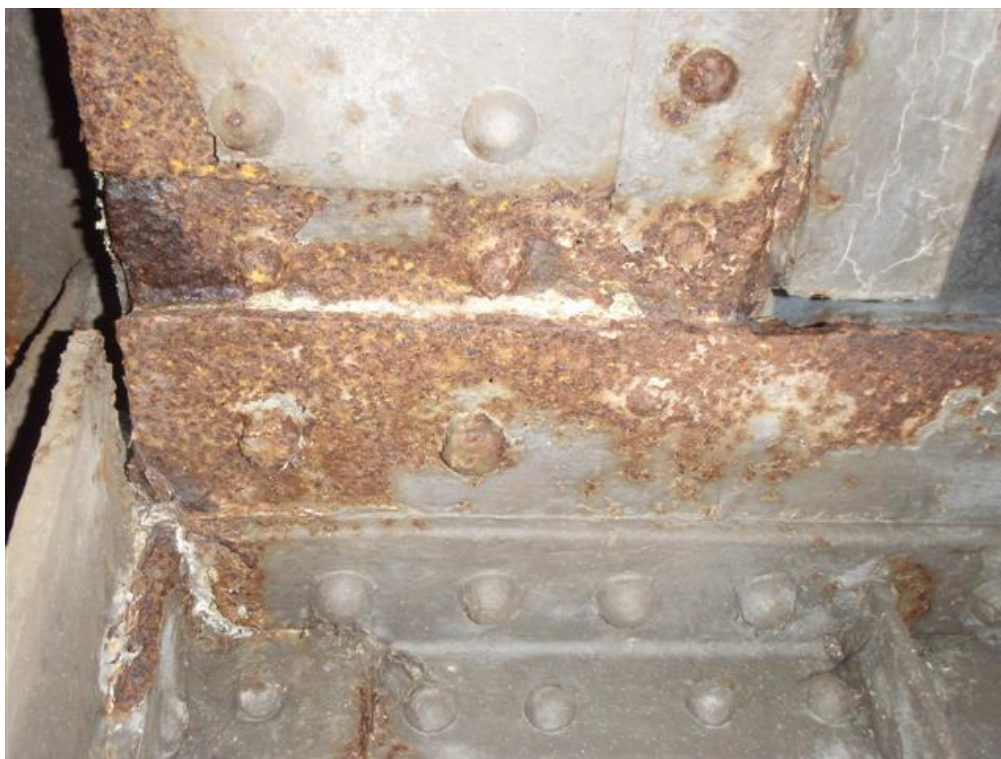
P39 - MGI6-TB downside-Thin/lamin at HM - 19/04/11

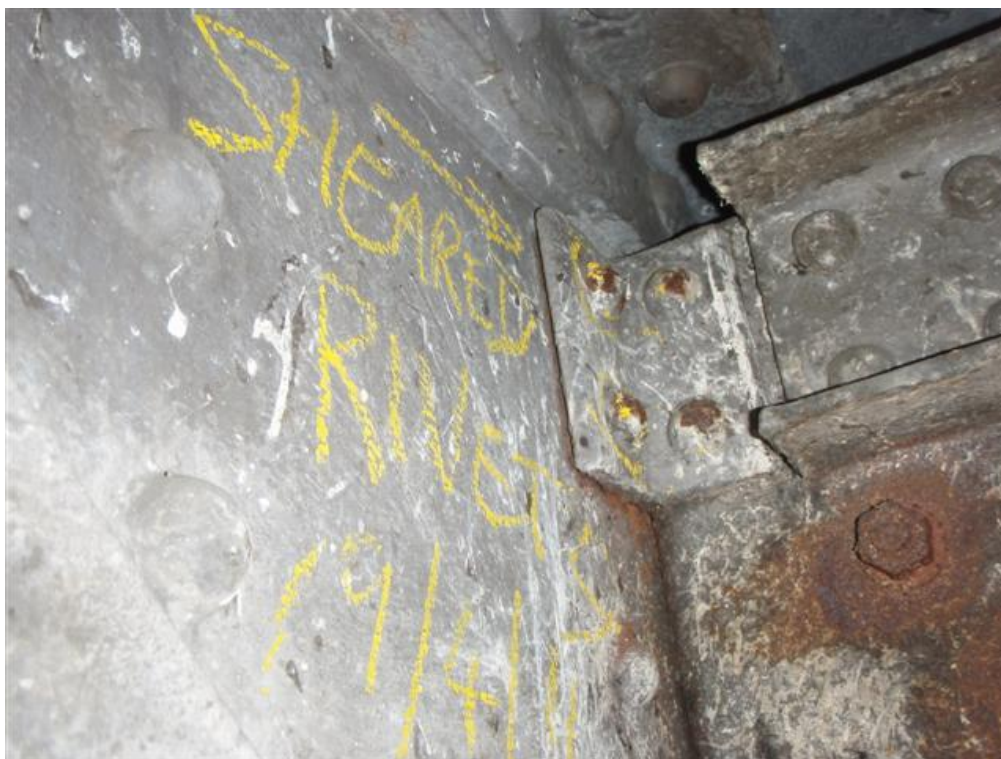
P43 - MG16-TB-Tie plate-Sprung plate at HM upside - 19/04/11

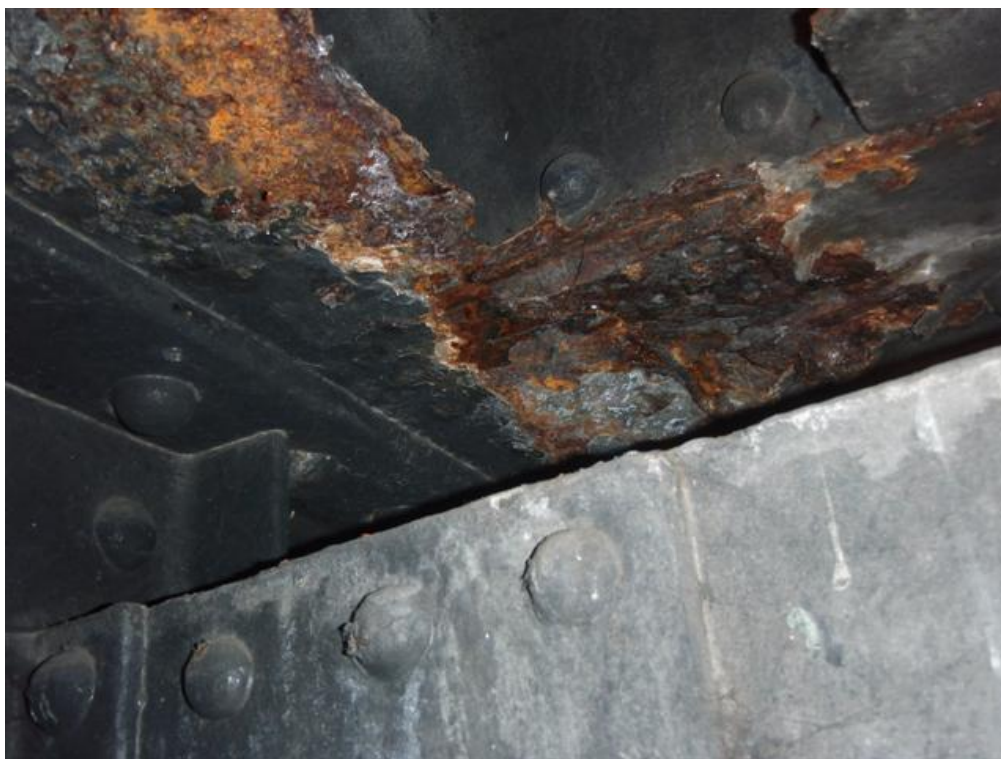
P45 - MGE2-TB downside-LOS at LM - 17/04/11

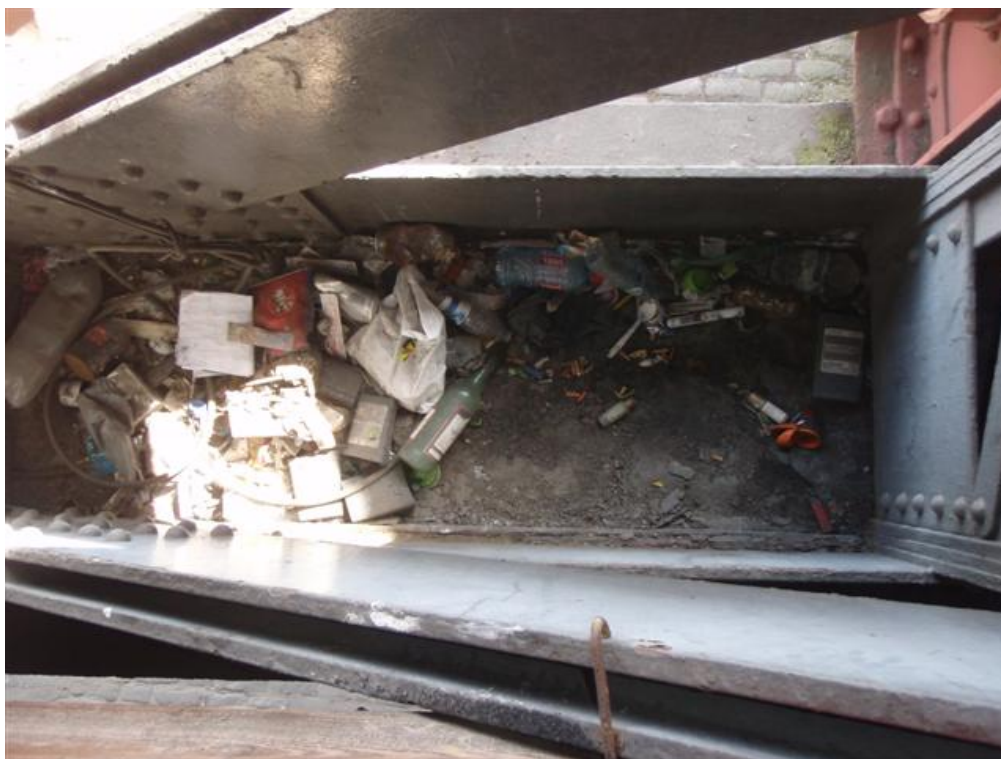
P49 - MGE2-BB-Debris in interal trough - 18/04/11

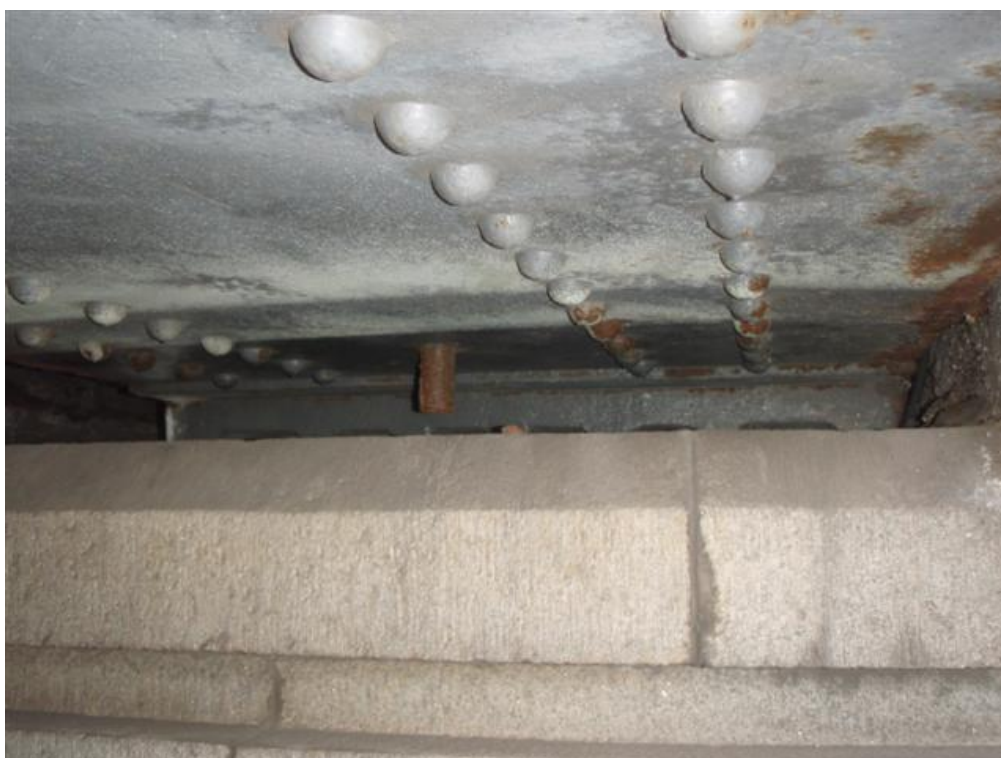
P50 - MGE2-BB-Typical corrosion to BB at HM end - 22/04/11

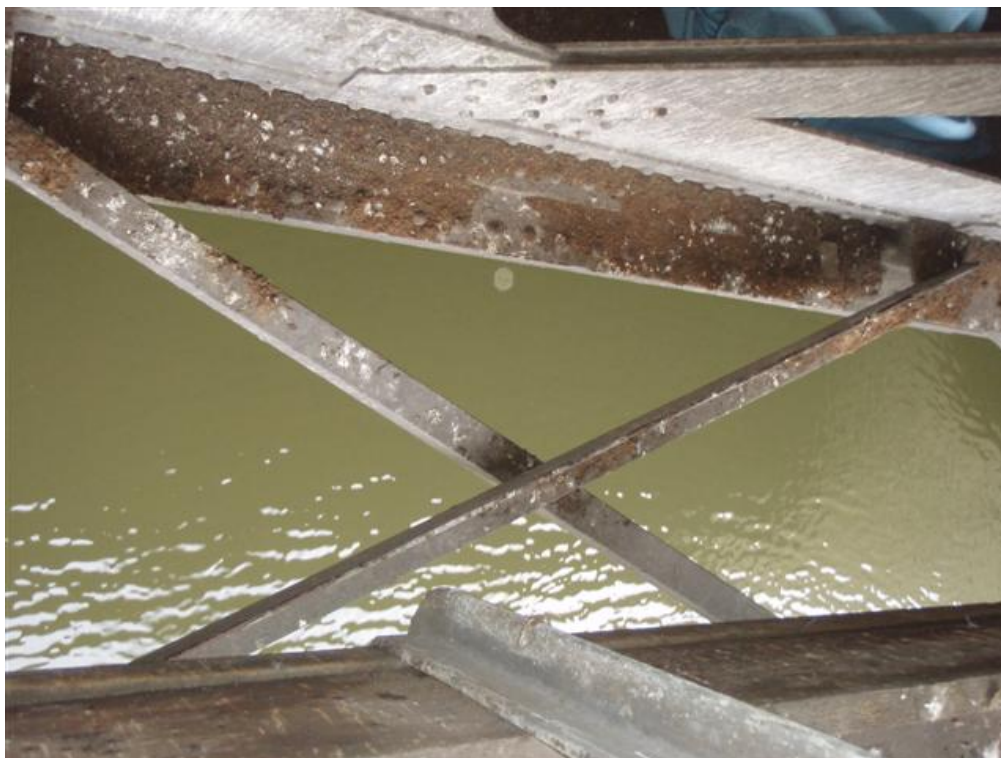
P60 - BRG-Typical corrosion to lower bracers - 18/04/11
