BRIDGE DETAILED & HCE EXAMINATION REPORT

ELR: WCM2	Contract Mileage: 102 m 0088 yds 4.00 ch			Struc. Ref 031/082A	
Examination Type:	Additional Assess HCE	NR ID:	11016334	Exam Date:	14-Feb-2012
Area:	Scotland West	BRS:	0	OS Ref:	NS58716475
Structure Name:	NEW CLYDE BRIDGE	Type:	BU	Exam ID	305231
Route:	Gretna - Glasgow Central (via Beattock)	Complete Examination:		N/A

OS Ref: NS58716475 BRS: Name: NEW CLYDE BRIDGE

The remit was to examine structural elements affected by HCE code MJA in accordance with document HCE – Codes v1.5.

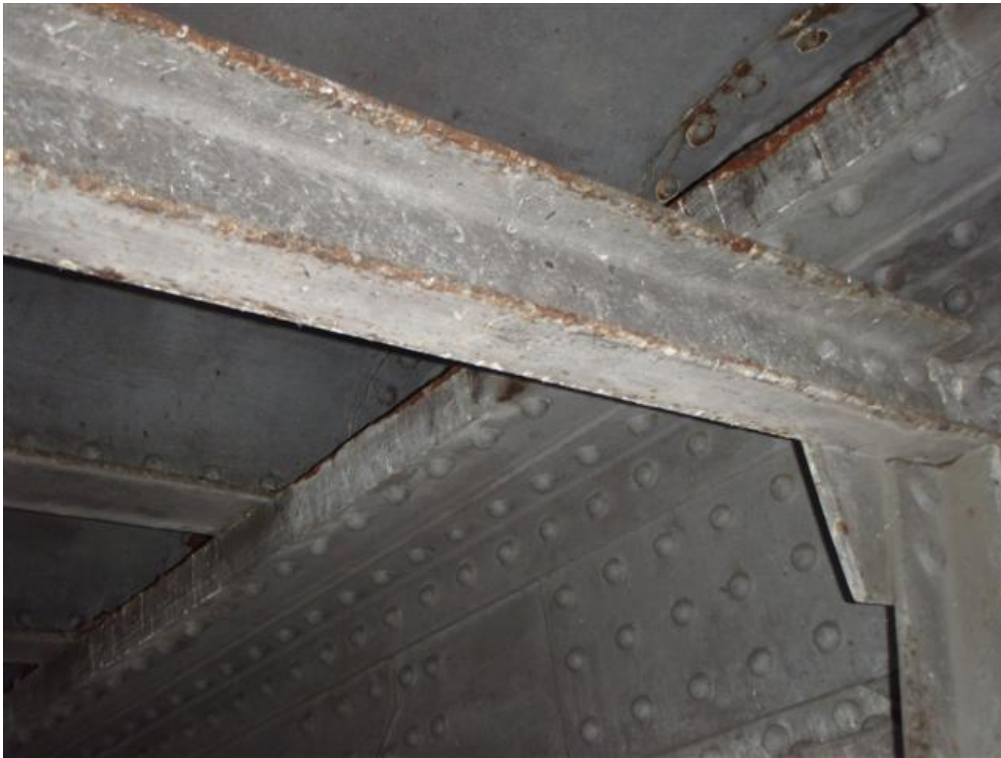
P61 - BRG-Typical corrosion to transverse bracers - 18/04/11

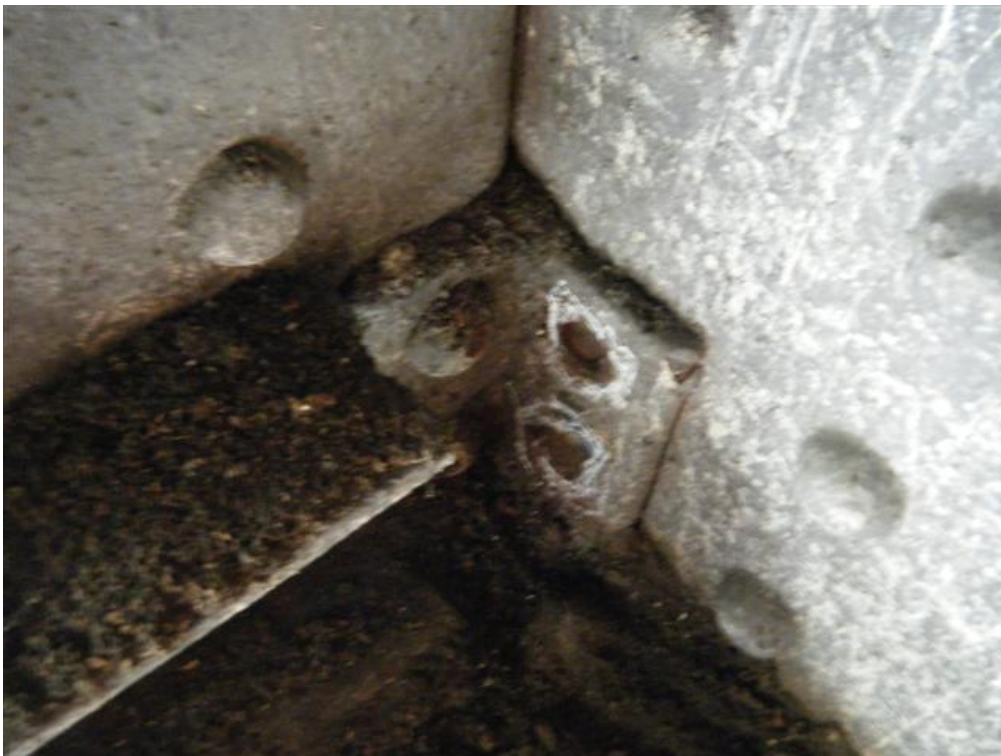
P62 - BRG-Sheared rivets at transverse bracer at MG17 - 20/04/11

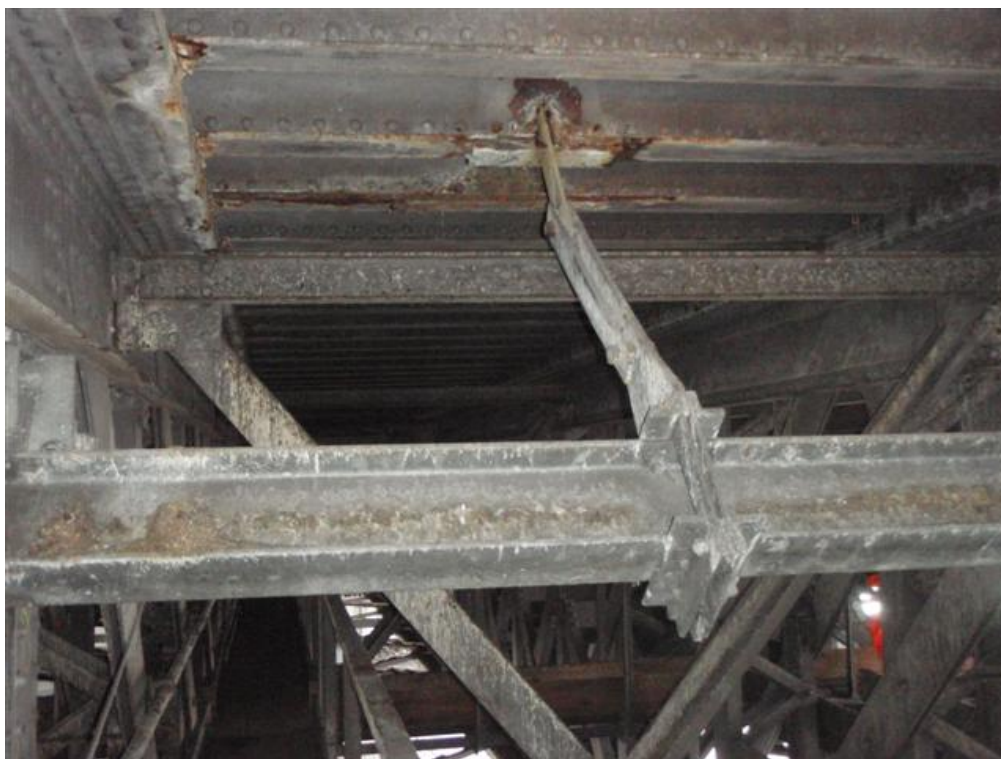
P67 - DCK3-Support beam at VP18 - 19/04/11

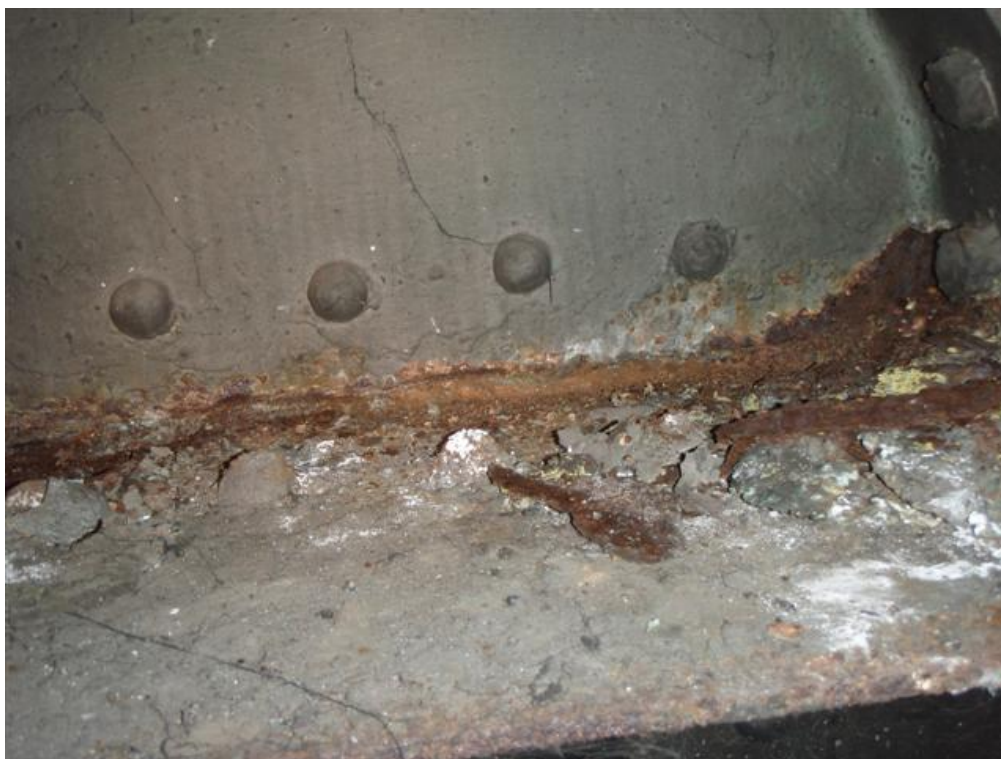
P69 - DCK6-Thinning to trough ends - 17/04/11

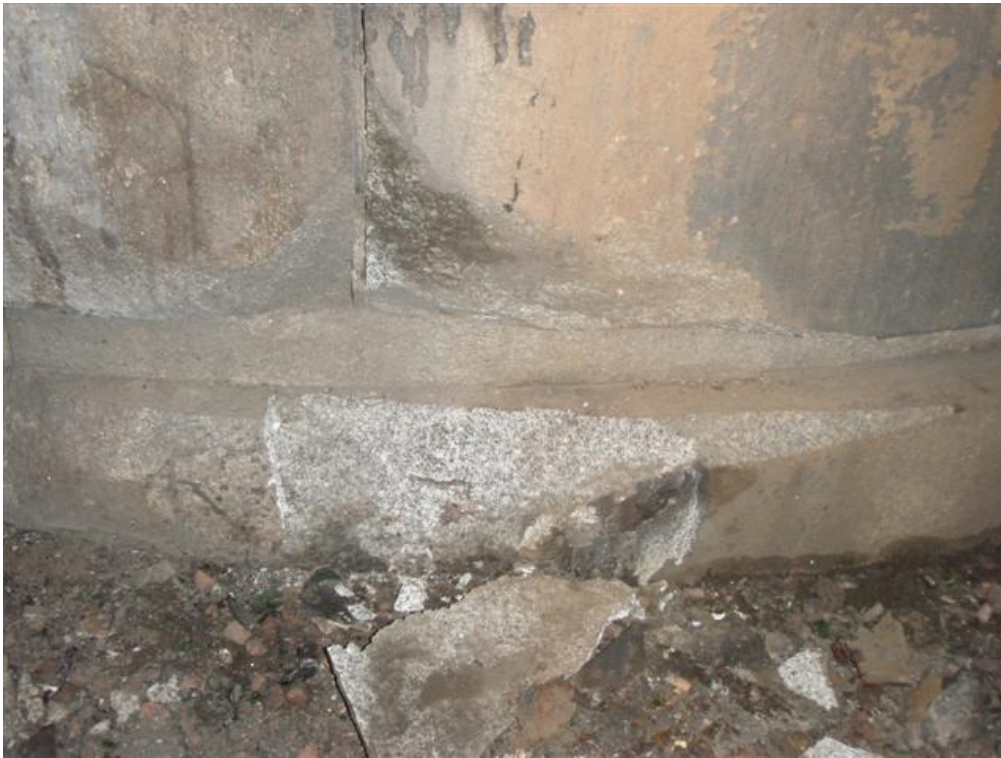
P73 - ES1-COL1-Spalling to upside rear - 20/04/11

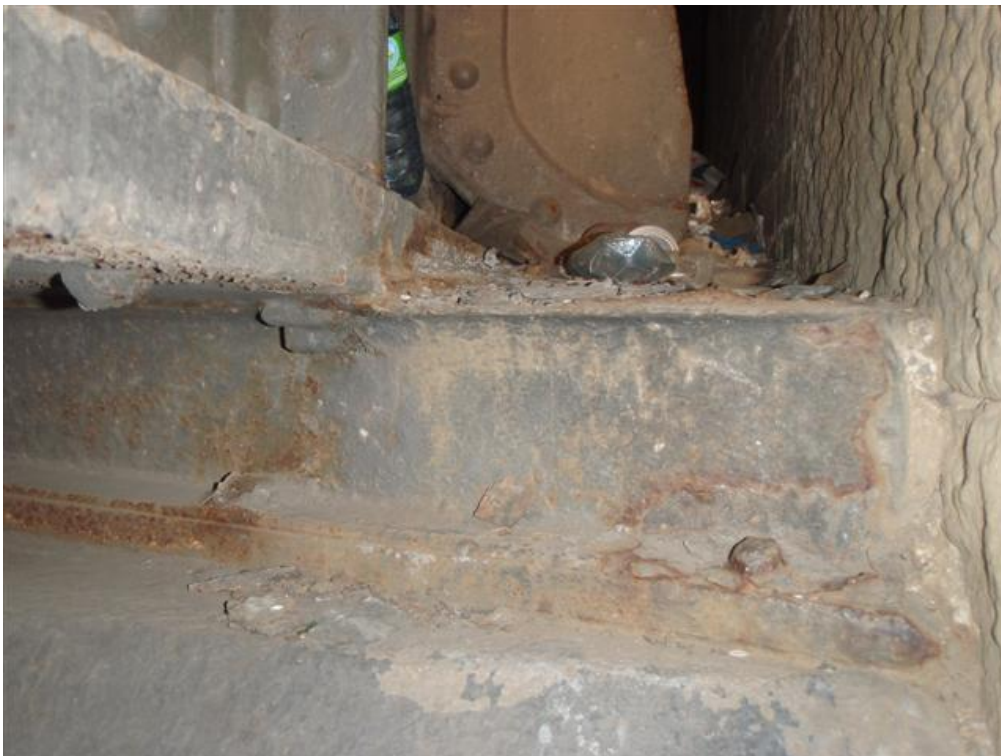
P74 - ES1-COL1-Thinning to KE of exposed steel - 20/04/11

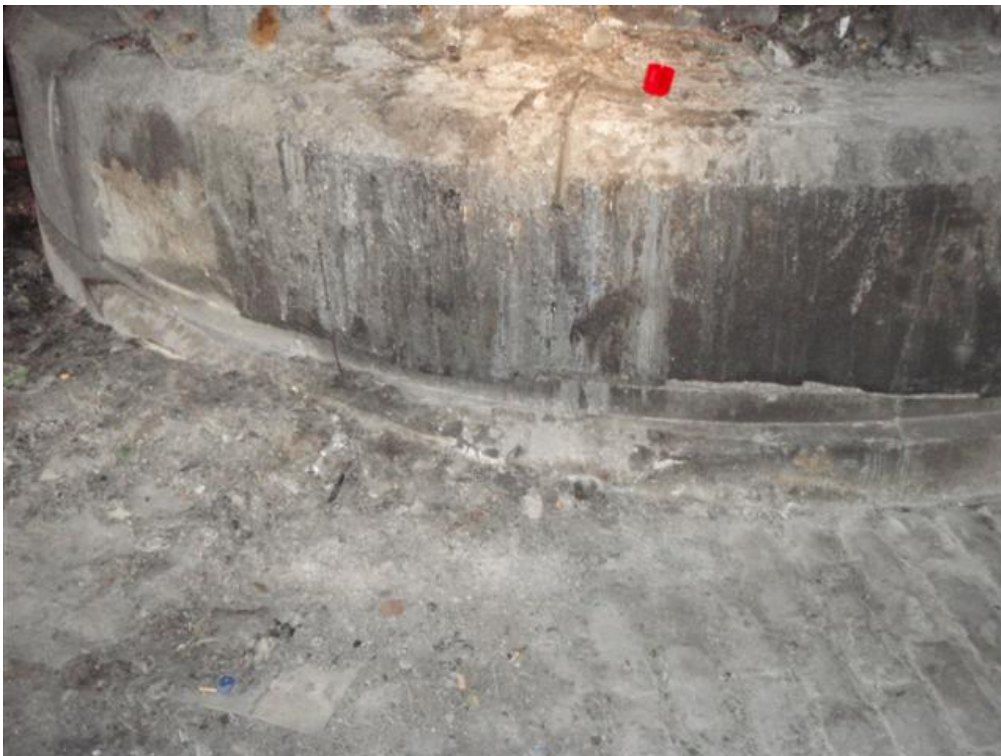
P76 - ES1-COL3-Spalling due to fire damage at HM - 20/04/11

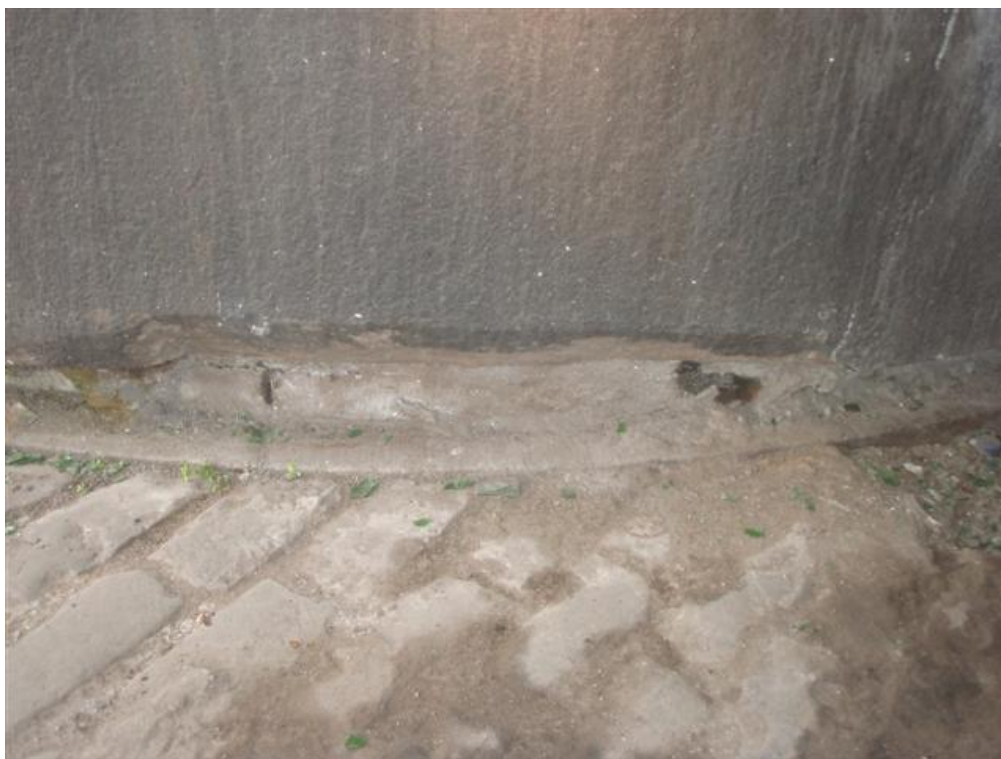
P77 - ES1-COL5-Spalling at HM downside - 20/04/11

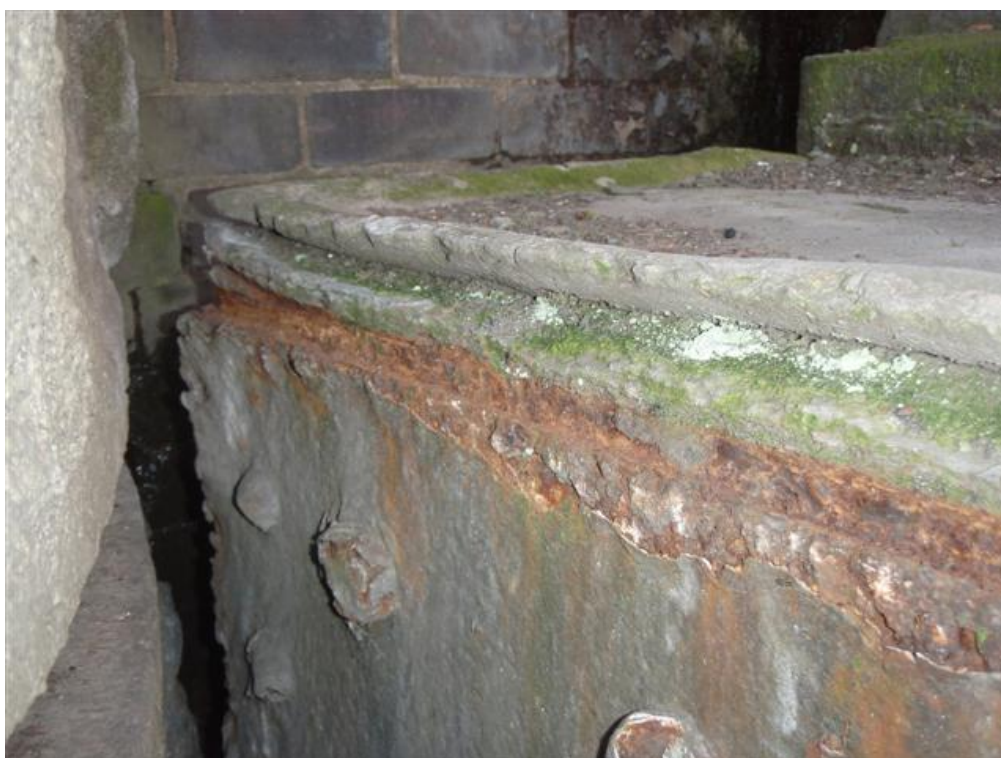
P78 - ES1-PCL1-Typical lamination to bitumen coating - 17/04/11

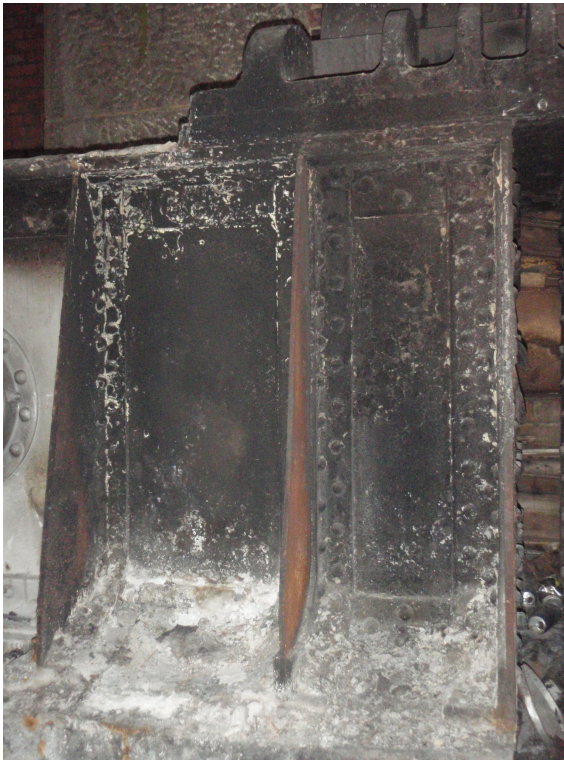
P81 - ES1-PCL1-Fire damage to Girder 3 downside - 20/04/11

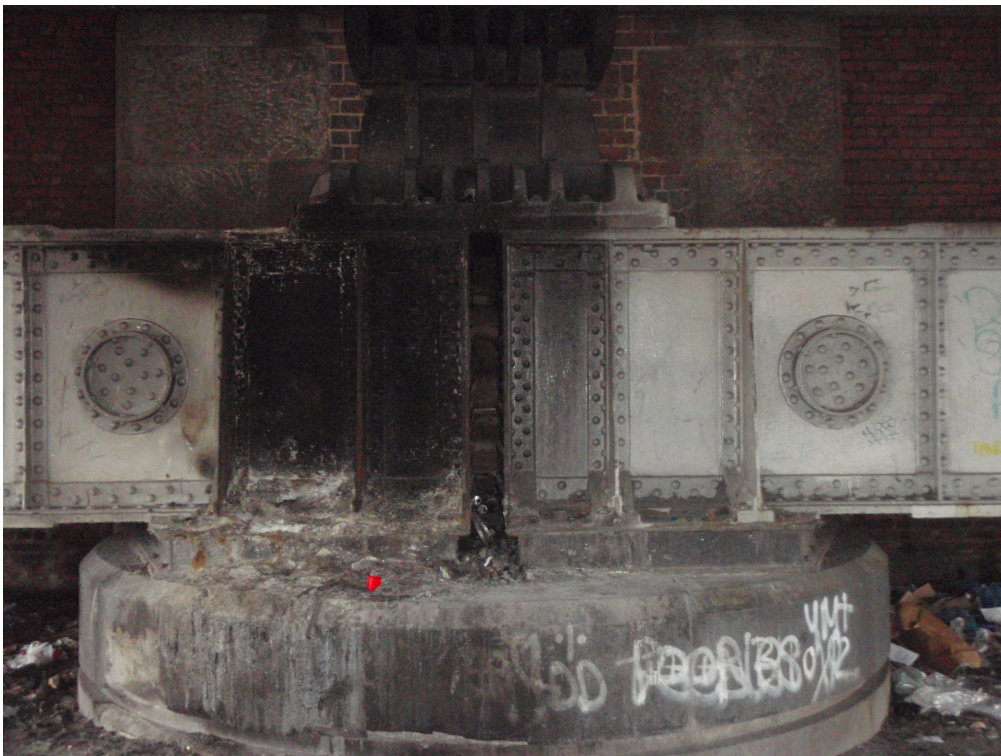
P82 - ES1-Fire damage to column, girder & bearing - 20/04/11

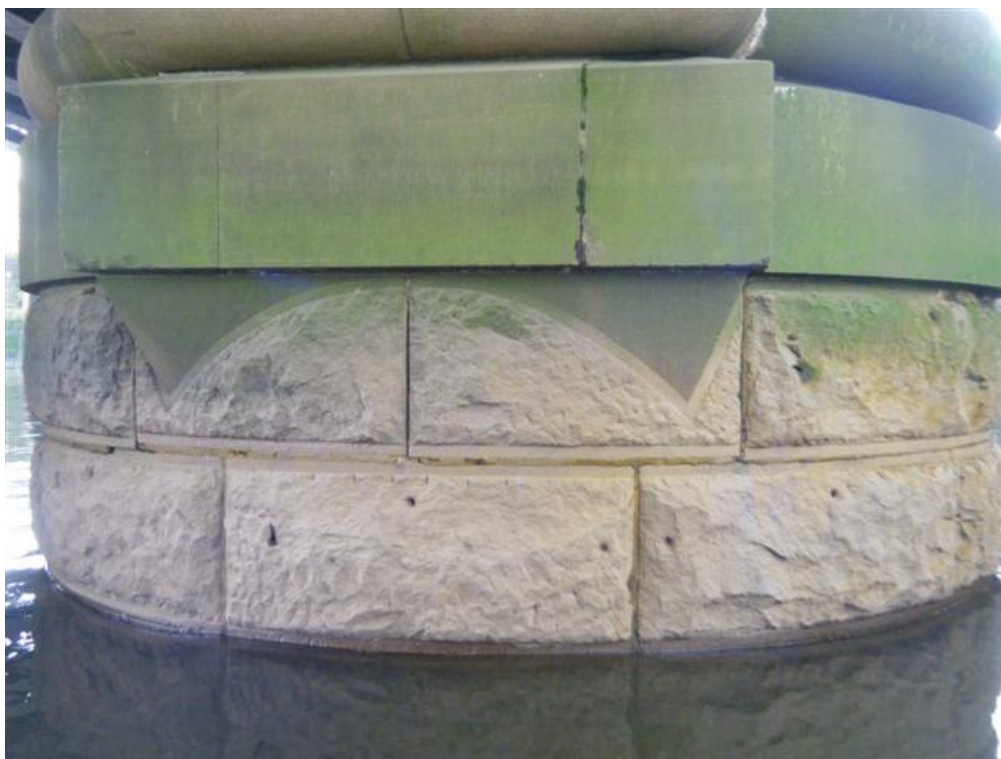
P87 - IS1-COL2-Typical open joints - 22/04/11

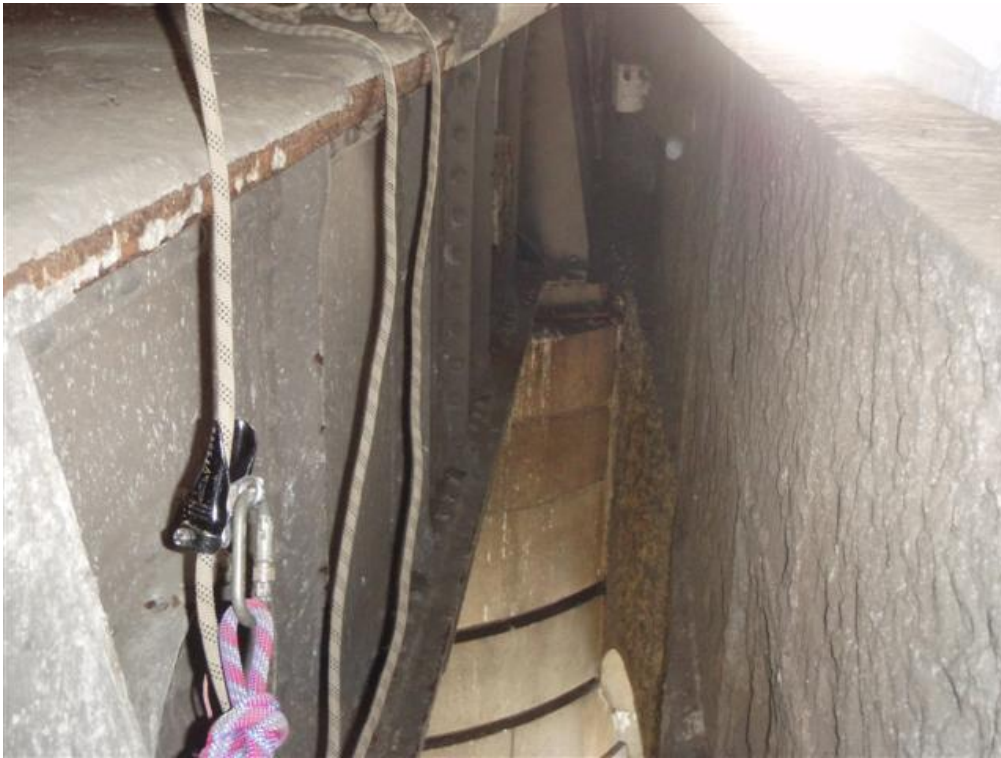
P89 - IS1-PCL1-Typical corrosion to top flange - 22/04/11

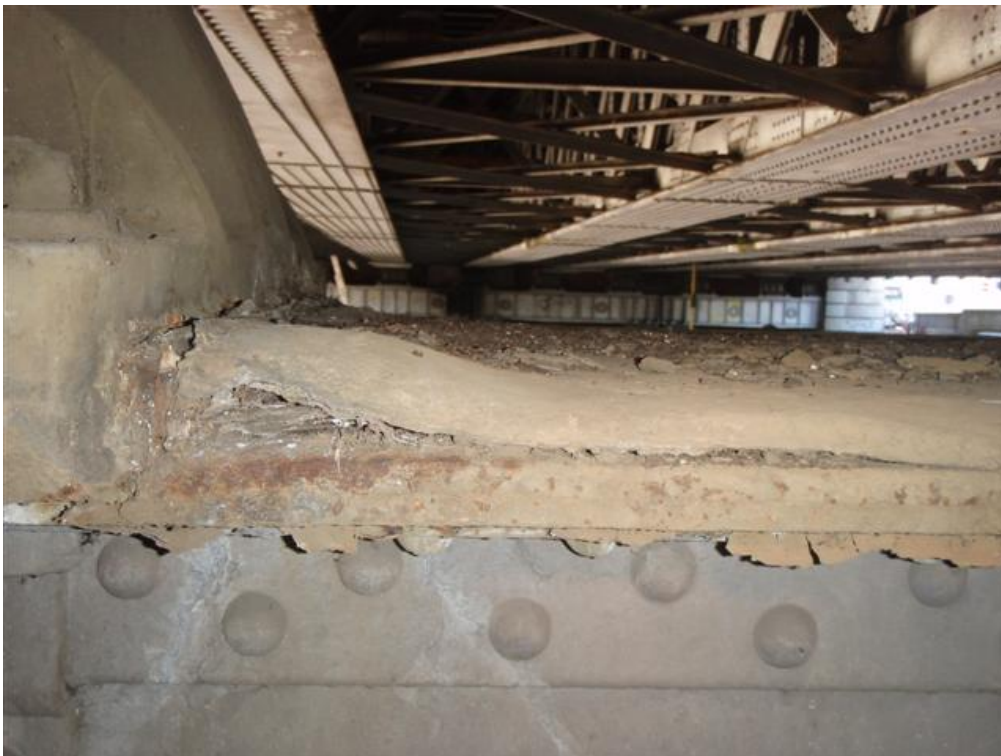
P90 - IS1-PCL1-Typical lamination to bitumen coating - 26/04/11

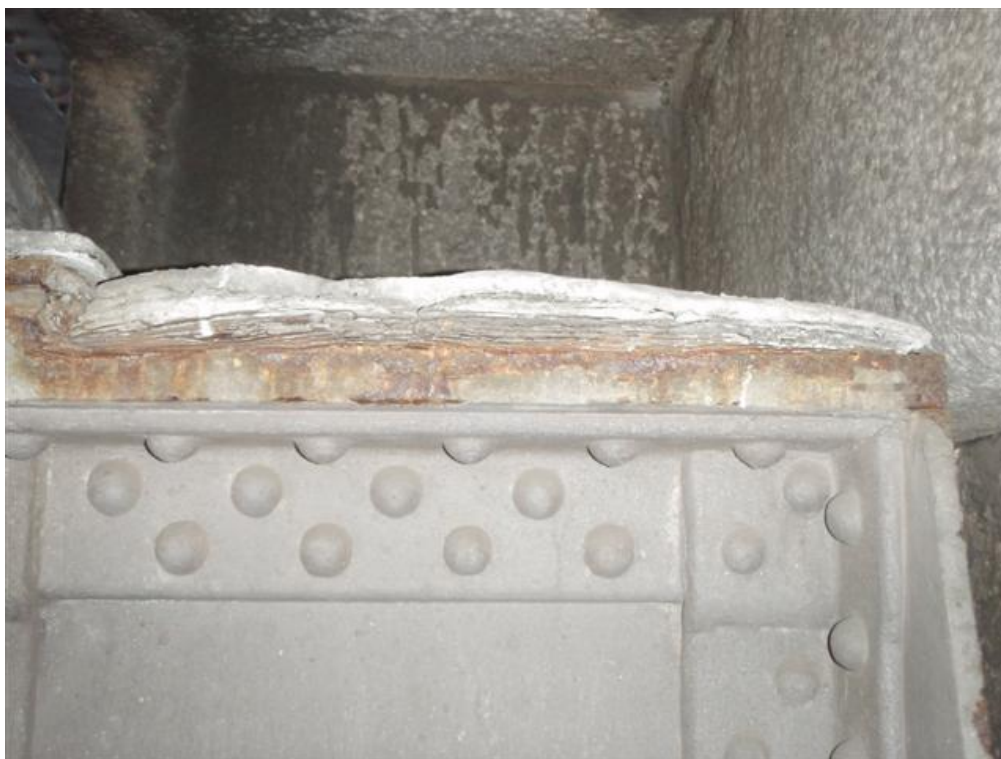
P91 - IS1-PCL1-Thin/lamin to top flange at HM down - 26/04/11

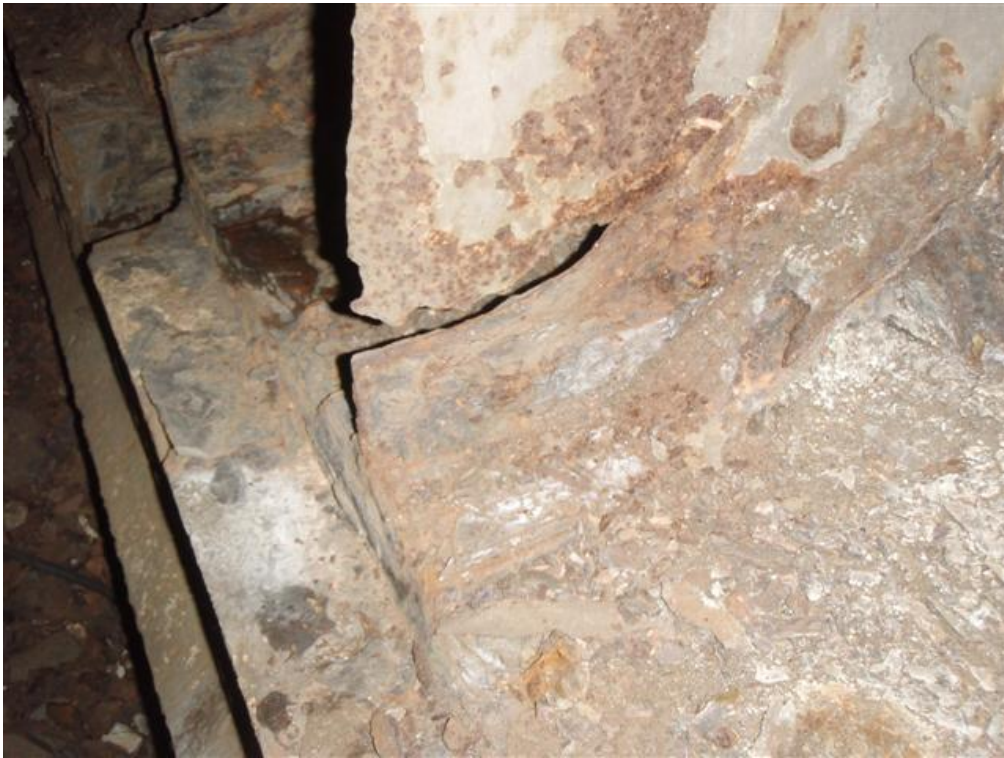
P95 - IS1-PCL1-LOS to 5th web stiff at HM up - 22/04/11

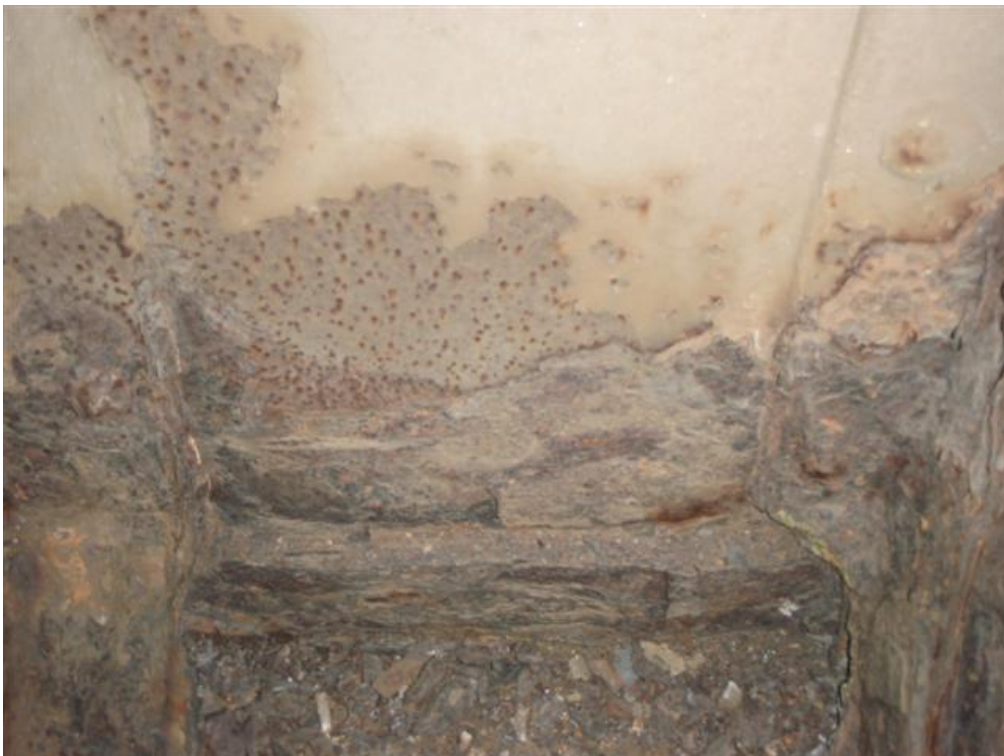
P96 - IS1-PCL1-Thin/lamin to web at HM up - 22/04/11

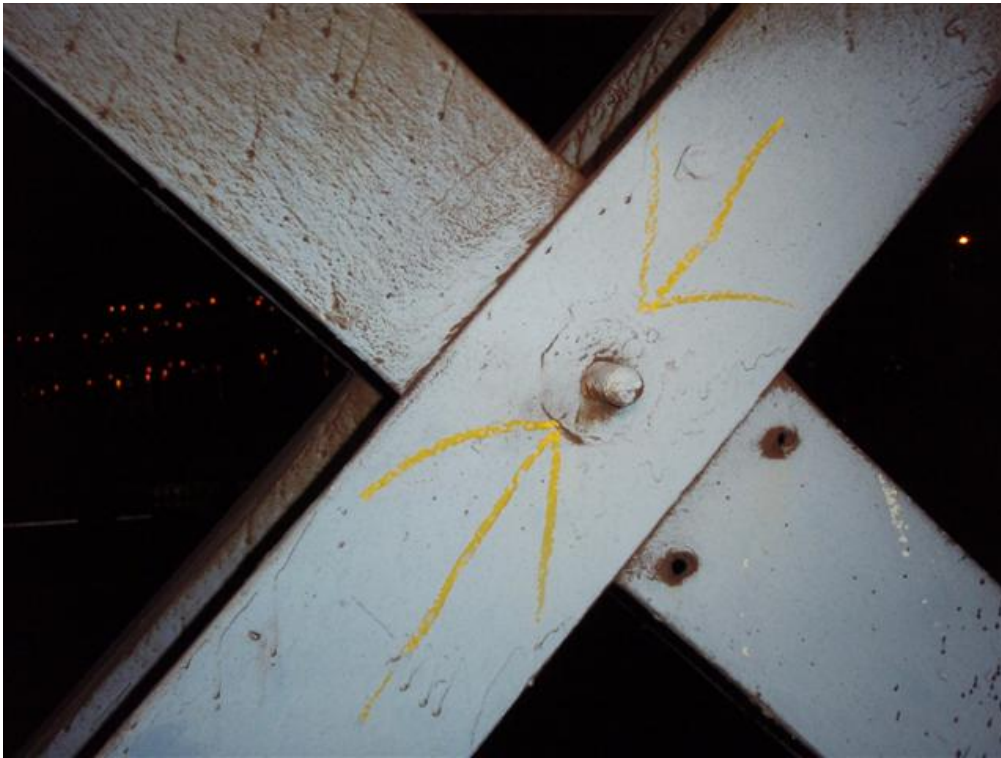
P101 - DK1-PPT2-Bolt missing at 17m from LM - 06/03/11

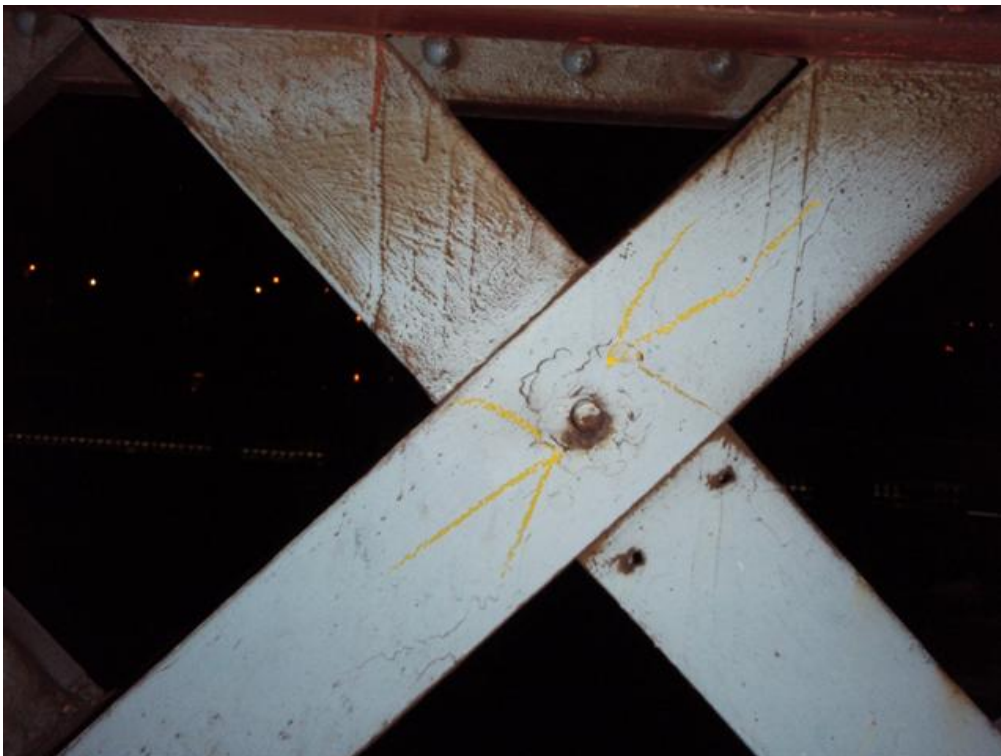
P102 - DK1-PPT2-Bolt missing at 10m from LM - 06/03/11

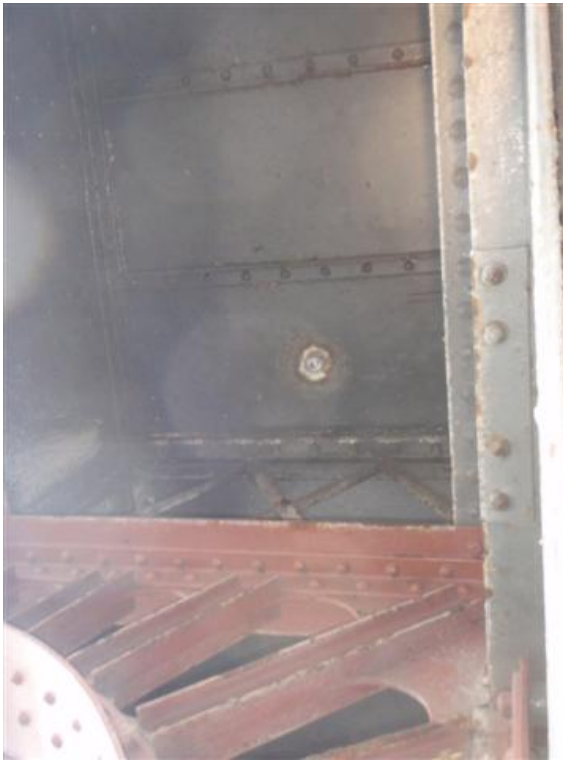
P105 - Walkway Downside-Typical corrosion to steel deck - 21/04/11

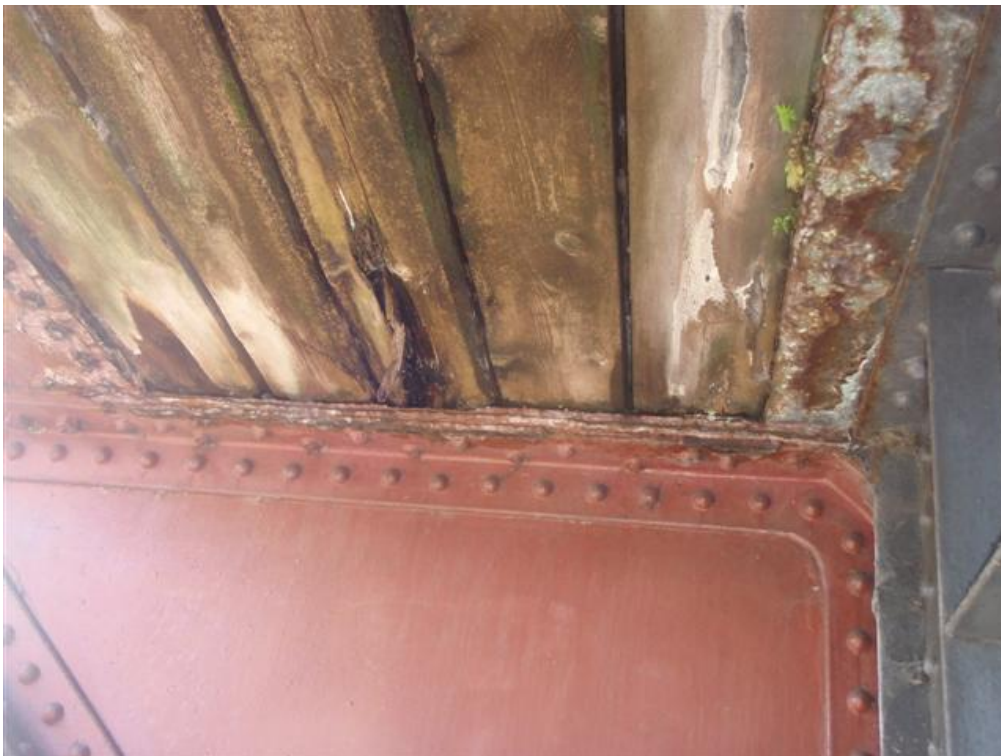
P106 - Walkway Upside-Rotting timber at LM side - 17/04/11

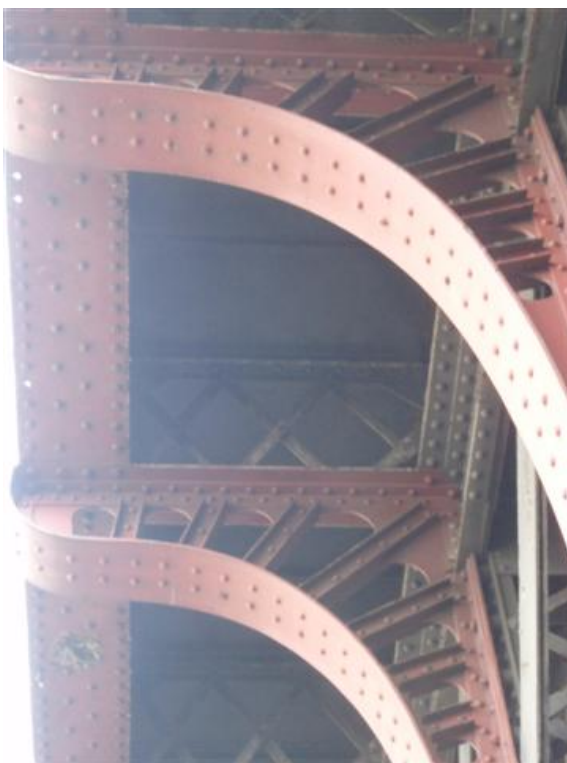
P107 - Cantilever Downside-Typical corrosion - 21/04/11

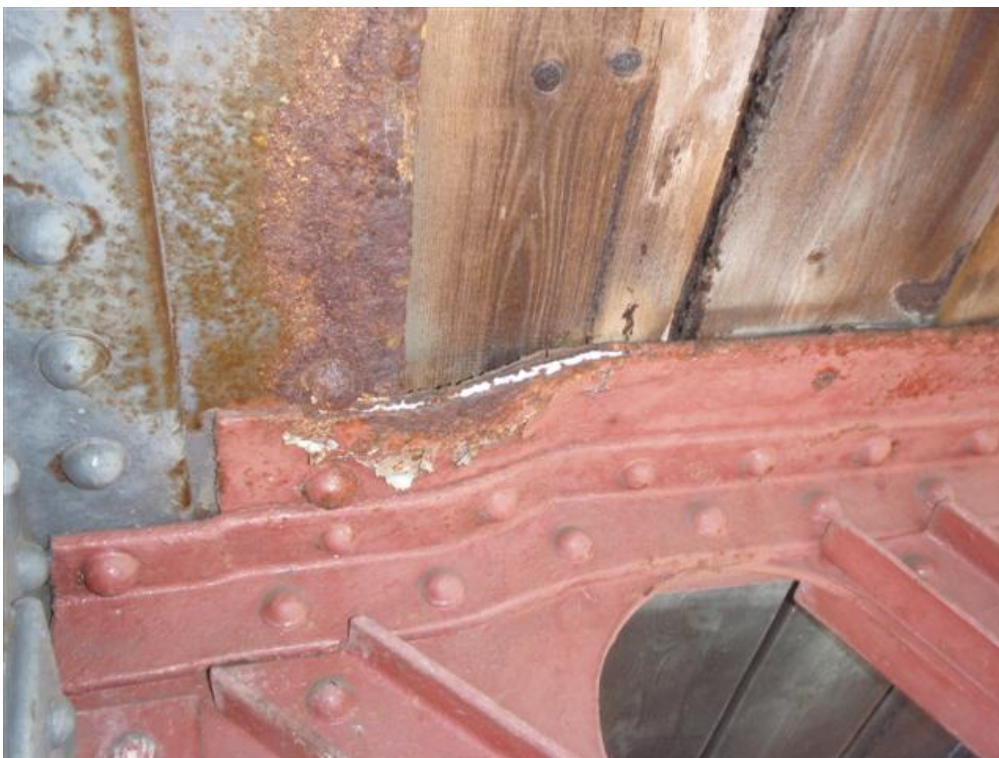
P108 - Cantilever Upside-Typical lamin & LOS - 17/04/11

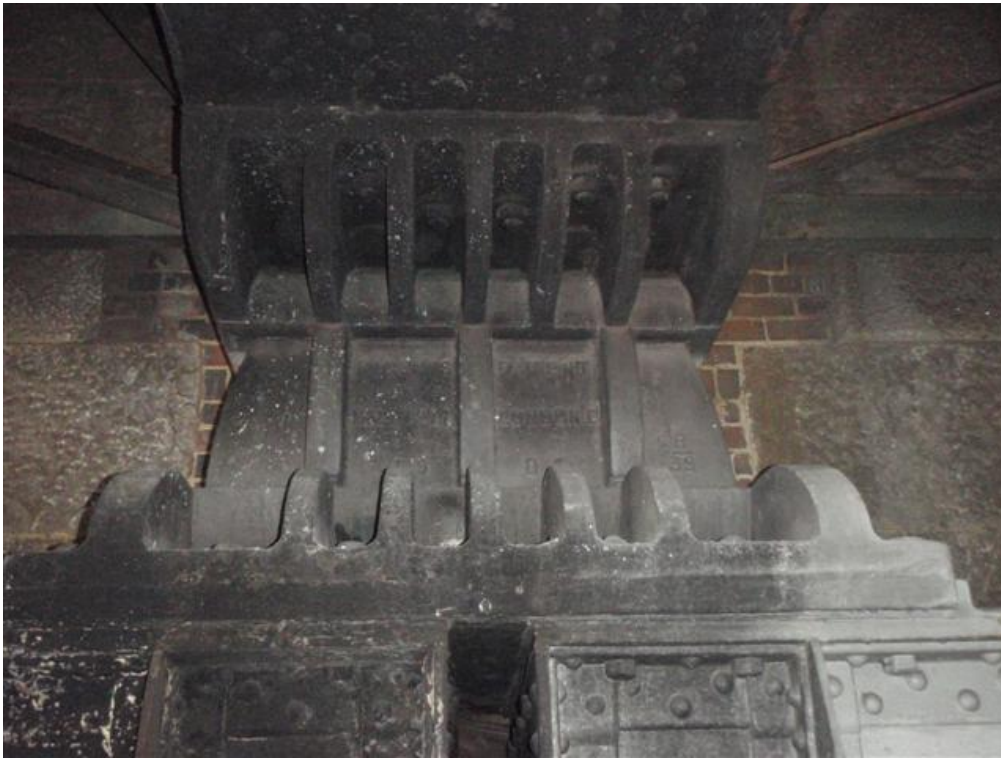
P109 - DK1-BGL1-Fire damage to bearing under MGI5 - 20/04/11

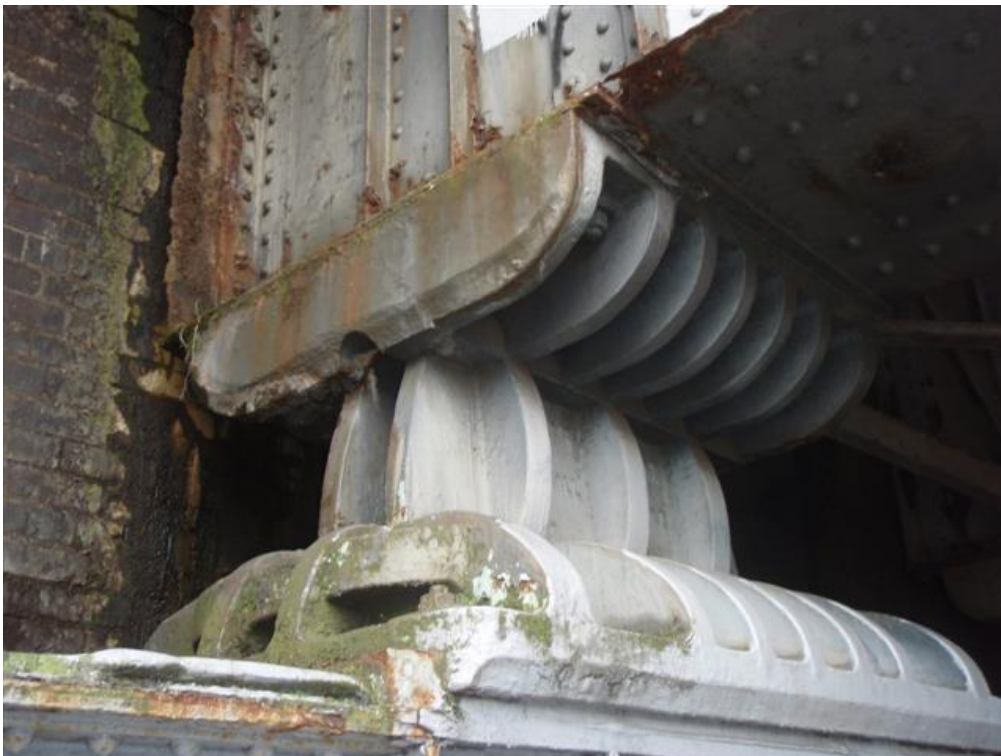
P110 - DK1-BGL1-Corrosion to bearing under MGE1 - 20/04/11

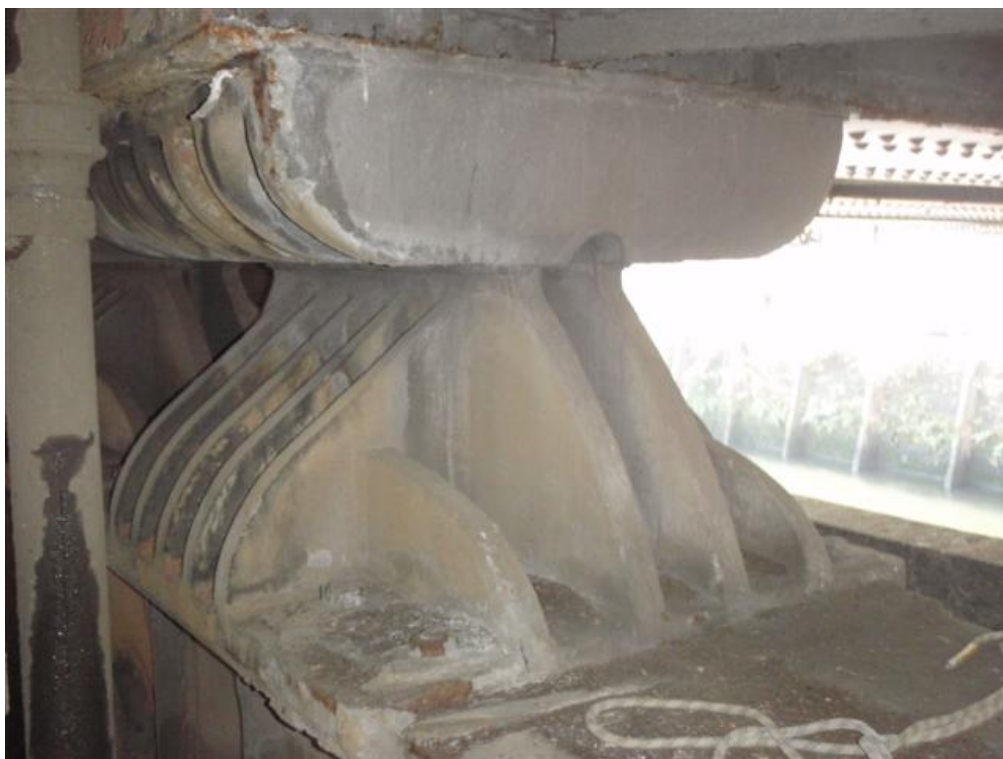
P111 - DK1-BGL2-Corrosion to bearing under MGI7 - 26/04/11

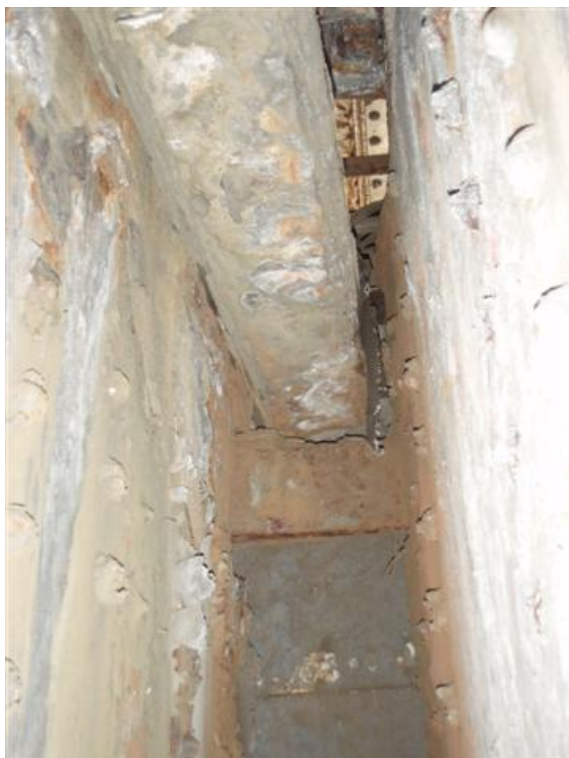
P112 - Gutter-Typical corrosion - 20/04/11

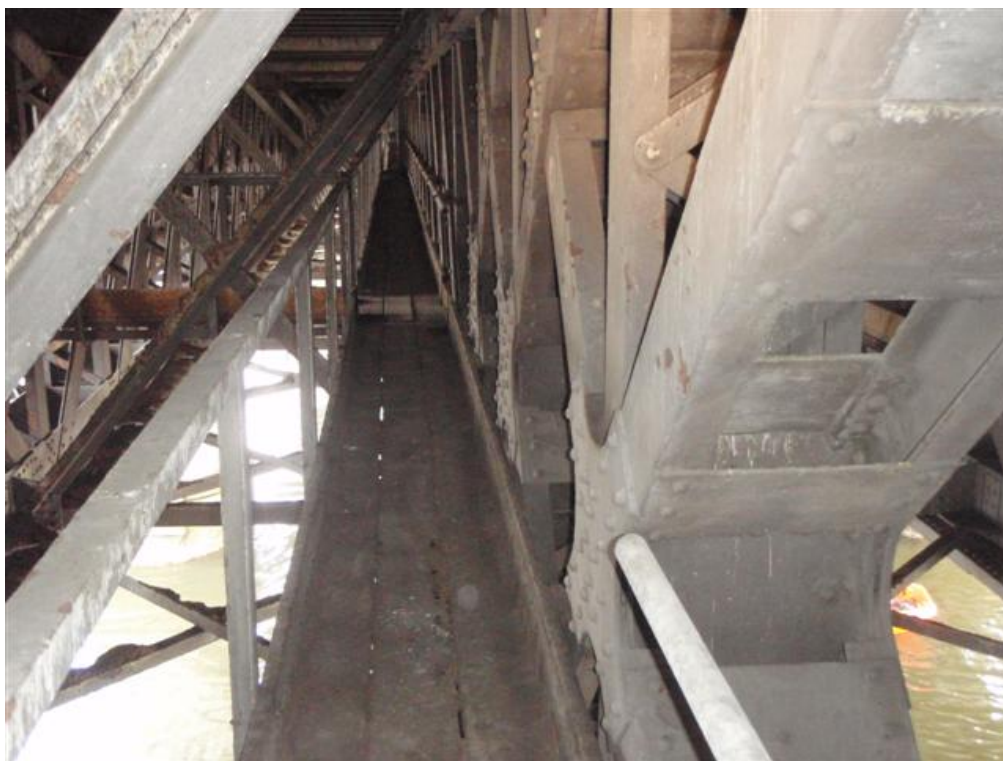
P113 - Walkway Handrail -Missing section at middle - 20/04/11

ITEM	DESCRIPTION	LOCATION	Est. Cost £ +/- 20%	Priority Within	Quantity	Severity	Probability	Risk Score	Works Category
1	Make good defective, damaged or missing sections of walkway handrailing	6m long section of rail tubing missing to main girders mid span, upside face	0.00		1.00 unit	5	2	E10	Handrail renewal/repair
2	Renew/repair & clean as appropriate walkway rails floor boards and toe boards. Area up to 100mm deep in bird dirt.	Isolated Toe boards missing, floor boards fire damaged and or damp.	0.00		1.00 unit	5	2	E10	Other
3	Clean out debris (general hazard), discarded timbers (fire risk)and any drug users detritus (needles) by appropriate methods.	Isolated MG btm boom areas, cut wood stacked by LM box bearing girders.	0.00		1.00 unit	5	2	E10	Other
4	Ensure bridge drainage guttering and downpipes are present and effective as water leakage from system as examined causing extensive steelwork corrosion.	Throughout superstructure.	0.00		1.00 unit	2	3	E6	Water Control

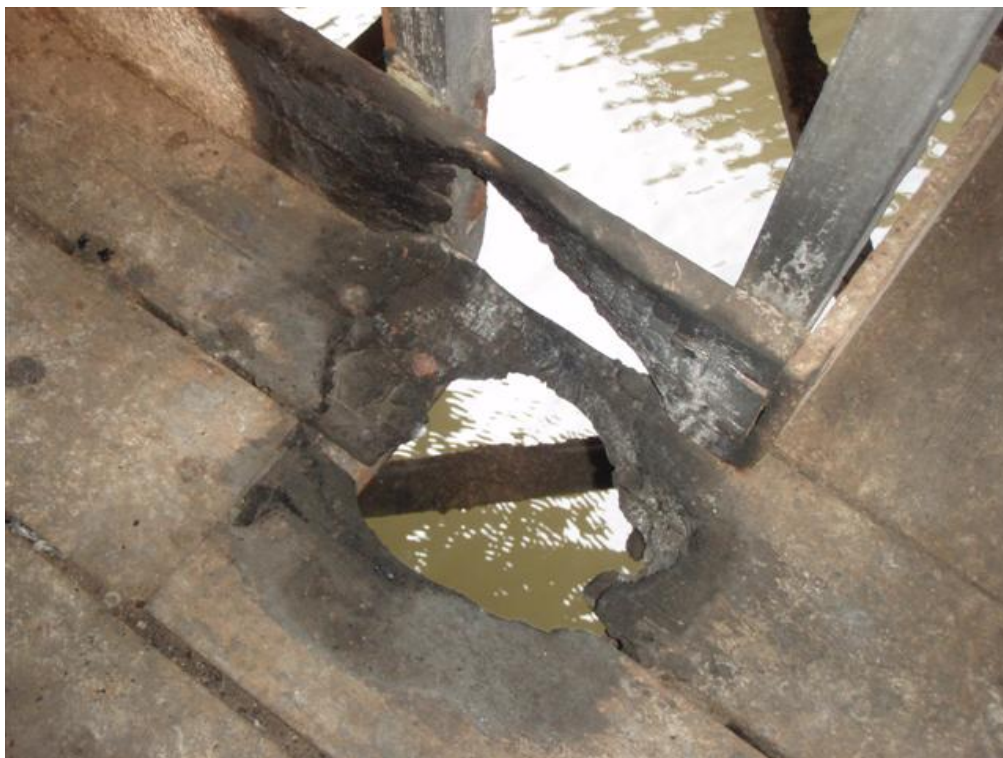
P114 - Walkway 2-Fire damage at VP15 at MGI2 - 20/04/11

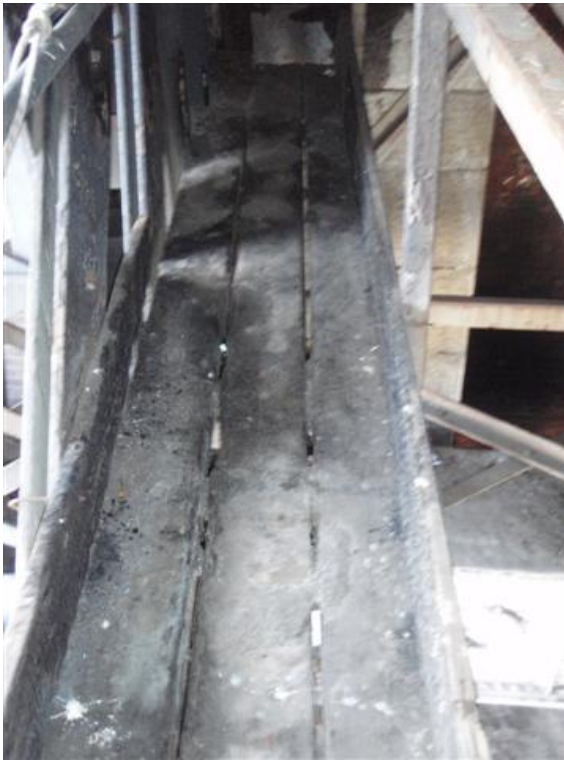
P115 - Walkway 9-Fire damage at LM end - 17/04/11
