St Andrews Harbour
North West Slipway

Feasibility Study into the
Reinstatement of the North
West Slipway & Harbour Wall

July 2024

CLIENT: St Andrews Harbour Trust
PROJECT TITLE: St Andrews Harbour North West Slipway
REPORT TITLE: Feasibility study into the Reinstatement of the North West
PROJECT REFERENCE: 159462
DOCUMENT NUMBER: 159462-DOC-01

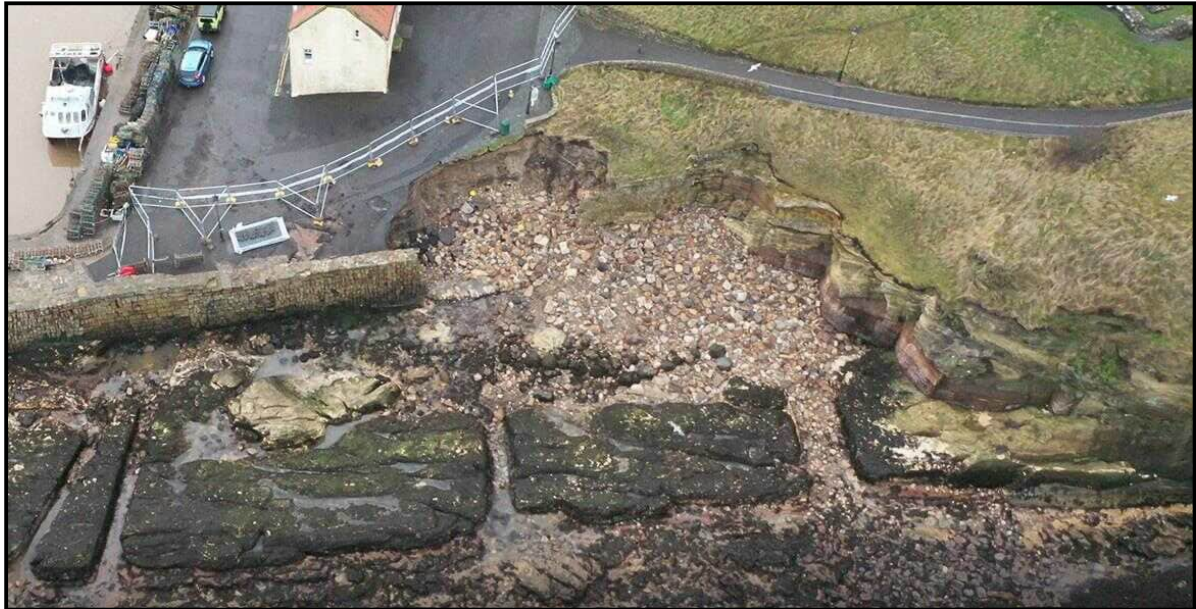
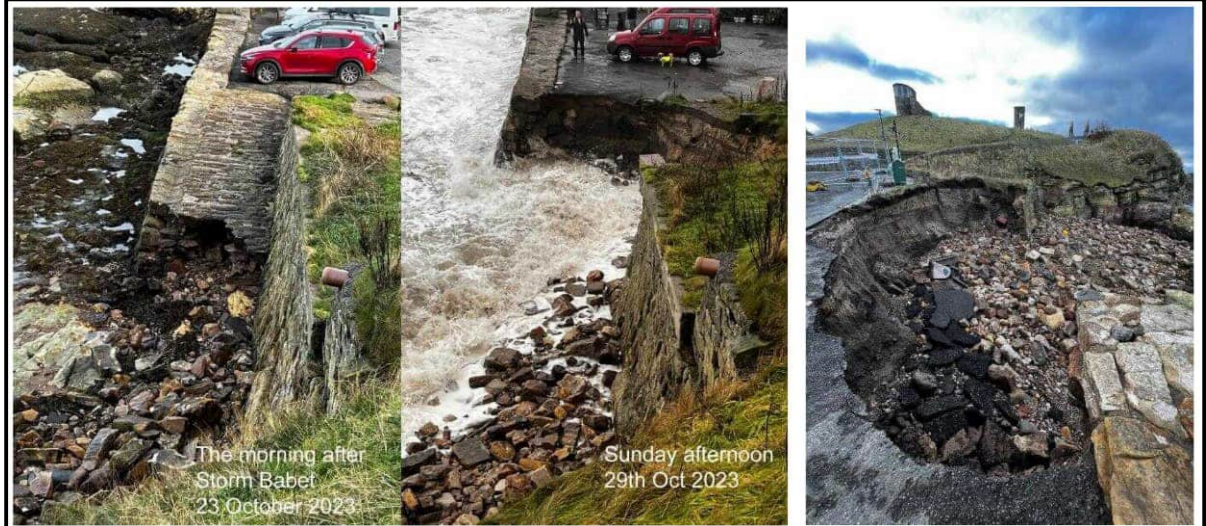
Aerial Photograph Dates: Aerial Photographs obtained on 15th November 2023

Rovarch Findings: The most obvious damage to the main pier was the loss of the adjoining NW slipway, the cliff and roadway/parking areas. This damage has exposed the western end and face of the north main pier seawall. Fife Council carried out temporary coastal protection works by installing a rock armour barrier.
