BRIDGE & STRUCTURE EXAMINATION REPORT

Additional Examination

161/343

Structure Name: ANNAN VIADUCT

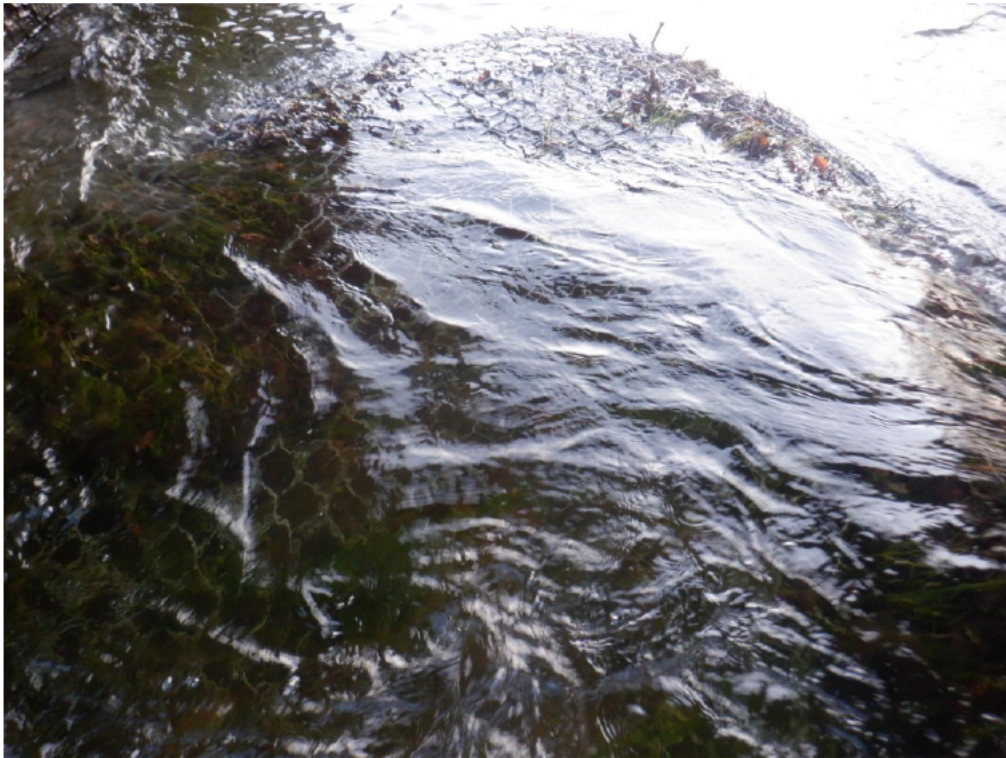
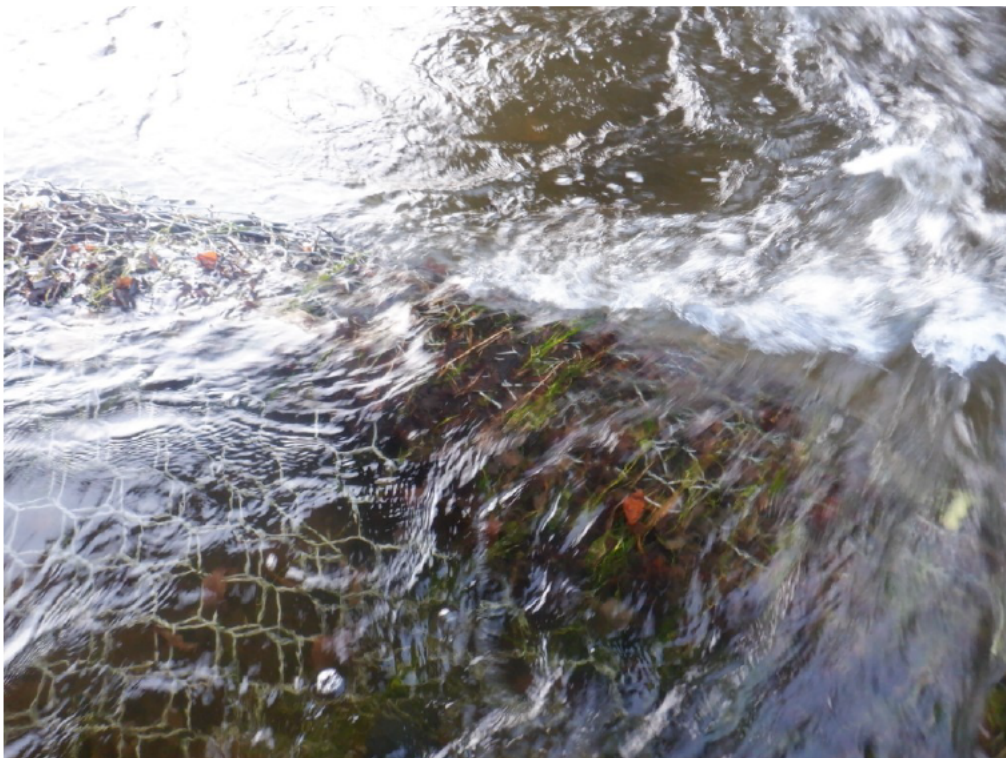
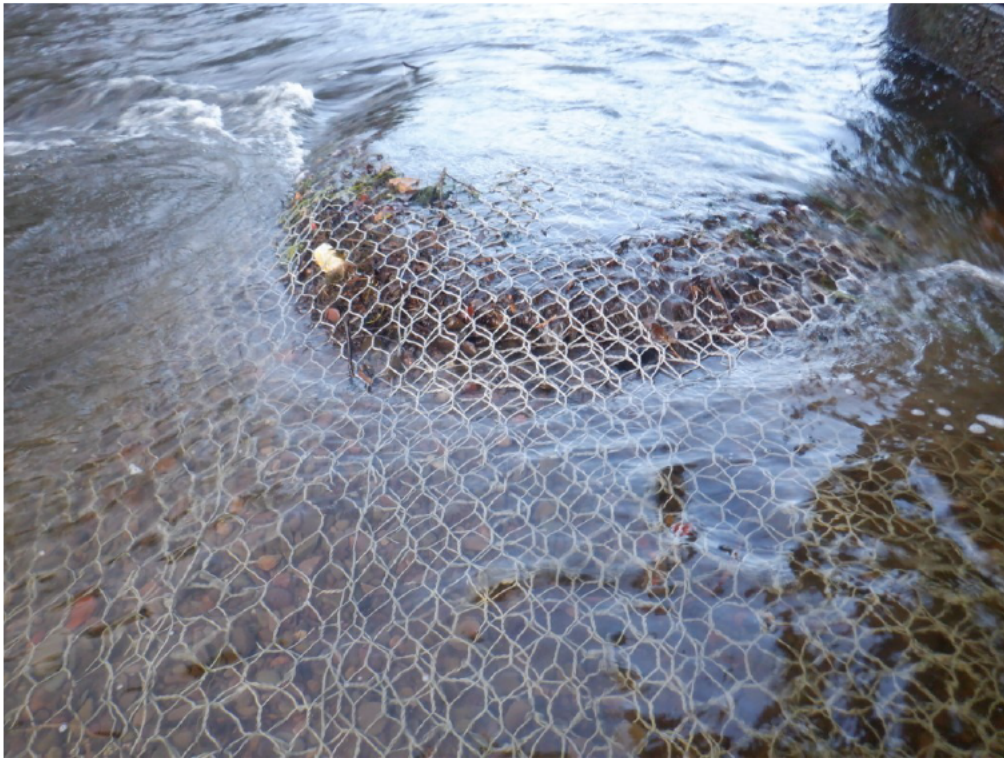
- O/S 0m and 4m to the upstream end, the top of the baskets are open and approx. 3sqm of fill has been lost. This has allowed the basket to deform and push up diverting the water into the pier face. SSD the bags have further deformed since the last exam (Photo 5-7)

P05 - Deformed gabion baskets

P06 - Deformed gabion baskets

P07 - Deformed gabion baskets

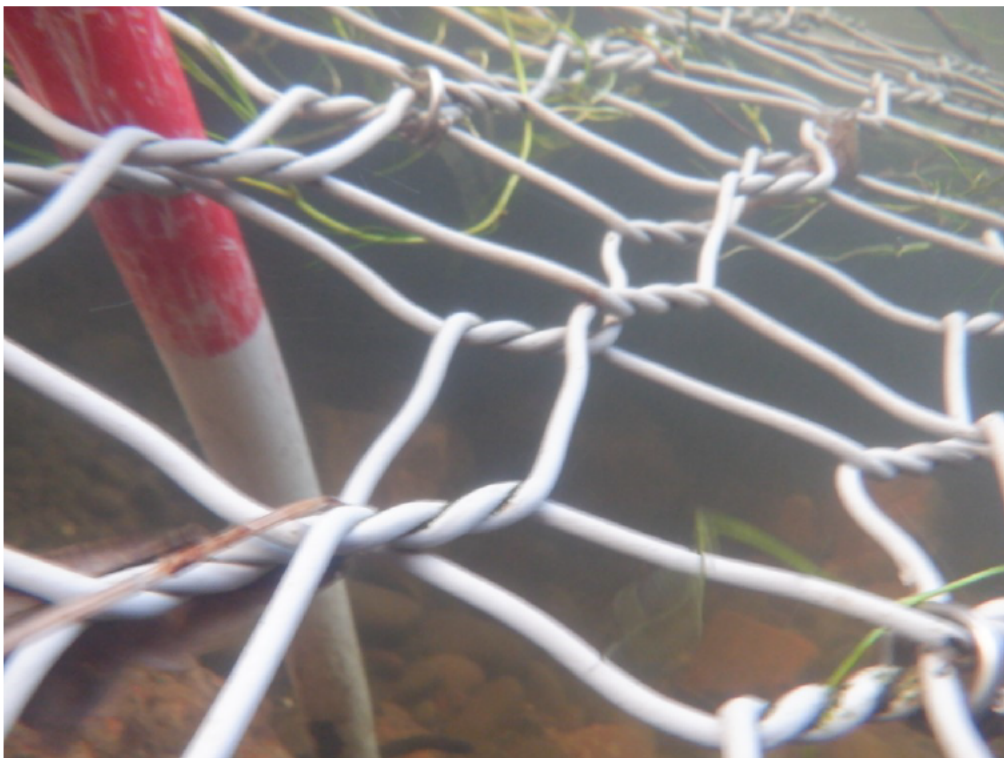
- O/S 0.5m³ loss throughout the baskets fronting the upstream nose, now with associated tear 500mm L this area was probed to 700mm depth at this exam. SSD (Photo 8)

P08 - Loss of fill to gabions

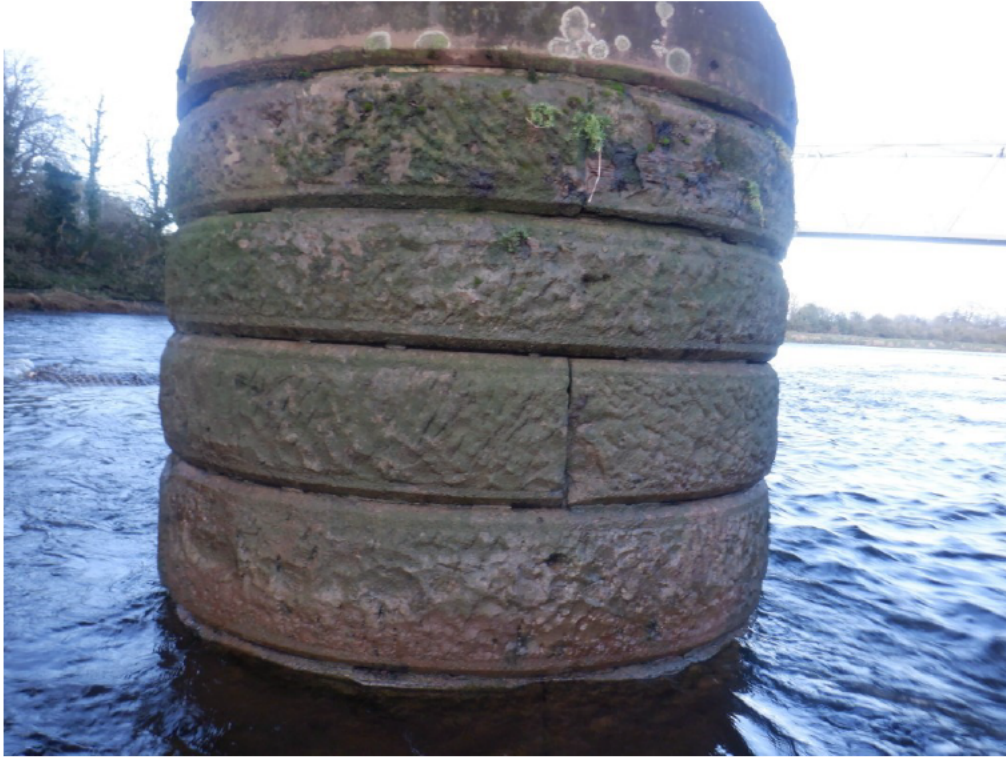
Downside (Downstream) Nose (Photo 9)

- O/S 2no vertical fractures each 2.5m L x 1-3mm W located to the LM side with associated spalling. NFD

- O/S Isolated spalling 0.3m² x 80mm D to the HM side. NFD

P09 - Pier 3 downstream nose

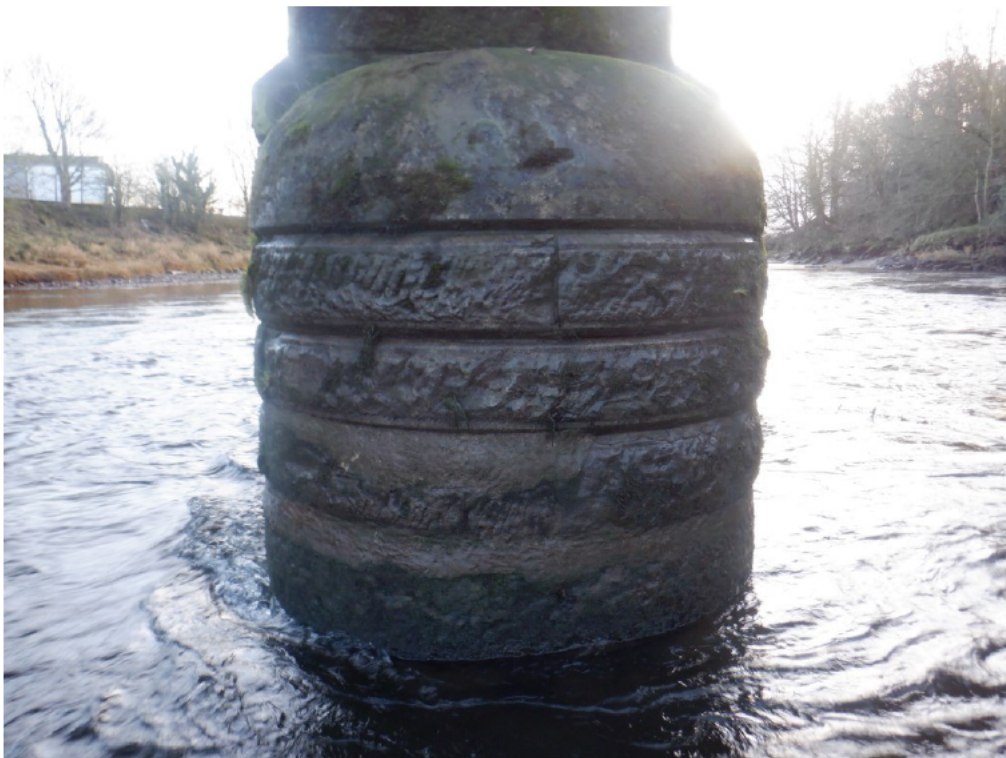
Upside (Upstream) Nose (Photo 10)

- O/S Isolated spalling 500mm L x 200mm H x 300mm D to the nose. Not seen at this exam.

- O/S 1m² joint loss x 100mm D located throughout the nose. NFD

P10 - Pier 3 upstream nose

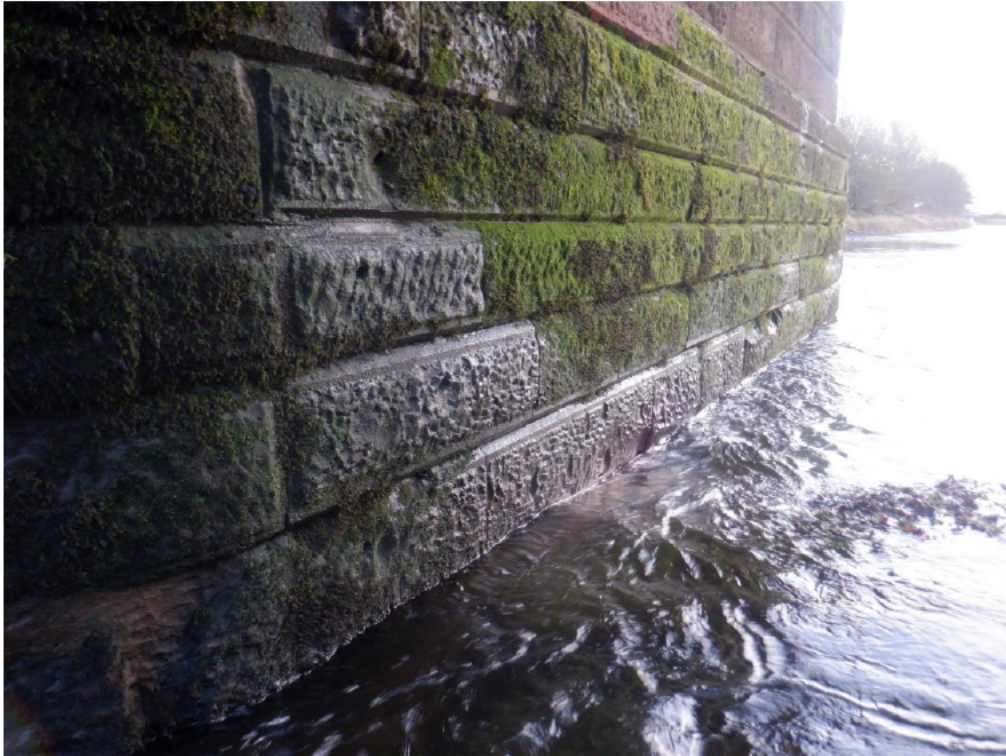
Dumfries Station (low mileage) Face (Photo 11)

- O/S 2no vertical fractures totalling 4.5m L x 2-10mm W located to the downstream end of the face. NFD

- O/S 1no vertical fracture 300mm L x 2mm W located 1.5m from the downstream nose, below water level at the time of the examination. NFD

- O/S 2no through block fractures each 800mm L x 2-10mm W located 2.2-2.5m from the downstream nose, below water level at the time of examination. NFD

- O/S 1no through block fracture 400mm L x 3-5mm W to the centre of the pier face, below water level at the time of the examination. NFD

- O/S 4m² joint loss x 200mm D located throughout the pier face NFD.

- O/S 1.5m² spalling x 60mm typical D located throughout the pier face, typically worse at and below water level to the upstream half. NFD

P11 - Pier 3 low mileage face

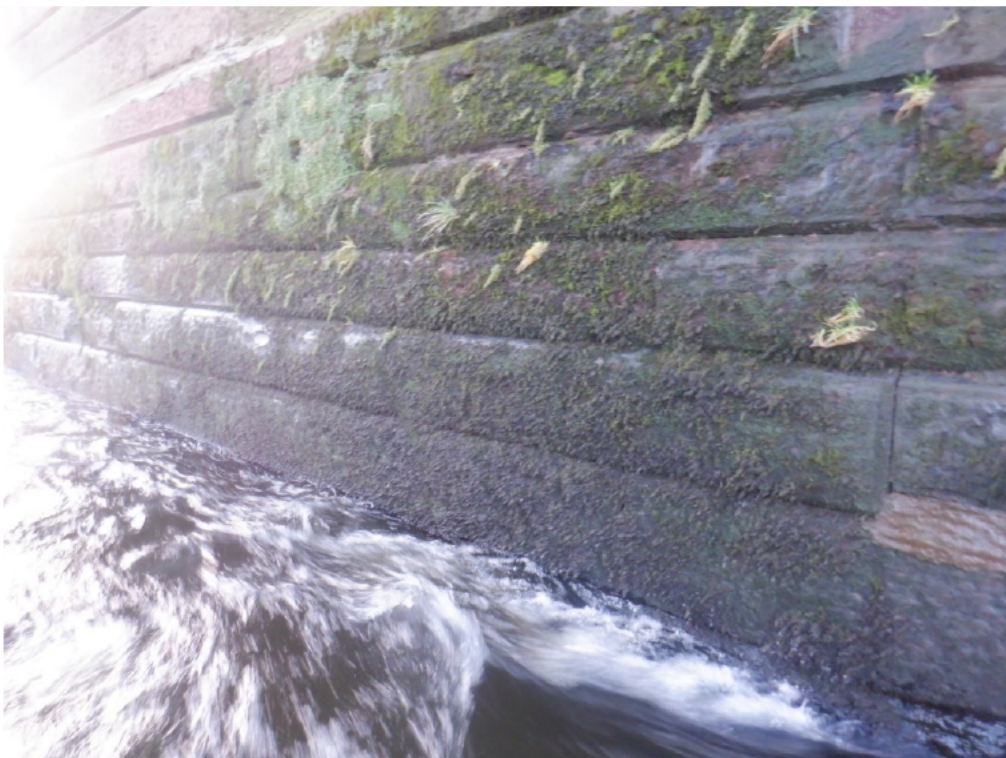
Annan Station (high mileage) Face (Photo 12)

- O/S 2.5m² joint loss x 200mm D located throughout the pier face. NFD

- O/S 2no vertical fractures totalling 2.5m L x 2-5mm W located to the downstream end of the face, with associated spalling 1.5m H x 400mm W x 60mm D. NFD

P12 - Pier 3 high mileage face
