| | | <b>BRIDGE &amp; STRUCTURE EXAMINATION REPORT</b><br><b>BRIDGE &amp; STRUCTURE UNDERWATER EXAMINATION REPORT</b> | | | | | |
| ELR: KYL | | Contract Mileage: 055m 0022yds ch - | | | Struc. Ref: 303/128 | | |
| Structure Name: | RIVER FERNAIG | | | Type: | - | Exam ID: | |
| Route: | Dingwall to Kyle of Lochalsh | | | | Complete Examination: | Yes | |

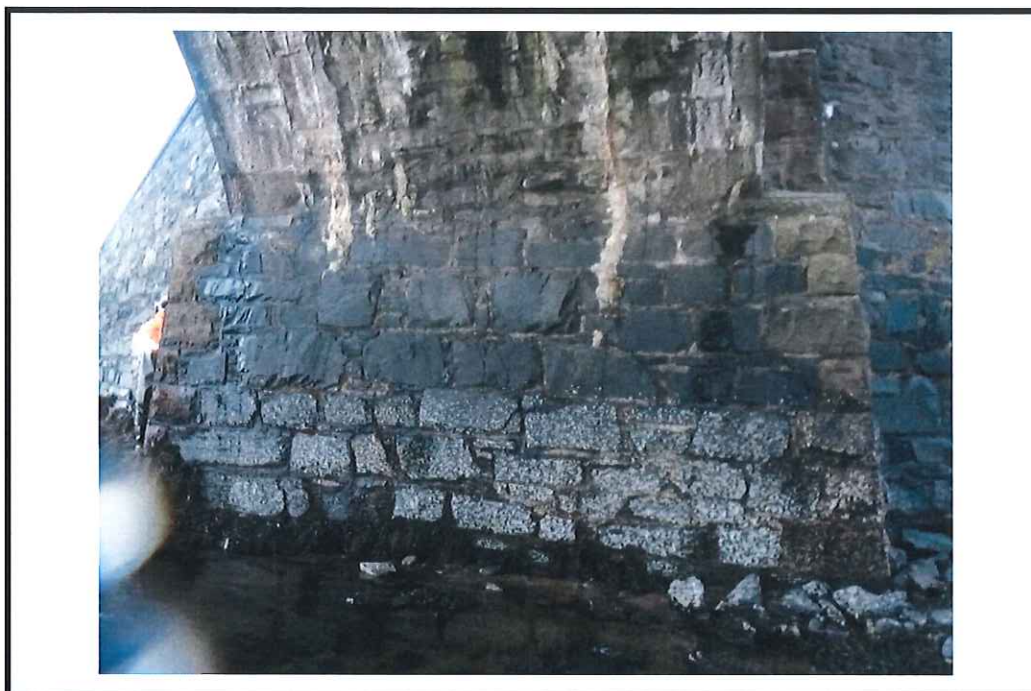
Constructed from masonry and concrete and is in fair condition ([Photo 5](#)).

**Photo 5:** Showing low mileage abutment

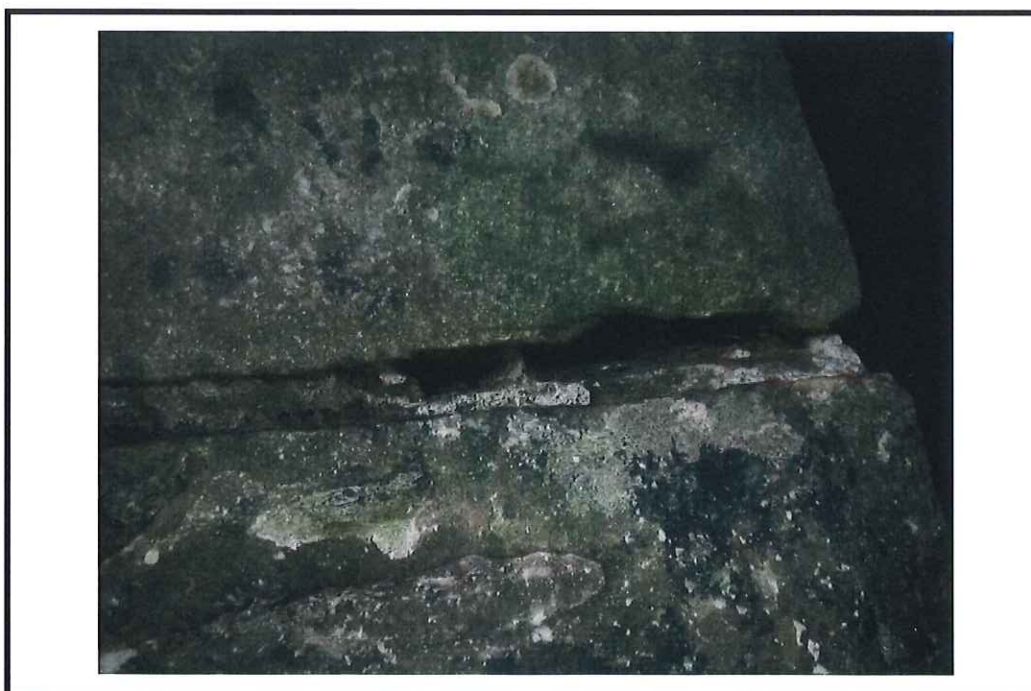
Isolated areas of pointing loss to the abutment at various locations ([Photo 6](#), [Photo 7](#) and [Photo 8](#)).

**Photo 6:** Showing pointing loss to upstream face of low mileage abutment

- a) Repair to the various areas of pointing loss around the structure
- b) Monitoring of the concrete apron on the downstream, high mileage side to prevent further deterioration and loss of protection to the downstream, high mileage abutment and wing wall
- c) Consider repair or replacement to the old weir present within the span

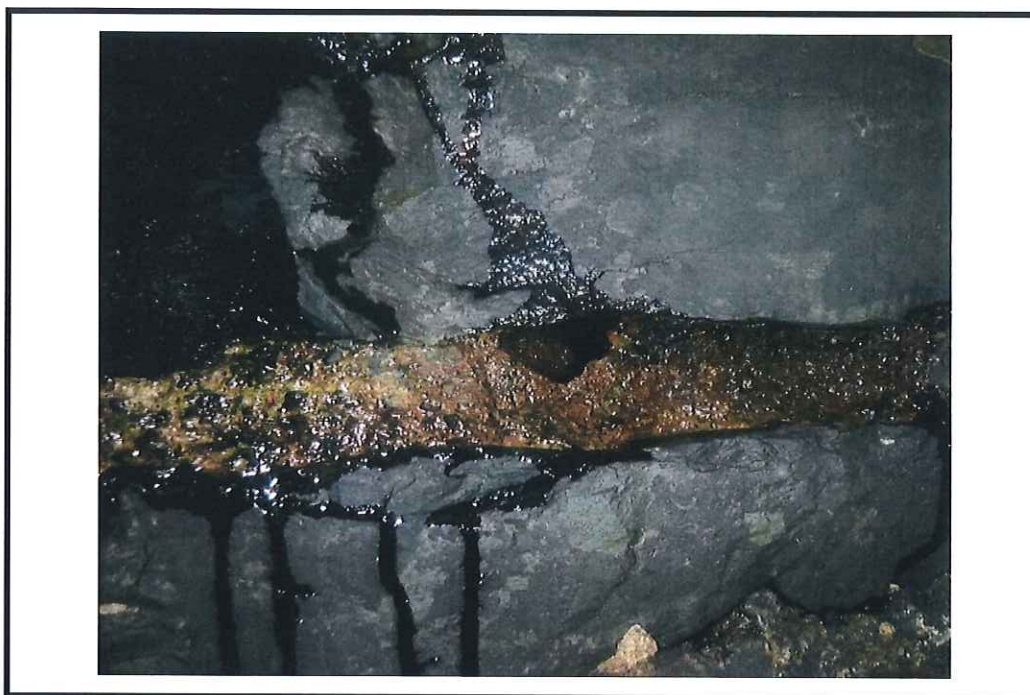
**Photo 7:** Showing pointing loss near centre of low mileage abutment

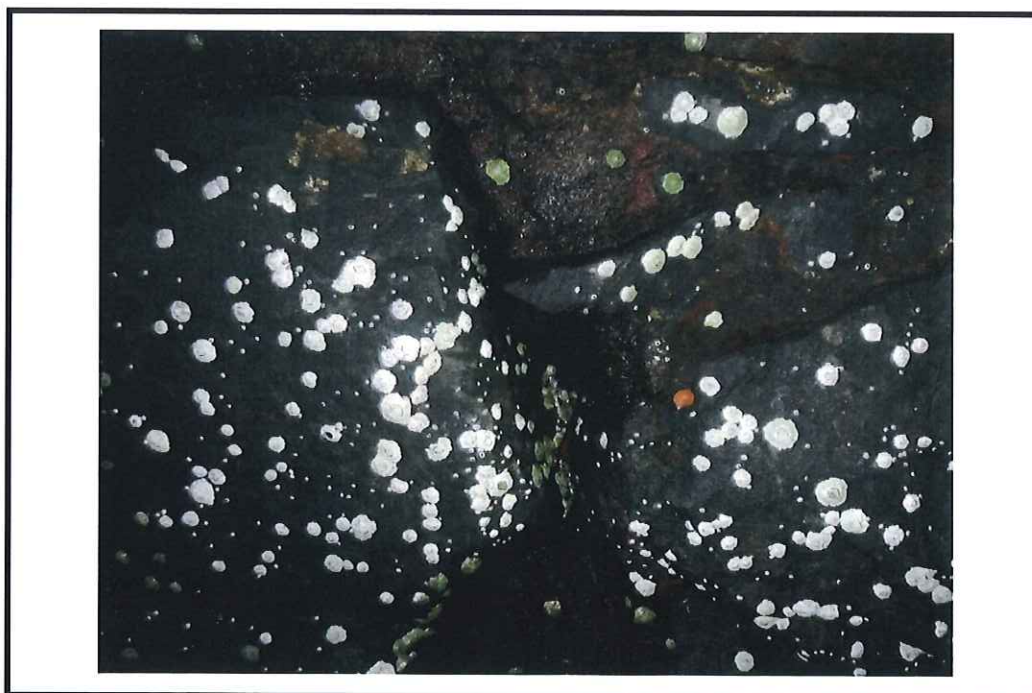
**Photo 8:** Showing pointing loss near downstream end of low mileage abutment

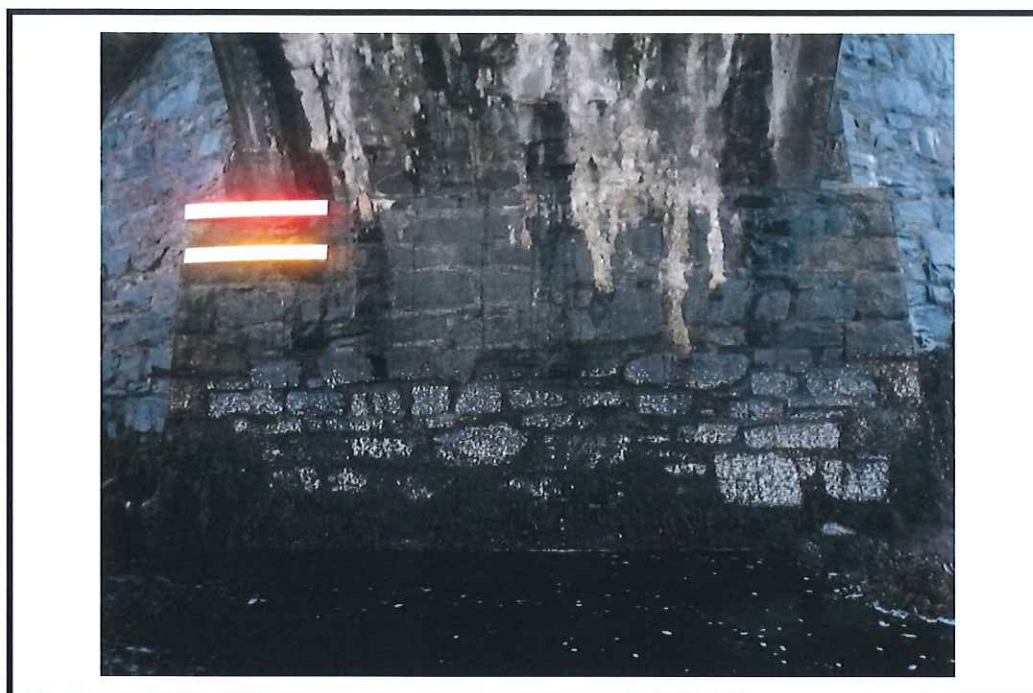
Constructed from masonry and is in fair condition ([Photo 9](#)).

**Photo 9:** Showing high mileage abutment.

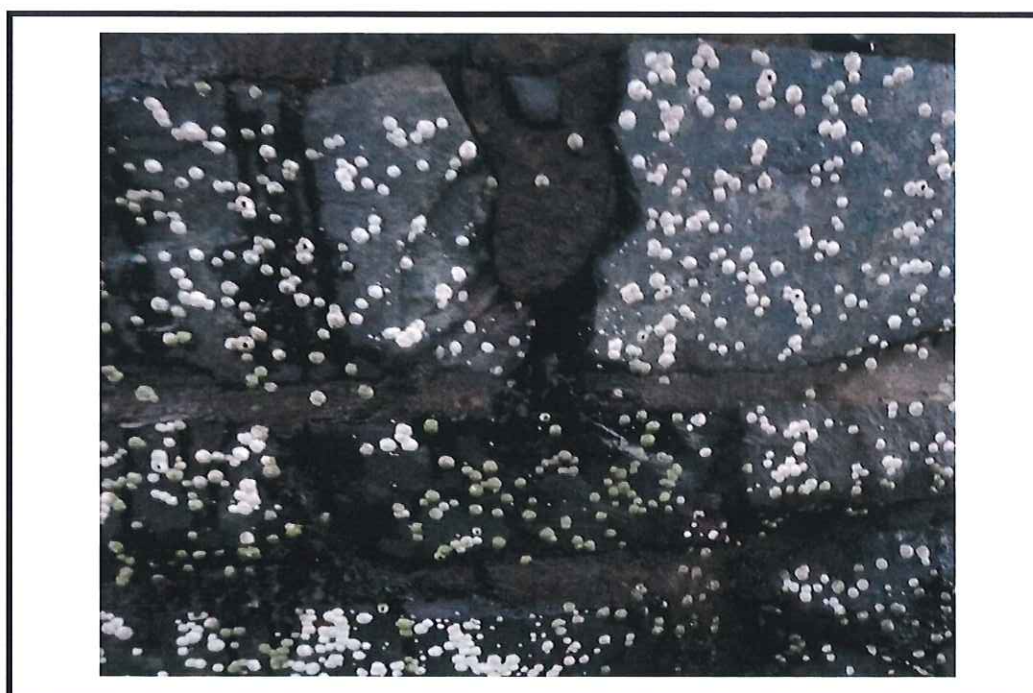
Isolated areas of pointing loss to the abutment at various locations ([Photo 10](#) and [Photo 11](#)).

**Photo 10:** Showing pointing loss at centre of high mileage abutment

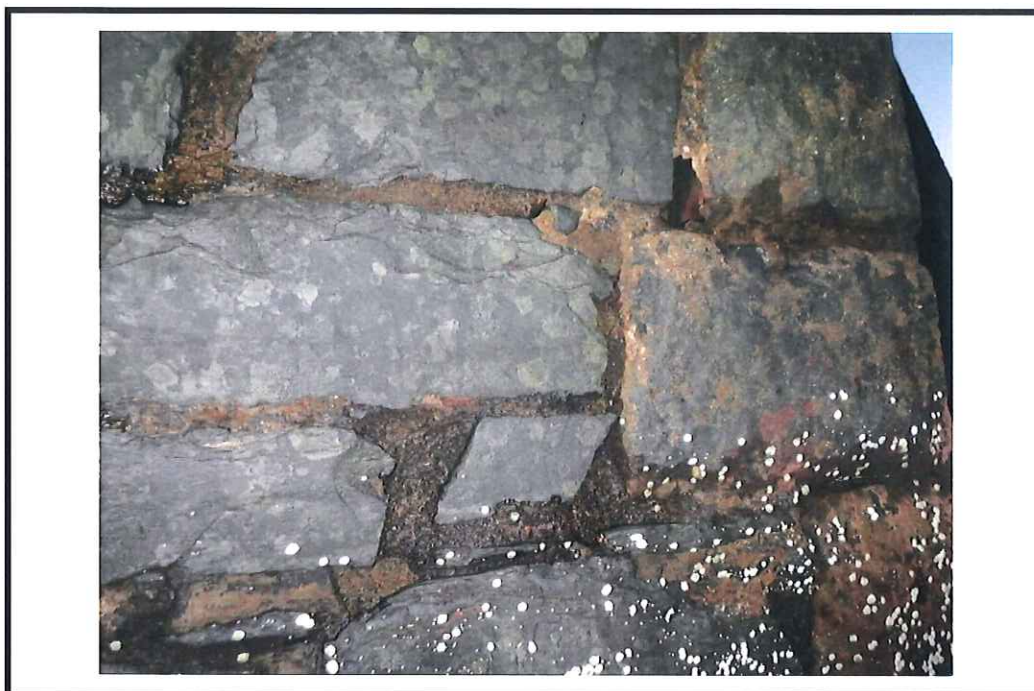
**Photo 11:** Showing pointing loss to downstream end of high mileage abutment

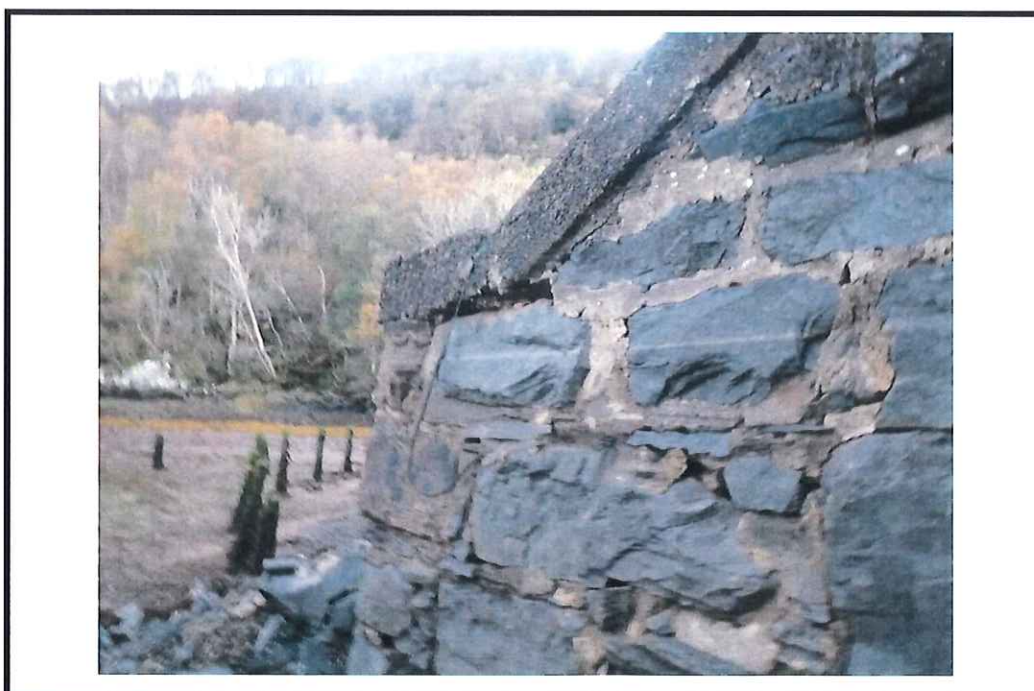
Located on the upstream and downstream side of both abutments. All wing walls are in fair condition with areas of pointing loss ([Photo 12 to Photo 19](#)).

**Photo 12:** Showing pointing loss to upstream, high mileage wing wall

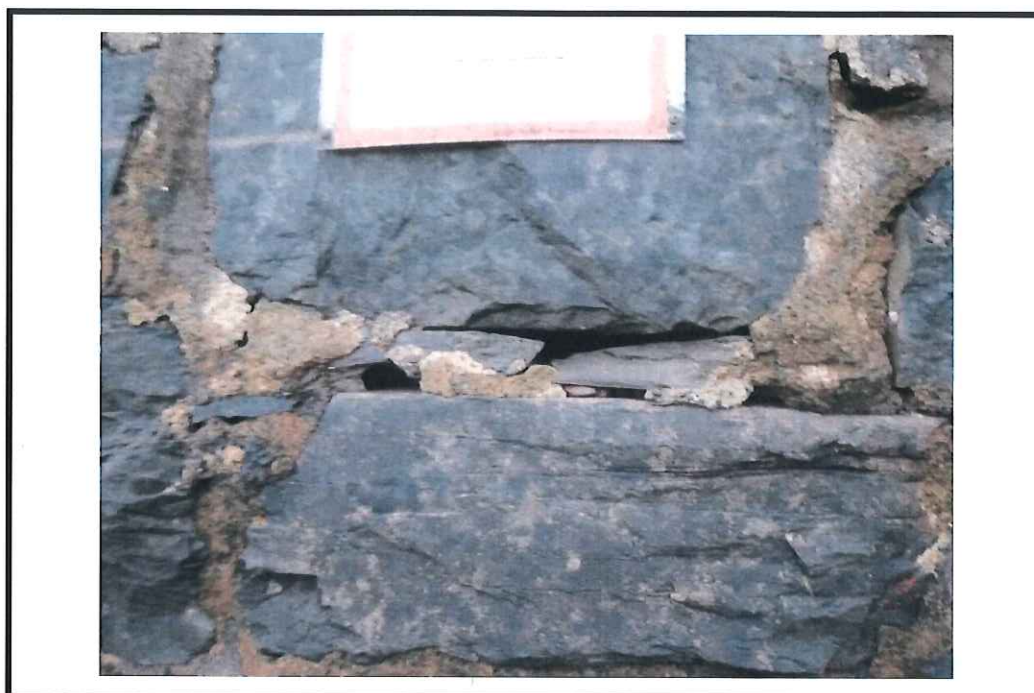
**Photo 13:** Showing pointing loss to upstream, high mileage wing wall

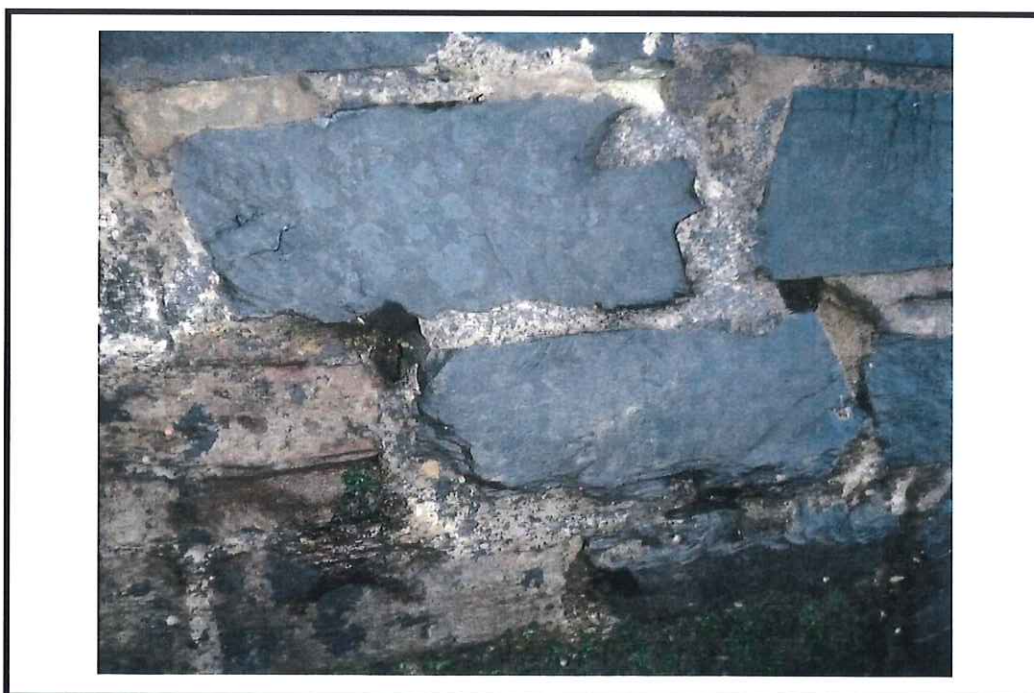
**Photo 14:** Showing pointing to repaired pointing on downstream, high mileage wing wall

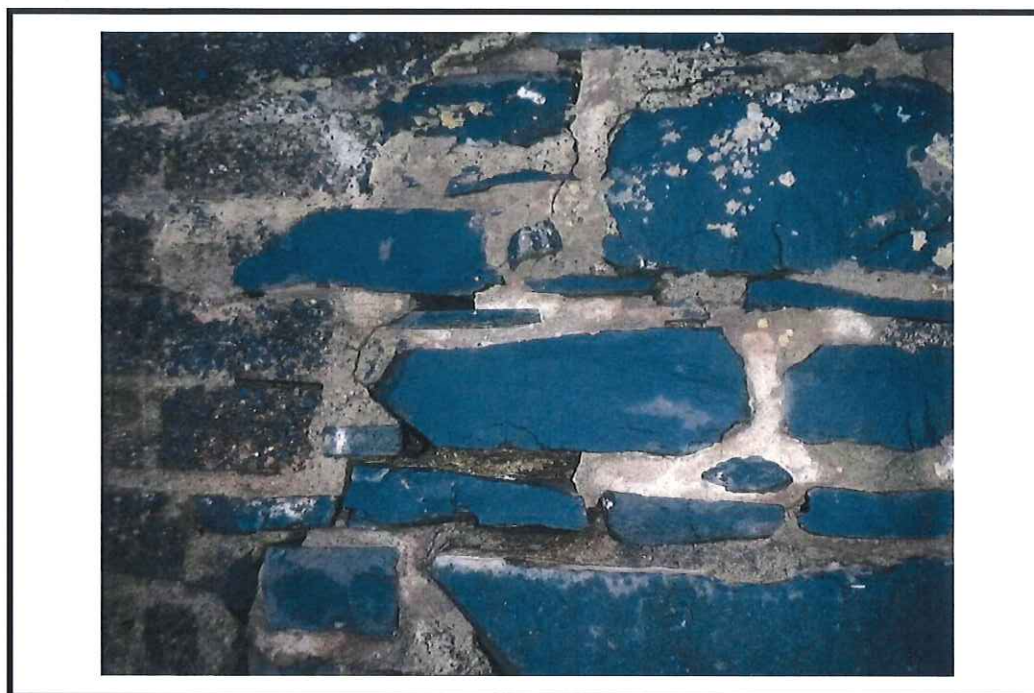
**Photo 15:** Showing pointing loss to downstream, low mileage wing wall

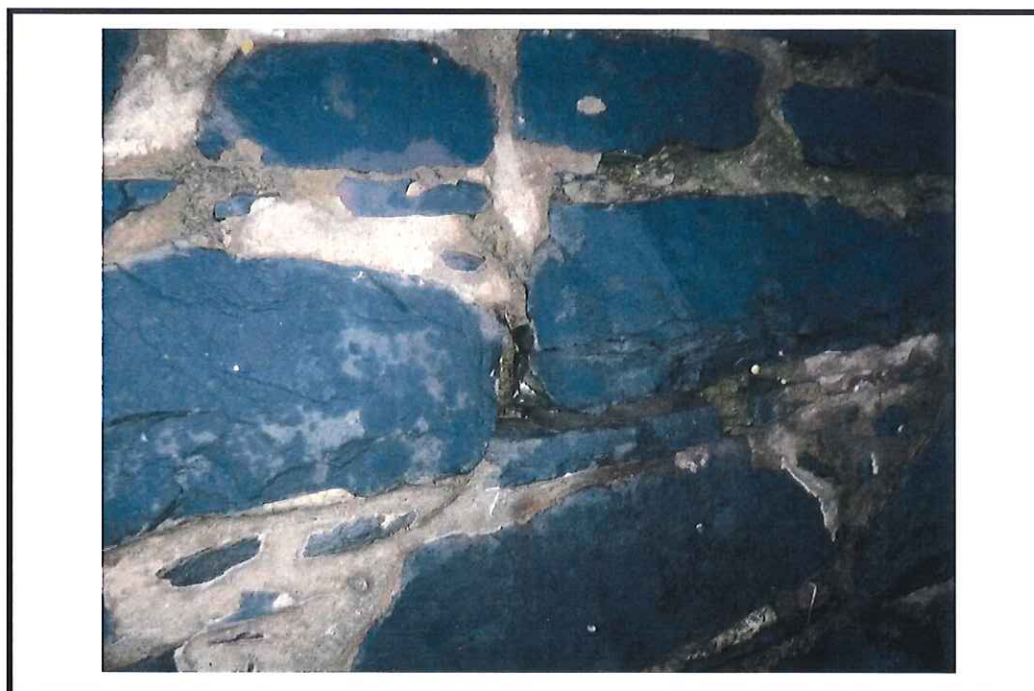
**Photo 16:** Showing pointing loss to downstream, low mileage wing wall

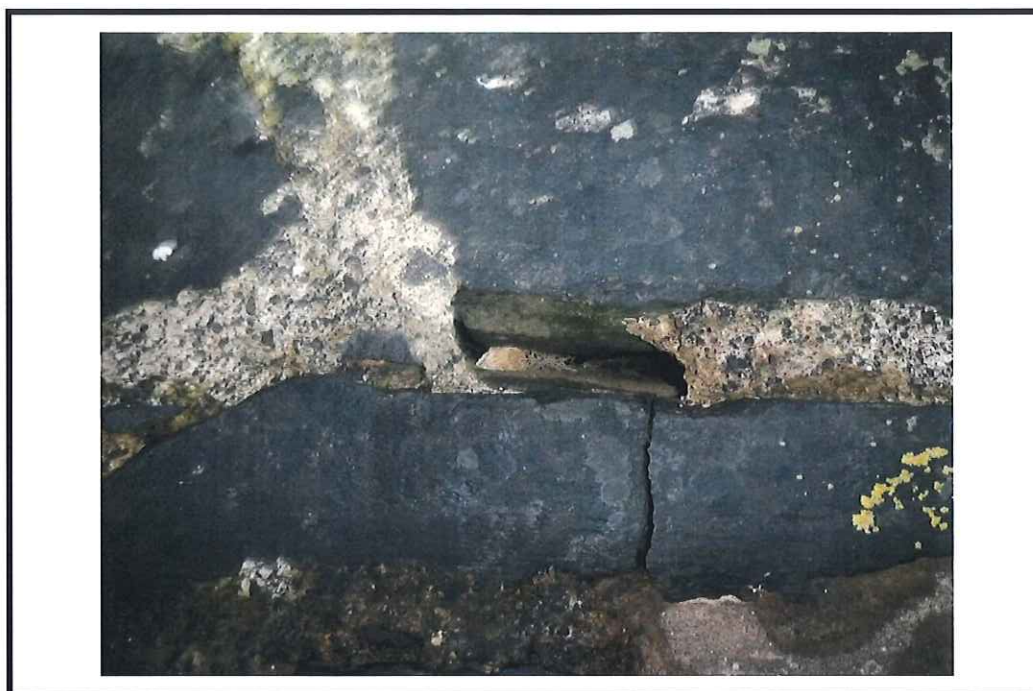
Hairline cracking was seen to the upstream, low mileage wing wall ([Photo 17](#)).

**Photo 17:** Showing pointing loss and cracking to upstream, low mileage wing wall

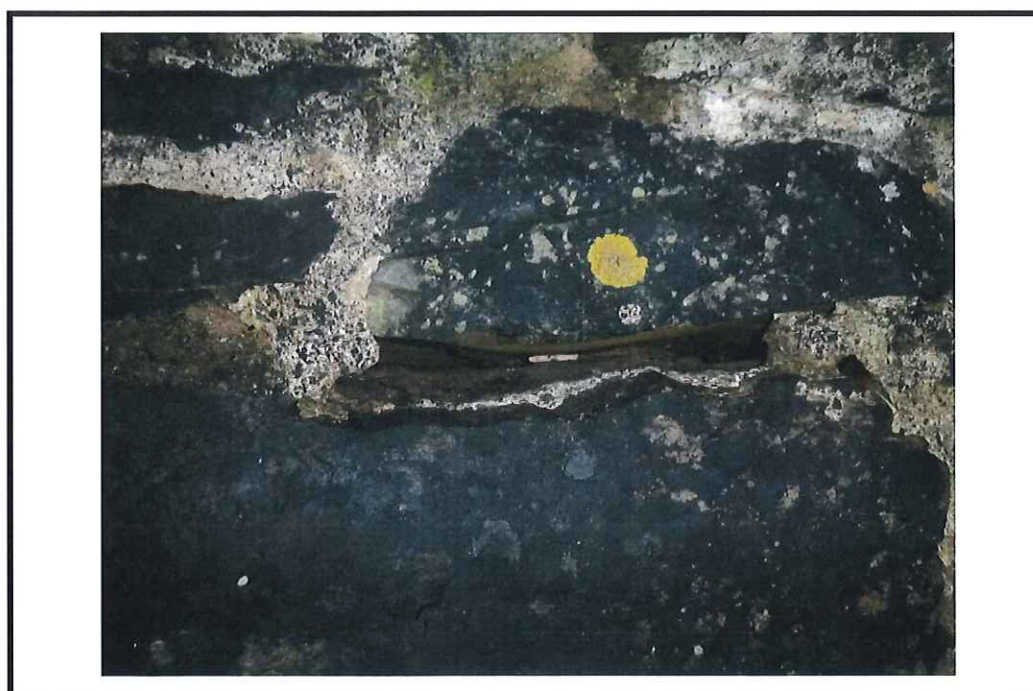
**Photo 18:** Showing pointing loss to upstream, low mileage wing wall

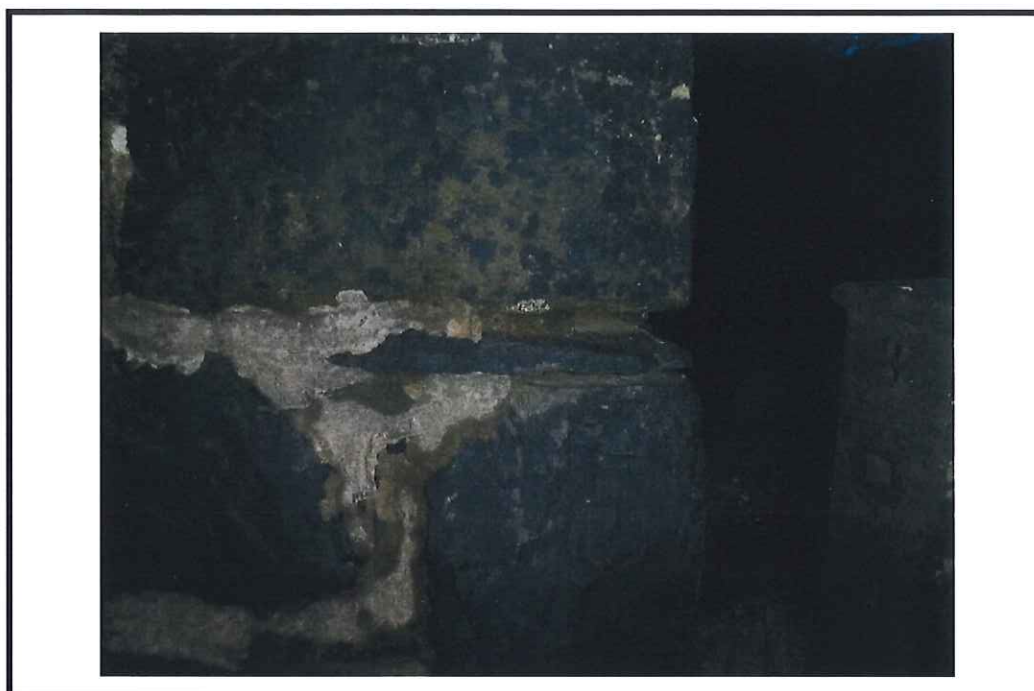
**Photo 19:** Showing pointing loss to upstream, low mileage wing wall

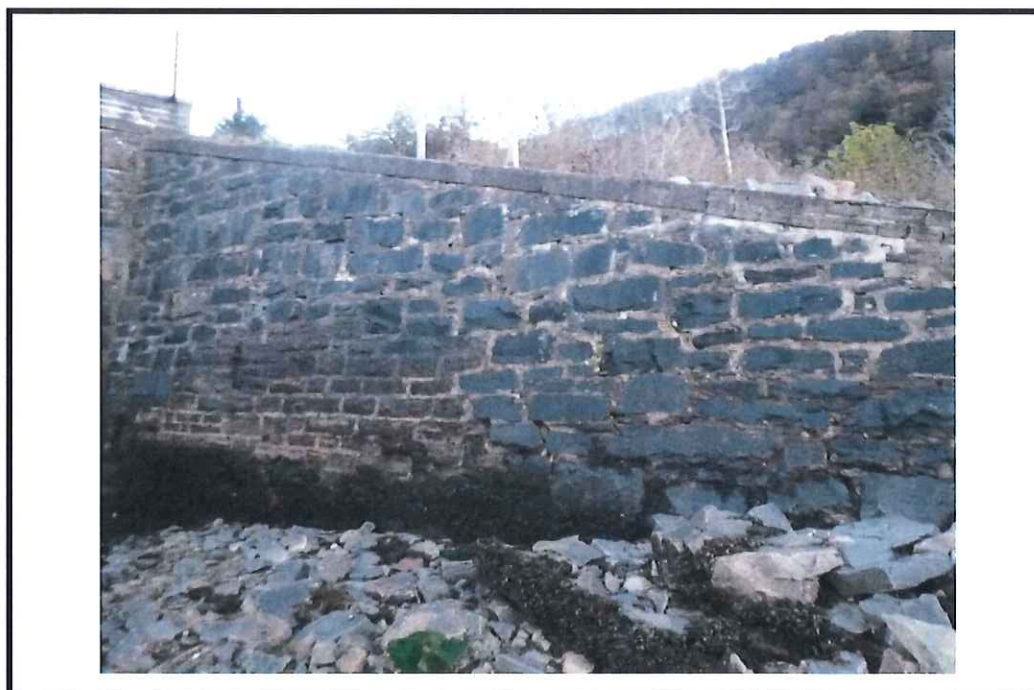
Seaweed growth to both abutments and all wingwalls within the tidal zone ([Photo 20 and Photo 21](#)).

**Photo 20:** Showing downstream, high mileage wing wall and vegetation growth in the tidal zone

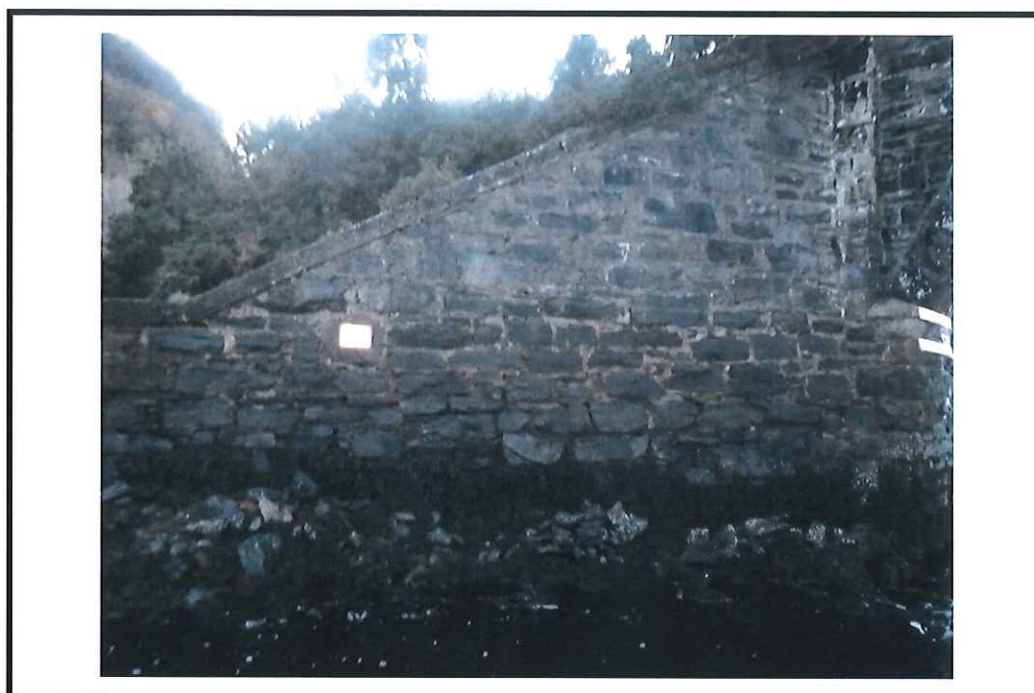
**Photo 21:** Showing upstream, high mileage wing wall and vegetation growth in the tidal zone

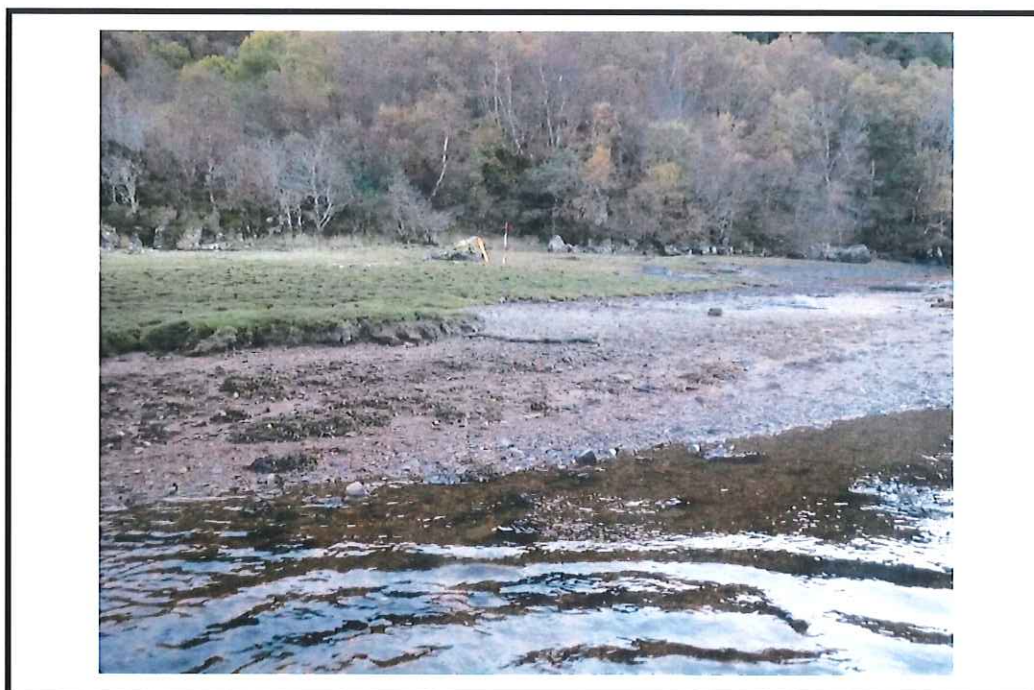
Upstream banks in this area are shaped by the tidal movement of the water. At low tide the river "bank" is a sandy area that is the seabed at high tide ([Photo 22 and Photo 23](#)).

**Photo 22:** Showing high mileage side upstream at low tide. Note the river "bank" is the bed when the tide is high. Extent of high tide seen at grass line

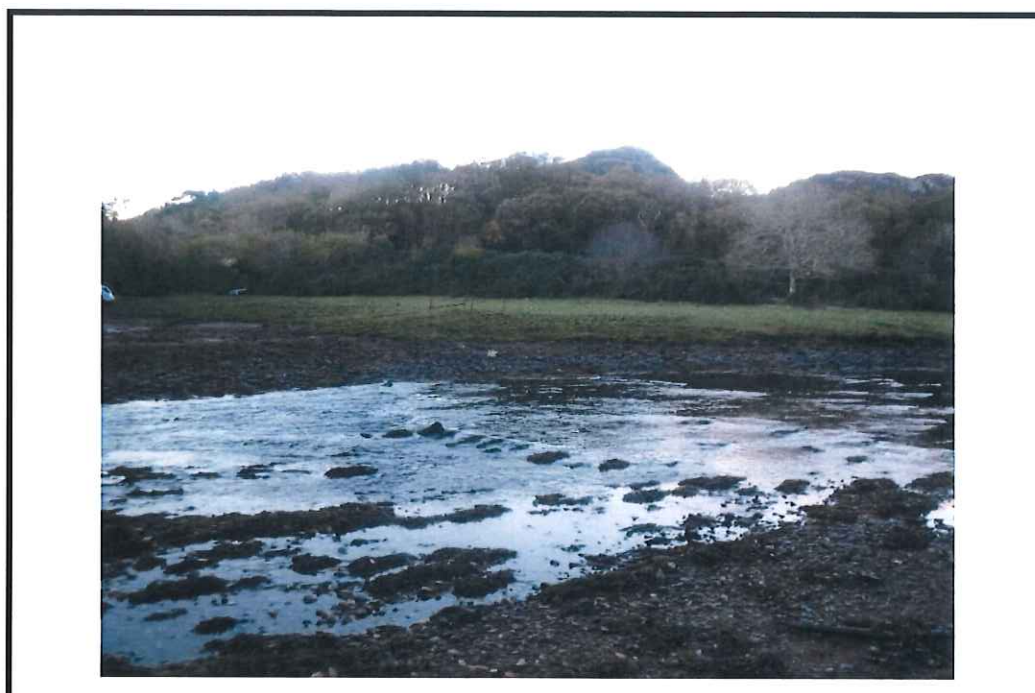
**Photo 23:** Showing low mileage side upstream at low tide. Note the river "bank" is the bed when the tide is high. Extent of high tide seen at grass line

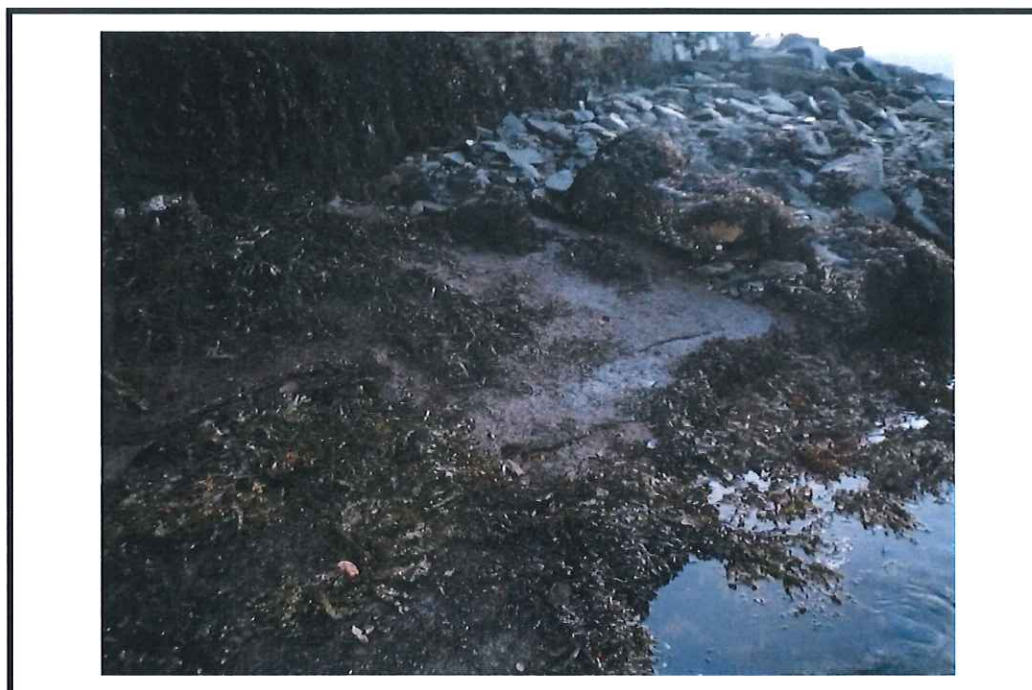
A large concrete apron is present on the downstream end of the structure, surrounding part of the high mileage abutment and wing wall at this location ([Photo 25 and Photo 26](#)). This is in poor condition with areas of spalling. This could be providing some protection to the abutment and wing wall from scour while it is still present.

**Photo 25:** Showing concrete apron at downstream high mileage abutment and wing wall

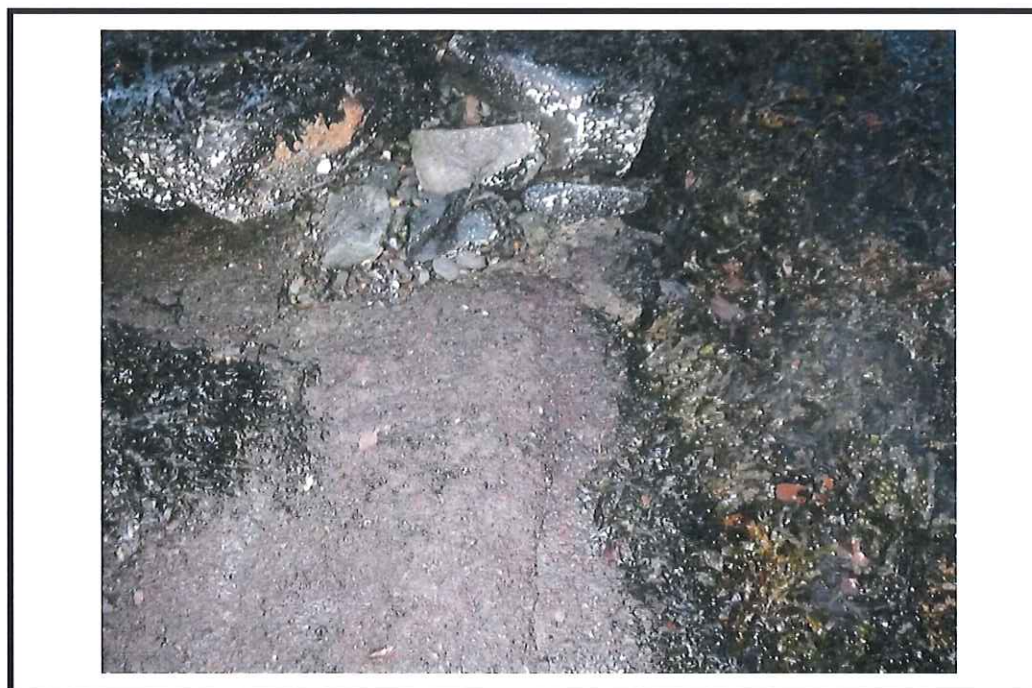
**Photo 26:** Showing edge of concrete apron in process of eroding
