UB 132/017 Forth Viaduct

Form 001

Doc. No.: 2444-MHB-REP-005

NR/L2/CIV/003/F001: APPROVAL IN PRINCIPLE				
Document reference	2444-MHB-REP-005	Revision	A	Page 1 of 27
GRIP Stage	3	Date	28 May 2021

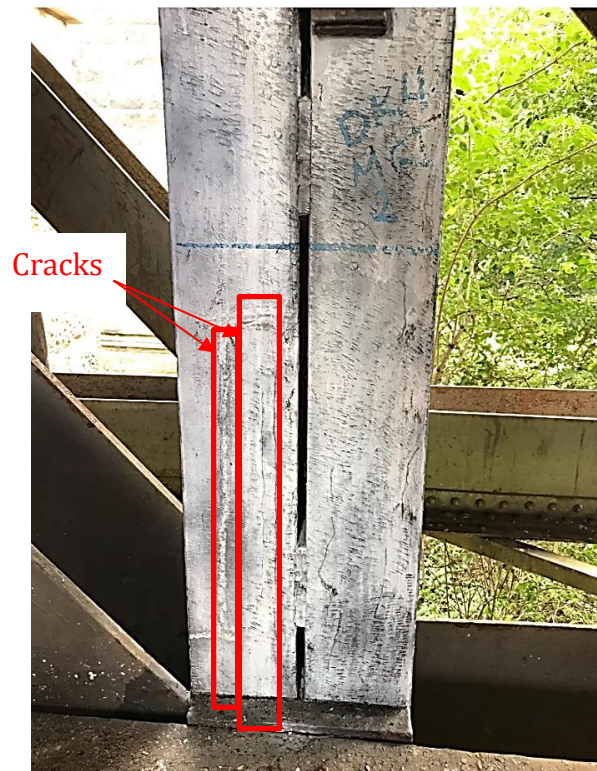
A typical example of the vertical cracks found during MPI testing can be seen in the picture below.

Figure 1-Typical examples of cracks found on compression elements during NDT testing

- Remedied via Repair Type 4.
- 7 out of 12 MPI tested vertical post were rejected. Evidence of cracking.
 - Repair Type 5 - 8 No. verticals per girder to receive repair (i.e. 4 No. at each end of girder) on all 3 Spans (96 No. in total)

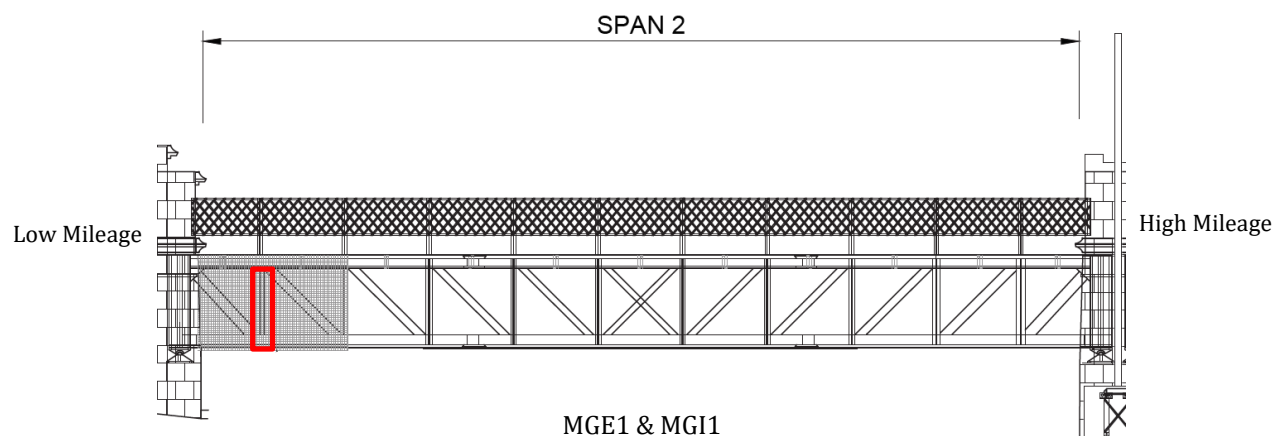
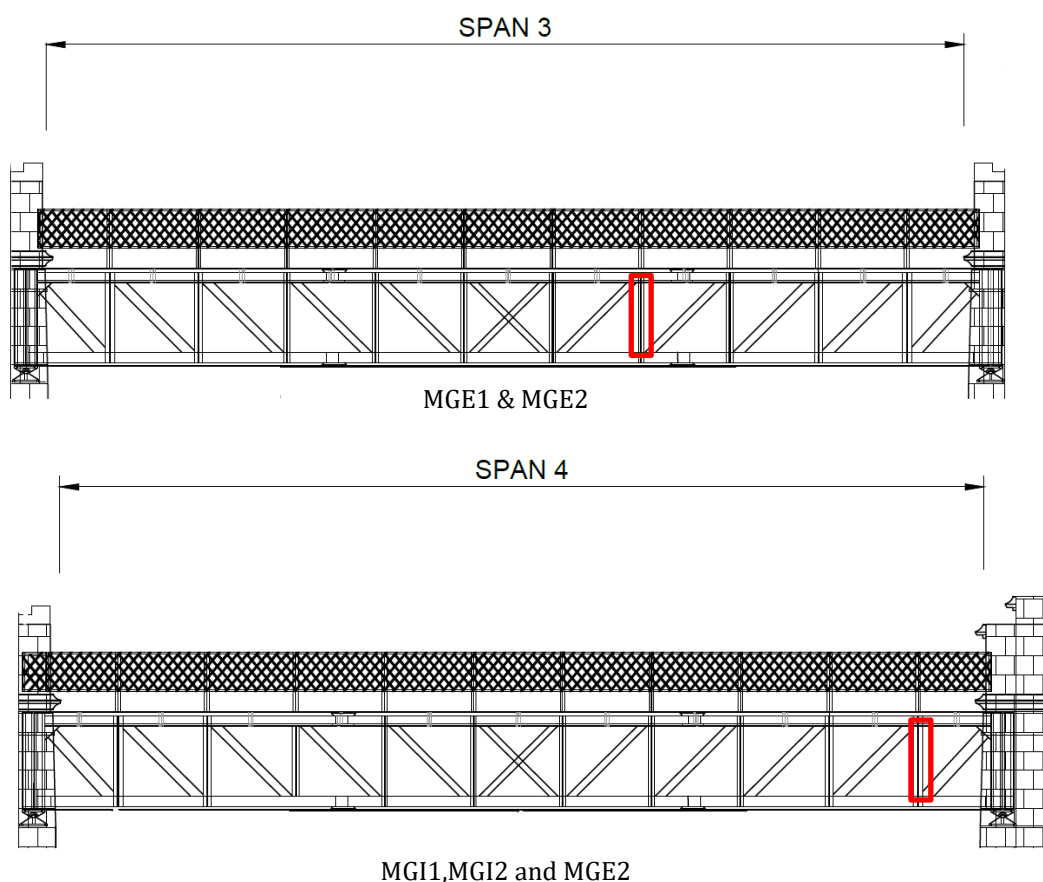
Figure 2-Locations of the vertical members which were rejected during MPI testing

Since during the MPI testing only 12% of the vertical posts were tested, considerations should be given for possible crack formation within rest of the compression elements that were not tested. A static elastic analysis was carried-out by MHB Consultants using the structural analysis package OASYS GSA to analyse the global behaviour of the bridge and particularly of the compression elements. The results suggested that the stress values developed in the last four vertical members (at either end of each span) are significantly higher than those developed in the middle members. Hence, it is proposed to conduct condition led-Repair Type 5 to 8 No. of vertical posts per girder (i.e. a total of 96 repairs). Should evidence of cracking be noted to the middle posts during the post-blast inspection, the number of envisaged Repair Type 5 shall be increased.

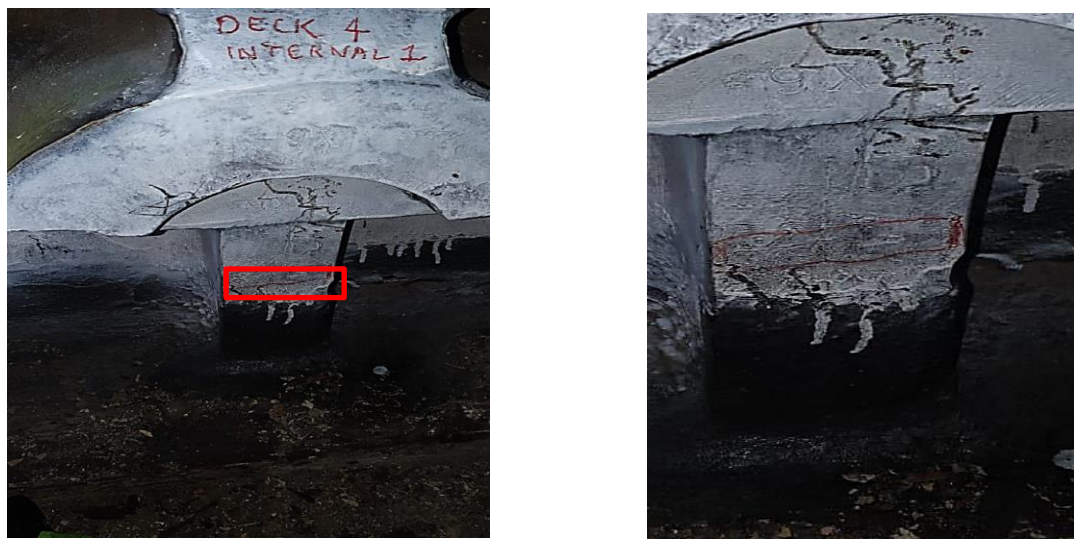
Figure 4-1 No. Crack to the outstand of the bearing extracted from LWC-Forth Viaduct 014

The crack found during the MPI testing (see Figure 4) appears to occur in the rocker assembly only. It is difficult to determine the reason for such crack to develop without further investigations but given the bearing type (i.e. Fixed) and the direction of the crack (i.e. transverse), it is possible the crack has occurred due to the presence of shear stresses occurring as the result of excessive horizontal forces being applied to the bearing.

From the above testing results, it is not possible to determine when the crack was formed and whether the defect is recent or historical. Conservatively, it should be assumed the crack occurred recently and the

In addition to the removal of the 4 No. bearings, it is proposed to apply anti-corrosive treatment to the exposed parts of all remaining bearings and, due to brittle nature of cast iron, install a monitoring system on the structure to allow all other bearings to be monitored for signs of cracking in the future.

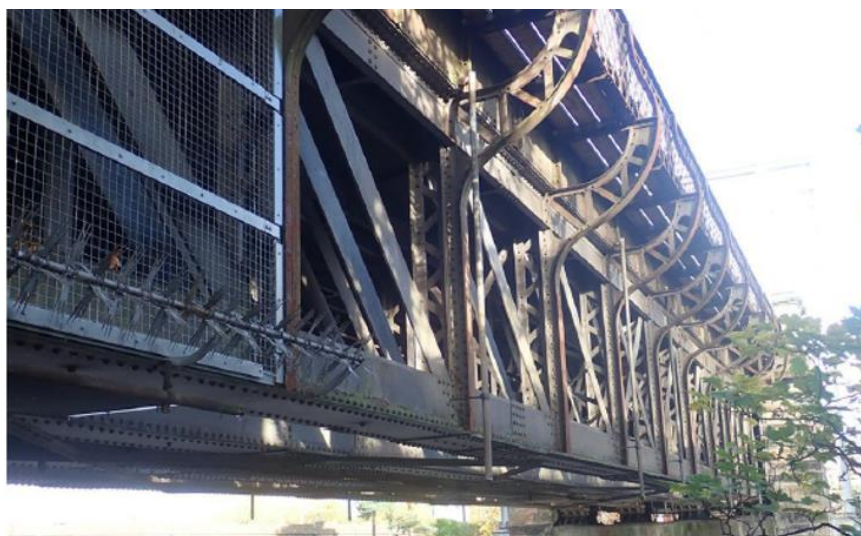
There are vertical drainage pipes installed to the elevations of DK2-4 MGE1 to MGE2 along the full span (i.e. 6 No. per elevation) see Figure 5. Weep pipes extending from the deck plates and top boom of main girders were noted, see Figure 7. Weep pipes in the centre of each bay in the bottom boom were also present throughout the structure (6No. per span), see Figure 6.

During the inspection and the Rope Access Survey, it was noted that the surface water drainage system consisting of metallic downpipes appears to no longer function with weep pipes through the centre of the top flange missing. This has led to surface water being discharged directly on to the structure which has contributed to the widespread corrosion of the elements. The drainage pipes running through the deck and inspection walkways also appear to be corroded. These drainage pipes are proposed to be replaced like-for-like. The approximate locations of the pipes and those requiring replacement are shown in Figure 8. It is envisaged to address the missing weep pipes in the top boom by painting and form a drip-check out of Sikadur prior to painting.

Figure 5-External Drainage pipe installed vertically along the main girders

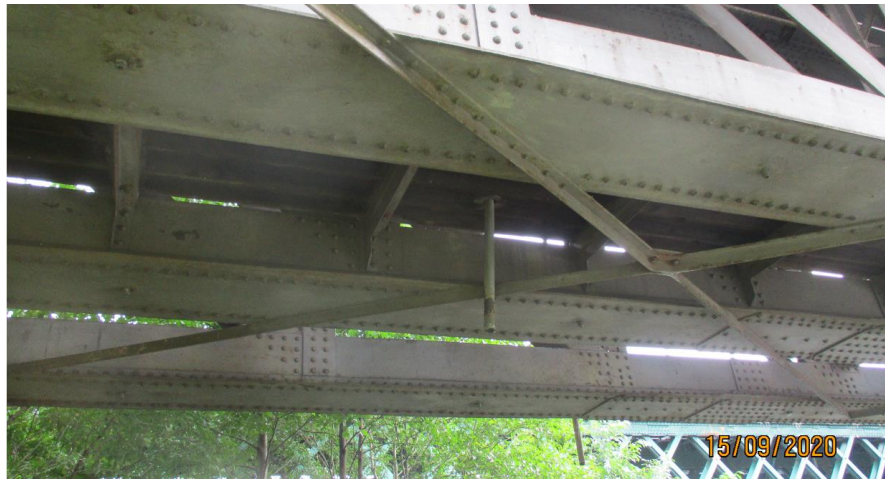
Figure 6-Corrosion and loss of section to drainage pipes passing through the inspection walkway

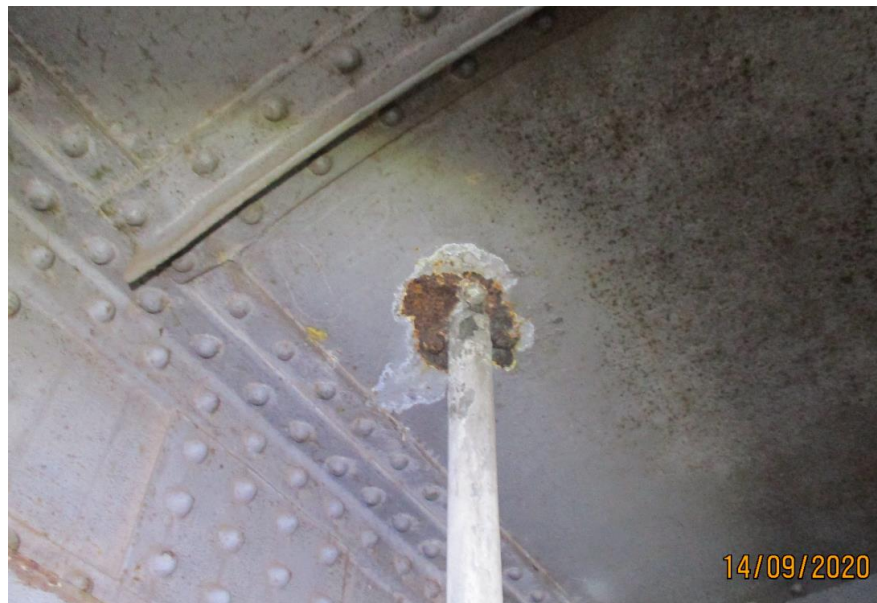
Figure 7- Radial corrosion to buckled deck plate around the drainage pipe

- 1No. Missing pipe. Ingress of water and 1-2mm radial corrosion. 2mm loss of section to soffit of top flange of DK2-MGI1 over 300mm length.
 - Addressed by painting. A drip-check out of Sikadur CF 31 Rapid to be formed prior to painting.

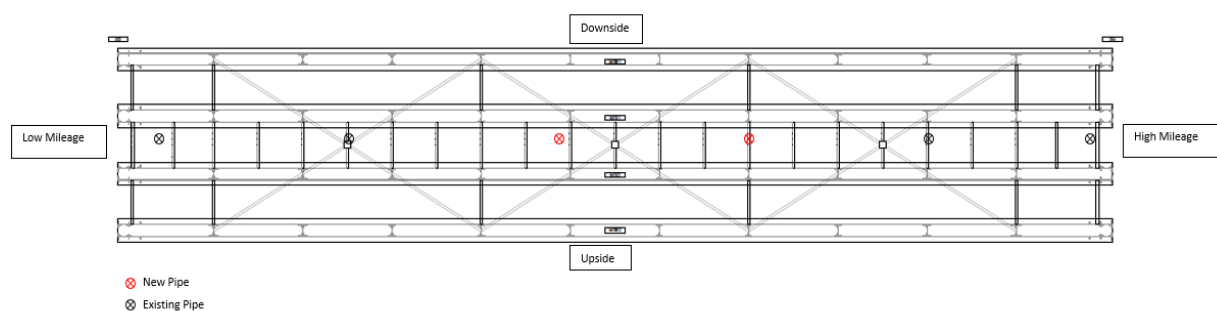
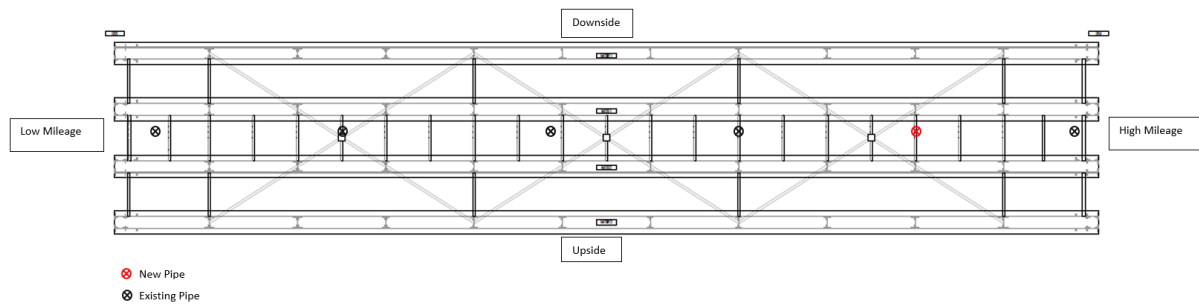
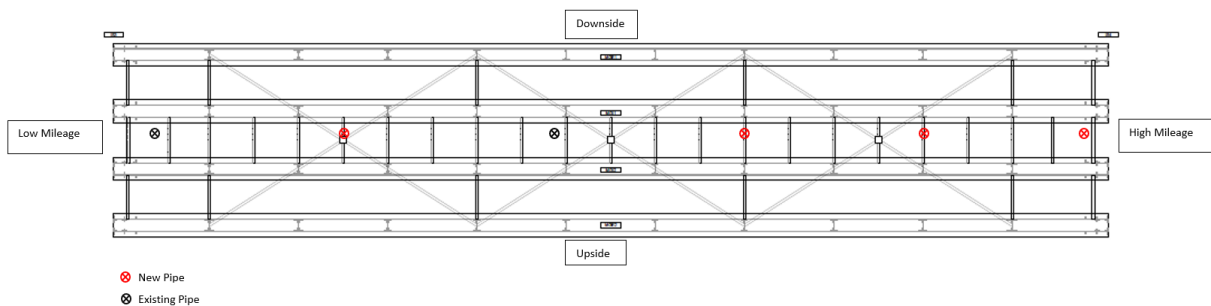
Figure 8- Approximate locations of weep pipes passing through the inspection walkway

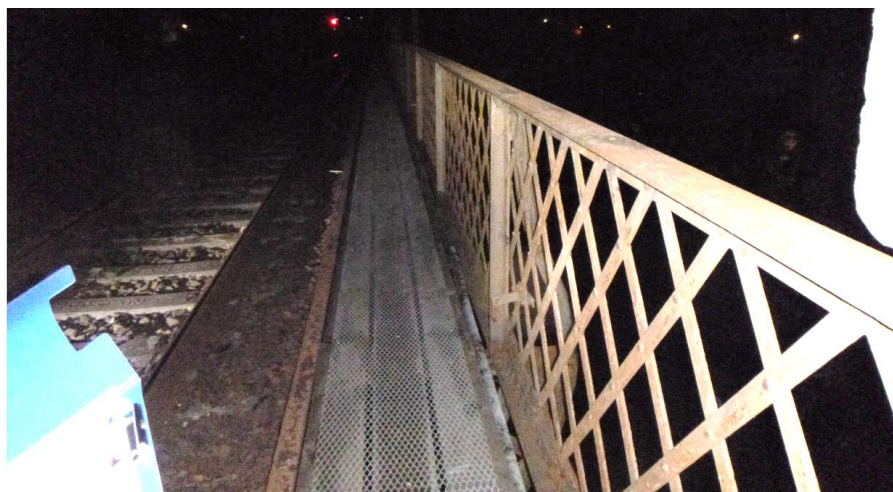
The trackside walkway comprises longitudinal timber and grid mech panel spanning along parapet girders. During the On-track inspection the trackside timber was found to be in good condition and no works are proposed.

*Figure 9-Trackside walkway, comprising longitudinal timber and grid mesh panel spanning along parapet girders (DK2-4)*
