Troqueer WwTW Bank Work Area Drone Photos 30th June 2025

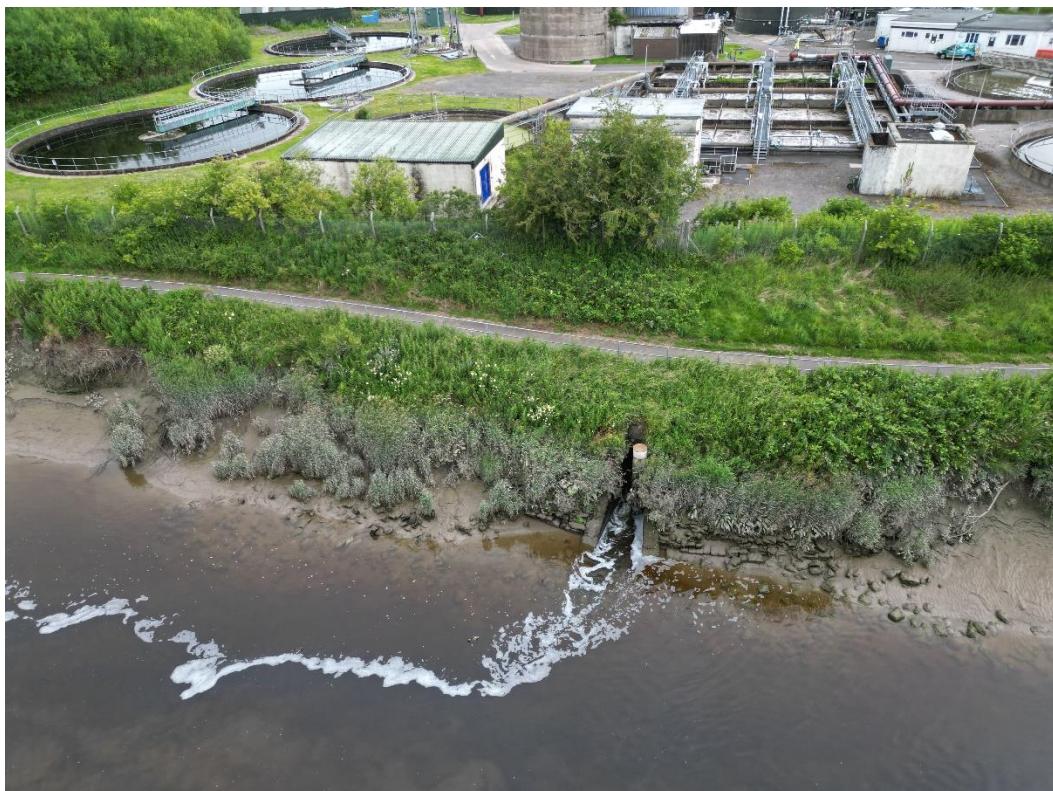
Photo 1 (below): Existing WwTW Outfall works area

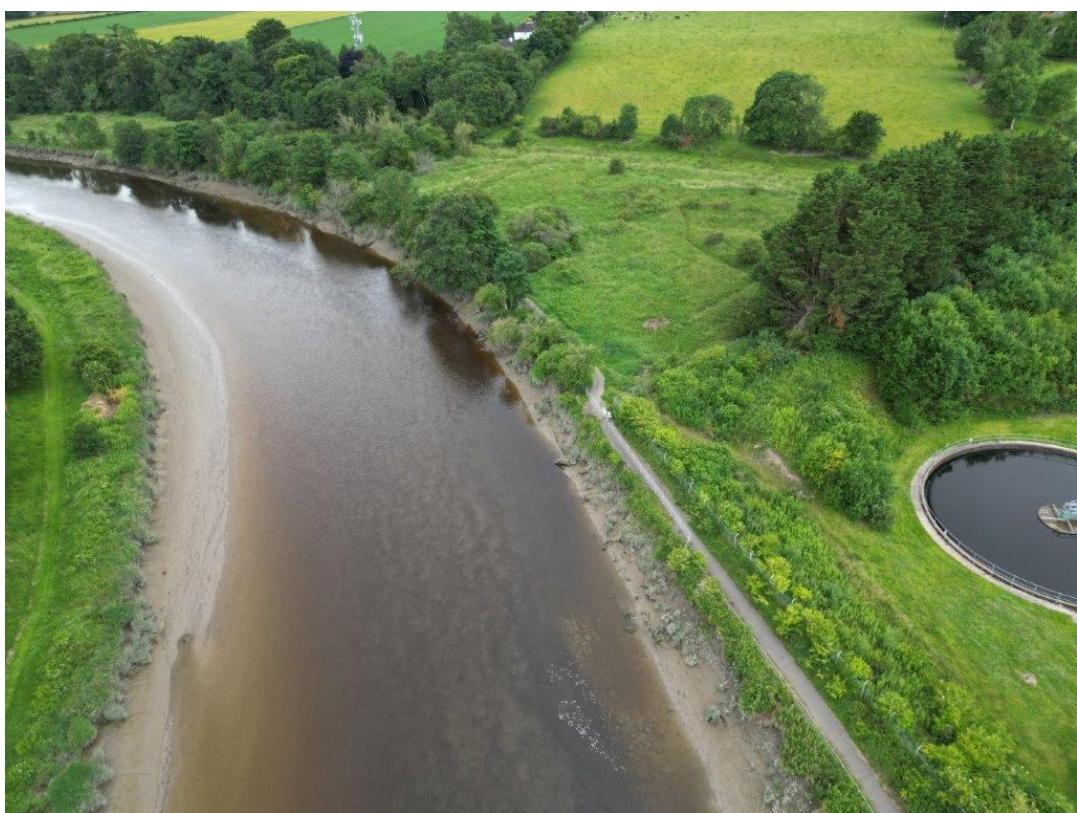
Photo 2 (below): Embankment work area looking downstream

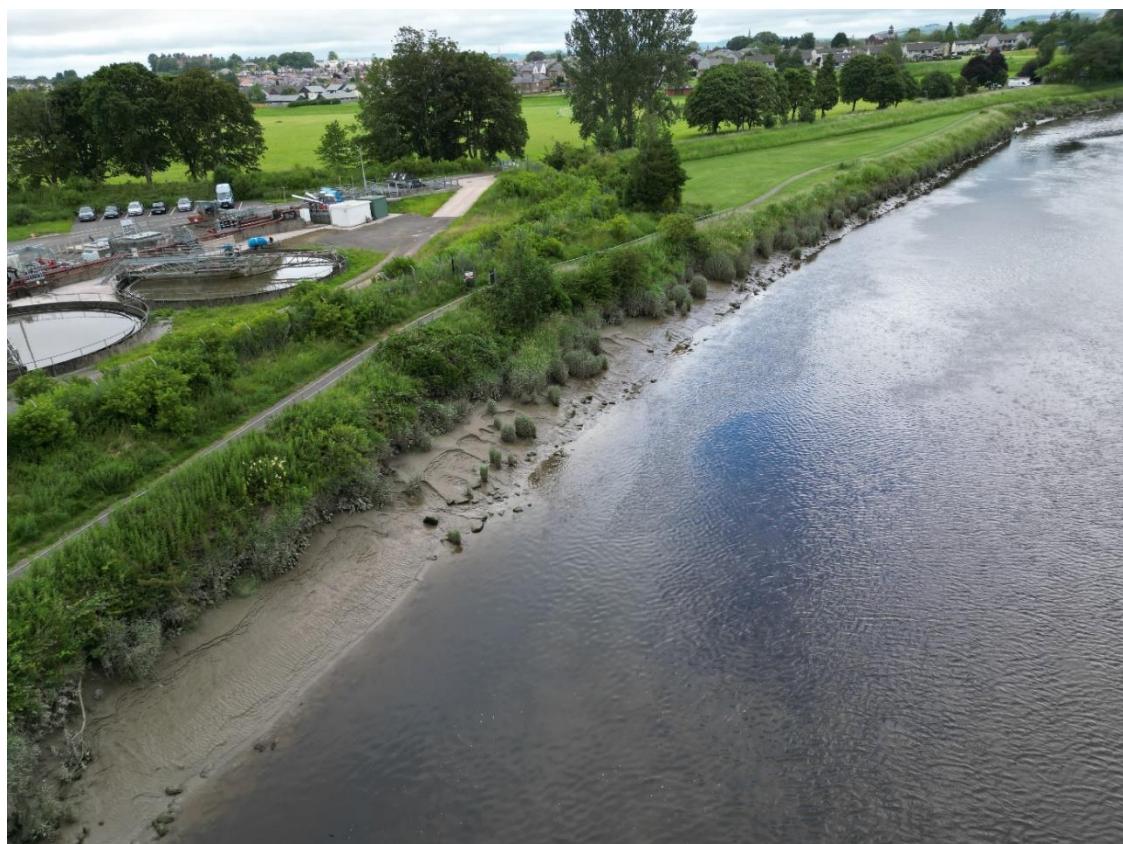
Photo 3 (below): embankment work area viewing upstream

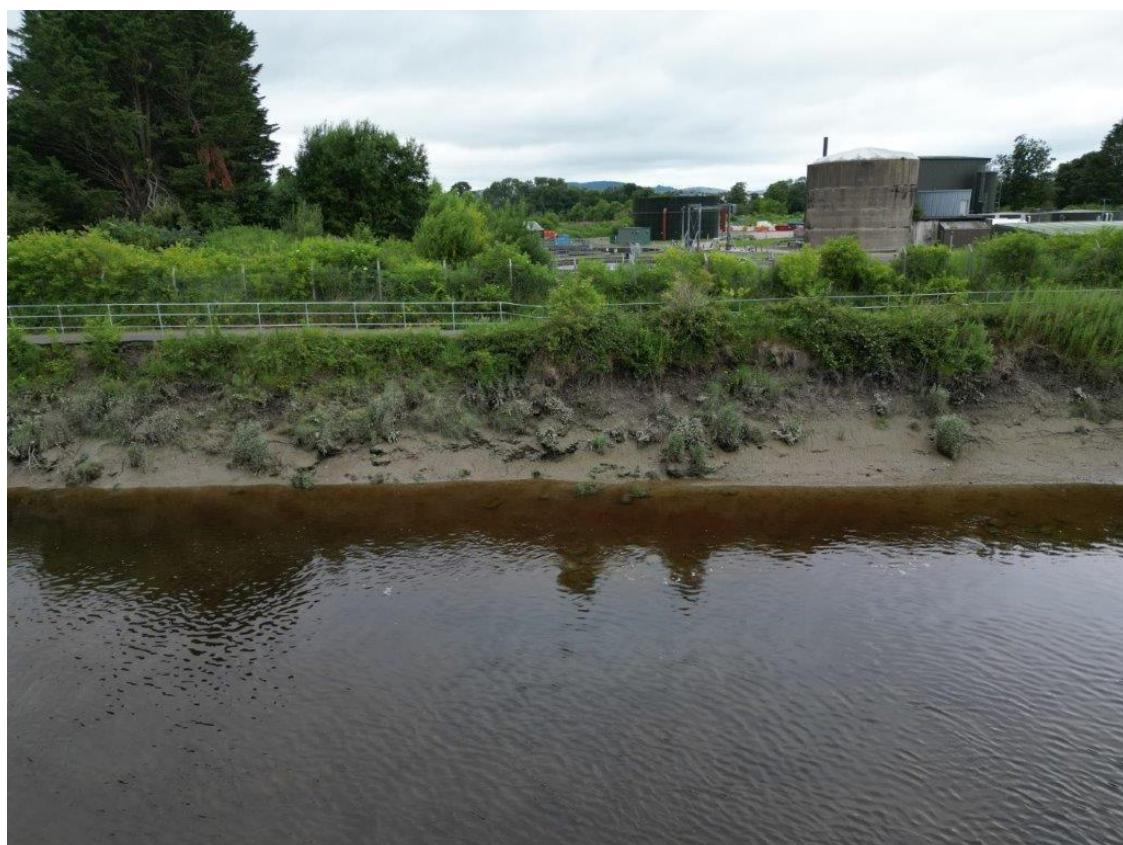
Photo 4 (below): Failing embankment adjacent to southern (downstream) end of WwTW

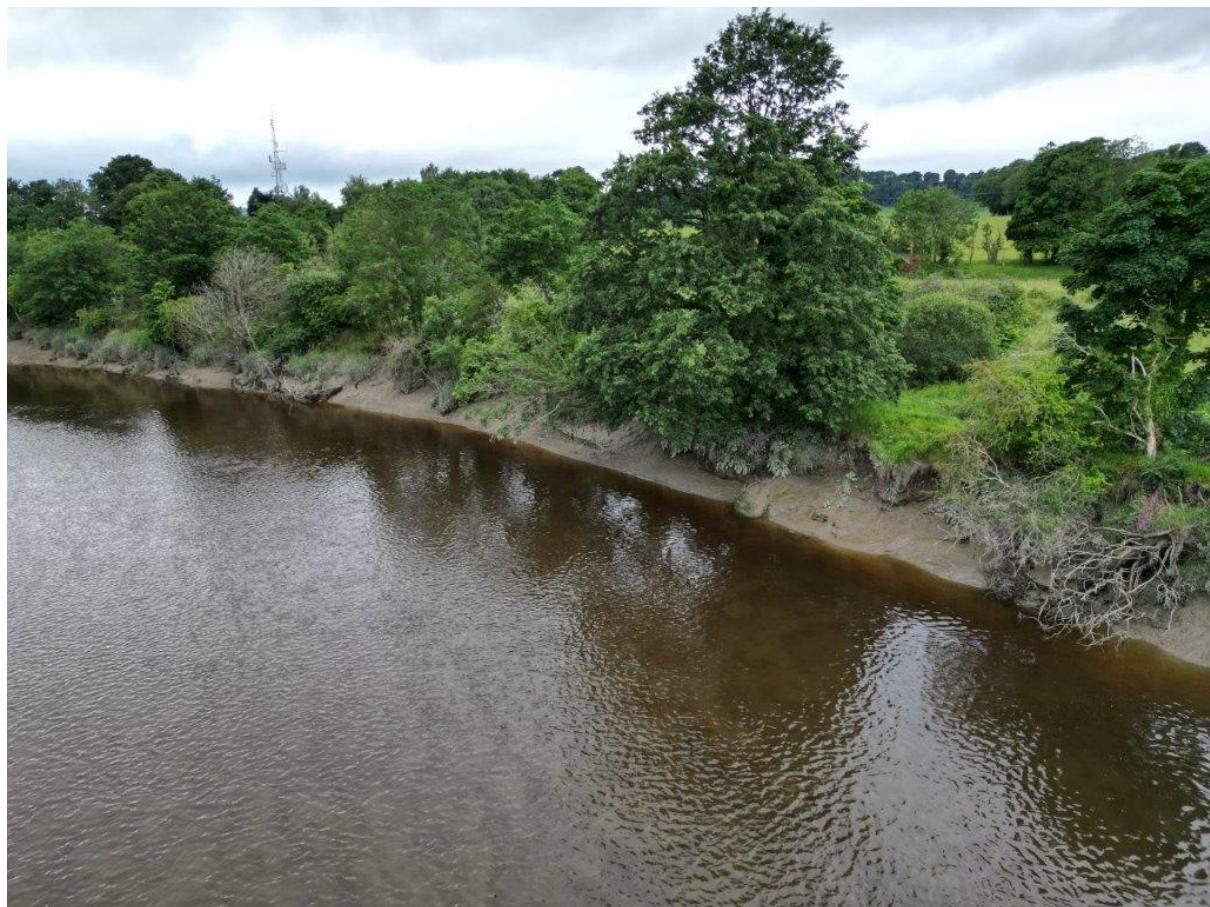
Photo 5 (below): Downstream work extent. Photo viewing downstream.
