**Levenmouth Demonstration  
Turbine**

**Revetment Inspection Report**

**DID/125740/01**

**June 2024**

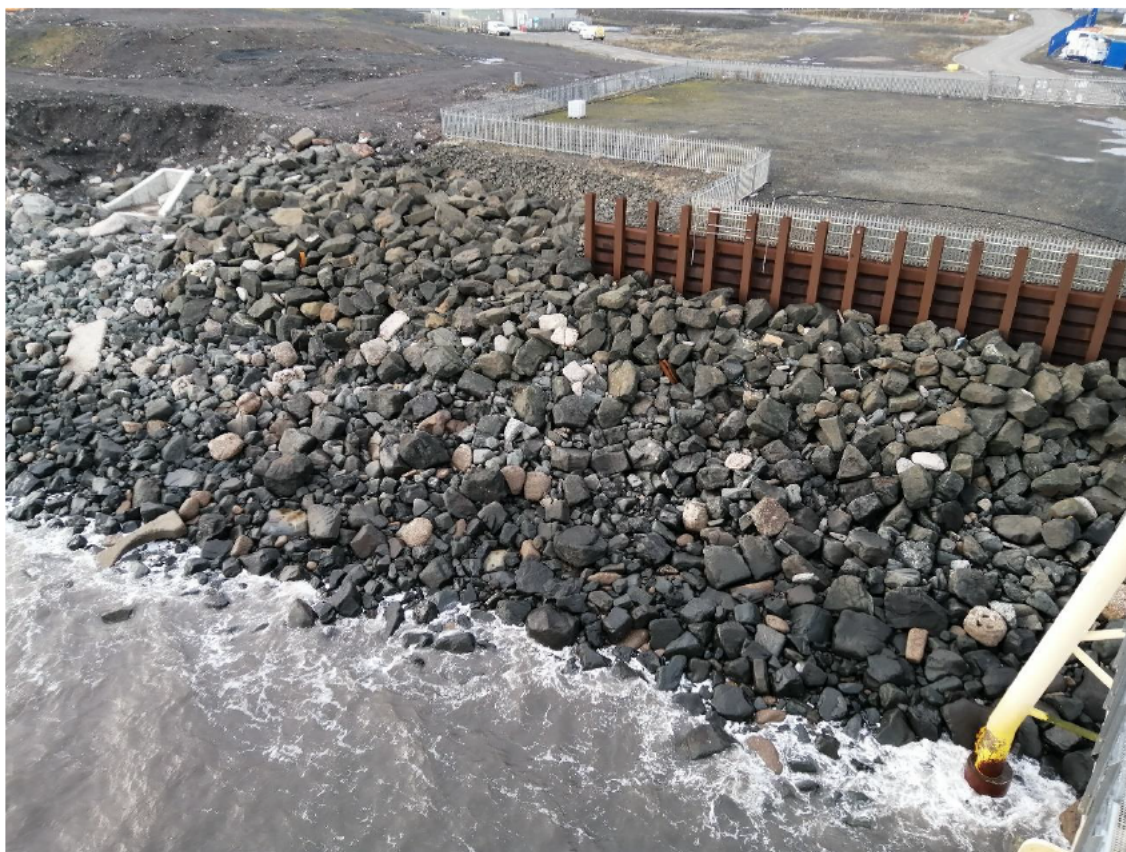
Within the western section of the revetment, adjacent to the King-Post retaining wall, it was evident some stones from the upper layer of primary armourstone have been displaced towards the toe of the revetment as a result of wave action, subsequently exposing the lower layer of primary armourstone as well as the secondary layers. This localised mobilisation of the primary armourstone also appears to have resulted in movement of the secondary armourstone, and hence isolated sections of rockfill have become exposed. The more finely graded material can be readily mobilised from the revetment under wave action (Figures 1-2).

Figure 1: Western section of revetment reconstructed in 2016 (taken: 22/11/2023)

Following review of the structures condition during both inspections, it is strongly recommended the primary armourstone units which have been mobilised towards the toe of the revetment, are recovered and repositioned within the revetment, to ensure the secondary armourstone and core are not directly exposed to incoming breaking waves. These stones will need to be repositioned in a manner which ensures the apertures between primary and secondary armourstones are insufficient to allow the migration of material from the layer below, under breaking waves. Subsequent to this, a further evaluation should be undertaken to assess the extent of protection which has been provided from recovery of existing material, and the requirement for the further importing of armourstone to further strengthen the existing revetment structure, notably within the areas which were not re-constructed in 2018.

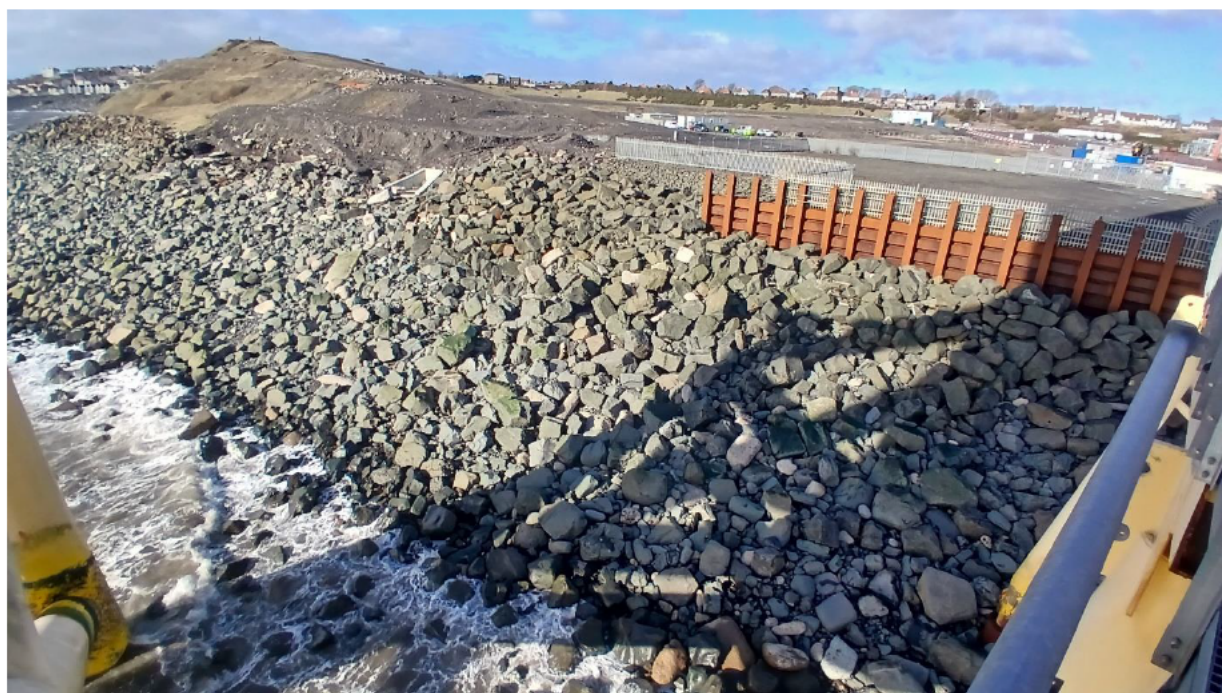
Figure 2: Western section of revetment reconstructed in 2016 (taken: 29/02/2024)

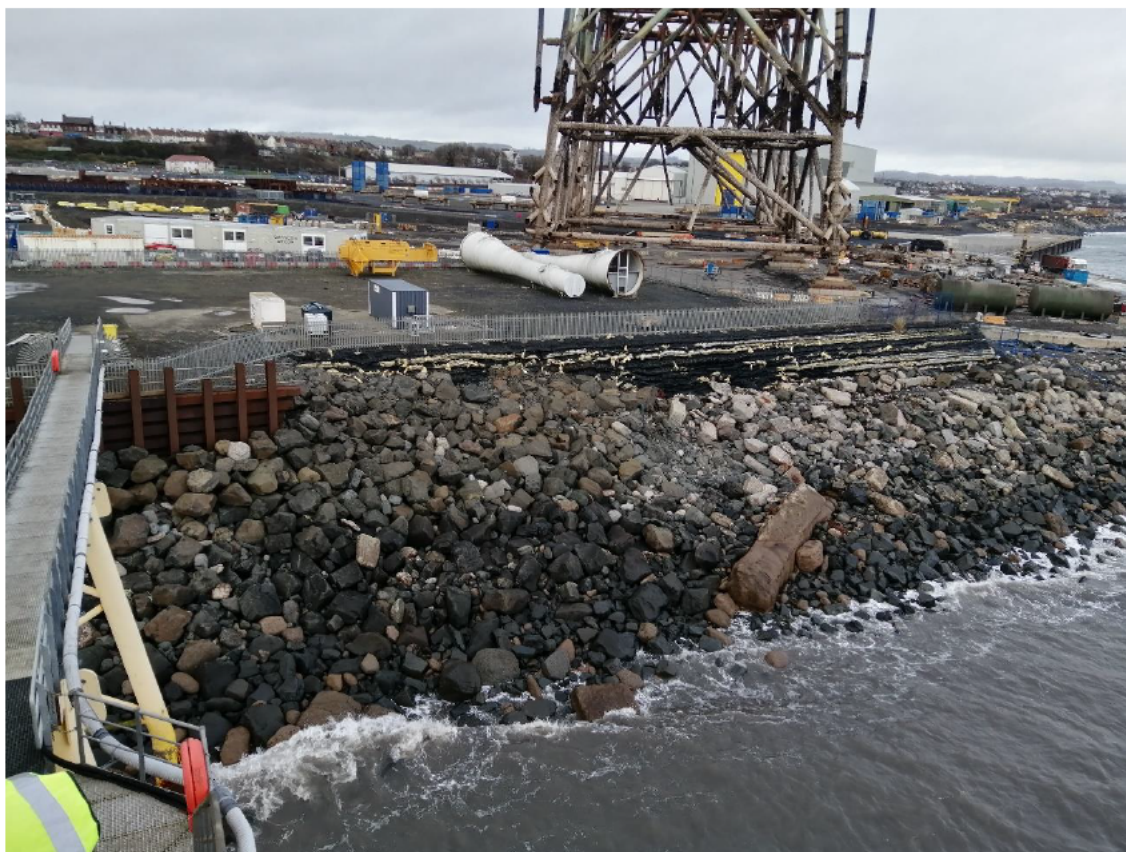
Within the eastern section of the revetment adjacent to the King-Post retaining wall, it was apparent that some material has been lost from the crest of the revetment, resulting in the displacement of a palisade fence post foundation. Similarly, within the area at approximately mid-tide, it was evident some of the material from the upper layer of primary armourstone has been displaced towards the toe of the revetment under wave action. Within this area, this has also resulted in some movement of the secondary armourstone and the exposure of rockfill, which can be readily mobilised from the revetment (Figures 3-4).

Figure 3: Eastern section of revetment reconstructed in 2016 (taken: 22/11/2023)

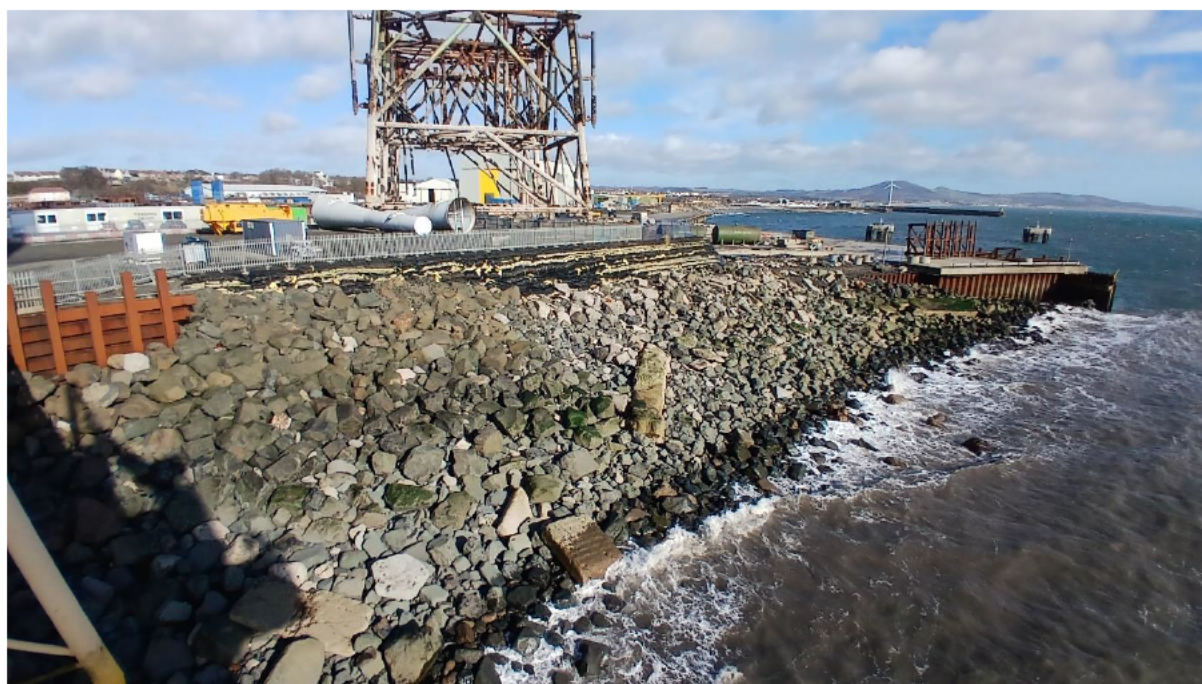
Figure 4: Eastern section of revetment reconstructed in 2016 (taken: 29/02/2024)

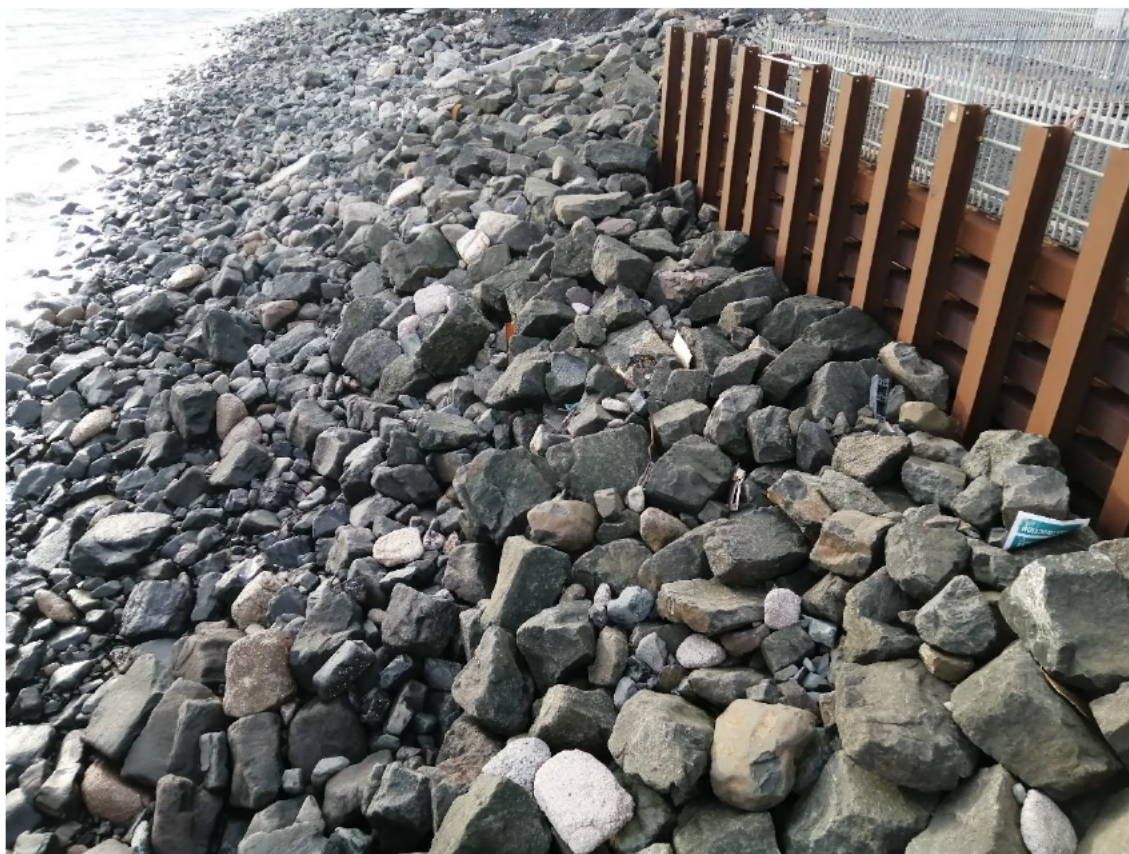
The revetment profile observed during the inspections was generally consistent with that of the original design drawings, with no significant areas of settlement or flattening of the profile or crest. It should be noted that some flattening of the revetment toe has occurred, to both sections of revetment, as a result of some primary armourstone units migrating towards the toe under wave action. From inspection, no apparent indications of breakage to individual stones were observed indicating a high degree of durability of the selected source material (Figures 5-6).

Figure 5: Western section of revetment reconstructed in 2016 (taken: 22/11/2023)

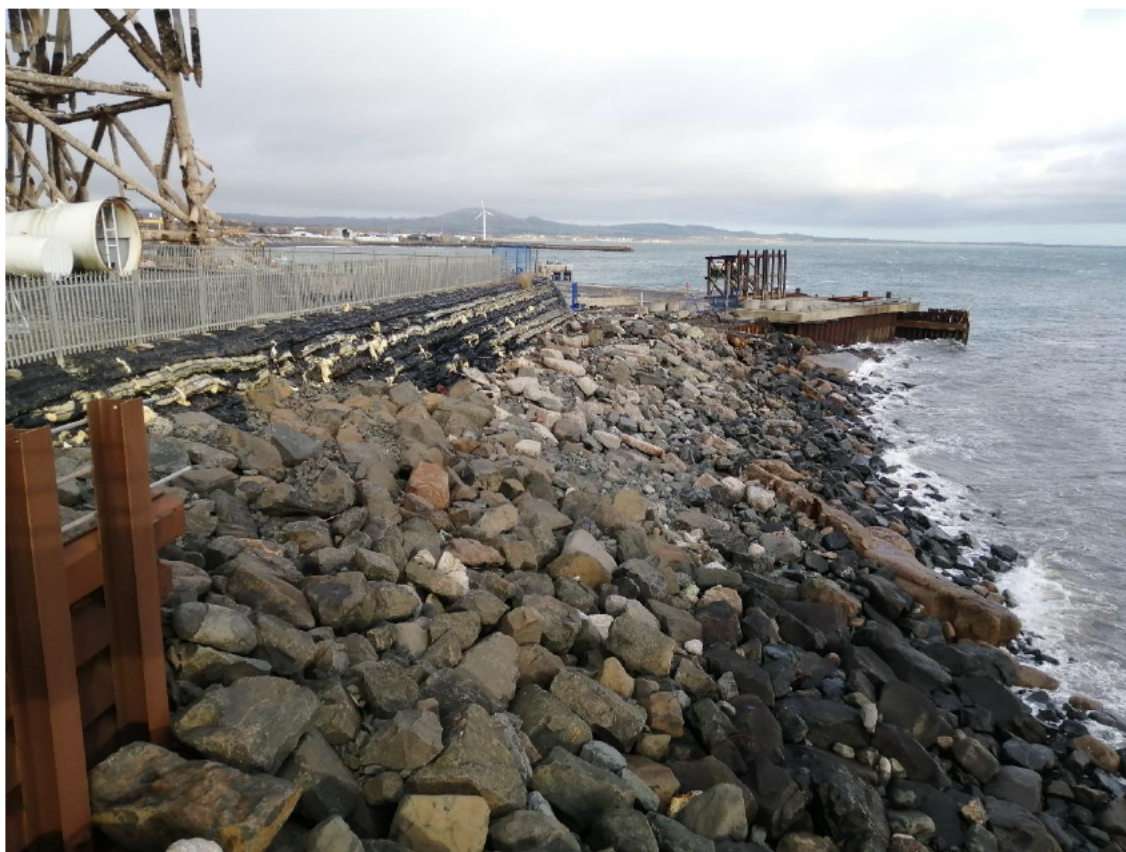
Figure 6: Eastern section of revetment reconstructed in 2016 (taken: 22/11/2023)

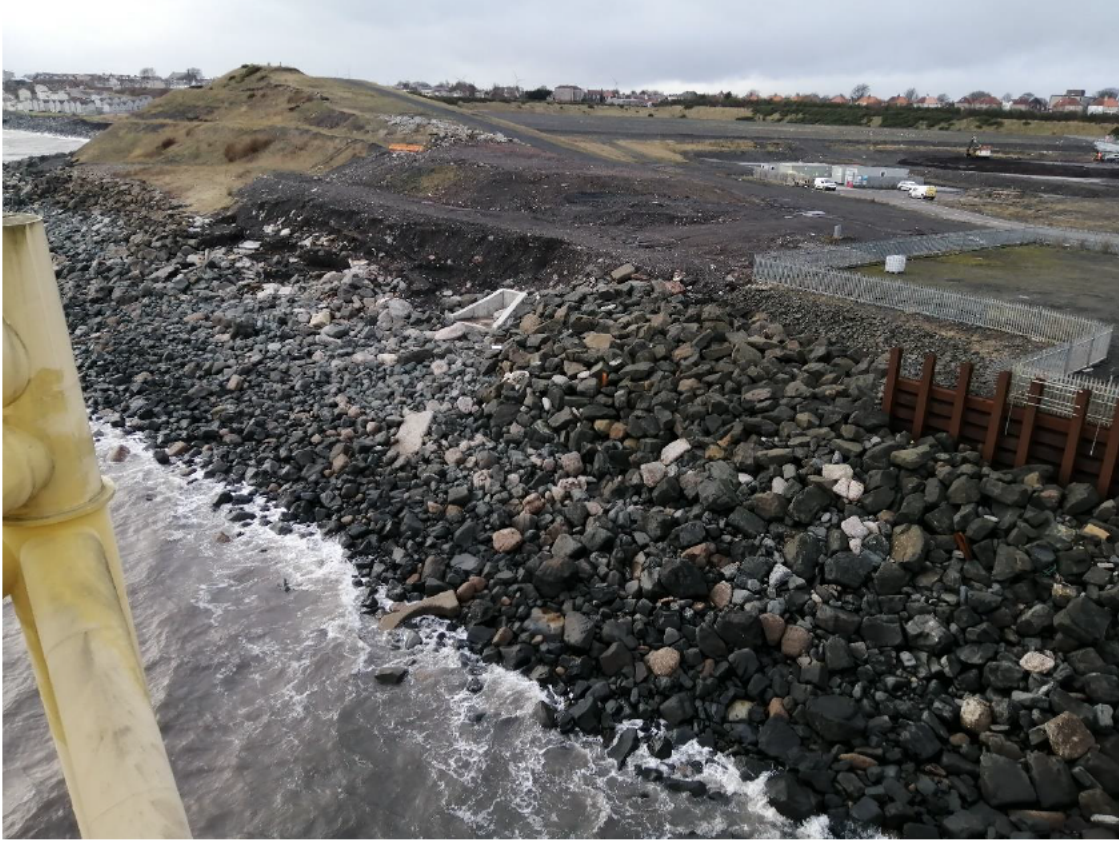
The westernmost section of structure within the jurisdiction of ORE Catapult, was observed to contain areas where the primary armourstone units have been mobilised towards the toe of the revetment or lost completely. This is resulting in the loss of the secondary armourstone due to the ability of incoming waves to mobilise these secondary units, as well as the progressive flattening of the revetment toe, as armourstone units migrate from the revetment crest towards the toe of the structure under wave action (Figures 7, 8, 11 & 12).

Furthermore, the loss of primary and secondary armourstone from this area has resulted in localised sections of exposed revetment core, being subjected to prevailing wave action. This has caused localised areas of scour to occur within and around the remaining sections of secondary armourstone, in areas where the primary layer has been lost. This action will continue to exponentially progress, with the extent and areas of scour increasing due to the particularly

aggressive wave climate observed at the site. This progressive loss of material from the revetment can be deduced between Figures 7 & 8.

Figure 7: Western section of existing revetment (taken: 22/11/2023)

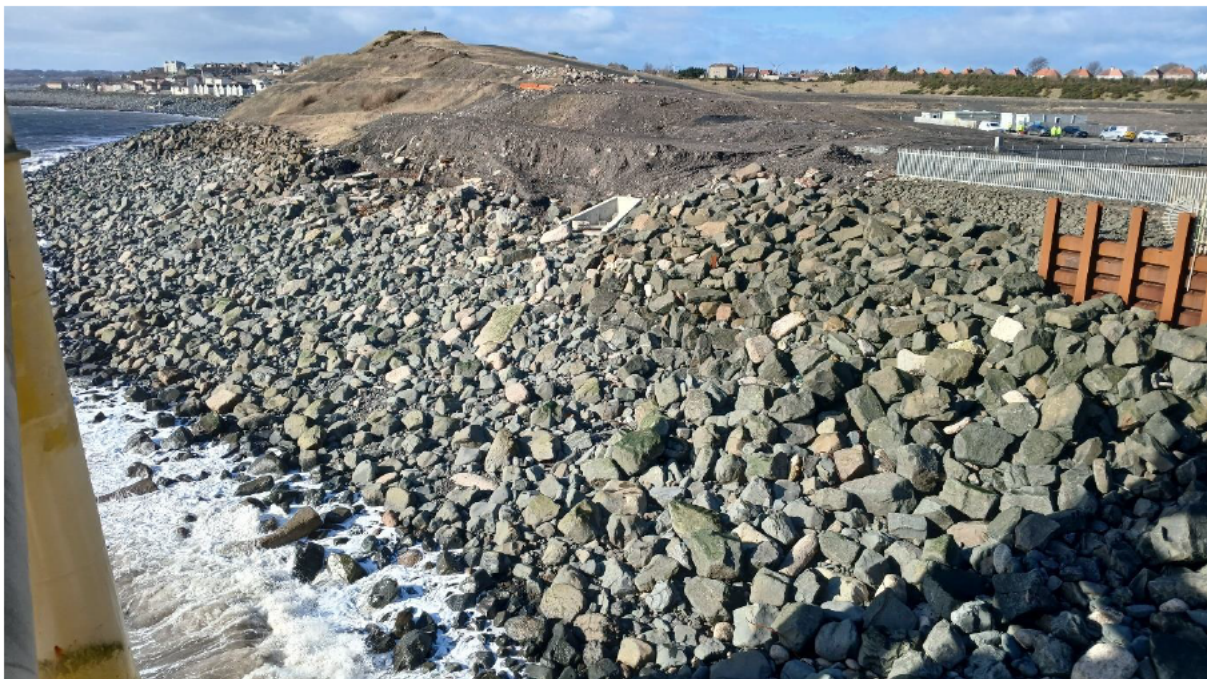
Figure 8: Western section of existing revetment (taken: 29/02/2024)

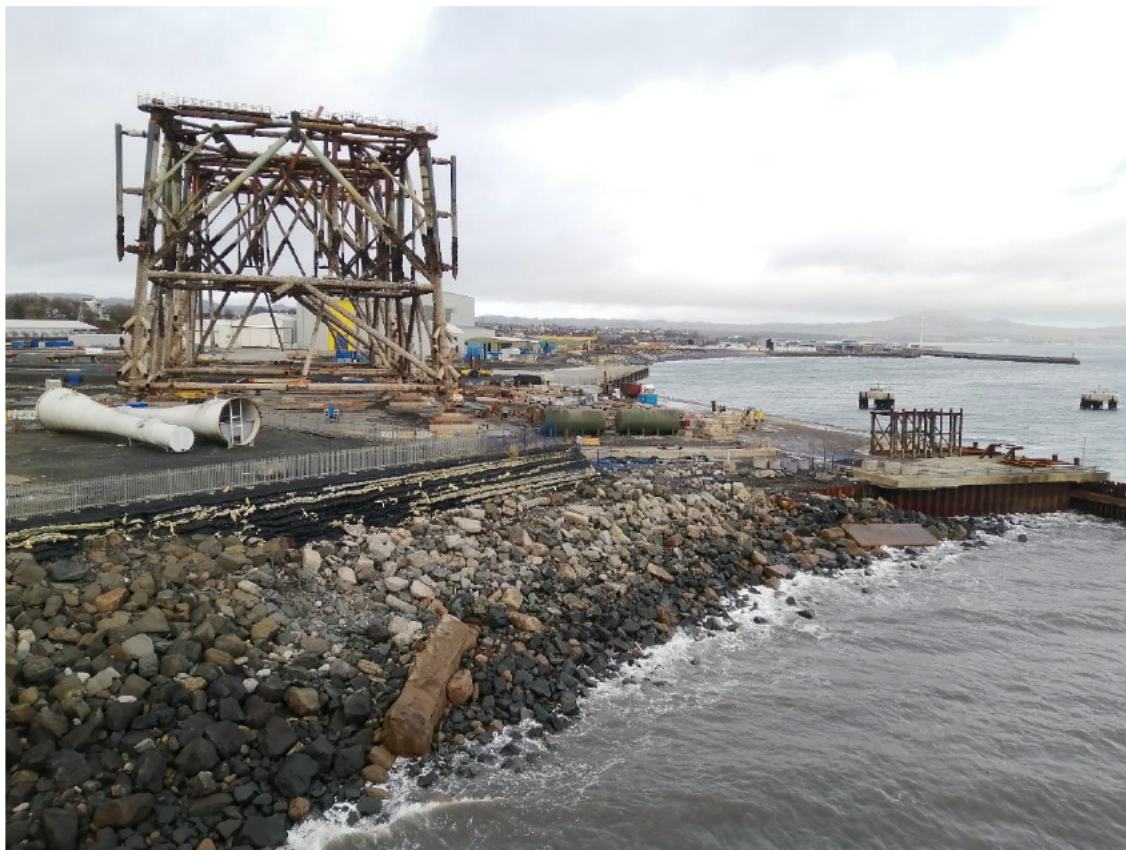
Similarly, within the eastern section of the structure, distinct areas of the revetment were observed to be largely unprotected as a result of the loss and migration of primary armourstone units, towards the toe of the revetment, resulting in the toe flattening. This loss is particularly prevalent in front of the earth retaining structure, where sections of the revetment core are exposed, and the loss of material is ongoing. In addition, further areas of exposed core were noted adjacent to the boundary with the neighbouring leaseholder, which is resulting in further ongoing scour (Figures 9, 10 & 12).

Figure 9: Eastern section of existing revetment (taken: 22/11/2023)

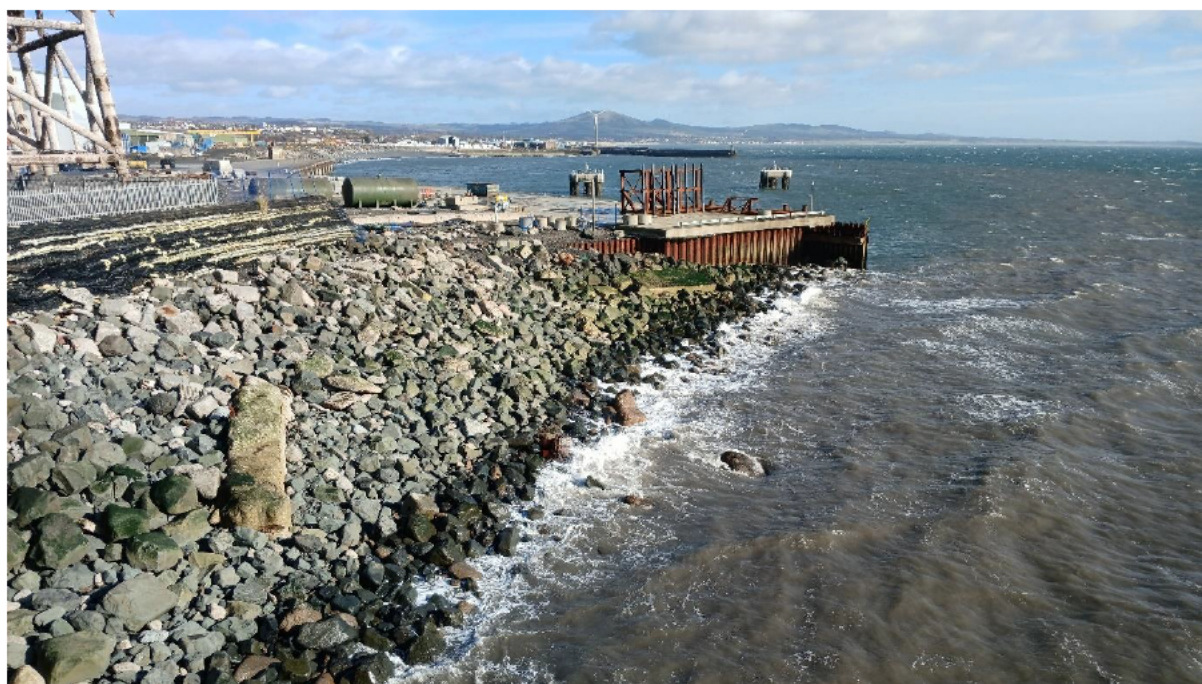
Figure 10: Eastern section of existing revetment (taken: 29/02/2024)

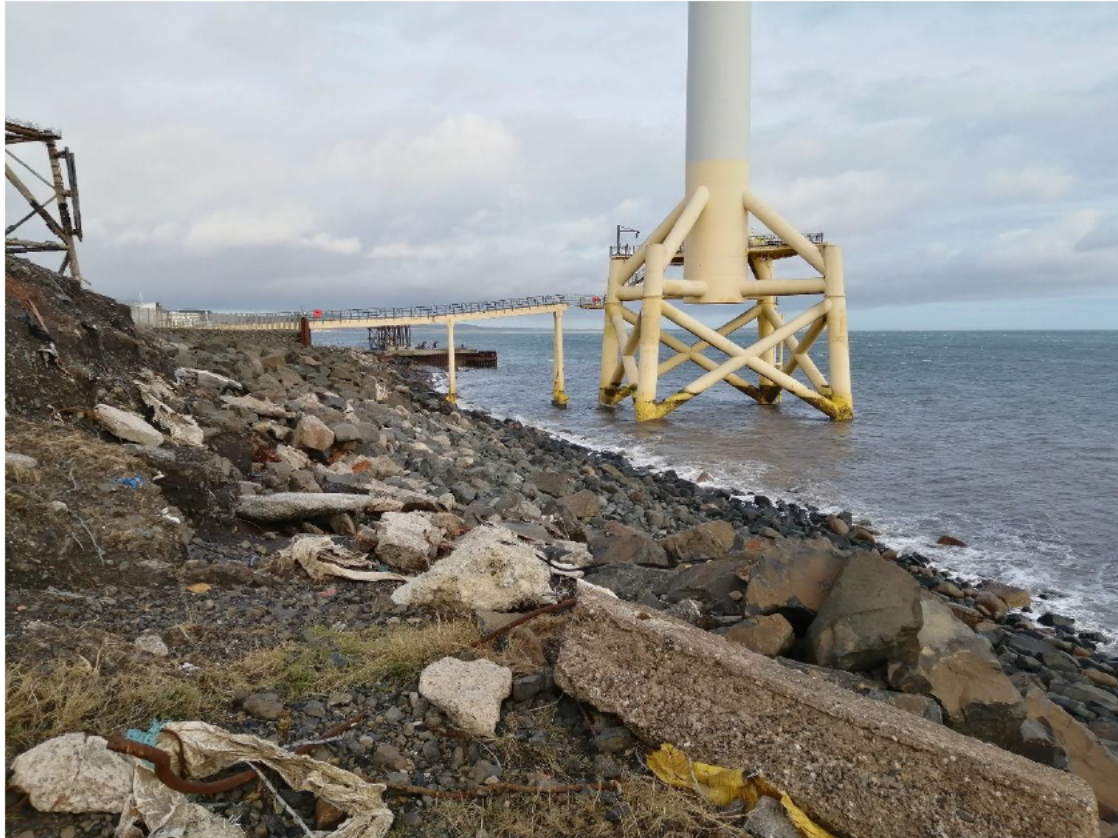
Figure 11: General profile of western section of existing revetment (taken: 22/11/2023)

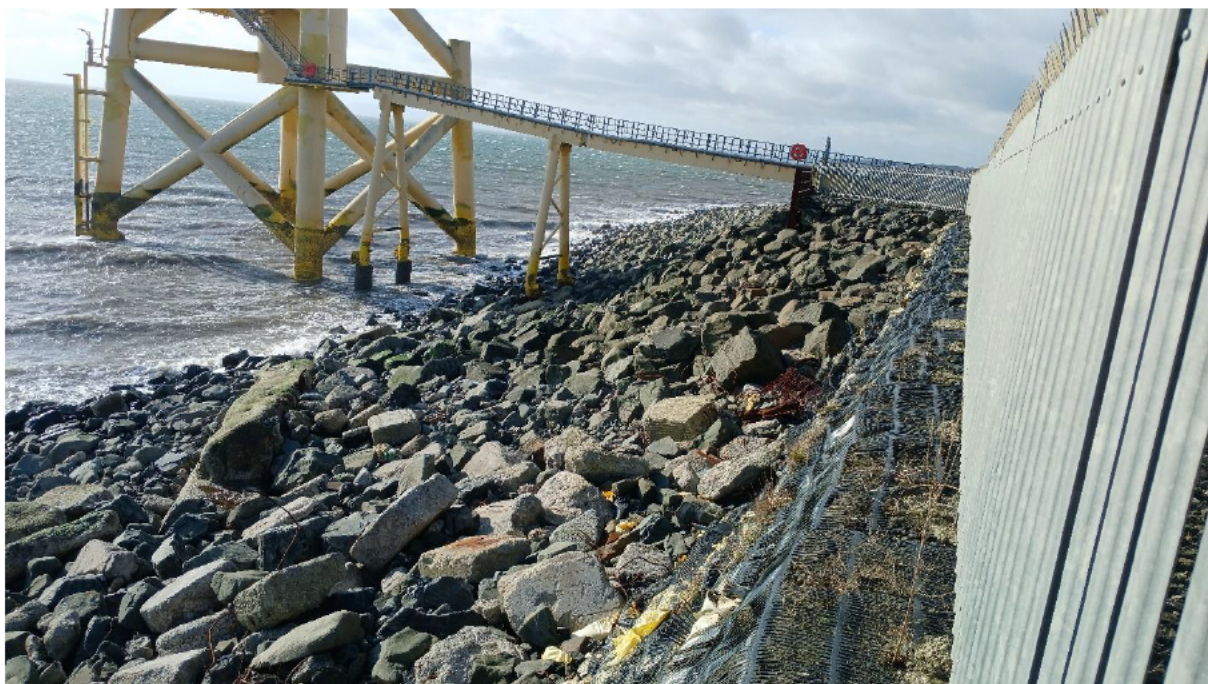
Figure 12: General profile of eastern section of existing revetment (taken: 29/02/2024)
