MSD101000 Wemyss Bay

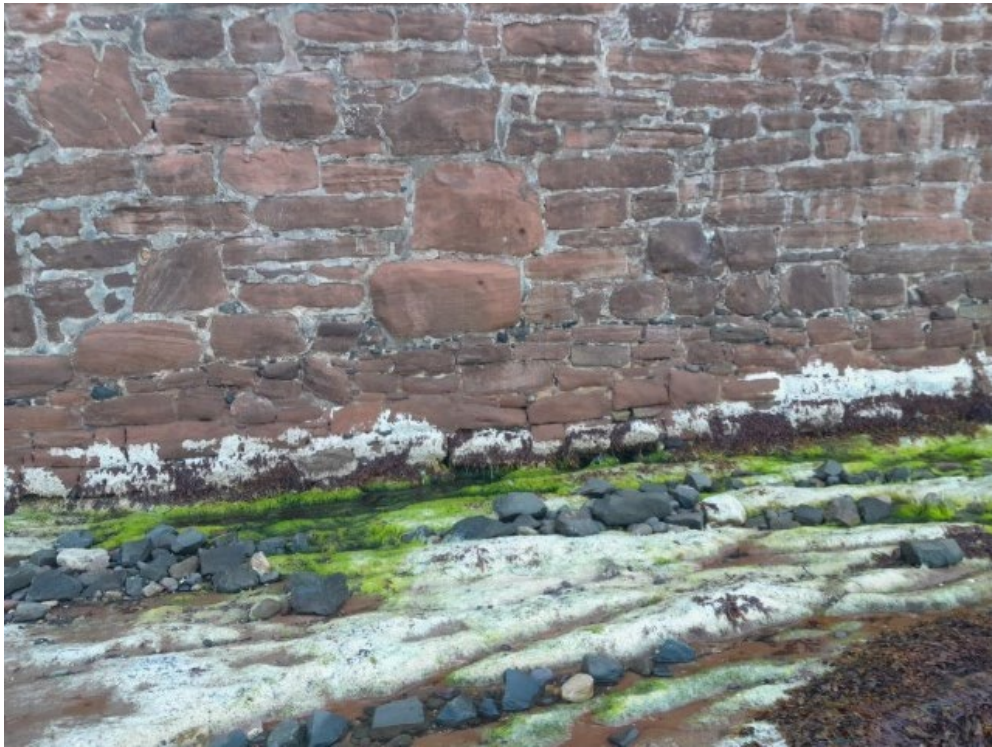
Photograph 14 - Section 3 - 9M 1328Y - Undermining at toe - 18.06.23

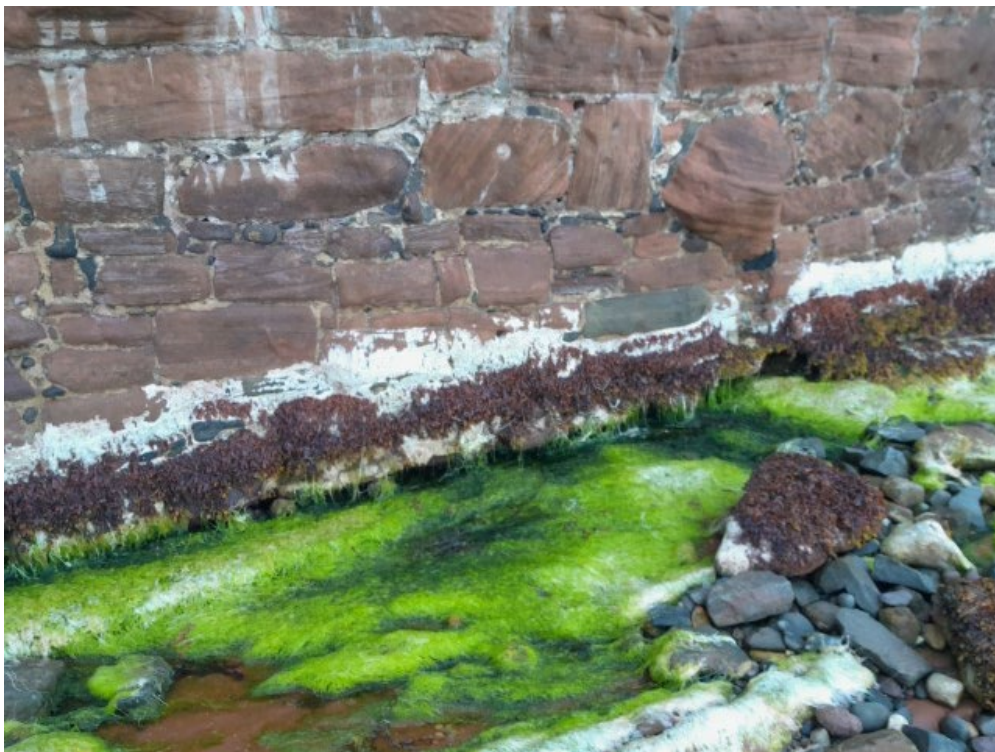
Photograph 15 - Section 3 - 9M 1344Y - Undermining at toe - 18.06.23

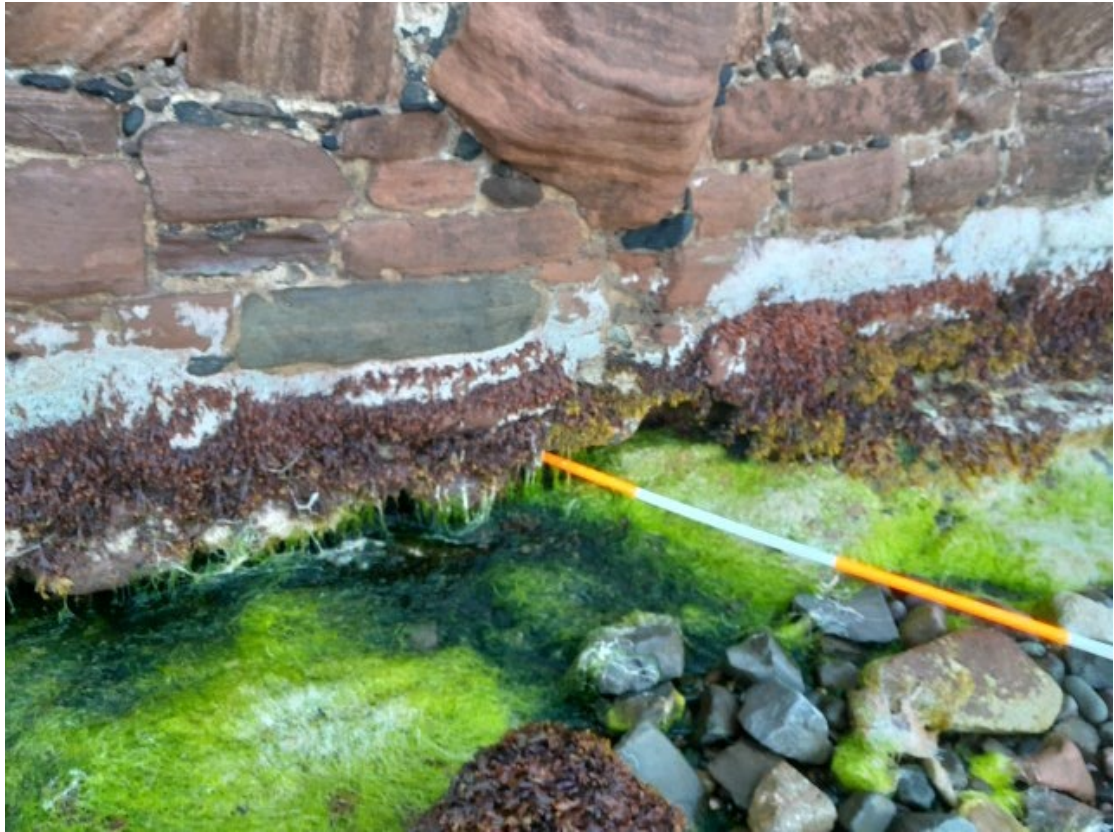
Photograph 16 - Section 3 - 9M 1359Y - Undermining at toe, majority of void filled shingle - 18.06.23

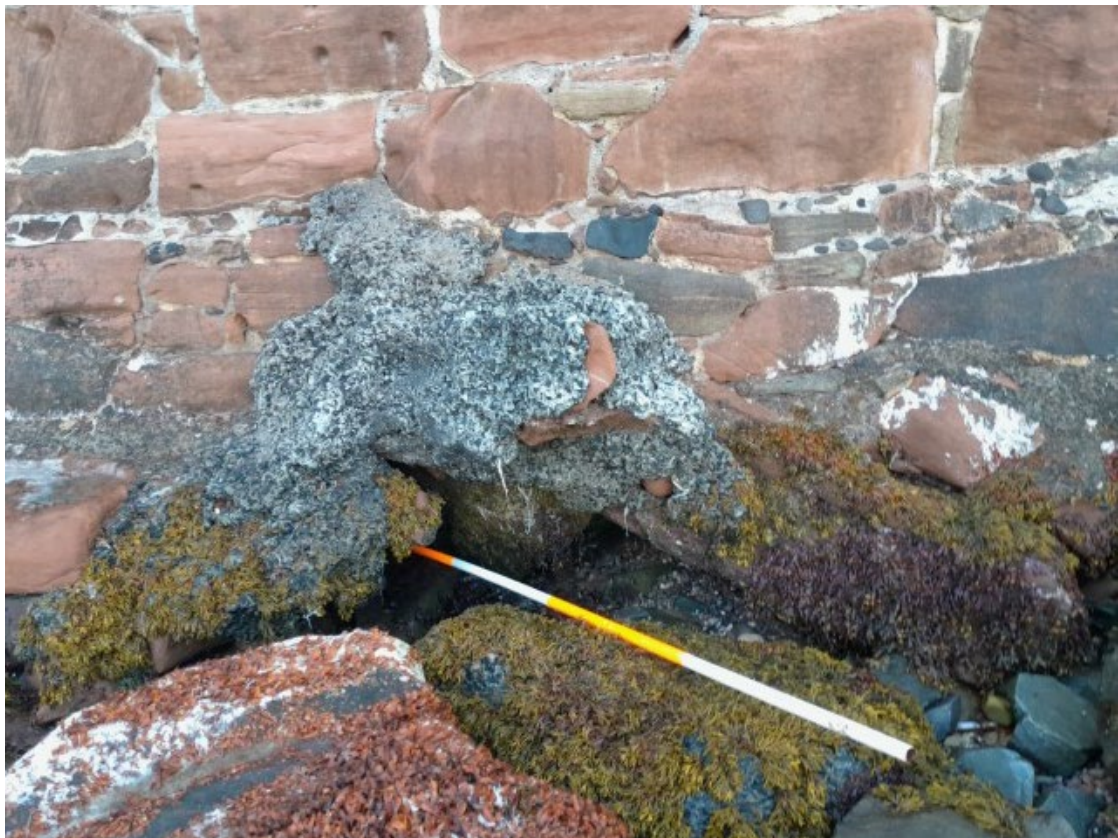
Photograph 17 - Section 3 - 9M 1395Y - Voids at toe of concrete repair no change (750mm) - 18.06.23

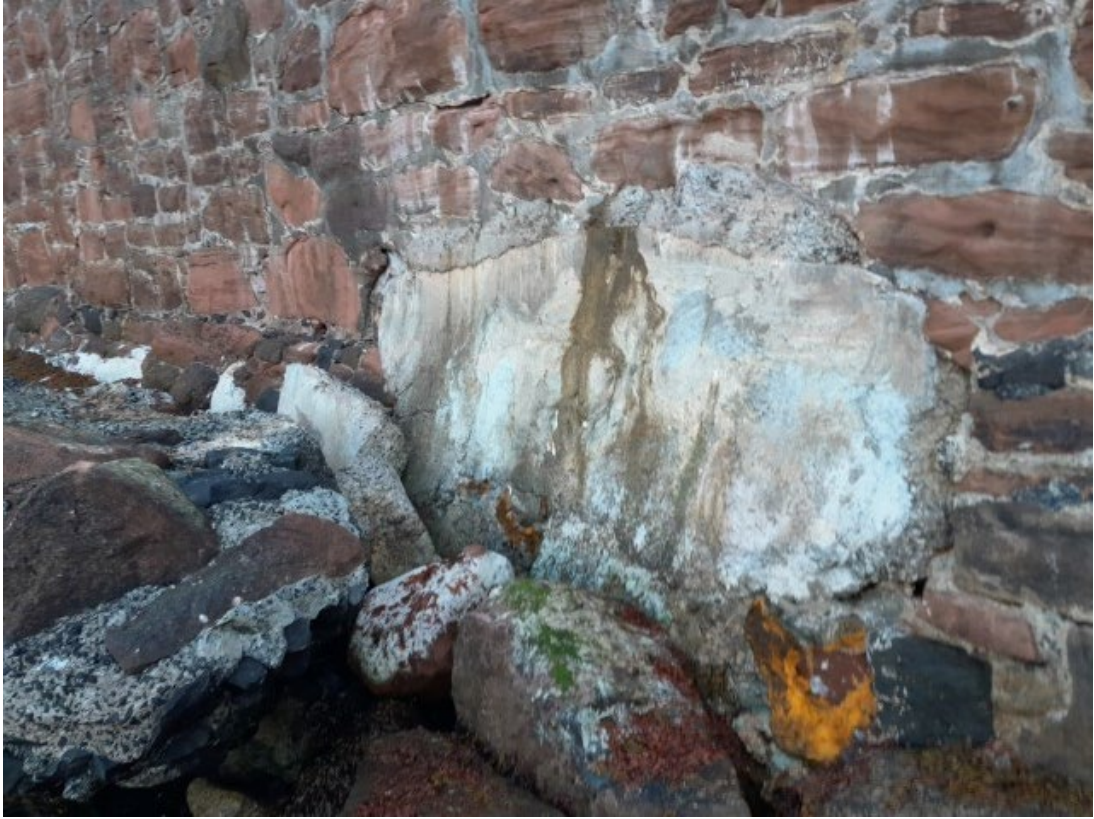
Photograph 18- Section 3M- 9M 1400Y- repair condition, void at toe of wall- 18.06.23

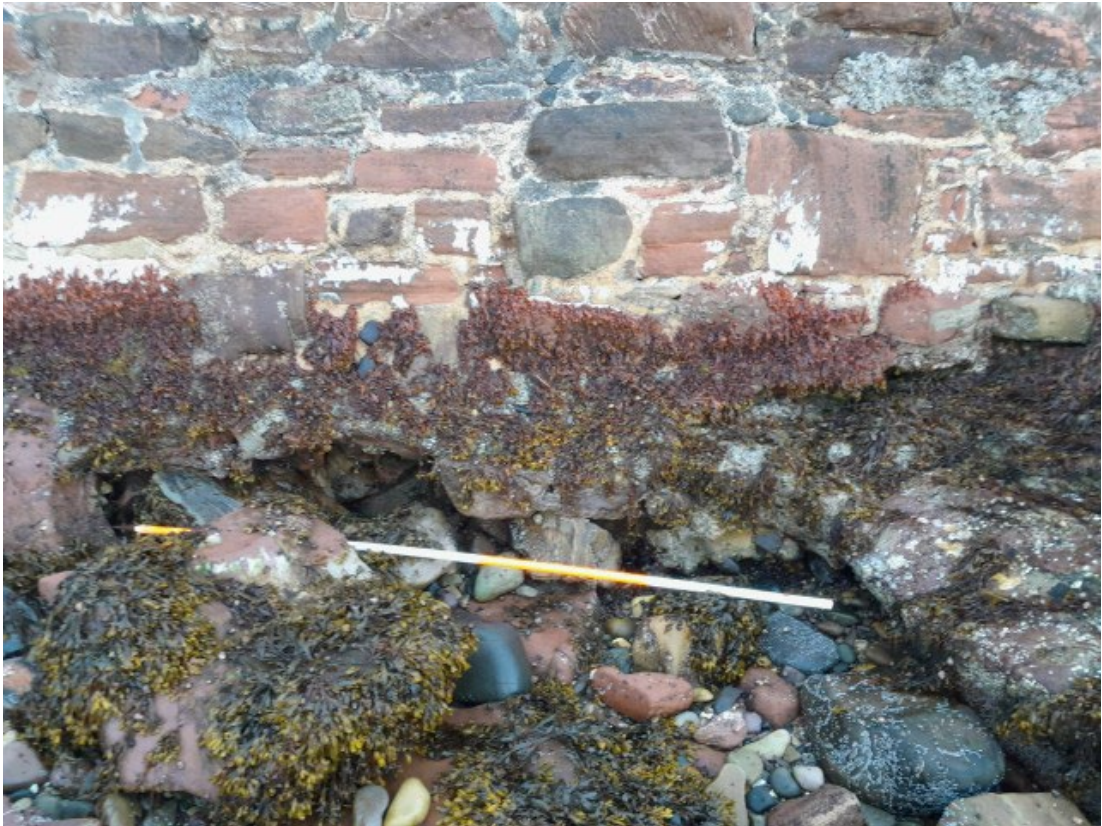
Photograph 20 - Section 3 - 9M 1400Y to 1412Y - Undermining at toe slight det - 18.06.23

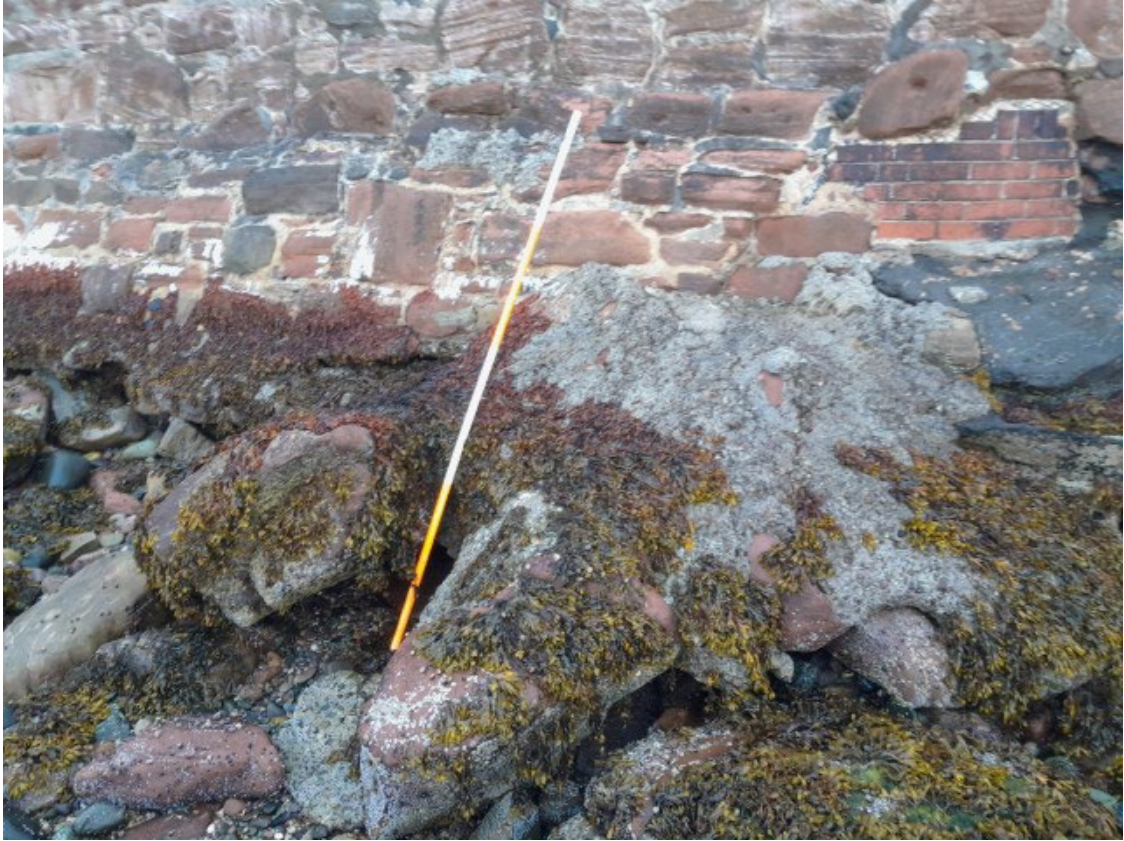
Photograph 21 - Section 3 - 9M 1411Y - mass concrete repair- 18.06.23

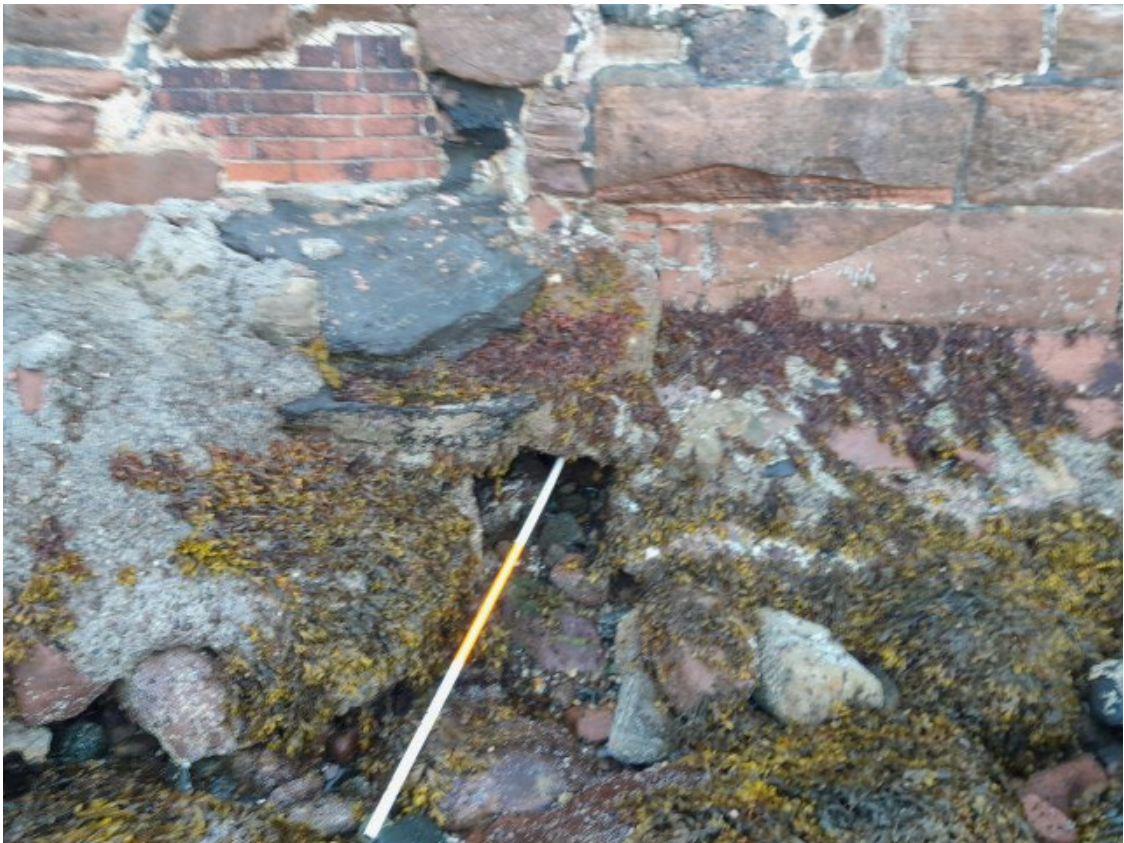
Photograph 22 - Section 3 - 9M 1414Y -void @ repair 750 deep- 18.06.23

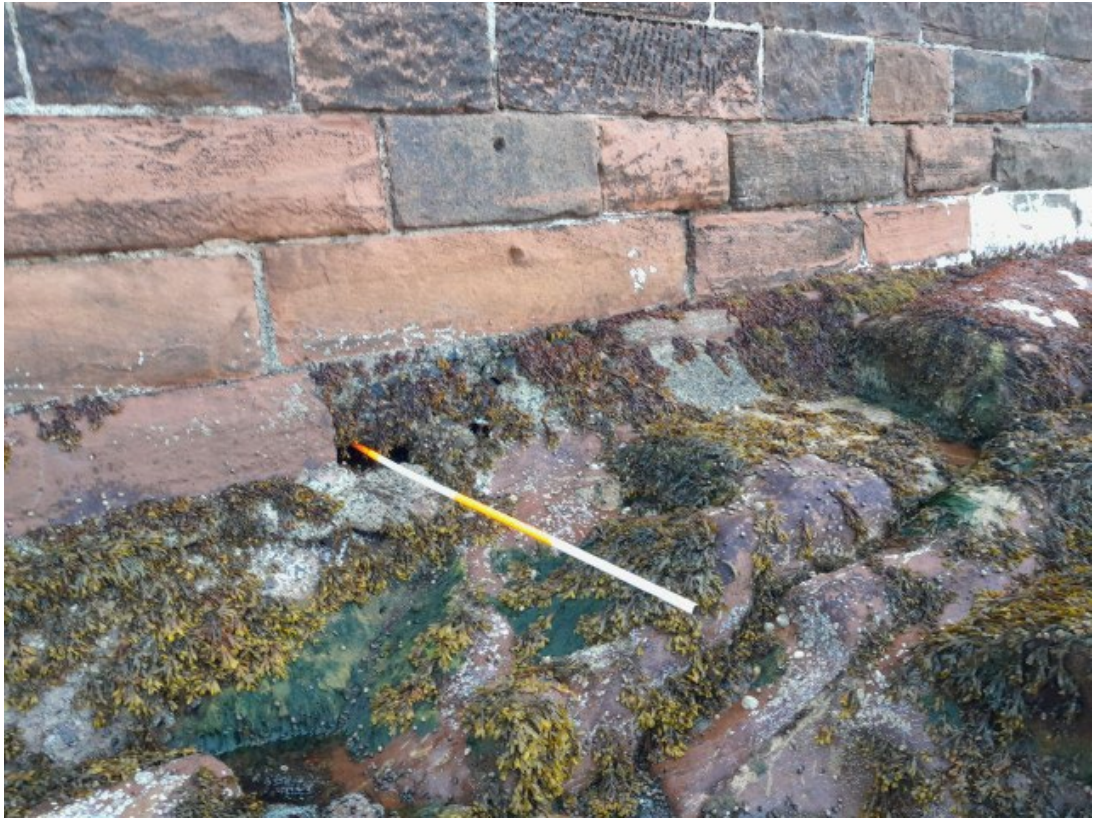
Photograph 23 - Section 3 - 9M 1416Y - Small void in concrete repair at toe 500mm deep- 18.06.23
