Site Hazard Log and Map

Workplace/Location/Access Ardoch Coach House Ardoch Cardross Dumbarton - W3W taskbar.fragment.skill -

Remit / Job Description 25/26 Repairs and Proactive works to scour and voiding - Replace damaged concrete toe to base of revetment at 18m 668-9yds, approx 2m length. (Opex Policy Target X)

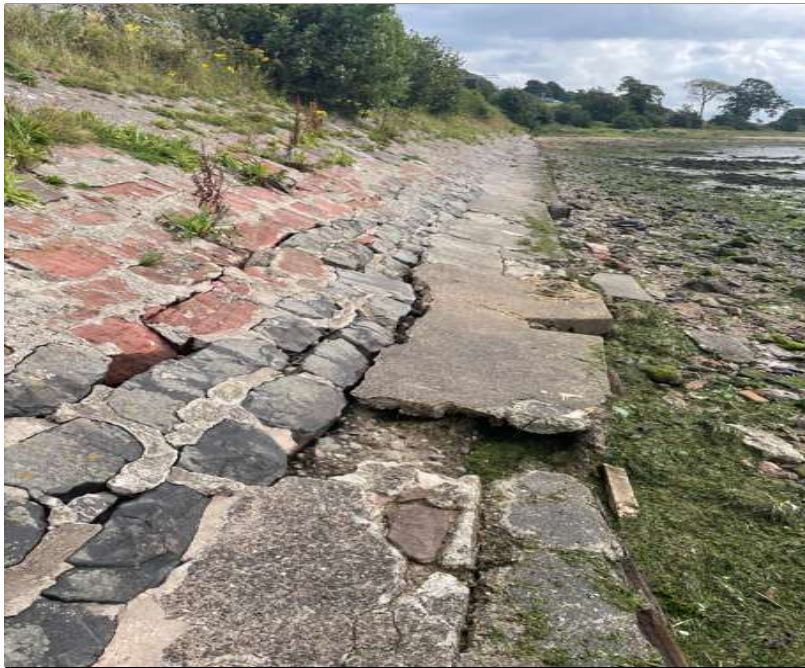
Key 2 - Section 1 - 18M 0668Y - Washout of concrete haunch along toe

- 8 The supervisor will mark-up defective areas at 18m 668-9yds of the concrete base around the extremities of the exposed concrete. The workforce will then proceed to saw draft edges and breakout the defective concrete with the use of a Stihl Saw and hydraulic breakers. The workforce will then proceed to remove loose stones and dig in 600mm deep, 1.2m wide x 3m long toe for new concrete apron/toe to be poured.

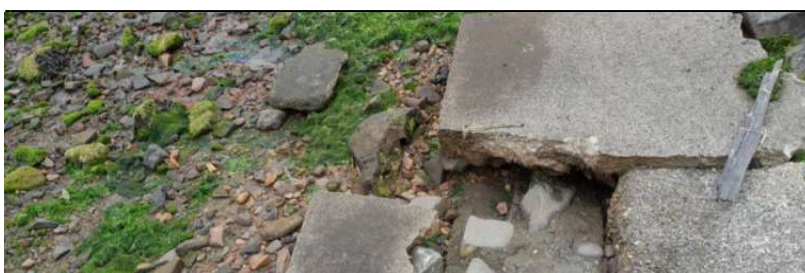
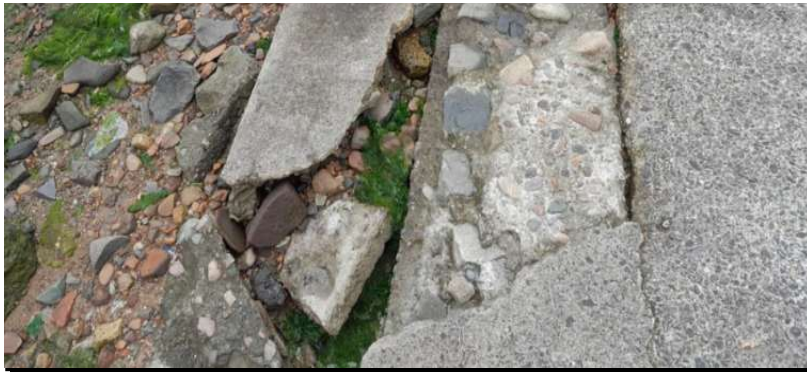
Key 4 - : Section 1 - 18M 0668Y - Washout of concrete haunch along toe -

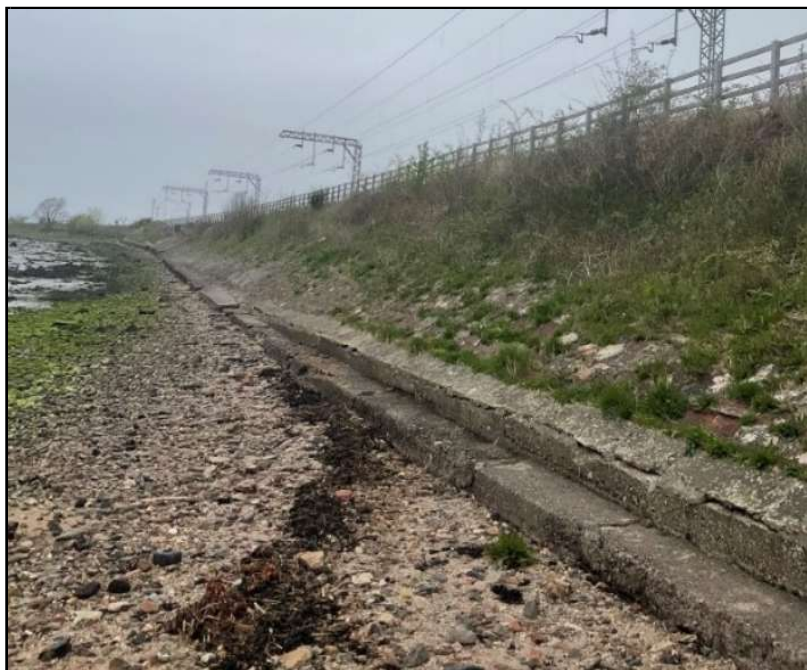
Key 6 - Section 1 -Start of defence to high miles

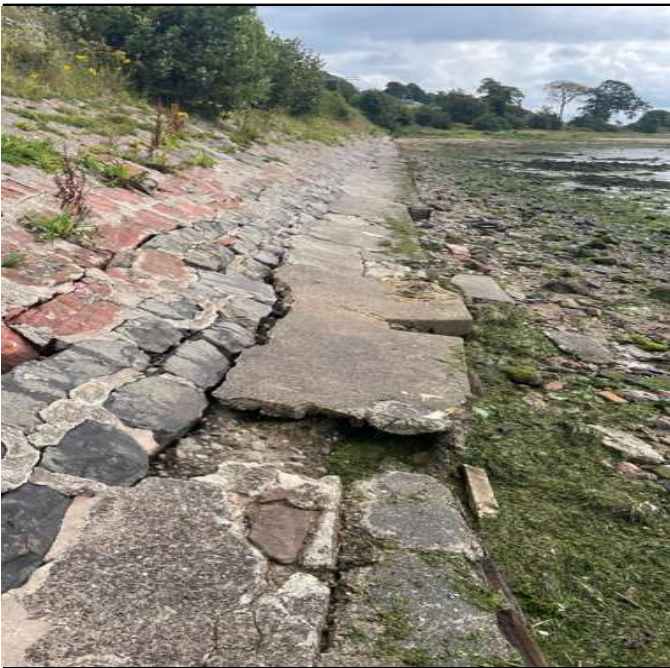
Section 1 - 18M 0668Y - Washout cracking of concrete
haunch along toe

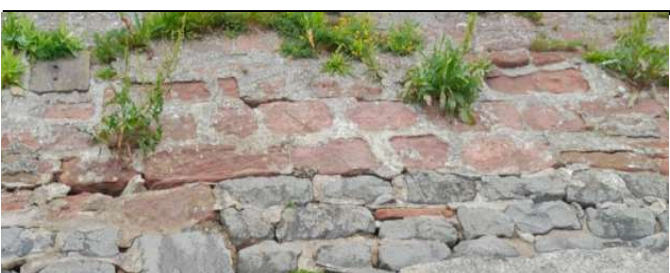
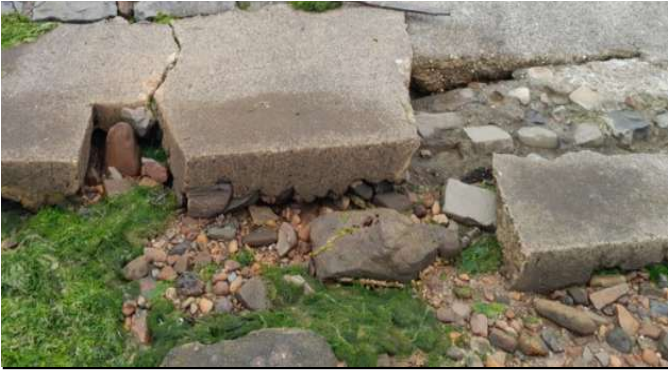
Section 1 - 18M 669Y-Pipe culvert (buried), cracking deterioration blocked

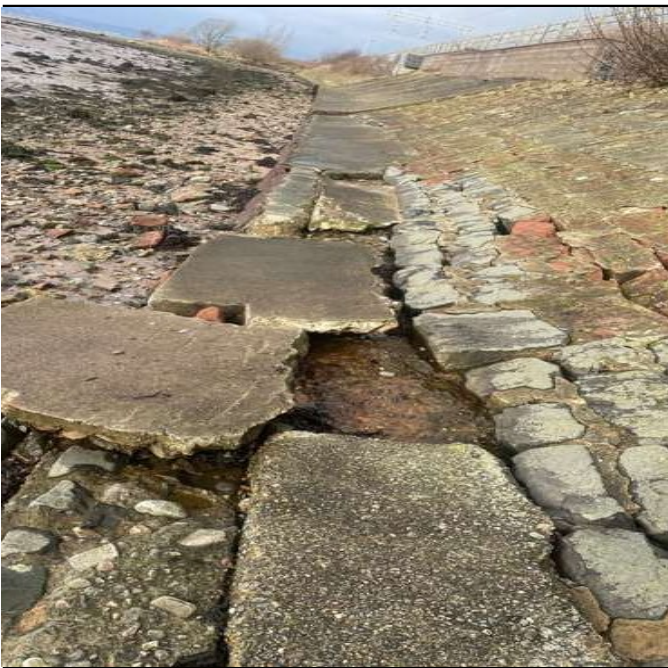
-Section 1 - 18M 687Y-End of section to low miles
