# **MORAY EAST** OFFSHORE WINDFARM

# **Post Construction Benthic Monitoring Report**

November 2024

Produced by Fugro GB Limited on behalf of Moray Offshore Wind Farm (East) Limited		
Produced by Paul English		
Document Status	Final	
Version	1	
File Name         MWE-OW-OP-REP-0002		
Date     21 November 2024

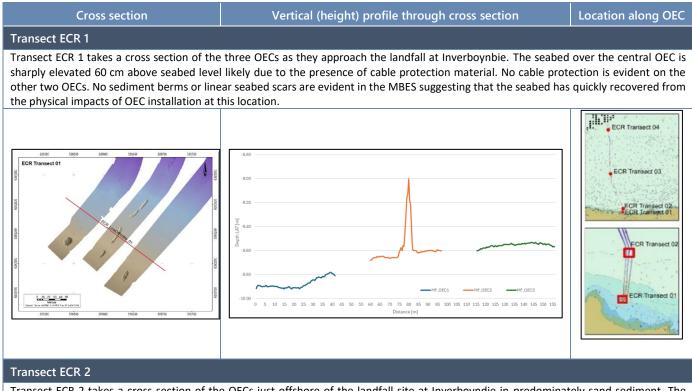
Linear seabed indentations corresponding to the trenched cable route and the tracks of the trenching tool either side of the trench are evident at Transects ECR 2, 3 and 4. In contrast, no seabed indentations or sediment berms are apparent in the MBES data at Transect ECR 1 located closest to shore suggesting that the seabed physical impacts had recovered at this location at the time of the 'as built' geophysical survey.

Transect ECR 2 takes a cross section of the OECs just offshore of the landfall site at Inverboyndie in predominately sand sediment. The seabed over the central and western OECs is sharply elevated up to 1.0 m above seabed level and is likely due to the presence of cable protection material. Seabed berms are evident either side of the OECs in the MBES data suggesting that physical impacts have yet to fully recover at this location.
