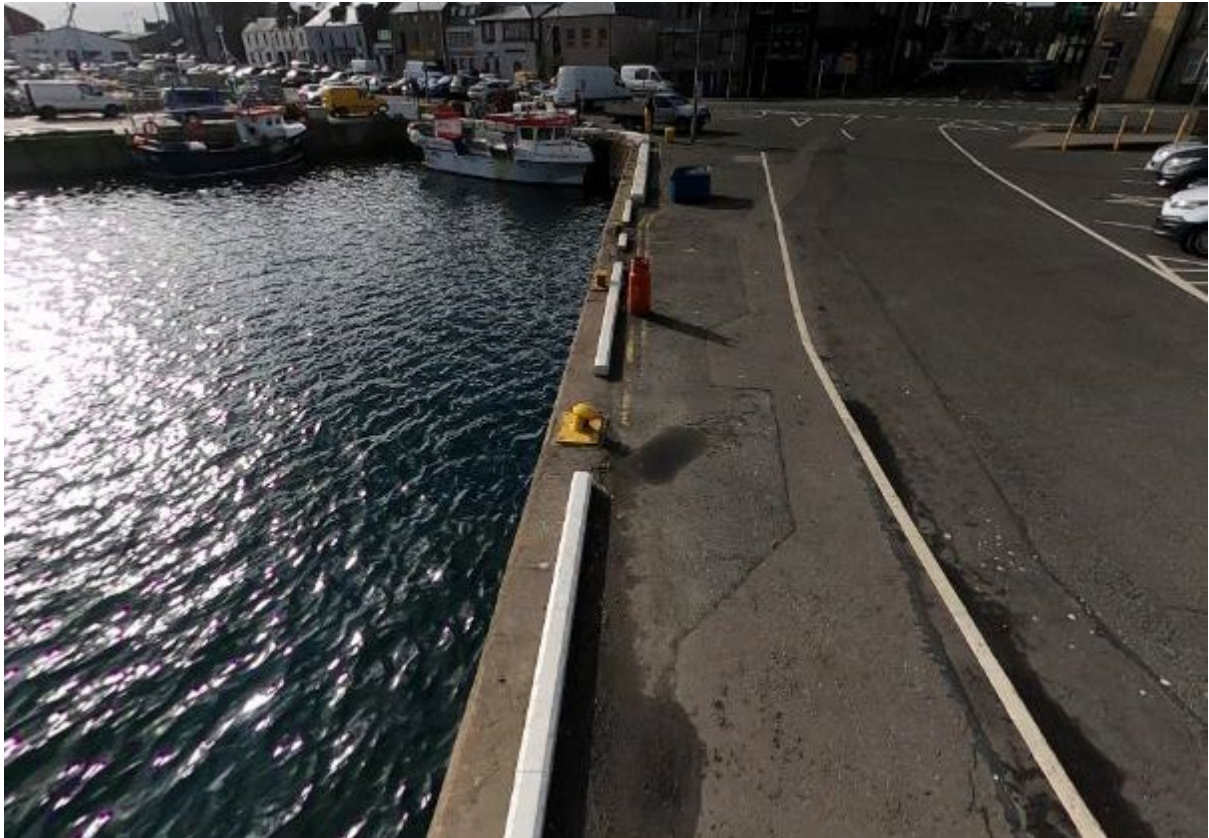
Photo 1 – View along quay at proposed pontoon location

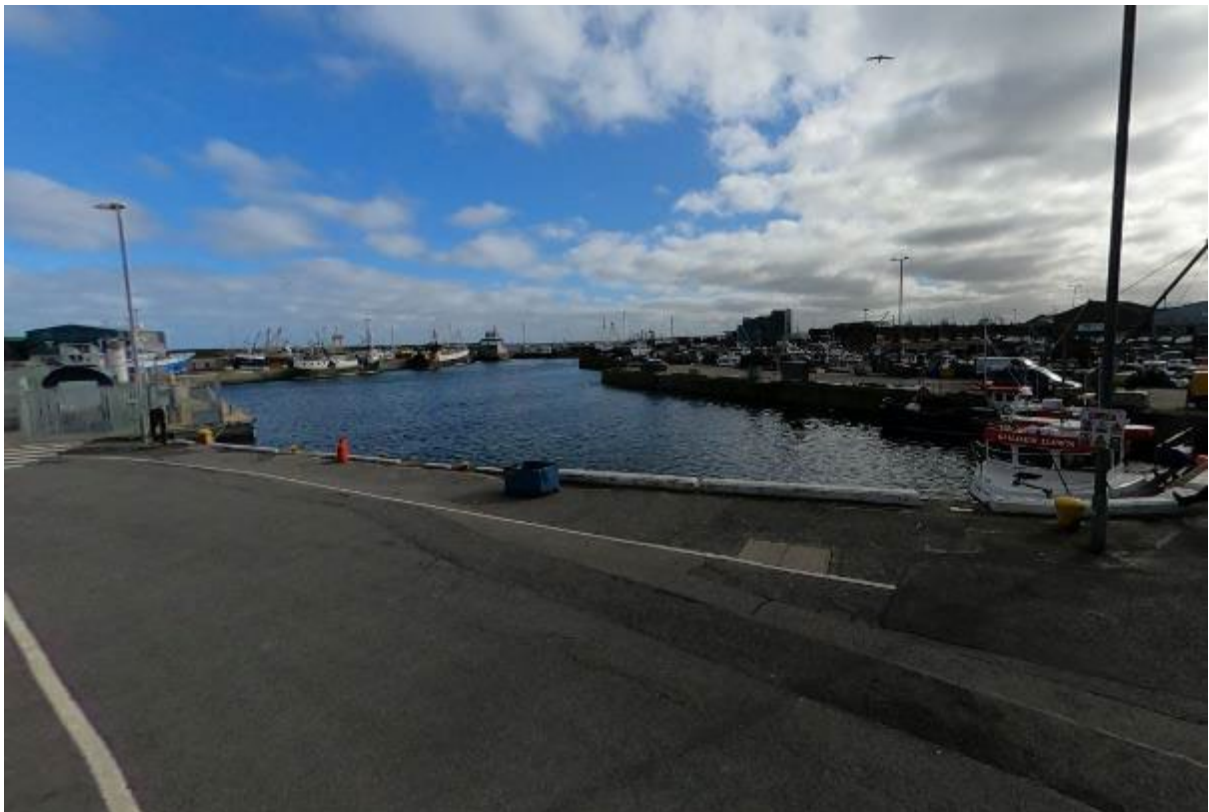
Photo 2 – General view of quay at proposed pontoon location

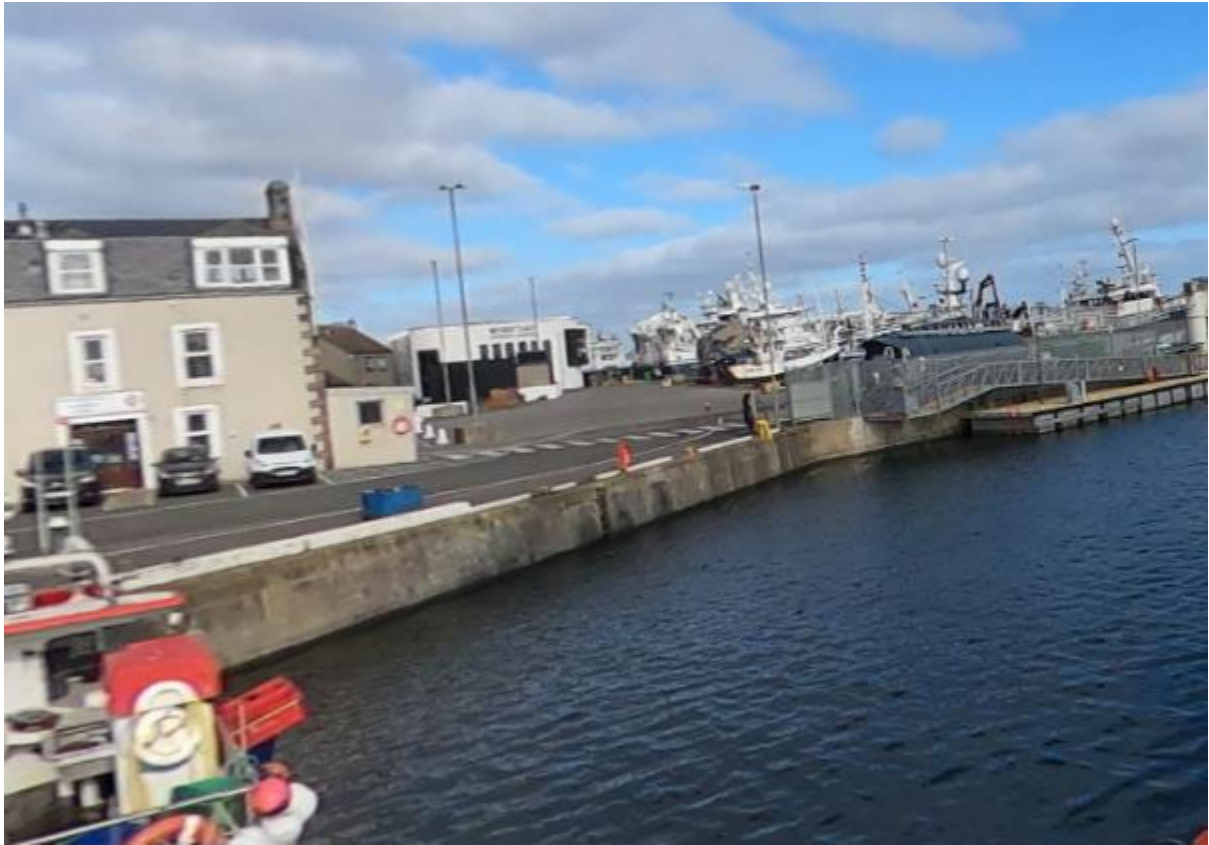
Photo 3 – General view of proposed pontoon location

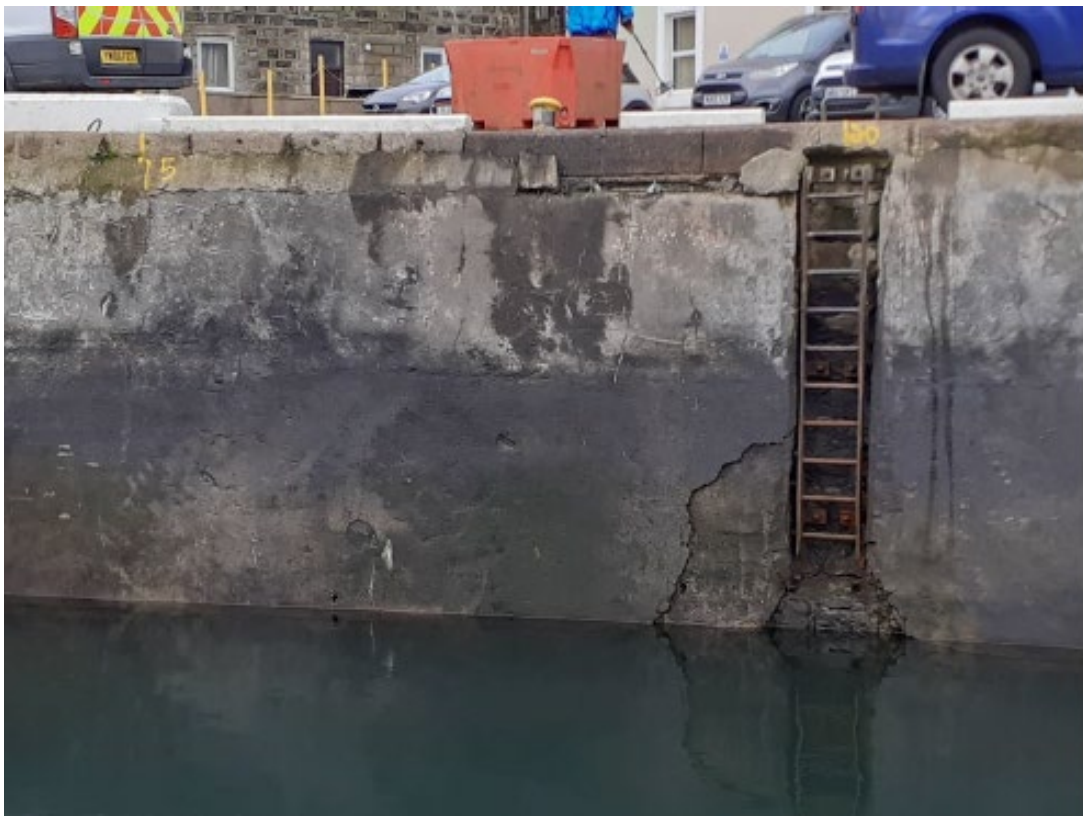
Photo 4 – General view of quay wall showing typical concrete defects and ladder to be removed

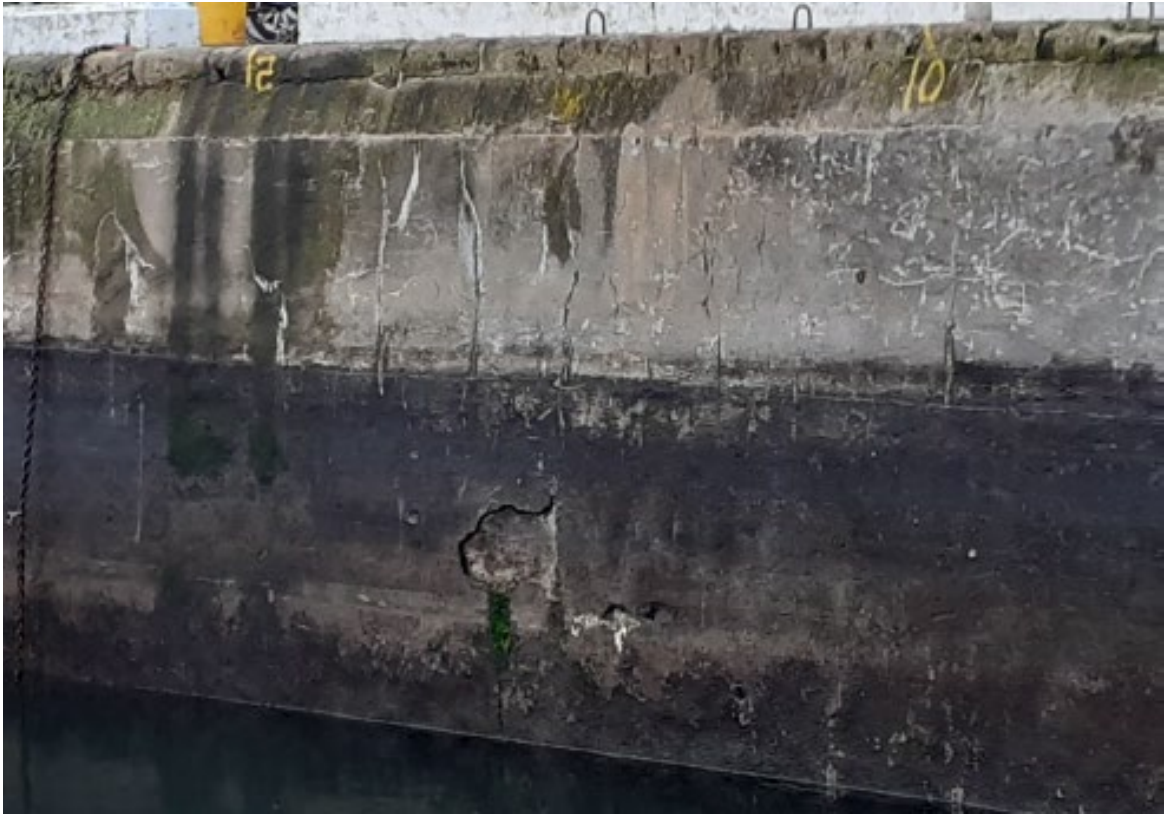
Photo 5 – General view of quay wall showing typical concrete defects

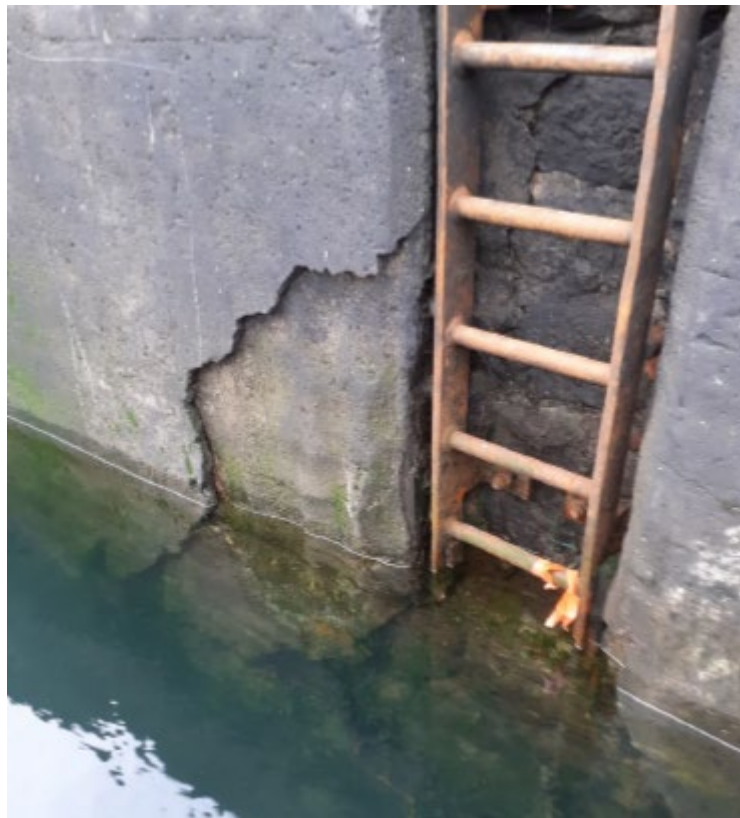
Photo 6 – General view of quay wall showing typical concrete defects

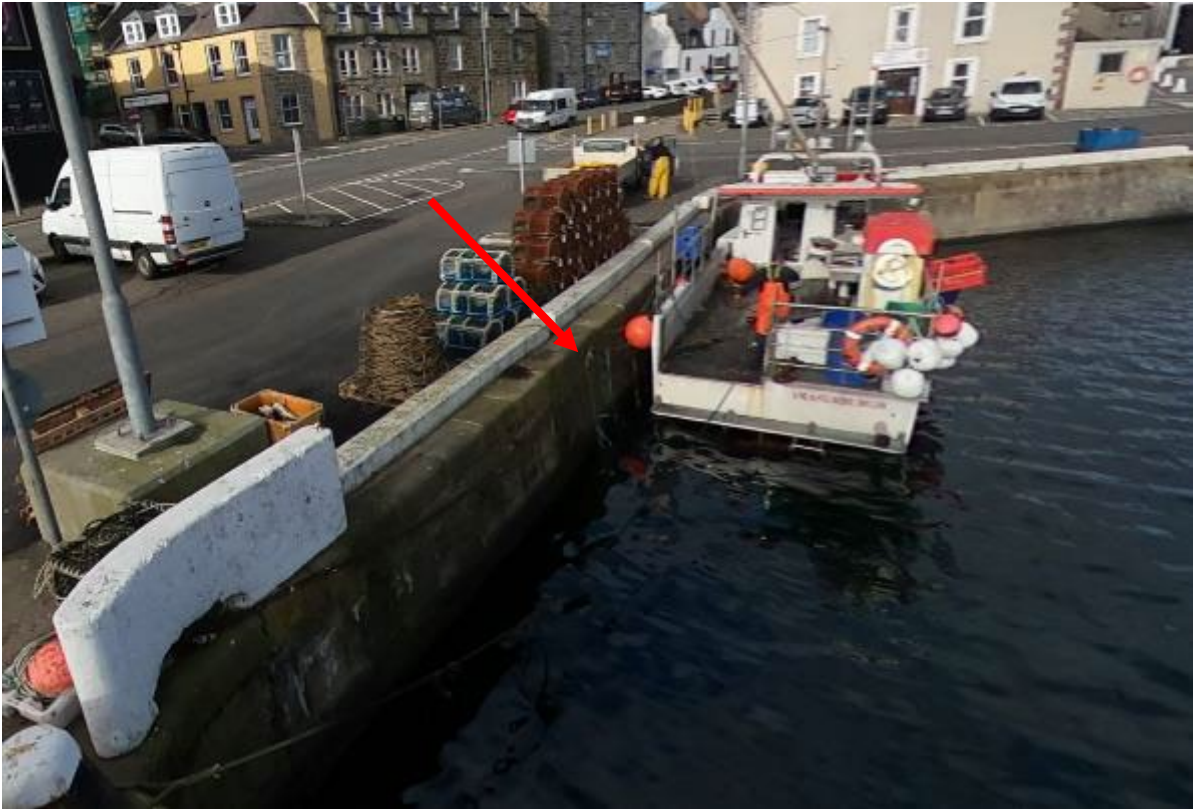
Photo 7 – Proposed location of new ladder recess and ladder
