FORTH PORTS
SCOTLAND

PORT OF DUNDEE DUNDEE EAST REDEVELOPMENT **FAIRHURST**

PCW PILE REPAIRS

18/04/19 18/04/2019 8/04/2019 130143/4201

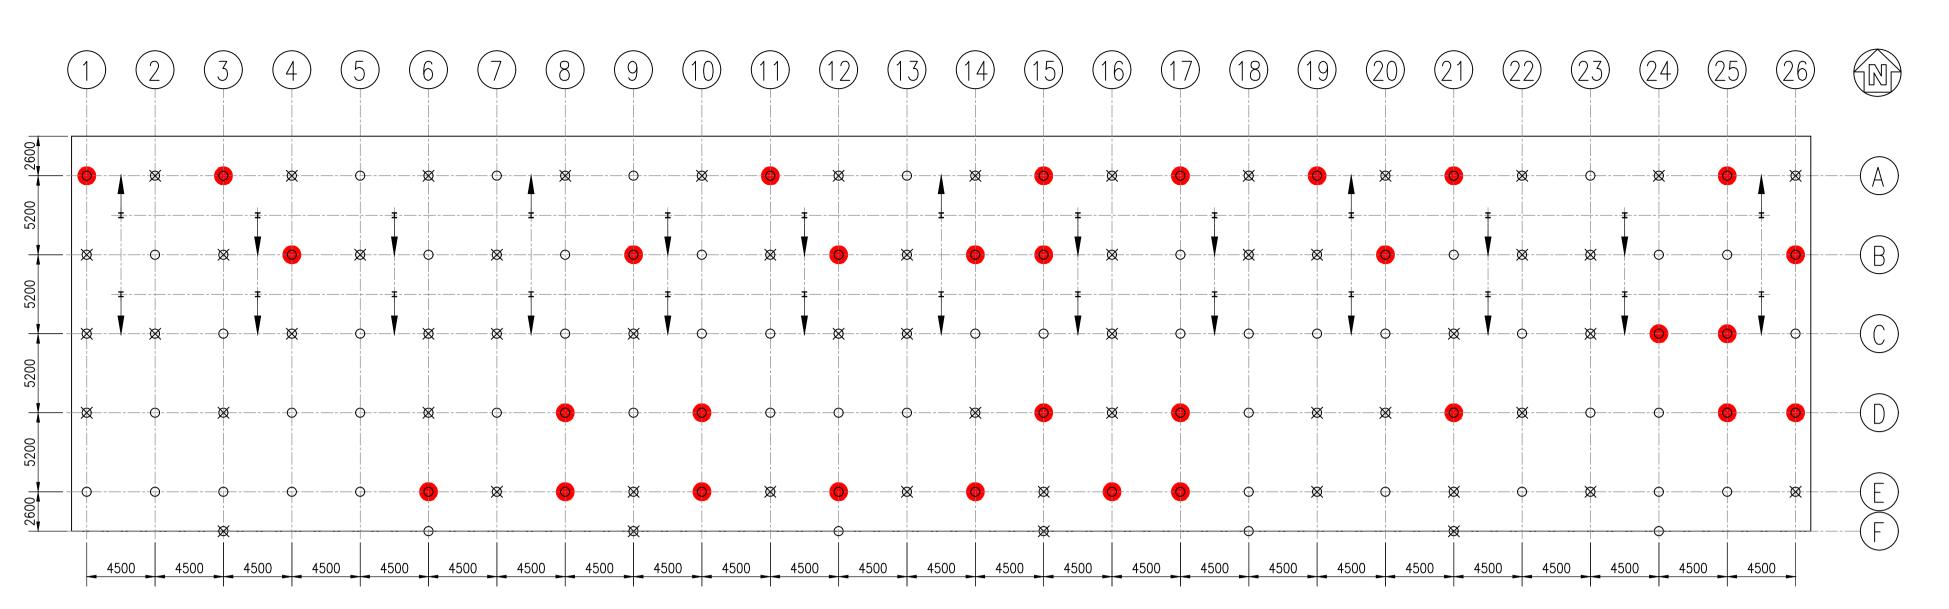
TYPICAL SECTION THROUGH QUAY

INDICATES ADDITIONAL PILE REPAIRS REQUIRED

INDICATES PILES VISIBLY INSPECTED, DEEMED TO BE IN GOOD CONDITION, NO THICKNESS MEASUREMENTS TAKEN

(< 10mm WALL THICKNESS)

1. Piles to be blast cleaned back to sound substrate prior to steel plate installation.

2. All bearing pile repair plates to be 8mm thick and bent to suit pile diameter.

3. All repair plates to be grade S355.

- Repair plate to be fixed using a 6mm fillet weld all around.
