Client: **PORT OF DUNDEE EAST REDEVELOPMENT**

Project Title: **MARINE WORKS PCW PILE REPAIRS 10.0T/M² CARRYING CAPACITY EXEMPLAR SOLUTION**

Drawing No.: 130143/5001

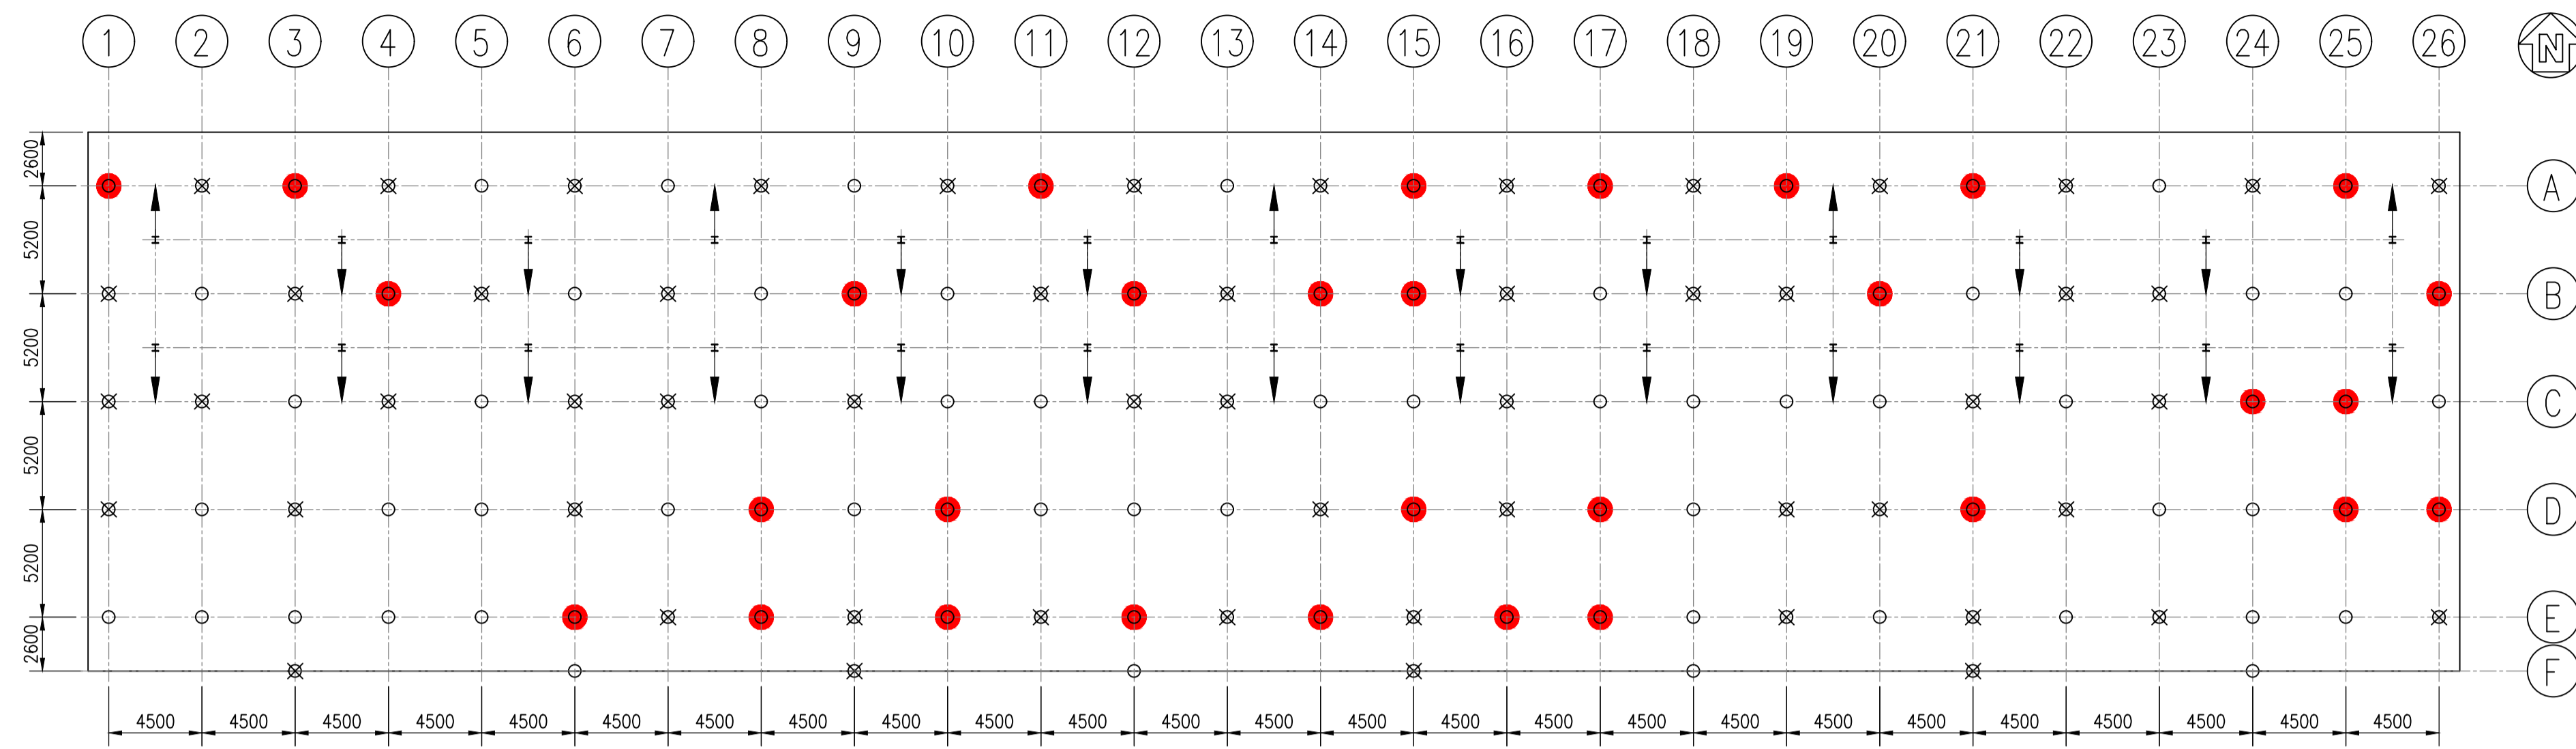
PLAN
Scale: 1-250

● INDICATES ADDITIONAL PILE REPAIRS REQUIRED (< 10mm WALL THICKNESS)

✕ INDICATES PILES VISIBLY INSPECTED, DEEMED TO BE IN GOOD CONDITION, NO THICKNESS MEASUREMENTS TAKEN

○ INDICATES PILES PREVIOUSLY REPAIRED TO 8.6T/m² OR WITH >10mm WALL THICKNESS

Preliminary Repair Design Summary			
Pile Type	Repair (W x H)	Quantity	Weight (T)
Bearing Piles	0.5 x 1.0	35	1.10
	0.75 x 1.5	10	0.71
	0.612 x 2.0	15	1.15
	Total	60	2.96
Fender Piles	No Repairs Required		
Raker Piles	No Repairs Required

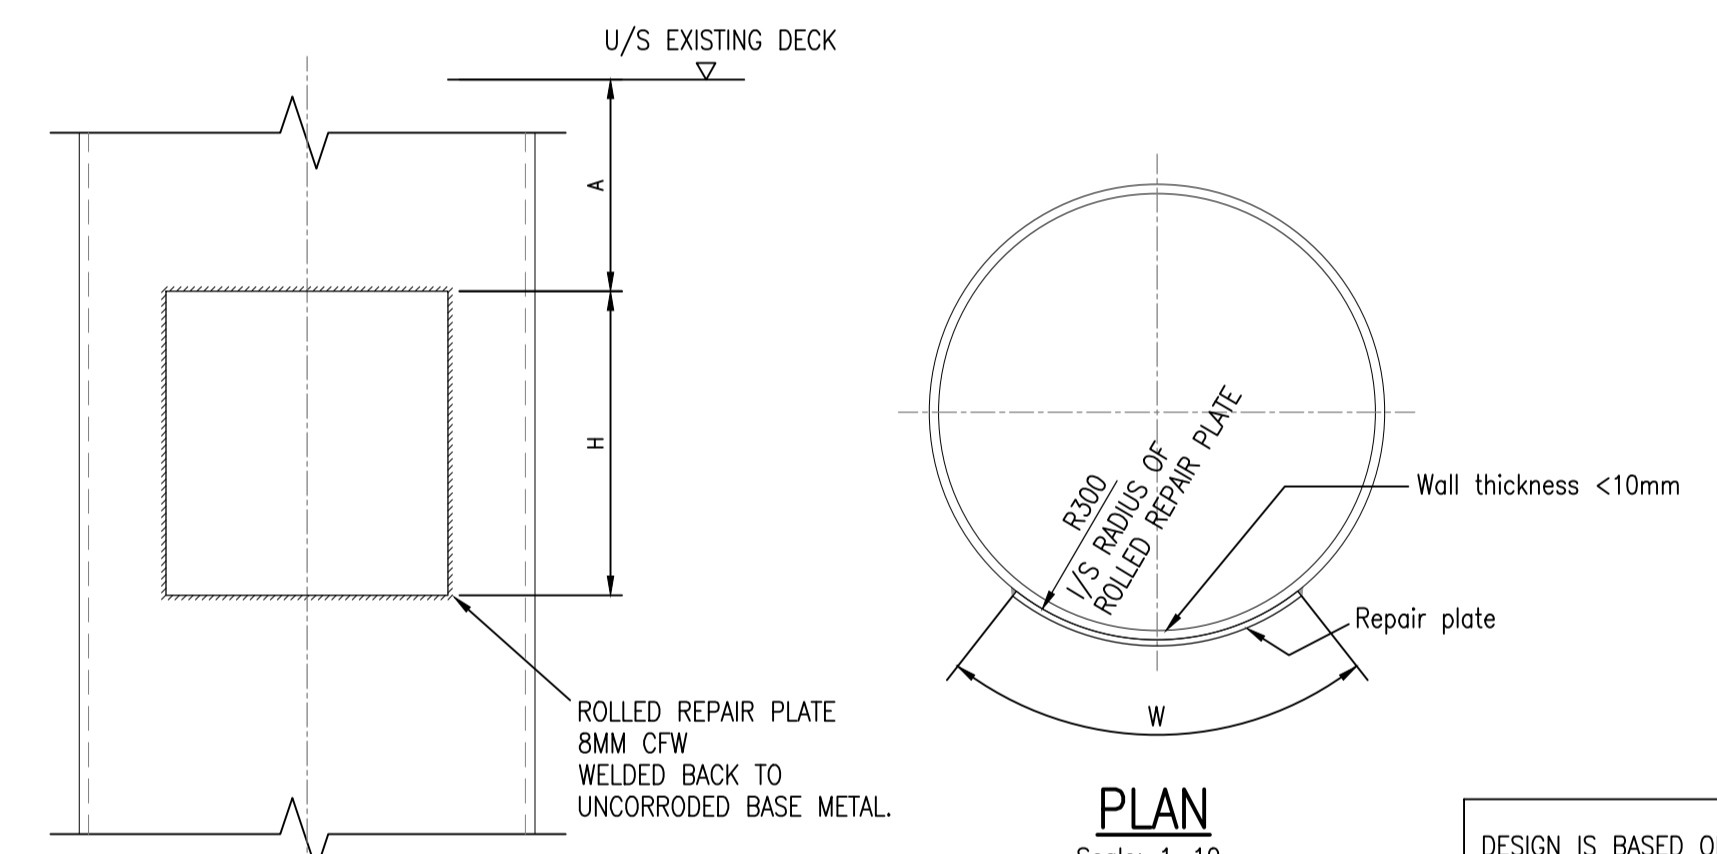
INDICATIVE REPAIR DETAIL
Scale: 1-10
See table for repair plate size & locations

DESIGN IS BASED ON THE WALL THICKNESS SURVEY DATA TAKEN FROM HARBOUR MARINE PILE THICKNESS SURVEY 2013 & 08/2015. ALL REPAIR AREAS ARE STANDARDISED TO 3 TYPES OF REPAIR PLATE.

- Piles to be blast cleaned back to sound substrate prior to steel plate installation.
 - All bearing pile repair plates to be 8mm thick and bent to suit pile diameter.

- All repair plates to be grade S355.
 - Welding**
-Repair plate to be fixed using a 6mm fillet weld all around.
-Grade of fillet weld to be S355.
-Where two or more plates are welded together and to the pile, filling between the plates may be necessary. Electrodes of S355 grade to be used for filling.
All welds to be grinded upon completion to achieve a smooth finish.
