Site Pictures MSC6281 Moonzie Burn

Site layout - ECN2 090/165

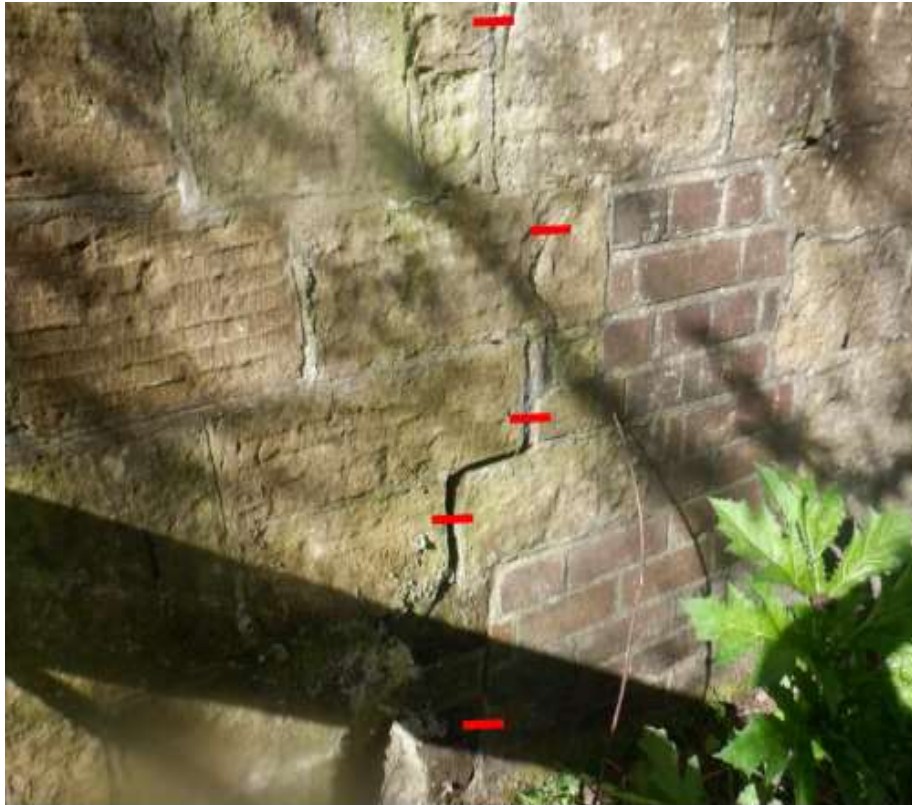
Example of cracks

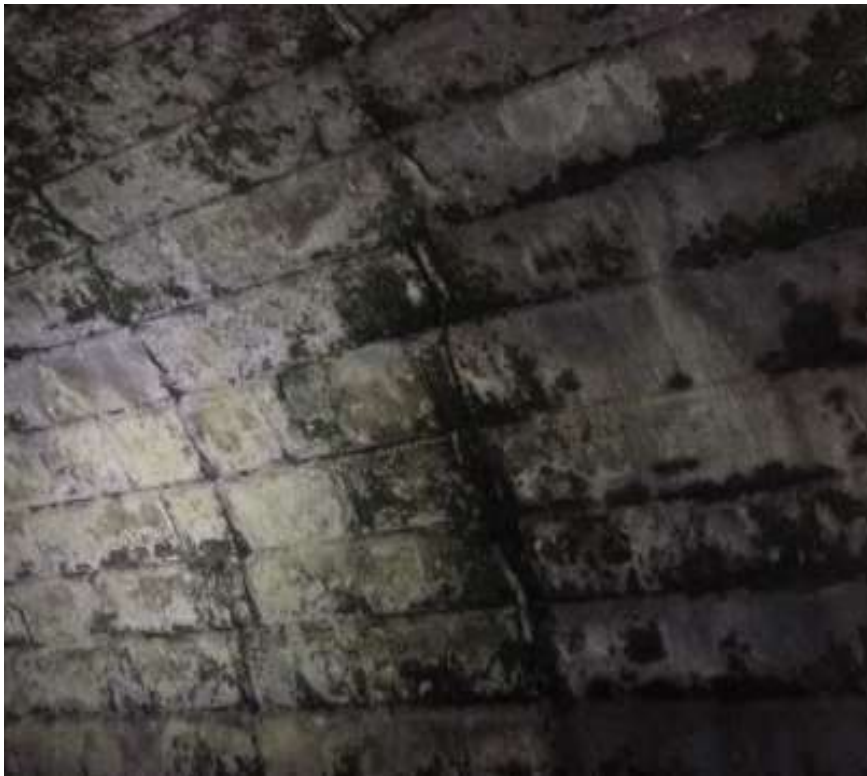
Cracks within structure

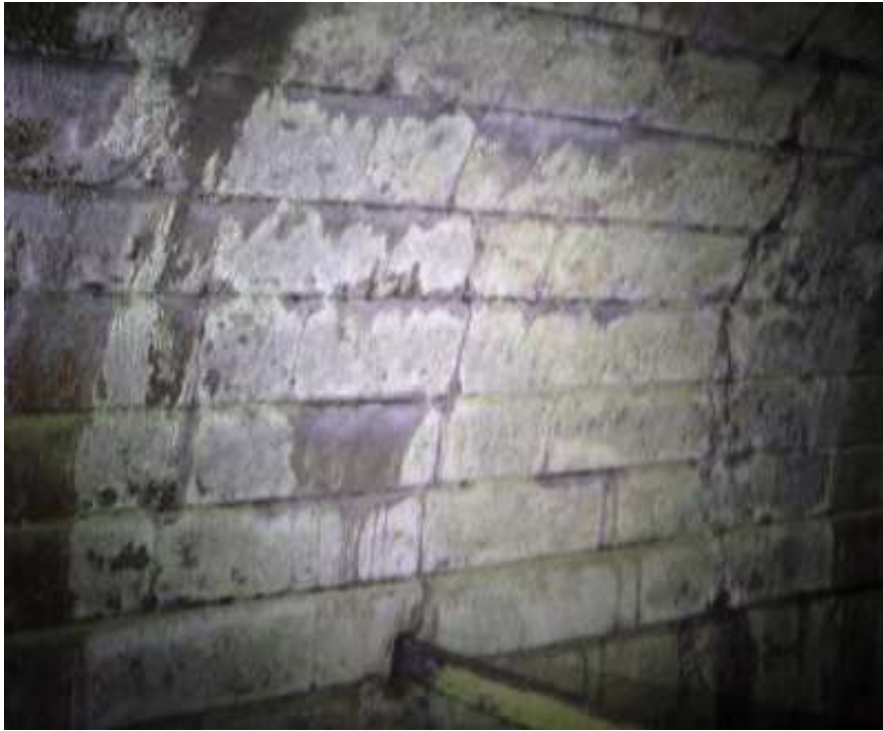
Cracks within structure

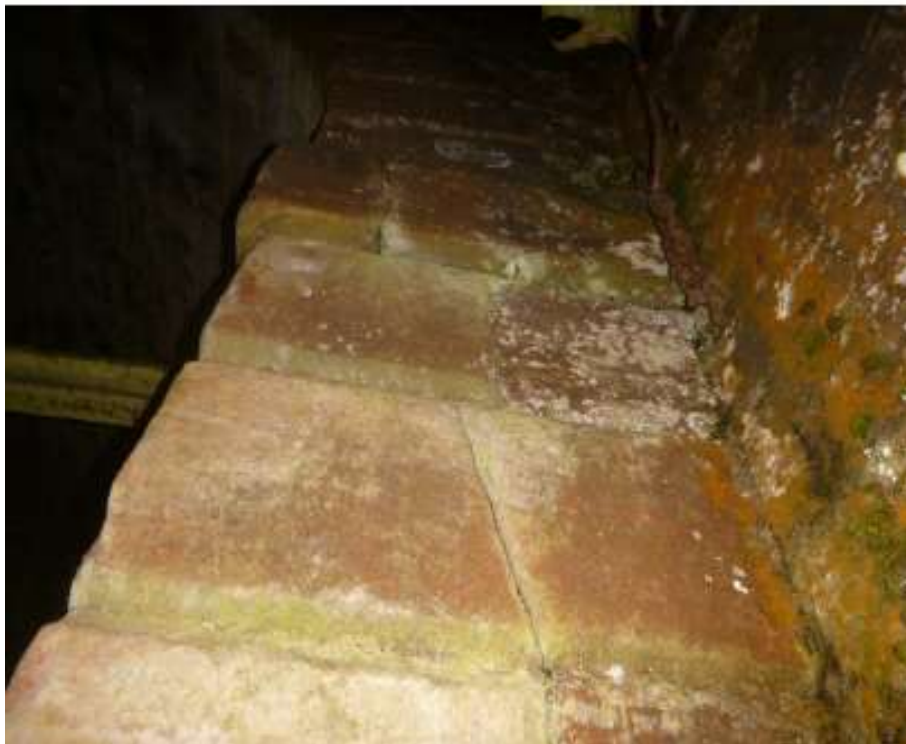
Return fracture
