NETWORK RAIL

Retaining Wall Detailed Examination Report													
ELR: WYS				Contract Mileage: 009m 1232yds 56.00chs						Struc. Ref: 200/550			
Examination Type: Retaining Wall Detailed								NR ID: 11017877			Exam Date: 11-Jan-2018		
Area: Scotland West								BRS: 0			OS Ref: NS19396910		
Structure Name: Wemyss Bay Sidings								Type: WD			Exam ID: 2718933		
Route: Wemyss Bay Jn - Wemyss Bay											Complete Exam: Yes		
Section A: To Be Completed By The Examining Organisation													
HIDDEN PARTS NOT EXAMINED (EXCLUDING FOUNDATIONS)				Part				Reason

ELR: WYS	Contract Mileage: 009m 1232yds 56.00chs			Struc. Ref: 200/550	
Struc. Type WCE RD	NR ID 11017877	Rpt ID 6248	OS Ref NS19396910	Exam ID	2718933
Dimensions	Max Height 5.00m	Max Length 724.00m		Exam Date	11/01/18
Side of Line				Last Detailed	04/02/17
Min dist. from Track	2.00			Last Visual	26/03/10
Line	Wemyss Bay Jn - Wemyss Bay				
Name:	Wemyss Bay Sidings

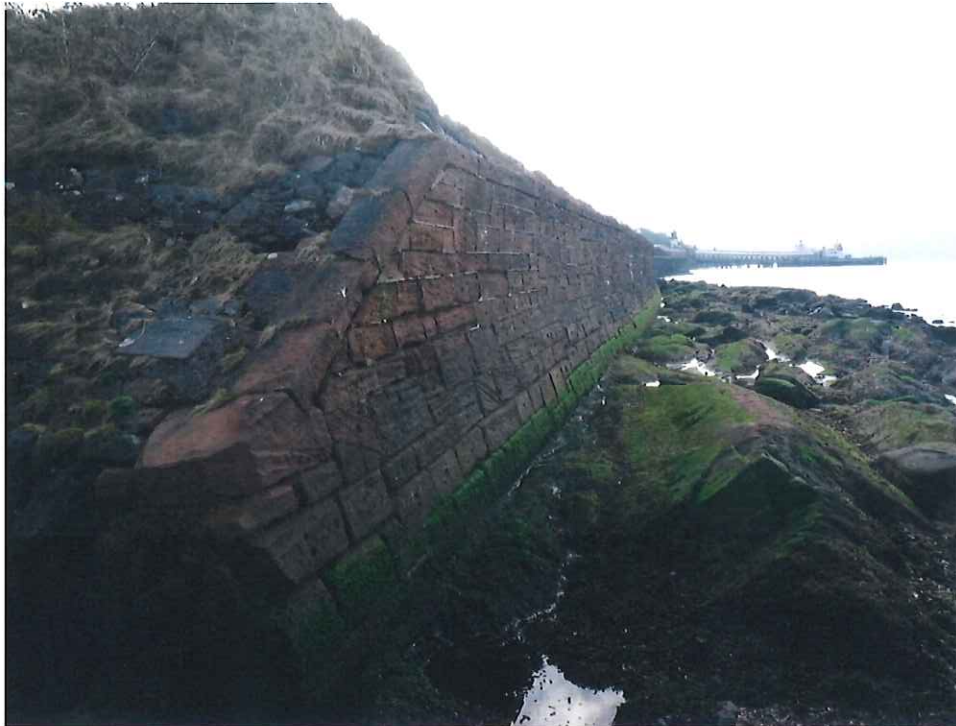
Photograph 1 - Section 1 - 9M 1327Y - General view at start of defence looking to high miles - 11.01.18.JPG

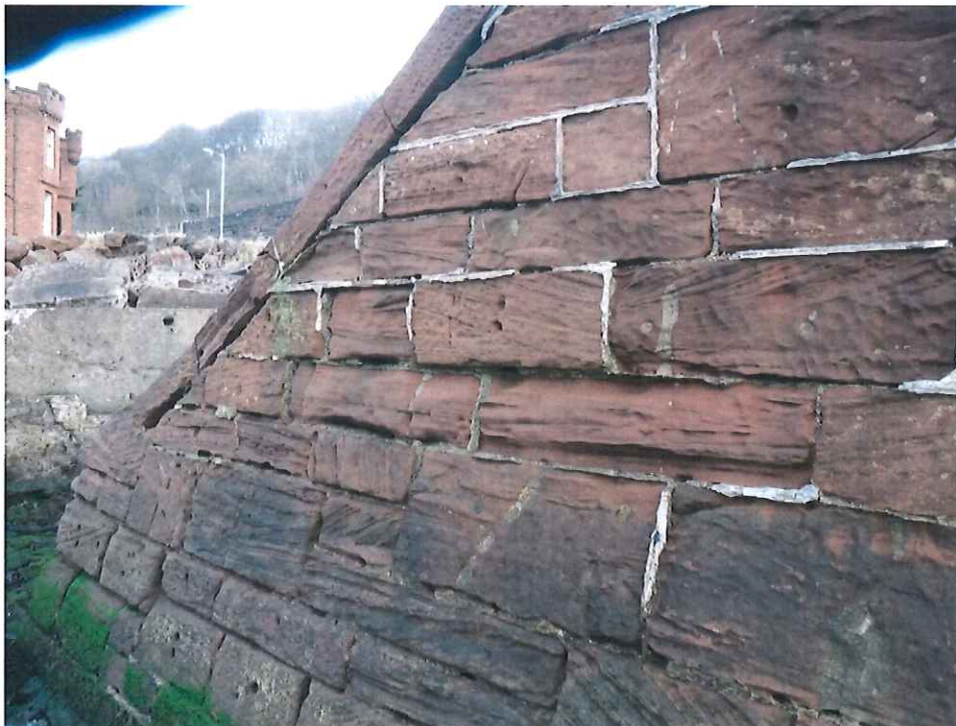
Photograph 2 - Section 1 - Erosion to stonework typical throughout - 11.01.18

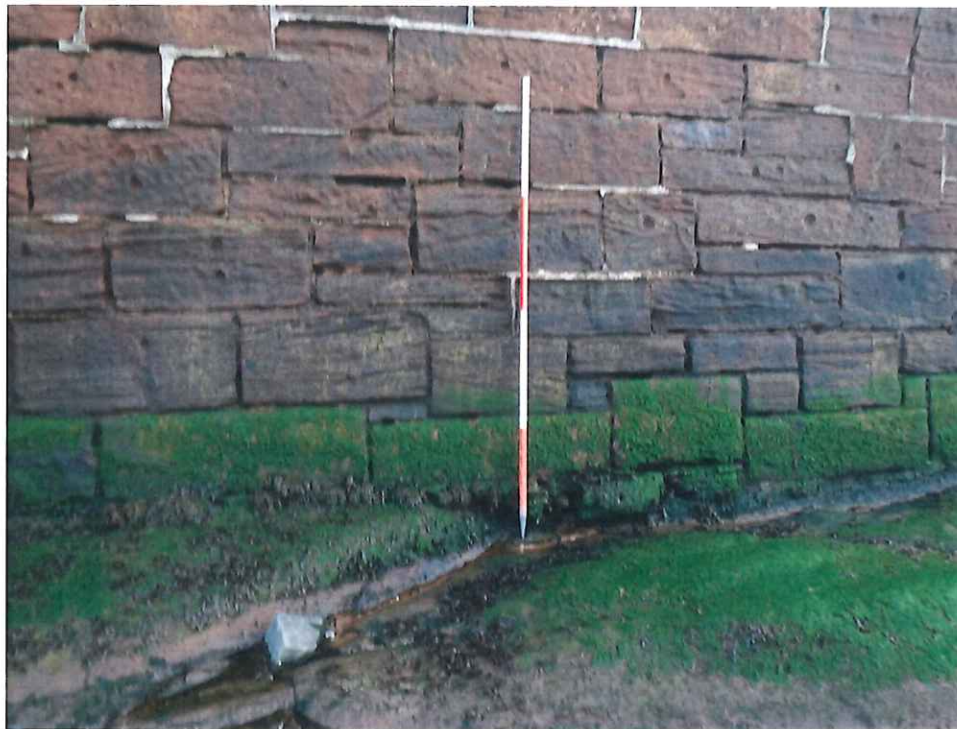
Photograph 3 - Section 1 - 9M 1240Y - Seepage at toe of defence (low flow) - 11.01.18

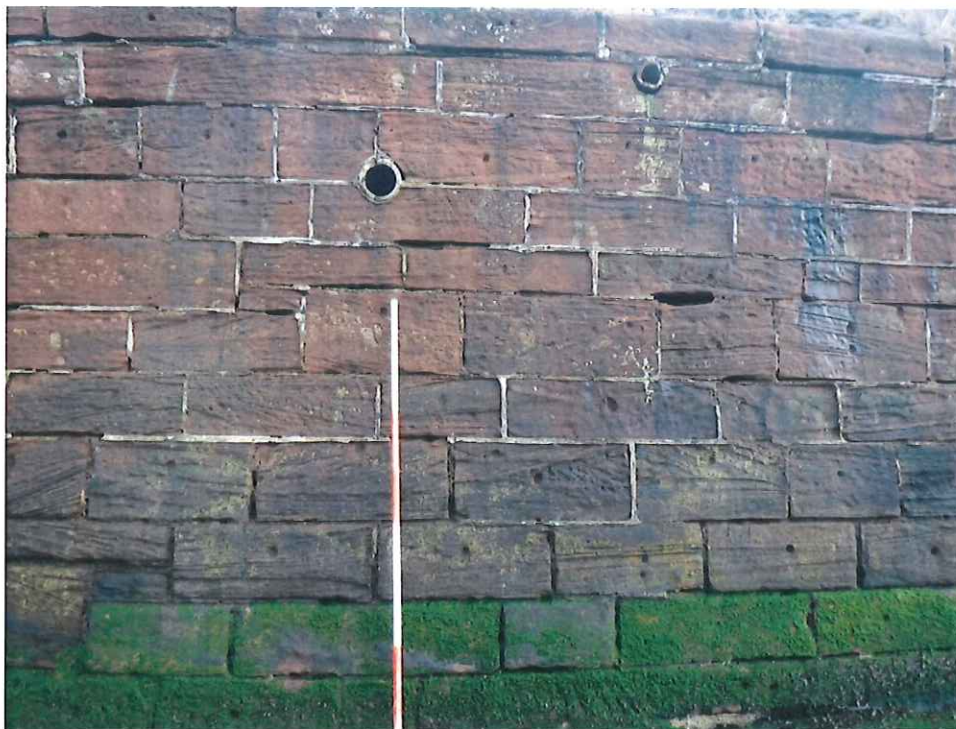
<p>The distance from running edge of track to top of defence is in the region of 25m to 30m.</p>		
<p>This section of the defence comprises a curved masonry wall approximately 3m in height. A high mileage view of the defence wall from the start of defence can be seen in Photograph 1. At the crest of the wall, a flat area of unused ground of approximately 25m to 30m wide is present (the old sidings). Beyond this, a secondary masonry wall is present which supports the railway tracks.</p>		
<p>There is some erosion to the blockwork along with areas of missing pointing throughout the sea defence wall as seen in Photograph 2 (typical). The area previously noted to be issuing minor seepage at the toe of the defence wall at 9M 1240Y was recorded to be issuing a low flow during this examination (see Photograph 3).</p>		
<p>There are several weep holes throughout this section of the defence (see Photograph 4), a trickle flow was noted from one weephole (top right in Photograph 4). The others were found to be dry at the time of inspection.</p>

Photograph 4 - Section 1 - Typical view of weep holes (no flow during exam) - 11.01.18

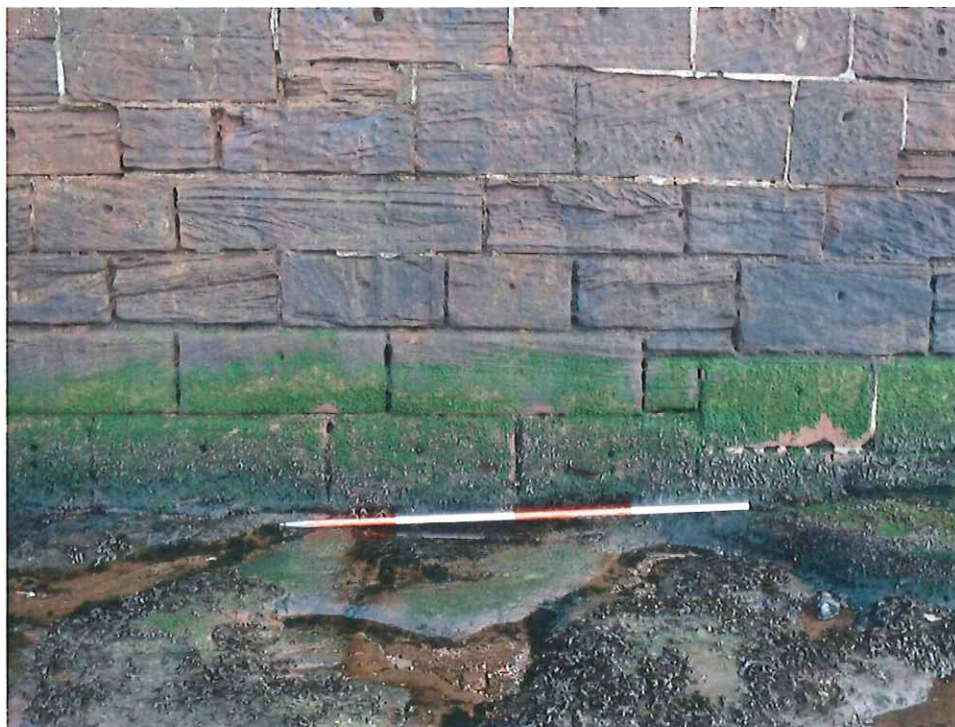
<p>The wall is showing evidence of undermining at the base where the interface meets the natural rock head (shown in Photograph 5).</p>		
<p>There is a small area of washout behind the crest of the defence at the end of section 1 (see Photograph 6).</p>		
<p>Photograph 7 is a view looking to low mileage, of the railway bridge crossing the A78 trunk road at the start of the upper defence wall.</p>		
<p>Photograph 8 is from the end of section 1 looking back towards low mileage.</p>		
<p>There has been no significant deterioration in this section since last year's examination.</p>		
<p>Section 2 – 9M 1308Y (NS 19365 69037) to 9M 1313Y (NS 19373 69022)</p>		
<p>Distance from running edge of track to top of defence is in the region of 15m to 25m.</p>		
<p>This section of the defence consists of masonry revetment, which is approximately 4m in height. A high mileage view of the masonry revetment can be seen in Photograph 9.</p>

Photograph 5 - Section 1 - Typical undermining at toe of defence - 11.01.18

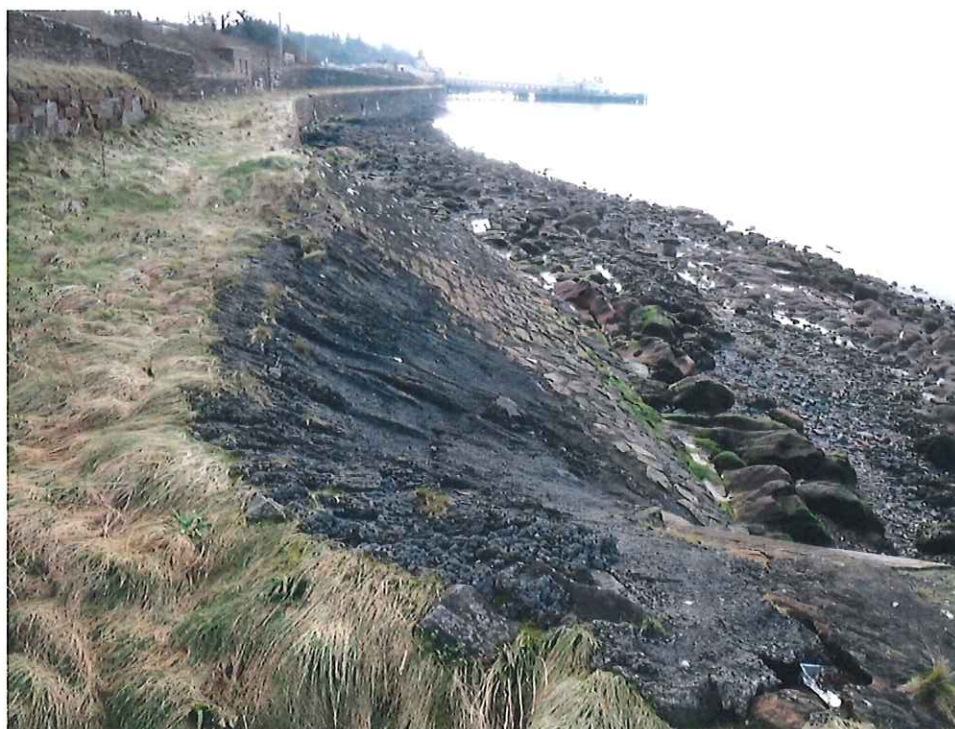
Photograph 6 - Section 1 - Washout of crest at end of section 1 - 11.01.18

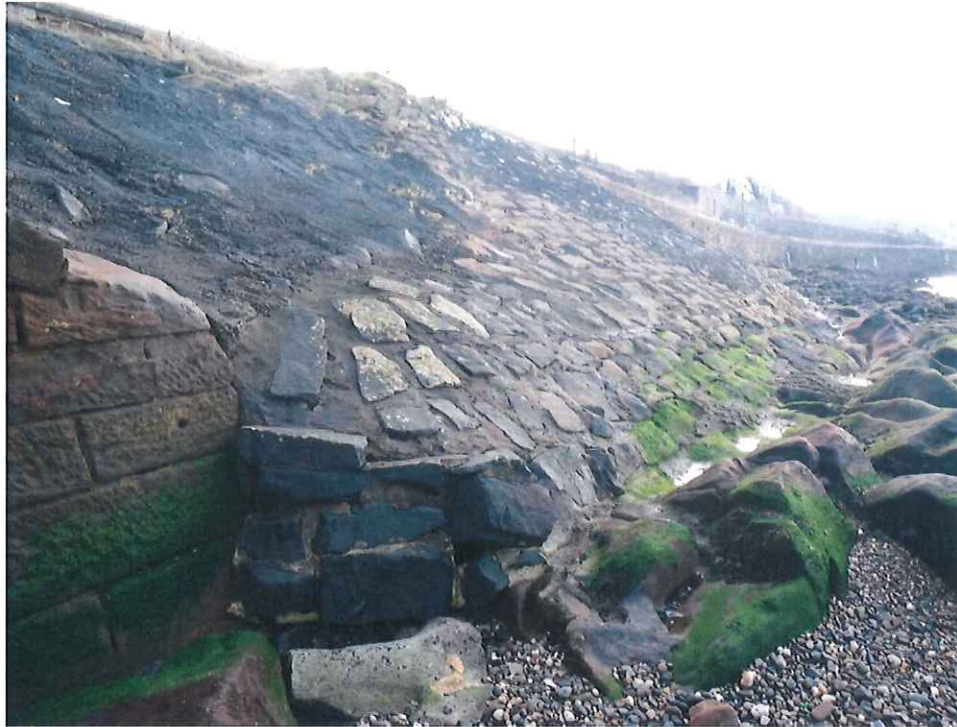
Photograph 9 - Section 2 - Start of section to high miles - 11.01.18

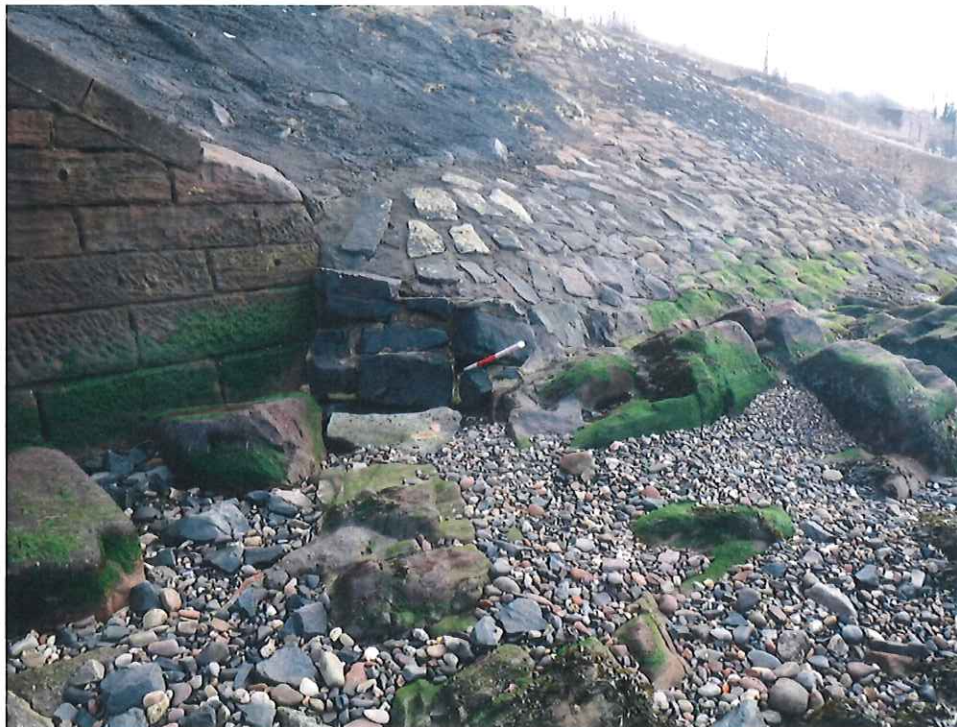
<p>A small void at the toe of the revetment was noted and can be seen in Photograph 10. The void was approximately 200mm deep and 100mm by 300mm wide.</p>		
<p>A small void noted in the toe of the defence at the end of section is now filled with shingle (Photograph 11).</p>

Photograph 10 - Section 2 - Small void at start of section (200x100x300mm) - 11.01.18

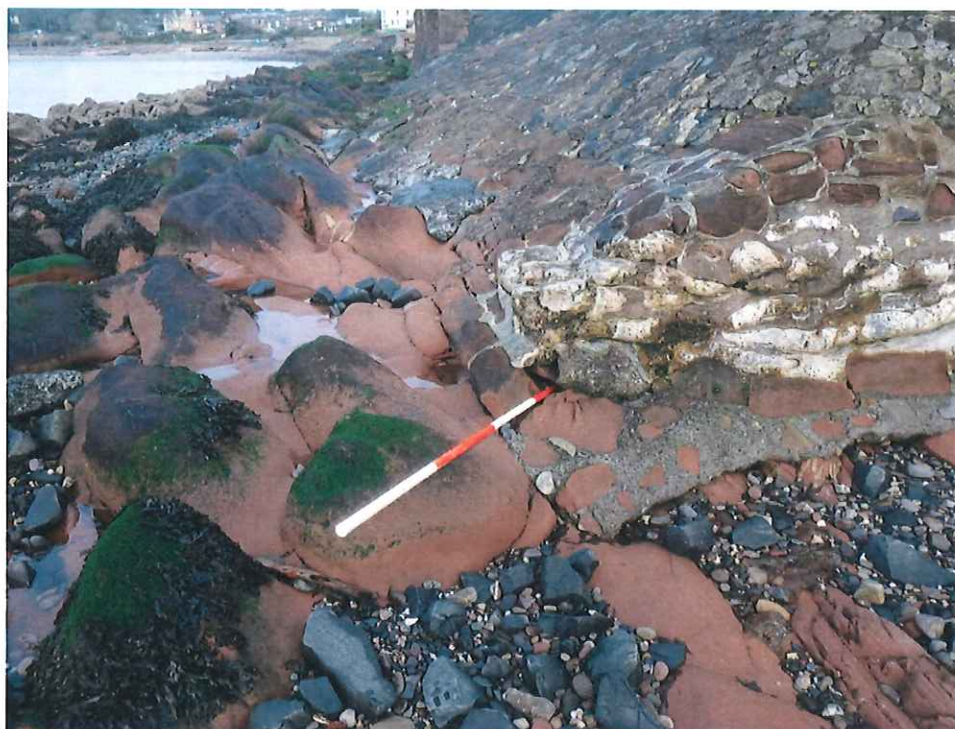
Photograph 11 - Section 2 - Small void filled with shingle - 11.01.18

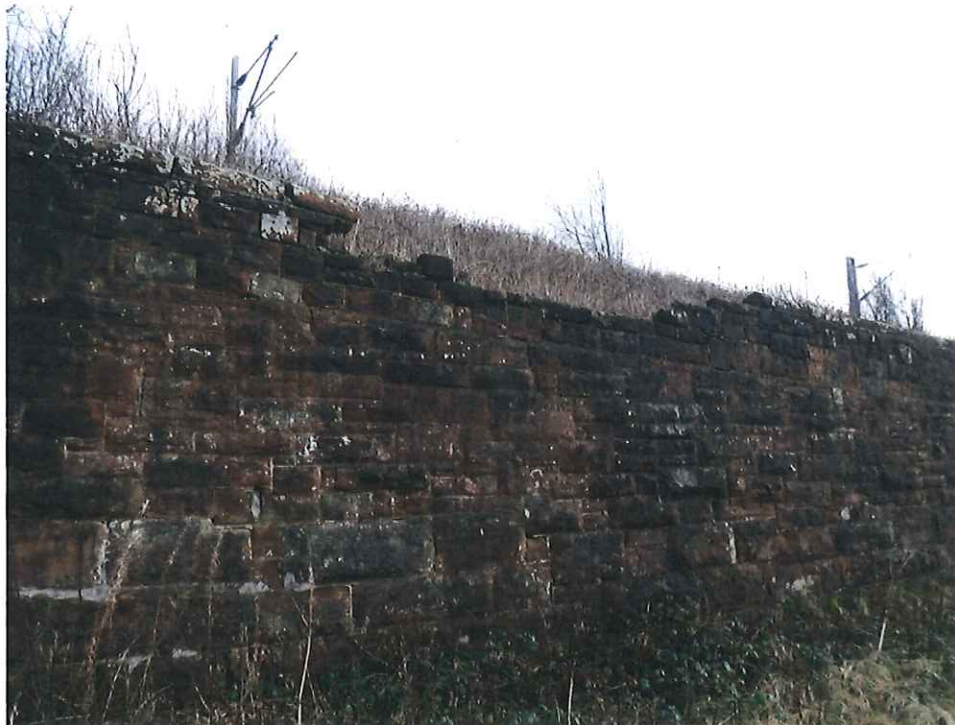
Photograph 14 - Section 3 - 9M 1350Y - Cope stone missing (approx 6m) - 11.01.18

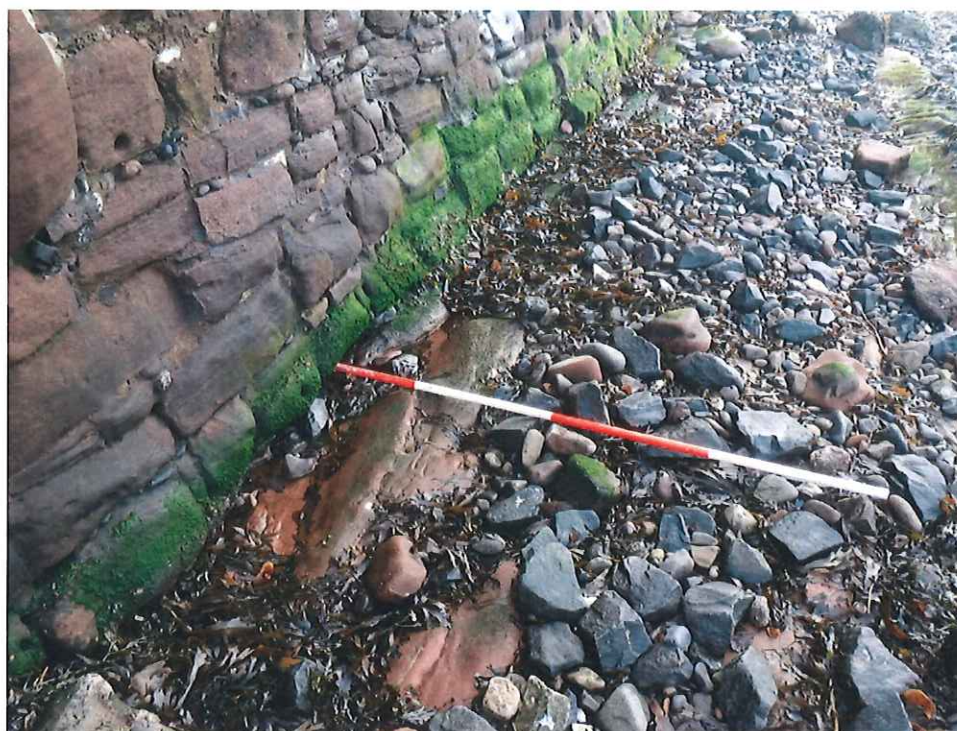
Photograph 15 - Section 3 - 9M 1345Y - Undermining at toe (200mm deep) - 11.01.18

- 1 – Install section markers over the full length of the defence.
- 2 – Repair voiding at toe of wall in Section 3 at 9M 1400Y.
- 3 – Repair other voids along the toe of the wall throughout Section 3.
- 4 – Remove dumped soil from crest of the wall.

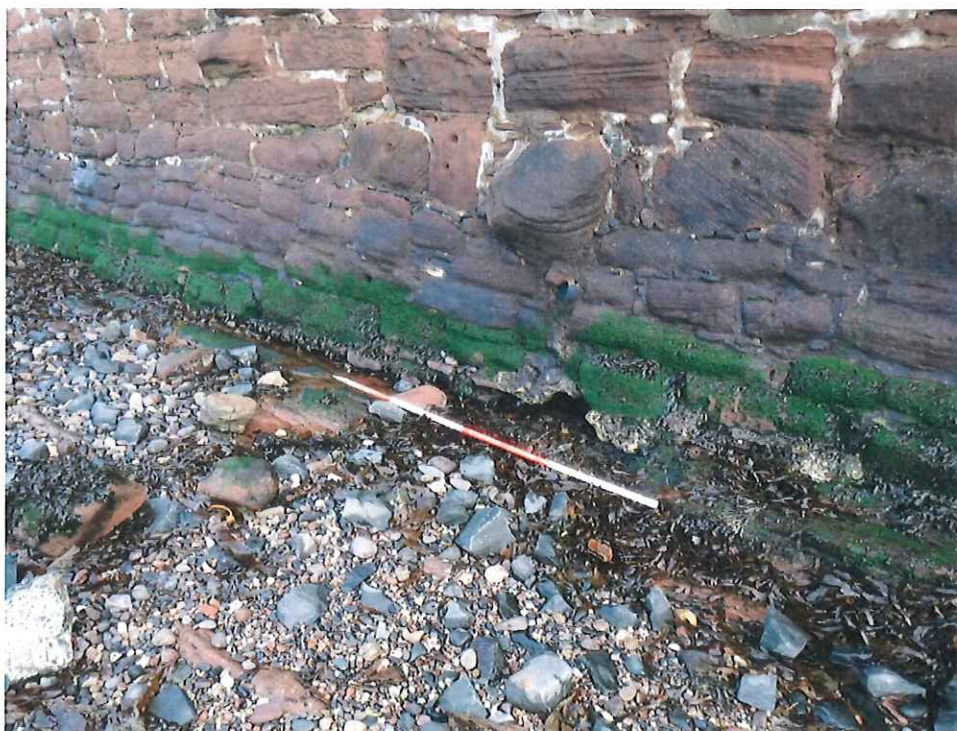
Photograph 16 - Section 3 - 9M 1359Y - Undermining at toe of wall (250mm x 600mm x 100mm) - 11.01.18

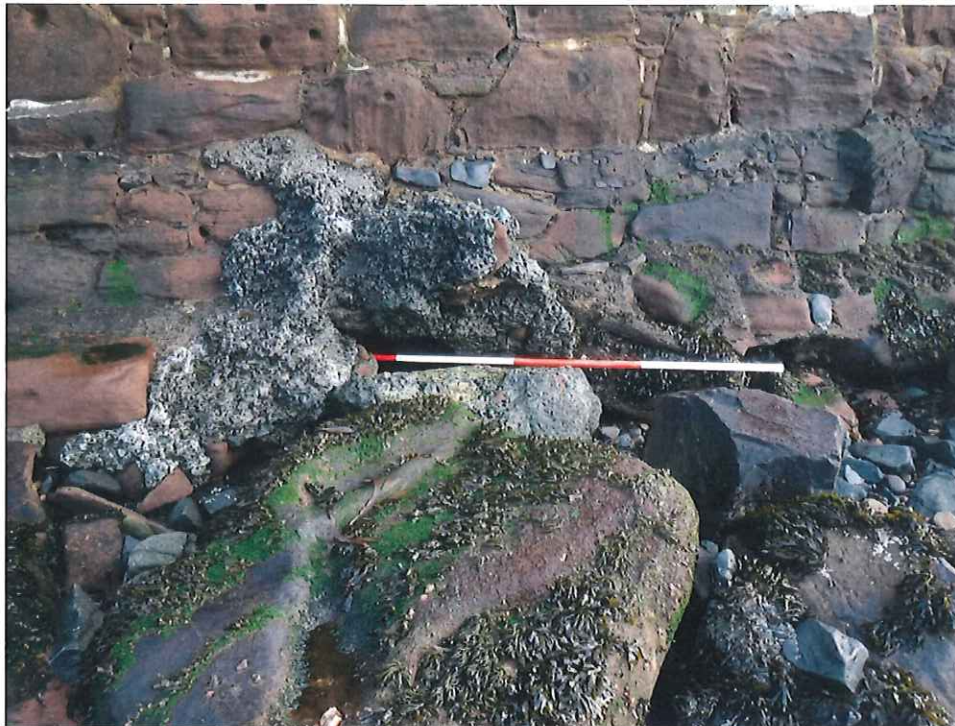
Photograph 17 - Section 3 - 9M 1395Y - Voids at toe of concrete repair (300mm x 400mm) - 11.01.18

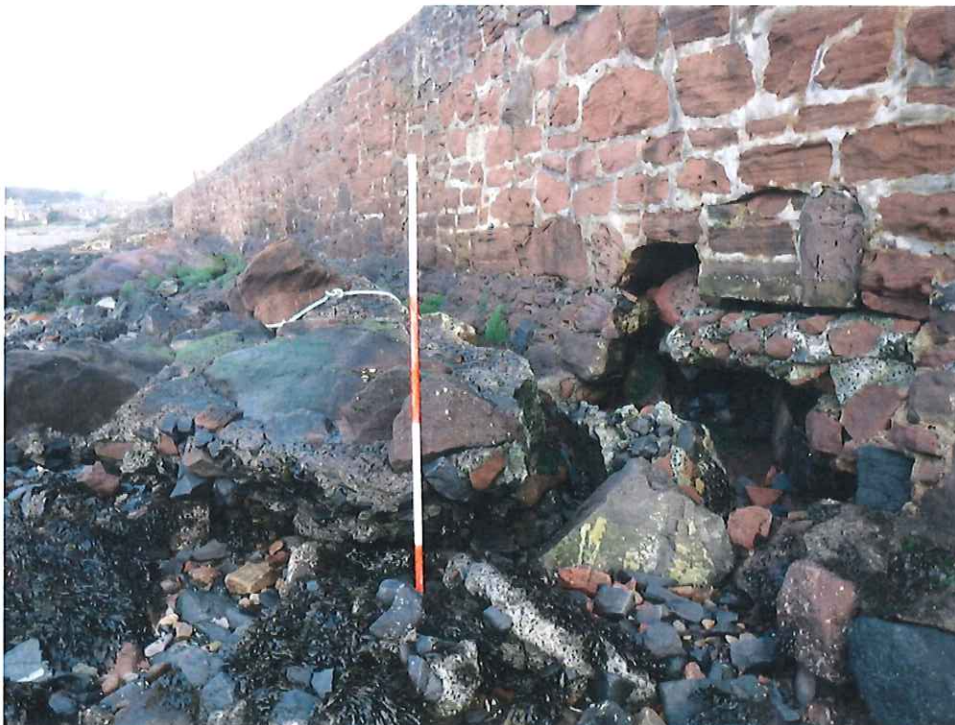
Photograph 18 - Section 3 - 9M 1400Y - Void at toe of defence (2.5m x 1m x 1.5m) loss of blockwork (approx 0.6m x 0.25m) - 11.01.18

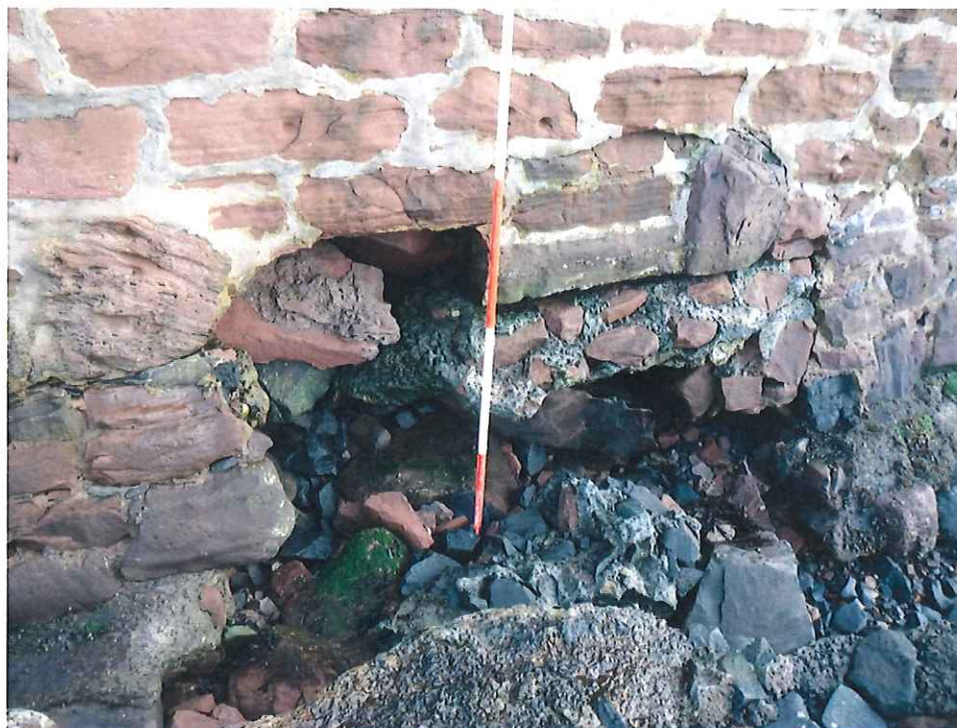
Photograph 19 - Section 3 - 3x2x1.5m void loss of finer stones slight deterioration - 11.01.18

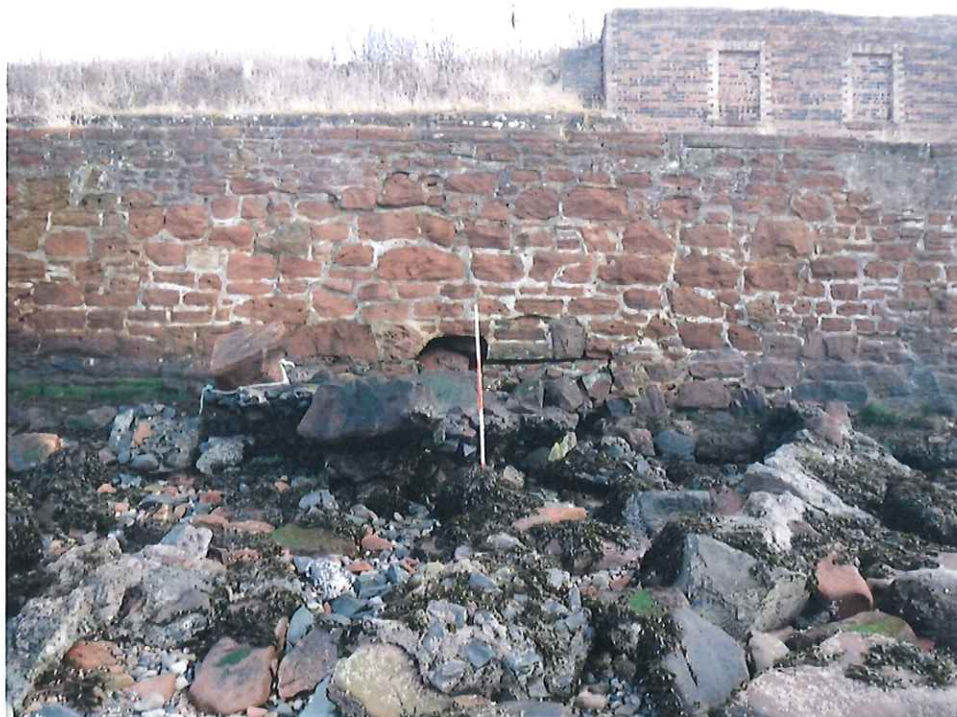
Photograph 20 - Section 3 - 9M 1400Y - Undermining at toe of wall - 11.01.18

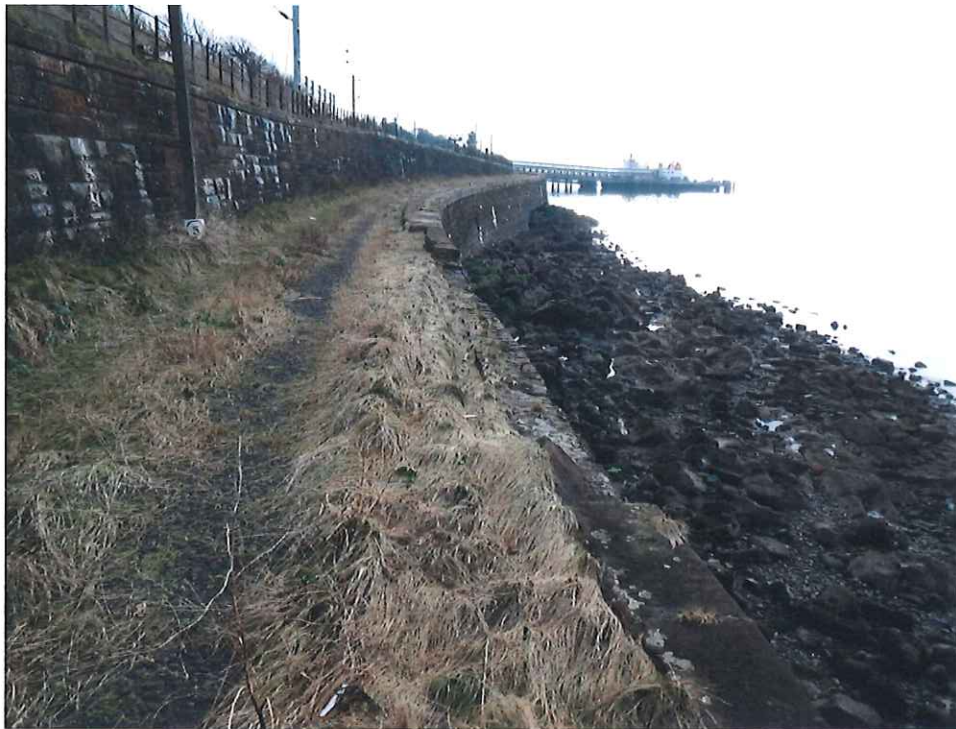
Photograph 21 - Section 3 - 9M 1402Y to 1415Y - View of missing cope stones from upper wall - 11.01.18

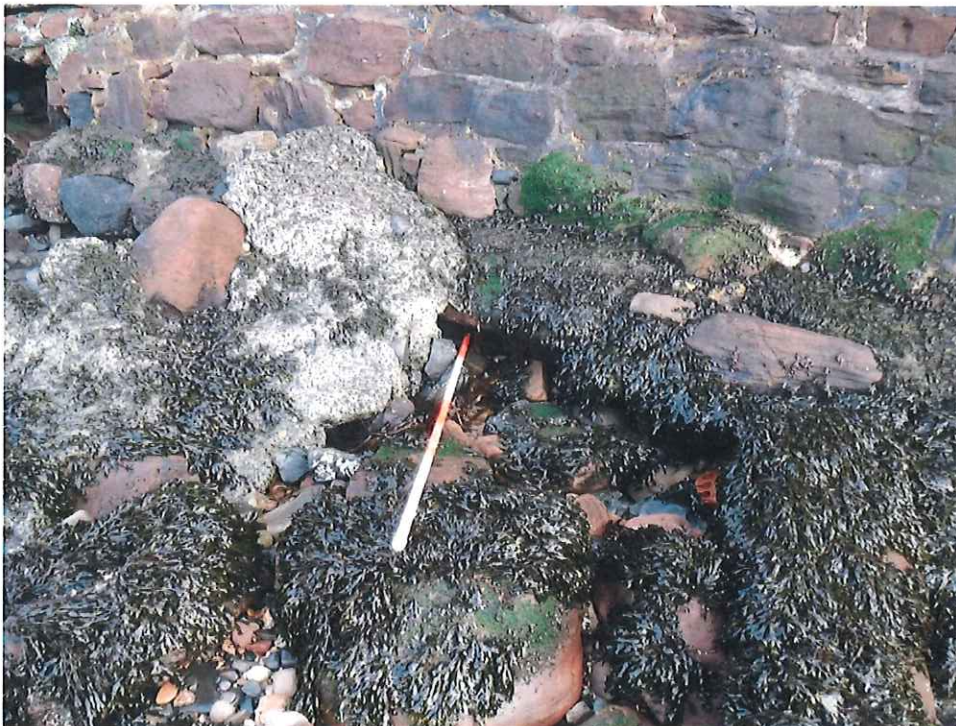
Photograph 22 - Section 3 - 9M 1400Y to 1412Y - Undermining at toe - 11.01.18

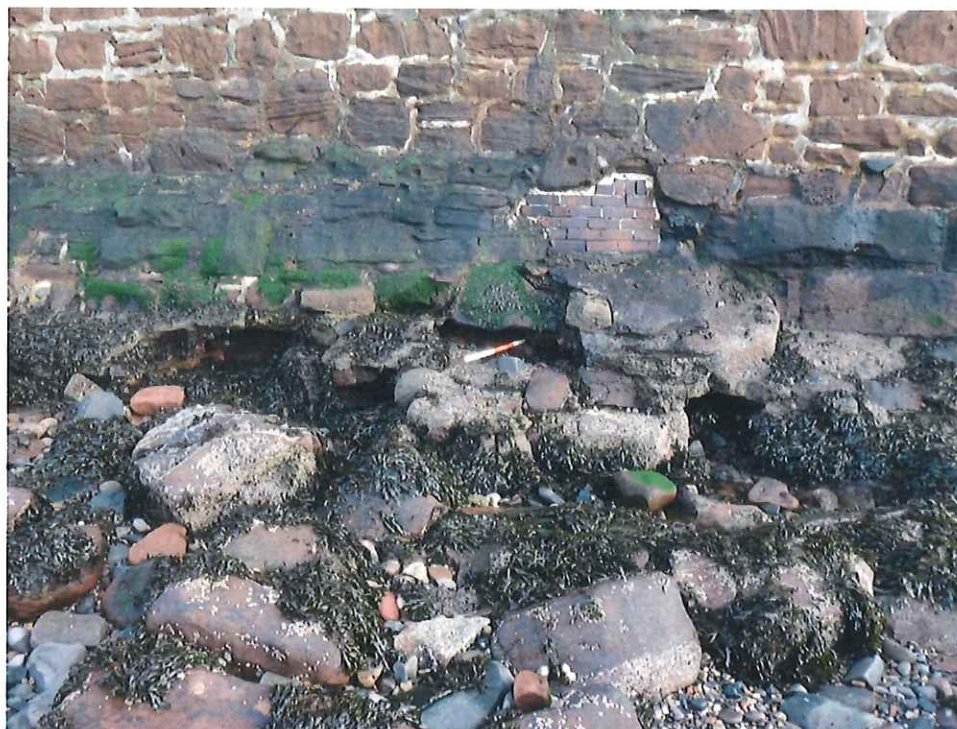
Photograph 23 - Section 3 - 9M 1411Y - Void at toe of wall, slight deterioration - 11.01.18

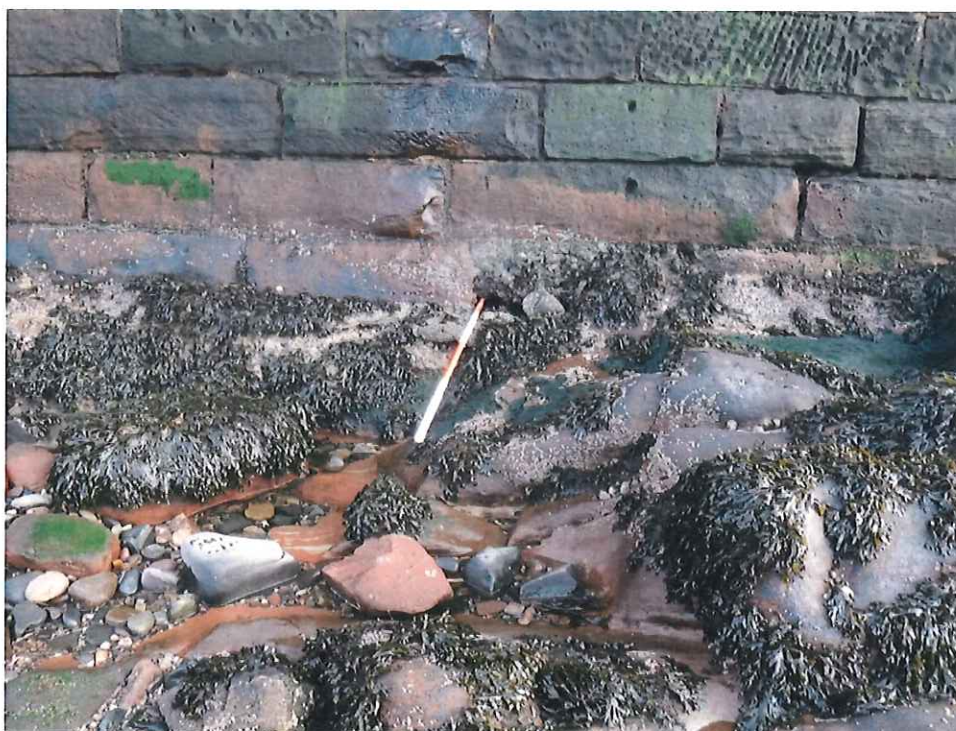
Photograph 24 - Section 3 - 9M 1416Y - Small void in concrete repair at toe 500mm deep - 11.01.18

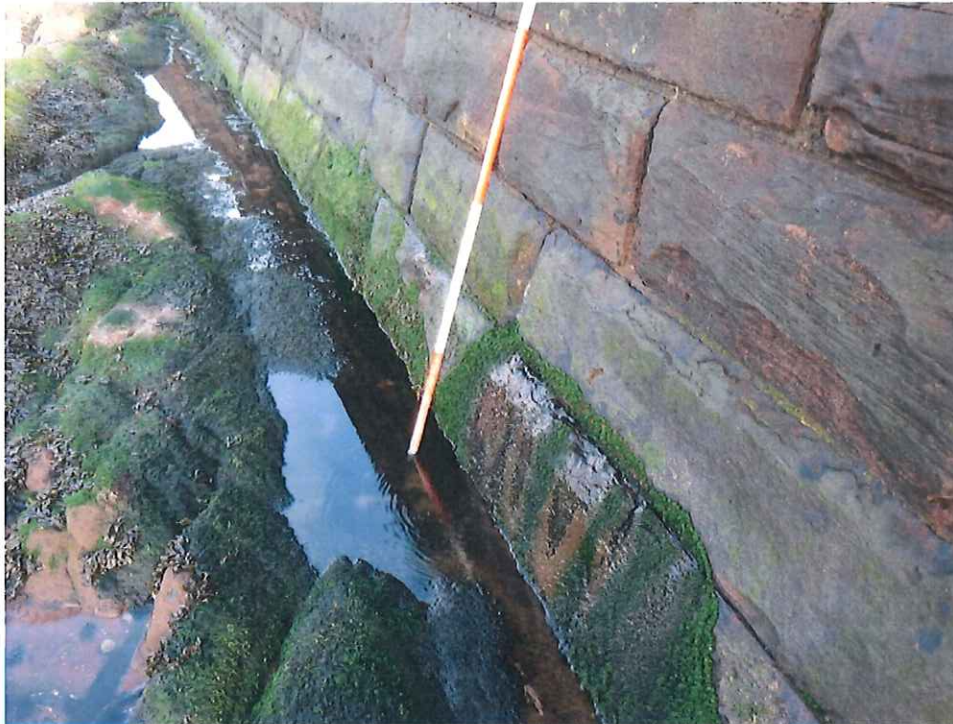
Photograph 25 - Section 3 - 9M 1440Y - Water issuing from wall and flowing towards high miles - 11.01.18

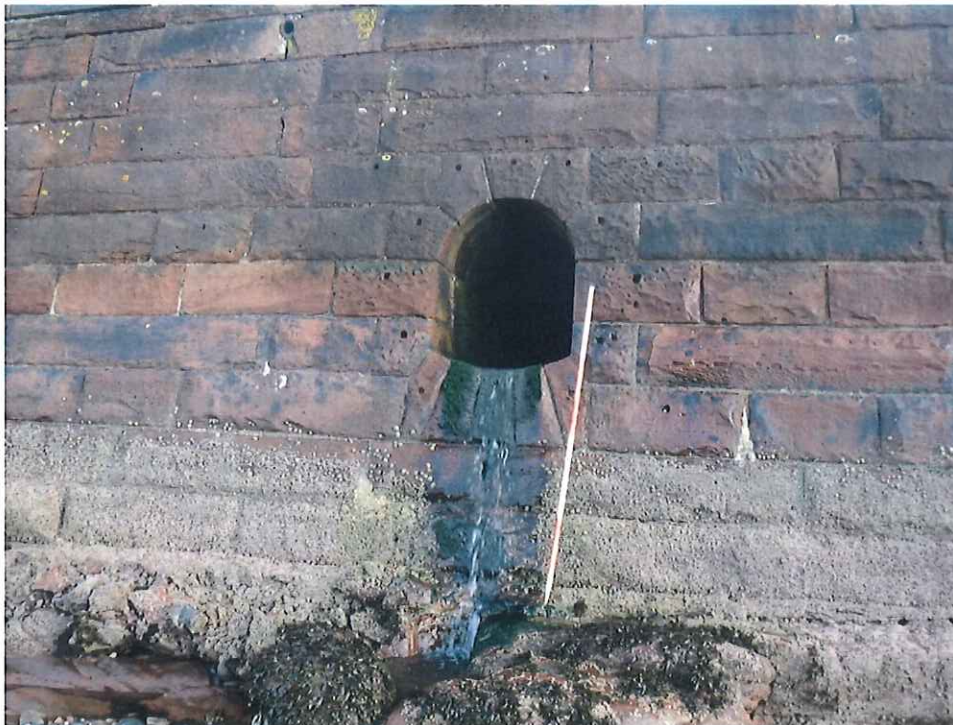
Photograph 26 - Section 3 - 9M 1474Y - Culvert with high flow issuing from wall - 11.01.18

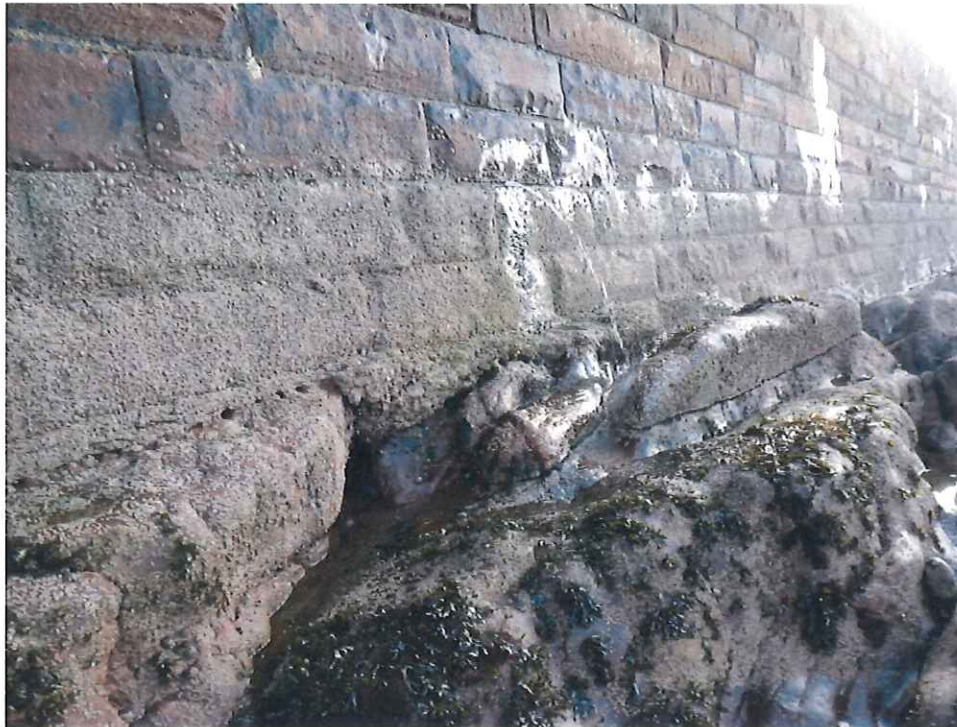
Photograph 27 - Section 3 - 9M 1490Y - Water issuing from wall and undermining - 11.01.18

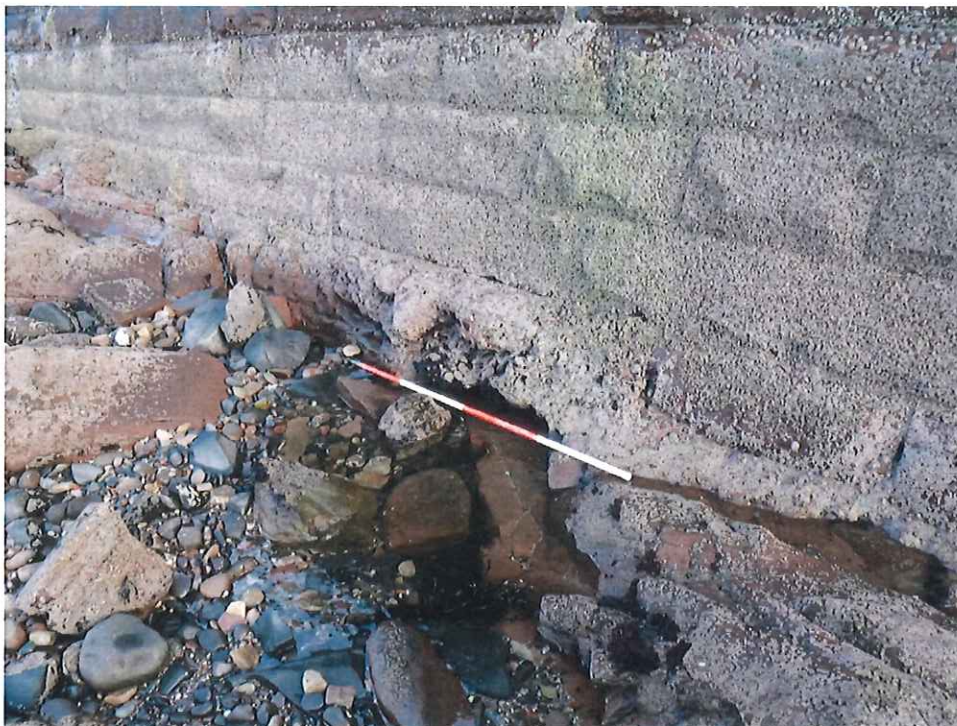
Photograph 28 - Section 3 - 9M 1490Y - Undermining at toe of wall no change - 11.01.18

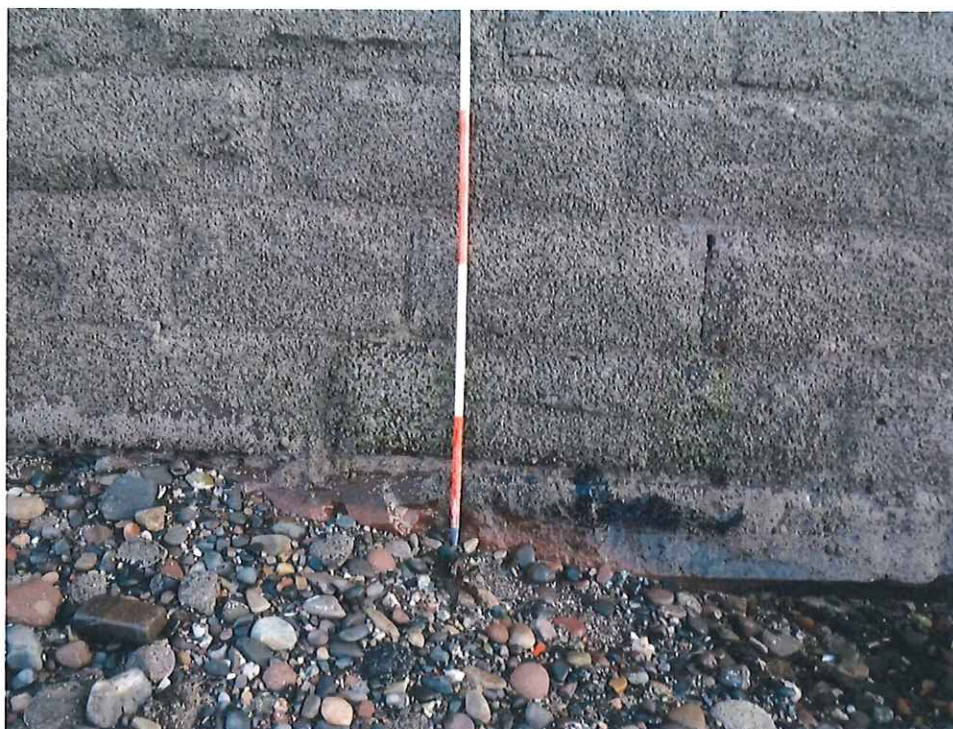
Photograph 29 - Section 3 - 9M 1515Y - Water issuing from toe of wall low flow - 11.01.18

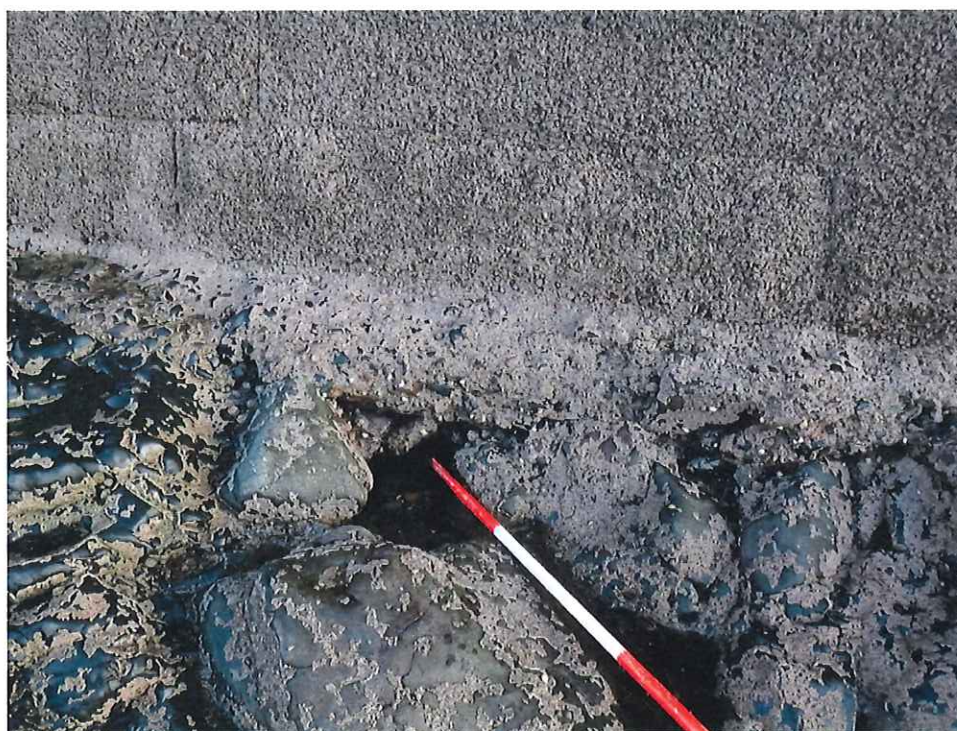
Photograph 32 - Section 3 - 9M 1550Y - Undermining (100mm deep) - 11.01.18

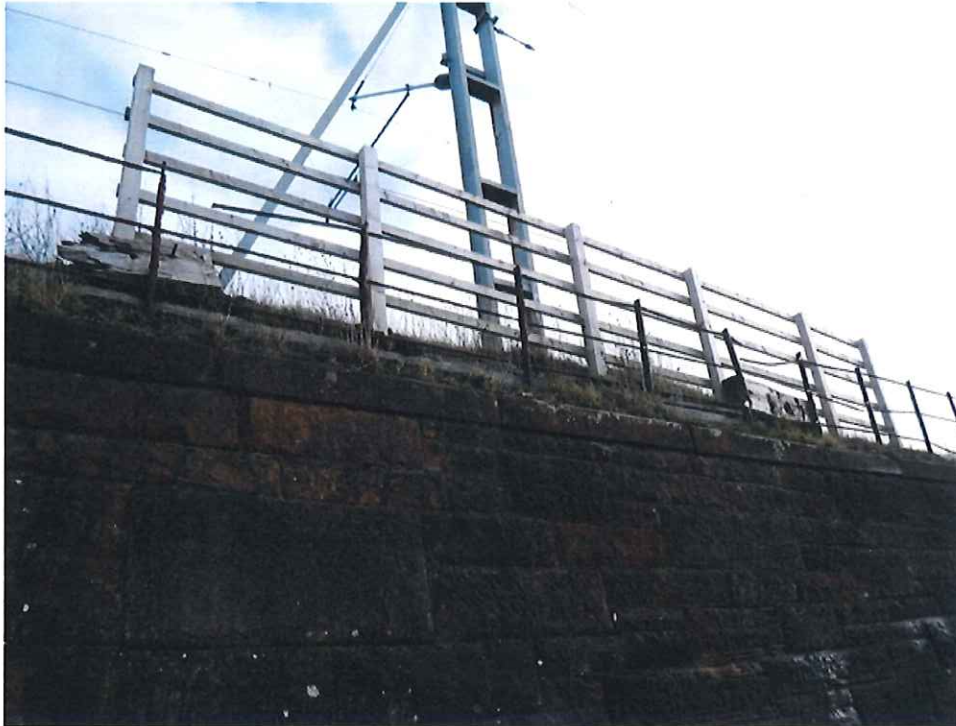
ELR: WYS	Contract Mileage: 009m 1232yds 56.00chs	Struc. Ref: 200/550
<p>Damage noted to the handrail in the upper defence wall has been repaired. A wooden pallet fence has been constructed as well as a wire fence attached (Photograph 35). There are areas of washout behind the crest of the lower defence wall from 9M 1600Y to 9M 1680Y (see Photographs 37).</p>		
<p>A view from the end of the defence to low mileage shows large amounts of soil and vegetation have been dumped behind the crest of the wall at the end of the defence. This should be removed as the additional surcharge may cause failure of the wall. (Photograph 38)</p>		
Record of Condition by Element		
Element Name	Status	Condition
Avongards		
Are Avongards Present?	No	
Date Tabs		
Are Date Tabs Present?	No	
Plumbing Points		
Are Plumbing Points Present?	No	
Environmental Factors Present: No

Photograph 35 - Section 3 - 9M 1565Y - General view of handrail - 11.01.18

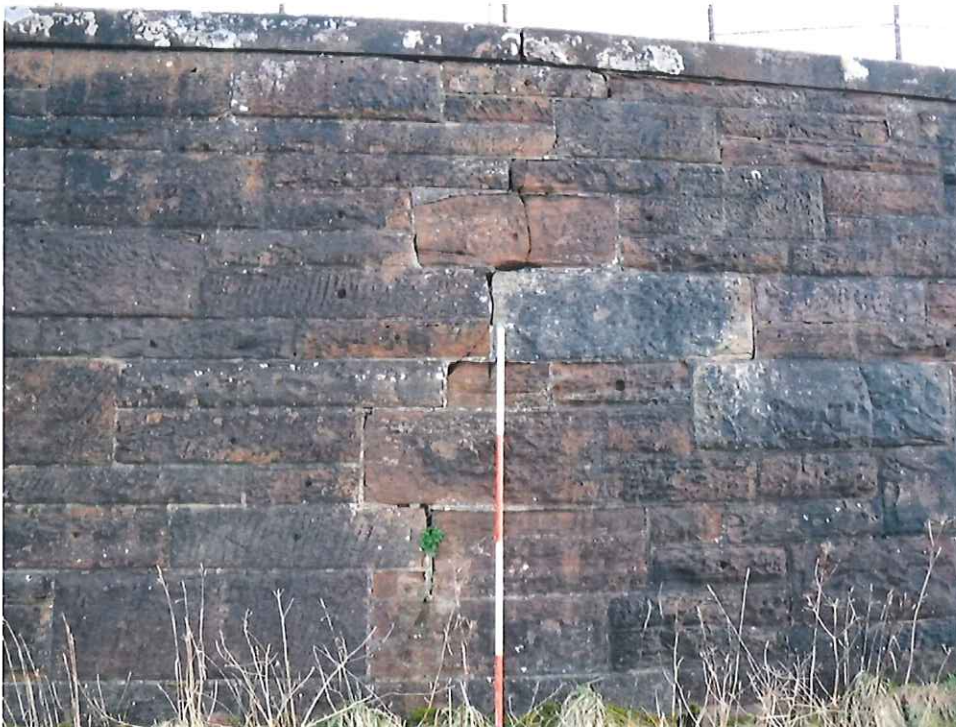
Photograph 36 - Section 3 - 9M 1485Y - Vertical Crack in upper defence wall - 11.01.18

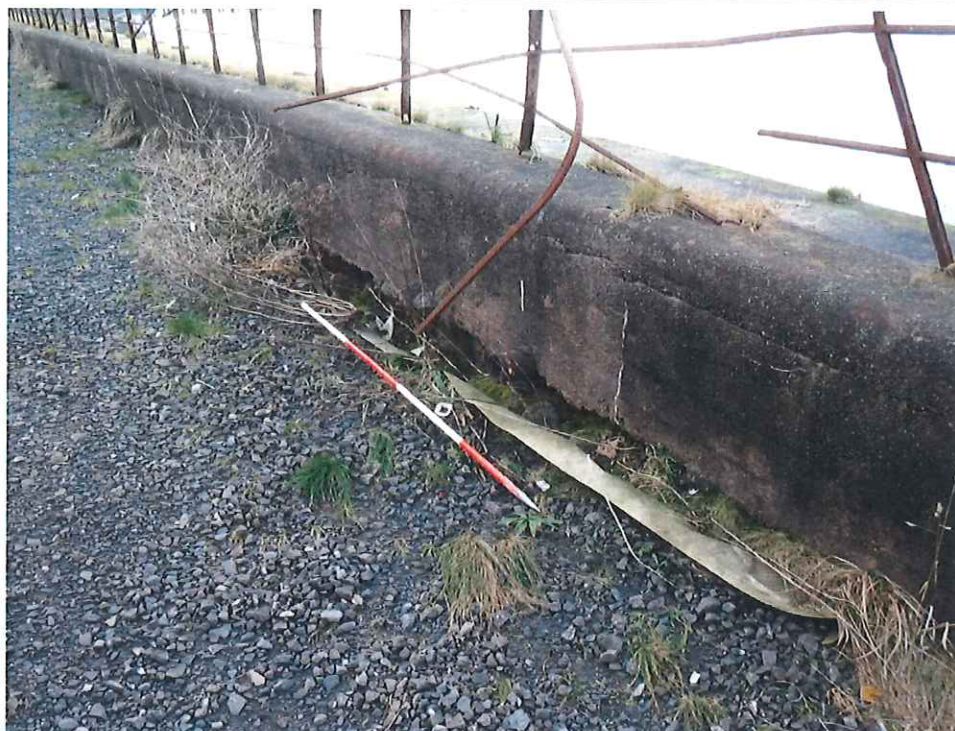
Photograph 37 - Section 3 - 9M 1600Y to 1680Y - Typical washout behind defence wall - 11.01.18

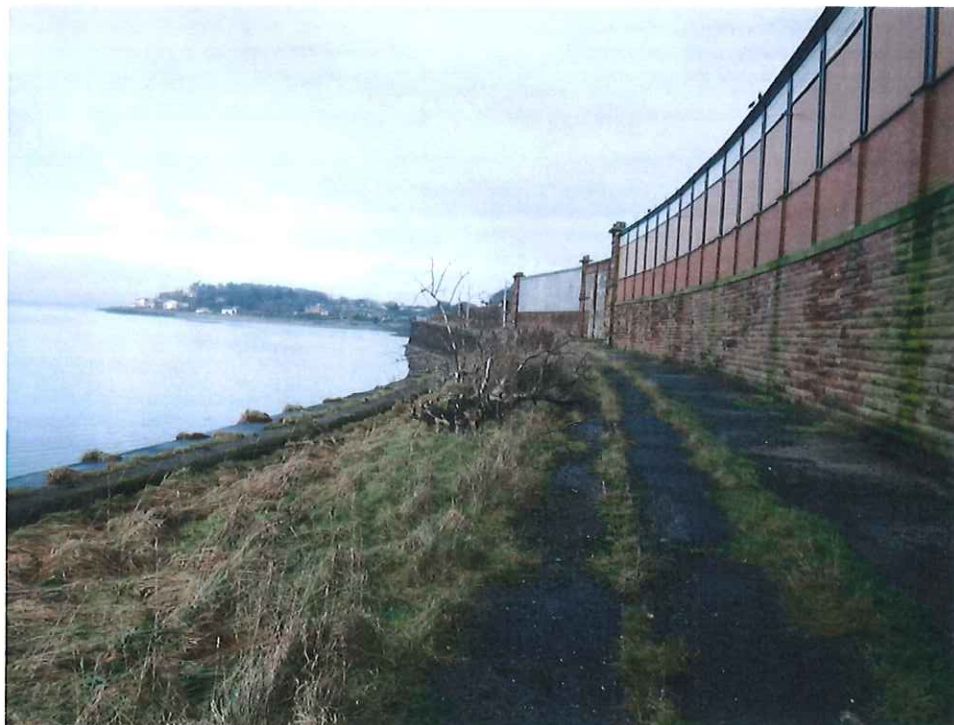
ELR: WYS	Contract Mileage: 009m 1232yds 56.00chs	Struc. Ref: 200/550
<p>Defect description: Soil and vegetation dumped behind crest of wall Dimensions: n/a Urgent: No Status: No deterioration See Photograph: 38</p>		
<p>PREVIOUS RECOMMENDATIONS AND STATUS</p>		
<p>The following Engineers recommendations were made in the 2016/2017 detailed examination report:</p>		
<ol style="list-style-type: none"> 1. Undertake stabilisation/protection work to areas of erosion/undermining voiding and washout. 2. Pointing repairs to open fractures. 3. Carry out further remedial works to defective concrete repair to prevent possibility of washout occurring again. 4. Remove of soil and vegetation to prevent additional surcharge. 		
<p>2.0 DETAILED EXAMINATION</p>		
<p>Section 1 - 9M 1232Y (NS 19370 69110) to 9M 1308Y (NS 19365 69037)</p>

Photograph 38 - Section 3 - Typical view of vegetation from end of defence to low miles - 11.01.18
