**Third Party Verification Report
Wello Oy**

**“Penguin” Wave Energy Converter
Installation at EMEC
Wave Test Site, Billia Croo**

Document Number OP 212.001

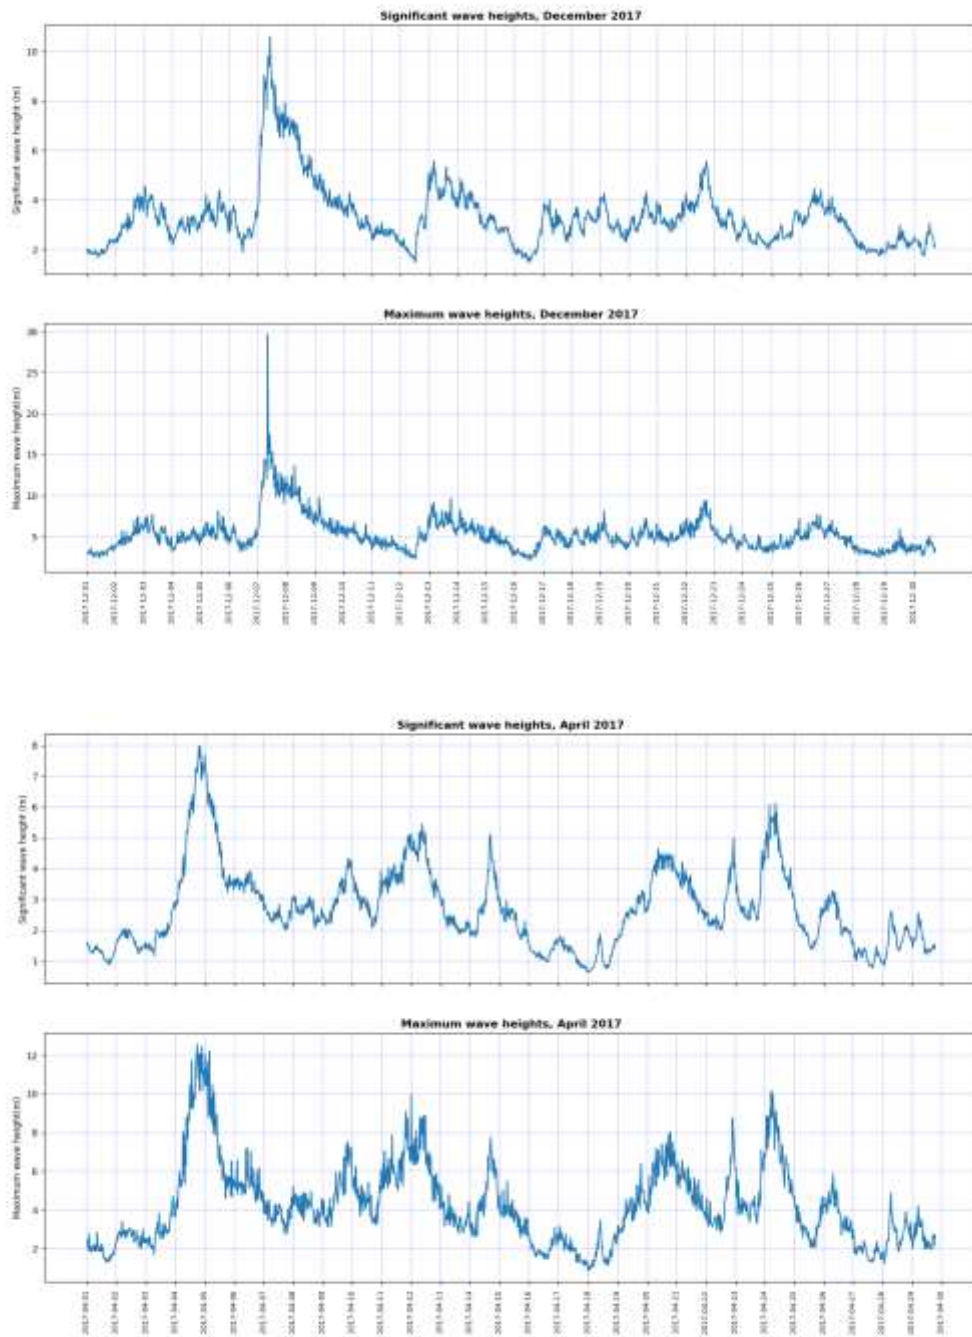
Figure 1 Recorded Significant Wave Heights on site April and December 2017

Two worst case examples of the recorded wave environment on site in 2017 and the 1 and 10 year predicted wind/wave environment used by Wello Oy are displayed below, and although the results may not be directly comparable due to limited information available, they do provide an indication of actual conditions experienced against the predicted return periods used in the mooring analysis.

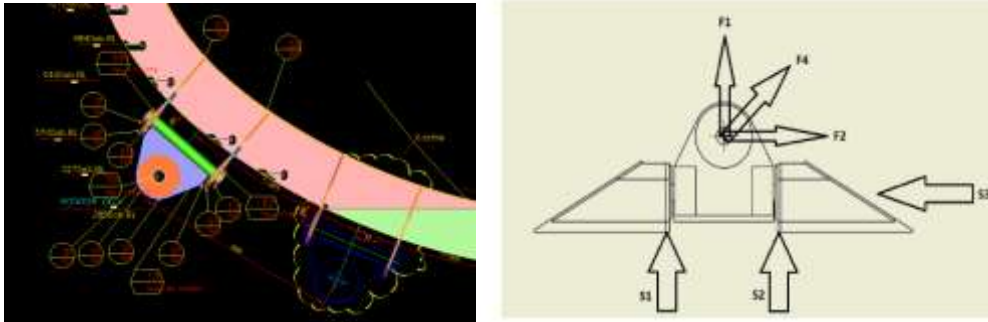
Figure 3 Mooring Bracket Structural Design Differences

Based on the information provided it is assumed that the forward anchor brackets and the stern anchor brackets are of the same dimensions [H]. The in-house analysis [B] used 2MN (approx. 204 tonnes) as the maximum load considered and therefore all the anchor brackets are adequate in design. Although there seems to be some minor differences in hull connection design, since the main stress areas identified in [B] are around the pad eye, it is deemed acceptable for the results to be applied for all four mooring brackets. In [G], it was noted that the connection design of the mooring bracket to the hull is different from those along the centerline.

Assuming shear strength as 0.58 of tensile yield strength, shear strength is around 205.9MPa. This gives a safety factor of 3.17 in the pin, and is thus acceptable.

The highest resultant Von Mises stresses as simulated in [D] using FEA was under the loading case with F2, giving 169.3MPa, which indicate that the design is adequate to withstand the loads since there is a safety factor of 2.1 using the material S355.

The mooring brackets therefore fulfill the ULS and ALS check.

It was noted that while the S-N curve referenced in the [J] indicates that the brackets would be able to last 3 years. However, regular inspection during service time should be carried out to ensure that there are not already significant crack propagations in the critical areas. Should signs of such fatigue damage be observed, Non-Destructive Testing may be required to ensure the validity of the component.

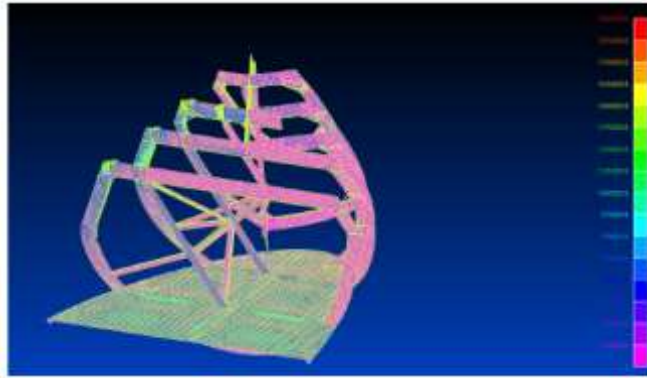
The underdeck support structure of the deck ballast was also reviewed. The methodology of the analysis described in [R] to determine the load and the recommended design appears reasonable.

The analysis suggests that the proposed design does not have high stress concentration on the support structure. It was however noted that the [R] concluded that analysis on the detailed design of the support structure was not completed. Between this work and the finalizing of the detailed design in [R] & [T], it was assumed that proper analysis was carried out. However, subjected to inspection of the existing structures for any buckling, deflections, cracks or other damages, the deployment history suggests that the structure should be fit for further deployment.
