Underwater Examination
ELR: GSW
Contract Mileage: 106 m 1481 yds 67.32 ch
Struc. Ref
161/343

| Structure Name: ANNAN VIADUCT | Type: BV | Exam ID: 3090230 |
| Route: Gretna - Glasgow Central (via Kilmarnock) | | Complete Exam: No |

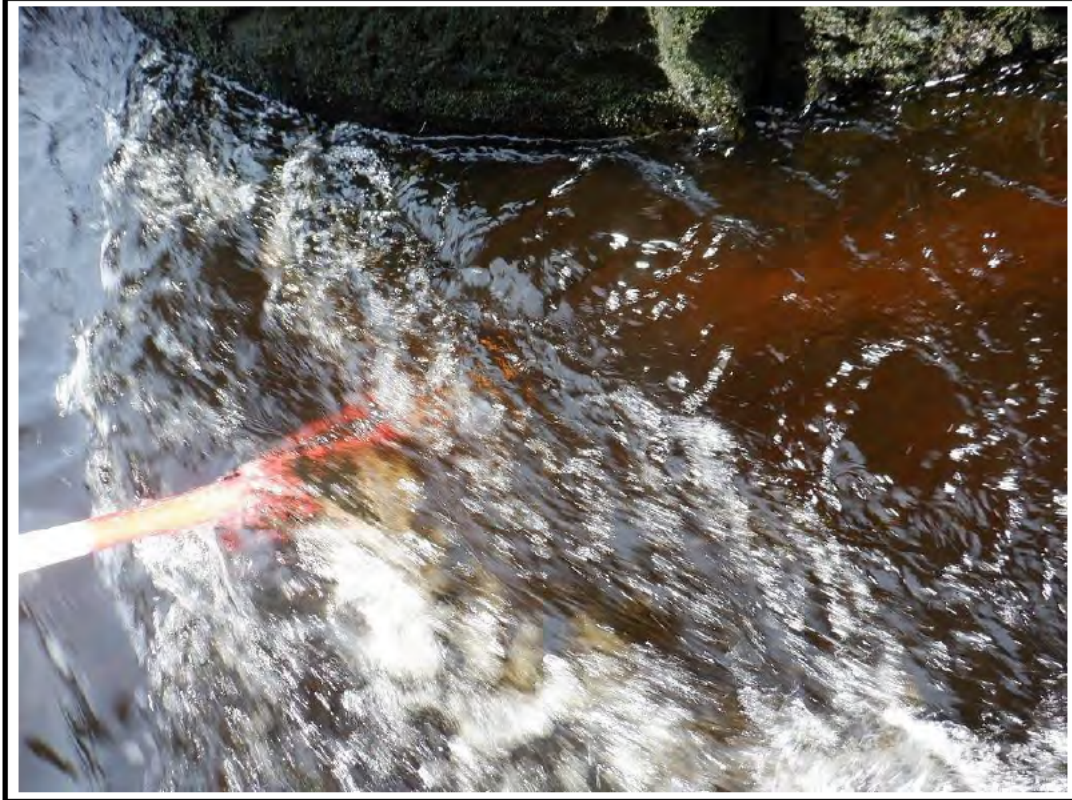
PHOTO 5: P5 - DAMAGED GABIONS 14/09/20

| HIDDEN PARTS NOT EXAMINED (EXCLUDING FOUNDATIONS) | | Part | | | Reason | | | | | Works Category |
|--|---|--|---|---|---|---|---|---|---|---|
| 2 | Carry out repairs to damaged gabions with loss of material. | Piers 1, 2 and 3 | | | | 2 | 4 | E8 | Other | |

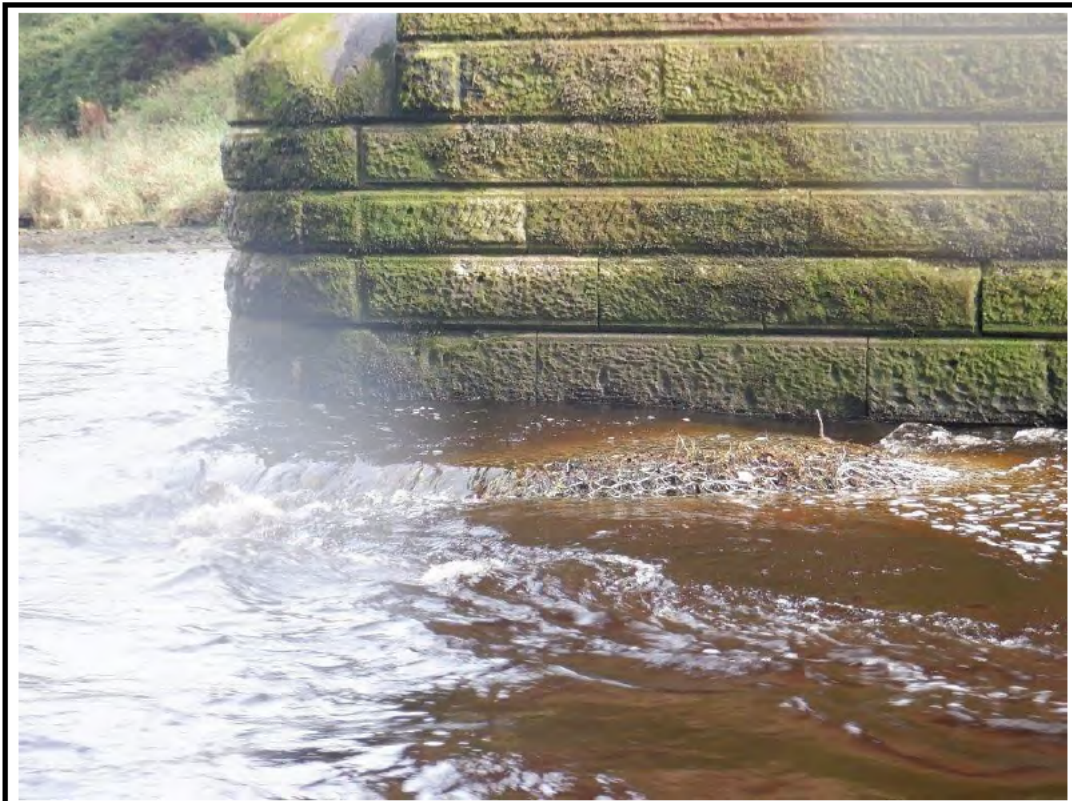
PHOTO 6: P6- PIER 3 DAMAGED GABIONS 14/09/20

| HIDDEN PARTS NOT EXAMINED (EXCLUDING FOUNDATIONS) | | Part | | | Reason | | | | | Works Category |
|--|---|--|---|---|---|---|---|---|---|---|
| 6 | Carry out immediate repairs to damaged gabion baskets ensuring no further scour is located. | Pier 3 LM face at the upstream end from 0m to 4m | | | | 4 | 3 | E12 | Other | |

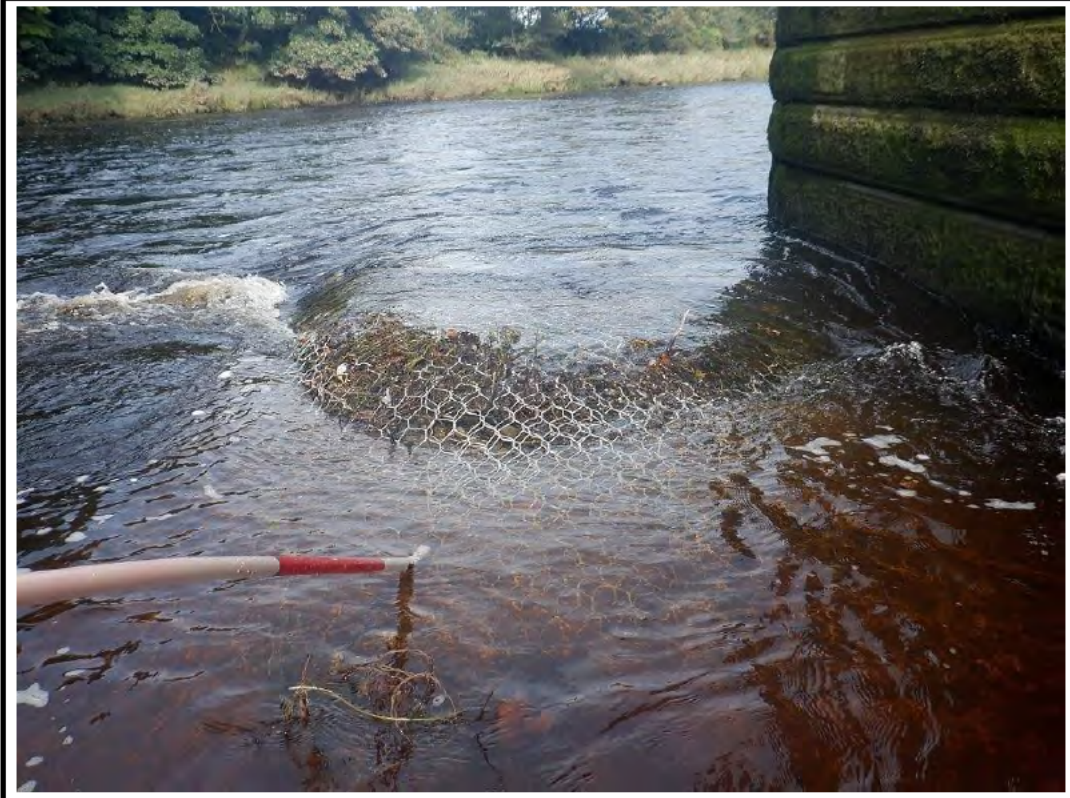
PHOTO 7: P7- PIER 3 DAMAGED GABIONS 14/09/20

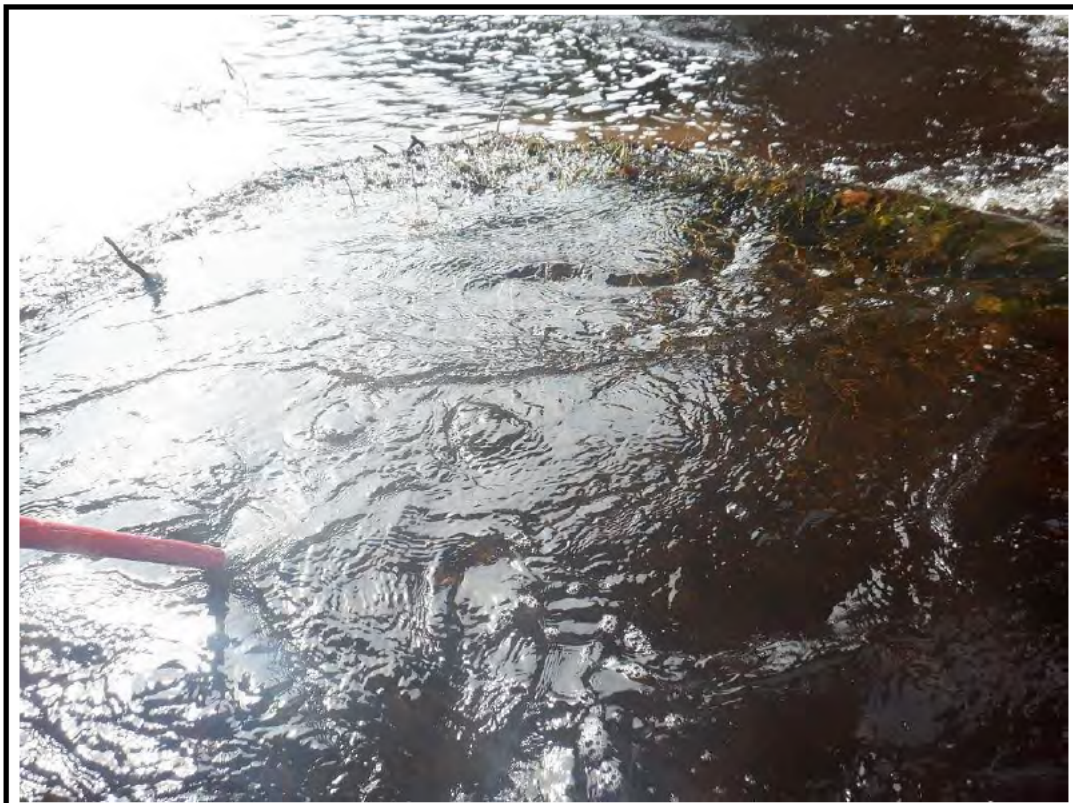
PHOTO 8: P8- PIER 3 DAMAGED GABIONS 14/09/20

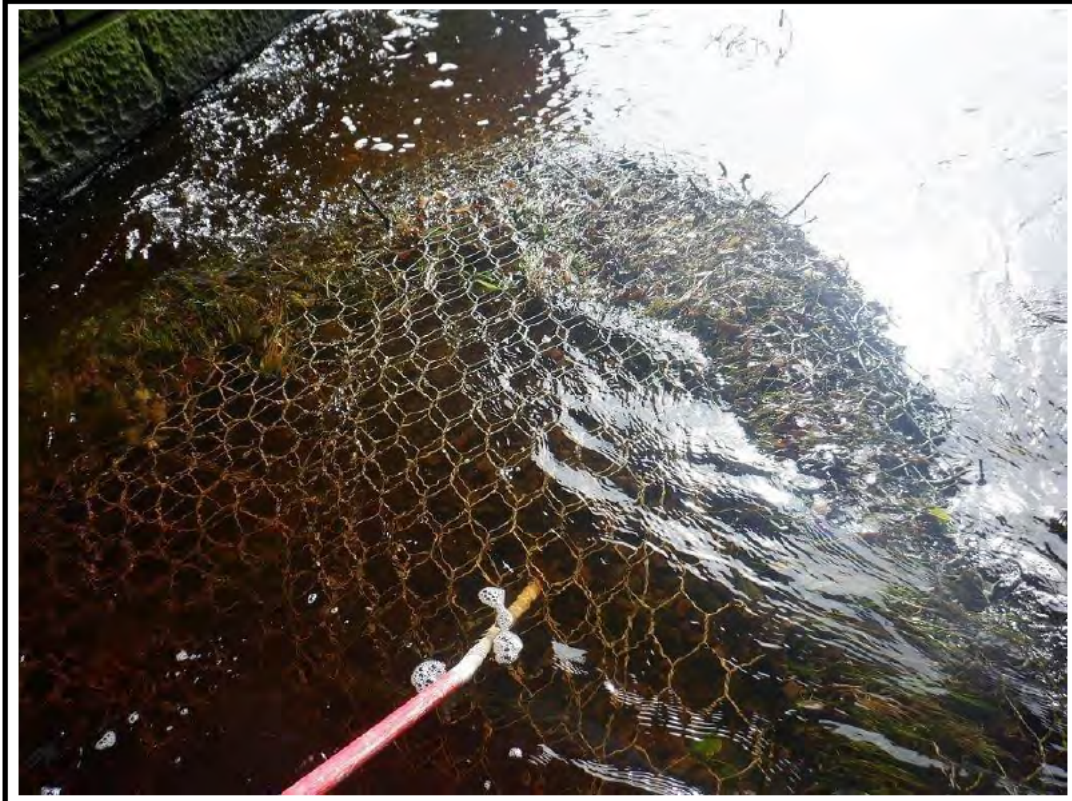
PHOTO 9: P9- PIER 3 DAMAGED GABIONS 14/09/20

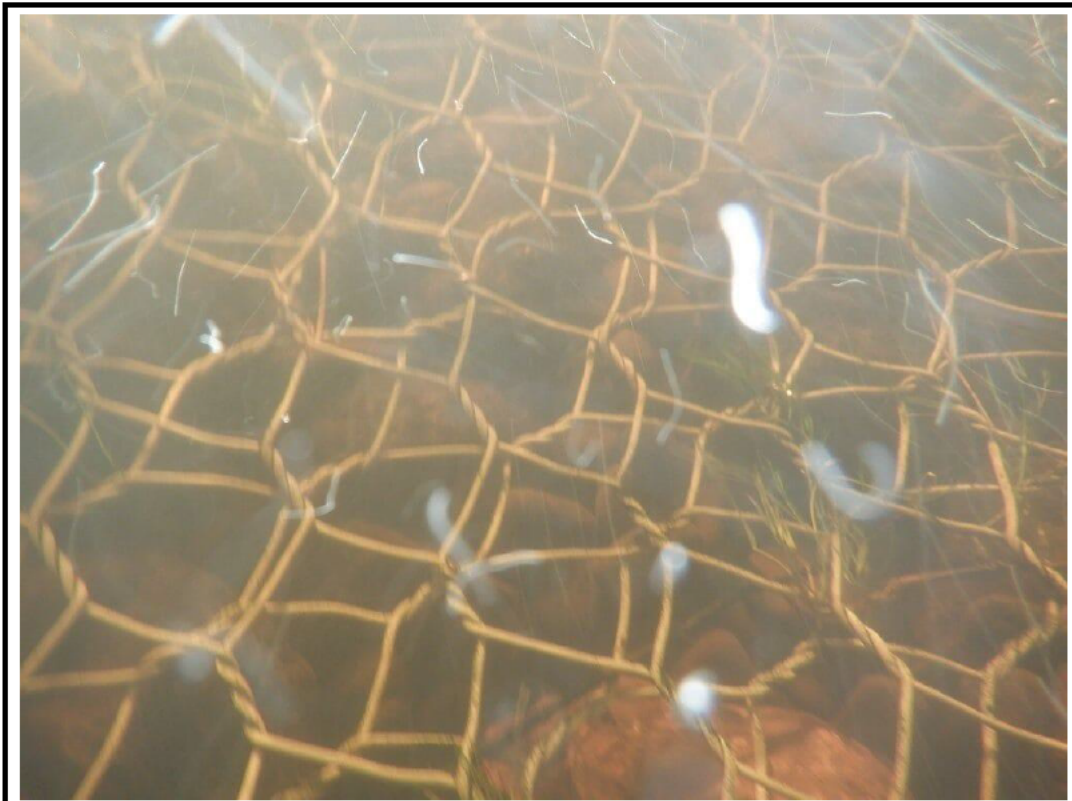
PHOTO 10: P10- PIER 3 DAMAGED GABIONS 14/09/20

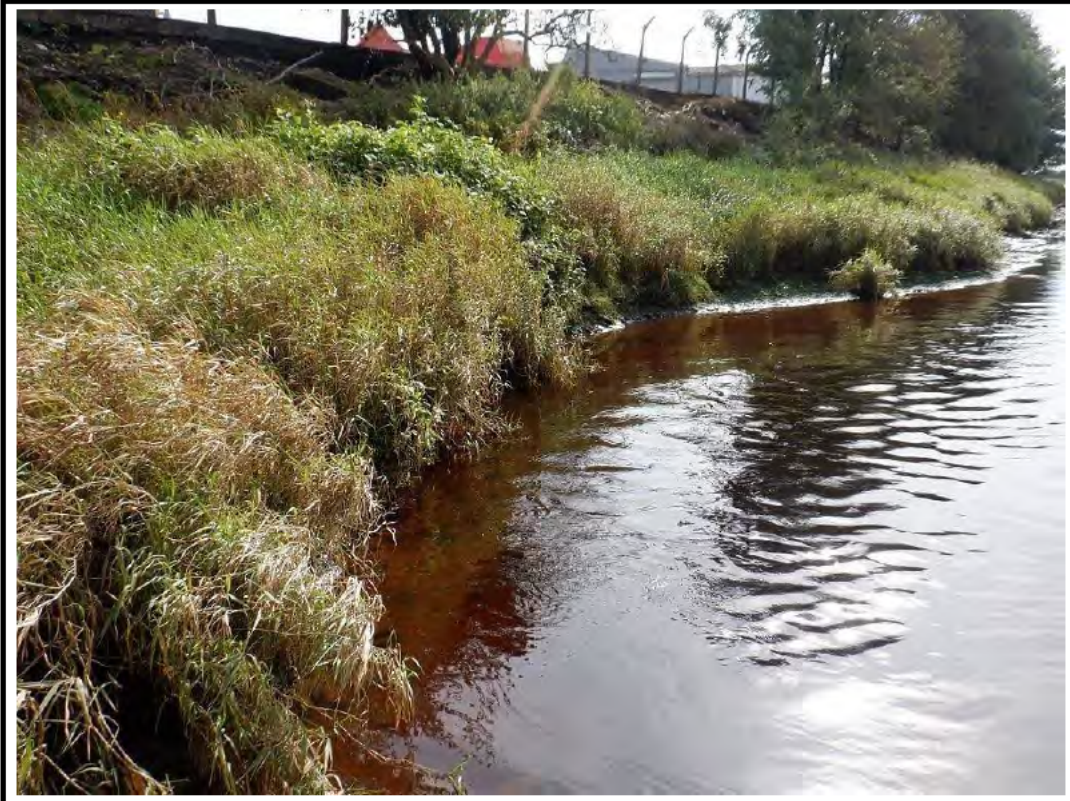
PHOTO 11: P11 - EROSION DOWNSTREAM HIGH MILEAGE 14/09/20

| HIDDEN PARTS NOT EXAMINED (EXCLUDING FOUNDATIONS) | | Part | | | Reason | | | | | Works Category |
|--|---|--|---|---|---|---|---|---|---|---|
| 3 | Re-nstate area of bank erosion and install protection | HM bank, downstream | | | | 2 | 4 | E8 | Other | |

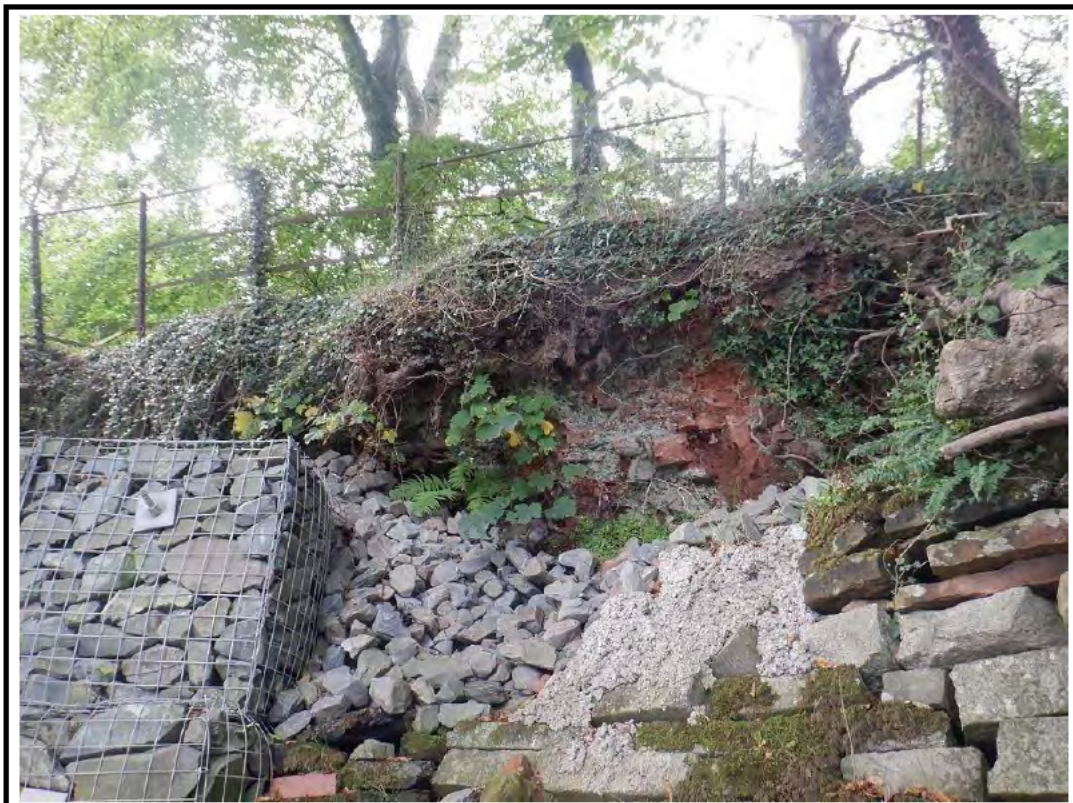
PHOTO 12: P12 - EROSION UPSTREAM LOW MILEAGE AFTER THE GABION BASKETS 14/09/20

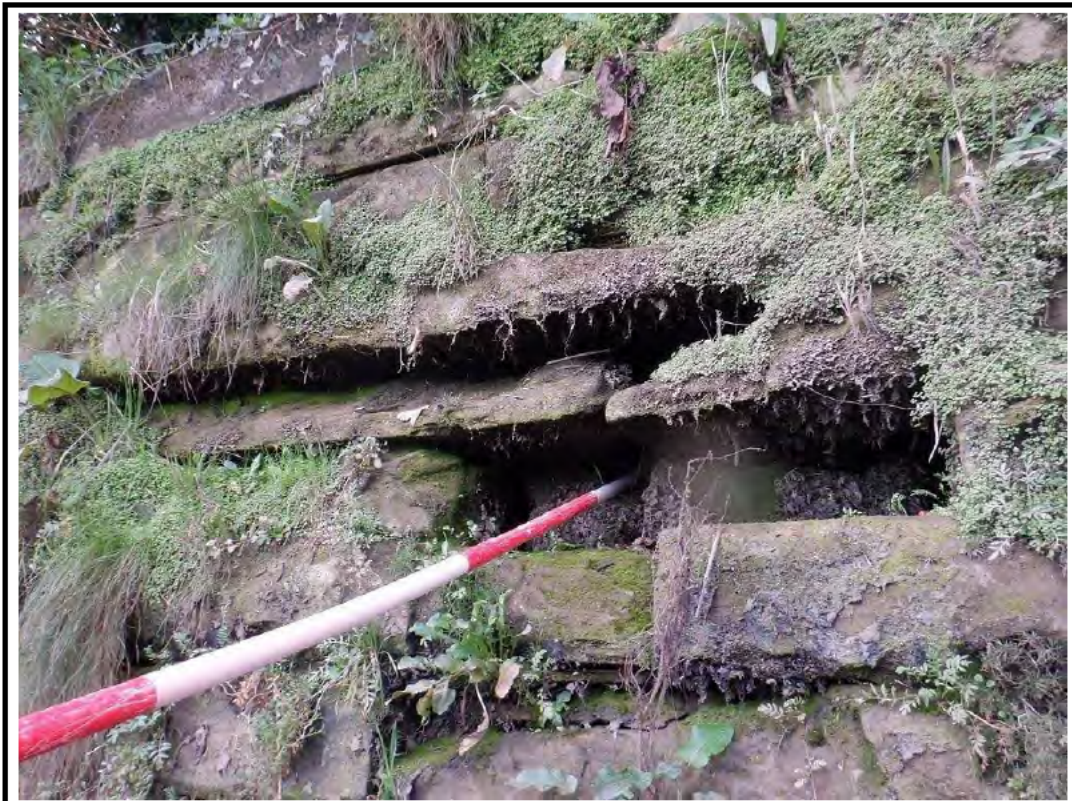
PHOTO 14: P14 - AREAS OF VOIDING AND SPALLING LOCATED THROUGHOUT 14/09/20

| HIDDEN PARTS NOT EXAMINED (EXCLUDING FOUNDATIONS) | | Part | | | Reason | | | | | Works Category |
|--|---|--|---|---|---|---|---|---|---|---|
| 5 | Carry out repairs to areas of spalling and voiding | LM up and downstream retaining walls | | | | 2 | 5 | E10 | Brickwork/Stone Repairs | |

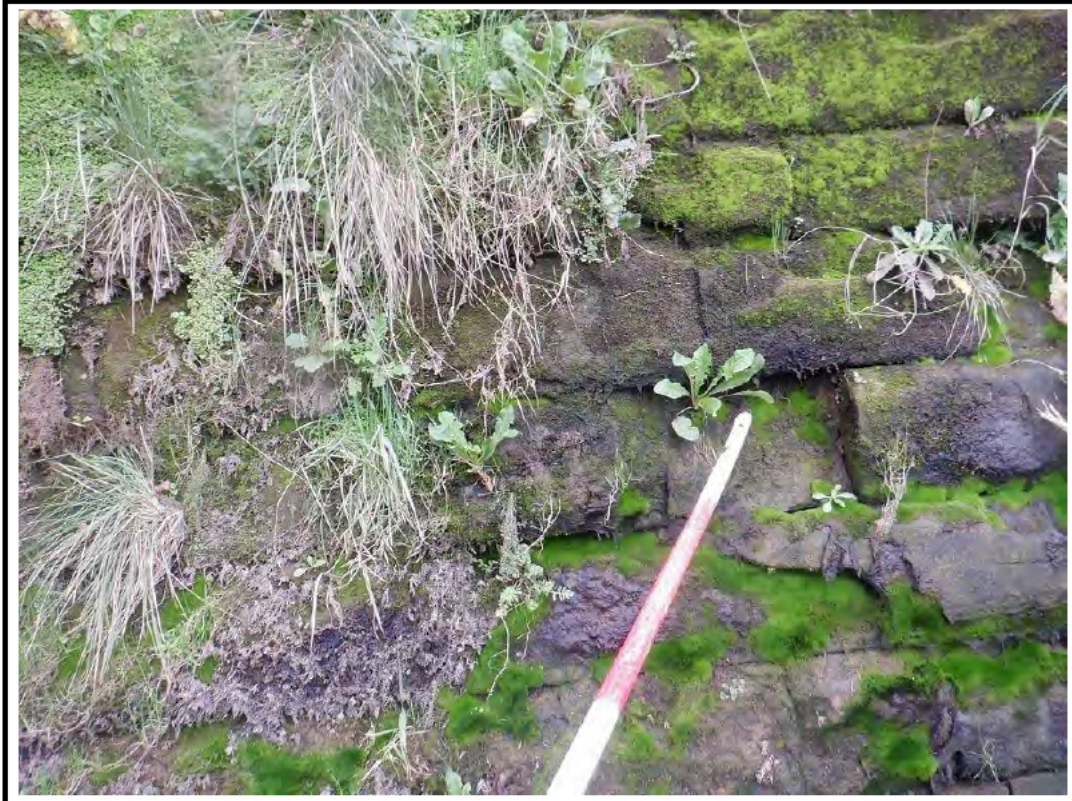
PHOTO 17: P17 - 8M FROM THE ABUTMENT 4M2 SPALLING 14/09/20

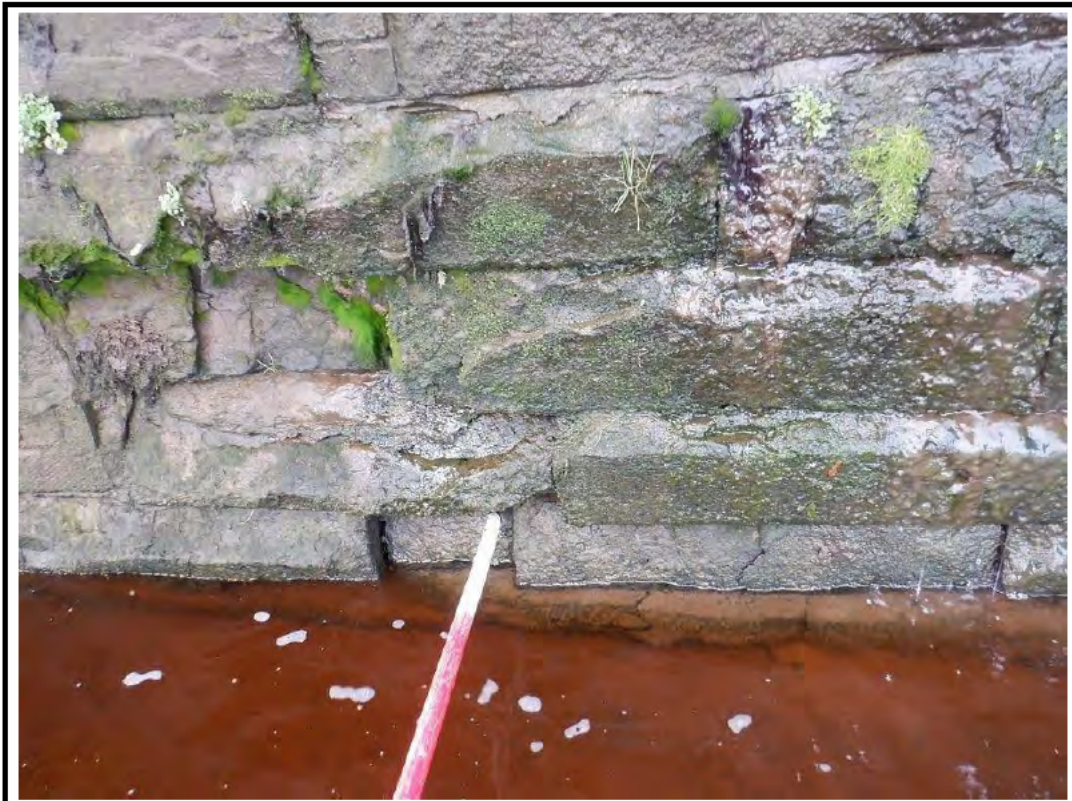
PHOTO 18: P18 - AT 9M FROM THE ABUTMENT SPALLING AT WATER LEVEL, 14/09/20

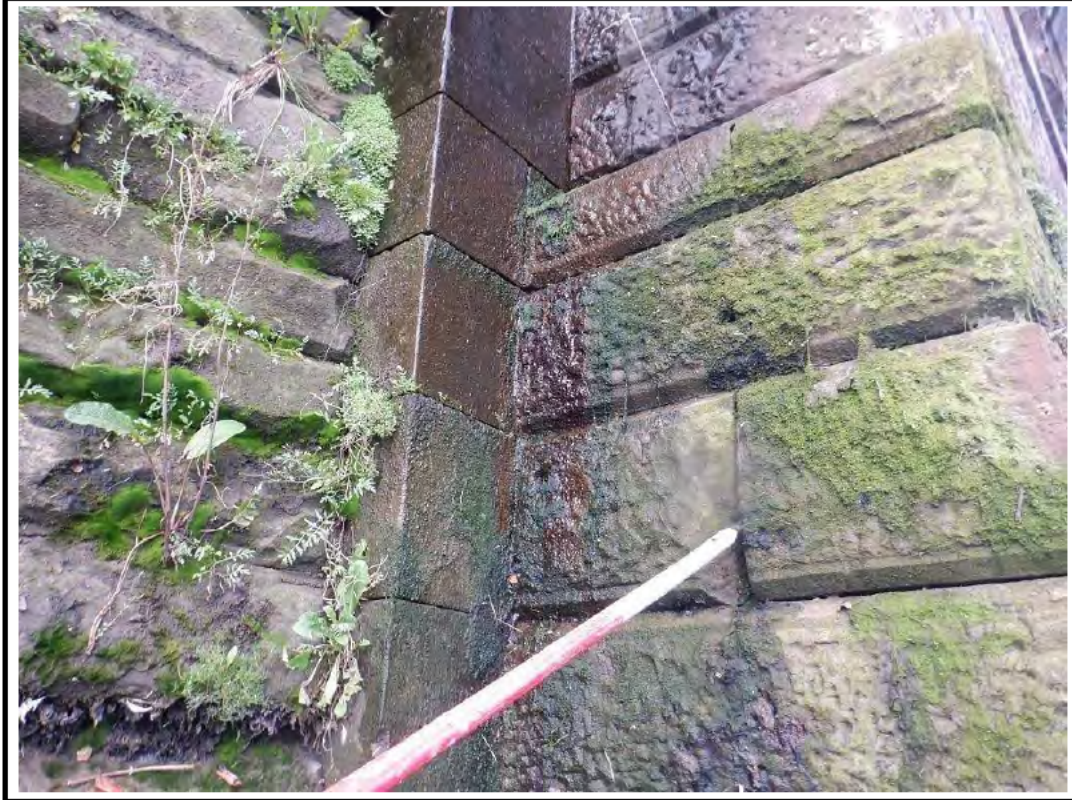
PHOTO 21: P21 - DOWNSTREAM RETURN - FRACTURE 14/09/20

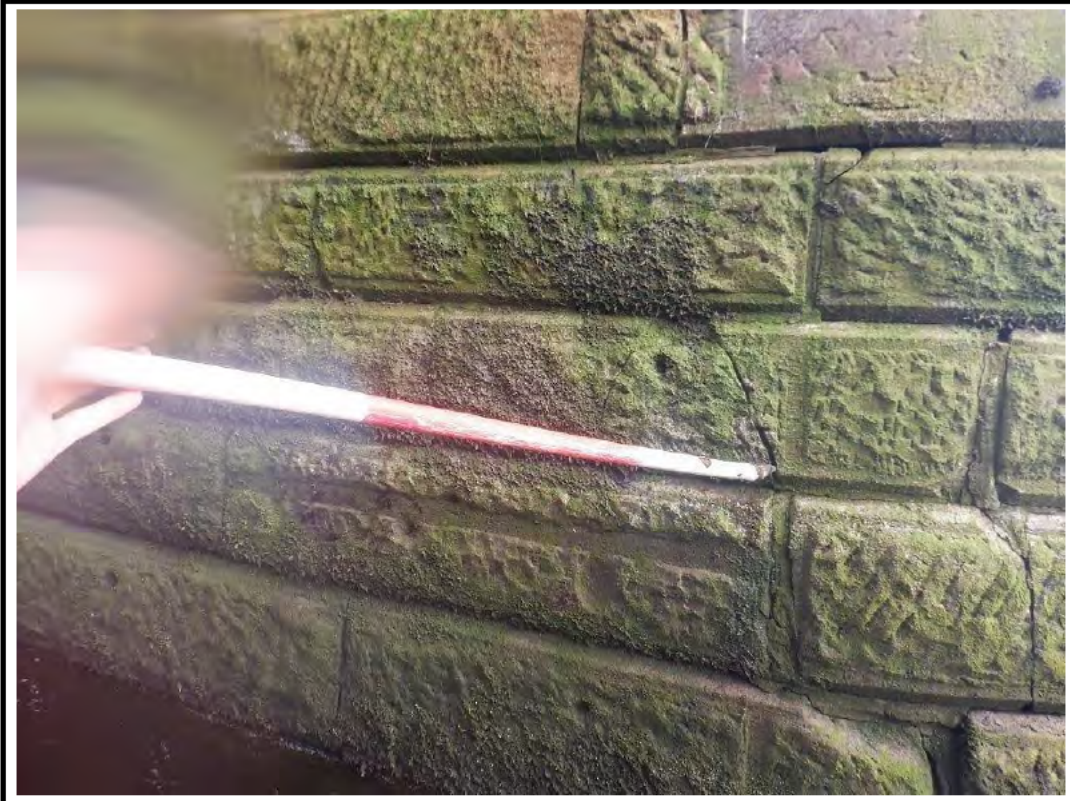
PHOTO 29: P29 - 2NO VERTICAL FRACTURES 14/09/20

| HIDDEN PARTS NOT EXAMINED (EXCLUDING FOUNDATIONS) | | Part | | | Reason | | | | | Works Category |
|--|---|--|---|---|---|---|---|---|---|---|
| 4 | Carry out hand pointing and date tabbing repairs to fractures | Pier 3 - Downside, HM and LM face | | | | 2 | 4 | S8 | Hand Pointing | |
