1.0 INTRODUCTION:

Tongland Bridge, a distinguished 'Category A' listed structure, stands as a testament to engineering brilliance with its 34m span circular segmented arch and three 2.7m gothic arch approach spans on either end. Crafted from the enduring rough-faced grey sandstone of Arran, this architectural marvel was conceptualized by the renowned Thomas Telford and brought to life between 1805 and 1808.

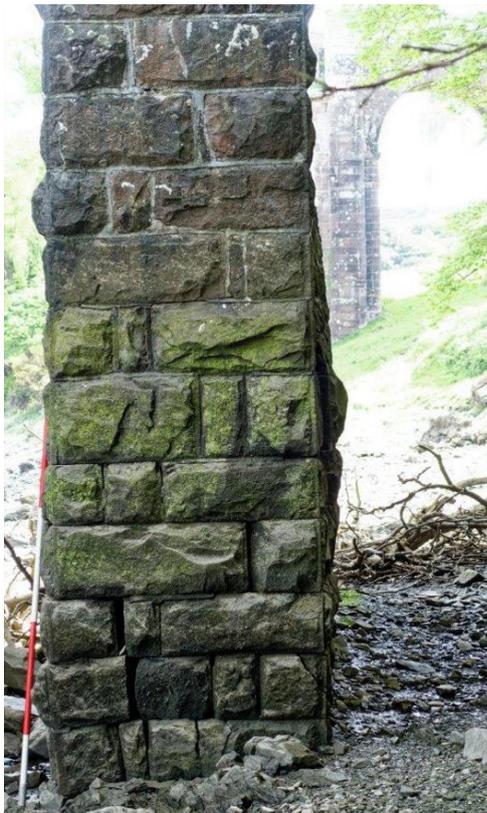
The recent inspection revealed concerning structural issues in the second pier from the south end, with the bottom 2 meters displaying signs of bursting over two-thirds of its length. A similar, though less severe, deterioration was observed in the second pier from the north end, primarily concentrated in the intertidal zone in both piers. Furthermore, the 2017 Geotechnical Investigation (GI) documented open joints and slight separation near the external faces of the spandrels in some of the approach gothic arches.

Figure 3 : Photo showing Elevation of second pier from South end (featuring bulging of Pier and cracks)

Our current proposal involves, grouting voids/ cracks in existing piers, anchoring without a Pattress plate and erecting a pier jacketing wall around the existing pier. This strategy serves as an interim measure to halt any further deterioration of the pier. For a visual reference, please refer to the General Arrangement (GA) drawing (DRG. : A711_110_KS_10). This interim solution is intended to provide stability and prevent further damage while more comprehensive measures are being planned and executed.

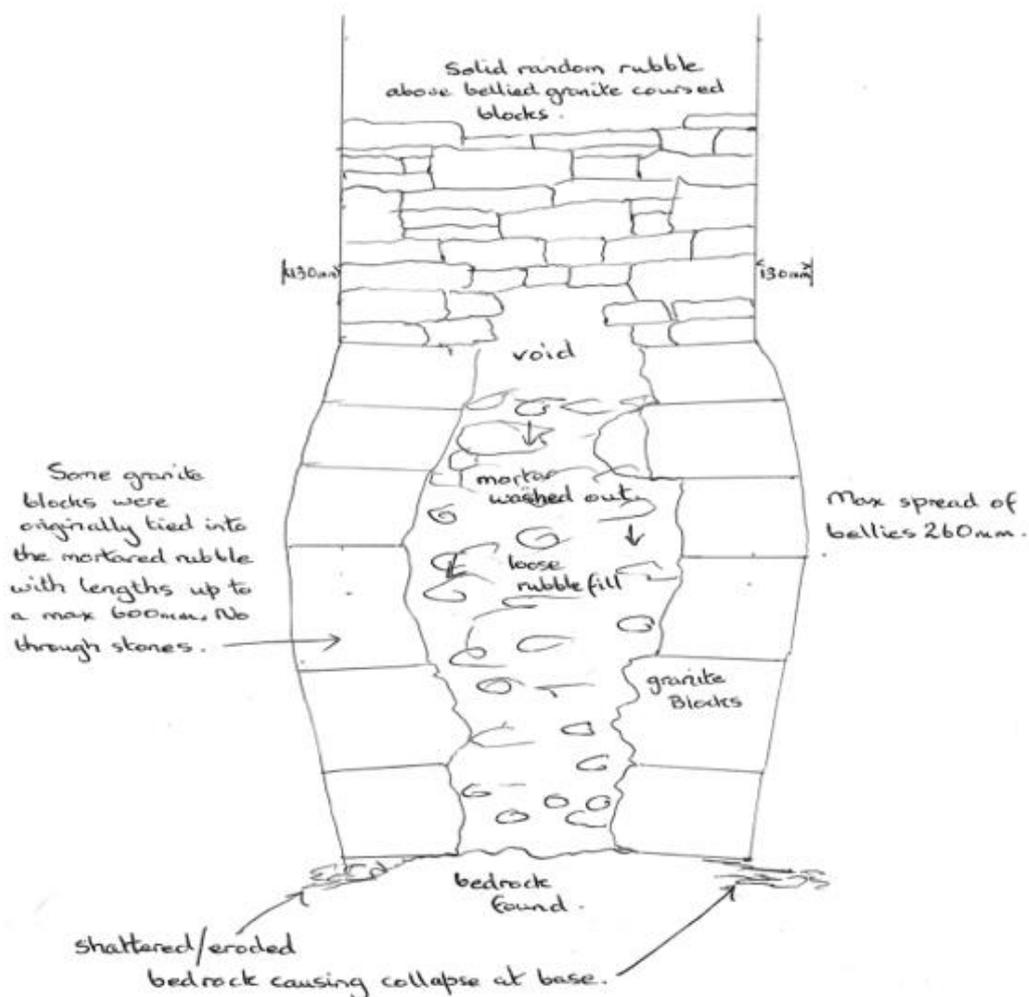
The water level of 'River Dee' undergoes bi-daily fluctuations, and over time, the binding mortar of inside rubble mortar fill has eroded, as depicted in the accompanying photo and sketch. This erosion has resulted in the transfer of the load from the superstructure and the self-weight of the pier to concentrate on the outer skin of the ashlar masonry wall. Consequently, the intended support from the entire cross-sectional area of the pier (1.1 m width x 7.4 m length) to superstructure is compromised, and currently, only the outer skin of ashlar stone masonry units, with a width of 0.2m at the periphery in the lower half of the pier, remains effective. This localized support is causing an undue concentration of compressive stress on the outer skin, potentially leading to the development of cracks in the stone blocks and bulging of the pier. Addressing this structural concern is imperative to ensure the pier's stability and prevent further deterioration.

Figure 4 : Sketch showing cross-section of the Pier

1. Anchoring is designed to bind the bulging pier, while grouting will play a crucial role in filling voids within the pier. The investigation revealed that tidal river water has eroded the original binding mortar within the loose rubble stone fill, emphasizing the need for internal restoration.
2. The installation of a pier jacketing wall serves as a protective barrier against direct exposure to tidal water, mitigating further deterioration.
3. Post-anchoring, the grouting process becomes instrumental in transforming the pier into a cohesive unit, restoring its original design by addressing gaps and voids.

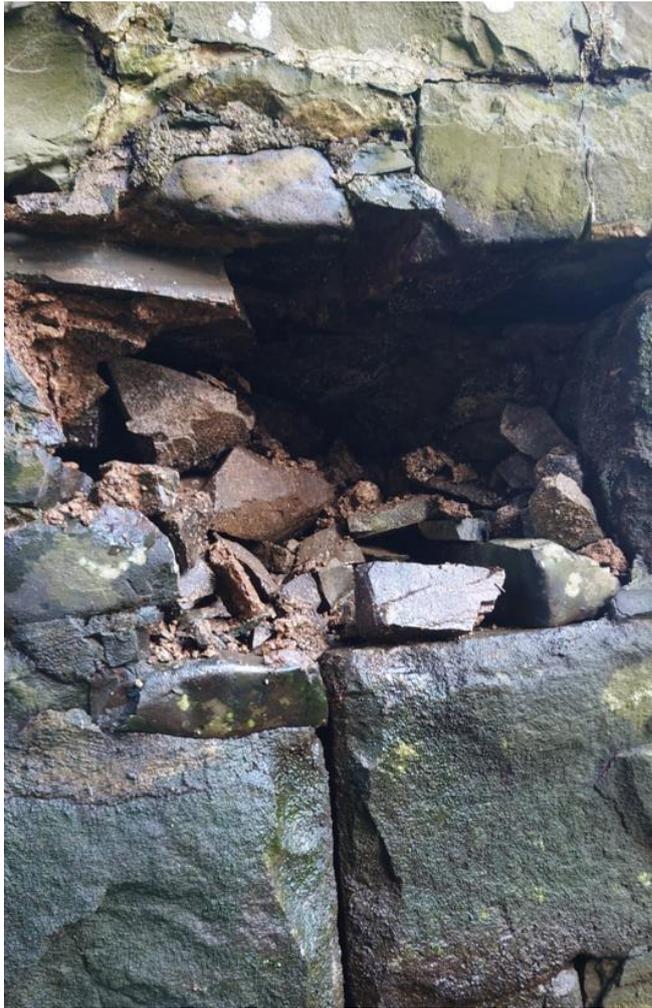
Figure 5: Photo Showing internal rubble fill when outer skin of Pier was removed during investigation

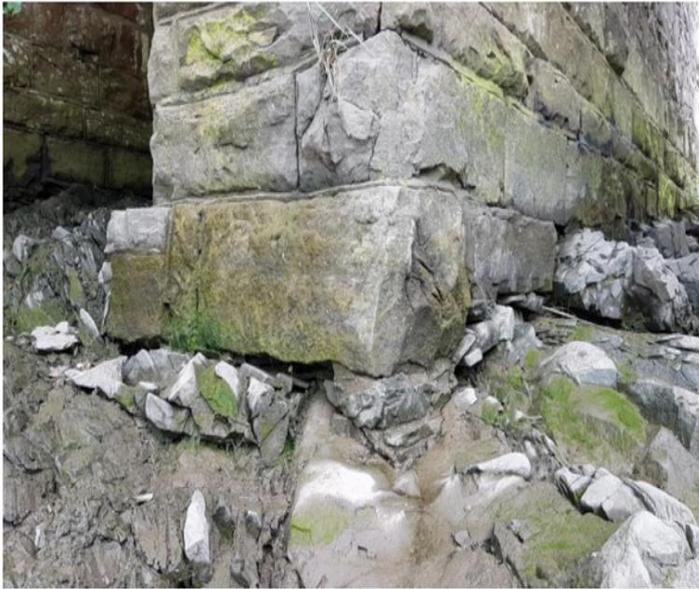
The structural integrity of the main arch piers is under scrutiny as the approach piers situated at both ends reveal a concerning issue. Built on an inclined rocky river embankment, the levelling rock beneath the pier footing has weathered in several areas, laying bare the foundation, as evident in the accompanying photos. This exposure has given rise to nonlinear stresses within the piers and their foundations. The compromised foundation likely contributes to the exacerbation of the piers' deteriorating condition, leading to the development of additional cracks in the unsupported sections of the structure. Addressing this foundational vulnerability is paramount to mitigating further structural damage and ensuring the long-term stability of the arch.

Figure 6 : Photo of Pier base springing from inclined face of weathered rocky river embankment

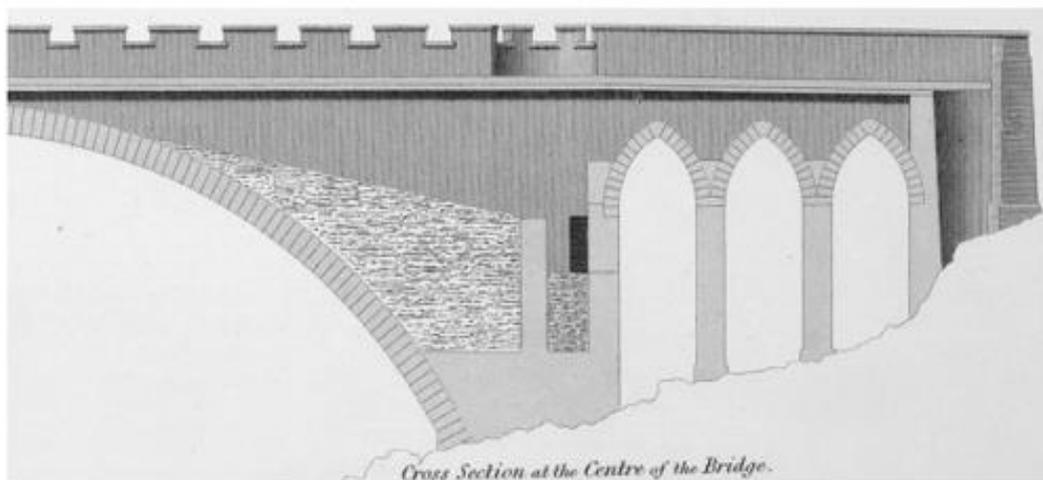
The original design of the bridge incorporated a strategic approach to minimize self-weight and distribute loads effectively. The section above the main arches featured voids, supported by intermediate spandrel walls and slabs, as illustrated in the artistic impression provided in the extract below. This design not only aimed to reduce the overall weight of the bridge but also facilitated internal access for inspection and maintenance purposes. However, it has come to light that these voids have been filled, and a RC slab has been casted in mid-20's. This deviation from the original design likely led to an increased load on the piers and their foundations. Consequently, the added pressure has manifested in bulging and the formation of cracks in the stone masonry units of the piers. Understanding and rectifying this deviation is crucial to restoring the structural balance and integrity of the bridge.

Figure 7 : Sketch showing Part sectional elevation of the bridge from archive drawing

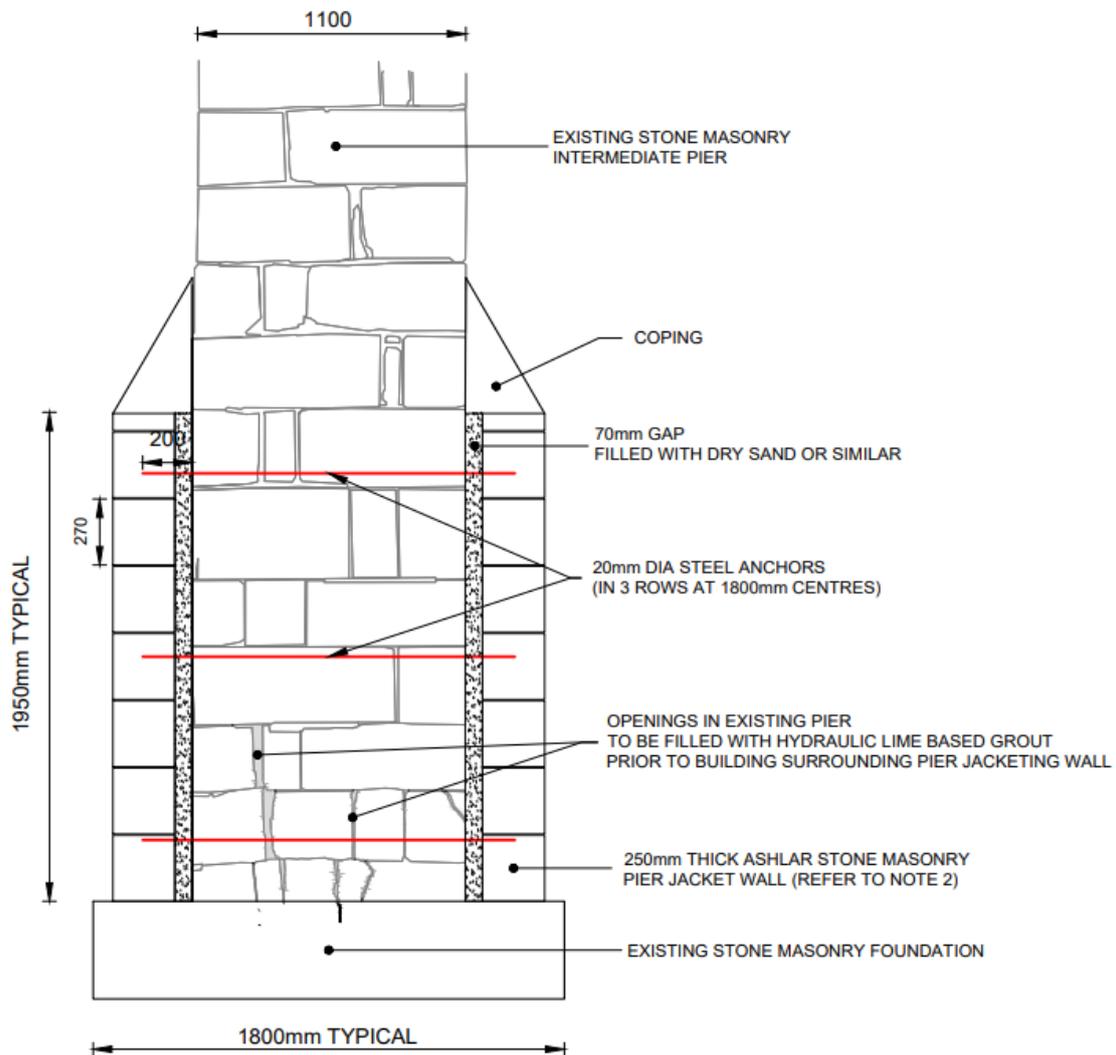
Figure 9 : Sketch showing existing Pier cross-section and Pier jacketing wall with ties

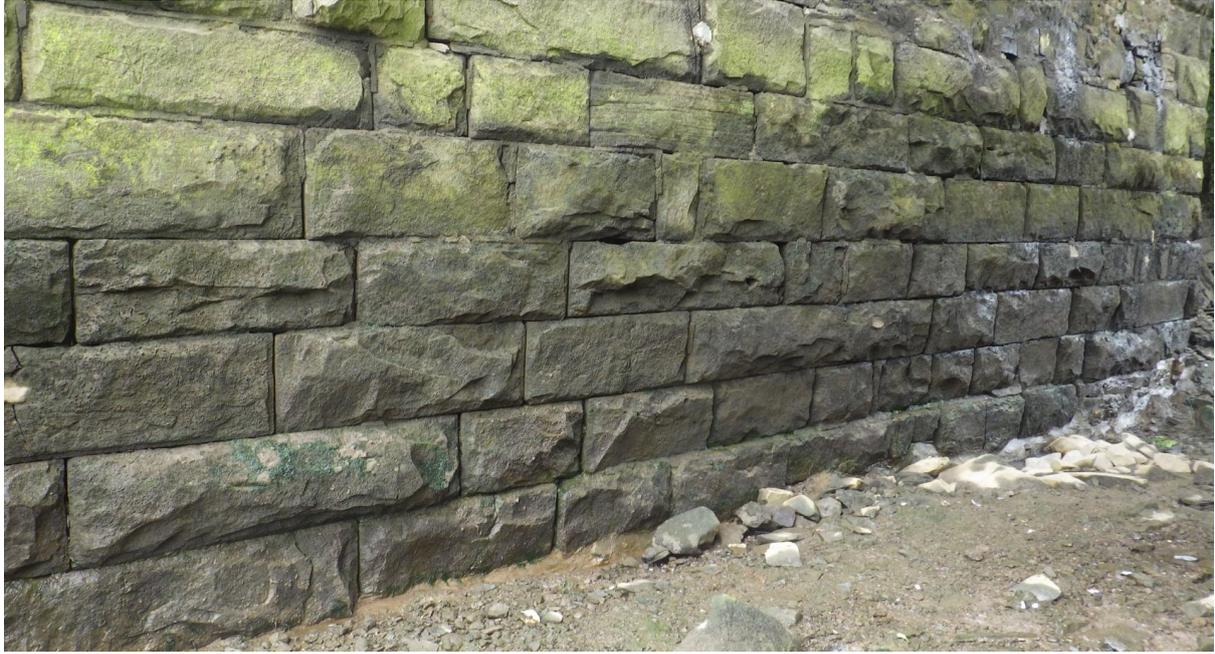
The current observation indicates variations in the existing coursework and texture of the ashlar masonry, particularly along the longer direction of the 'Intermediate Piers' with differences in the length, height, and texture of individual stone units. This could be attributed to this section of the bridge being obscured from direct view. For visual reference, please refer Figures 10 and 11.

Figure 10: Photo showing layout of existing ashlar Stone masonry Intermediate (South) Pier

Given the varying nature of the coursework, our proposal suggests employing a coursework pattern resembling 'Flemish bond' showcased in 'Figure 12' along the longer surface of the 'Pier Jacketing wall' for South and North Intermediate Piers.

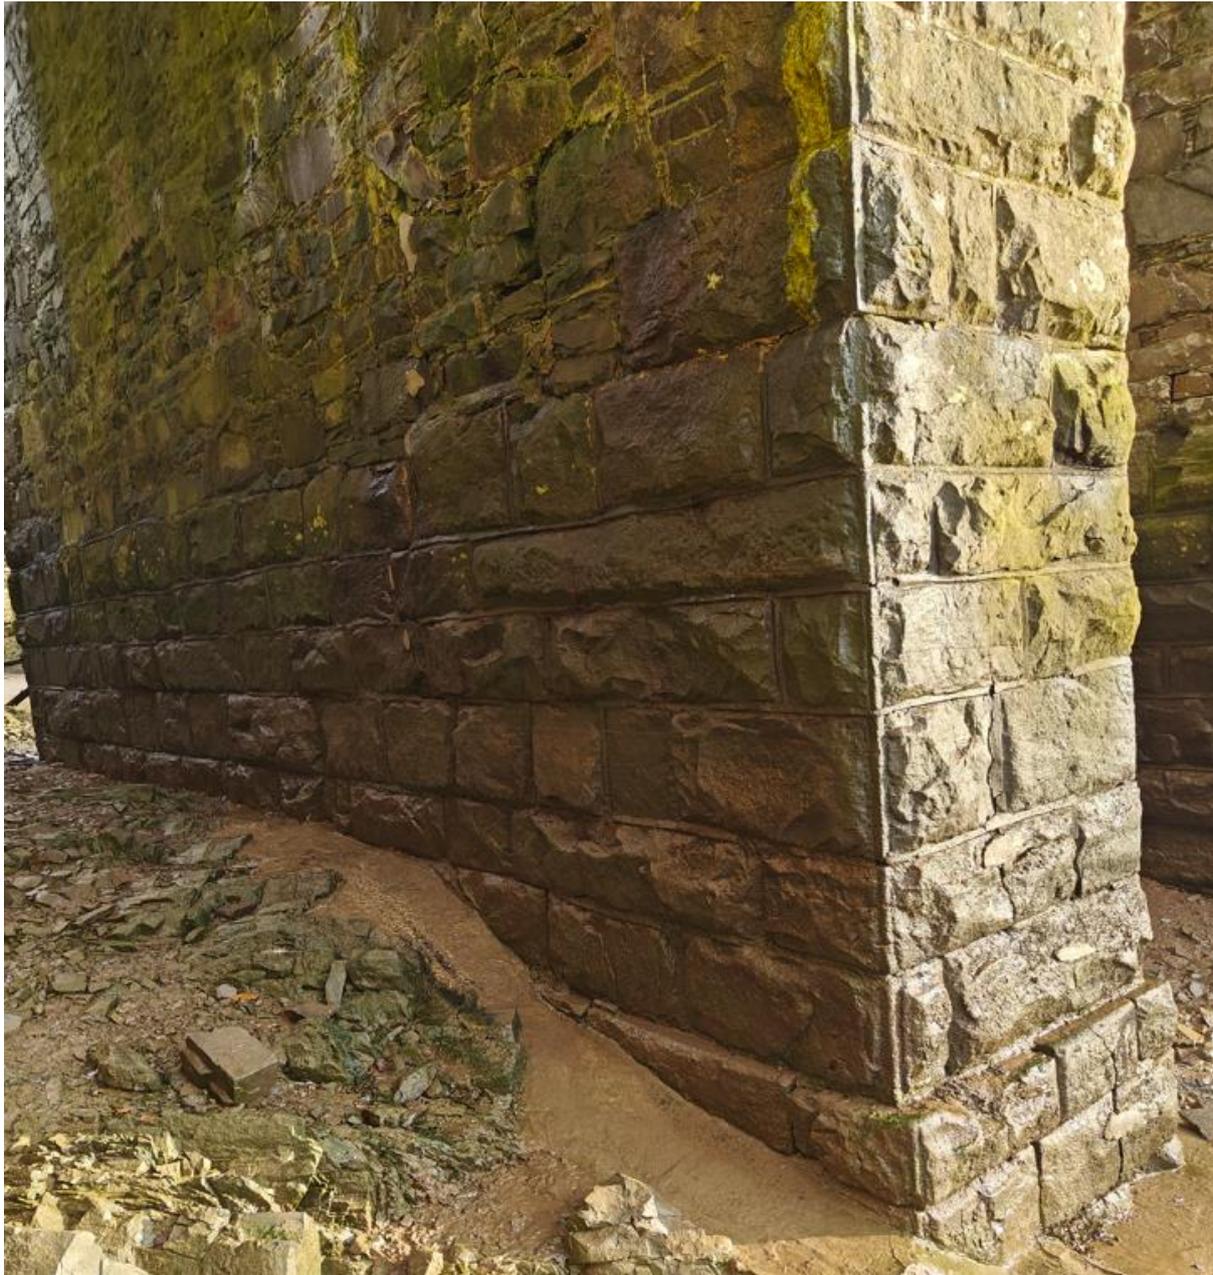
Figure 11: Photo showing layout of existing ashlar Stone masonry Intermediate (North) Pier

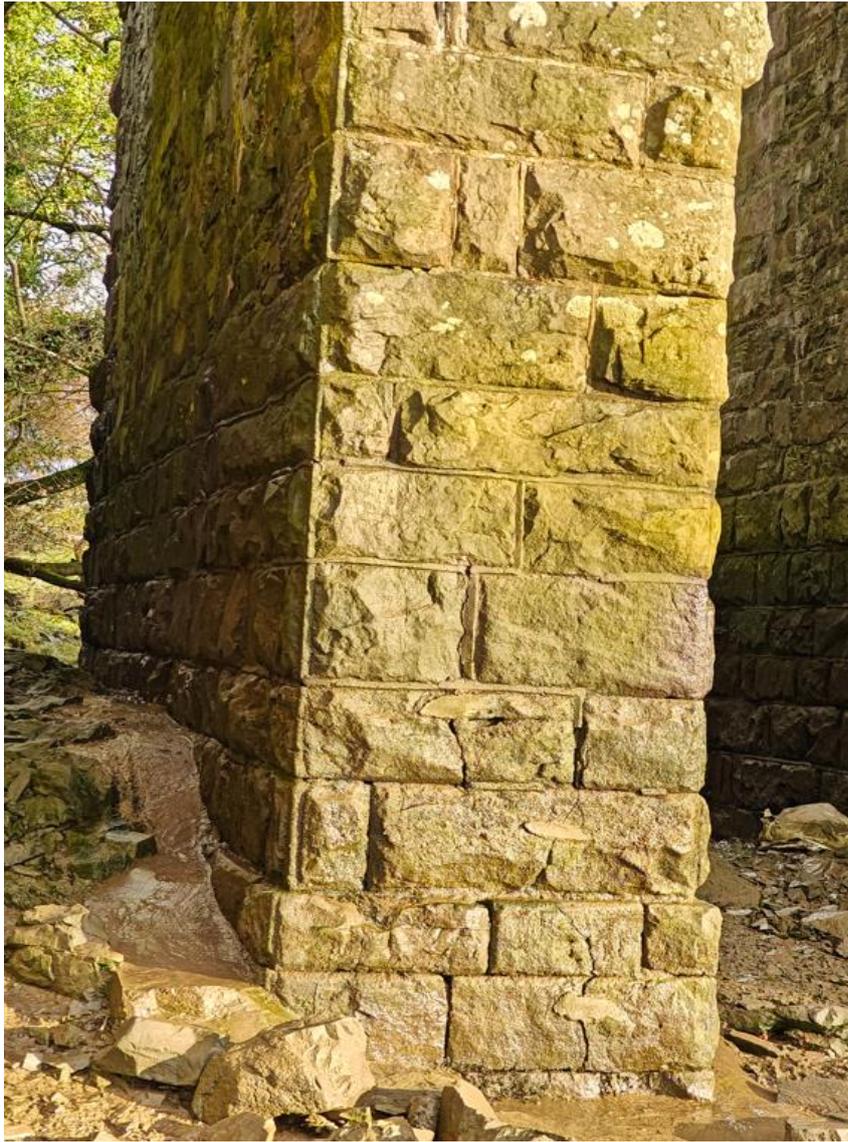
Conversely, in shorter direction of existing Pier has different arrangement of 'Stone pattern'. See Figure 13 for reference. This pattern is closer to 'Running bond' pattern and similar arrangement is proposed for the new 'Pier Jacketing wall' Refer to 'Figure 14' for the detail .

Figure 13: Elevation showing coursework of existing (North) Intermediate pier at shorter face

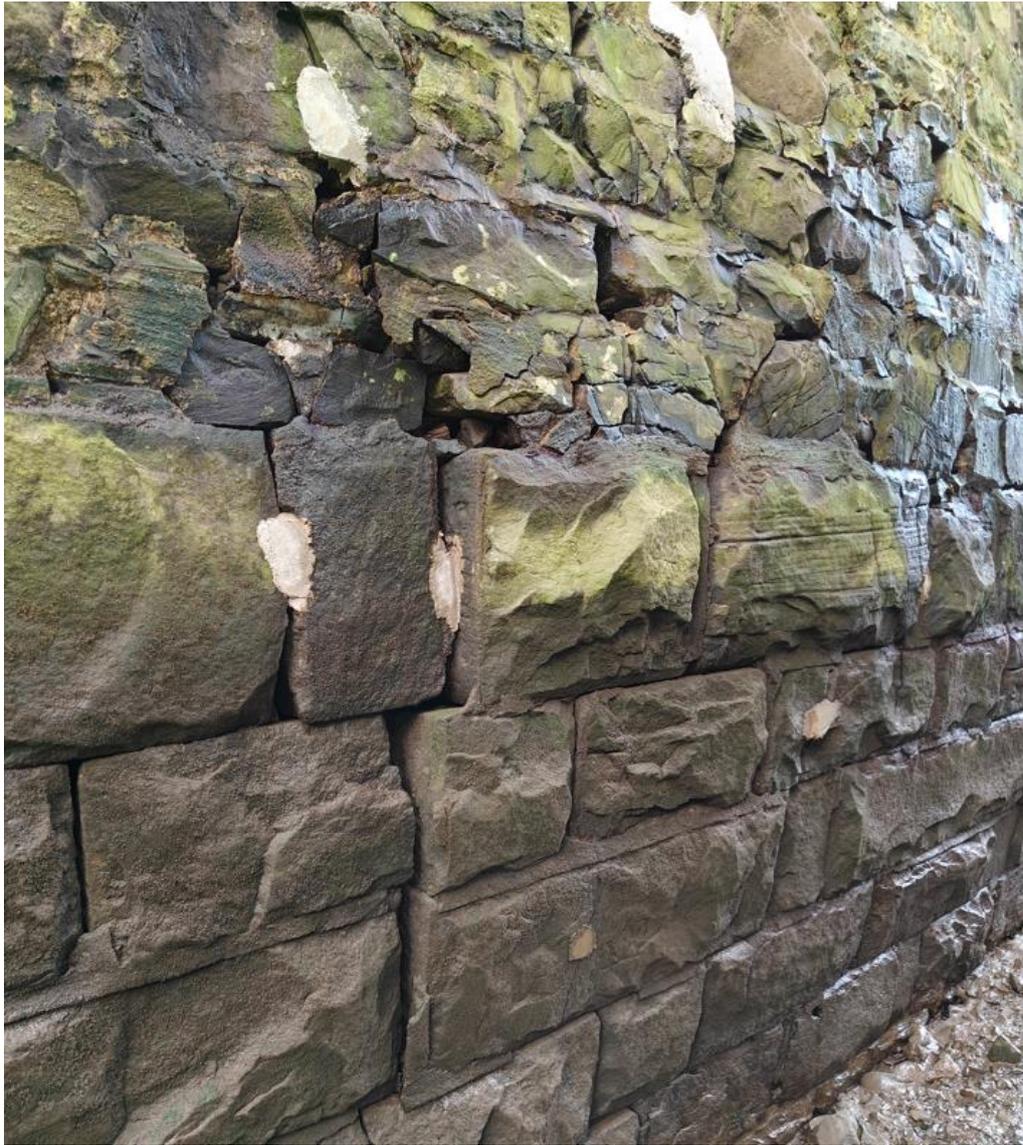
Furthermore, there have been observations of localized isolated bulging exceeding 100mm in certain isolated spots of both the North and South Intermediate Piers. Refer to Figure 15 for detail. This substantiates the proposal to maintain a 70mm gap between pier jacketing wall and the existing intermediate pier. This space will be filled with dry sand or a similar material to prevent a tight bond between stonework of the outer skin of new wall and the existing pier, as recommended by the HES and Planning department during the 'Pre-application' discussions. Refer 'Figure 9' for cross-section showing current proposal.

Figure 15: Photo showing localised bulging and opening of the joints in isolated locations of existing 'Intermediate Pier'
