Queensferry Harbour

Visual Inspection

May 2019

CONTROL SHEET**CLIENT:** City Of Edinburgh Council**PROJECT TITLE:** Queensferry Harbour**REPORT TITLE:** Queensferry Harbour**PROJECT REFERENCE:** 130763**DOCUMENT NUMBER:** 130763/GLA/G/001**STATUS:** DRAFT

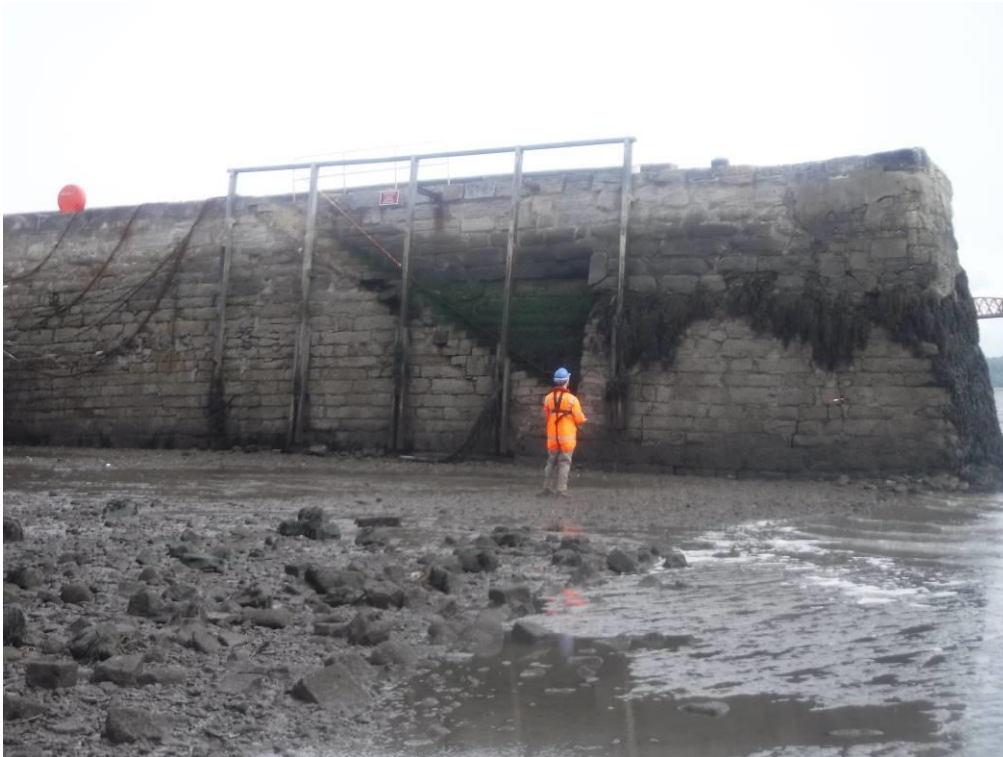
The recessed stone staircase within the eastern half of the north pier interior wall was found to be in poor condition. Loose stone steps, missing mortar, corroded metal handrails and vertical cracking in stonework were all evident within the staircase and in the immediate surrounding. Rubber fenders in this area were also found to be missing.

Photo 1 – View of north pier interior wall at harbour entrance. Note cracks, poor condition staircase, subsidence (in image LHS). Taken looking north.

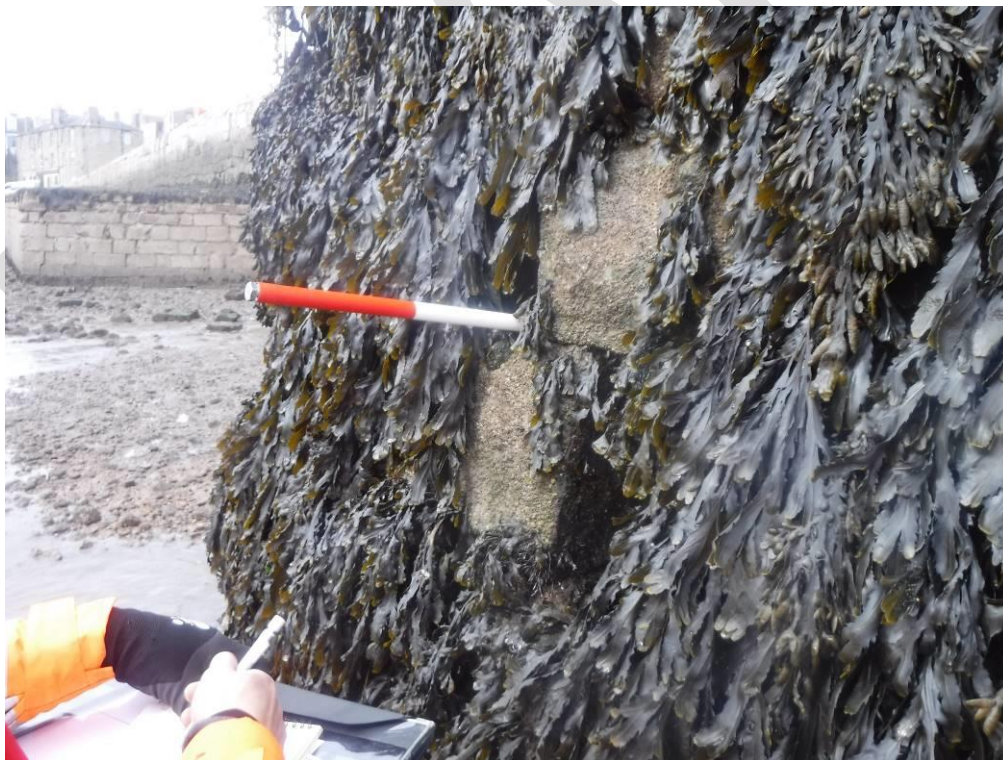
At the eastern end of this pier (nose), a length of wall approximately 20.0m long, extending westwards from the harbour entrance was found to include a significant number of defects within a small area. Full wall height cracking was noted within the inner, nose and external walls. Joints throughout this section of the wall were observed to be dilated beyond what would be expected for the form of wall construction. Several of the joints had dilated sufficiently to probe their depths with a ranging rod. Voids were generally confirmed to be between 600 and 800mm depth from the face of the structure, however several locations were probed to depths of between 1100mm and 1500mm.

Photo 2 – View of typical dilated joints and voids between blocks visible within nose of north pier at harbour entrance. Staff for scale inserted into void up to 1200mm. Total staff length 1600mm. Taken looking approximately south west from nose, approximately 1.2m above ground level.

Based upon the number and type of defects observed within the 20.0 to 25.0m of structure adjacent to the harbour entrance, a significant repair may be required; beyond replacing stones and repointing.

There is currently uncertainty of the mechanism causing the distress features visible. Without identifying and addressing the cause of the defects any repairs carried in this location would be unlikely to provide a long term solution. Intrusive investigations and design work would be required to ensure the continued long term functionality of the harbour entrance.

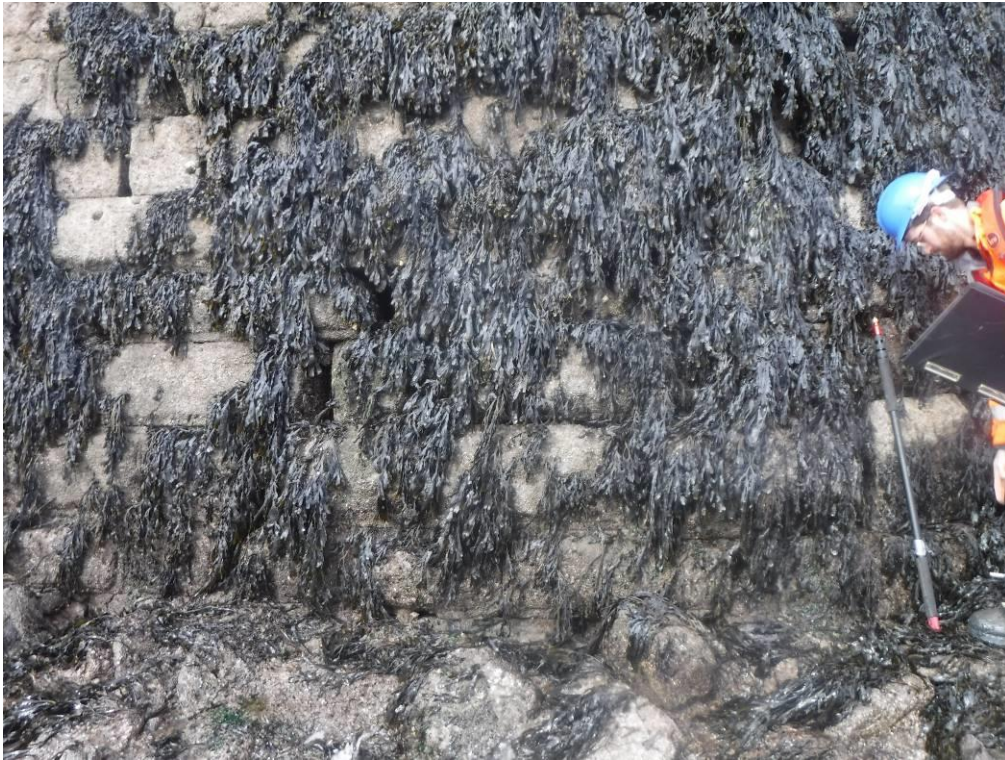
Photo 3 – Displaced blocks, dilated joints and voids within toe of north pier nose wall. Note crack defined block in image right fore, on corner of nose (east) and outer wall. Black staff for scale approximately 1.0m long.

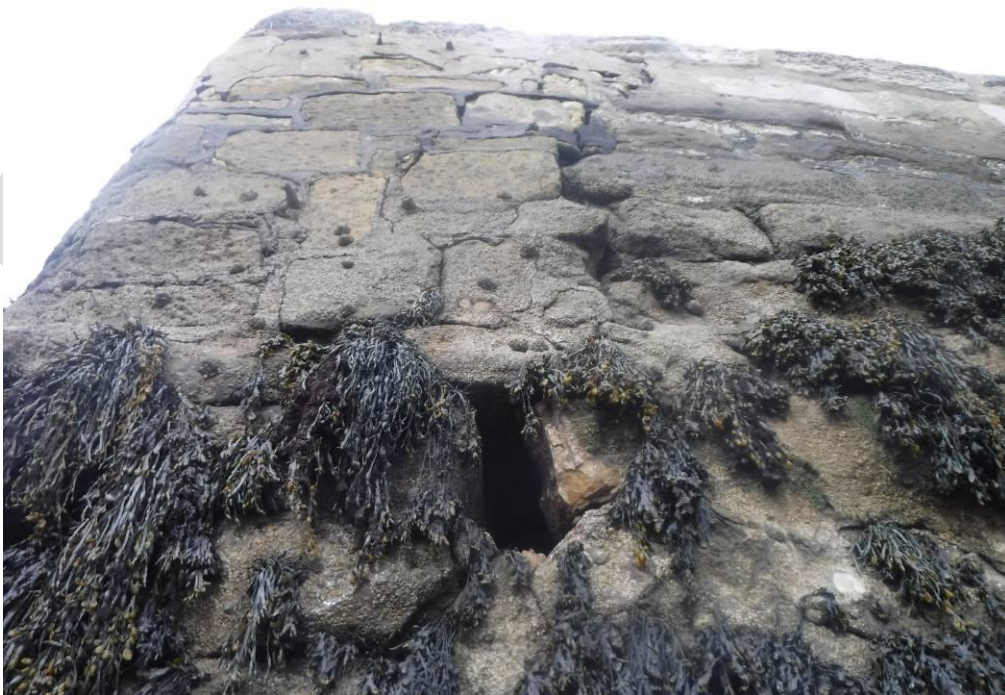
Photo 4 – View of dilated joints/ voids and defective pointing visible in upper part of north pier nose. Taken from toe of wall looking west at corner between nose and inner wall.

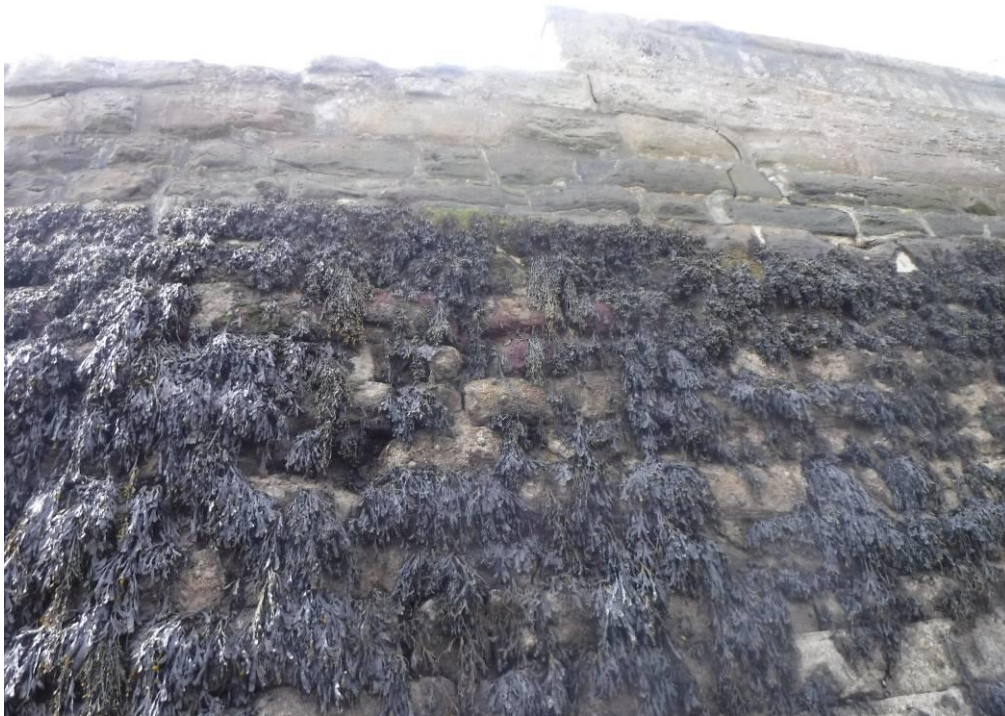
Photo 5 – View of weathered stonework within outer wall of north pier, partially obscured by seaweed. Note crack in right side of image extending from parapet wall, and weathered condition of stonework within tidal (seaweed) area. Located within 20.0m of harbour entrance.

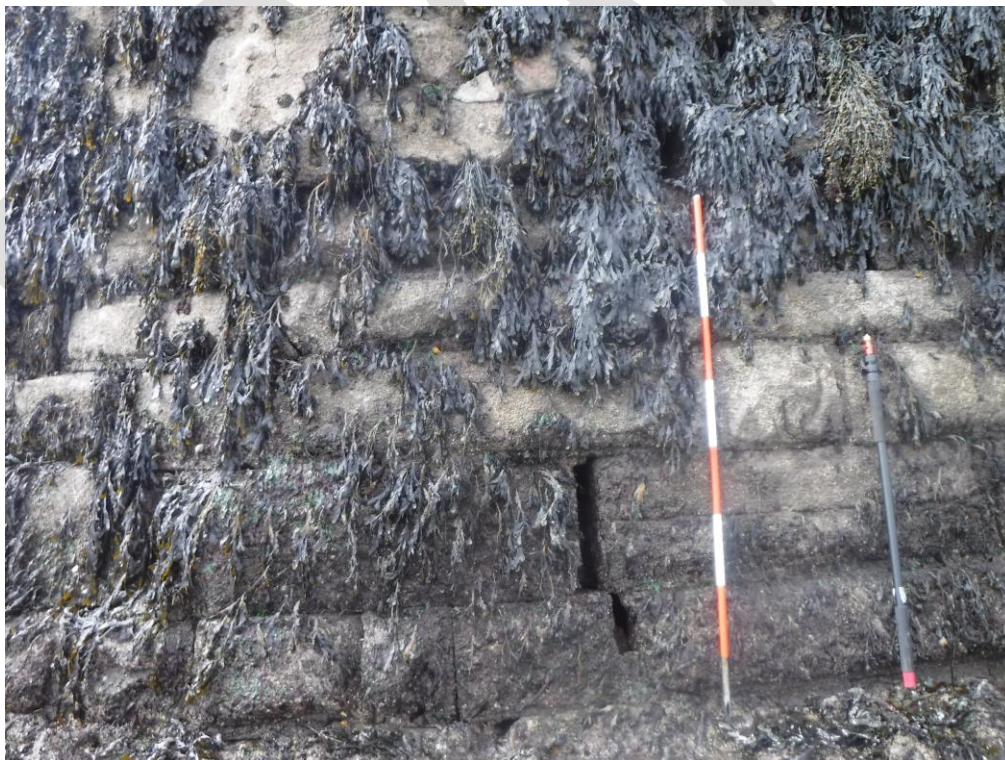
Photo 6 – View of typical voids/ dilated joints in outer wall of north pier, within approximately 20m of harbour entrance. Staff for scale is approximately 1600mm length, with 200mm gradations. Taken looking south from scour protection.

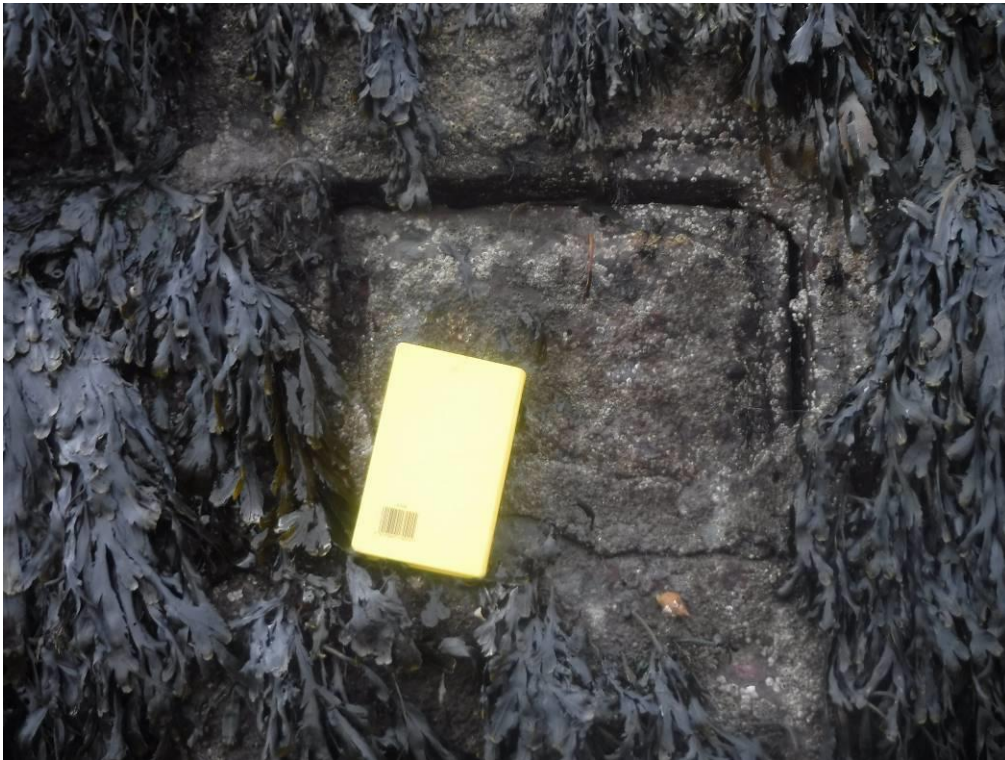
Photo 7 – Missing pointing around stone block, approximately 300 x 300mm. Yellow notebook for scale approximately 190mm long.

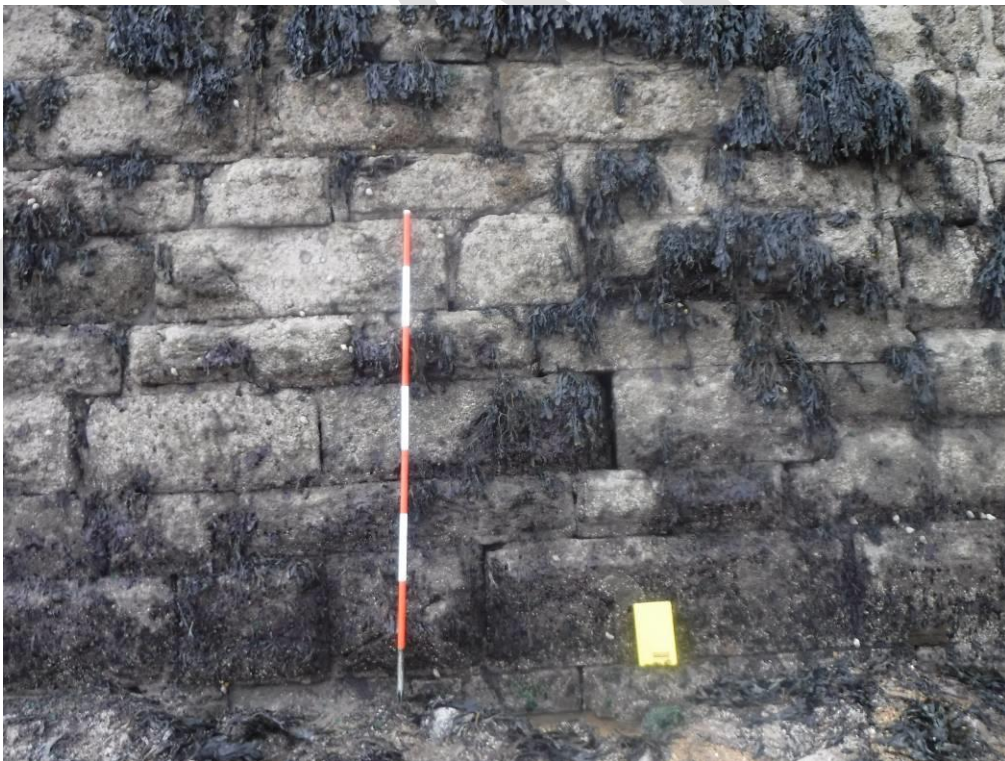
Photo 8 – Defective pointing and dilated joints visible at toe of north wall. Staff for scale approximately 1.6m long.

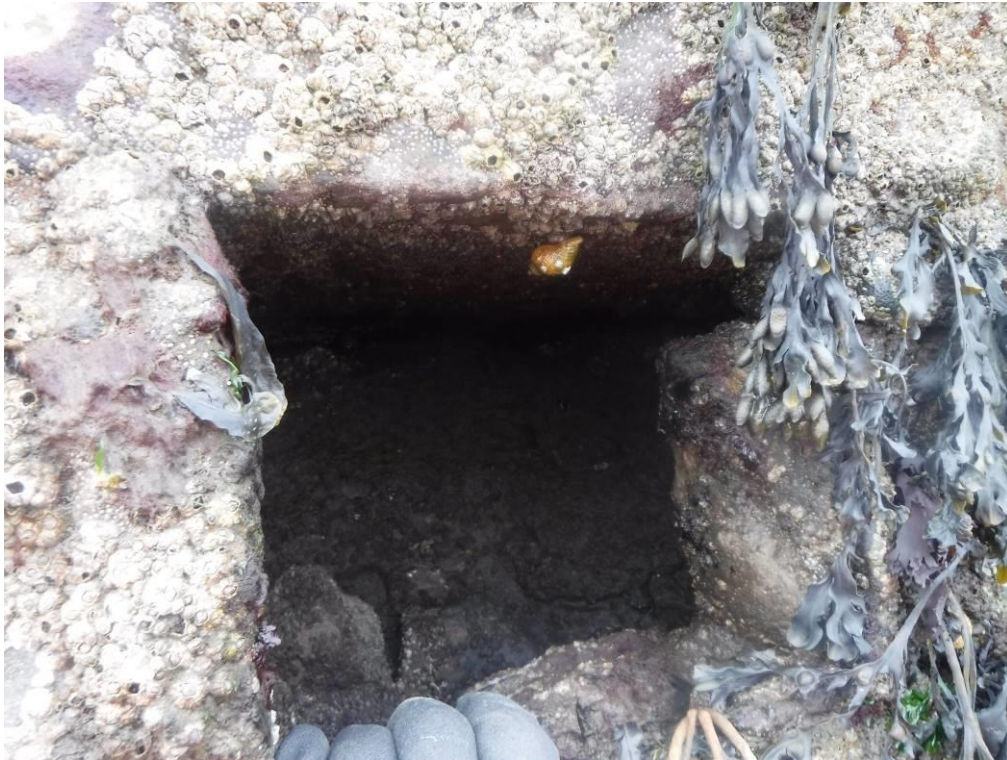
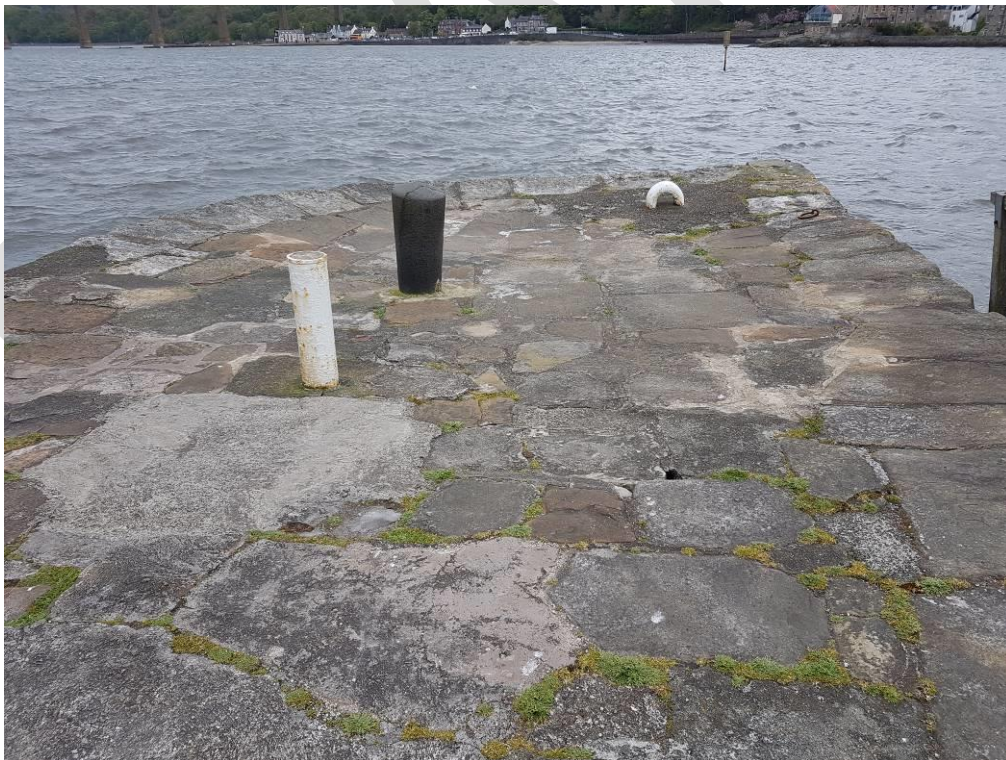
The eastern half of the northern pier deck was found to have been affected by subsidence. The profile of this area was found to have formed a concave surface approximately 8.0m long and 5.0m wide and estimated to be 0.2m lower than the wider deck level. Several voids were found in the dilated joints between exposed stonework and probed to depths of between 200 to 500mm depth. Joints/ cracks between stone blocks in the dished area varied between 10mm to 50mm width. Embedded timber was identified within this area deck, flush with the deck level.

Photo 9 – View looking of subsidence area in deck of north pier, taken looking east along pier. Subsidence area measures approximately 8.0m x 5.0m. Note bollards out of vertical.

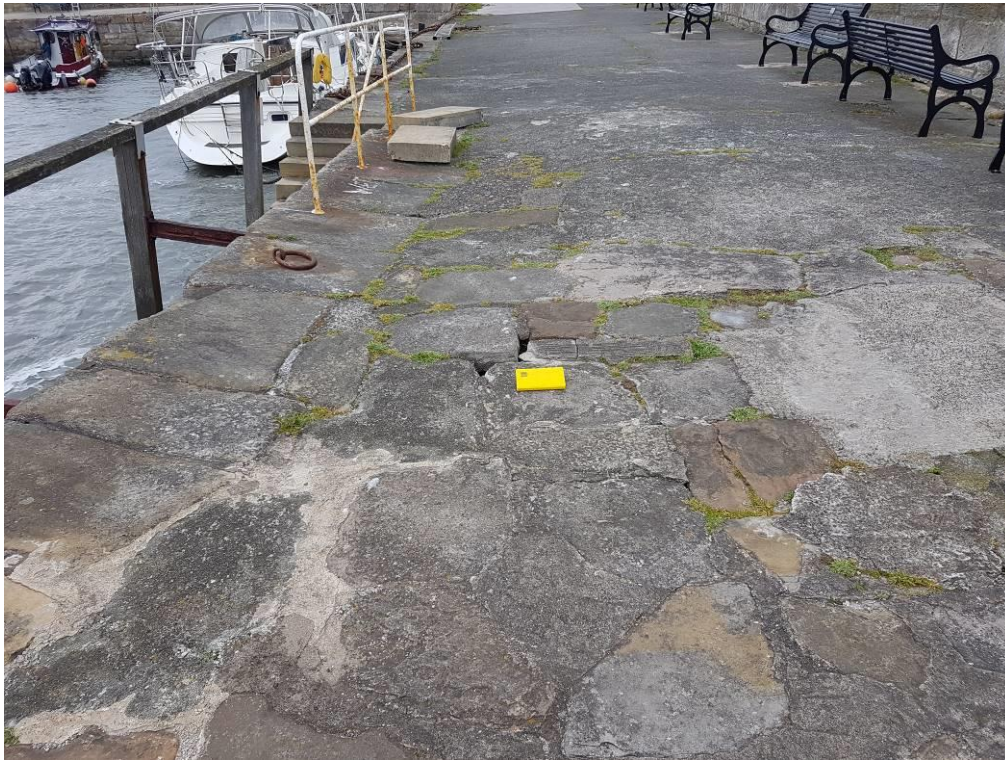
Photo 10 – View of void in mortar between stones blocks in deck of pier behind damaged staircase (north pier) taken looking west. Yellow notebook for scale approximately 200mm long. Void probed to approximately XXm.

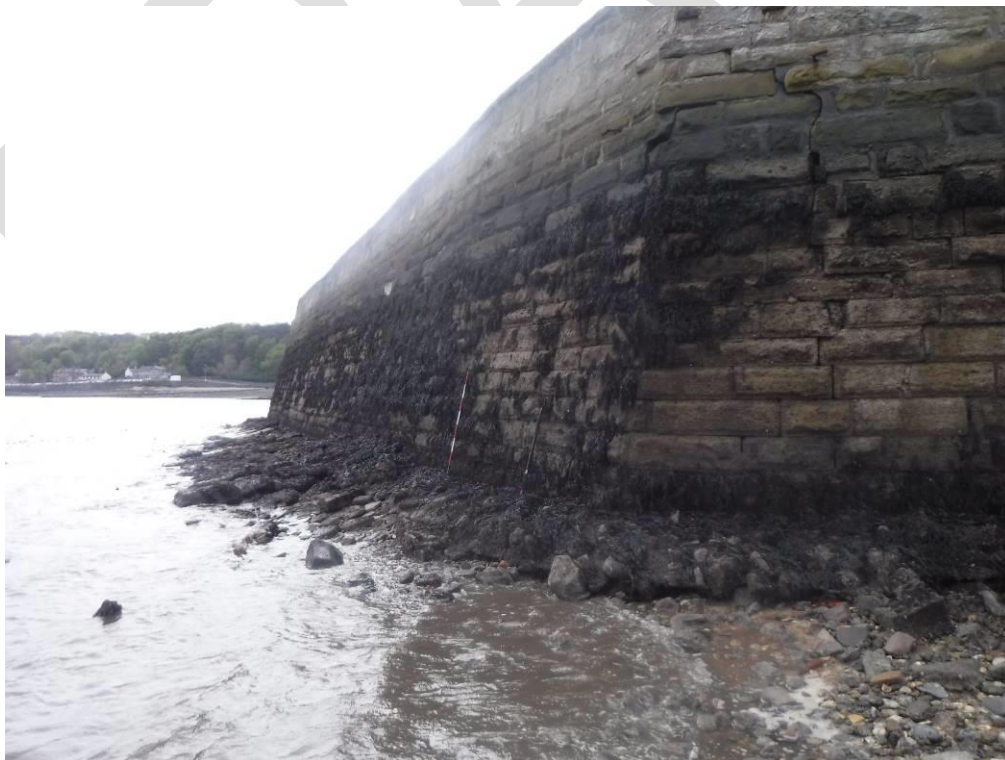
Diagonal and vertical cracking extending the full height of the outer pier wall was observed at the western end of the structure; where the north and west piers meet. Cracking was observed to delineating a mass of stonework covering an area of approximately 6.0 to 8.0m². The depth of the crack delineated block is not known, however cracks were probed up to 1100mm depth. Cracking visible in the outer wall at this location was also evident in the overlying parapet wall. Scouring up to 200mm depth was visible underneath the concrete scour protection in front of this section of wall, however it was not possible to verify if scour extended across the wider wall extents.

Photo 11 – Profile view along outer face of north pier, taken from western end looking east. Note scour visible beneath toe of scour protection. Cracking visible in wall probed to approximately 1100mm depth. Survey staff for scale approximately 1.6m long.

Existing scour protection and water at the toe of the outer wall obscured the condition of the pier along this structure, however evident of scouring was noted at the western end and the presence of scour elsewhere along the pier cannot be discounted. Improvement of the scour protection may be required.

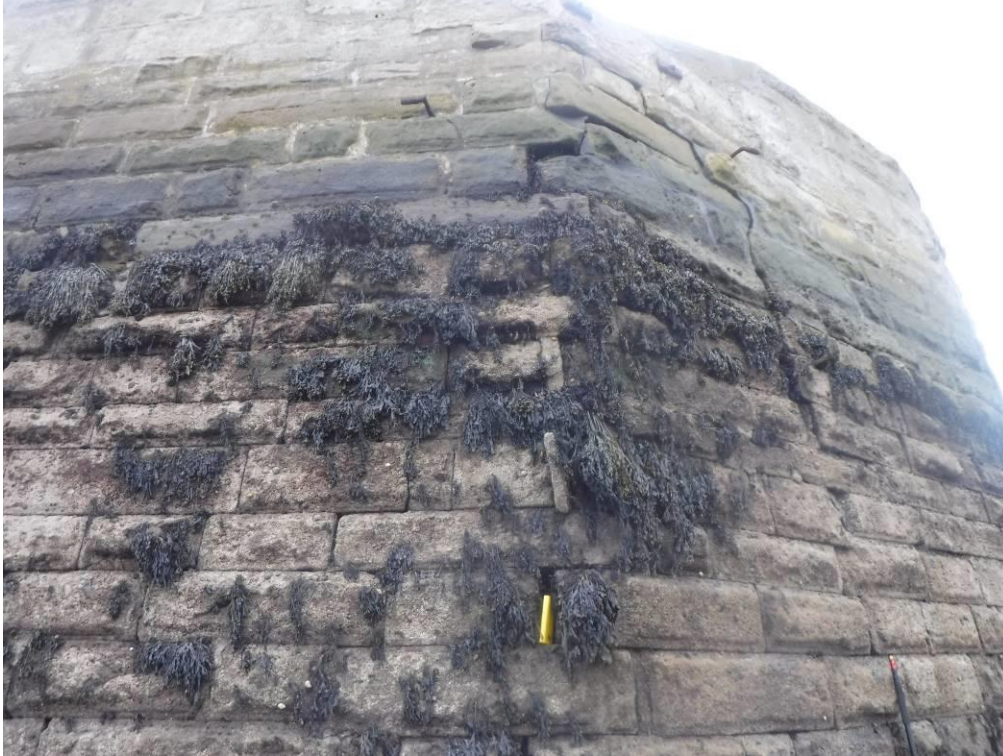
Photo 12 – Alternative view of crack in north wall shown in Photo 11, taken looking south at wall. Yellow notebook inserted into crack for scale approximately 190mm long.

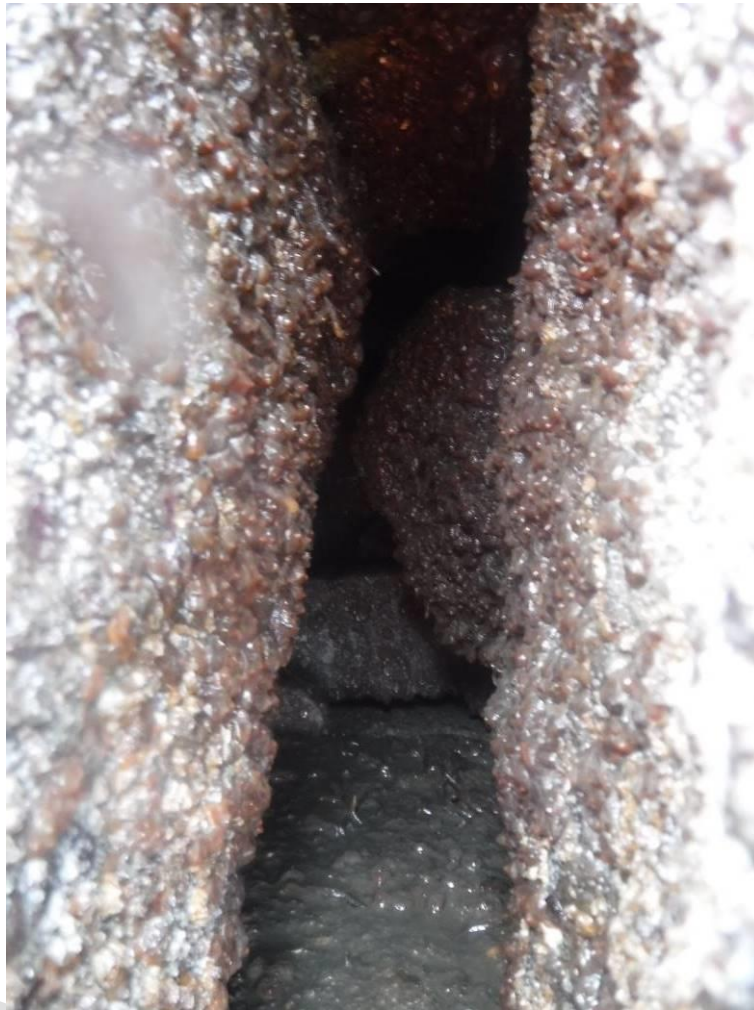
Photo 13 – Close up of crack in western end of north pier outer wall. Note rounded cobble sized material visible behind dressed facing stone.

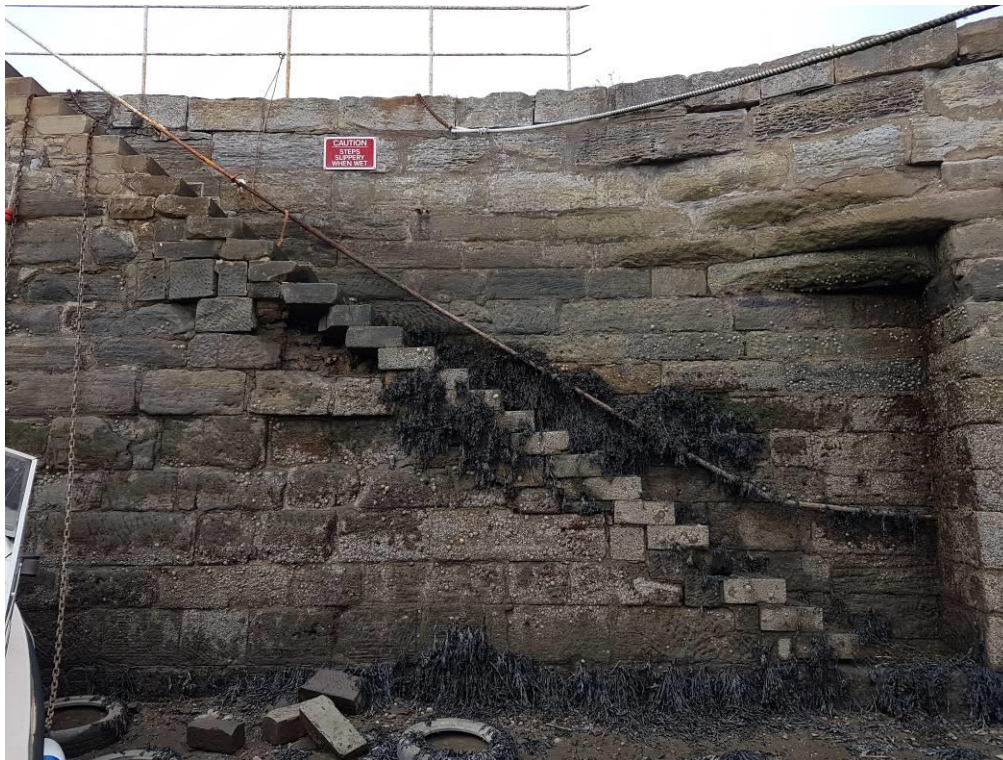
The staircase opposite the harbour entrance (Staircase 1) has a number of missing blocks from the wall underlying the steps, and washed out mortar. The remaining staircases were considered to generally be in good condition, with missing pointing visible from joints between blocks. The second staircase in the west pier (middle) was noted to include a cracked stone in the corner above head height.

Photo 14 – View of staircase 1 (north) within inner wall of west pier. Note displaced/ missing stonework, missing mortar and poor condition rail. Displaced stonework visible on floor of harbour below staircase.

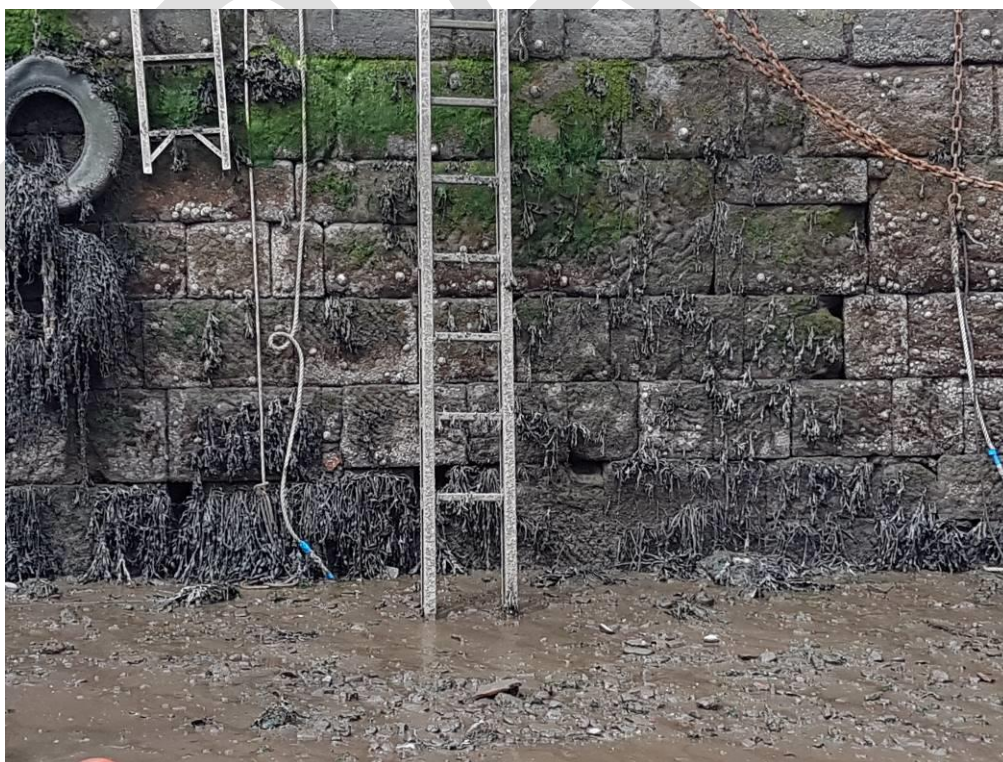
Photo 15 – View of typical stone work within inner wall of west pier, note missing mortar and minor voids between blocks.

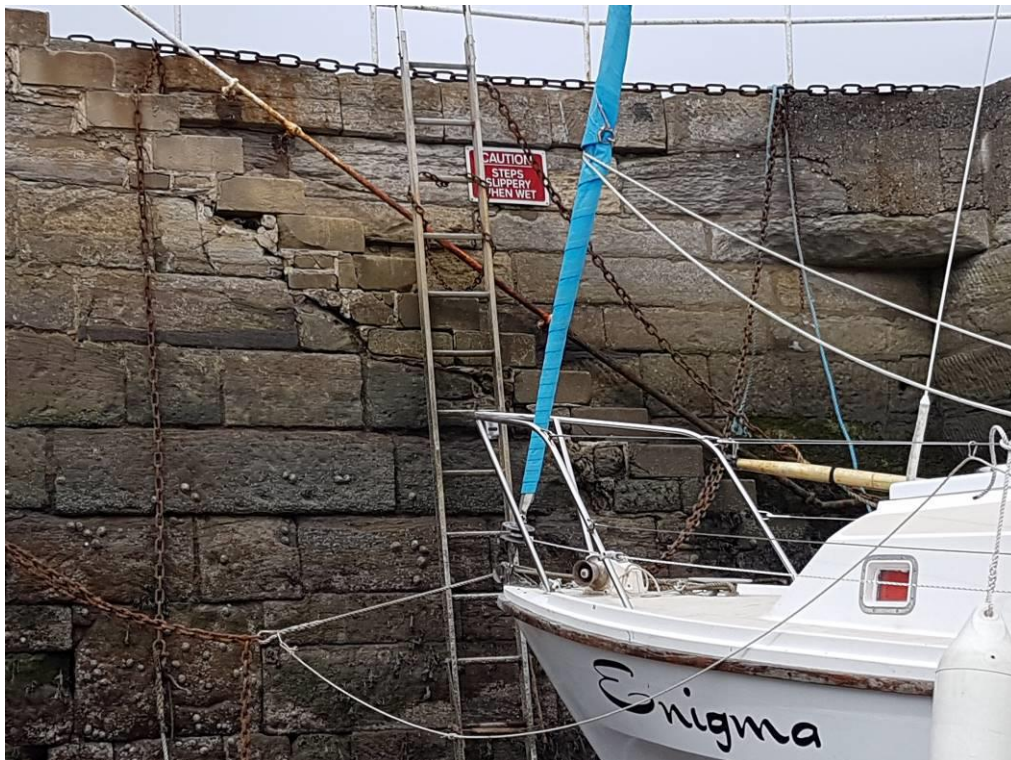
Photo 16 – Staircase 2 (middle) within west pier. Cracked lintel visible at head height. Note corroded hand rail, defective pointing and dilated/ displaced joints below cope stones.

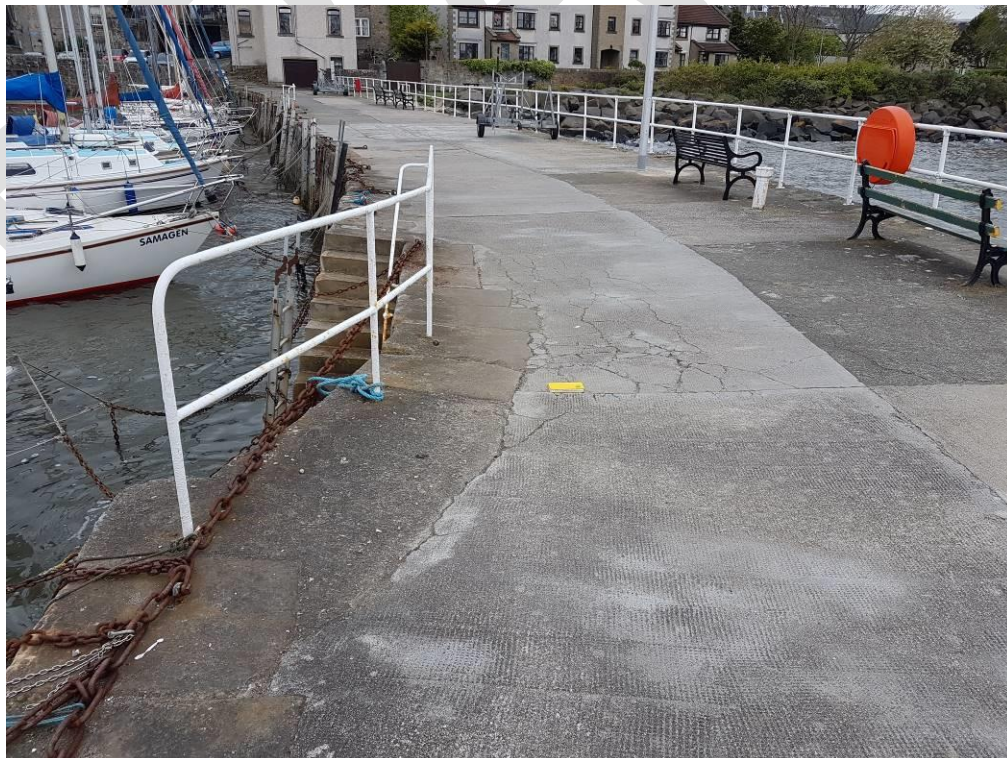
Photo 17 – Cracking and distress in concrete deck surfacing above Staircase 1, behind cope stones.

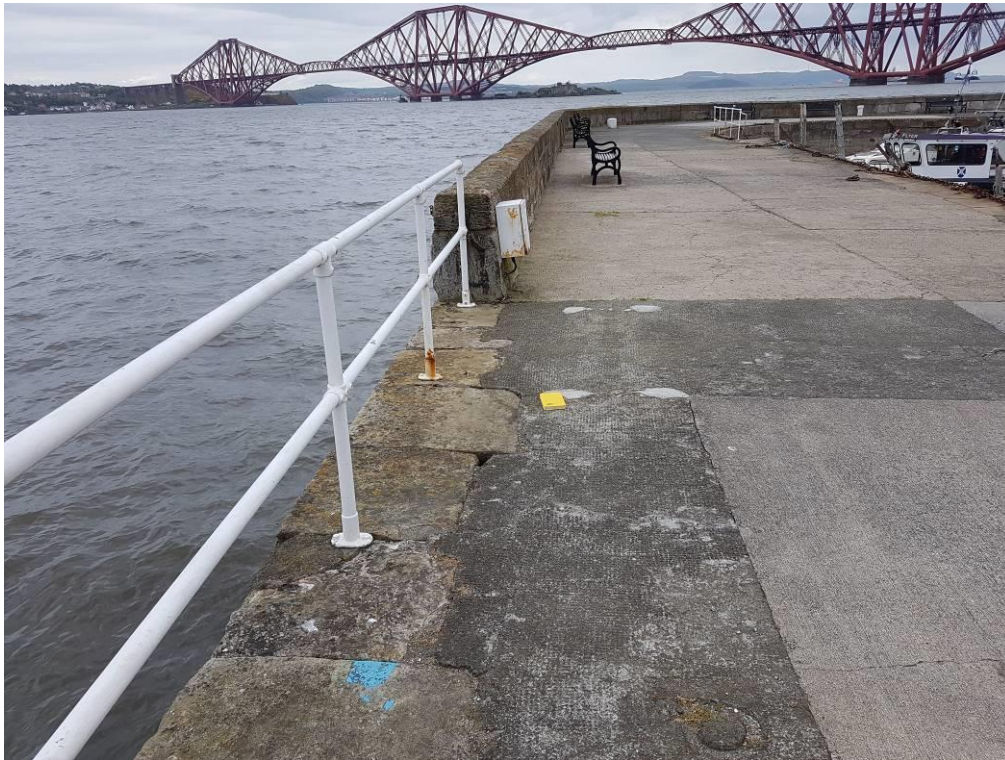
Photo 18 – Missing pointing around cope stone on outer wall of west pier, visible in surface to left of yellow notebook. Taken looking north along outside wall.

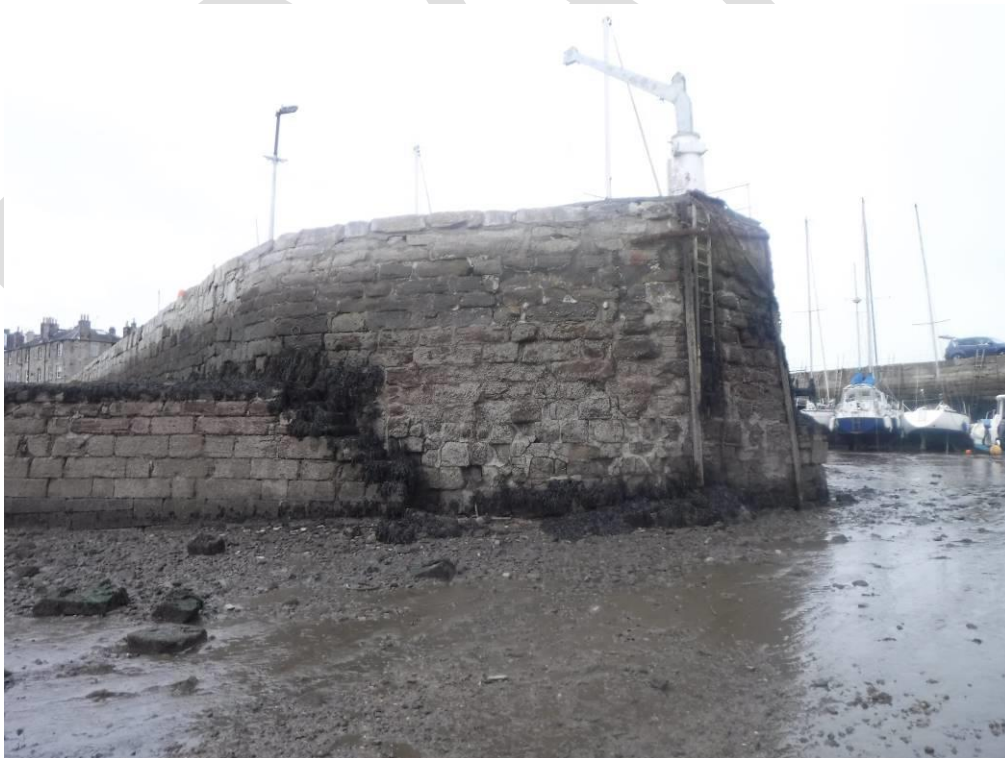
The cause of the defects is not currently known, however slipped stonework visible at the toe of the east pier, combined with the cracking and dilated joints in the stonework suggest that there has been outward movement of the walls.

Photo 19 – Nose of eastern pier, taken looking south from harbour entrance. Note dilated joints/ full height cracking and possible bedrock exposed at base of structure. Metal davit on top of pier wall.

We would recommend removing the metal davit present at the north end of the pier to reduce the loading on the pier in this area.

As with the section of north pier at the harbour entrance, an intrusive investigation is recommended to ascertain the condition of the structure and cause of the defects noted during this inspection. The appropriateness of grouting, reconstruction or strapping we be confirmed.

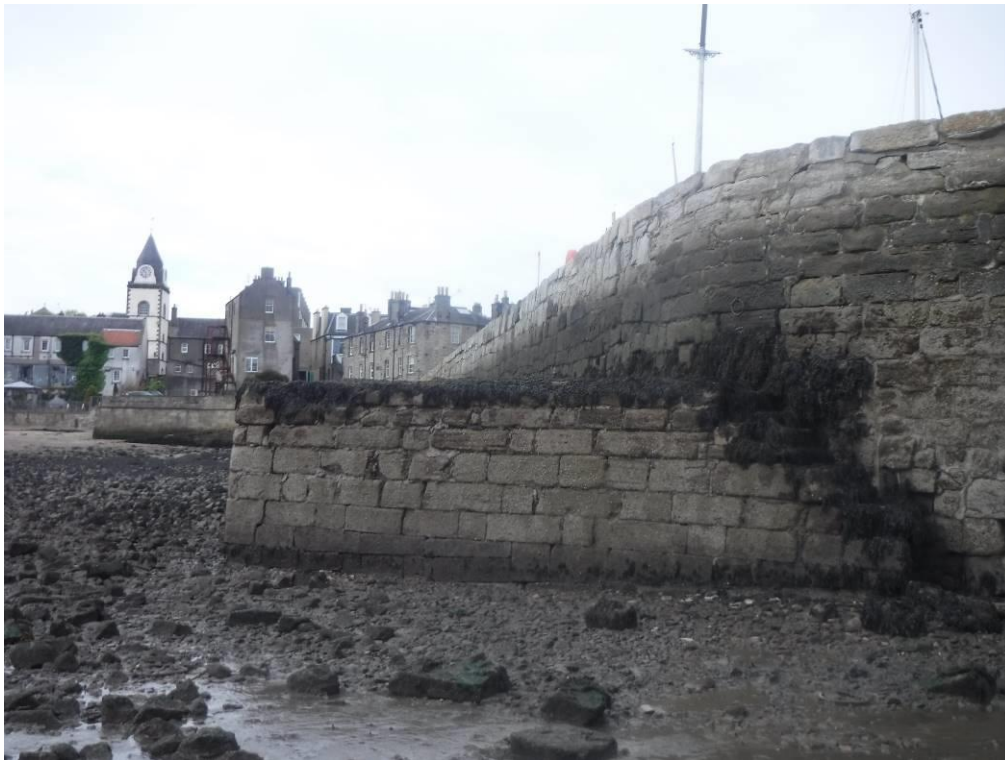
Dilated joints and cracking was evident in the corner transition between the slipways north and east facing walls, defining a stonework wedge approximately 6.0 to 8.0m² in area. Dilated/ open joints within the eastern wall were most prevalent within the uppermost 1.5m of the wall.

Photo 20 – View looking south at nose wall of east pier slipway. Note dilation in joints and cracking forming a wedge shaped block on corner with east facing wall of slip.

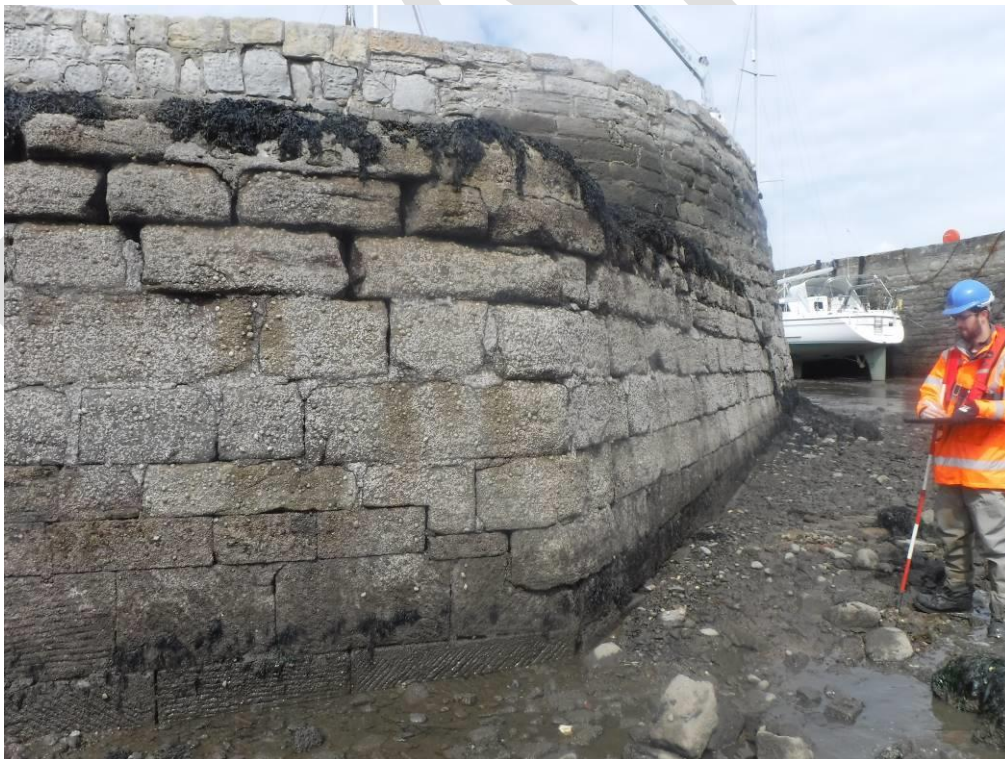
Photo 21 – View looking approximately west along corner between east and nose wall of east slipway. Note defective pointing, dilated joints and cracking over full height of wall. Displacement in blockwork to right of crack visible at toe of wall corner, opposite Engineer.

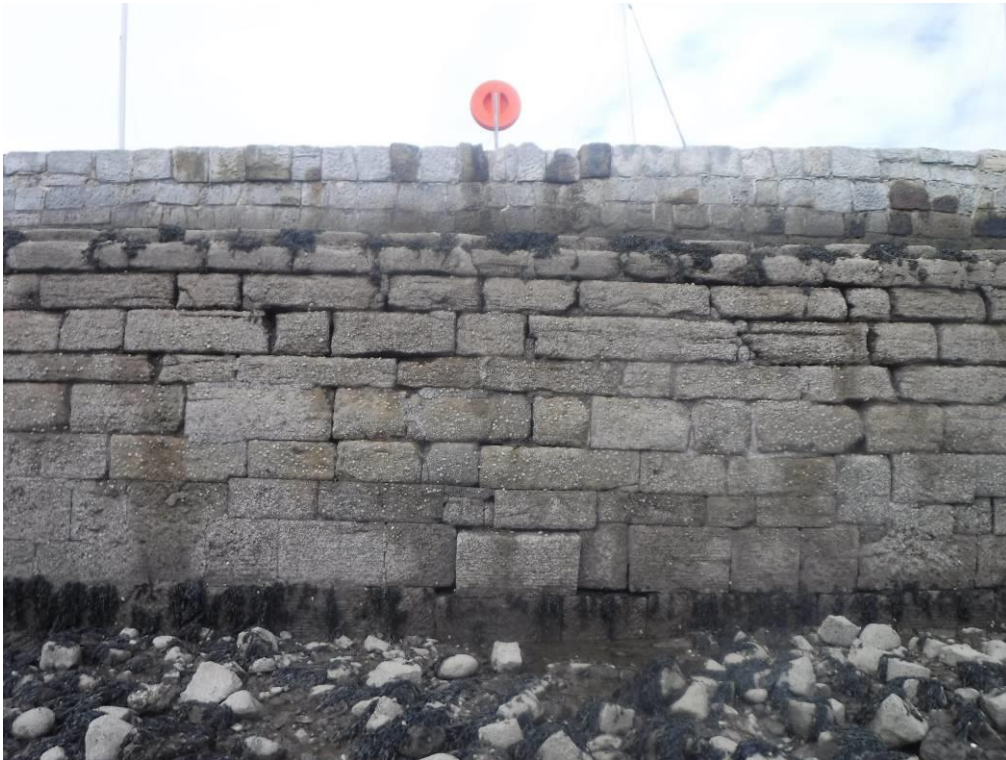
Photo 22 – Protruding block visible at toe of slipway wall in image centre front.. Note missing pointing and dilated joints in upper part of wall below cope stones, typical of slipway wall.

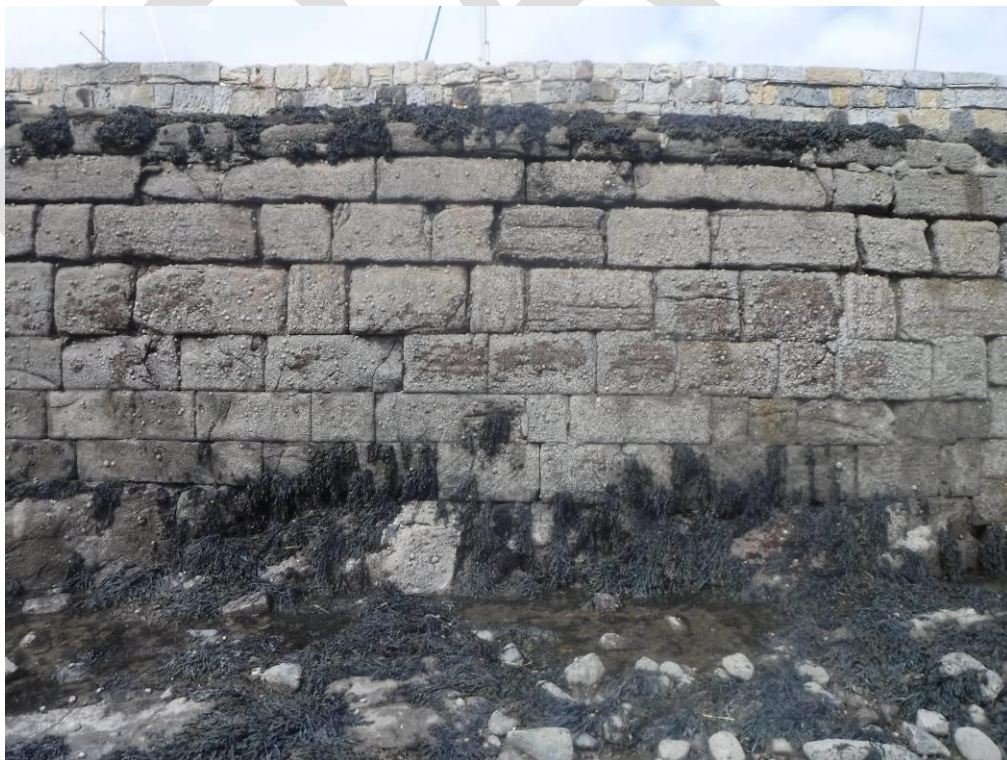
Photo 23 – Water seepage observed from wall interface with possible bedrock at toe of structure. Note dilated joints visible in upper wall stonework.

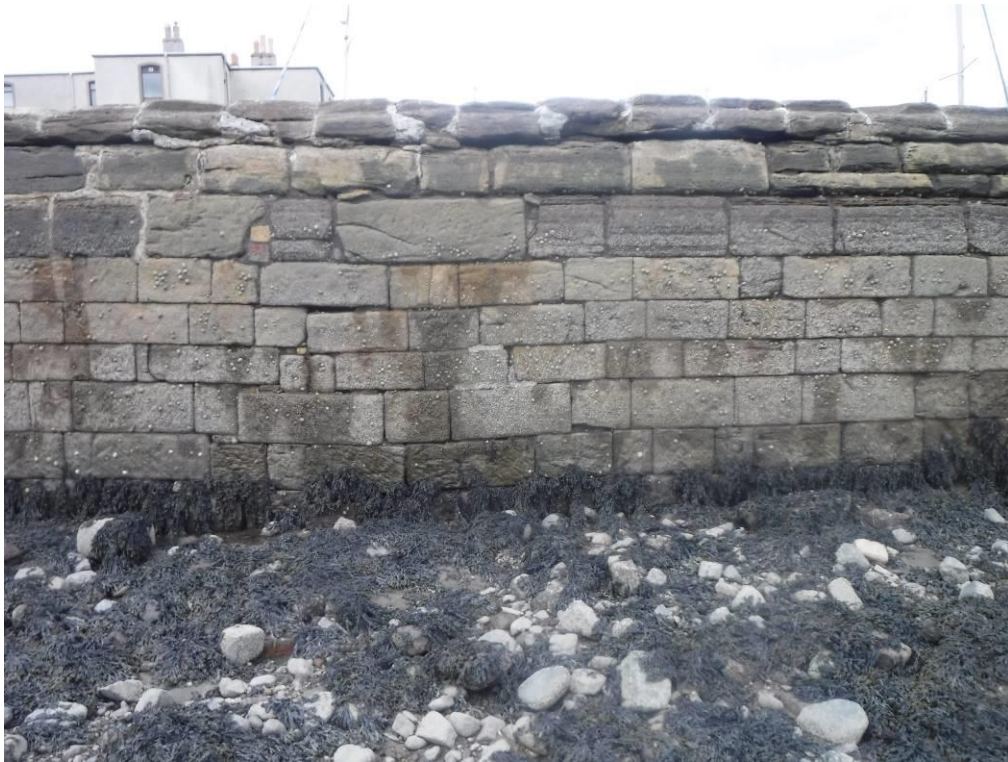
Photo 24 – Distressed/ misaligned stonework east slipway wall. Taken looking east, note dilated joints around upper courses.

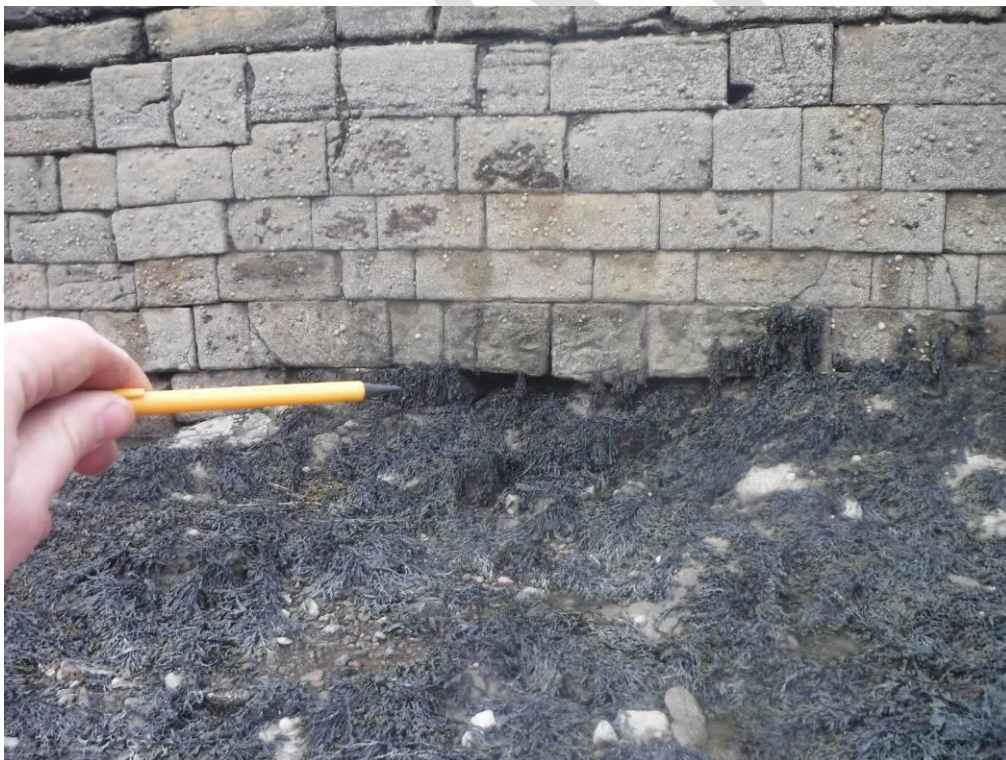
Photo 25 – Missing stone/ void at base of east slipway.

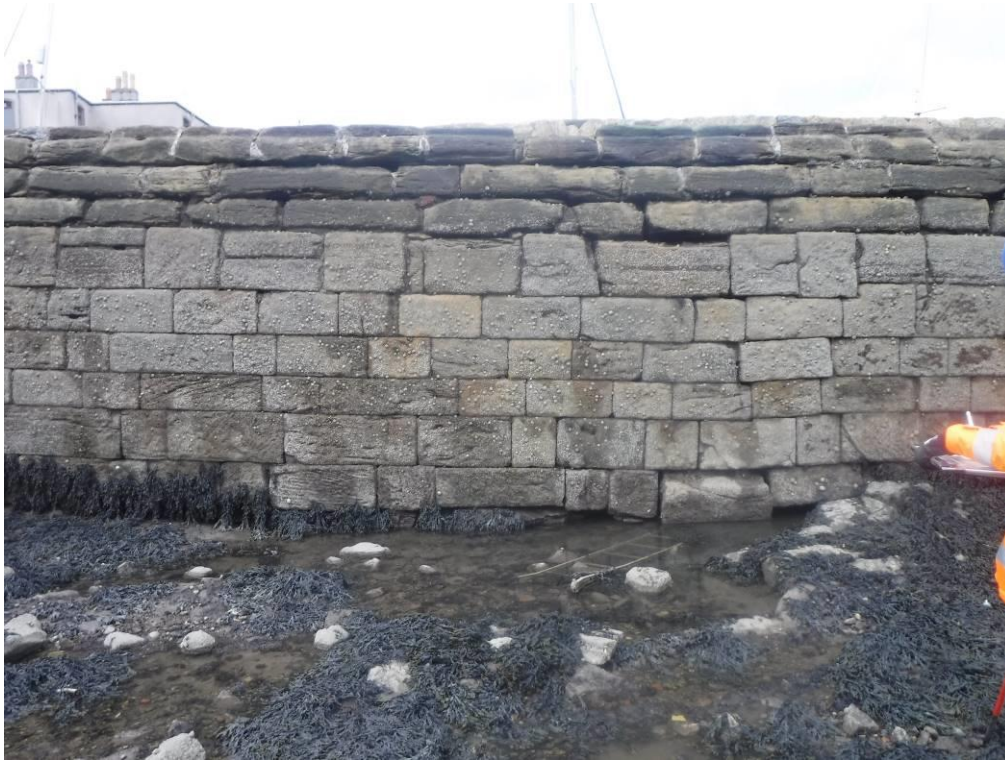
Photo 26 – Void and displaced stonework visible in water filled hollow at toe of slip wall. Note dilated joints and missing pointing in upper wall.
