Queensferry Harbour

Visual Inspection

May 2019

CONTROL SHEET**CLIENT:** City Of Edinburgh Council**PROJECT TITLE:** Queensferry Harbour**REPORT TITLE:** Queensferry Harbour**PROJECT REFERENCE:** 130763**DOCUMENT NUMBER:** 130763/GLA/G/001**STATUS:** DRAFT

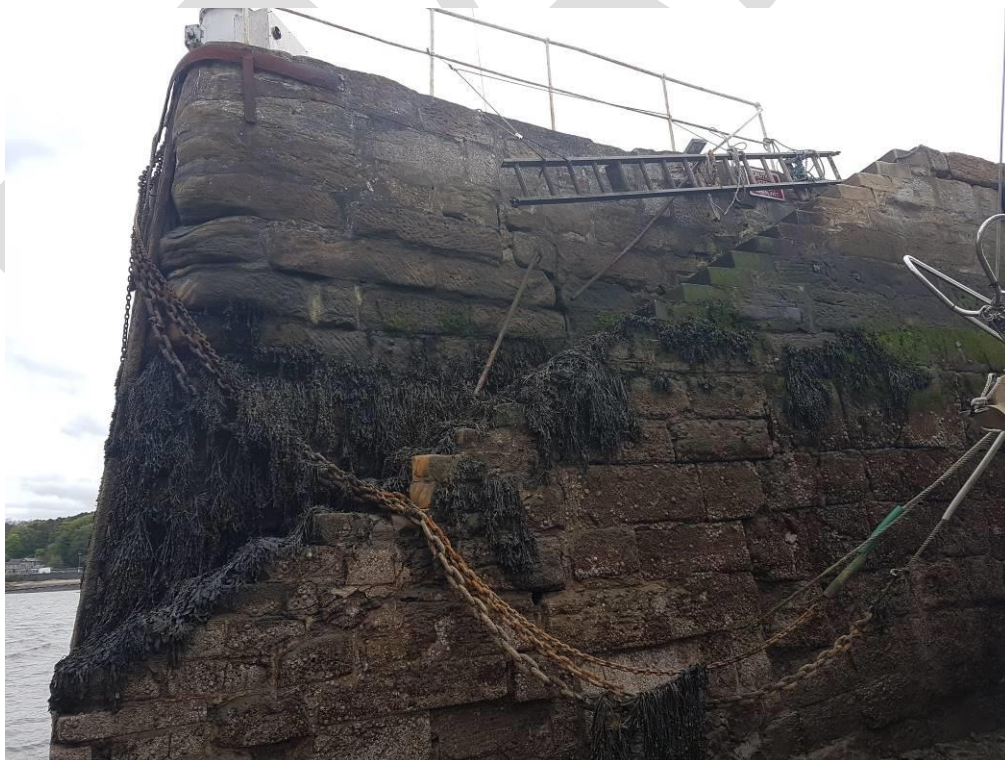
Photo 27 – View looking east of upper east pier interior wall. Poor condition staircase, distressed stonework, dilated joints visible. Corroded strapping visible on corner of wall in upper image left.

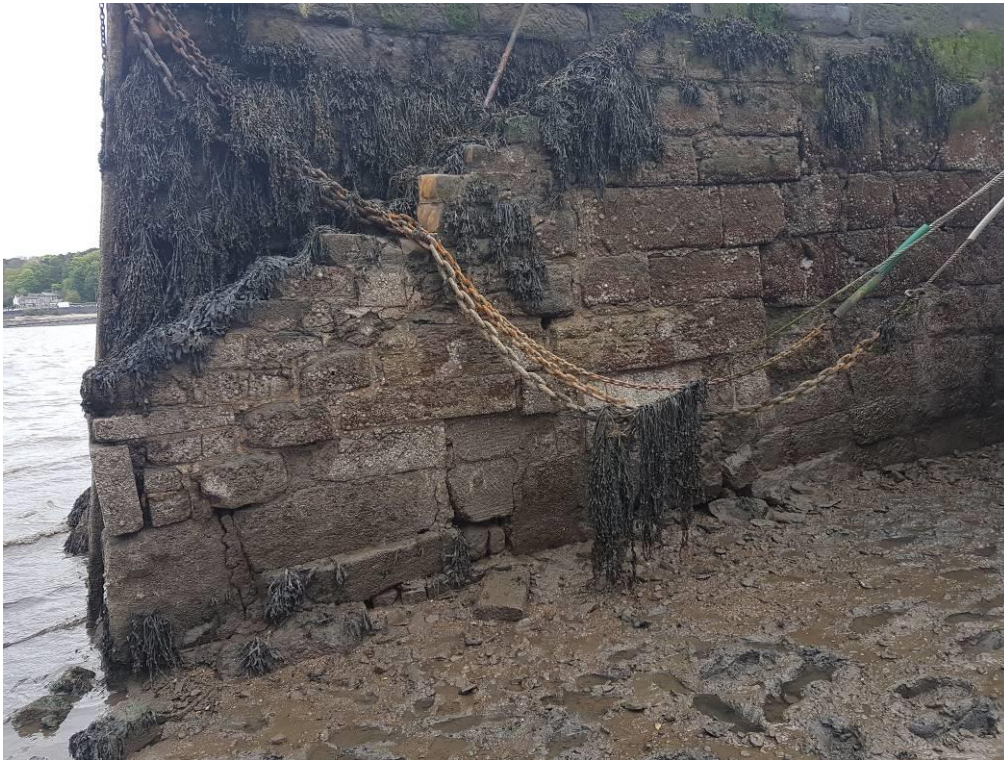
Photo 28 – Lower interior wall of east pier at harbour entrance. Note missing mortar, dilated joints and voids visible around blocks, displaced blocks also evident. Voids probed up to 1100mm depth.

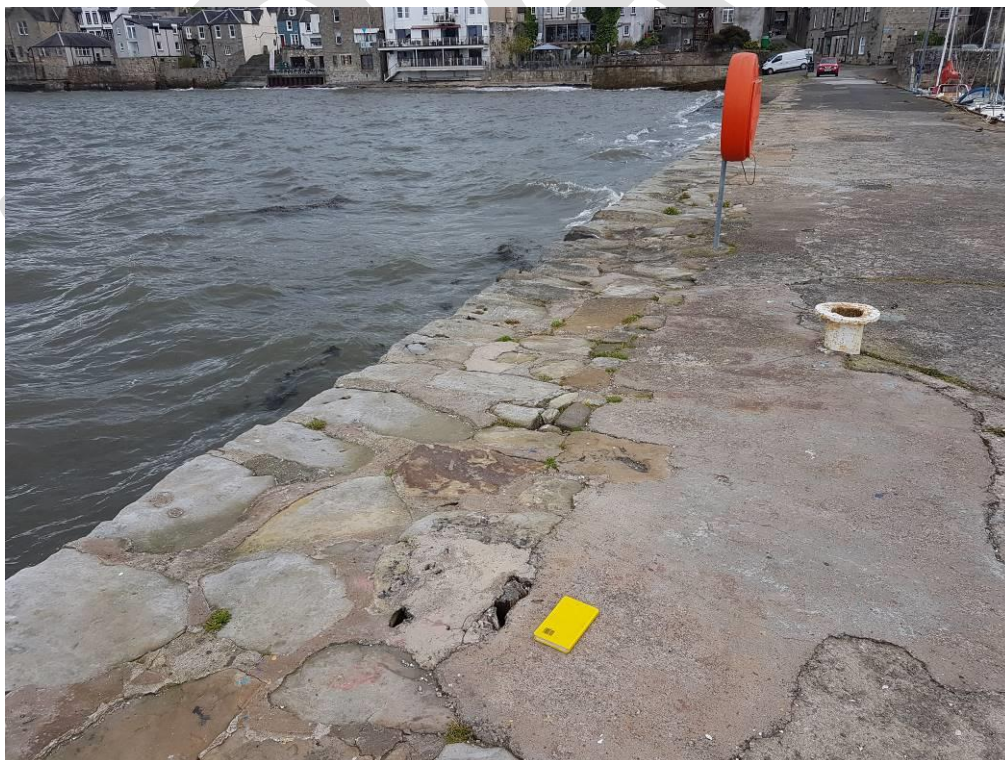
Photo 29 – View of east pier deck, approximately 10.0m south of harbour entrance. Void visible adjacent to yellow notebook (200mm length), probed to depth of XXXmm.

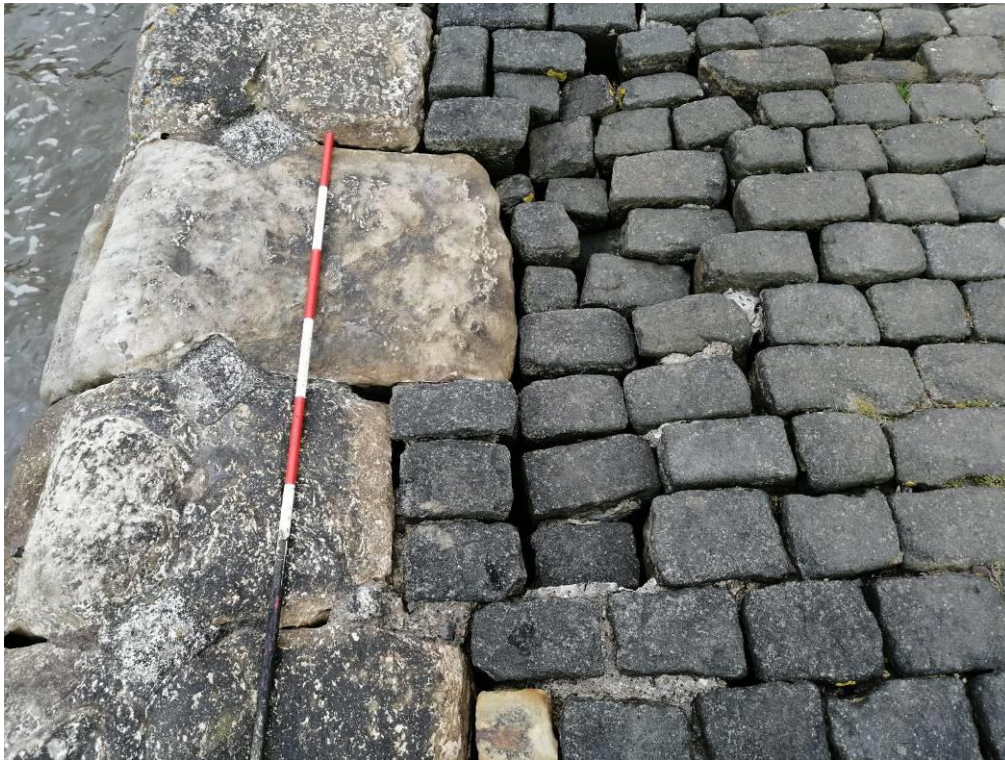
Photo 30 - Example of poor condition sets typical behind cope stones along eastern slipway (image top is south aligned). Red and white increments on staff at 200mm intervals.

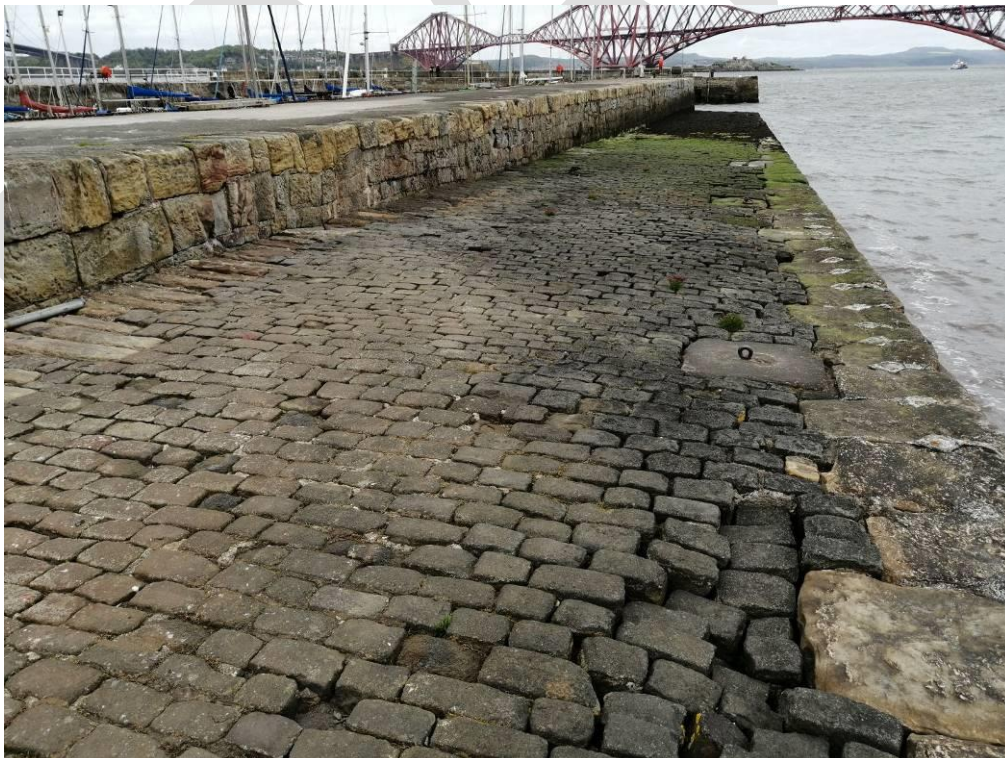
Photo 31 – View looking north along slipway, note undulating deck surface with displaced sets visible behind cope stones.

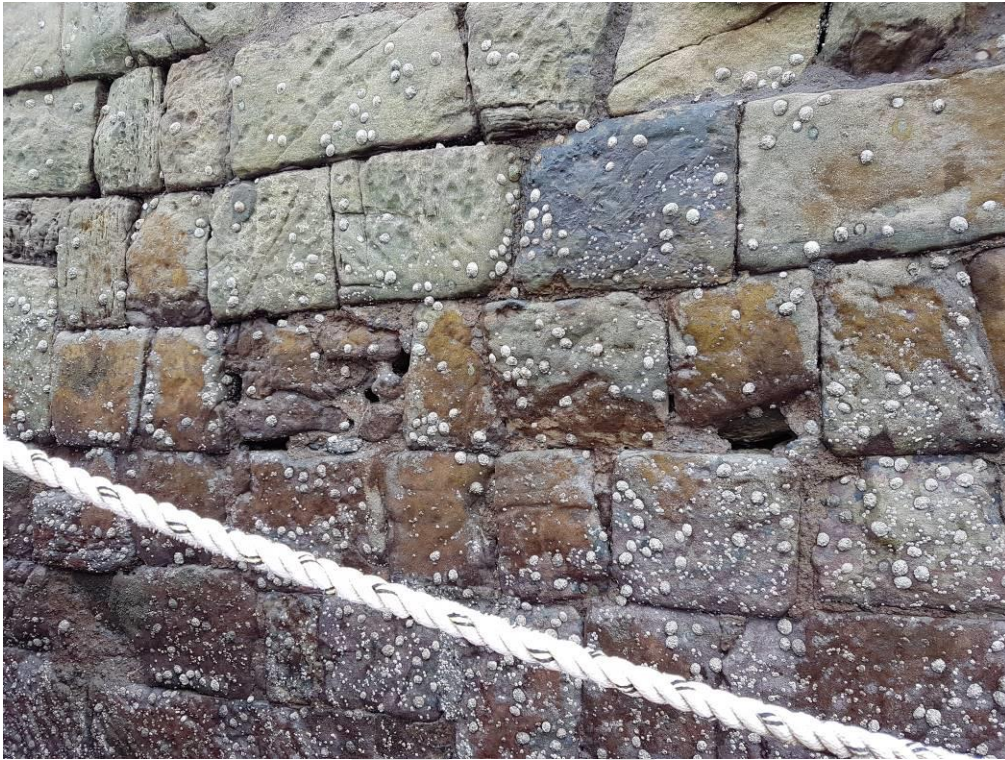
Photo 32 –Example of missing pointing and washed out historical repairs (voids) within interior wall of eastern pier.

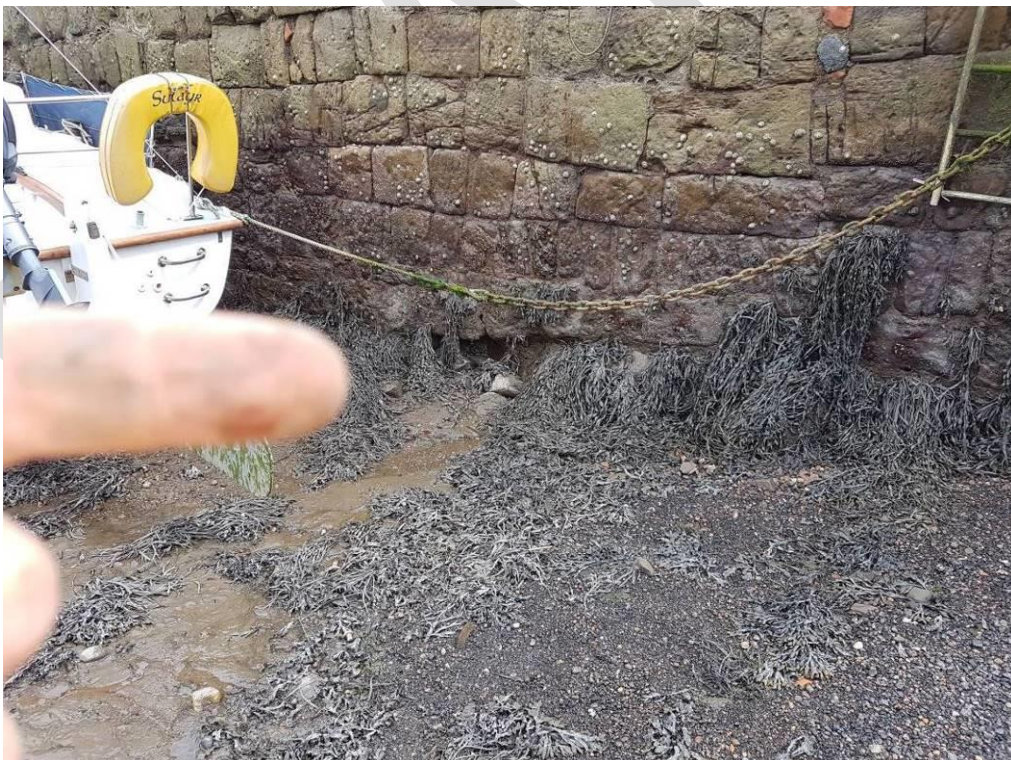
Photo 33 – Missing stone visible from toe of wall (right of finger), water seepage from void.

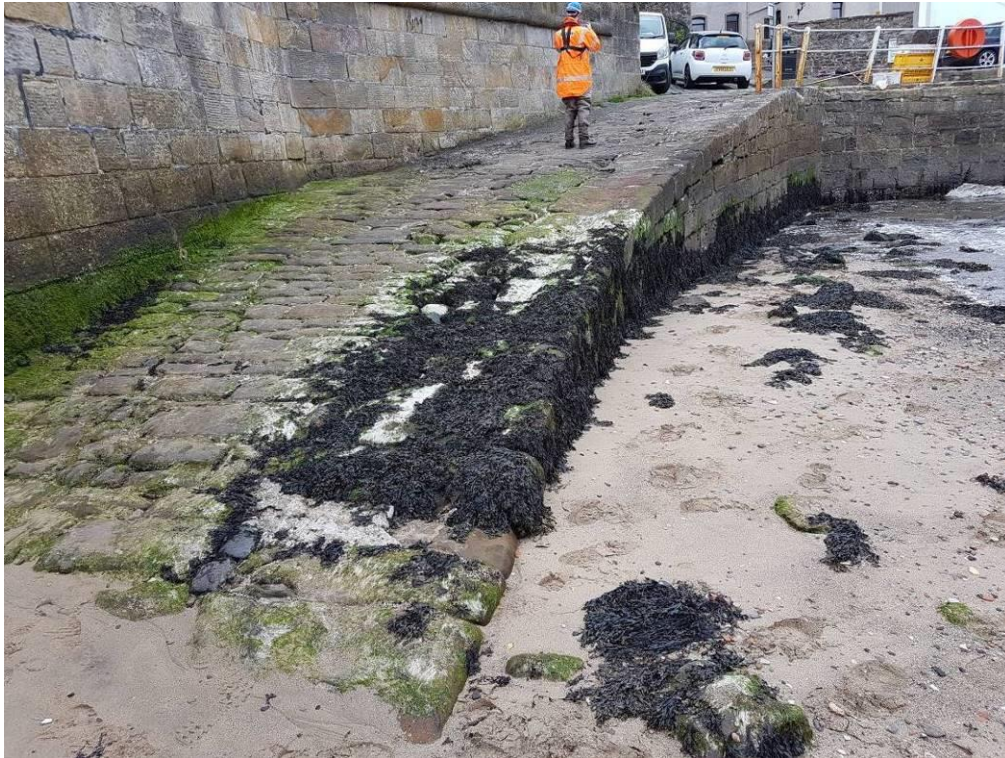
Voids were found to extend up to approximately 800mm measured back from the face of the wall and up to 200mm from the deck of the ramp. Displaced stone work and a semi-circular subsidence crack were visible in the deck, within approximately 2.0m of the cope stones. There appeared to be good connectivity between the wall defects and those visible within the wall of the ramp with potential for the further deterioration of the ramp as water flows through the defects.

Photo 34 – View west of access ramp to eastern foreshore. Note distressed deck and semi-circular subsidence

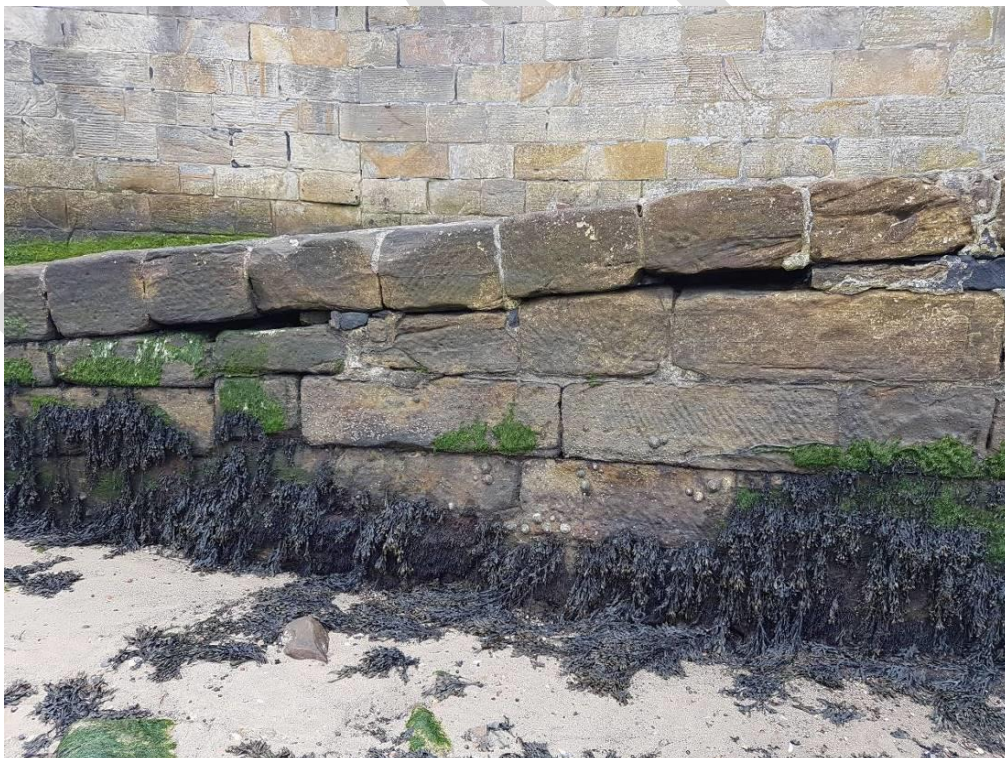
Photo 35 – View south of voids around cope stones in access ramp wall. Probed up to 800mm deep, congruent with area shown in Photo 34.

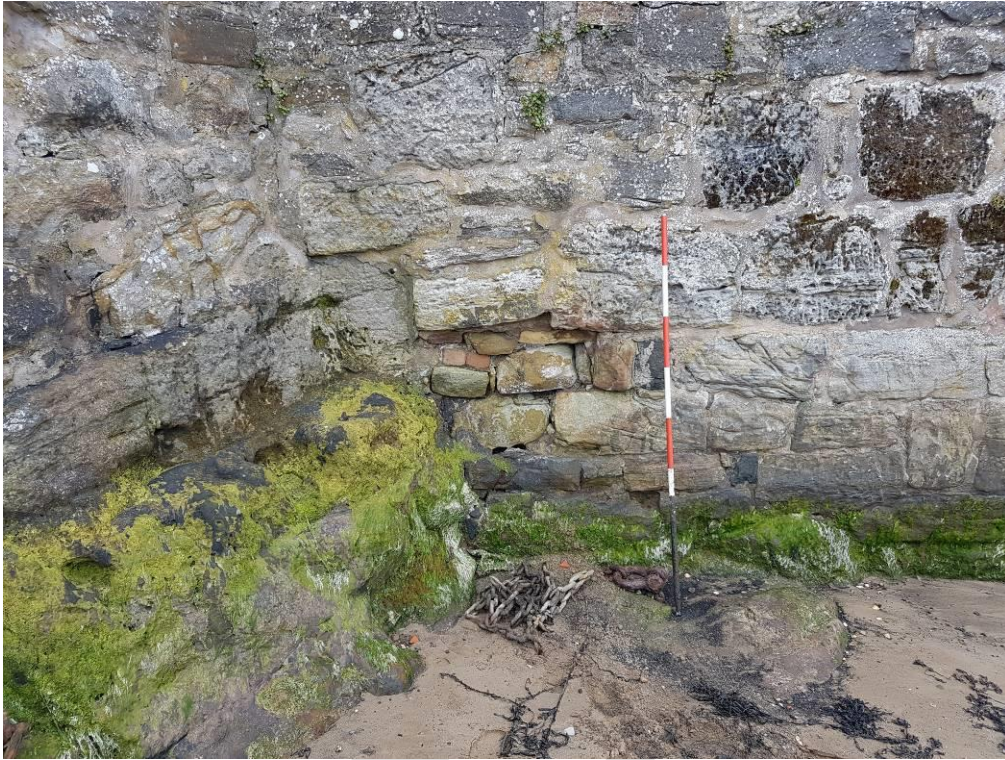
Photo 25 – Packed void at base of southern wall missing pointing. Staff for scale approximately 1.6m long with 0.2m gradations.
