LOCH ETIVE PIER – REMEDICATION REPORT

Dawnfresh Loch Etive Trout Farm, Taynuilt, PA35 1HU

Project no: E13537
Project title: Loch Etive Pier – Remediation Report
Client: Dawnfresh
Document ref: E13537-WRD-XX-XX-RP-S-00001

Loch Etive Pier Inspection

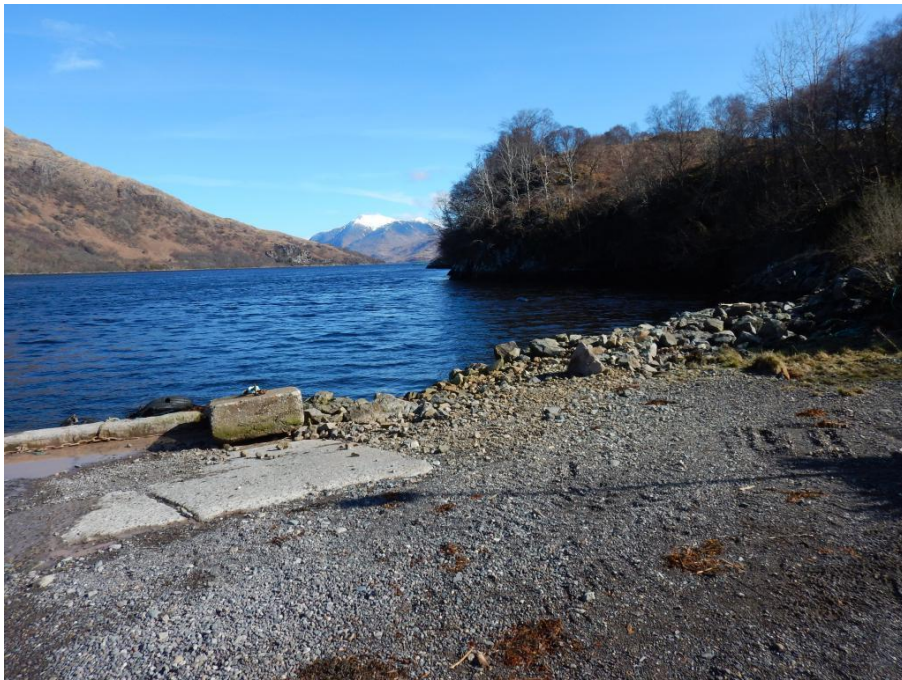
Photo 5 – Looking north east toward shoreline and pier return

750mm long
void below
water line on
berthing face

It is recommended that the voids are infilled and the erosion to the concrete berthing face is repaired within the next 12 months to stabilise the pier.

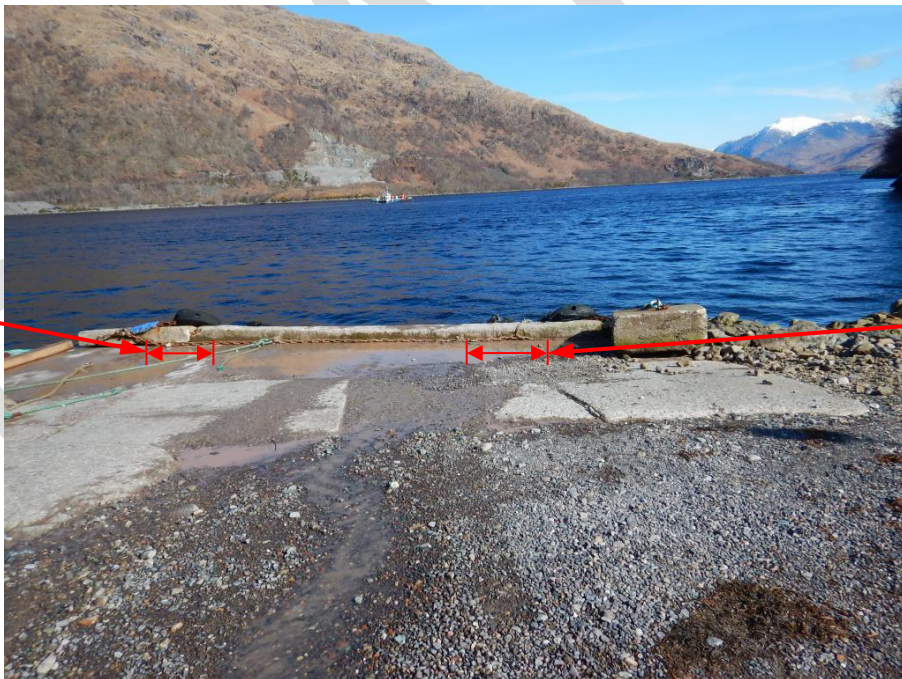
Photo 6 – Looking down slope to berthing face

1.2m long void
below water line
on berthing face

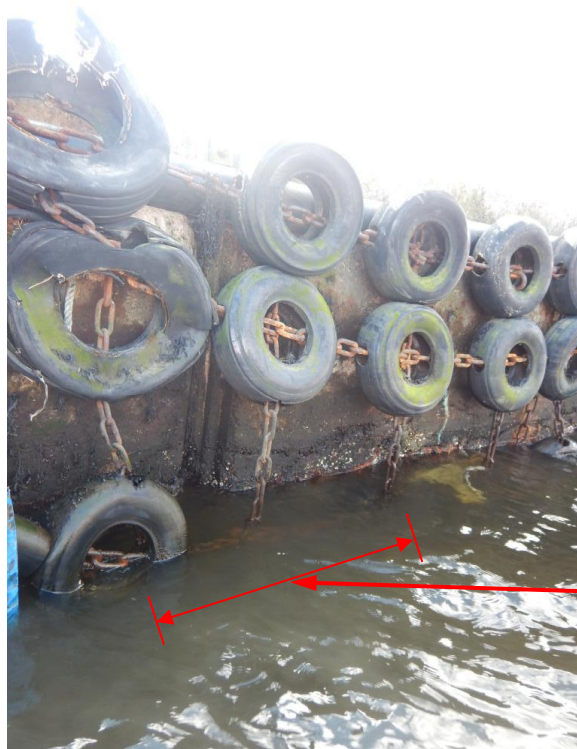
Photo 13 - Showing berthing face and fender arrangement with missing tyres along bottom chain

Location of
1.2m long void
below water line

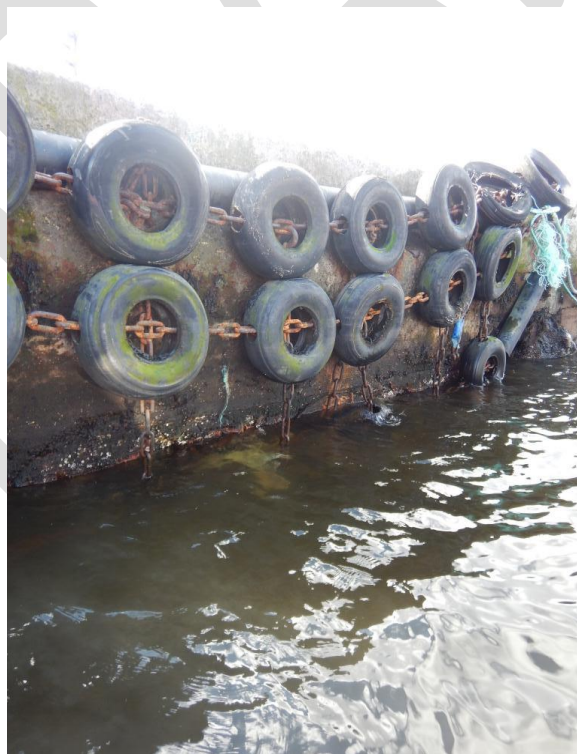
Photo 14 - Showing berthing face and fender arrangement with missing tyres along bottom chain

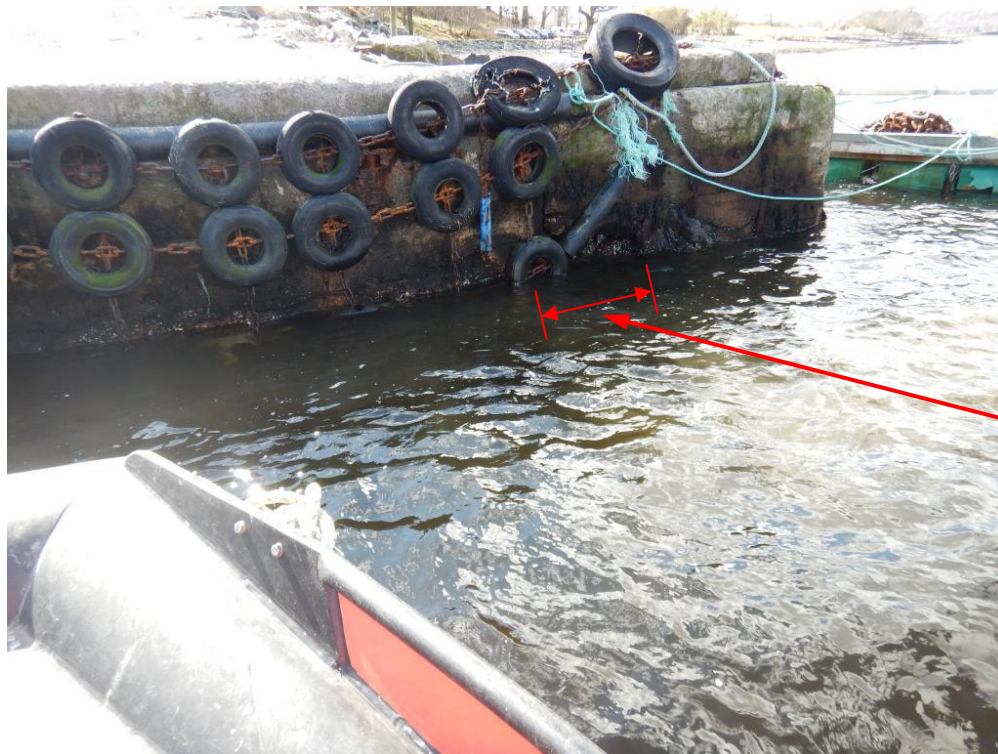
Location of
750mm long
void below
water line

Photo 15 - Showing berthing face and fender arrangement with missing tyres along bottom chain

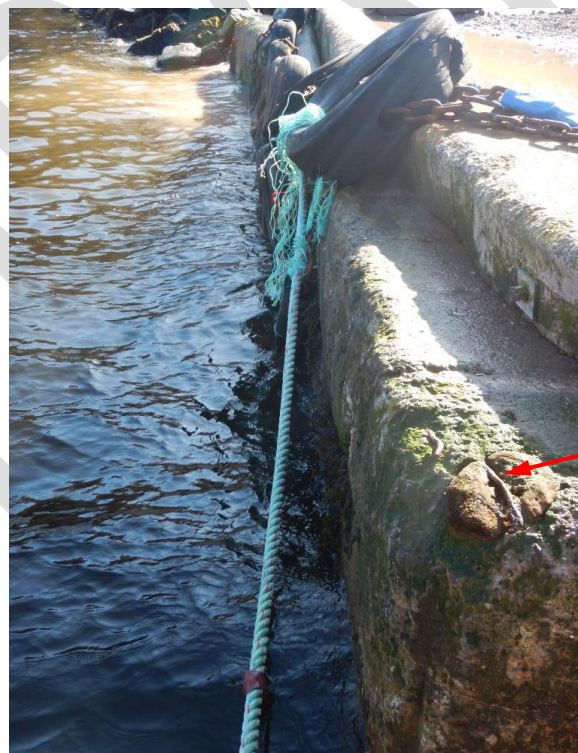
Photo 16 – Looking west along berthing face

Exposed and
corroding
reinforcement

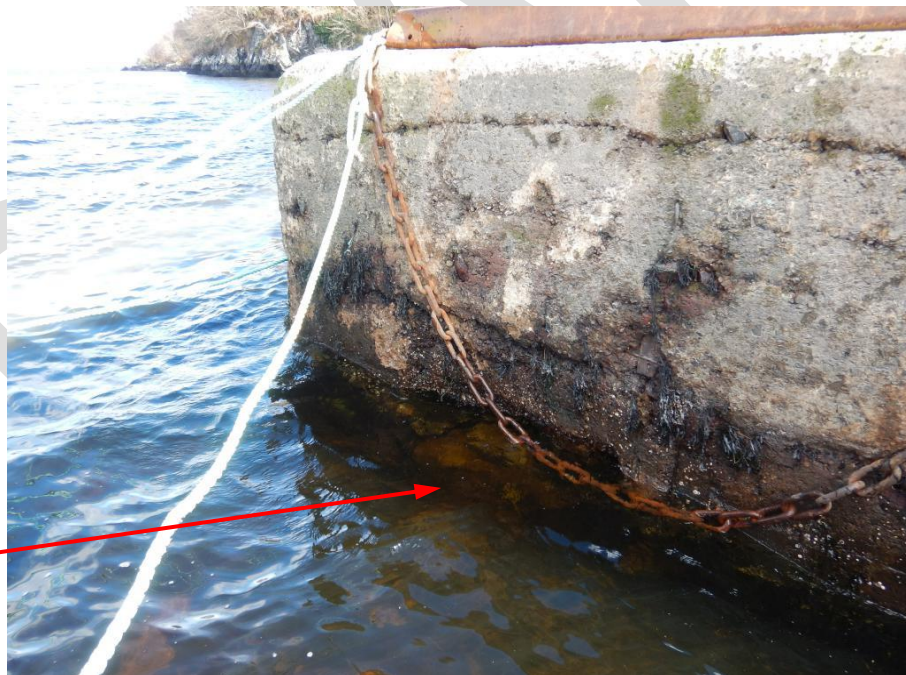
Photo 18 – Showing north west return

Erosion to
concrete
below water
line

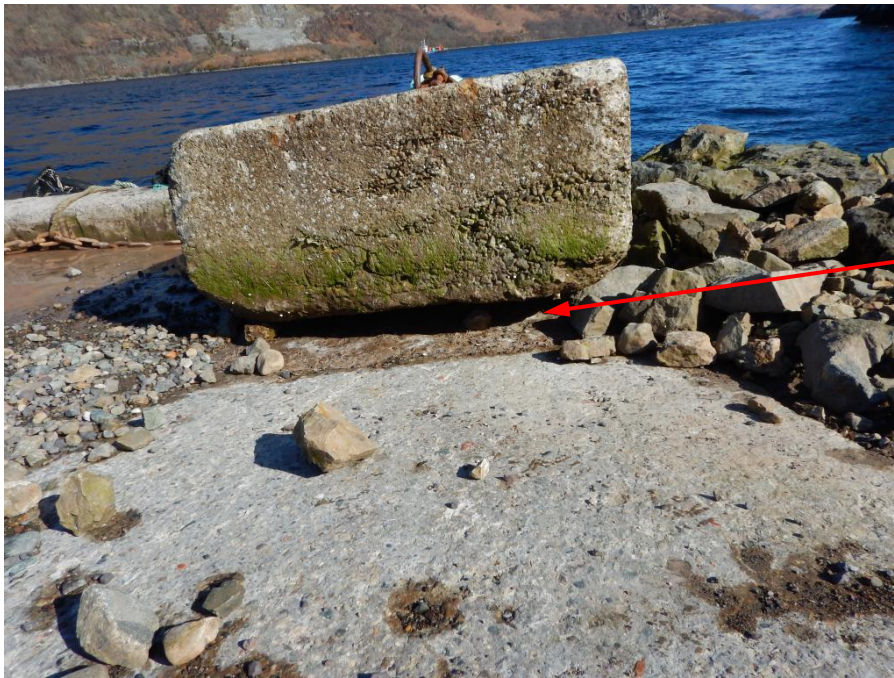
Mass concrete block not fixed to concrete pier

Photo 21 – Showing mass concrete block

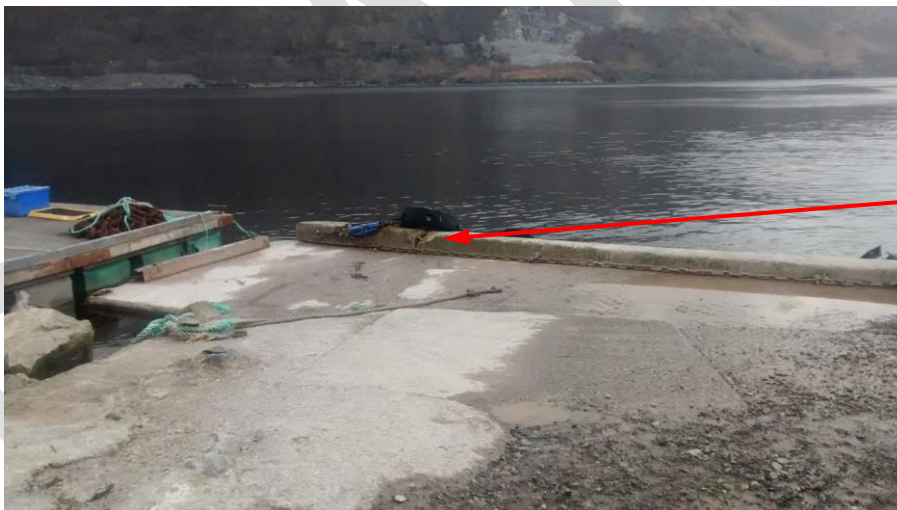
Damage to concrete upstand

Photo 22 – Showing damaged concrete upstand

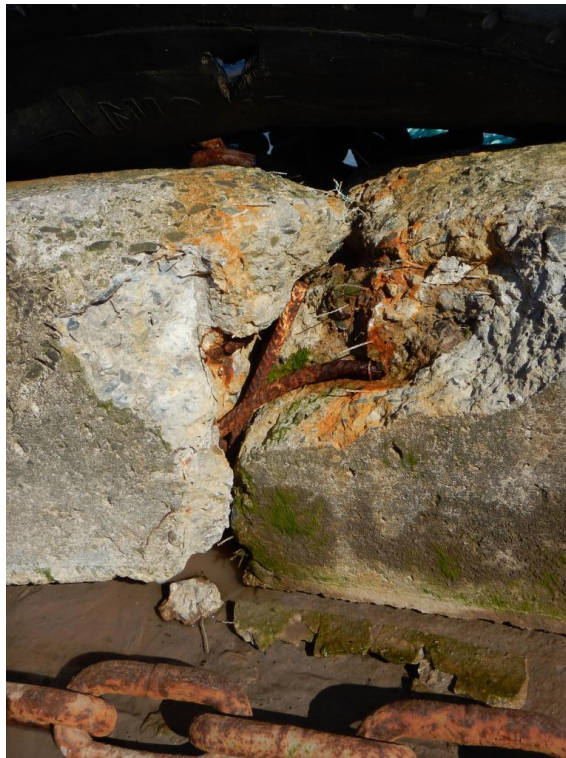
Photo 23 – Showing close up of damaged concrete upstand

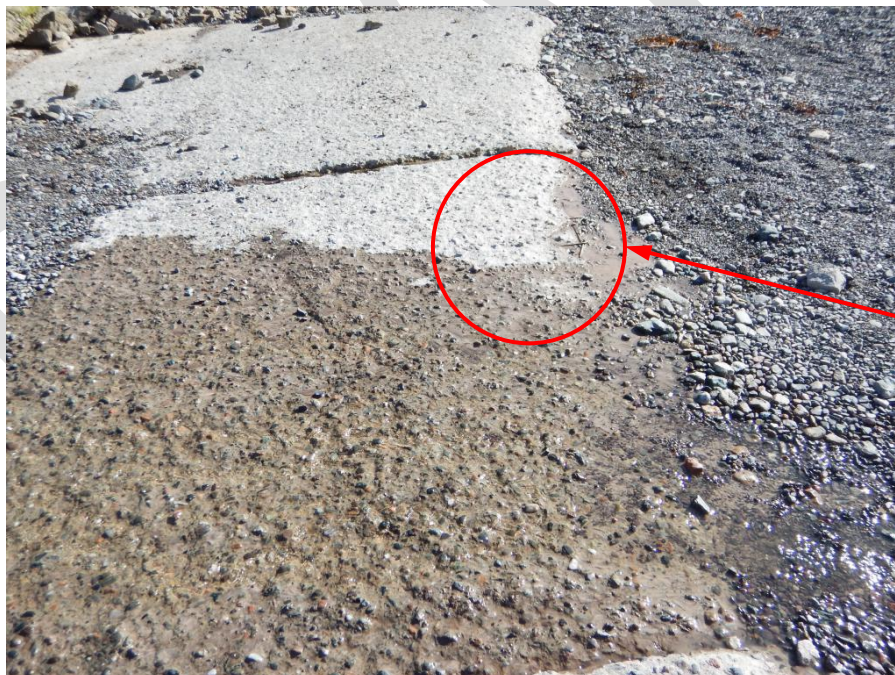
Photo 24 – Showing transition from informal surfacing to concrete transition slab

Exposed and
corroding
reinforcement

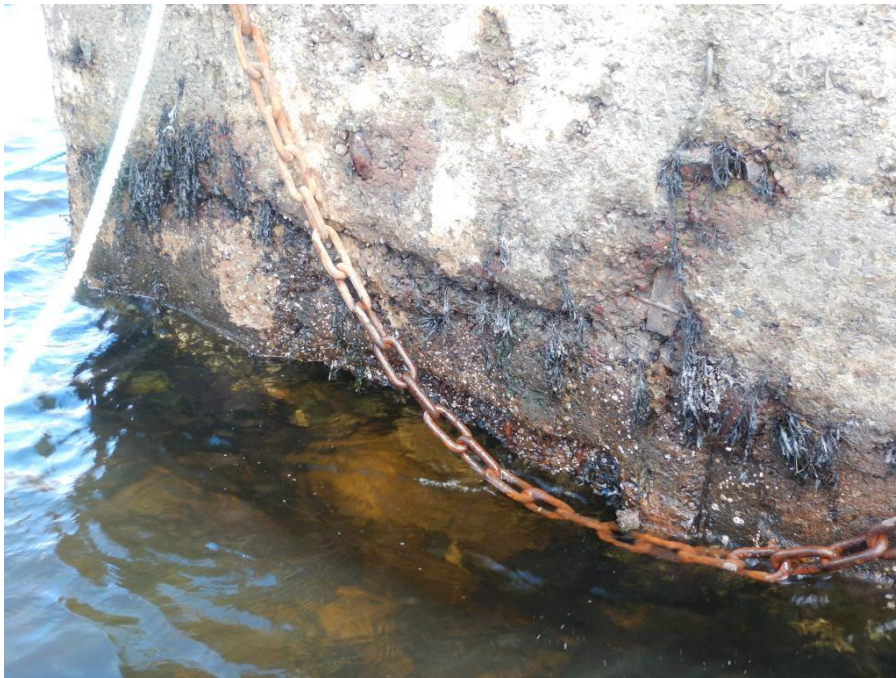
Photo 27 – Showing erosion below water line on north west return

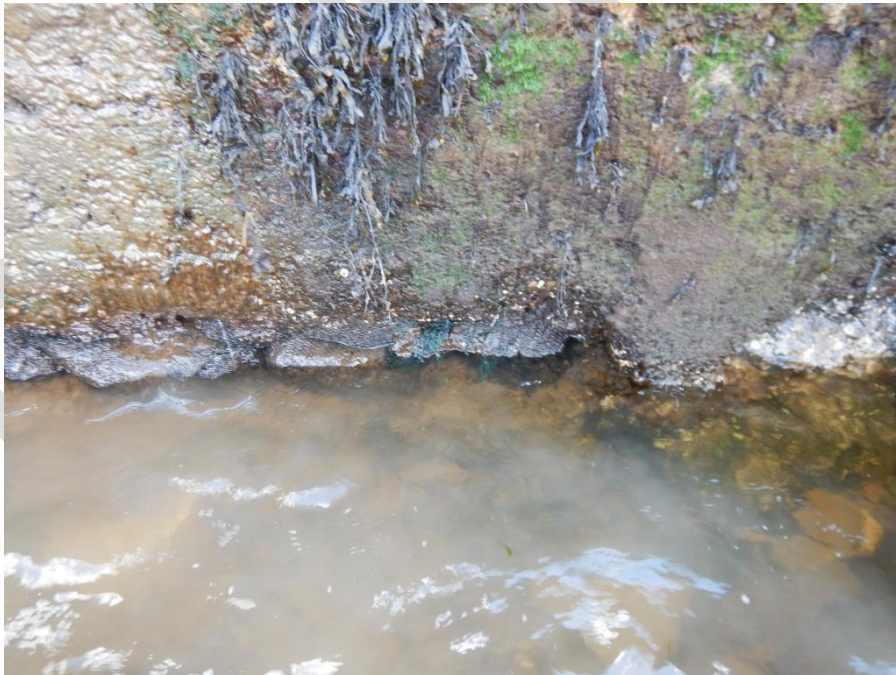
Photo 28 – Showing erosion to concrete below water line along berthing face starting at north east of pier

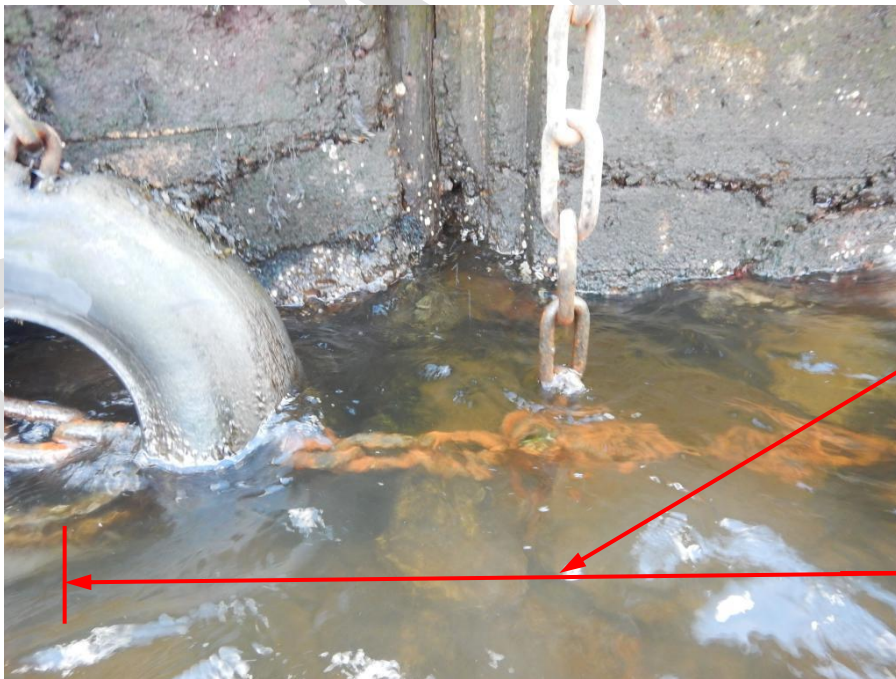
Location of
1.2m void
below water
line

Photo 32 - Showing erosion to concrete below water line along berthing face

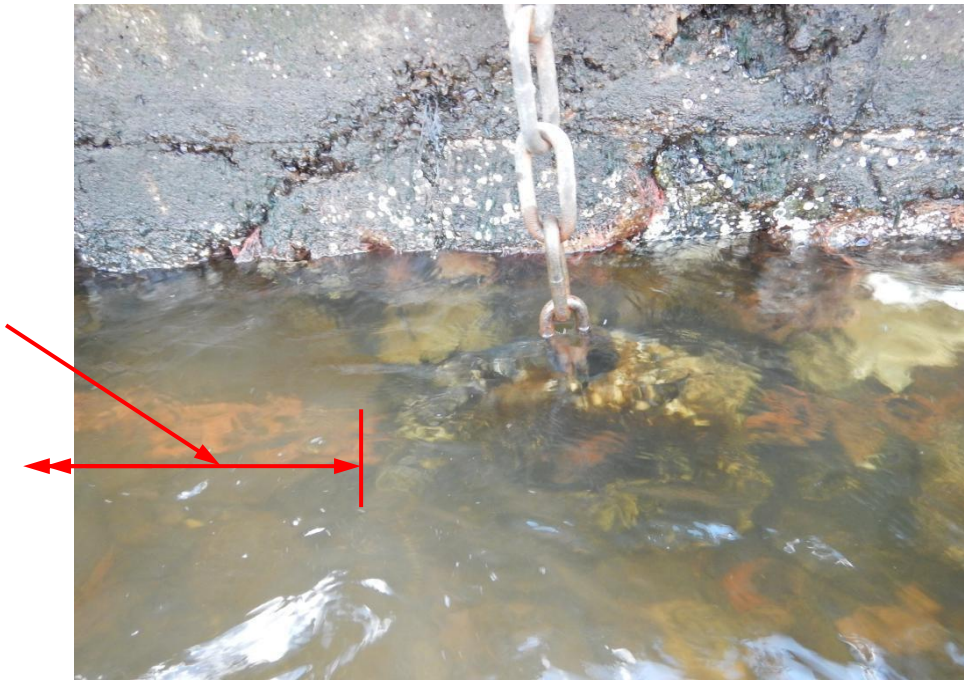
Extent of
1.2m long
void below
water line

Photo 33 - Showing erosion to concrete below water line along berthing face

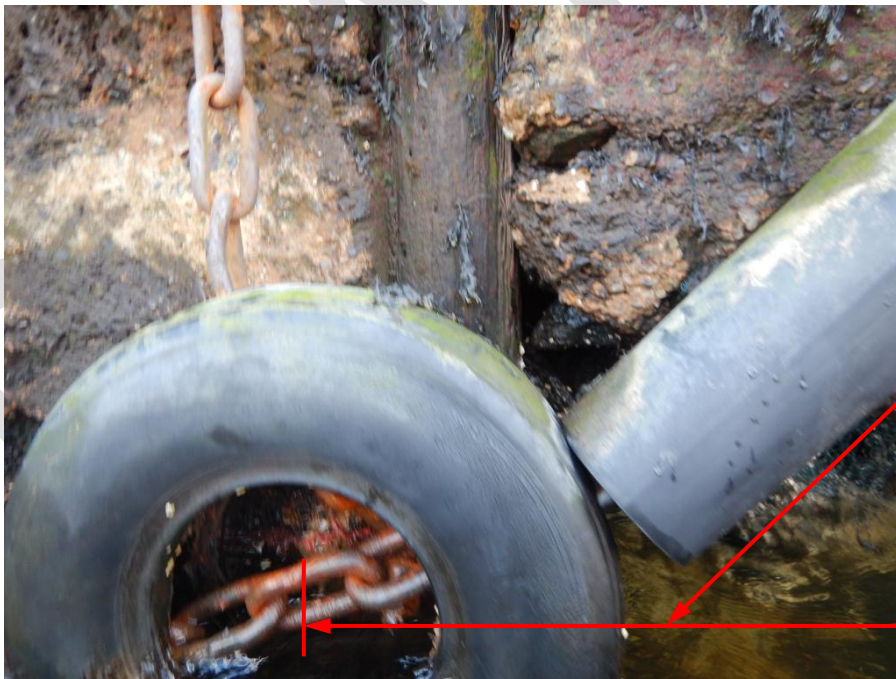
Photo 38 – Showing location of void

Location of
750mm long
void below
water line

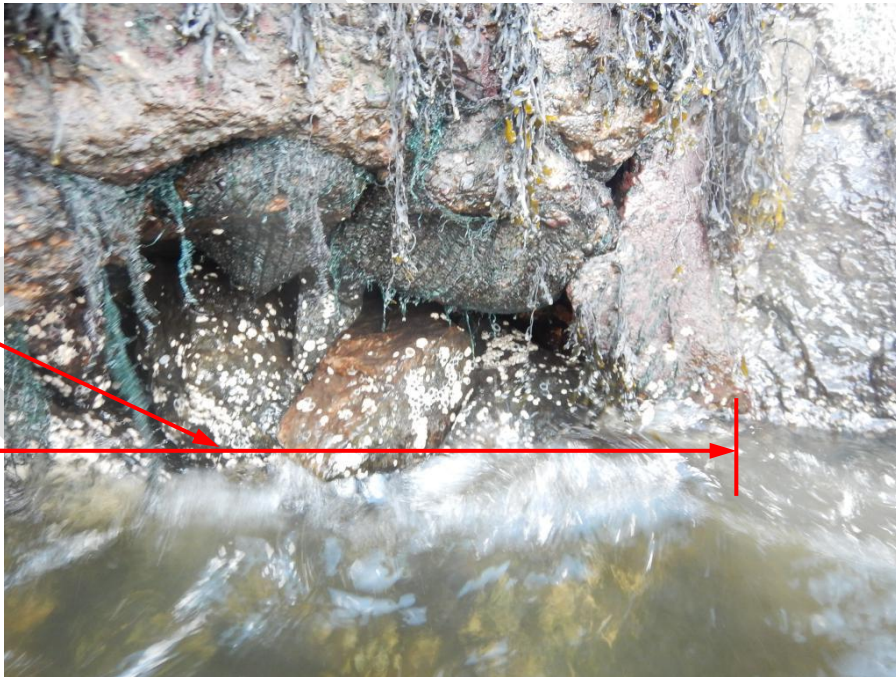
Photo 40 – Showing continuation of void

Extent of
750mm long
void below
water line

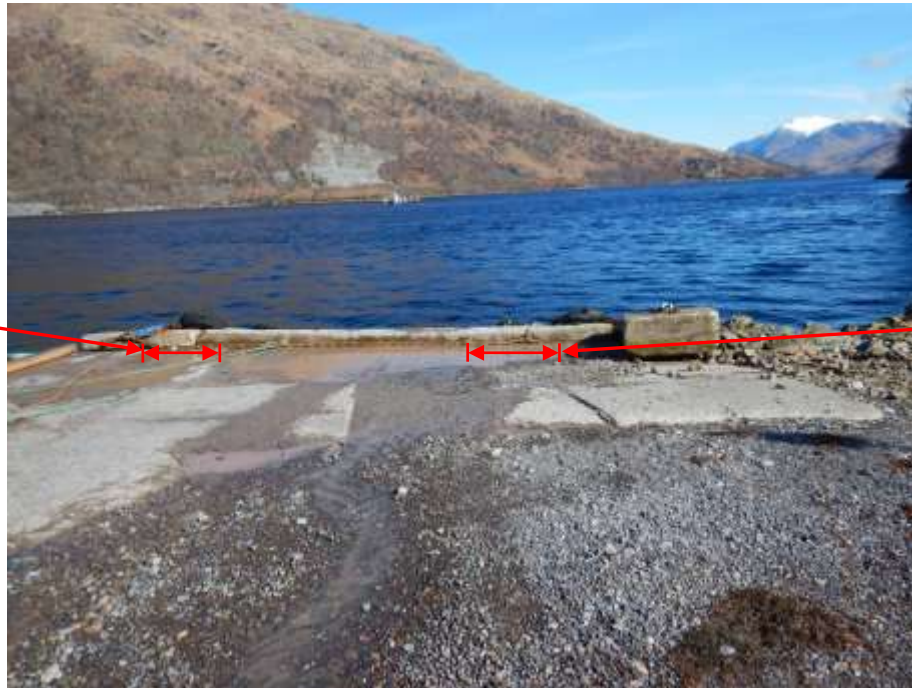
March 2018
750mm long void
below water line on
berthing face

5th April 2022
Void is now more
than 1500mm

1.2m long void
below water line
on berthing face

Until the works are carried out the pier should be closely monitored for any further degradation, particularly following any storm events. See Appendix D for hole monitoring information.
