Kyleakin fish factory

Marine Harvest

Hydrogeomorphology Report

B2264800-GEOMORPH-001 | P01

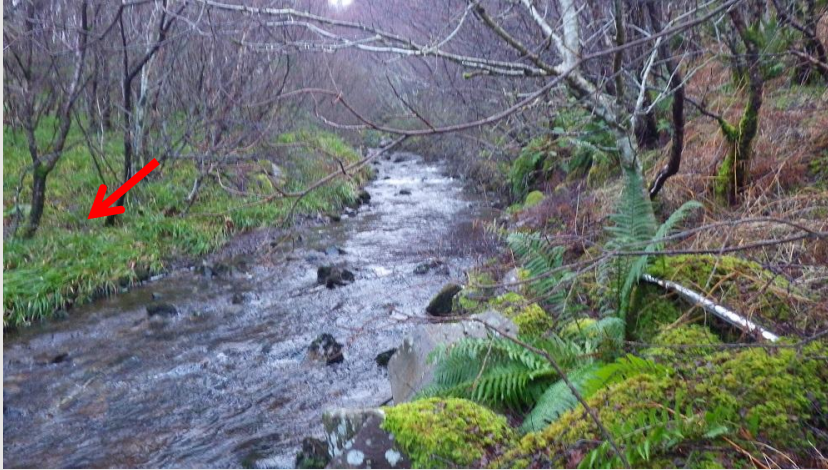
Figure A1.1 Alt Anavig upstream of A87, showing semi-natural channel form within steep valley; also trash line and high flow level along treeline on right bank (left side of image), approximately 0.7m above shown water level

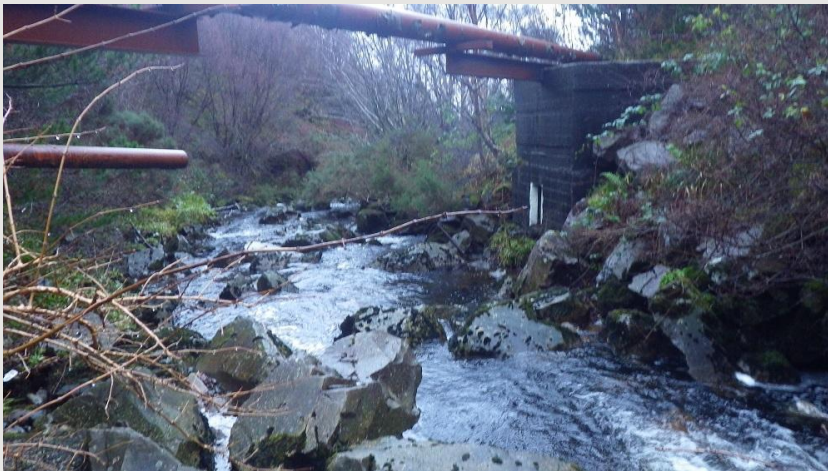
Figure A1.2 Alt Anavig downstream of A87, showing large boulders exposed within plane channel and additional revetment at pipe crossing point on face of left bank.

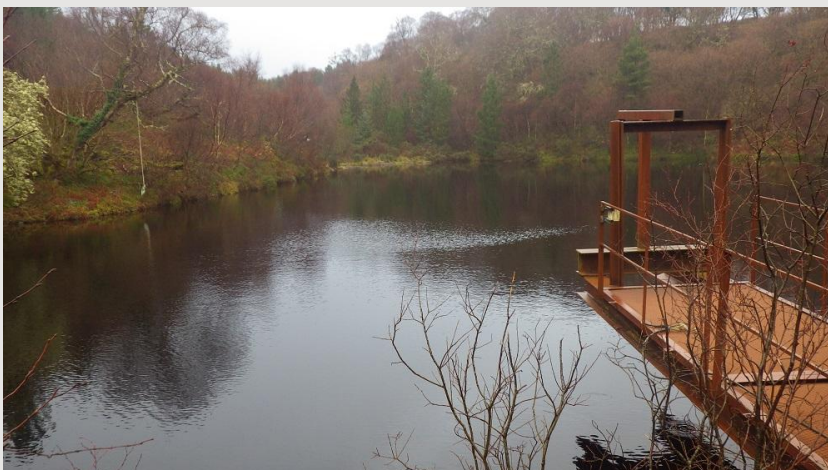
Figure A1.3 Reservoir impoundment on Alt Anavig

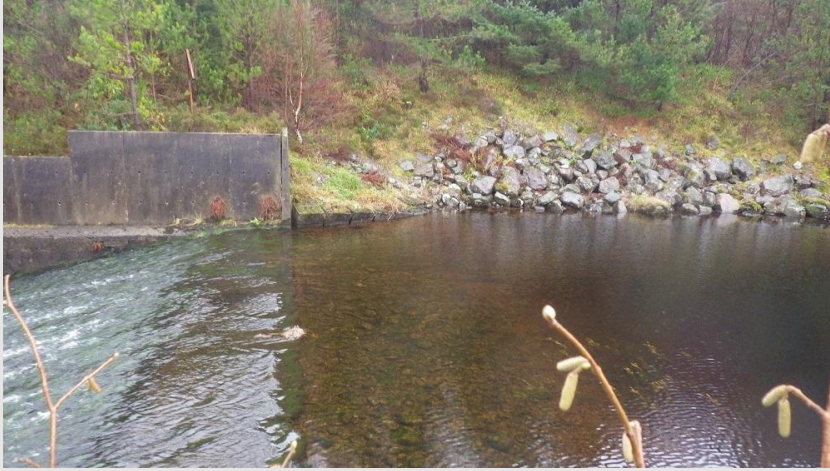
Figure A1.4 Alt Anavig –spillway at the reservoir outlet, showing accumulations of finer sediments (gravel and silt) retained behind concrete crest, concrete wing walls and boulder revetments approximately 1.8-2.0m above water level.

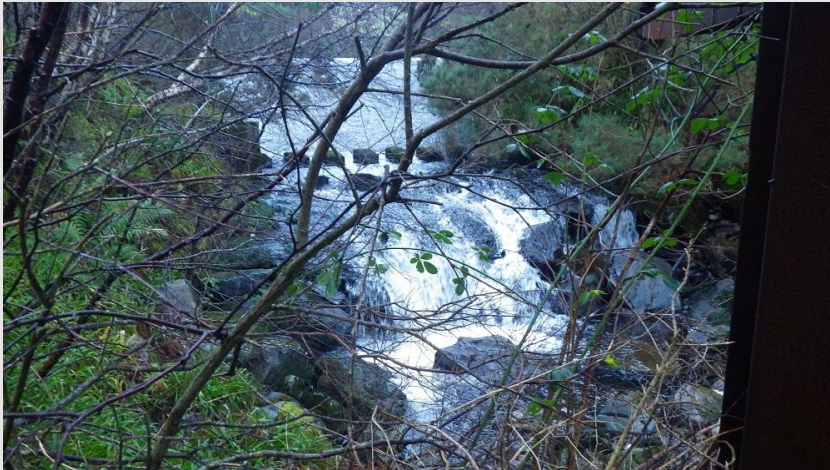
Figure A1.5 Alt Anavig – view upstream of current discharge from reservoir, showing concrete spillway apron with baffles and boulder waterfall dissipating hydraulic energy at steepest channel length

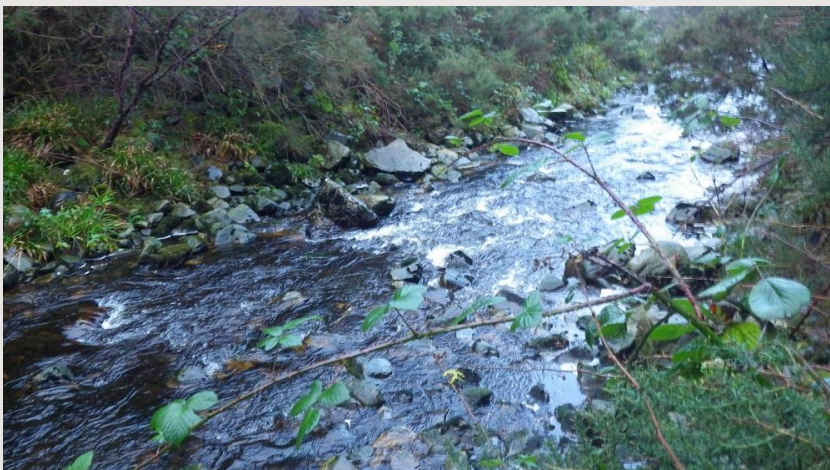
Figure A1.6 Alt Anavig – view downstream showing boulder with cobble / coarse gravel riffle bed dissipating residual energy along lower gradient slope
