# Bullhole Berthing Structure

## Construction Methodology

Project reference: HP2171065  
Project number: 60637648  
BUHO-ACM-XX-XX-RP-MT-000005

October 2022

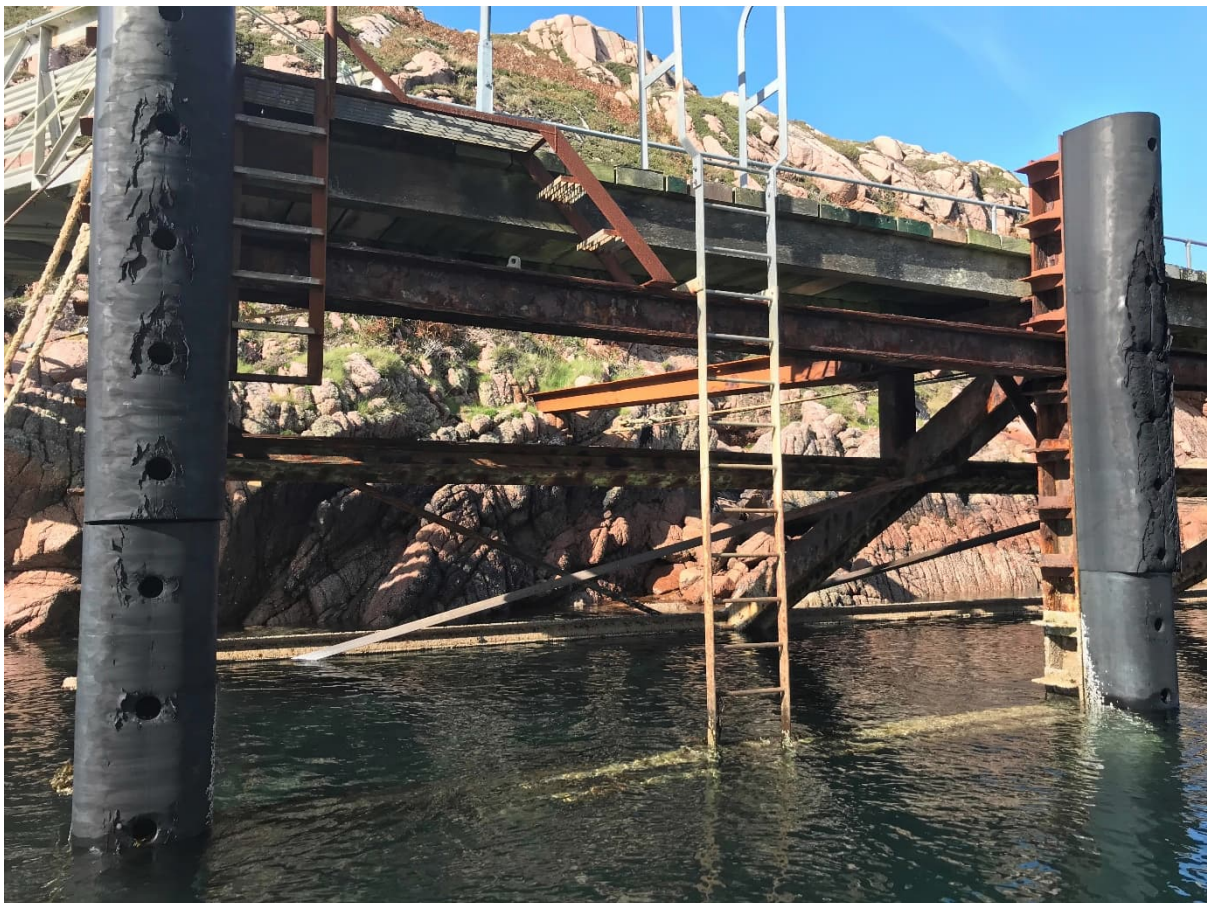
**1.20** *Waling Beams-* One of the waling beams spanning between the piles was observed to have experienced damage in the form of permanent bending deformation around its minor axis. It was considered that the large spacing of the piles would allow the bow of the vessel to impact these beams, and this was assumed to be the cause of this damage.

Figure 4-2 : General Condition of Berthing Structure (waling beams to be strengthened)

**3.10** New steel struts are to be installed between waling beams to provided additional strength.

- Remove surface corrosion from existing steelwork in connection areas.
- Weld new brackets connection plates to existing waling beams
- Install new steel struts, including drilling bolted fixings to existing waling beams.

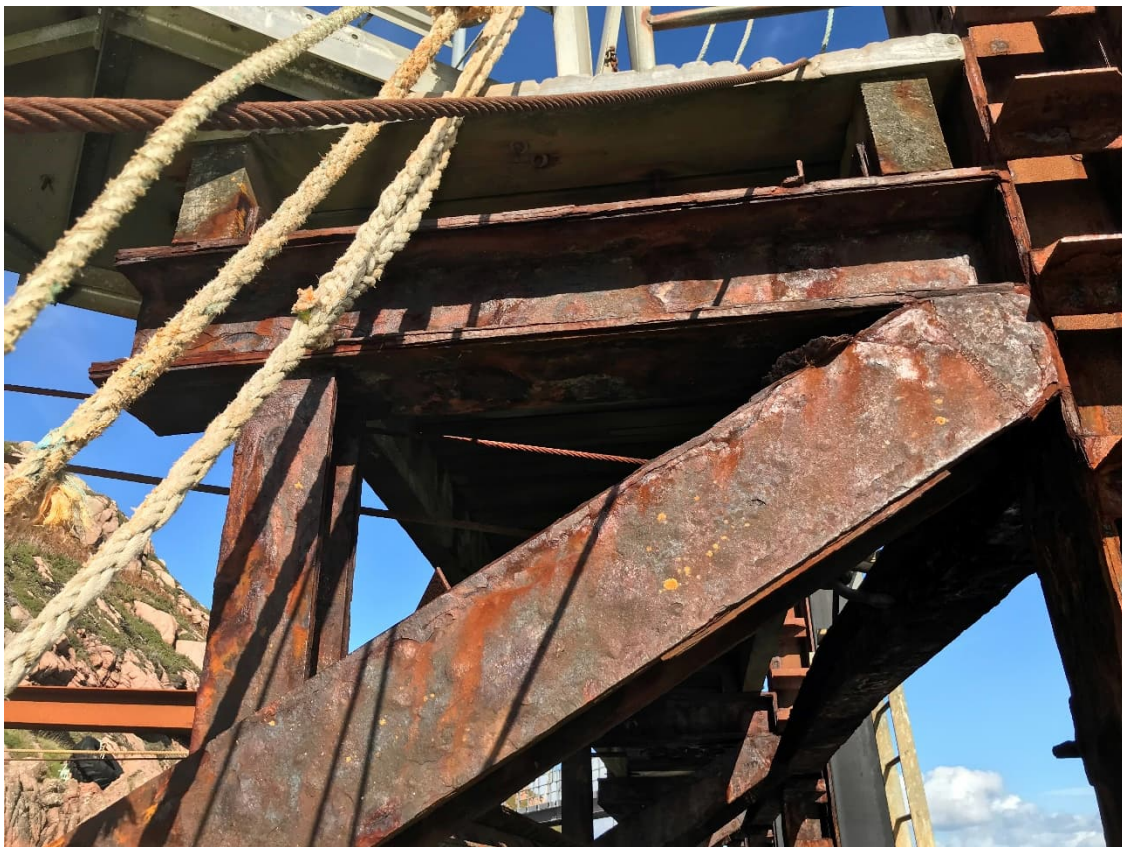
**1.17** *Steel Member Corrosion-* The steel members located within the marine environment have experience loss of thickness due to corrosion. Thickness measurements were taken during the 2020 dive survey as part of the Visual Inspection report and are discussed later in this report. It was noted that if the original system had a painted protection system, this is no longer present, and no cathodic protection system appears to have been installed.

Figure 4-4 : Typical Steelwork Corrosion
