Scottish Water

515344 Holm Septic Tank Coastal Protection

Ecological Survey Report

October 2022

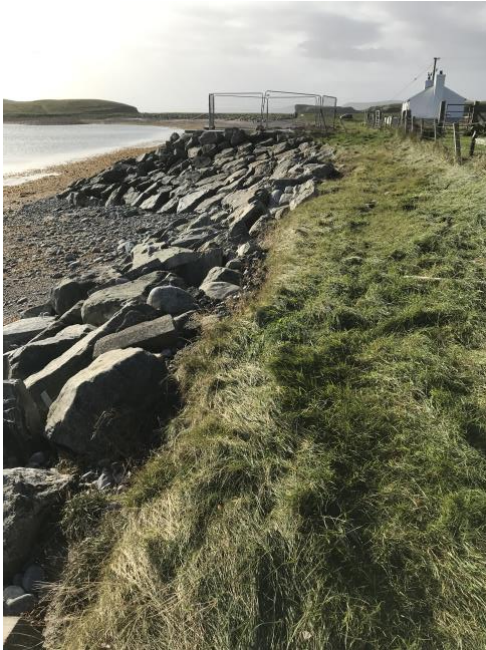
Photograph 1

Septic tank and coastal protection, coastal grassland above MHWS, coast to the south

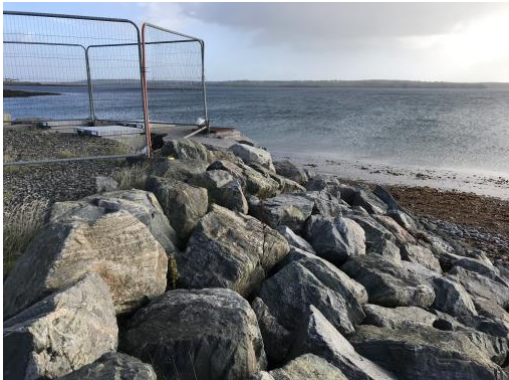
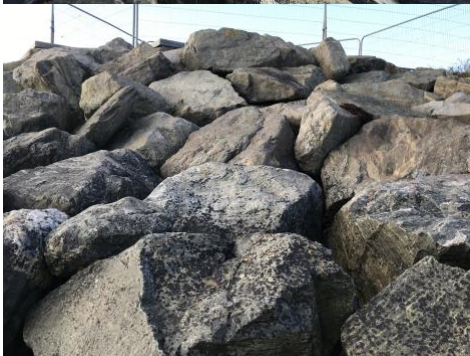
Photographs 2 and 3

Scottish Water (SW) is required to undertake an emergency project to reinstate coastal protection around the Holm septic tank, grid reference NB 4596 3142. The coastal protection has large voids and cracks and is currently a health and safety risk.

Rock armour coastal protection of septic tank requiring repairs.

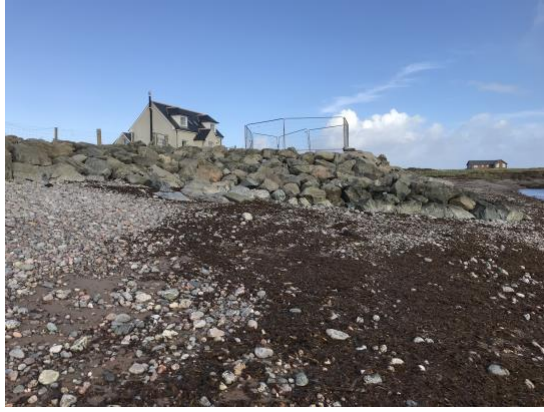
Photograph 4

Septic tank with rock protection
and surrounding intertidal
habitat

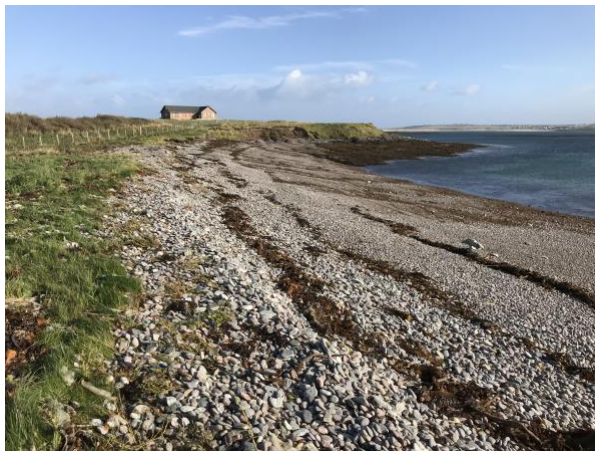
Photograph 5

Coastline to the north of the
septic tank
