NWM 1620 Glensanda Seabed Survey Report

The Findings of The Survey Undertaken at Rhugh Garbh, Loch Creran

Project: NWM 1620 Glensanda Seabed Survey

Client: Yeoman Glensanda Aggregate Industries

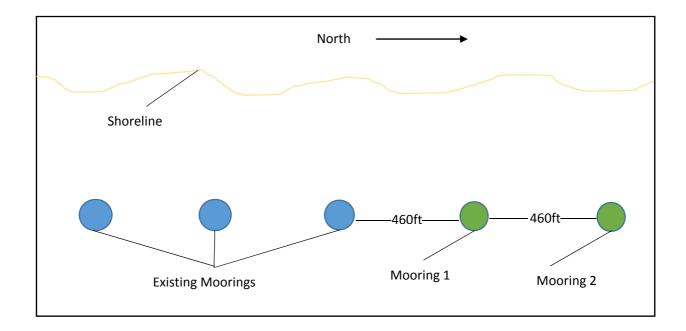
2 potential mooring positions were surveyed, the first was 460ft north of the 3 existing moorings and the 2^{nd} was 460ft north of the 1^{st} surveyed location. Below is a diagram and Lat and Longs of the positions:

Mooring 1: N56.31.087, W005.21.808

Mooring 2: N56.31.127, W005.21.694
