# Loch Carnan Jetty Refurbishment South Uist, Outer Hebrides Method Statement

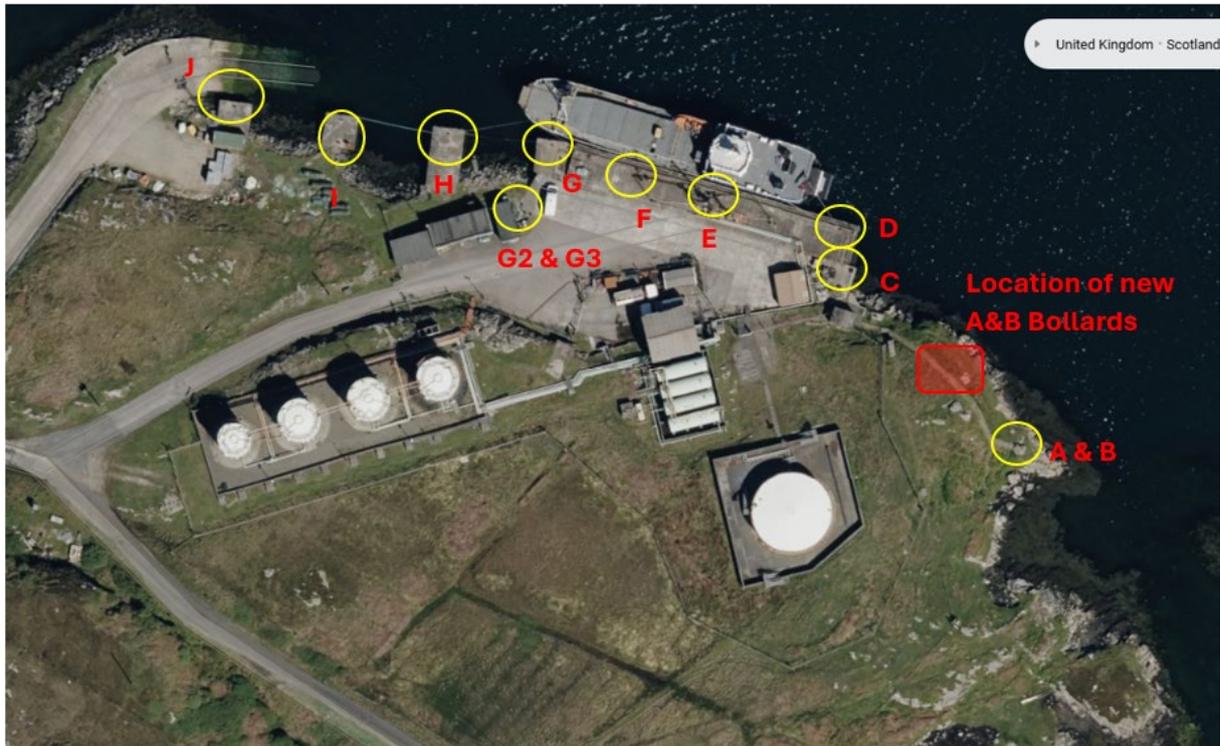
Figure 1 Location of jetty bollards

Bollard locations are shown on Figure 1 (a number of which are on land adjacent to the jetty but are included for completeness). As detailed in Table 1, existing bollards will be either:

- Removed and replaced on a like-for-like basis<sup>1</sup>
- Removed and not replaced (mooring arrangement to be revised to use other available bollards); or
- Retained and refurbished.

Installation of replacement bollards on the jetty structure (E1 & E2) would involve removing the timber deck and welding a steel plate with stiffeners to the existing main steelwork members. This plate has threaded bars protruding as anchor bolts with spacer tubes and a second plate at deck level to attach the bollard onto; finally, the timber deck will be replaced.

Refurbishment of existing bollards would involve rust removal (by hand) and re-painting.
