Sound of Islay Demonstration Tidal Array

Volume 2: Technical Appendices

Environmental Statement: Chapter 2 – Scoping and Assessment Methodology

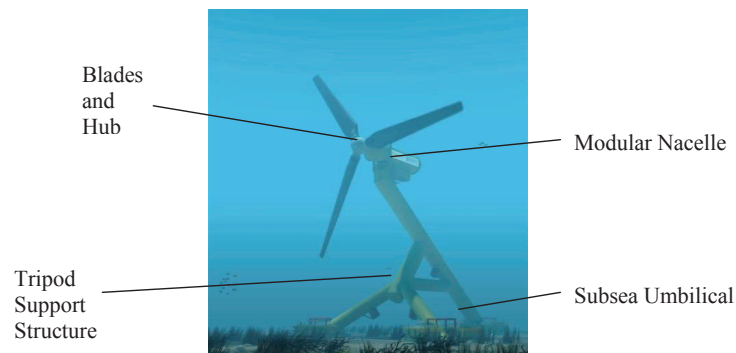
The seabed mounted turbines to be installed in the Sound of Islay are based on a 300 kW prototype marine current turbine (see figure 1) designed by Hammerfest Strøm installed in Kvalsund in Finnmark, Norway (Hammerfest Strøm, 2009). The turbines will comprise a tripod-base support structure (20 m in height), modular nacelle, hub and blades resulting in the hub being 22 m above the seabed (SPR, 2008). The tidal devices will generate electricity by converting the kinetic energy produced during the tidal cycle and electricity will be produced in both directions of water flow.

Figure 1. Graphical representation of the 300kW tidal device developed by Hammerfest Strøm, installed in Kvalsund in Finnmark, Norway (SPR, 2008).

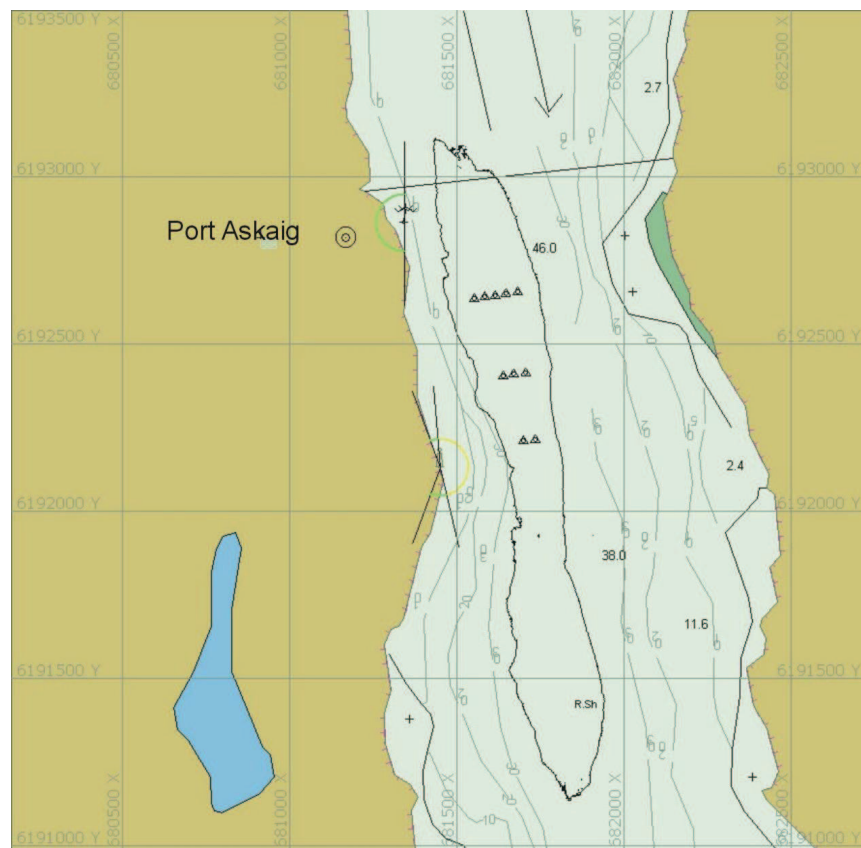
Figure 3. Proposed location for the tidal devices in the Sound of Islay (the 48 m contour shown in black and the proposed turbine sites (black triangles) within the 48 m contour).

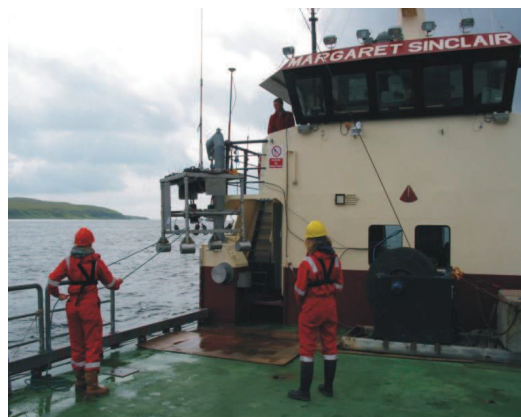
The camera system used for the drop-down camera survey was a Kongsberg OE DTS-6000 drop-down camera system (figure 5). This was used in conjunction with a Mariamatech E-Sea sound dual frequency (33/200KHz) echosounder and a Leica RTK GPS (GX1230 Real Time Rover System) to acquire navigational positions (for further details see appendix I).

Figure 5. The DTS-6000 camera system onboard MV Margaret Sinclair used during the survey operations.

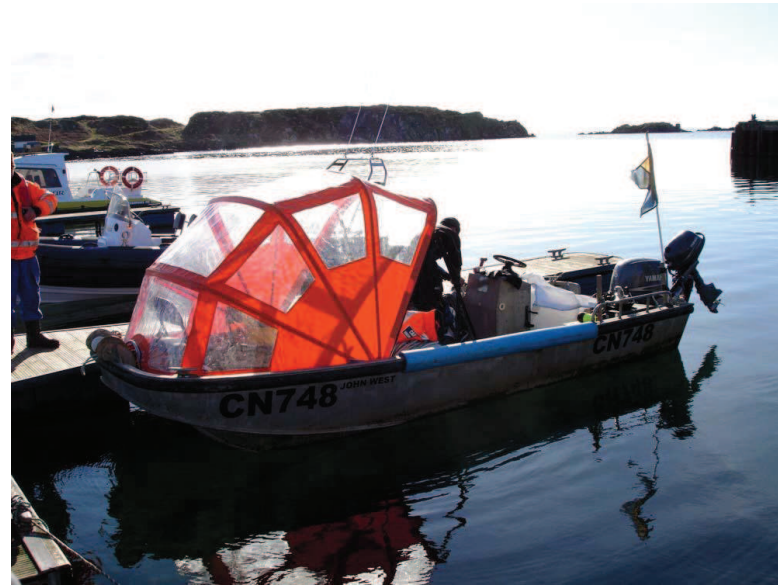
A small survey vessel was used for the cable route survey (Figure 2.3, below). One outboard engine providing high manoeuvrability was used with a small backup outboard engine which was not used. A cover was placed over the vessel to protect the electrical equipment when required. The small draft on the vessel allowed very shallow sites inshore sites to be surveyed.

Figure 2.3 Survey vessel used for cable route survey

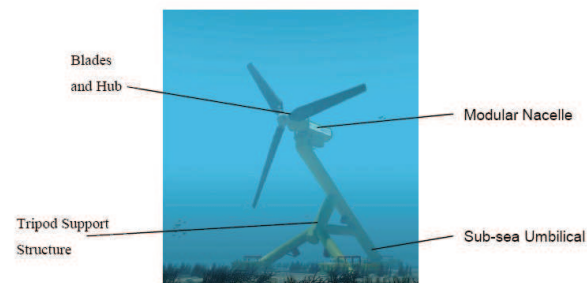
The tidal turbine blades rotate with a typical and maximum speed of 7.2 rpm. In addition, there is a generator inside the nacelle behind the blades (see Figure 2), which has a maximum rotation speed of about 504 rpm.

Figure 2 Illustration of the tidal turbine (Hammerfest Strøm).

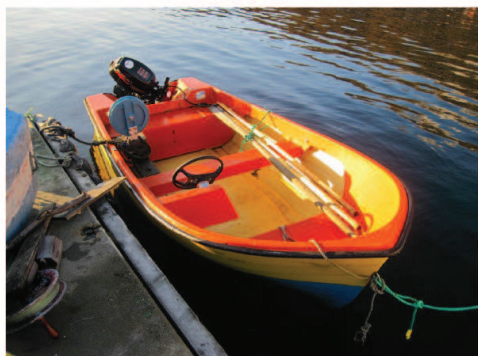
Figure 5 The boat (Askeladden 14 feet), from which measurements were carried out.

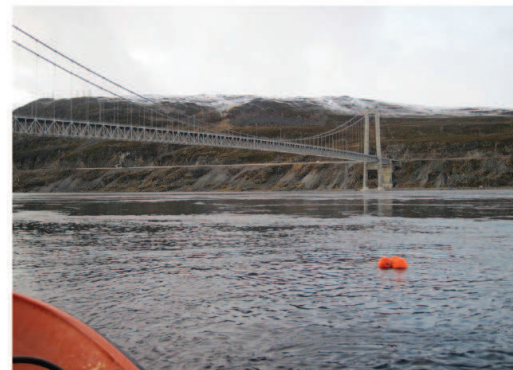
Figure 7 Measuring from a fixed mooring position close to land (south). The Kvalsund Bridge is in the background. The tidal turbine is about 200 m behind the floating buoys. The floating buoys are attached to the mooring and to the boat. The picture is taken during strong currents towards east (rising tide) 22nd October 2009. The measuring boat is located in calm water, by the compensation current, and is right here drifting towards land.

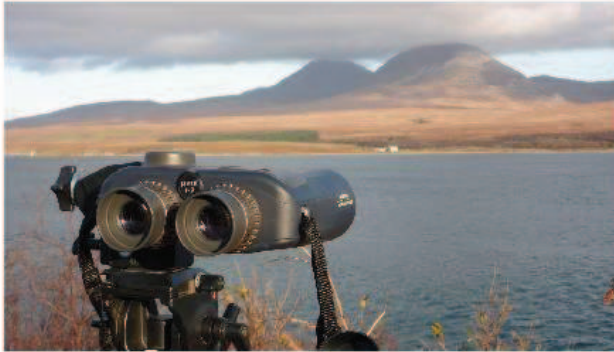
Photograph 5. Compass binoculars mounted level on a tripod. Looking east from cliffs above Port Askaig (at VP 13).

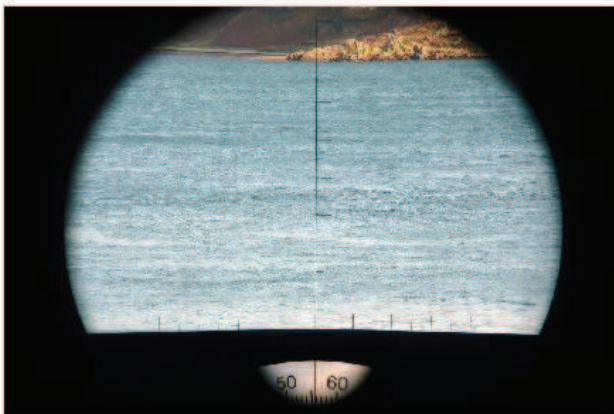
Photograph 6. View through compass binoculars showing compass bearing and vertical graticule.

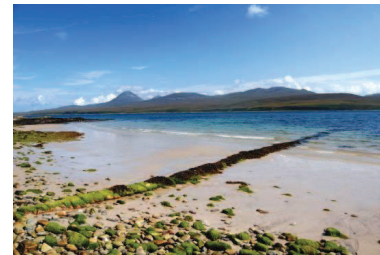
Plate 3.1 Transect A1 location along existing cable, viewed from the south west

Two transects were surveyed at this site (Figure 3.1) – the first (A1: NR 42951 65348, Plate 3.1) took the line of the existing cable to determine the species which had established on the artificial reef created by the cable armouring. Biotopes for this transect are described in Table 3.1 and Plates 3.3 and 3.4. The second transect (A2: NR 43047 65472, Plate 3.2) assessed the bedrock/rock pool outcrop to the north of the cable. Biotopes for this transect are described in Table 3.2 and Plates 3.5 to 3.8

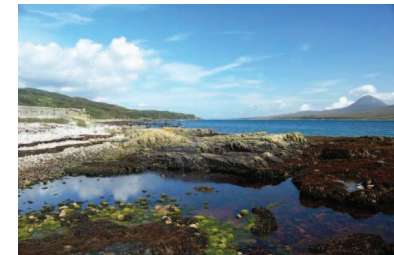
Plate 3.2 Transect A2 location at rocky outcrop, viewed from the south

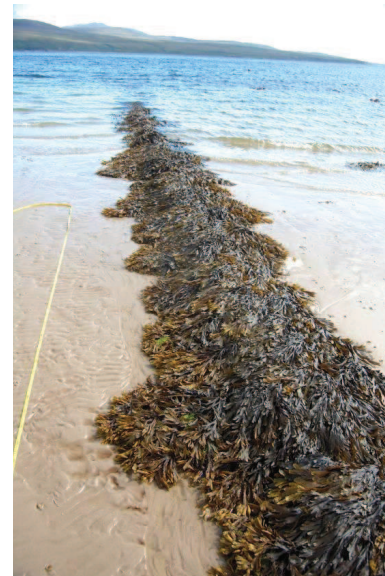
Plate 3.3 Transect A1 lower shore facing west, view along cable armouring

27.70 – 43.50	Cable armouring dominated by <i>Fucus serratus</i> supporting <i>Spirorbis spirorbis</i> , rare <i>Laminaria digitata</i> on scattered boulders. Cable armouring is on on clean fine sand sediments supporting <i>Arenicola marina</i> casts 5/m ² .	LR.LLR.F.Fserr.FS and LS.LSa.FiSa.Po
Below 43.50	<i>Laminaria digitata</i> , <i>Laminaria saccharina</i> and <i>Himantalia elongata</i> on scattered half buried boulders, with <i>Fucus serratus</i> dominating the	IR.MIR.KR.Ldig.Bo

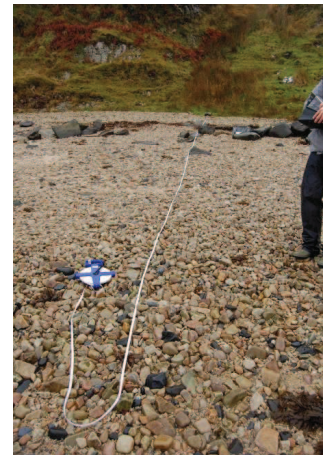
Two transects were surveyed at this site (Figure 3.1) – the first (A1: NR 44083 69275, bearing: 295°, Plate 3.1 & 3.2) took the line of least resistance up the shore and was therefore considered probably the most suitable line for the installation of a cable. Biotopes for this transect are described in Table 3.1 and shown in Plates 3.3 and 3.4. Transect A1 was not deemed typical of the shore at this predominantly rocky site so a second transect (A2: NR 44104 69359, Bearing 281°, Plate 3.2) was surveyed to assess the exposed bedrock and rock pool habitats of the northern part of the bay. Biotopes for this transect are described in Table 3.2 and Plates 3.5 to 3.8.

Plate 3.1. Transect A1: View up transect from water level

Location on tape measure (m)	Description	Biotope
0.00 – 2.30	Shingle composed mainly of pebbles	LS.LCS.Sh
2.30 - 2.80	Strand line on boulders and pebble shingle.	LS.LSa.St
2.80 - 13.80	<i>Fucus spiralis</i> , on loose cobbles, pebbles and some small boulders	LS.LCS.Sh
13.80 - 15.00 (water line) and below	<i>Fucus vesiculosus</i> , in small clumps on gravel and pebble substrate	LS.LCS.Sh and LR.LLR.F.Fves.X

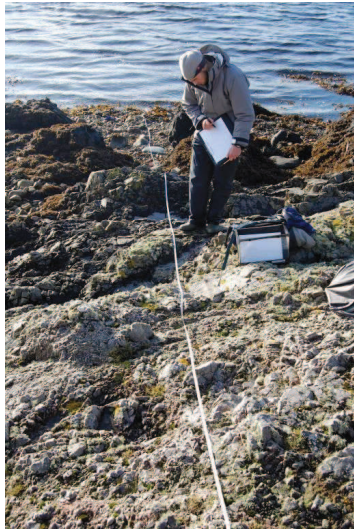
Two transects were surveyed at this site (Figure 3.3) – the first (C1: NR:44241 67190 plate 3.13) took a line from the headline down through the edge of the border between bedrock and shingle (Figure 3.3) and was positioned to capture as many different habitats as possible. The second transect (C2: NR: 44267 67167, Plate 3.14) assessed the middle of the bay along a line with few

Plate 3.13. Transect C1: View down transect from the foot of the rocky headland.

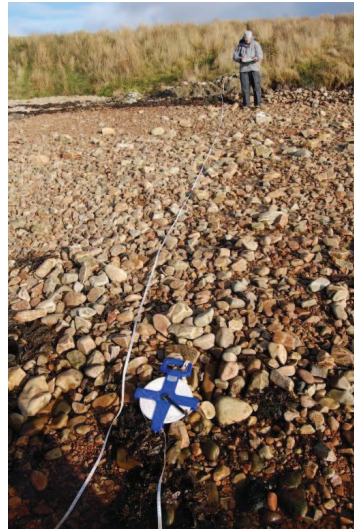
features to gather information which was more typical of the bay and also a more appropriate line for cable landfall (Figure 3.3).

Plate 3.14. Transect C2: View up transect from the water line

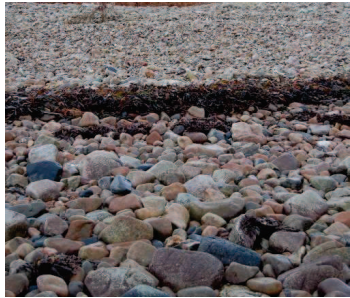
Location on tape measure (m)	Description	Biotope
10.20-0	Pebbles and cobbles arranged in steps.	LS.LCS.Sh
11.30-10.20	Strandline on cobbles and pebbles (plate 3.19)	LS.LSa.St

Plate 3.19. Transect D: The strandline

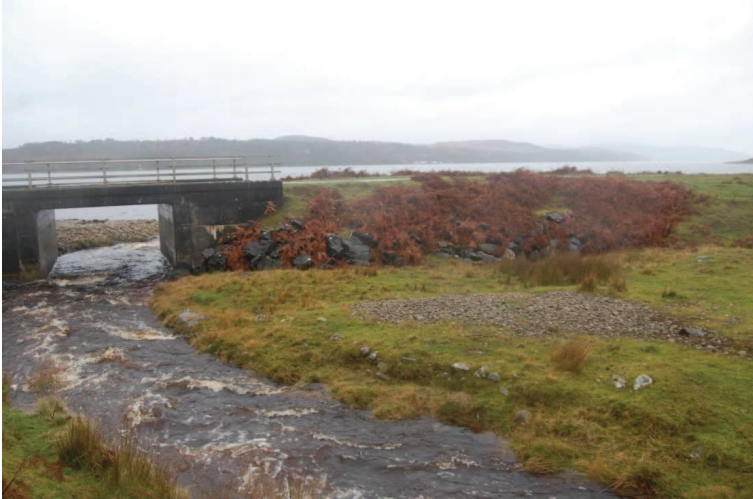
Plate 4.2 Rock armouring around the road bridge (all four sides) over Abhain Mhor – potential otter lie-up site (Survey Site B).

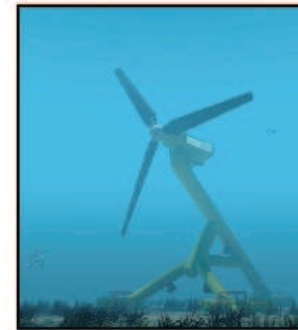
Figure 5 Hammerfest Strøm Tidal Turbine

The tidal device to be deployed has been designed and developed by Hammerfest Strøm UK (HSUK), a subsidiary of HSAS and collaboration partner with SPR. The device is a development of a 300kW device currently undergoing a period of research, development and testing. The existing prototype device will be developed to provide a device of 1MW output to be deployed at the Islay site in a demonstration array of approximately 10 devices.

Figure 5 shows an artists impression of the deployed device and Figure 6 shows front and side elevations.
