Marine Licence Application for Construction Projects

Marine (Scotland) Act 2010

PROJECTNAME: ---
 CITY: SAN RAFAEL, CA
 C:\BIM\04\ARCADIS\BOWLING\UK\2019\08\08\DWG\ISSO\Bowling - Figs 1a 1b - Barrier Footprint.dwg LAYOUT: 1A
 PLOTTED: 7/2/2019 10:23 AM BY: HARRIS, JESS
 XREFS:
 X-BASE_EXISTING

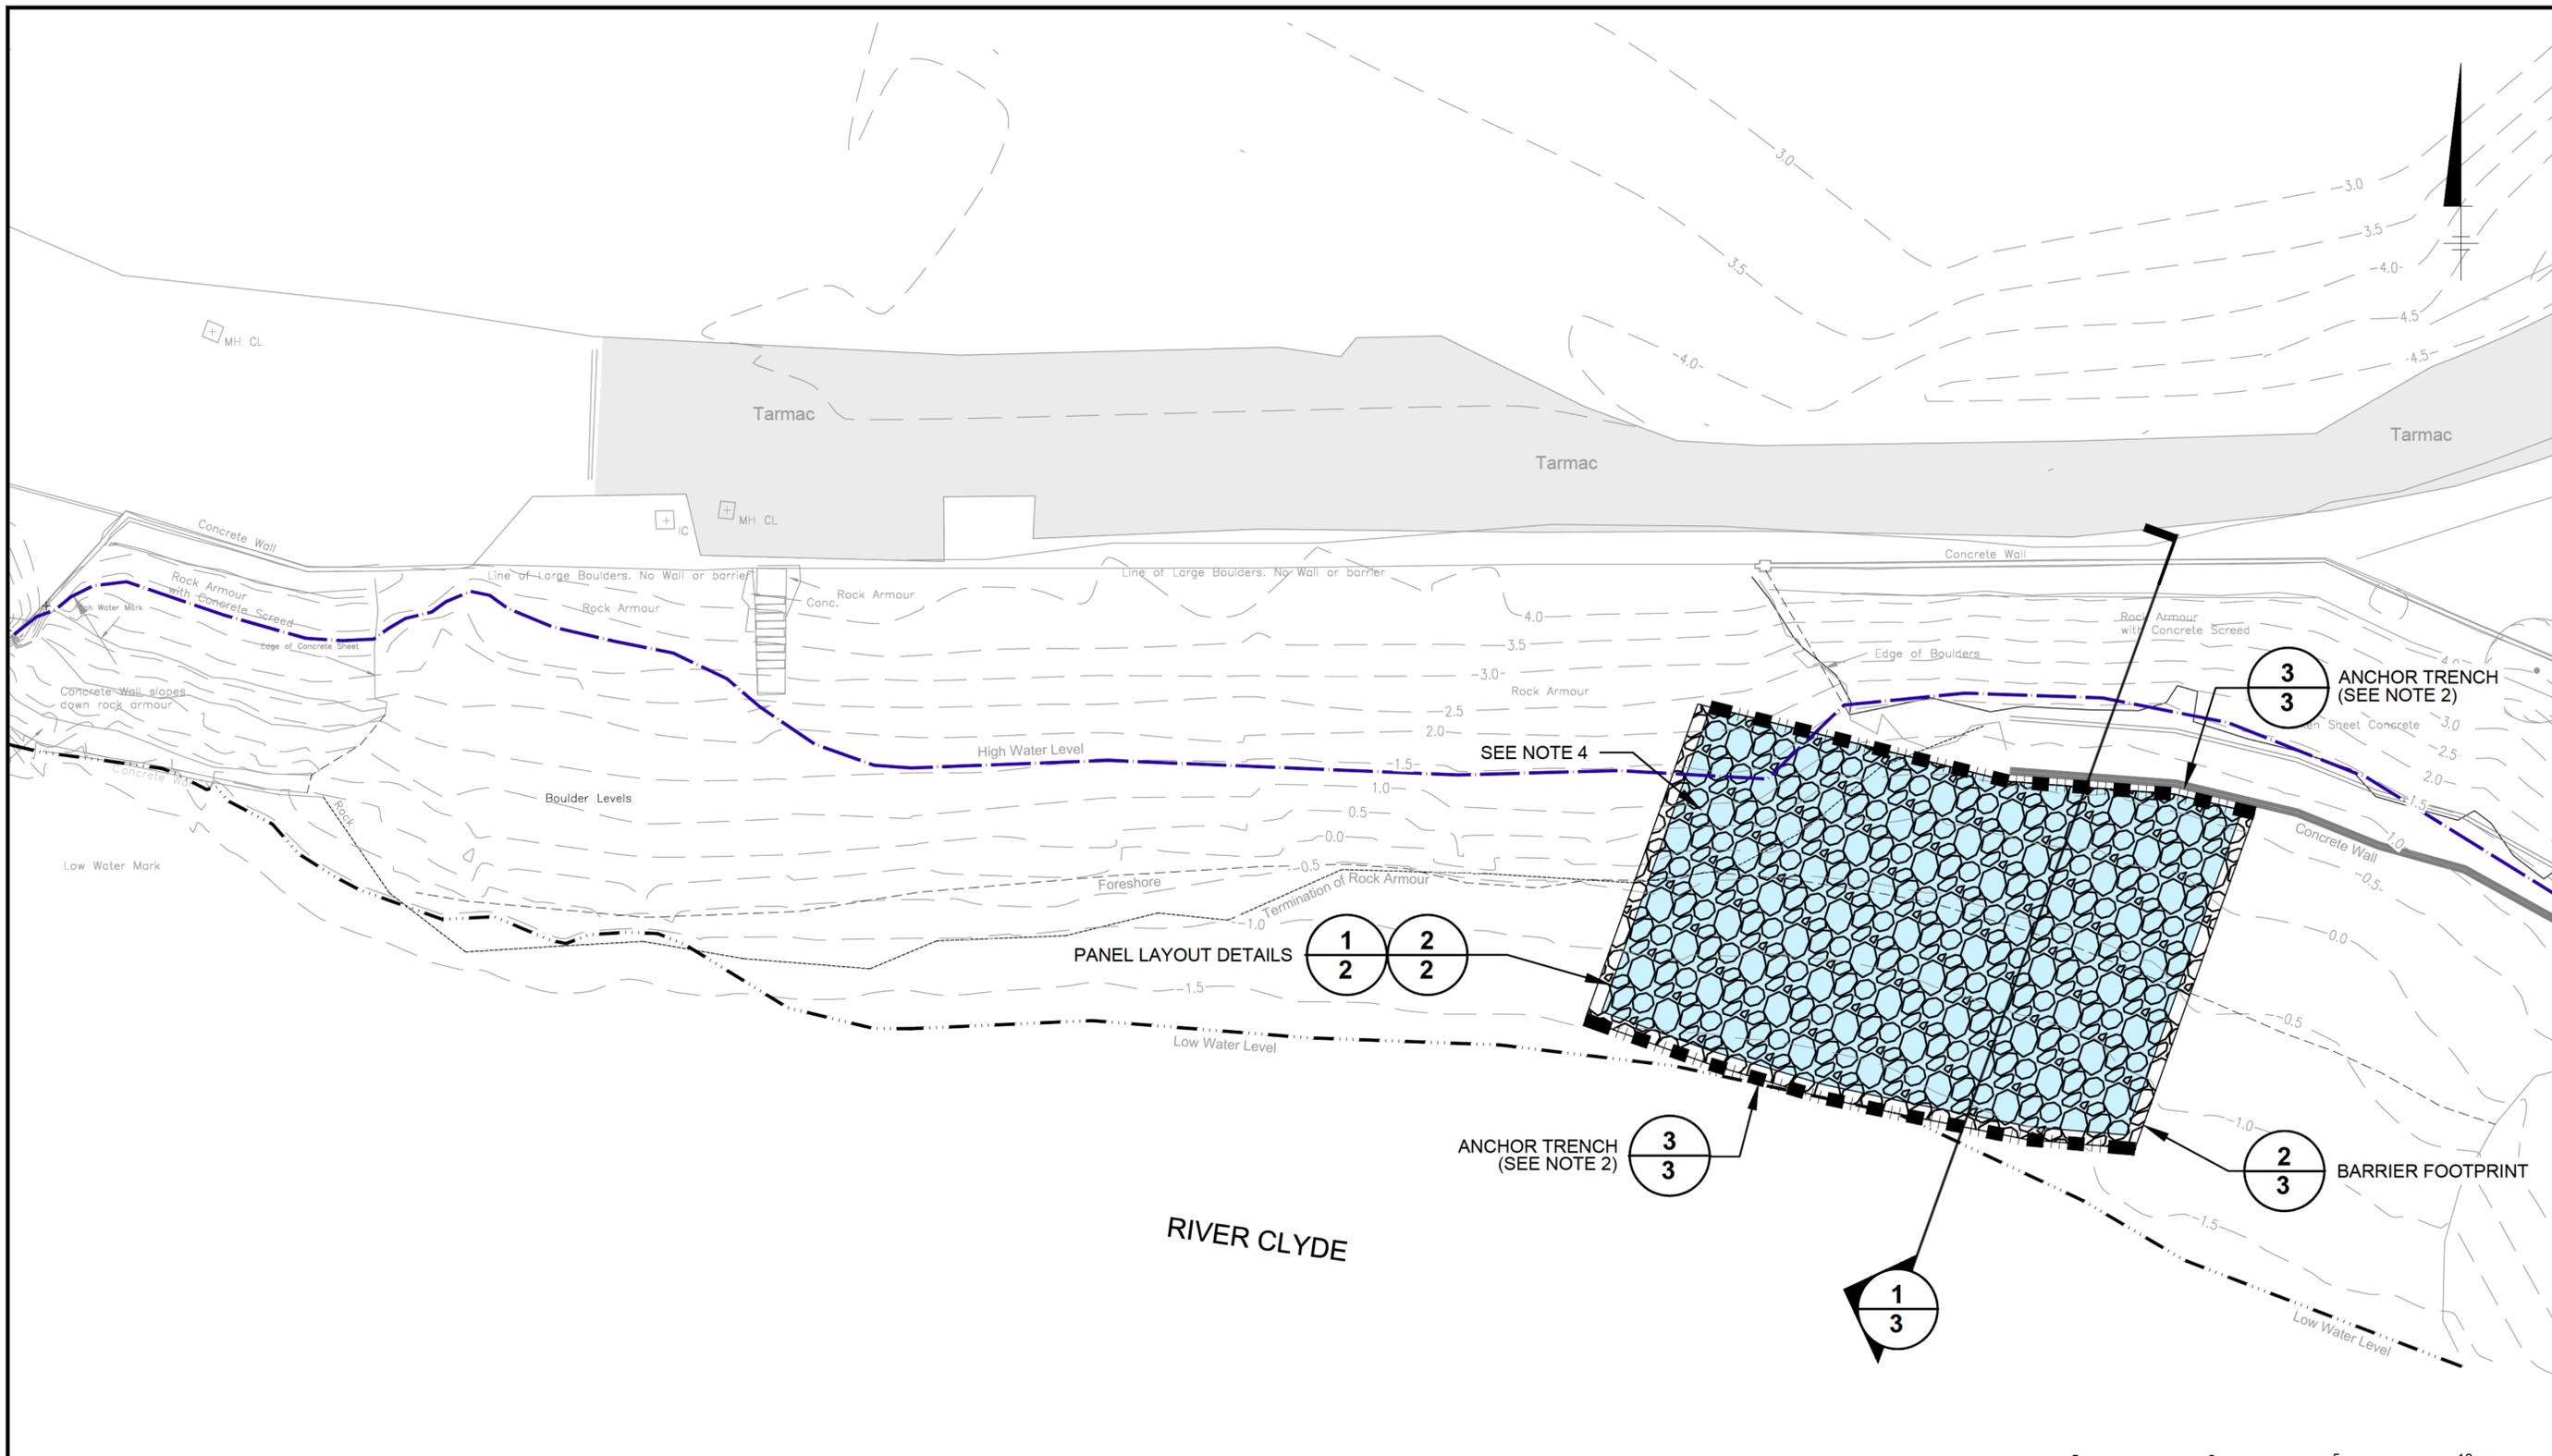
FIGURE 1a

1. APPARENT HIGH AND LOW WATER LEVELS ARE BASED ON VISUAL OBSERVATION.
2. ANCHOR TRENCH WILL BE CONSTRUCTED ALONG BASE OF CONCRETE WALL FEATURE, EXTENDING FROM TERMINATION OF WALL IN DIRECTION PARALLEL TO FORESHORE EDGE.
3. RIP RAP AND SAND COVER MATERIALS WILL EXTEND 0.5M BEYOND REACTIVE CORE MAT AND GEOCOMPOSITE FOOTPRINT.
4. SOIL UNDERLYING ROCK ARMOUR IN NORTHWEST CORNER OF BARRIER FOOTPRINT MAY BE IMPACTED BY HYDROCARBON. IF HYDROCARBON IMPACTS ARE OBSERVED DURING CONSTRUCTION ACTIVITIES, BARRIER FOOTPRINT MAY BE ADJUSTED BASED ON CONDITIONS OBSERVED IN FIELD.

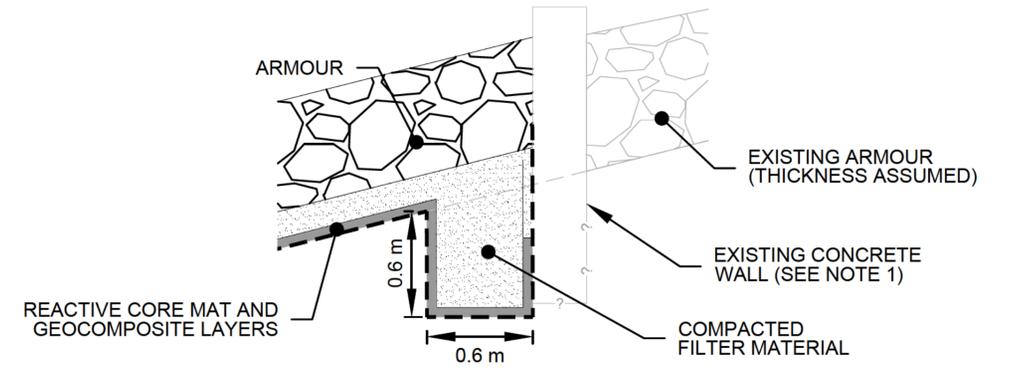
3/3 ANCHOR TRENCH DETAIL
 0 1m 2m

NOTE:
 1. CONTRACTOR SHALL EVALUATE STABILITY OF WALL BASED ON FIELD CONDITIONS. IF WALL IS DETERMINED TO BE UNSTABLE, WALL SHALL BE REMOVED.

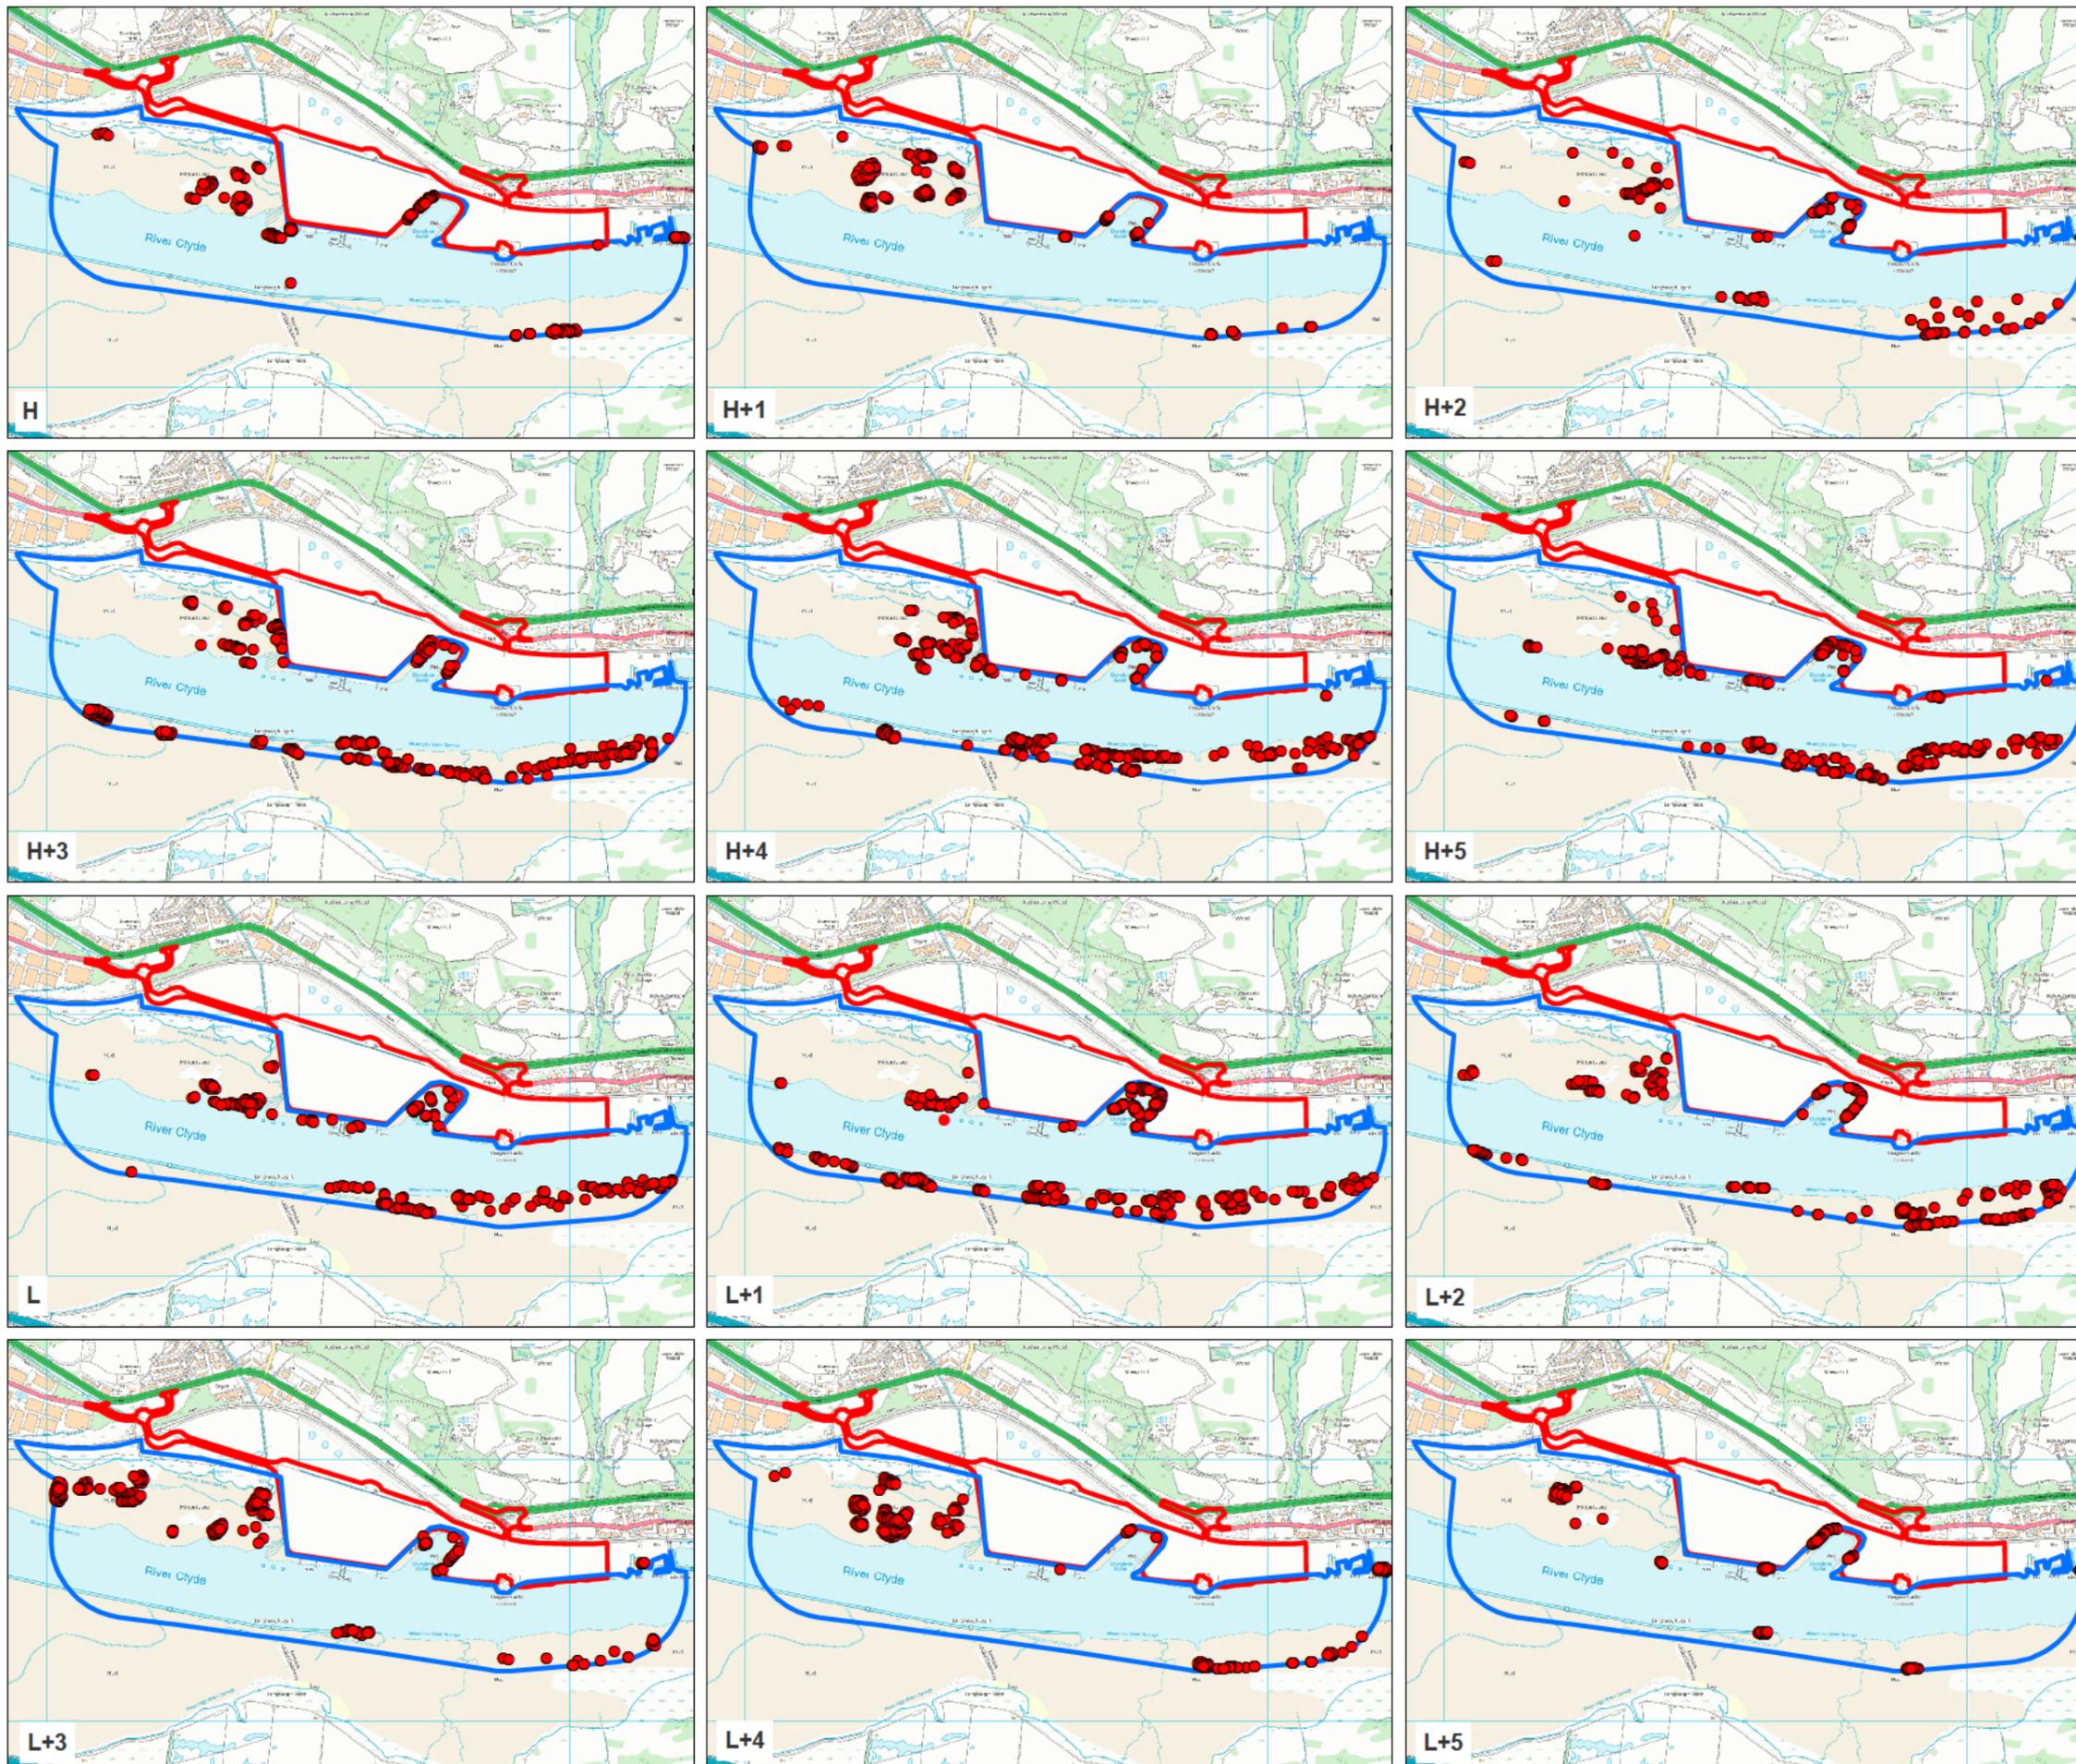
Figure 4.3

Over-Wintering Redshank
Through-the-Tide
Sept 2016 - April 2017

- site boundary
- count area
- redshank

- 4.6 The two key locations for redshank within the study area were within the Dunglass Basin and the south-eastern edge of the study area, including the end of the causeway on the southern shore of the River Clyde, opposite the mouth of the Dunglass Basin. In addition to these two key locations, there were pockets of higher usage by redshank at Frisky Wharf at the extreme eastern end of the study area and on the higher ground within Milton Island.

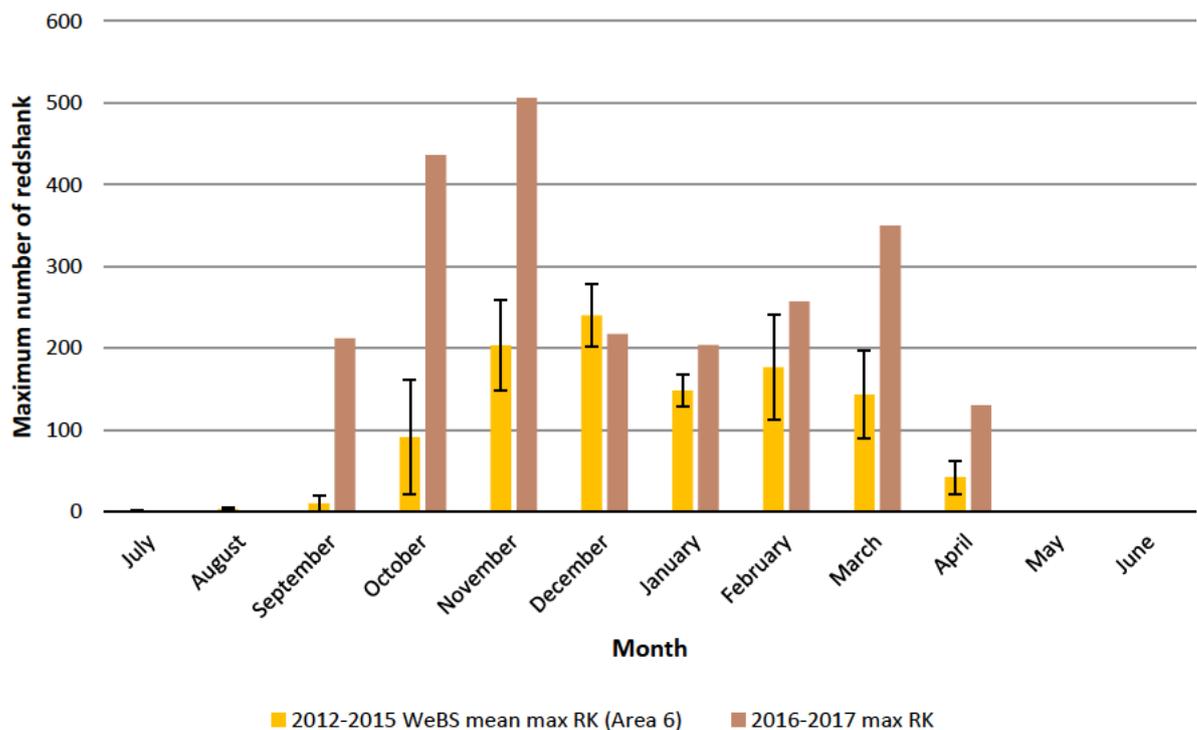
Figure 5.1: Comparison of 2016-2017 data with WeBS data (Area 6) recorded 2012-2015.

- 5.2 A comparison of the 2016-2017 data from the study area with the WeBS data for Area 6 (2012-2015) is provided in **Figure 5.1**. A direct comparison is not possible, due to the incomplete geographical overlap between the study area and WeBS area 6, and that the 2016-2017 data were only collected for the study area between the months of September and April. However, the general trends are similar – the redshank are reliably within the part of the SPA covered by the study area by September each year, and have left before the start of May. Peak numbers are slightly less predictable but the data suggest that this occurs around November or December for each of the years covered by these studies. There was a second peak in March 2017 which was not reflected in the WeBS data (but may be so in the Clyde Estuary 2 dataset).
