# Ecology Surveys of West Boathouse, Glasgow Green

## Report

Version 1.2

May 2017

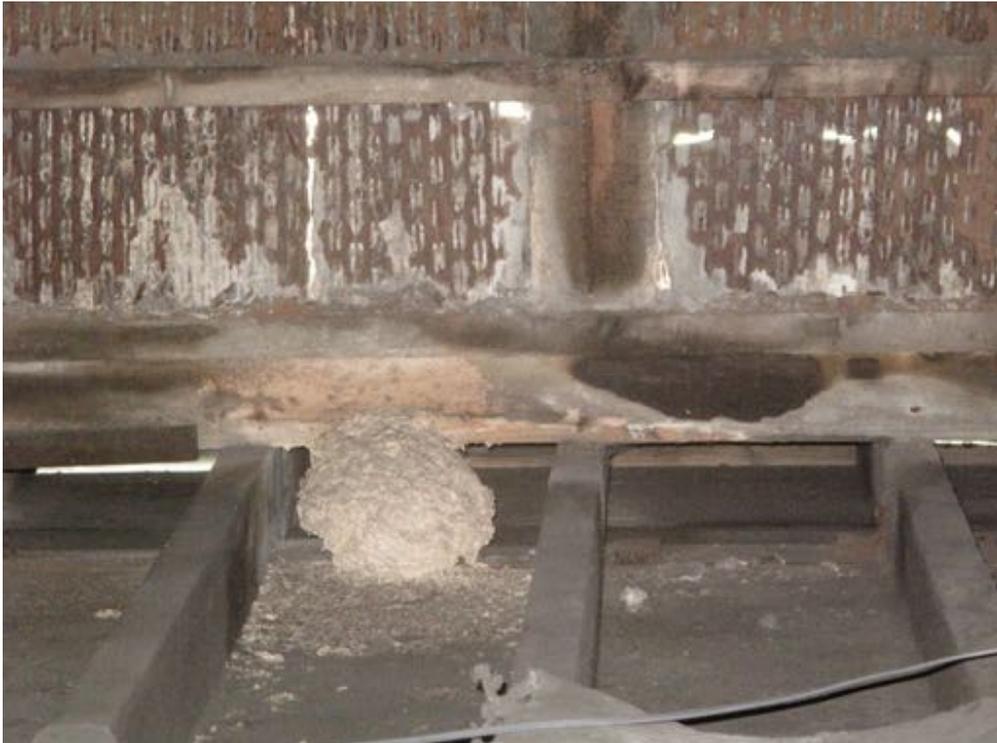
The interior of the boathouse including the attic space was searched for bats and signs of bats including droppings, urine stains and greasy marks. Approximately 95% of the attic space was surveyed although the northeast corner was avoided due to the presence of a large wasp nest (Photo 1). Such colonies can be dangerous in attics where it is not always possible for surveyors to exit the loft space quickly.

Photo 1 Wasp nest in northeast corner of attic. Light patches are holes in the roof.

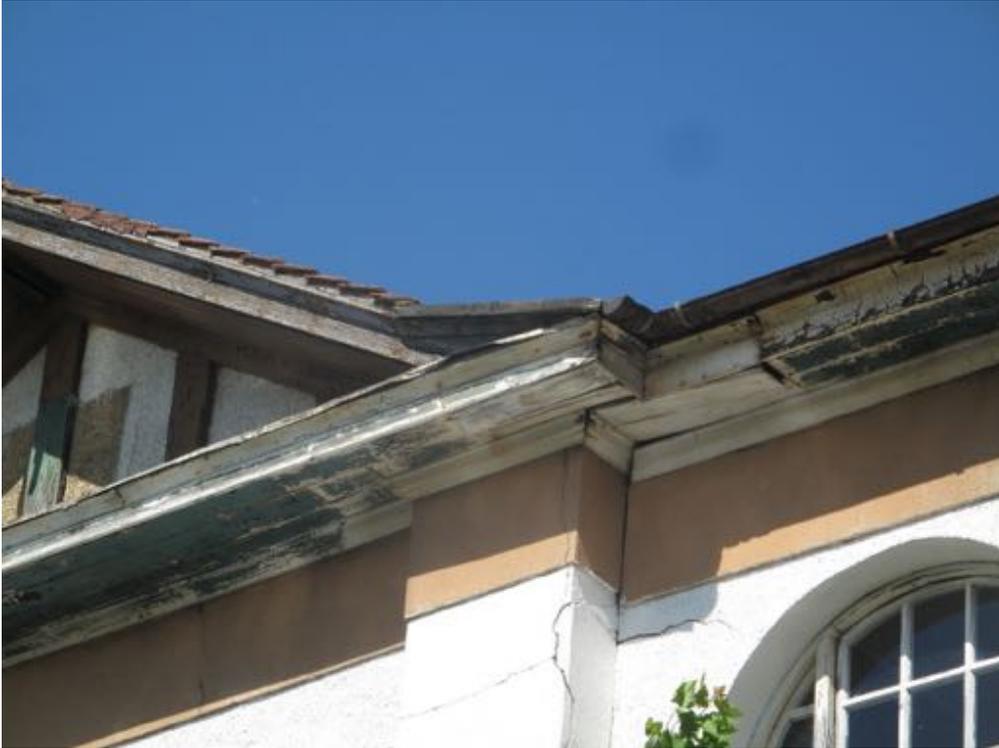
Gaps were also noted in the barge boards, fascias and soffits (Photo 3). Species such as pipistrelles in particular prefer to roost in spaces between buildings and exterior structures such as cladding and the riverside face of the boathouse is highly suitable for this species. The proximity of the boathouse to the river bank means that there is a natural animal commuting route present for bats. A common toad (*Bufo bufo*) and a red fox (*Vulpes vulpes*) were observed using this corridor in the daytime and evening respectively. The river itself will provide valuable feeding habitat for species which feed on insect life over open water e.g. soprano pipistrelle. The presence of numerous park trees and park grassland nearby can also provide appreciable amounts of insect biomass for bats to feed on even if insect species diversity is low.

Photo 3. Gaps in the bargeboards, fascias & soffits

The BCT guidelines do not state a timeframe over which bat surveys remain valid but indicate that factors such as changes in building condition should be taken into account. It is recommended in this report that emergence surveys are conducted during the summer prior to renovation in order to minimize the period between surveying and construction.

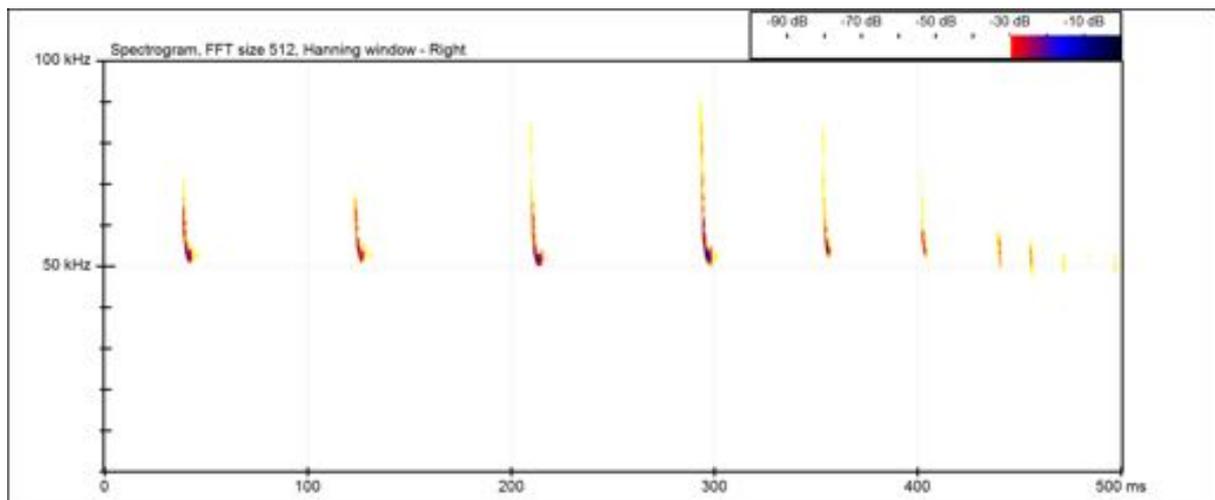
Bats were not recorded emerging from the building during the evening survey although Soprano Pipistrelles (*Pipistrellus pygmaeus*) were feeding continuously around the western gable end of the building from 10:05pm onwards (Figure 2). Generally one individual and occasionally two flew in a circle between the building and nearby bushes. It is likely that this area was selected as it was the most sheltered on the evening of the survey during which a light breeze was present.

Figure 2. Spectrogram of Soprano Pipistrelle echolocation calls recorded 14<sup>th</sup> May.

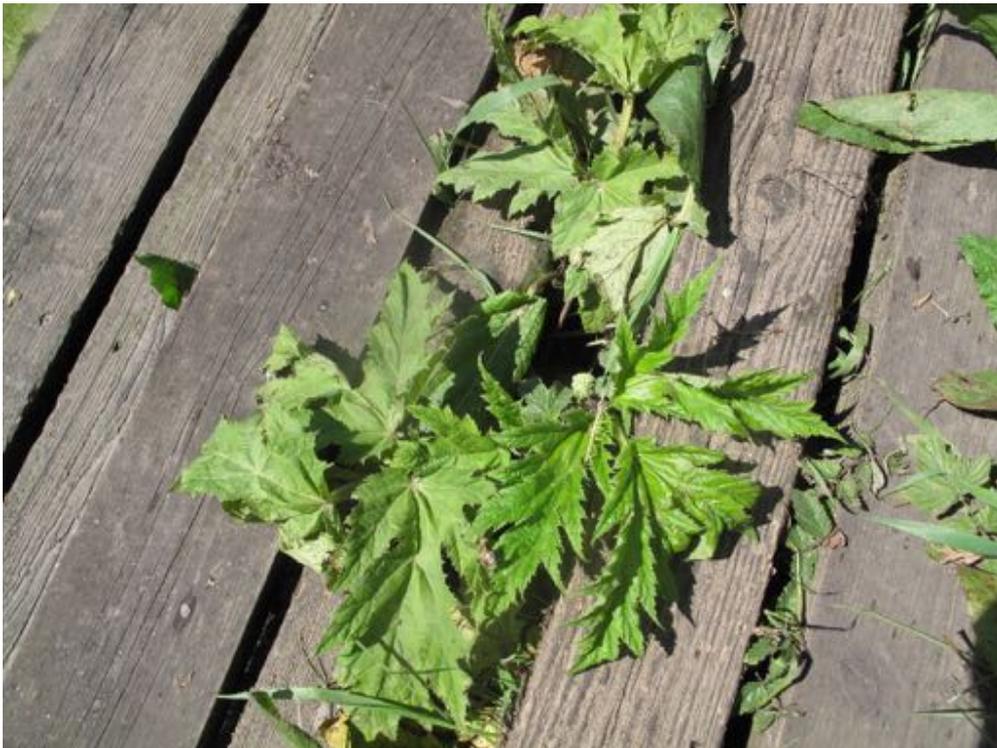
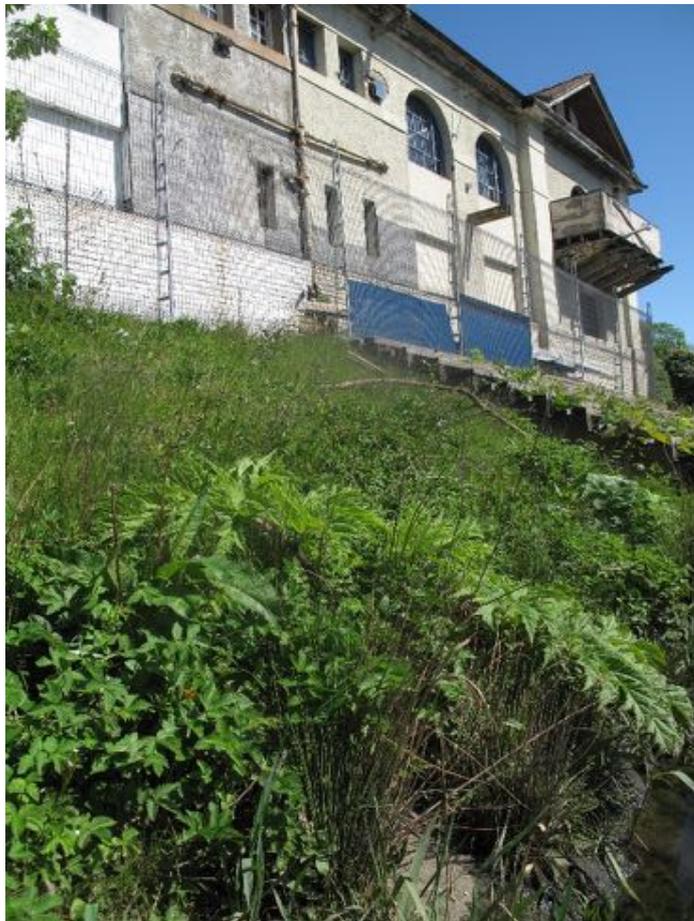
Giant hogweed (Photo 4 & front cover picture) contains large amounts of poisonous sap which, on contact with the skin and in the presence of sunlight, causes severe irritation, swelling and painful watery blisters. This reaction can occur up to 24 hours after exposure to sunlight. Contact with eyes can cause temporary blindness.

Photo 4 Giant hogweed growing through the boathouse riverside steps.

In order to avoid infringement of the wildlife legislation, care must be taken to avoid moving plant seeds and fragments including those in surrounding soil unless as part of an eradication program. Given the extent of giant hogweed in the grounds of the boathouse it may be desirable to initiate an eradication program prior to the construction phase in order to prevent transport of vegetative material off site e.g. on the wheels or tracks of construction plant.

SEPA have recently requested general biosecurity measures on construction sites in south west Scotland which involves pressure washing construction plant tracks & wheels prior to arrival on, and departure off site. In addition, they require photographic records to be kept with an associated register of construction plant movements and washing history. This policy was primarily adopted to reduce the risk of spreading signal crayfish eggs and hasn't been launched nationally yet (*pers comm*, John Gorman SEPA, 29/05/17) although it should be followed for the boathouse project given the risks associated with the site.

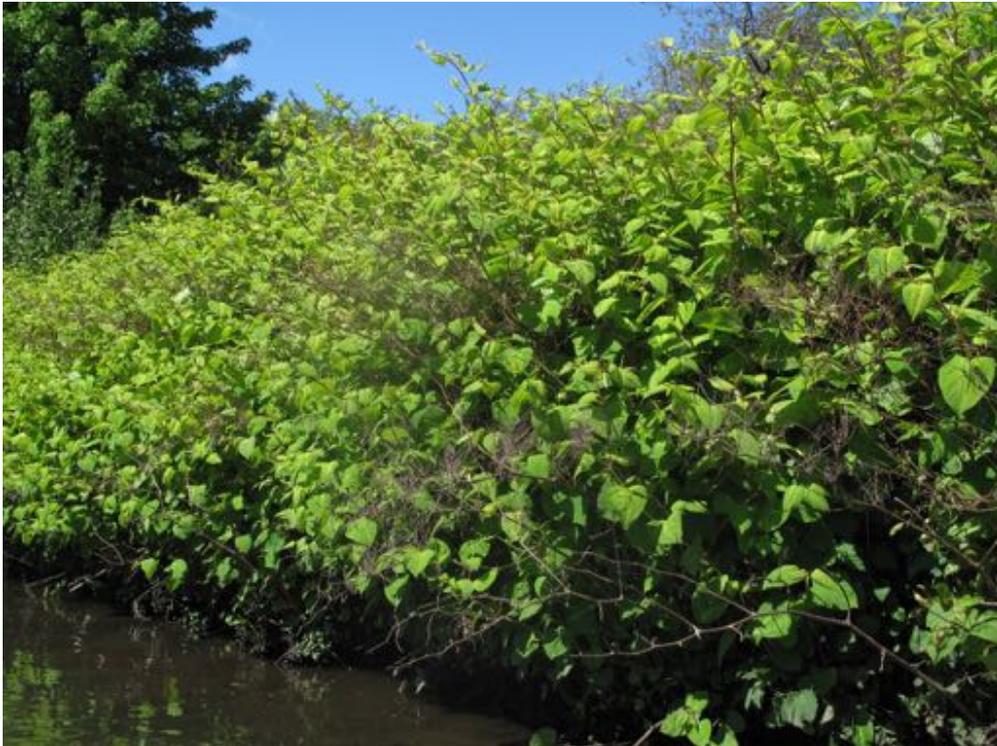
The root system of Japanese knotweed (Photo 5) can extend several metres from the original plant and grow up to 2m deep. The plant spreads rapidly through growth of its root system and because fragments of its stem or root can grow to form new plants. The plant is strong enough to damage foundations, walls, roads and drainage pipework.

Photo 5. Large stand of Japanese knotweed upstream of the boathouse

The current location of Japanese knotweed is unlikely to conflict with the boathouse renovations but the plant's distribution should be monitored in case new growth occurs nearer to the boathouse.
