August 2015

GEOLOGICAL, HYDROGEOLOGICAL BASELINE DESK STUDY BRIMS TIDAL ARRAY

PROPOSED TIDAL DEVELOPMENT

IN ORKNEY

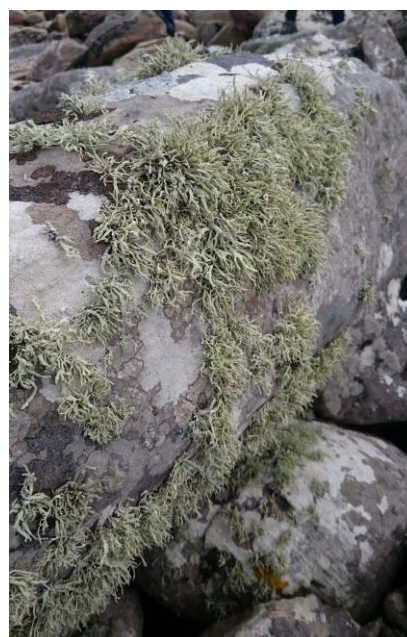
Figure 13 Lichen cover indicative of long period with zero movement

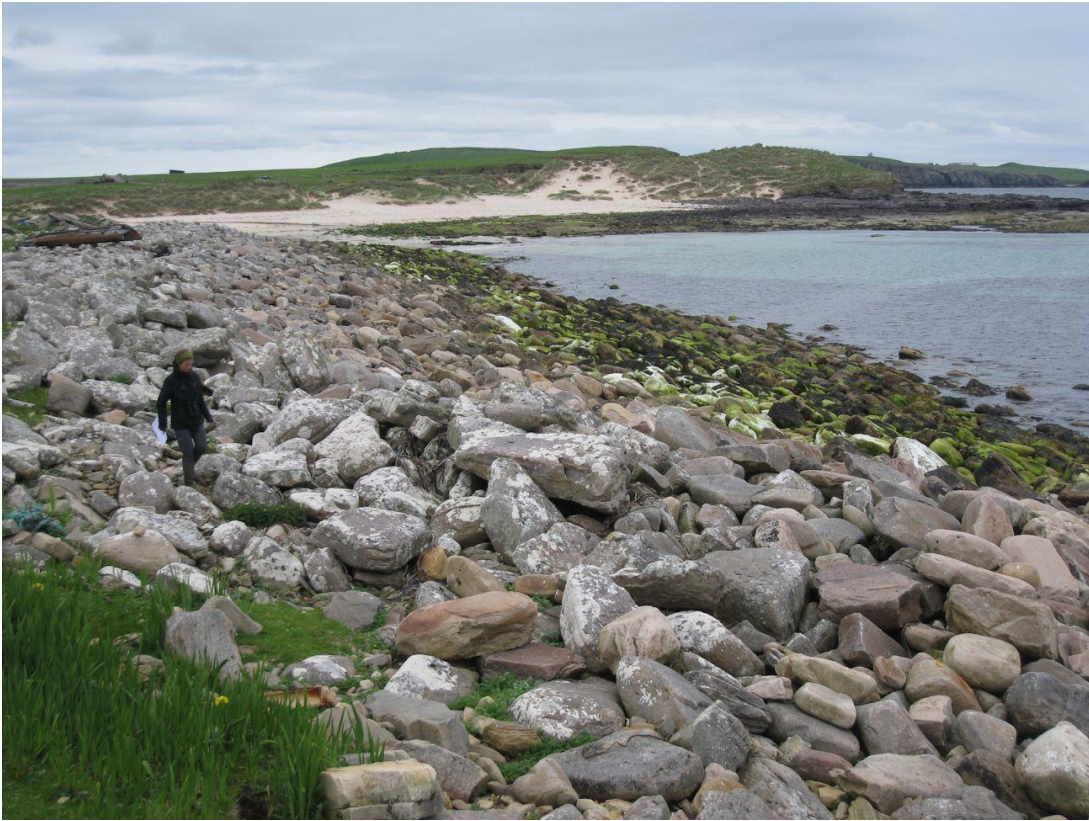
*Figure 14 Tapered southern end of storm beach showing age profile from the foreground and right-hand side of picture to the lichen covered upper beach left – intertidal and salt splash zone clearly delineated*

This suggests that the lichen cover at the back of the beach at Torness indicate that those boulders have not been turned over for many decades. Differences across the boulder beach from more angular blocks on the upper side to more rounded blocks imbricated on one another are common of the intertidal zone. This is quite common on boulder storm beaches - the landward blocks have been eroded in big storms and then thrown high up, so they do not get rounded.

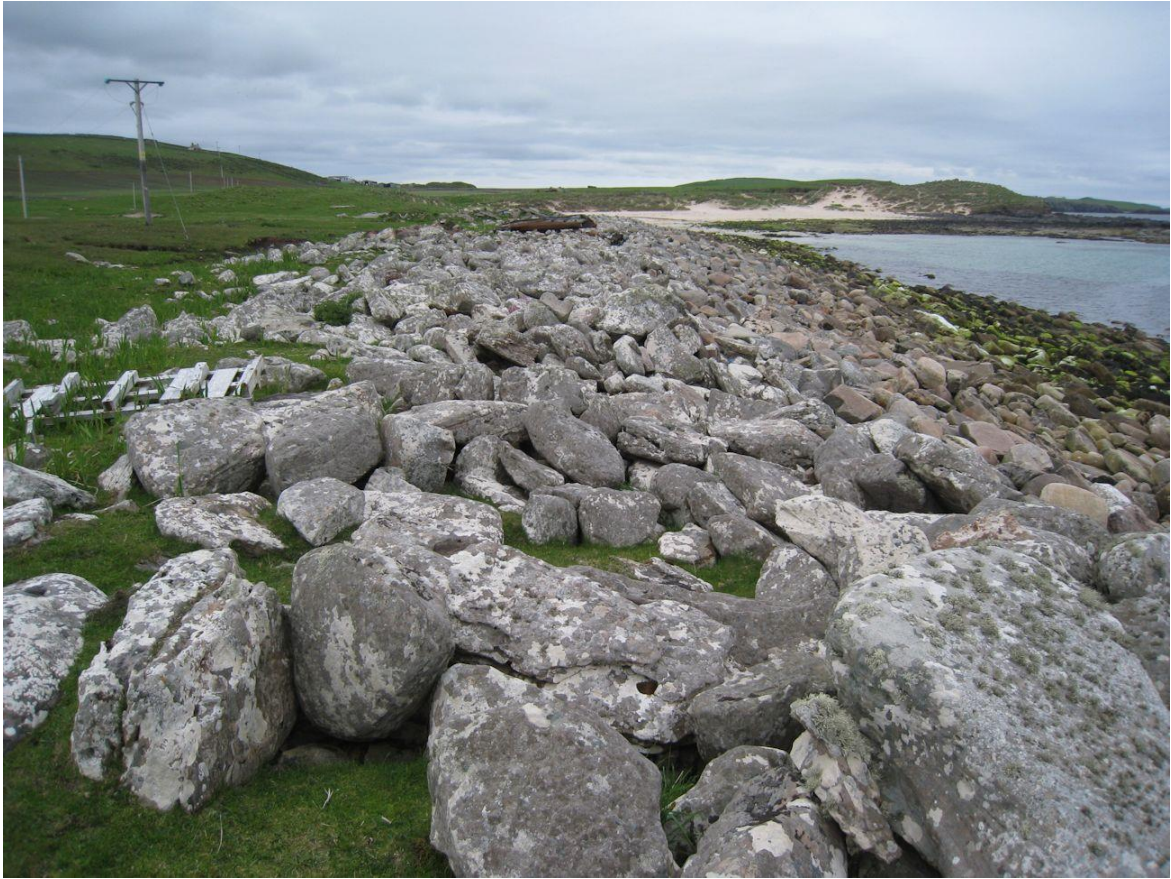
Figure 15 Sandstone Boulders here are Hoy Sandstones and not Eday Sandstones which are orange and yellow in this area

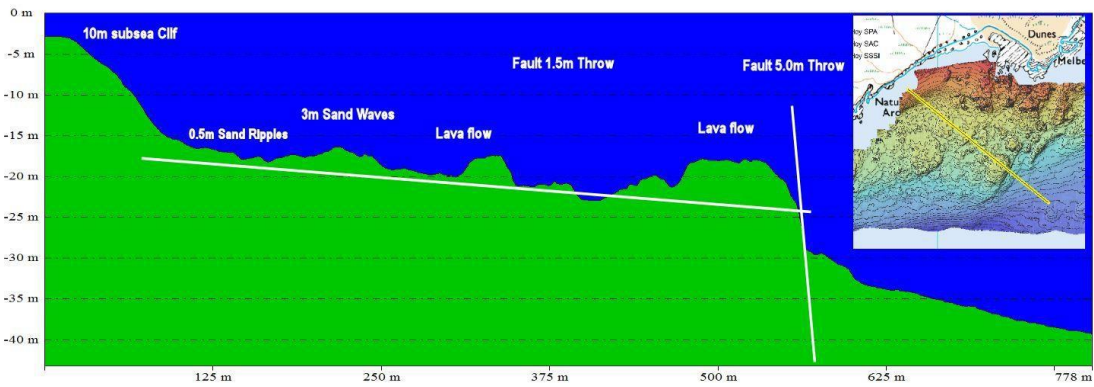
Figure 23 Cross section showing outcrop of Volcanic Rocks
