BAE Govan - New Assembly Hall

Geotechnical & Geo-environmental Desk Study

June 2022

Document reference: | 107212-MMD-00-XX-RP-GE-0003 | |

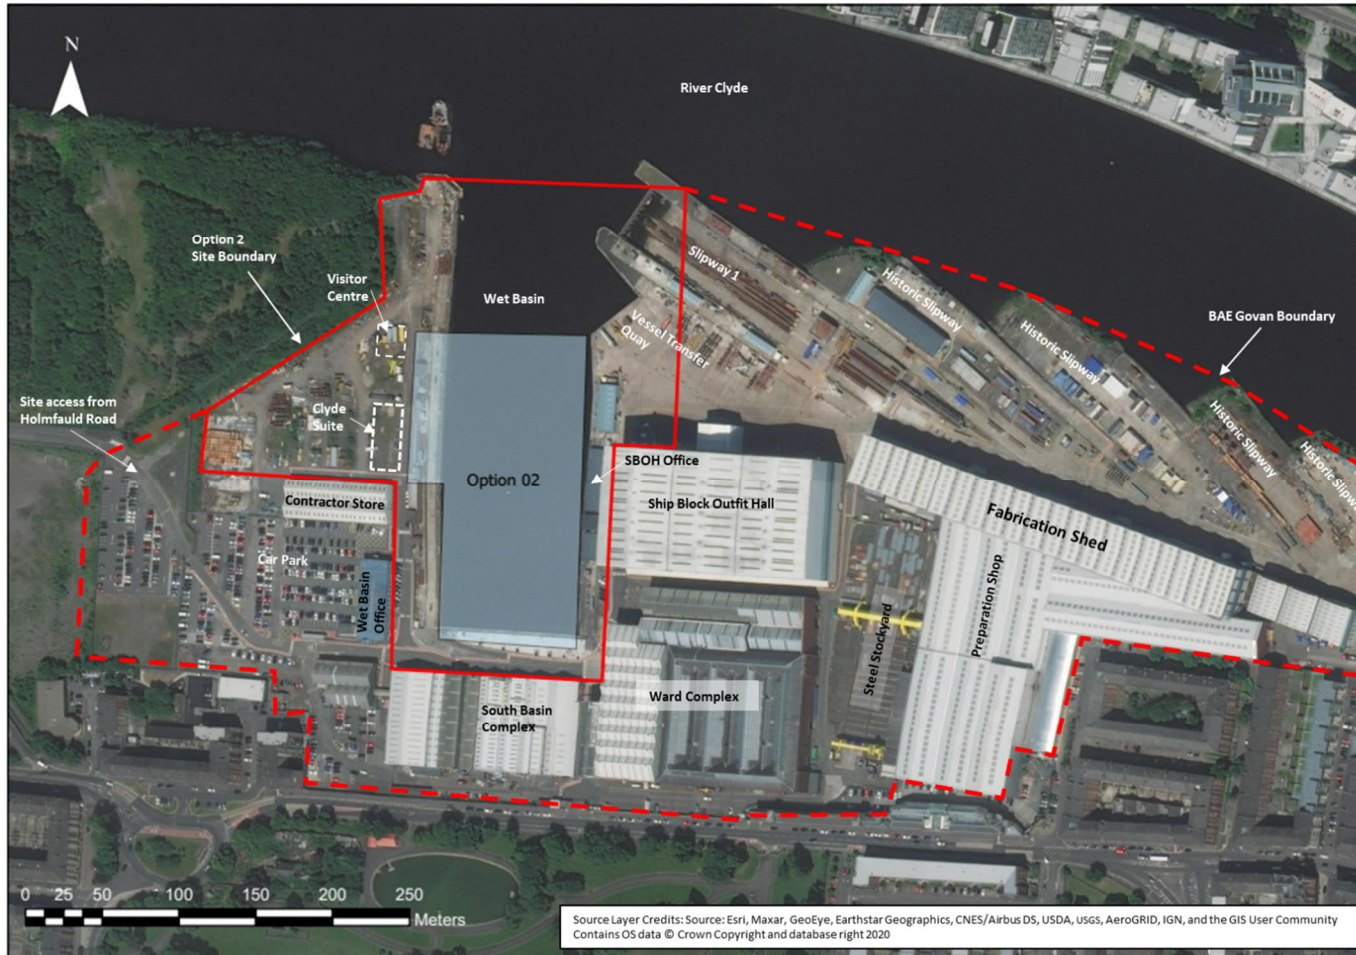
Figure 2-1: BAE Govan Shipyard – Site Features Plan

Source: ESRI Mapping. [Note: Building annotations taken from 2017 'Govan Site – General Arrangement – Yard Layout'].

A general description and summary of pertinent site information is given in Table 2.1 (with salient site features highlighted in Figure 2-1) based on the following data sources:

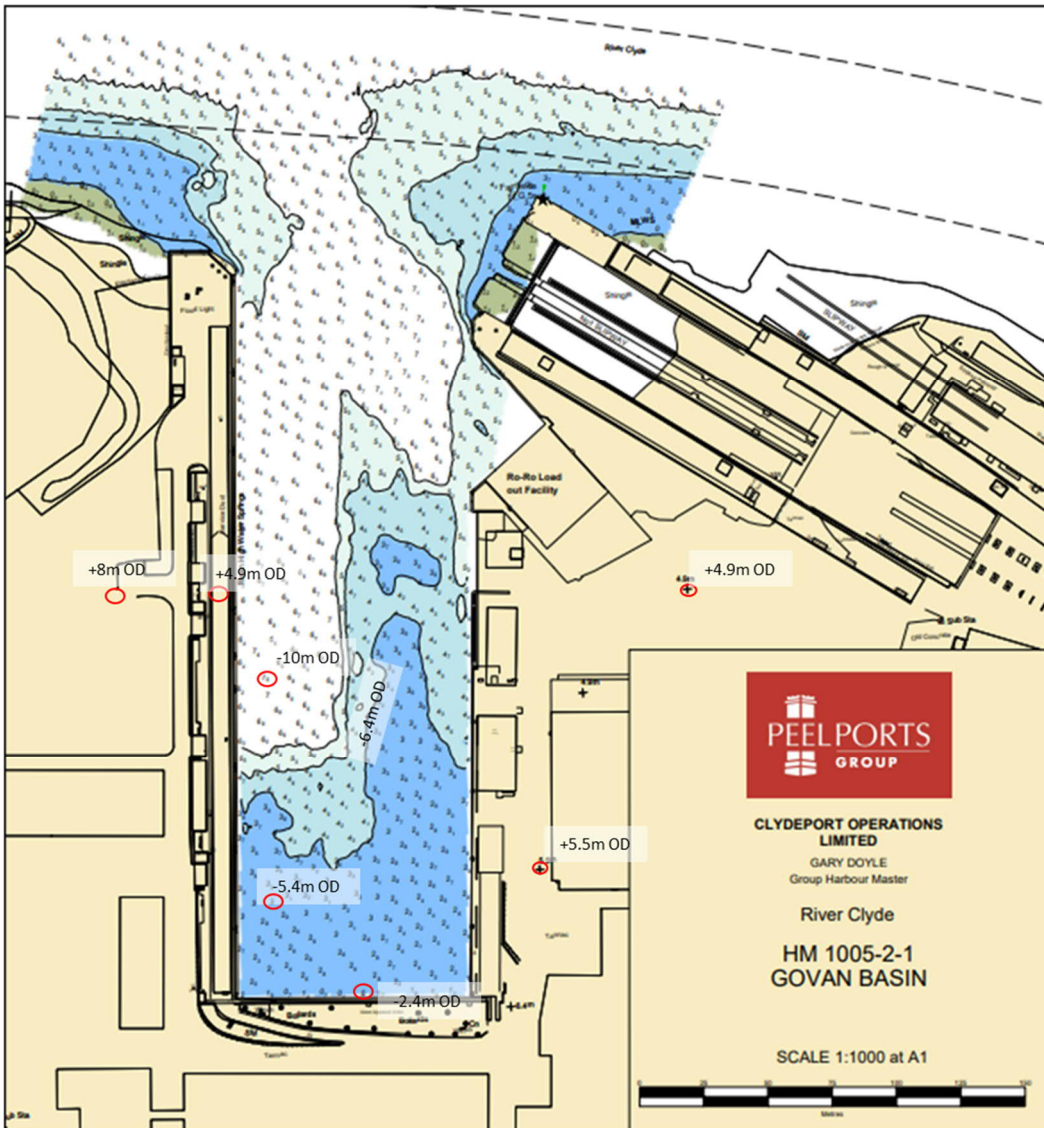
Figure 5-3: Bathymetric Survey completed by Aspect Surveys in January 2021

Source: Extract of Drawing HM 1005-2-1, Aspect Surveys, 2021 (**Note;** MM added approximate elevations in mOD for riverbed and quayside for appreciation of potential existing steel pile quay wall retained heights).

An over-water Geophysical Survey of the BAE Govan site was undertaken in March 2015 by Aspect Surveys, however this only covered the northern extent of the Wet Basin along with the River Clyde. This survey comprised sub-bottom profiling by means of seismic reflection to seek to determine the depths to 'significant seismic reflectors', particularly those that can be correlated to changes in geological strata. This identified Horizon 1 which is interpreted as the base of a well-stratified layer of sediment, however this horizon is missing from the Drawings provided in the Appendix of the report.

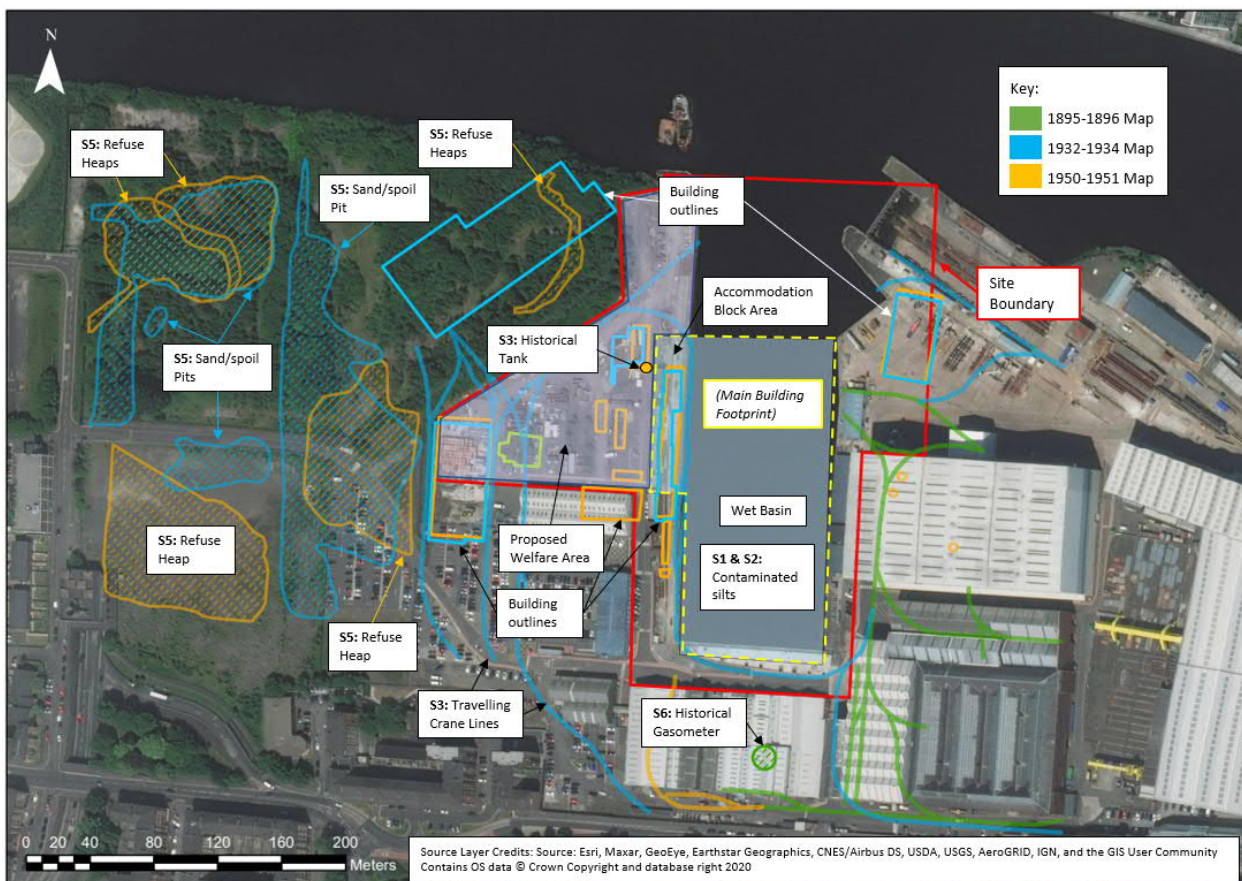
Figure 7-2: Locations of Potential Contaminant Sources

Potential Sources	Details	Contaminants of Concern
S5: Made Ground associated with historical Refuse Heaps and Sand Pits (1913-1971 maps) situated west of site boundary.	Historical mapping shows sand pits to have been previously infilled with unknown material that may be contaminated.	Metals, hydrocarbons (oils, diesel), PAHs, cyanides, VOCs, SVOCs, asbestos
S6: Historical soil and groundwater contamination associated with historical gasometer (1895-1896 map).	A gasometer was recorded approximately 60m south of wet basin in 1895-1896 mapping only.	Metals, coal tars (hydrocarbons/PAHs), inorganics incl. ammonium sulphates/cyanide, asbestos

Table 7.6 provides a summary of the potential sources and associated contaminants of concern for the site, informed by the Department of Environment 'Industry Profiles' (DOE 1995). It is not intended to provide an exhaustive list of contaminants for analysis during any future ground investigation on site, as selection of the contaminants for analysis should be based on the objectives of the investigation, the Conceptual Site Model (CSM) and the ground conditions encountered on site. Figure 7.2 shows locations of potential contaminant sources.

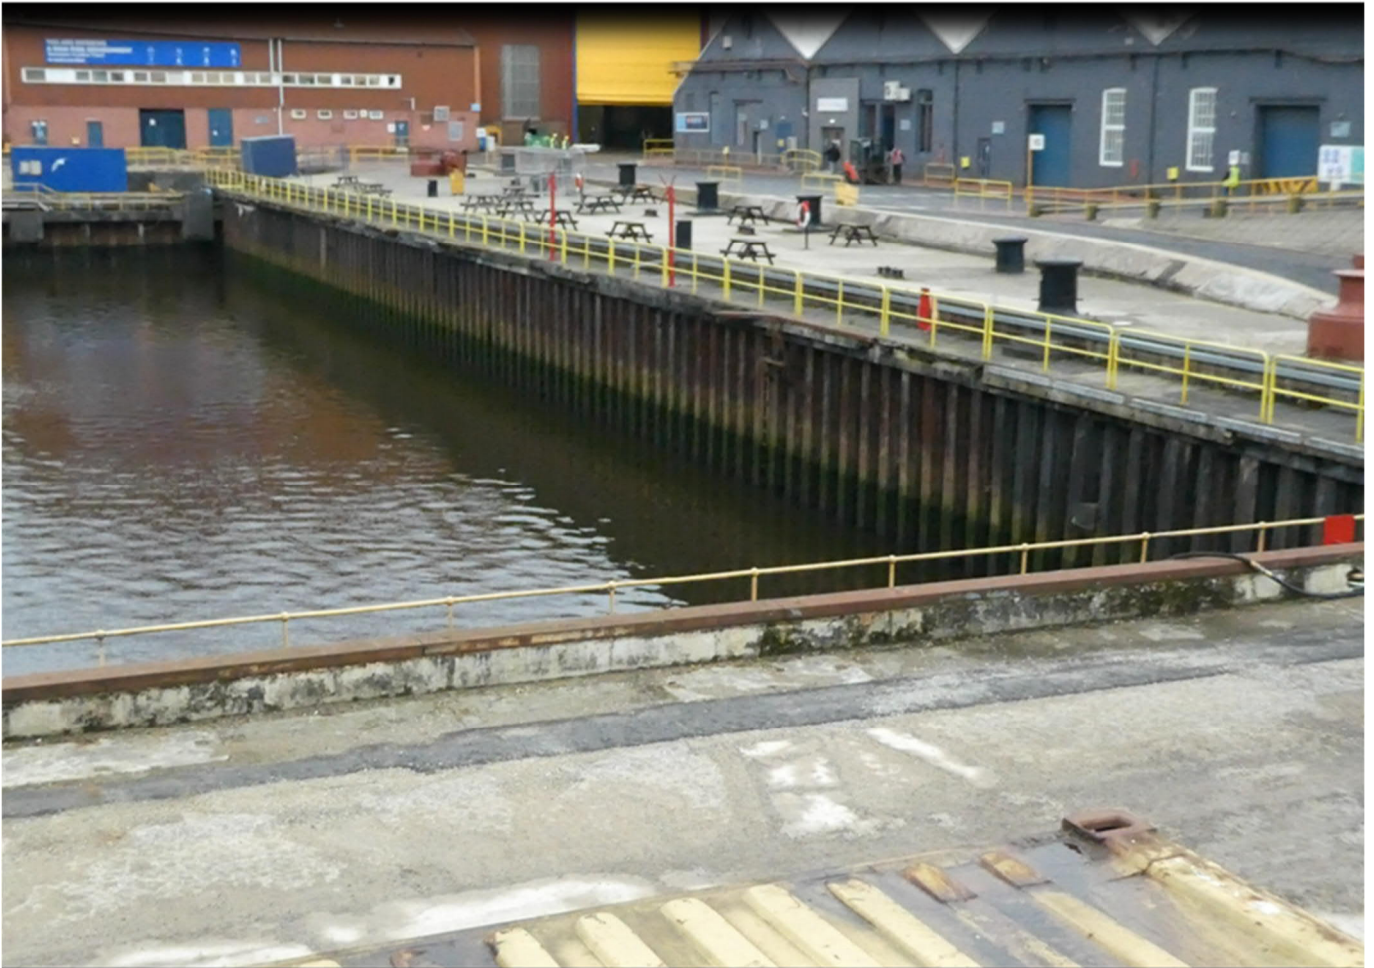
Photo B.2: View of Wet Basin and southern quay wall, taken from western quayside

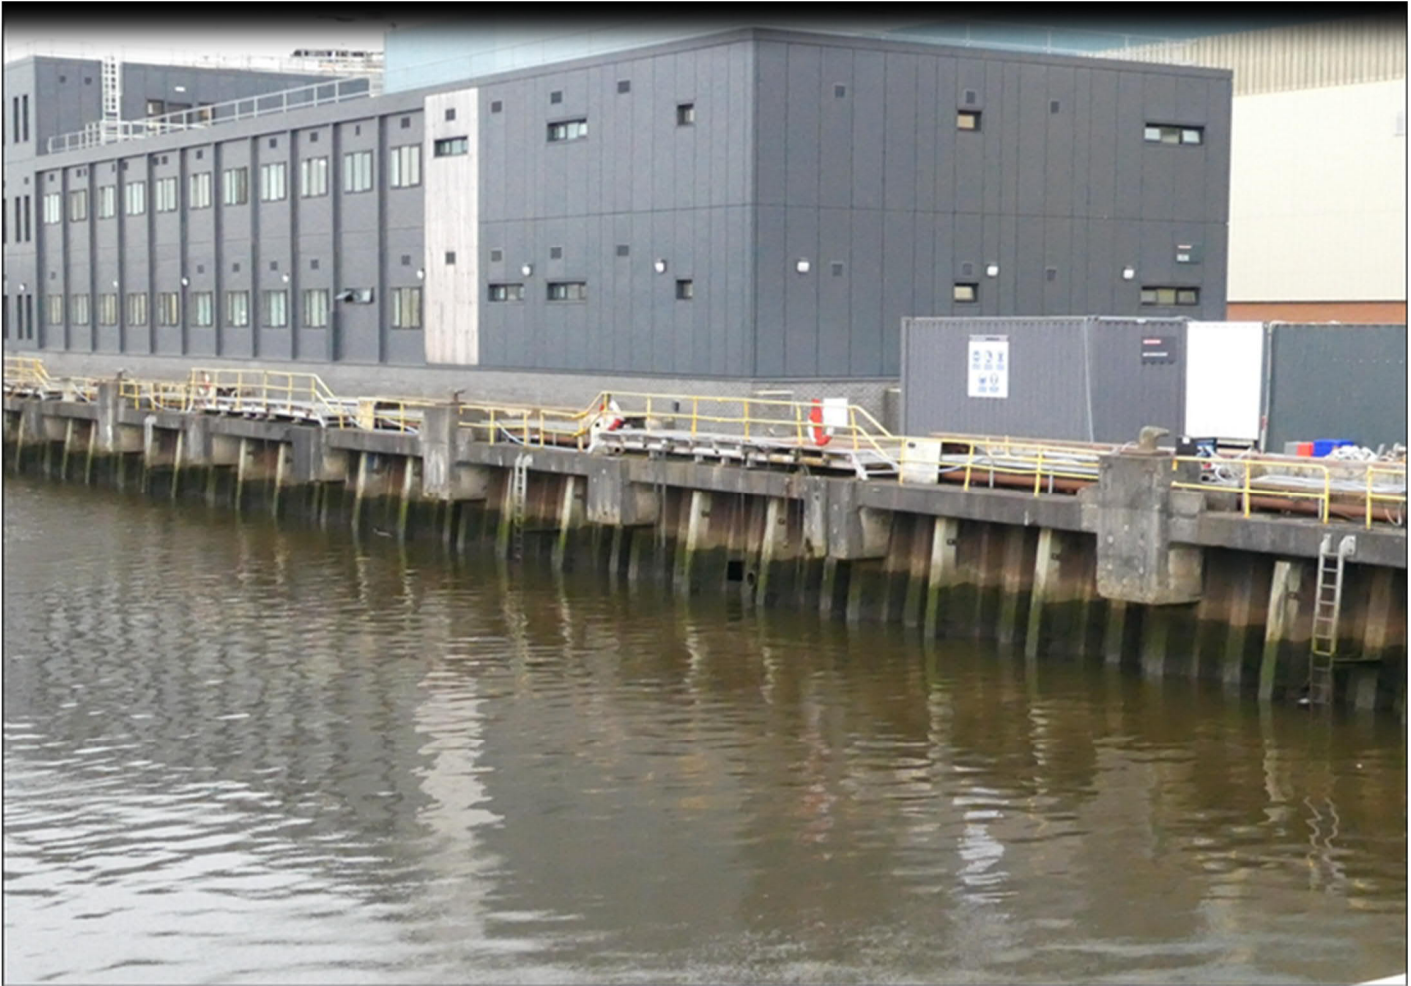
Photo B.3: View of Wet Basin and eastern quay wall, taken from southern quayside

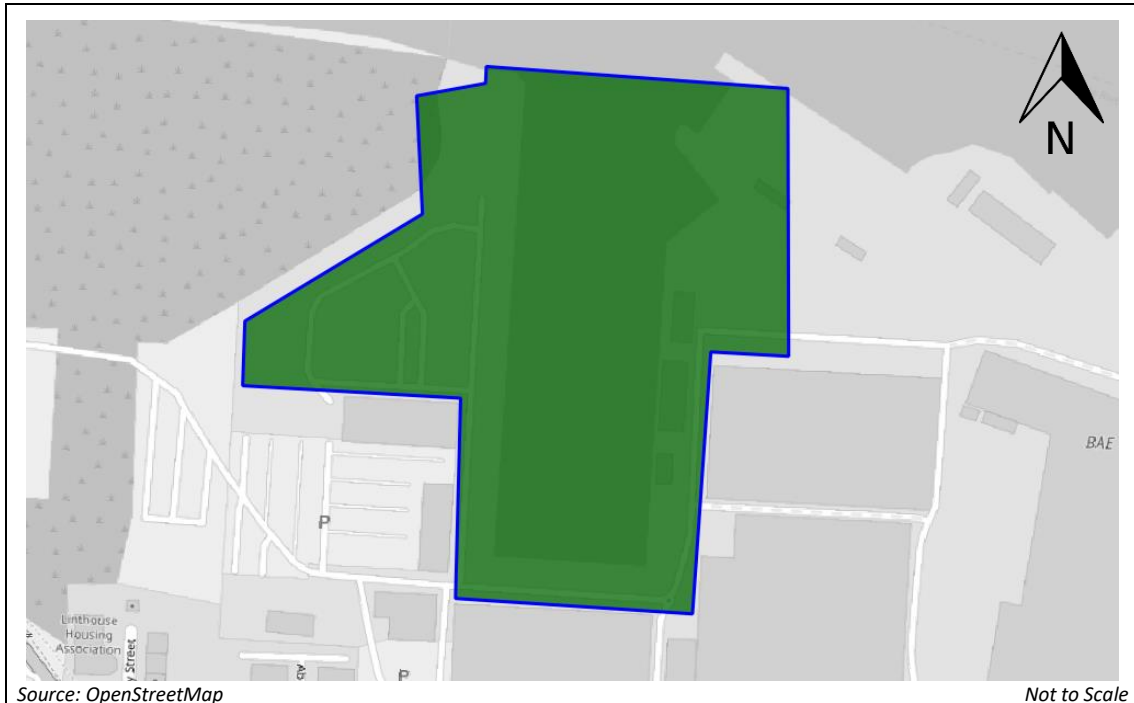
Legend	Very Low	■	Low	■	Moderate	■
	High	■	Very High	■	Site boundary	—

The UXO hazard zone plan of the Site is also given in the accompanying P11620-22-R1-MAP01-A.

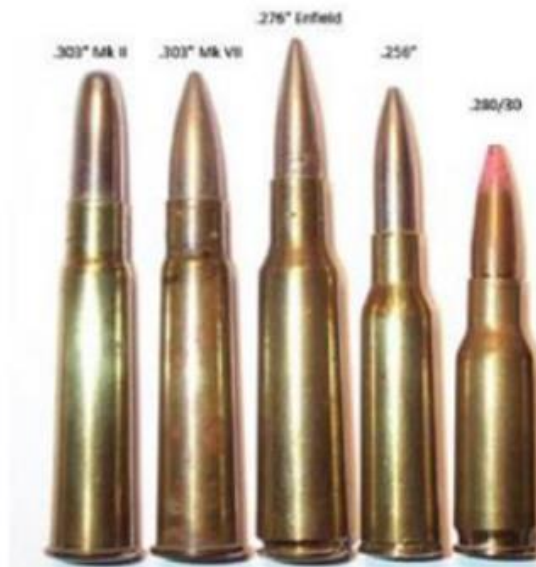
Category Small Arms Ammunition
Type Various

Description Small Arms Ammunition (SAA) is one of the more recognisable categories of ordnance which is primarily designed for anti-personnel use. SAA include items such as bullets, generally up to a calibre (diameter) of 20mm.

Generally small arms ordnance has a relatively low risk as UXO, although the larger calibre categories may have the same detonation risk as larger high explosive ordnance.

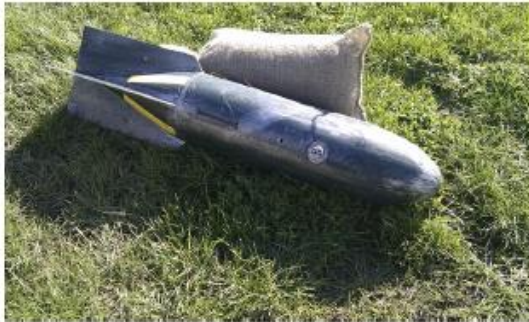
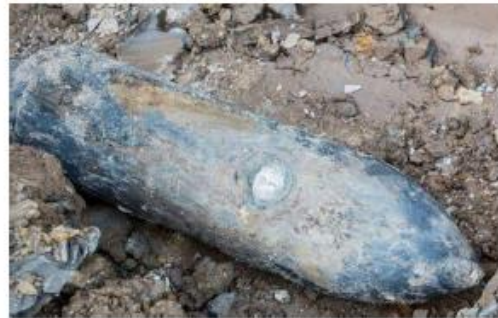
Category Bomb
Type Sprengbombe-Cylindrisch (SC) 250kg

Description Thick nose welded to steel body. Nose may be attached to Kopfring (triangular section steel ring) or spike. Sheet metal tail attached to body with rivets/ screws. Suspension eye bolt in the nose/body. Originally painted green-grey with a yellow stripe on the tail. TNT; amatol; TNT and aluminium powder, naphthalene, ammonium nitrate and wax/ wood meal filling.

Function Designed to maximise shock waves through air, water and earth and general demolition. Used against railway installations, large buildings, ammunition depots and below-ground installations (to 8m). Spike bombs/ 'Stabo' (SC 50 with spikes attached to nose) used against rail lines and country roads.

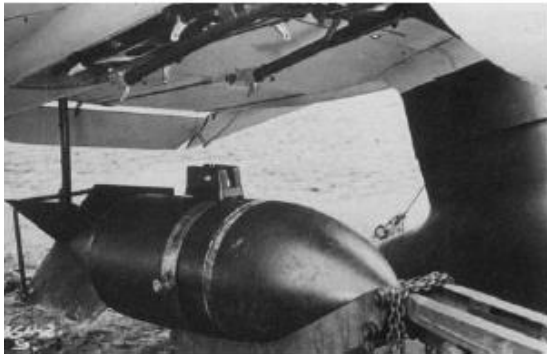
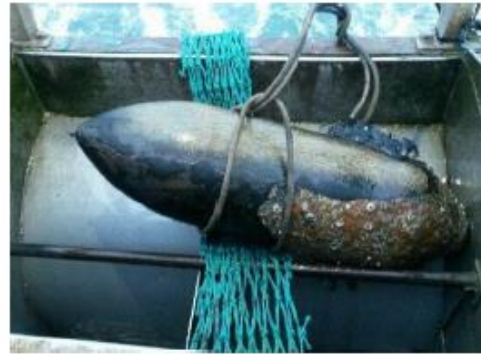
Category Bomb
Type Sprengbombe-Cylindrisch (SC) 500kg

Description Thick nose welded to steel body. Nose may be attached to Kopfring (triangular section steel ring). Tail either steel sheet or drum-shaped. Suspension band. Originally painted green-grey/ buff (some later versions sky blue) with yellow stripe on tail. Filled with amatol, TNT or trialen.

Function Designed to maximise shock waves through air, water and earth and for general demolition. Used against railway property, large buildings, shipping and below-ground installations.

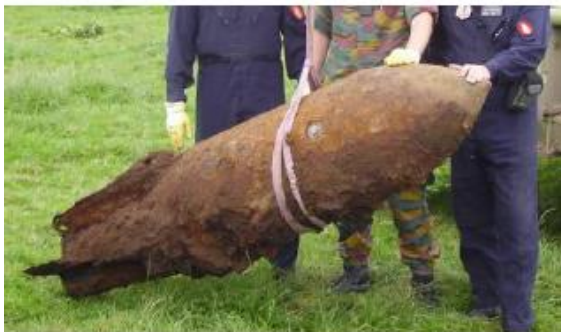
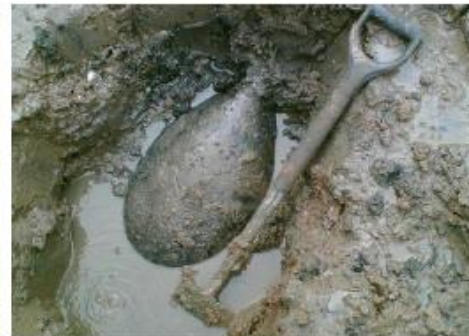
Category Bomb
Type Sprengbombe-Cylindrisch (SC) 1,000kg (HERMANN)

Description Thick nose welded to steel body. Nose attached to Kopfring (triangular section steel ring). Drum-shaped tail made of magnesium alloy. Suspension band. Originally painted sky-blue. Filled with amatol, TNT/aluminium/wood meal or trialen.

Function Designed to maximise shock waves through air, water and earth and for general demolition.

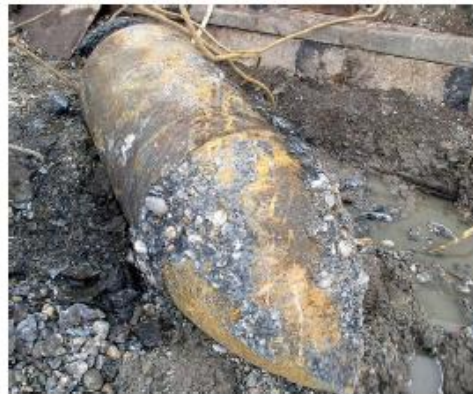
Category Projectile
Type 3.7" Anti-Aircraft Shell

Description Brass cartridge case. Square-based shell with tapered nose, filled with Amatol, TNT or RDX/TNT. MK6 had forward centring bands and a wider driving band.

Function Used as a defence against enemy aircraft, fired from fixed batteries and mobile mountings. Could fire approximately 20 rounds per minute with a maximum ceiling of 41,000ft and horizontal range of 20,600 yards.

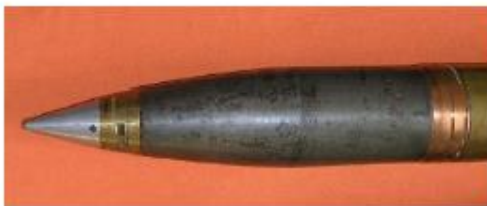
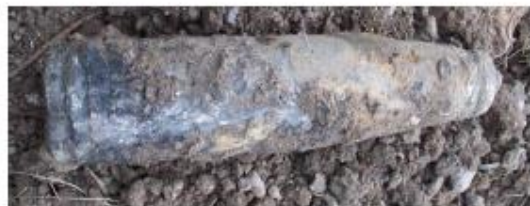
Category Projectile
Type 4.5" Shell (Mark II – Anti-Aircraft)

Description Square-based, tapered-nosed shell filled with TNT or Amatol. Steel casing, rotating band of either copper or gilding metal located 3.5" in front of the base end with single groove.

Function Used as field artillery and adapted for use in anti-aircraft defence from fixed batteries. Rate of fire of 8 rounds per minute, maximum ceiling of 44,000ft and horizontal range of 22,800 yards.

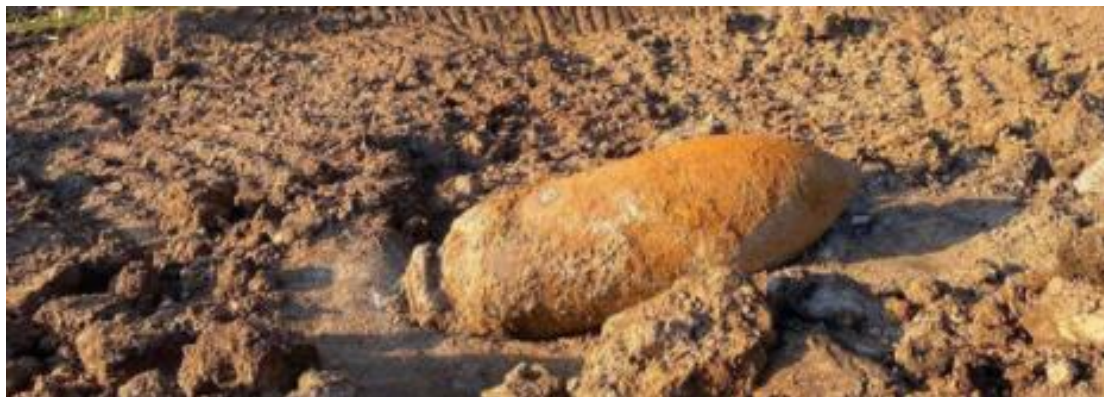
On the 26th February 2021, a 1,000kg German “Hermann” UXB was discovered by builders at Exeter University campus (see plate below). It was investigated and detonated in-situ following the evacuation of nearby properties and University halls of residence.
