# Inch Cape Offshore Wind Farm

Appendix 19B: Navigational Risk Assessment Offshore Export Cable

# Navigational Risk Assessment Offshore Export Cable Corridor

Prepared by: Anatec Limited

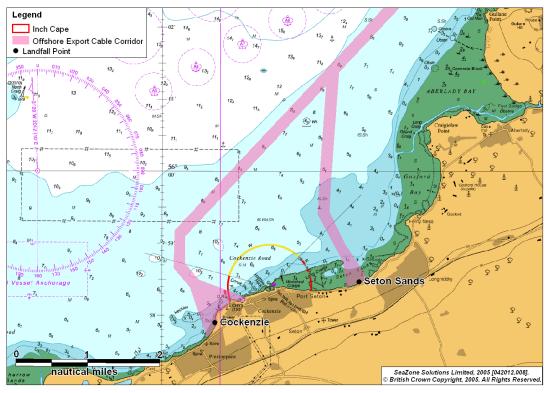
Figure 19B.2 Detailed Chart Overview of the Offshore Export Cable Corridor

It can be seen on the detailed chart overview of the Offshore Export Cable Corridor that there is a light located between Cockenzie and Seton Sands. This light has an isophase pattern (equal duration of lightness and darkness), is white and red in colour and has an elevation of 10 m above height datum. The period of light is 4 seconds with the range of the lights in clear visibility being 9 sea miles for the white light and 6 nm or the red light.

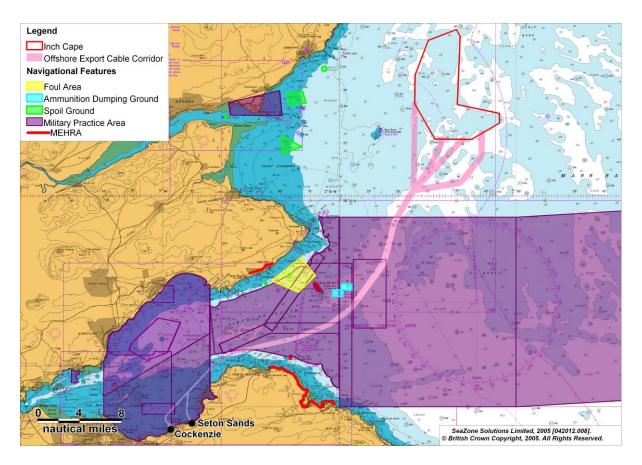
Figure 19B.3 Navigational Features Relative to Offshore Export Cable Corridor

There are two charted ammunition dumping grounds (disused) approximately 0.7 nm west of the Offshore Export Cable Corridor. There is also a foul area located approximately 4.3 nm to the west of the Offshore Export Cable Corridor, on the other side of the Isle of May. Vessels are cautioned from anchoring or fishing within this area due to the existence of foul areas and obstructions on the sea bed.

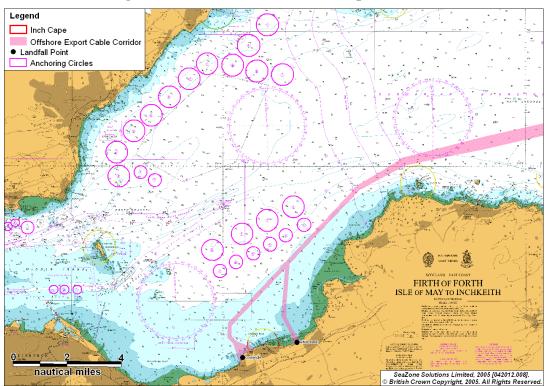
Figure 19B.5 Anchorage Circles Relative to Offshore Export Cable Corridor

It can be seen that there are a number of designated anchorage areas and anchor berths in the Firth of Forth and along the east coast of Scotland, none of which intersect the Offshore Export Cable Corridor.

Consultation with Forth Ports Harbour Master (see Section 19B.4) indicated no concerns with the proximity of the Offshore Export Cable Corridor to the anchorage circles. However it was noted that once an exact location was defined or during construction works Forth Ports would work with ICOL to ensure navigational safety is maintained.

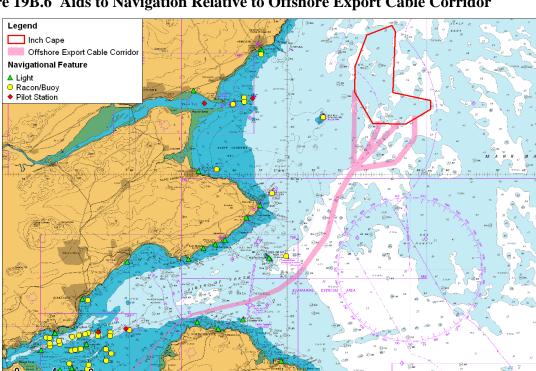
Figure 19B.6 Aids to Navigation Relative to Offshore Export Cable Corridor

There are a number of buoys to the west of the Offshore Export Cable Corridor, which are mainly associated with the marked channels in the Firth of Forth.

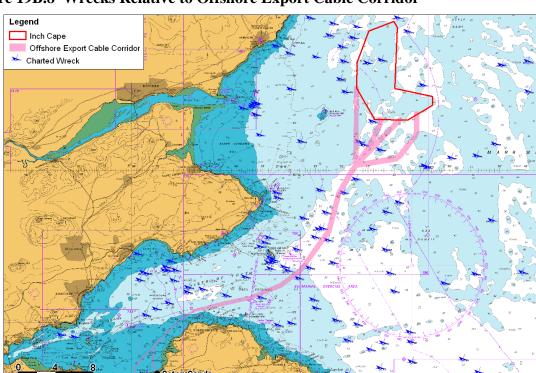
Figure 19B.8 Wrecks Relative to Offshore Export Cable Corridor

It can be seen that there are a number of wrecks in the vicinity of the Offshore Export Cable Corridor and two located in the Development Area, within which the OSPs are to be situated.

Based on admiralty charts of the Forth and Tay area, the locations of wrecks in the vicinity of the Offshore Export Cable Corridor are presented in Figure 19B.8.

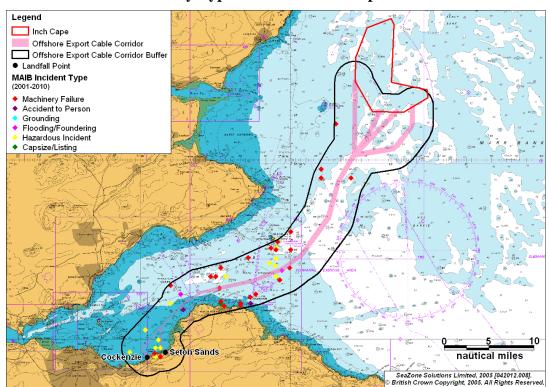
Figure 19B.9 MAIB Incident by Type within Offshore Export Cable Corridor Buffer

A total of 60 incidents were recorded within the Offshore Export Cable Corridor Buffer over the ten years analysed, involving 51 vessels, corresponding to an average of six incidents per year. Of these, there were two incidents recorded in the Offshore Export Cable Corridor. A summary of these incidents is provided below:

MAIB incidents within the Offshore Export Cable Corridor Buffer, between January 2001 and December 2010 are presented in Figure 19B.9, colour-coded by type.

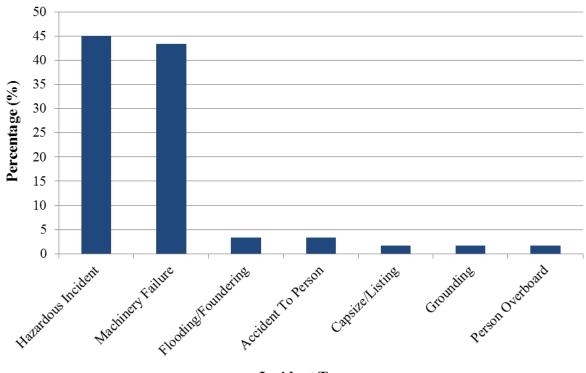
Figure 19B.10 MAIB incidents by Type within the Offshore Export Cable Corridor Buffer (2001-2010)

The most common incident types recorded within the Offshore Export Cable Corridor Buffer were hazardous incidents (45 per cent) and machinery failures (43 per cent).

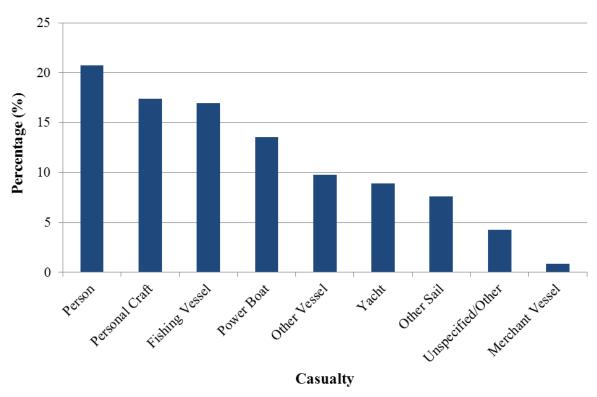
Figure 19B.12 RNLI Incidents by Type within the Offshore Export Cable Corridor Buffer (2001-2010)

Accident to person (21 per cent) was the most common casualty type involved. The remainder of casualties generally consisted of personal craft (17 per cent), fishing vessels (17 per cent) and power boats (14 per cent).

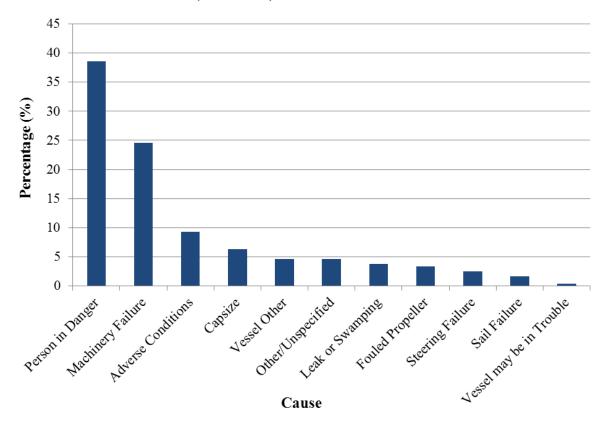
Figure 19B.14 RNLI Incidents by Cause within Offshore Export Cable Corridor Buffer (2001-2010)

The main reported causes were person in danger (39 per cent) and machinery failure (25 per cent).

The overall distribution by cause is summarised in Figure 19B.14.

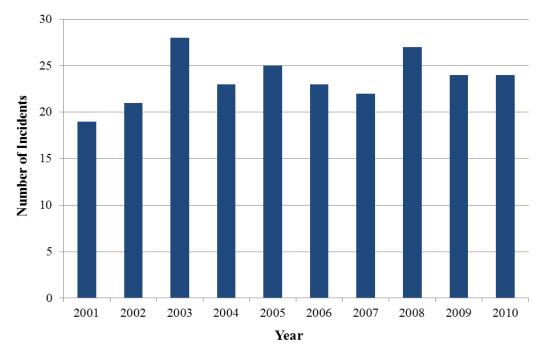
Figure 19B.15 RNLI Incidents by Year within Offshore Export Cable Corridor Buffer

There were an average of 24 RNLI incidents per year recorded within the Offshore Export Cable Corridor buffer and the year with the most incidents was 2003 when 28 were recorded.

The annual rate of incidents in the ten years analysed is summarised in Figure 19B.15.

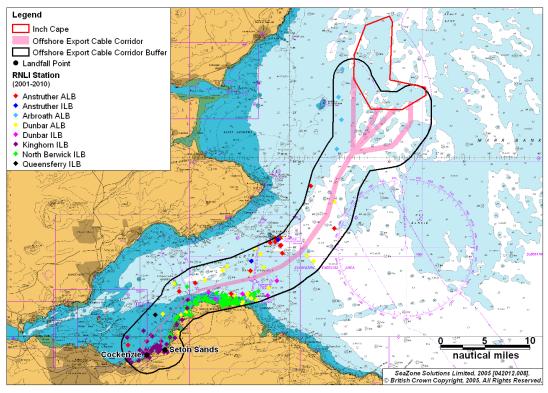
Figure 19B.16 RNLI Stations Responding to Incidents

From the ten year period of RNLI data analysed (2001-2010), North Berwick ILB responded to 46 per cent of incidents and Kinghorn ILB to 23 per cent of incidents.

A plot of the RNLI stations responding to the incidents is presented in Figure 19B.16.

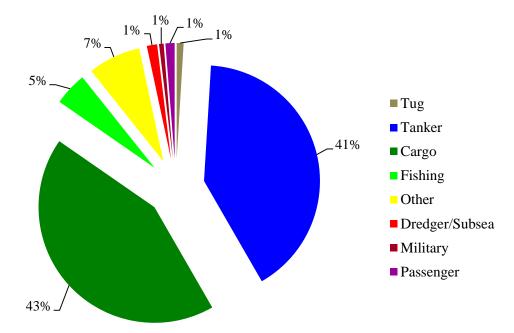
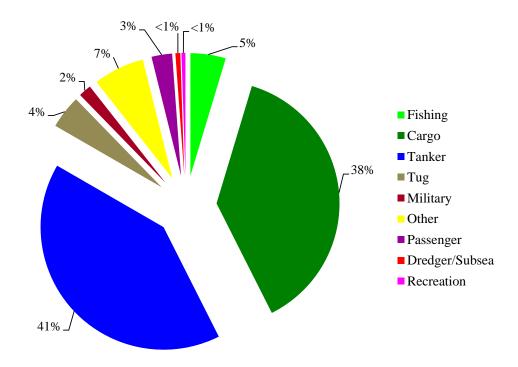
In January/February 2011, the most common types of vessel recorded within the Offshore Export Cable Corridor Buffer were cargo vessels (43 per cent) and tankers (41 per cent) with 'other' vessels making up seven per cent of traffic with the remaining nine per cent made up by military, tugs, dredgers and fishing vessels. In May 2012, tankers and cargo vessels made up 41 per cent and 38 per cent of traffic respectively with 'other' vessels comprising 7 per cent with the remaining 14% made up by fishing, tug, military, passenger, dredgers and recreation.

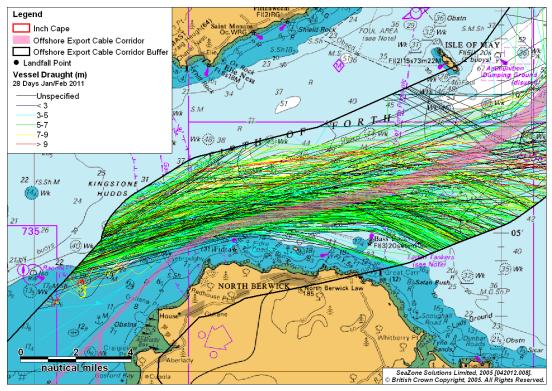
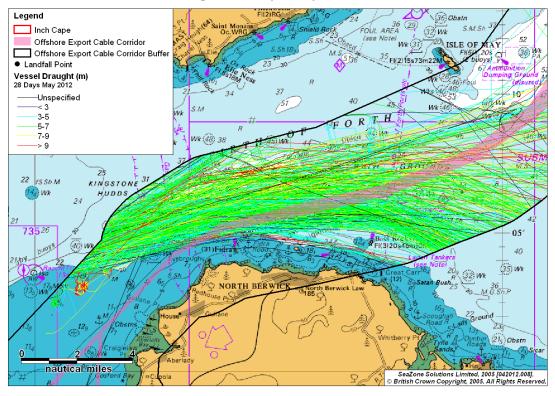
In January/February 2011 the average draught of vessels within the Offshore Export Cable Corridor Buffer was 5.5 m (excluding those which did not specify a draught). The vessel with the deepest draught was the tanker *British Gannet* at 11 m.

In May 2012 the average draught of vessels within the Offshore Export Cable Corridor Buffer was 5.6 m (excluding those which did not specify a length). The vessel with the deepest draught was the utility vessel *Forth Jouster* at 25 m.

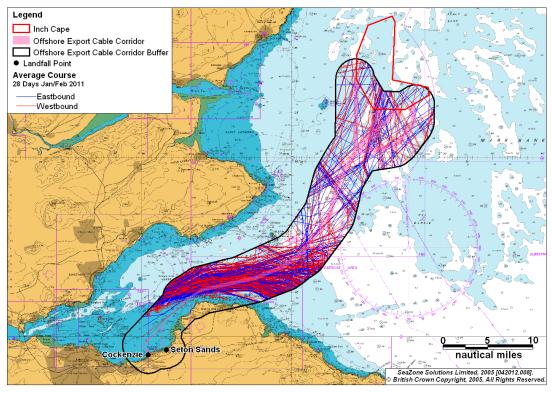
Figure 19B.33 Vessel Course (28 Days January/February 2011)

In January/February 2011, 47 per cent vessels were headed eastbound and 53 per cent westbound.

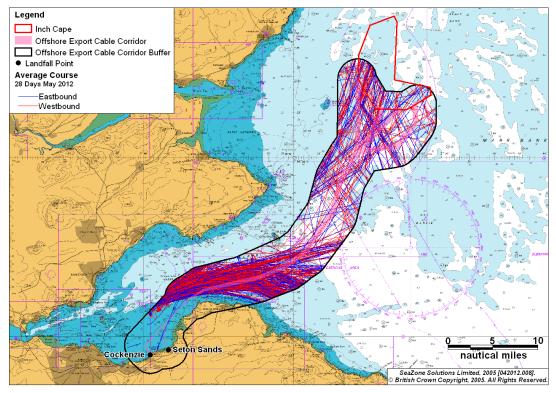
**Figure 19B.34** Vessel Course (28 Days May 2012)

In May 2012, 49 per cent of vessels were headed eastbound and 51 per cent westbound.

The average course of vessels in May 2012 is presented in Figure 19B.34.

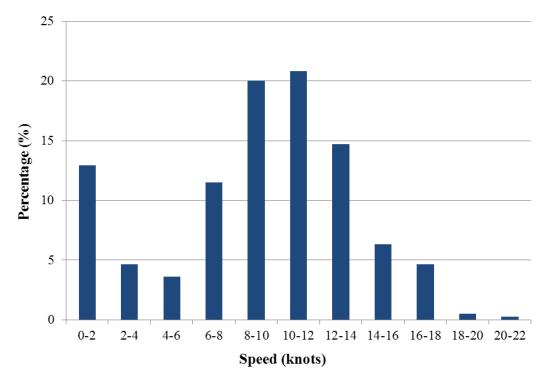
Figure 19B.38 Speed Distribution (28 Days May 2012)

The average speed of vessels within the Offshore Export Cable Corridor Buffer in May 2012 was 9.1 knots. The fastest vessel recorded was the pilot vessel *Forth Leopard* at speeds of up to 20.7 knots.

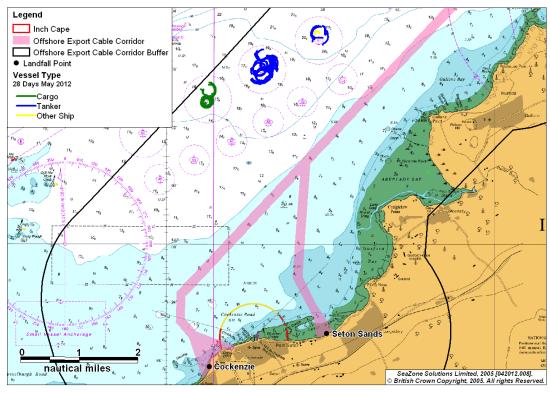
Figure 19B.44 Zoomed in Plot of Anchored Vessels (28 Days May 2012)

It can be seen that a number of vessels anchored in the designated anchorages north of the landfall sites and on the North Berwick coastline. No vessels were recorded at anchor within the Offshore Export Cable Corridor. Details of the vessels recorded at anchor within the Offshore Export Cable Corridor Buffer are presented in Table 19B.4.

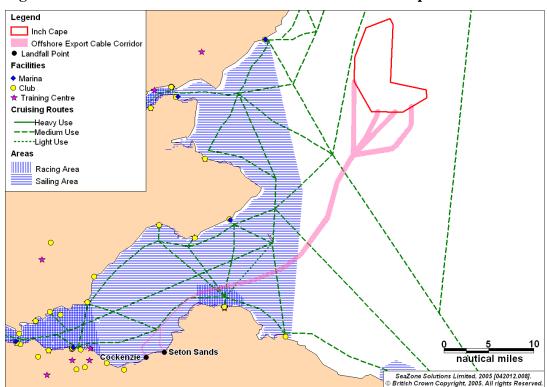
Figure 19B.48 Recreational Overview for Offshore Export Cable Corridor

Based on the RYA published data, the Offshore Export Cable Corridor is intersected by a number of medium use cruising routes and one light use cruising route. There is a yacht club at North Berwick which holds a number of events and races during the year.

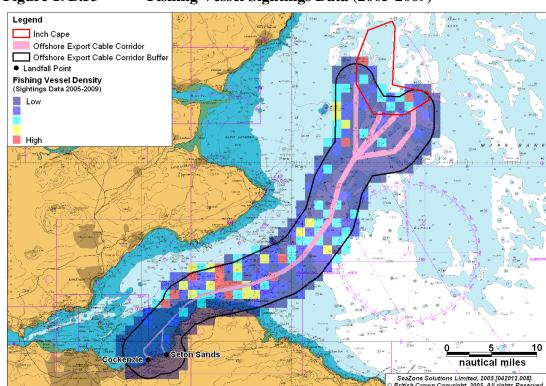
Figure 19B.53 Fishing Vessel Sightings Data (2005-2009)

Figure 19B.53 presents a density grid based on the 2005-2009 sightings data to highlight the hot spots of fishing vessel activity within the Offshore Export Cable Corridor Buffer.

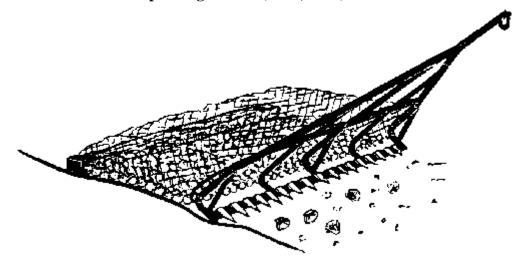
Most scallop dredgers have a chain bag which drags along the bottom collecting the catch. Some also use steel teeth which penetrate the seabed by a few centimeters. Like other gear types, greater seabed penetration can occur under unusual conditions, such as when a dredge pushes a rock ahead of it. A dredge 4.5 m wide with tickler chains can weigh in excess of 2,200 kg when empty. With towing speeds ranging up to five knots, this type of gear can easily damage a submarine cable. In some fisheries, deflecting bars and wheels have been added to help the gear pass over seabed obstacles. Such devices may also help prevent entanglement with cables. An example of typical scallop dredger gear is presented in Figure 19B.60.

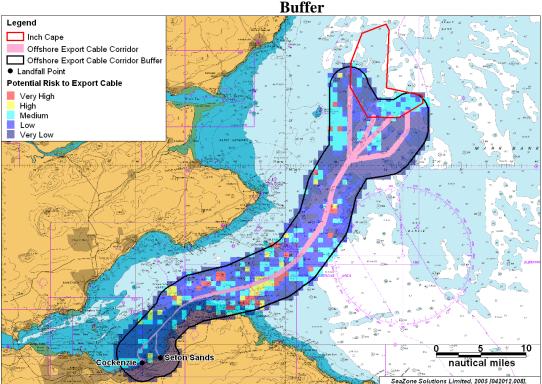
Figure 19B.61Overview of Cable Risk Ranking for Offshore Export Cable Corridor

Figure 19B.61 below presents an overview of the cable risk ranking for the buffer around the Offshore Export Cable Corridor, based on the three rankings described above.

Corridor where a very high risk was recorded. This can be attributed to the presence of fishing vessels in these areas and the history of incidents recorded by the RNLI and MAIB which could have led to a vessel foundering on the Offshore Export Cable.
