Environmental Statement

Technical Appendix 5.5 A - Archaeology Technical Report

Telford, Stevenson, MacColl Wind Farms
and associated Transmission Infrastructure
Environmental Statement

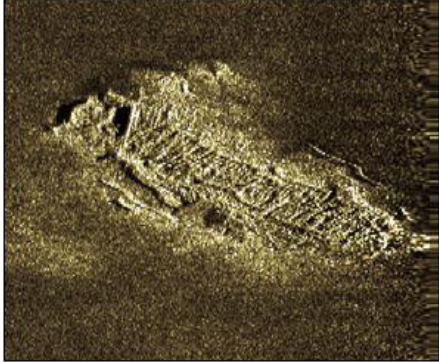
HW No.	Description	Image
157	<p>HA157 is the known wreck of the SS Carisbrook (possibly) sunk in June 1915 and recorded as being a 'live' wreck in the UKHO SeaZone database (UKHO-WO-1328). The steamer ship has dimensions from the geophysical sidescan data of 68.1m x 17.38m and a height of 1.14m above the seabed. The sidescan sonar image is shown on Illustration 1 and on Figure 8. An associated high potential magnetometer target (HA9) is also interpreted as this target. Osiris Projects identified this remain namely S302 and magnetometer target M35. This wreck is not visible on the seabed in the bathymetry dataset unlike the other two wrecks (HA 158 & 159). This is likely to be due to geological features and the poor preservation condition observed from the geophysical sidescan data. Medium potential target HA75 is located near to this vessel (28m away) and may be associated shipwreck debris remains. Figure 8 also identifies shipwreck debris on the seabed surrounding the vessel.</p>

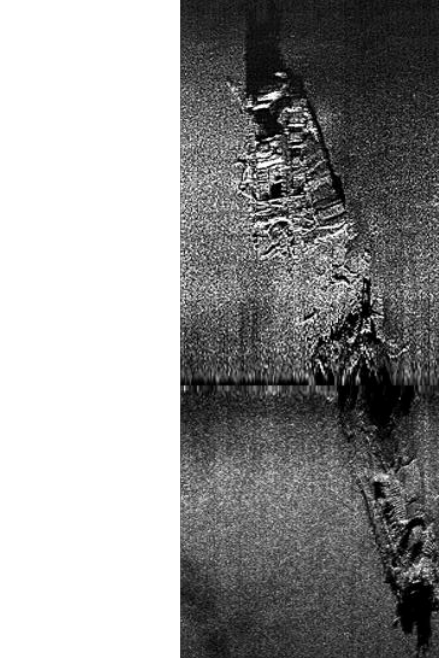
159	<p>HA159 is identified as the remains of the Llanishen vessel which is broken in two on the seabed (Illustration 2). The ship has a UKHO status as 'live' and its geophysical dimensions are recorded as 137.7m x 49.94m and a height of 4.28 (UKHO-WO-1306). The location of the ship is at UTM30N 514759mE and 6458893mN (Figure 3). Osiris Projects have located this shipwreck (S288 and M33). This wreck is identified in the magnetometer data (HA11) and also visible in the bathymetry data (Figure 4), illustrating a relatively featureless part of the seabed (Figures 3 & 6).</p>

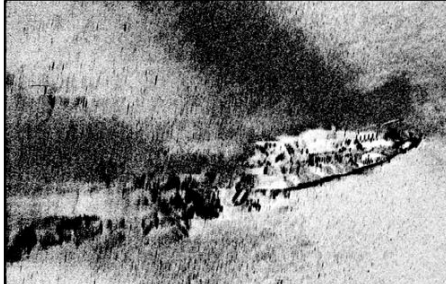
HW No.	Description	Image
158	HA158 is the third known wreck site located at UTM30N 516485mE and 6453673mN. This is an unidentified vessel first discovered in 1949. It is recorded as 'live' in its UKHO status (UKHO-WO-1182) with dimensions taken from the sidescan sonar image as 150.23m x 34.59m and a height of 3.96m (Illustration 3). This target has also been identified in both the bathymetry (Figure 4) and magnetometer (HA10) data. Osiris Projects identified both sidescan and magnetometer targets for this wreck (S359 and M39).

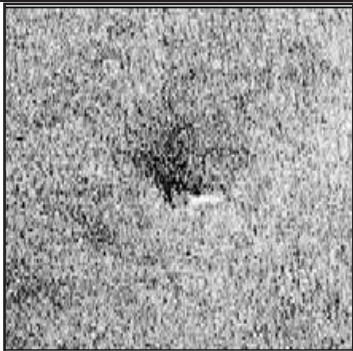
HW No.	Description	Image
44	Headland target HW44 is interpreted as a possible object of medium archaeological potential being a dark and light reflector in the sidescan data. This possible object has dimensions of 5.16m x 4.43m and a height of 0.88m and is located at UTM30N 521132.44mE and 6446478.56mN in the MacColl wind farm. This area of the seabed is identified as being uneven with outcroppings of glacial till noted from the bathymetry data. There are no associated magnetic anomalies or Osiris targets within 50m of this target.

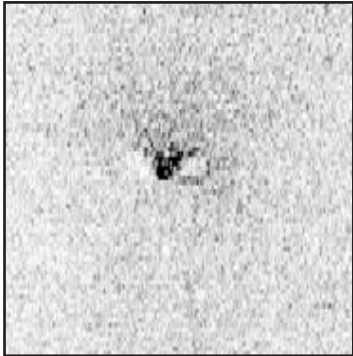
52	HW52 is again identified as being debris on the seabed due to its manmade characteristics. The dimensions of the anomalies are 4.23m x 3.13m and a maximum height of 1.07m and have been recorded at coordinates UTM30N 520384.78mE and 6447576.11mN in the MacColl wind farm. No associated Osiris targets or magnetic fluctuations were identified. The possible object appears to have a thin linear feature extending from it or perhaps illustrating a partially buried object.

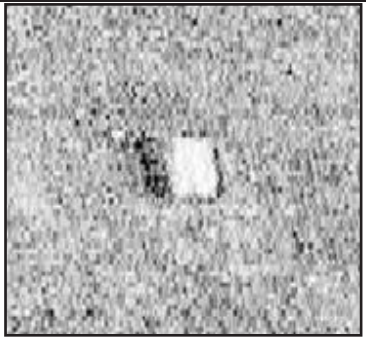
HW No.	Description	Image
61	<p>Target HW61 appears to be a possible linear object assessed as being of medium archaeological potential. The dimensions of the anomaly are recorded as 4.3m x 1.59m and a height of 1.58m. This anomaly is located in the Telford wind farm at coordinates UTM30N 523746.07mE and 6454552.91mN. This target is possibly associated with Osiris Projects sonar target S753 located within 50m of HW61. The area that this target is located in is highly uneven and common outcrops of glacial till are present. The feature is a dark and light reflector and individual fragments are visible on the data.</p>

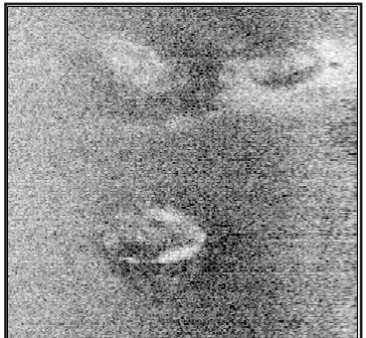
71	<p>Sonar target HW71 is interpreted as being the remains of a wellhead installation and associated with nearby Osiris Projects target S592 recorded as seabed depressions. This target is composed of three roughly circular anomalies visible in the sidescan data with approximate dimensions of 25.55m x 22.63m and a height of 0.78m. This is located at UTM30N 520779.49mE and 6448861.74mN in the MacColl wind farm. There is also a magnetic fluctuation (HW22) in the vicinity (within 100m) of the target which again supports this interpretation. The SeaZone data also shows wellhead installations to be present in the immediate vicinity</p>

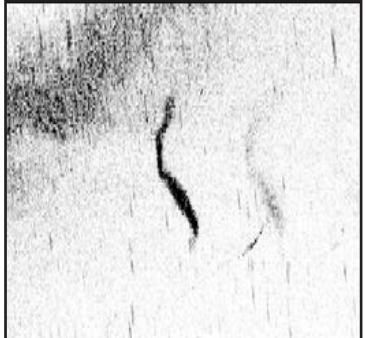
72	<p>HW72 is recorded as being possible linear debris remains located at UTM30N 516404.69mE and 6447811.88mN to the east of target HW71 in the Stevenson wind farm. The targets dimensions are 25.32m x 0.77m with no measurable height as the target is a dark reflector in the sidescan data. The feature is curvilinear in shape and has potential anthropogenic characteristics.</p>

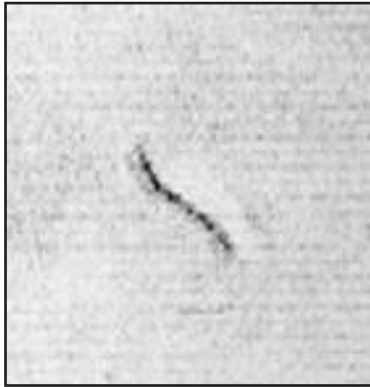
HW No.	Description	Image
76	<p>Target HW76 is linear debris measuring 12.31m x 2.76m and a maximum height of 0.25m, located in the Telford wind farm at UTM30N 515642.48mE and 6462110.21mN. There are no magnetic anomalies or Osiris sonar targets located within 50m of this anomaly. The Carisbrook wreck site HW157 is approximately 600m away from this recorded target.</p>

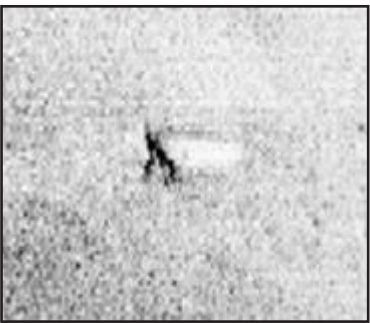
77	<p>HW77 is a possible object with dimensions of 7.07m x 2.44m and a height of 0.84m being a dark and light reflector in the sidescan sonar data set. It is located at UTM30N 511513.2mE and 6456395.32mN in the Stevenson wind farm and is not associated with any Osiris targets or magnetic fluctuations. Low potential Headland target HW166 is within 5m of this, identified as a possible natural feature. The object appears to be made up of two thin linear elements.</p>

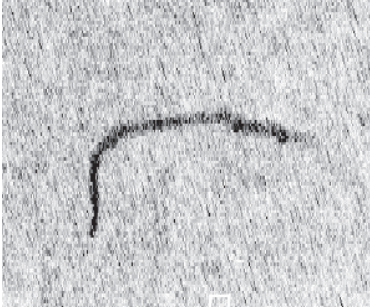
80	<p>HW80 is located in the Stevenson wind farm at coordinates 517192.39mE and 6450733.81mN. The debris has a curvilinear shape and a linear appearance with approximate dimensions of 28.41m x 2.8m width. This is a dark reflector in the sidescan data.</p>

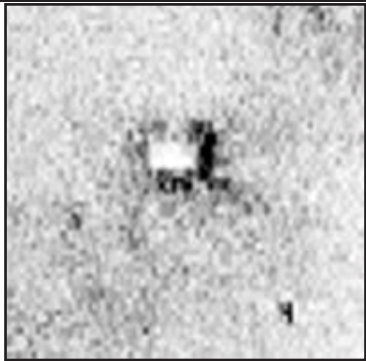
HW No.	Description	Image
100	Target HW100 is located in the Telford wind farm at UTM30N 513356.46mE and 6458593.32mN. This target is a possible object or debris with dimensions of 6.34m x 1.65m and a height of 1.48m. No associated Osiris targets or magnetic fluctuation are identified in the datasets. The possible object is a dark and light reflector in the sidescan data and appears to be partially buried.

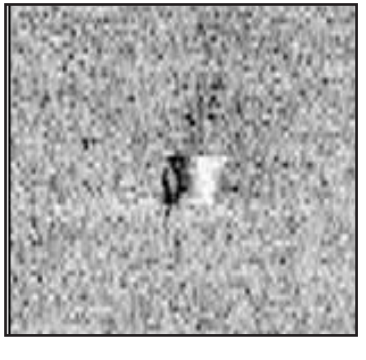
117	HW117 is a possible object measuring 10.46m x 1.69m and a height of 0.74. The object is recorded at coordinates UTM30N 509730.22mE and 6439767.39mN in the MacColl wind farm and is a dark and light reflector in the sidescan dataset. Osiris target S96 is located 2m away from the Headland target. Likewise Headland target of low archaeological potential HW140 is less than 5m from this possible object. HW117 has very defined curvilinear attributes visible in the sidescan data.

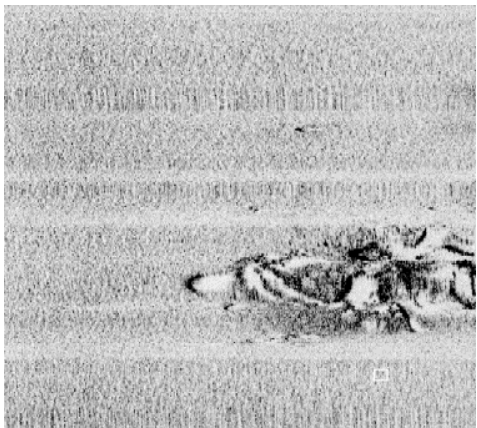
HA Number	Description	Image
52	HA52 is located in the central area of the OfTI at coordinates 549507mE and 6424778mN. This wreck corresponds with unknown SeaZone entry 15901 and is visible in the multibeam data. The wreck has dimensions of 32.6m x 16.71m and a geophysical height of 1.01m and appears to be partially buried or damaged. The wreck is in an area of the seabed that has outcropping rocks and sand lenses. Three other high potential targets and a medium potential debris remain are within 40m of this wreck (HA55, 65, 66 and 53). There is a magnetic anomaly within 60m of the wreck.

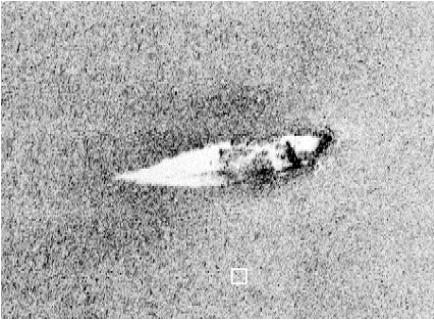
116	HA116 is located at coordinates 527301mE and 6442006mN northern area of the OfTI. There is a slight scour mark around the wreck visible in the sidescan data and it looks to be partially buried in sand. Again no SeaZone entry is recorded in the area and there are no associated magnetic anomalies. The buried wreck debris dimensions are 21.66m x 8.09m and height of 2.82m.

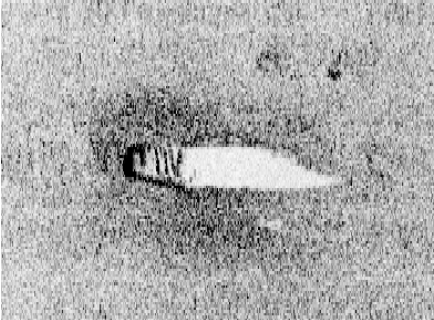
129	HA129 is a partially buried wreck with visible dimensions of 6.04m x 5.76m and a geophysical height of 0.84m. The debris has been identified at coordinates 570669.48mE and 6414087.14mN. This is a dark and light reflector in a relatively sandy area of the seabed. There are no associated SeaZone records.

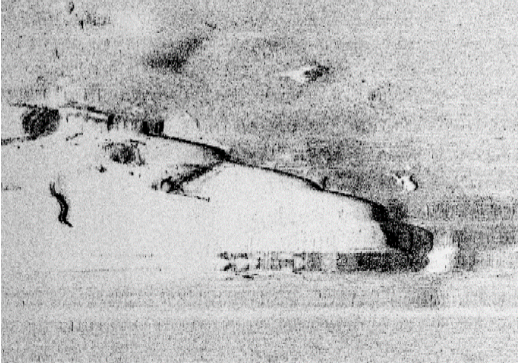
137	HA137 is SeaZone wreck Svarton (Probably) located in the southern part of the OfTI at coordinates 567751mE and 6414519mN. The wreck is very large with dimensions of 63.84m x 13m and height of 0.71m and is clearly visible in the multibeam data. The wreck is visibly damage and broken in two with surrounding debris (medium potential target HA142).

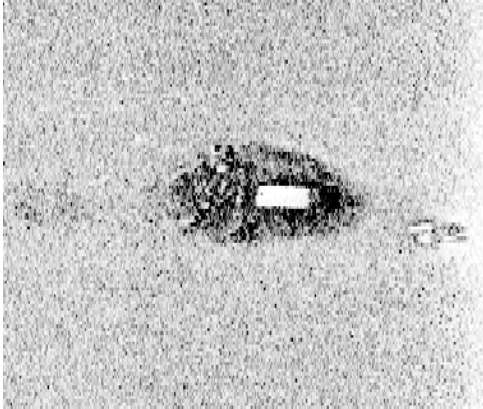
HA Number	Description	Image
168	<p>HA168 has been identified in the northern area of the OfTI at coordinates 529157mE and 6439612mN. Again the area is made up of observable sandbanks and a scour mark is visible off the debris. Its dimensions are 12.55m x 9.93m and a maximum height of 1.24m; this is visible in the multibeam data. Located 10m from this is medium potential target HA169 which may be associated debris. A magnetic anomaly is also within 50m of the target which suggests they may be related. Gardline have identified debris remains within 10m of this target which is likely the same debris.</p>

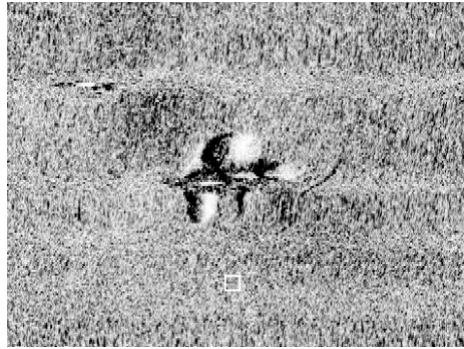
179	<p>This debris is located in the nearshore area of the OfTI at coordinates 560649mE and 6394484mN. The target is on an area of the seabed with rock outcropping present, though the sidescan seems to show that the feature is perhaps on a sandy lens and is somewhat visible in the multibeam data. The features dimensions are 10.21m x 5.28m and a maximum height of 1.84m. No SeaZone wrecks are recorded in the area and there are no magnetic anomalies present. Medium potential target HA181 is 10m from this possible buried wreck and could be associated debris.</p>

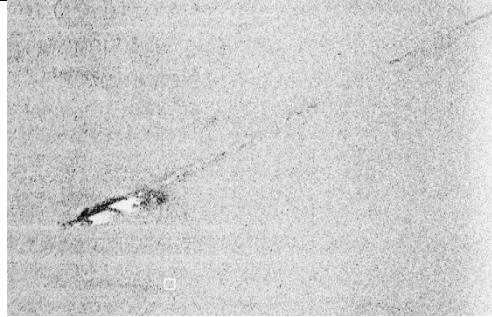
302	<p>HA target 302 is located near the southern end of the OfTI at coordinates 571144mE and 6415234mN. The possible buried wreck has dimensions of 18.43m x 5.66m and a maximum height of 0.49m. The target is on a fairly even part of the seabed. Large scour mark can be seen coming off the feature. Neither SeaZone entries nor magnetic anomalies are in the vicinity of the possible wreck.</p>

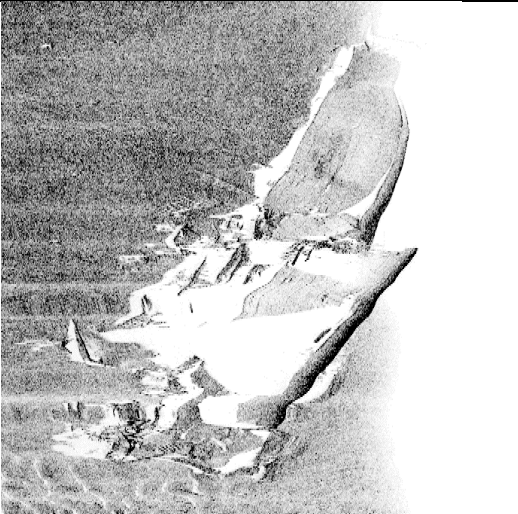
HA Number	Description	Image
352	HA352 is a partially buried wreck remain located at coordinates 566636.97mE and 6405082.18mN in the OfTI. The wreck has geophysical dimensions of 41.19m length, 6.77m width and a height of 0.69m. The wreckage appears to be partially buried in sand and has broken up bits of debris surrounding it.

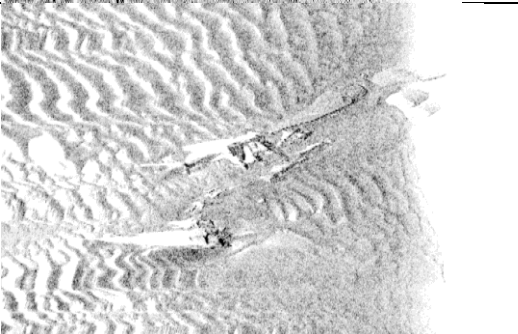
357	HA362 corresponds with HA1014, the SeaZone entry TRSAT (probably). This is located at coordinates 566202.38mE and 6403193.8mN. The wreck has geophysical dimensions of 42.79m x 11.26m and a maximum height of 1.34m. Again the wrecks is in an area of the seabed with sand mega ripples and is partially buried and broken up on the seabed.

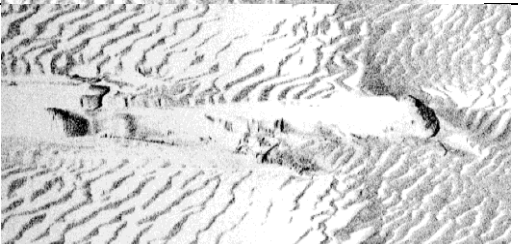
362	HA362 is the same wreck as HA357 from another sidescan survey line angle. Again the preservation condition of the wreck can be seen as highly broken up on the seabed. This wreck was bombed by a German aircraft in 1941.

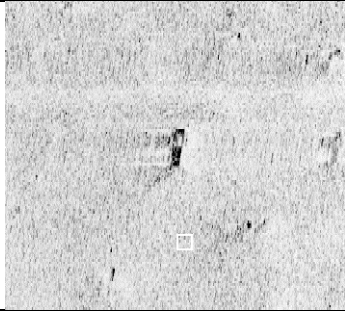
HA No.	Description	Image
5	HA5 is in the northernmost part of the OfTI at coordinates 520204mE and 6460925mN. The debris has dimensions of 6.05m x 0.86m and a geophysical height of 0.33m. There are no associated magnetic anomalies in the area.

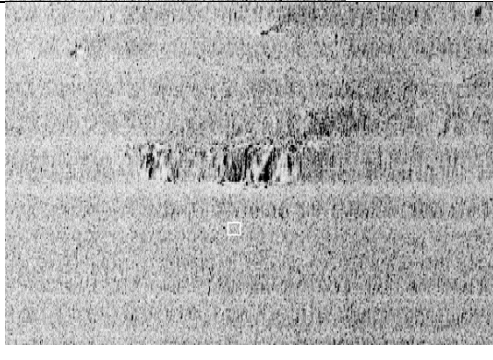
21	HA21 is located at coordinates 524596mE and 6453925mN with dimensions of 14.06m x 6.04m and height of 0.13m in the northern area of the OfTI. It looks to be partially buried rectangular debris with a slight scour mark coming from it. There are no associated magnetic targets near this debris remains and the seabed appears to be quite even with gravel and boulders present.

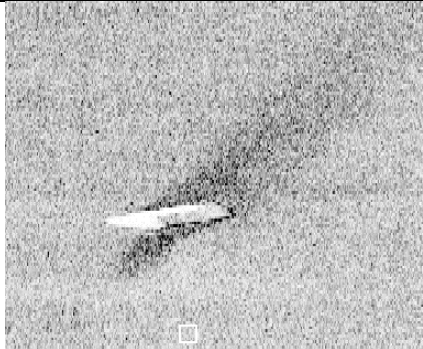
HA No.	Description	Image
28	HA28 is a right angled debris remain in the northern part of the OfTI located at 522428mE and 6459665mN. The debris remains is 6m in length and 2.48m wide with a geophysical height of 1.79m. There are no magnetic anomalies present and the debris appears to be in a depression on the multibeam data, there is also a scour mark coming off the debris in the sidescan image.

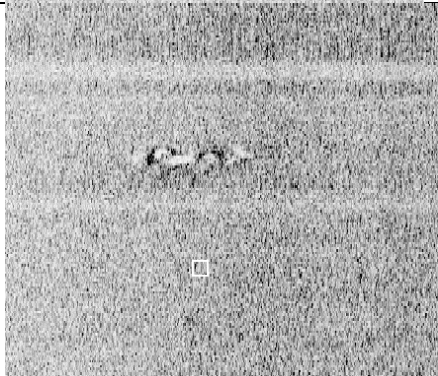
29	HA29 is located at coordinates 525409mE and 6454632mN in the northern area of the OfTI. The debris is partially buried with curvilinear characteristics, with dimensions of 6.49m x 2.87m and maximum height of 0.40m.

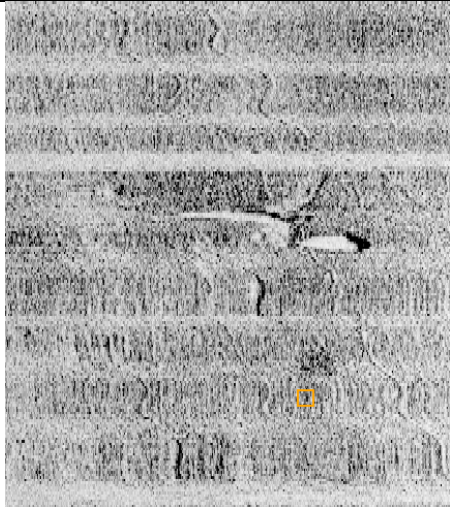
HA No.	Description	Image
63	HA63 is partially buried debris located at coordinates 549599mE and 6423337mN in the central area of the OfTI. This area of the seabed is quite gravelly and uneven. The debris spread has dimensions of 10.70m length 4.94m width and 0.56m height. There are four Gardline boulder targets within 20m of this debris.

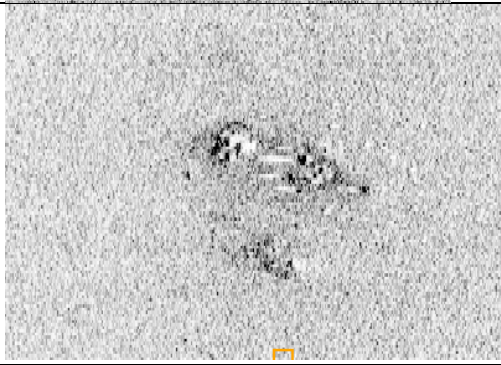
69	HA69 is located in the central southern part of the OfTI at coordinates 553189mE and 6419774mN. The debris remains have manmade characteristics and are made up of individual pieces of fragments with dimensions of 10.65m x 4.3m and a geophysical height of 0.31m. No magnetic anomalies have been identified in the area which is characterised by sand and gravels on the seabed.

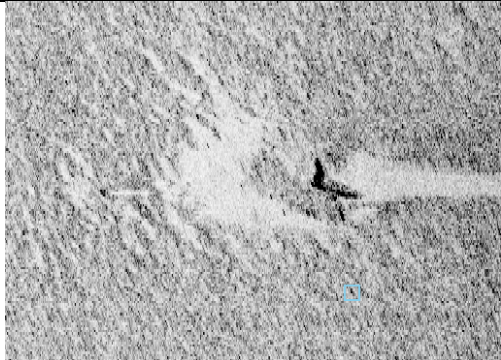
72	HA72 is positioned in the most eastern part of the OfTI at coordinates 572036mE and 6409226mN. The area of the seabed is principally made up of sand and gravels and the target looks to be partially covered or buried by these. The target is a solid right angled feature with dimensions of 6.36m x 1.01m and a geophysical height of 1.01m. There are no associated magnetic targets near this debris.

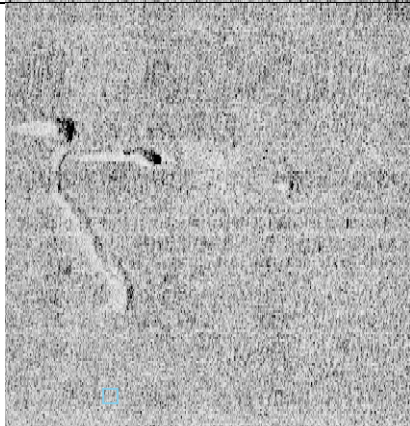
84	HA84 is located at coordinates 549209mE and 6423552mN in the central area of the OfTI. The debris remains are made up of a small solid piece with a chain or rope coming off and dimensions of 28.45m x 0.54m and a height of 0.34m. There are no associated magnetometer targets present and seabed is characterised by sands and gravels.

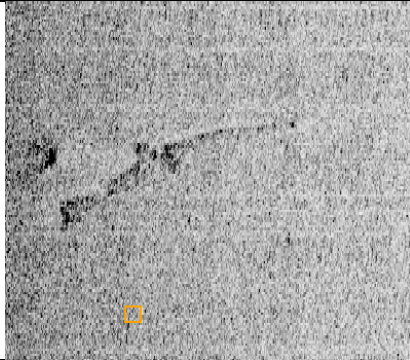
HA No.	Description	Image
85	HA85 is located in the central southern part of the OfTI at coordinates 567097mE and 6415733mN. The debris is curvilinear with small out strutting elements and with dimensions of 21.53m x 2.65m and a geophysical height of 0.1m. The seabed is relatively even with sands and gravels visible in the sidescan data.

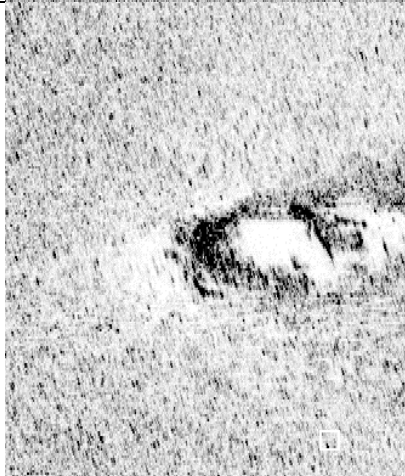
114	HA114 is possible wreck debris identified at coordinates 527681mE and 6441736mN in the northern part of the cable route. The debris has dimensions of 22.18m x 8.1m and a maximum geophysical height of 2.65m. There is no evidence in the multibeam for wreck remains though the debris looks to be partially buried in the seabed sands and gravels, also there are no associated magnetometer targets.

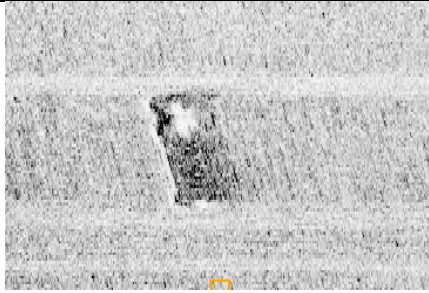
HA No.	Description	Image
122	HA122 is located in the southern area of the OfTI at coordinates 571716mE and 6413089mN. The debris is right angled and has measurements of 12.26m x 3.97m and a geophysical height of 0.40m. There are no associated magnetometer targets within HA122 vicinity and the seabed characteristics are quite sandy and even.

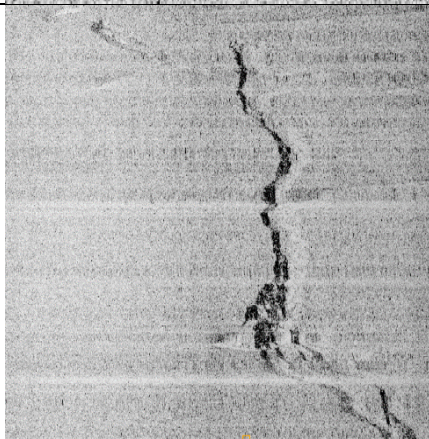
136	HA136 is a long debris and possible chain remains identified at coordinates 568530mE and 6413906mN. The target has dimensions of 99.26m length x 7.48m maximum width and a geophysical height of 0.72m. This area of the seabed is quite uneven with visible geological fissures in the multibeam image. Parts of this target appear to have manmade characteristics and as such have been assigned a medium archaeological potential rating.

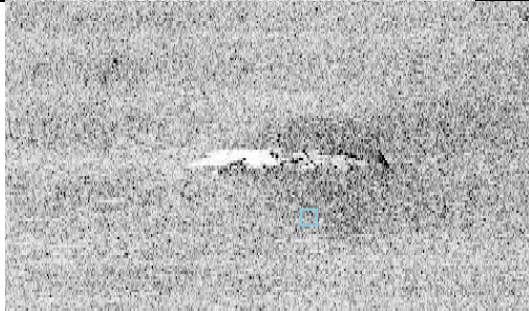
160	HA160 is a buried and abraded possible wreck in close proximity to HA114 (36m) at coordinates 527645mE and 6441737mN. The debris has measurements of 12.35m length, 1.87m width and geophysical height of 0.81m. There is a depression visible on the multibeam data, though no magnetic anomaly or SeaZone entry in the vicinity.

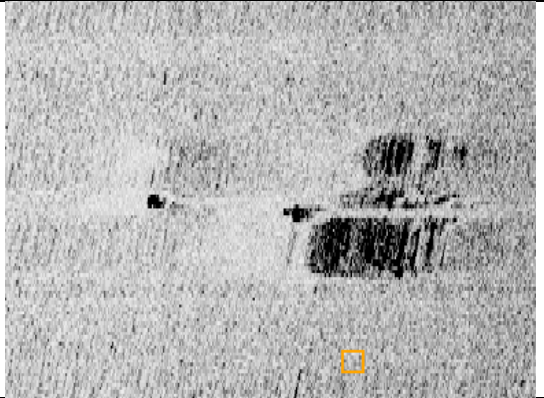
173	HA173 is located in the nearshore area of the OfTI cable route at coordinates 560573mE and 6394565mN. The debris is a thick linear feature with dimensions of 3.27m x 1.93m and height of 1.33m. The debris is not visible in the multibeam data which shows the area to be highly uneven with outcropping bedrock and there are no associated magnetic anomalies.

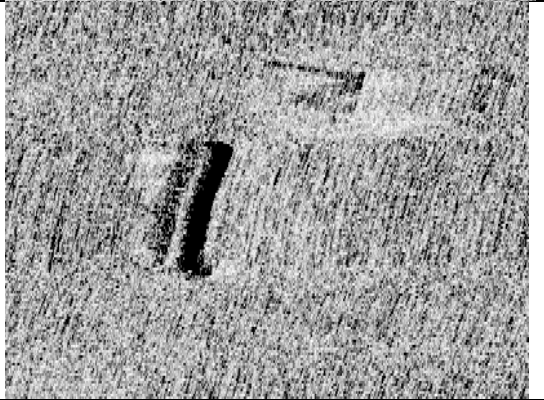
174	HA174 is located 37m northeast of HA73 in the nearshore area of OfTI at coordinates 560606mE and 6394582mN. The linear debris is clearly visible in the multibeam data with dimensions of 18.76m length, 1.97m width and 0.19m height, the debris looks to be partially buried.

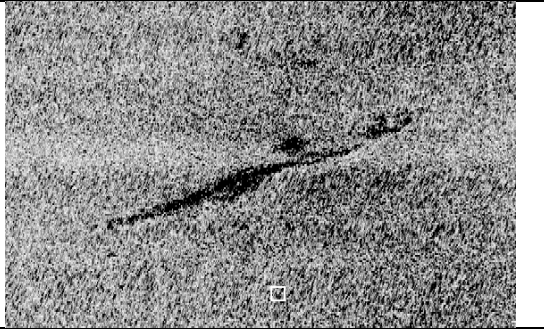
180	HA180 is again located in the nearshore area of the OfTI at coordinates 560518mE and 6394350mN. The debris is long and thin with a rounded piece of debris at one end and dimensions of 5.87m x 0.73m and height of 0.18m. There are no associated magnetic anomalies with this target and again the seabed characteristics in this area of the cable route are highly uneven and rough terrain.

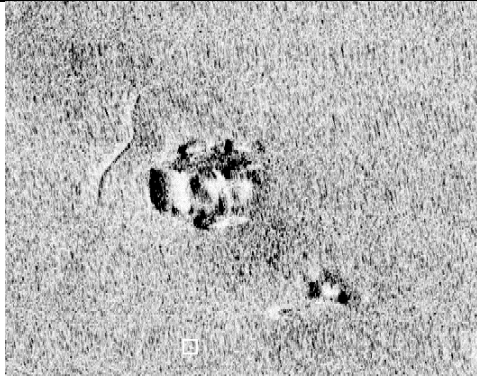
182	<p>HA182 possible chain or rope debris has been identified at coordinates 560248mE and 6394177mN OfTI nearshore area. The debris has manmade characteristics and dimensions of 6.34m x 0.74m and a maximum height of 0.10m. The seabed areas topography is highly uneven with outcropping bedrock and as such the debris is not clearly visible within the multibeam data. There are no associated magnetic anomalies.</p>

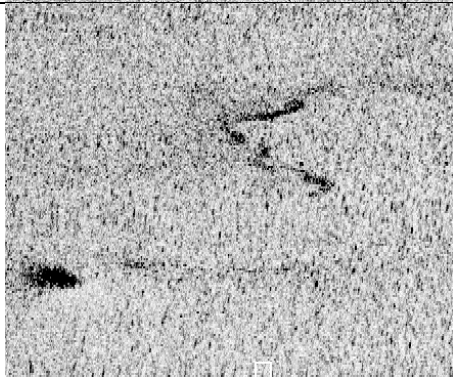
185	<p>HA185 is located in the nearshore OfTI area at coordinates 560749mE and 6394451mN. The debris is located on an area of the seabed that is highly uneven with outcropping bedrock and sand lenses. The debris looks to be partially buried with curvilinear characteristics and dimensions of 8.22m x 0.73m and a maximum height of 0.50m. There are no associated magnetic anomalies with this target.</p>

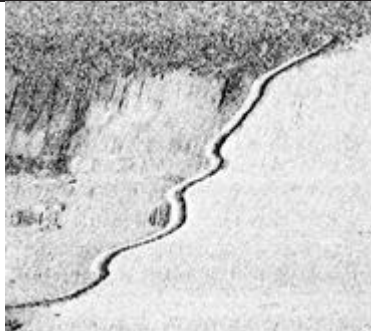
HA No.	Description	Image
198	<p>HA198 is a long and thin rope or chain debris remains located at coordinates 559904mE and 6394827mN in the OfTI nearshore. The debris has dimensions of 27.56m length and a maximum width of 0.33m with height of 0.07m. The target is in an area with commonly outcropping bedrock and sands present.</p>

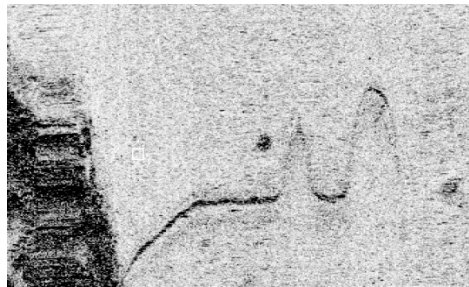
200	<p>HA200 is located in the nearshore OfTI area at coordinates 560262mE and 6394776mN. The debris has been interpreted as a possible chain and associated debris with measurements of 35.80m x 0.35m and a height of 0.19m. There is a magnetic anomaly that could be associated with this target 100m away. Again the seabed in this area of the cable route is highly uneven with outcropping bedrock.</p>

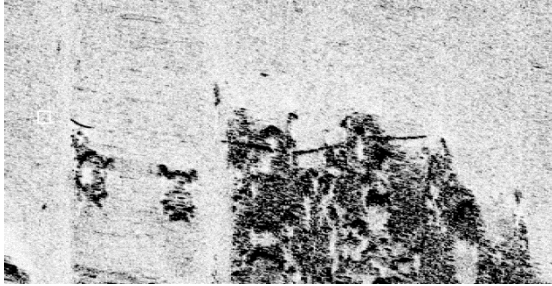
HA No.	Description	Image
211	<p>HA211 and HA212 are in the same group of debris being 4m from one another. HA211 is located in the OfTI at coordinates 560643mE and 6395082mN. The debris appears to be situated on top of and within an area of outcropping bedrock and has dimensions of 24.29m 2.58m and a geophysical height of 0.54m.</p>

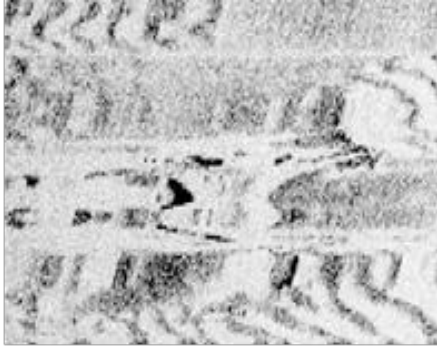
HA No.	Description	Image
356	HA356 is located in the OfTI at coordinates 566183mE and 6403216mN. This debris is likely associated wreck debris of the Trsat (Probably) HA357 and HA362. The remains appear to be partially buried and are surrounded by sand megaripples in the sidescan sonar image with dimensions of 12.57m x 8.58m and maximum height of 0.42m. This debris and associated wreck are clearly visible in the multibeam data and have an associated magnetic anomaly within 40m.

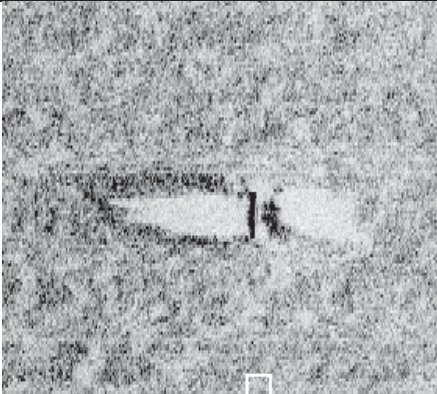
366	HA366 has been identified in the Fraserburgh area of the cable route at coordinates 567014mE and 6402338mN. The debris remains has dimensions of 4.77m x 1.86m and a geophysical height of 0.55m. There are no magnetic anomalies located near to this debris remain.

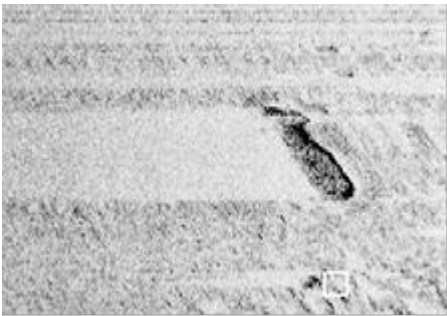
386	HA386 is recorded in the OfTI at coordinates 564846mE and 6398078mN. The remains look to be partially buried and slightly curvilinear in shape with measurements of 17.87m x 2.92m and a maximum height of 0.75m. This area of the seabed has lots of surrounding boulders and some outcropping bedrock; no magnetic anomaly has been identified.

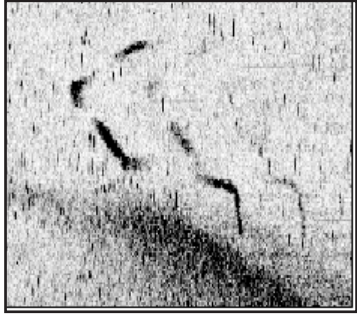
HW No.	Description	Image
36	Anomaly HW36 is recorded as being a possible object of medium archaeological potential. It is located at UTM30N 525711.49mE and 6447160.95mN in the central area of the wind farms. The potential objects dimensions are 15.35m x 3.9m with a height of 0.4m from the seabed. It is characterised as a dark and light reflector in the sidescan data. This target has no associated magnetic anomalies or Osiris Projects targets.	
73	HW73 looks to be potentially partially buried debris. The target has measurable dimensions of 12.73m x 1.74m and a height of 0.20m located in the western area of the wind farms at coordinates UTM30N 509171.25mE and 6446862.47mN. No Osiris targets or Headland magnetometer targets are associated with HW73.

Any high or medium potential targets located in the Inner and Outer Study Areas could be subject to potential impacts from adverse direct and secondary effects such as the installation of turbine foundations and associated infrastructure such as inter-array cabling and vessel anchoring activities during the development operations. As such, and pending further investigation, it is recommended that temporary exclusion zones should be implemented for all anomalies of high and medium archaeological potential. HW157; 158 and 159 are classified as high potential and it is recommended that these targets be furnished with a 100m exclusion zone. It is recommended that those targets identified as exhibiting medium potential (HW 36; 44; 52; 61; 71; 72; 73; 74; 75; 76; 77; 78; 80; 100; 102, 108, and 117)

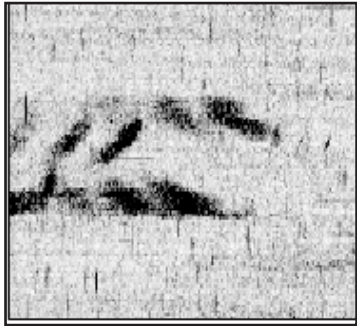
HW No.	Description	Image
74	HW74 is located approximately 50m west of target HW73 and could potentially be associated debris. The sidescan sonar data shows a scatter of possible objects with approximate dimensions of 7.58m x 1.86m and maximum height of 0.30m. These remains are located at UTM30N 508985.42mE and 6447060.9mN. This is not located in the vicinity of any Osiris Projects magnetic or sidescan anomalies. The geology of this area of the seabed is recorded as being uneven and having a common occurrence of glacial till outcropping.

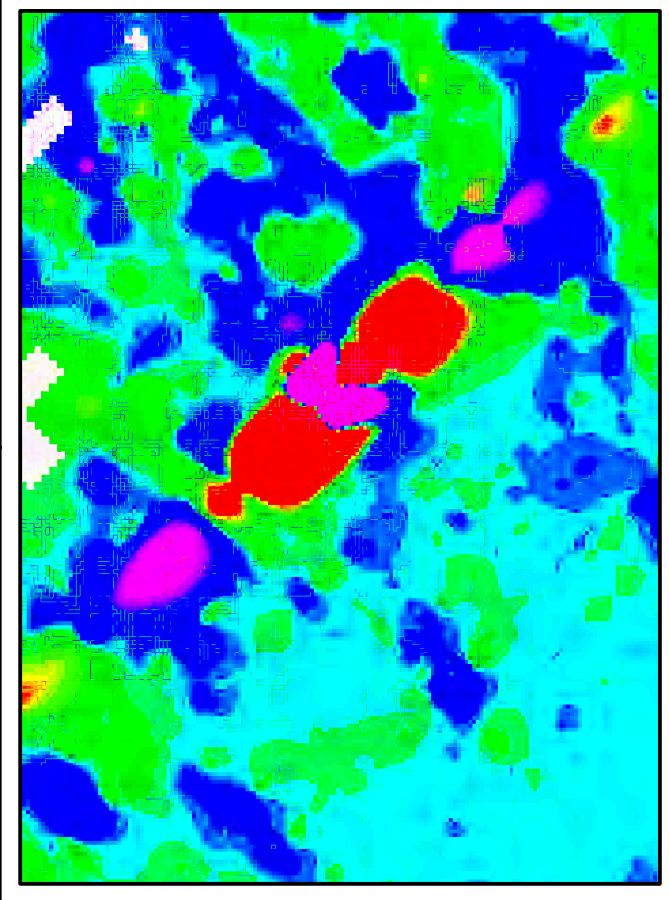
A. HA9 The northernmost wreck thought to be *Carisbrook* presents a strong magnetic signature.

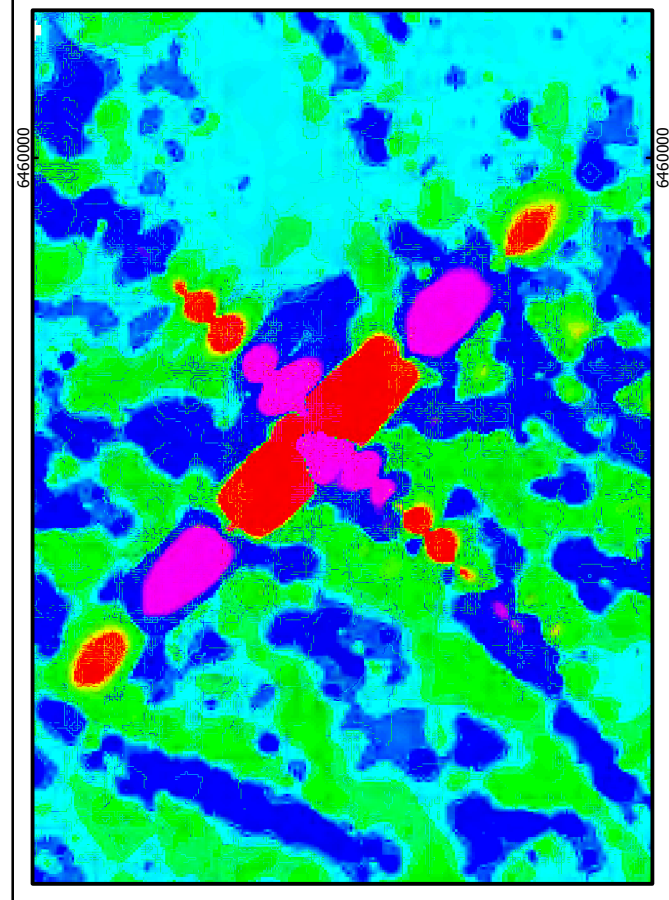
B. HA11 This wreck is thought to be *Llanishen* and presents a very strong magnetic signature.

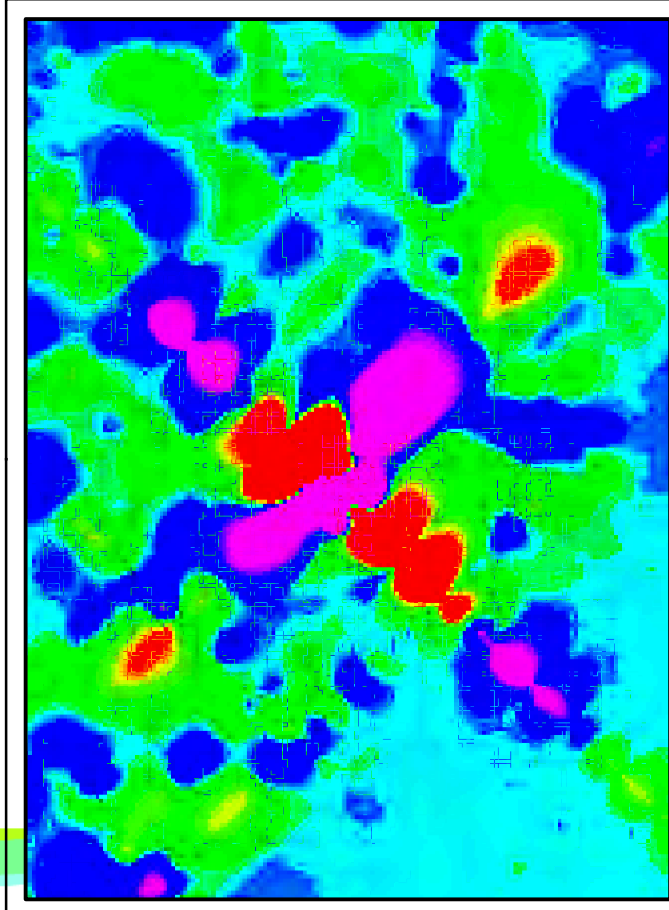
C. HA10 This unidentified wreck in two parts presents a strong magnetic signature.

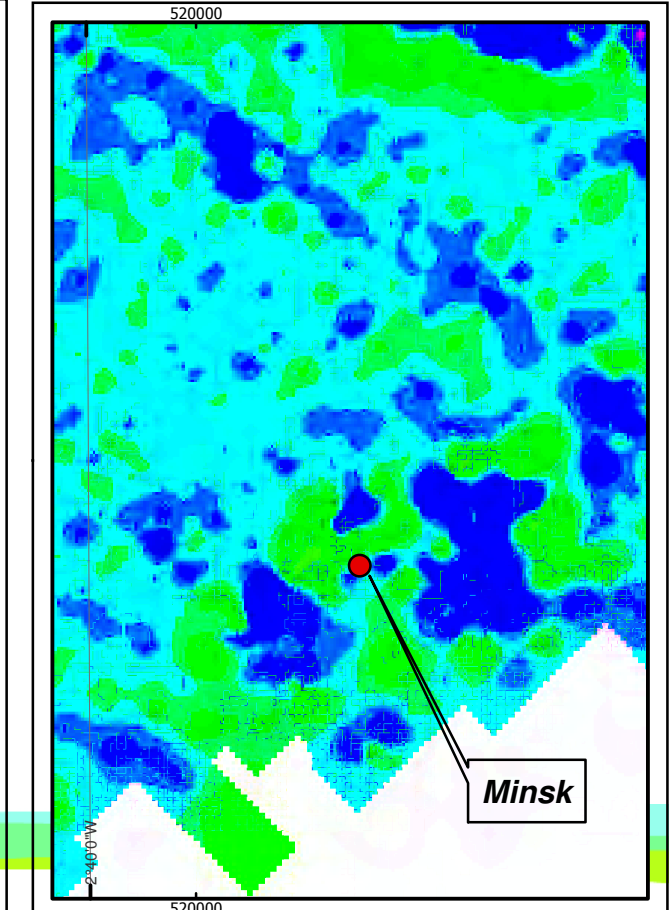
D. There is no significant magnetic anomaly at the previously recorded location of *Minsk*, suggesting that the wreck may lie further to the south.
