Environmental Statement

Technical Appendix 3.7 A - Hydrology, Geology and Hydrogeology Technical Report

Telford, Stevenson, MacColl Wind Farms and associated Transmission Infrastructure Environmental Statement

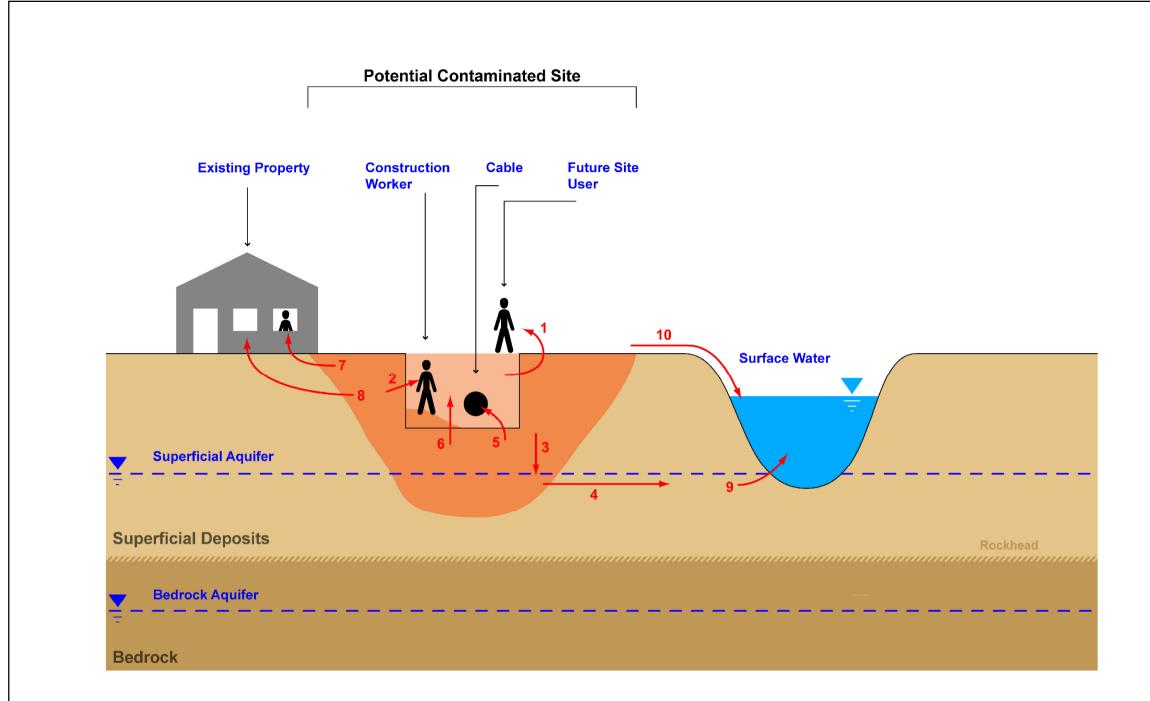
Linkages Applicable To All Sites

- Linkage 1 Direct exposure (dermal contact, ingestion or inhalation) of contaminated soils to future site users;
- Linkage 2 Direct exposure (dermal contact, ingestion or inhalation) of contaminated soils to construction workers;
- Linkage 3 Migration of soil leachate/liquids through the unsaturated zone to underlying groundwater;
- Linkage 4 Migration of mobile contamination/solutes through the saturated zone to groundwater off site;
- Linkage 5 Direct contact with cable materials; and
- Linkage 6 Build up of soil gases/vapours in confined spaces (e.g. excavations) and inhalation/asphyxiation of construction workers.

- Linkage 7 Inhalation of indoor vapours by future users of existing properties on or adjacent to the sites;
- Linkage 8 Migration of soil gases to indoor air and subsequent asphyxiation or explosion, on or in the vicinity of the sites;
- Linkage 9 Migration of mobile contamination/solutes through the saturated zone to surface water; and
- Linkage 10 Direct run off of contaminated materials to surface water receptors on or adjacent to the sites.

edp renewables
	REPJOL
Moray	Offshore Renewables Ltd
Key	
	Source (Contaminant Mass)
(₁	Linkage
Blue Text	Receptor
Horizontal	Scale: Not To Scale A3 Chart
Produced: KAG Reviewed: Reviewed Approved: PH	
Date: 18/01 REF: 84600	/2012 Revision: B 01-PPW0200-RPS-MAP-141
Figure	12
Figure Conce	ptual Site Model
	Moray Offshore Renewables Ltd
