Explosive Ordnance Threat Assessment
in respect of
Near Na Gaoithe Offshore Wind Farm
for
Emu Limited

3165TA_Rev1

Explosive Ordnance Threat Assessment

Neart Na Gaoithe Offshore Wind Farm

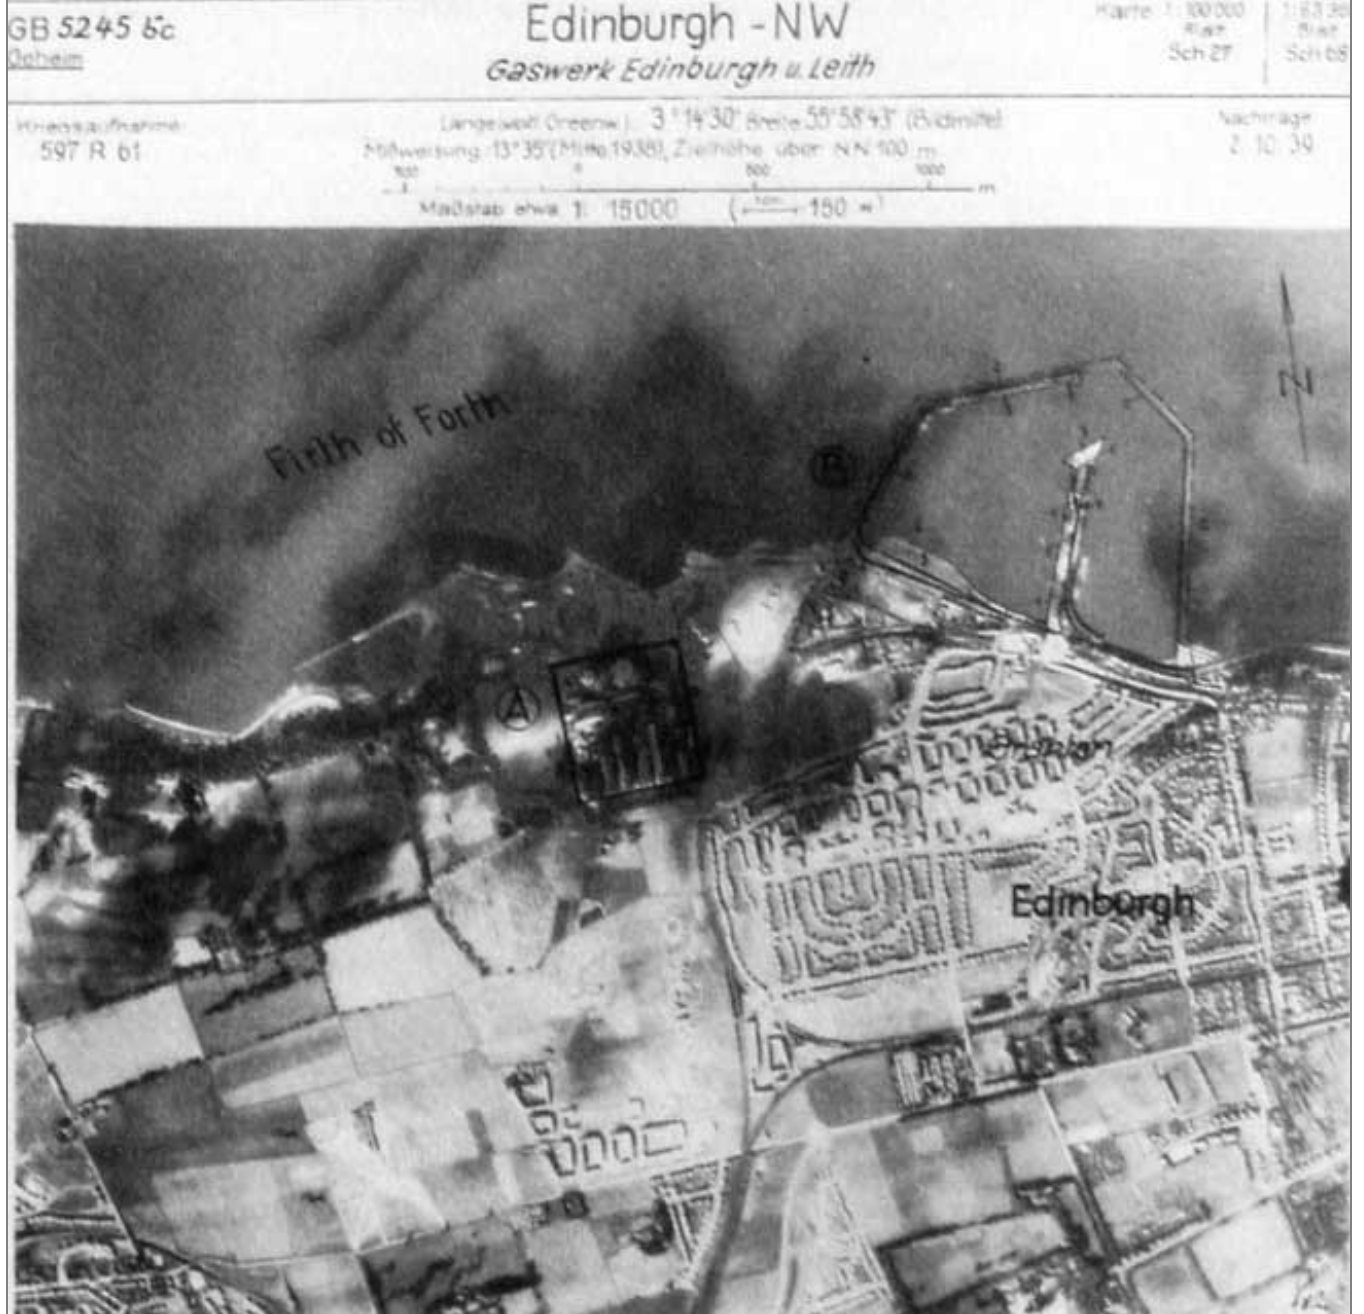
Annex D: Luftwaffe Reconnaissance Target Photograph

The photograph highlights the two main targets in the vicinity; Edinburgh Gas Works (A) and Granton Harbour (B)

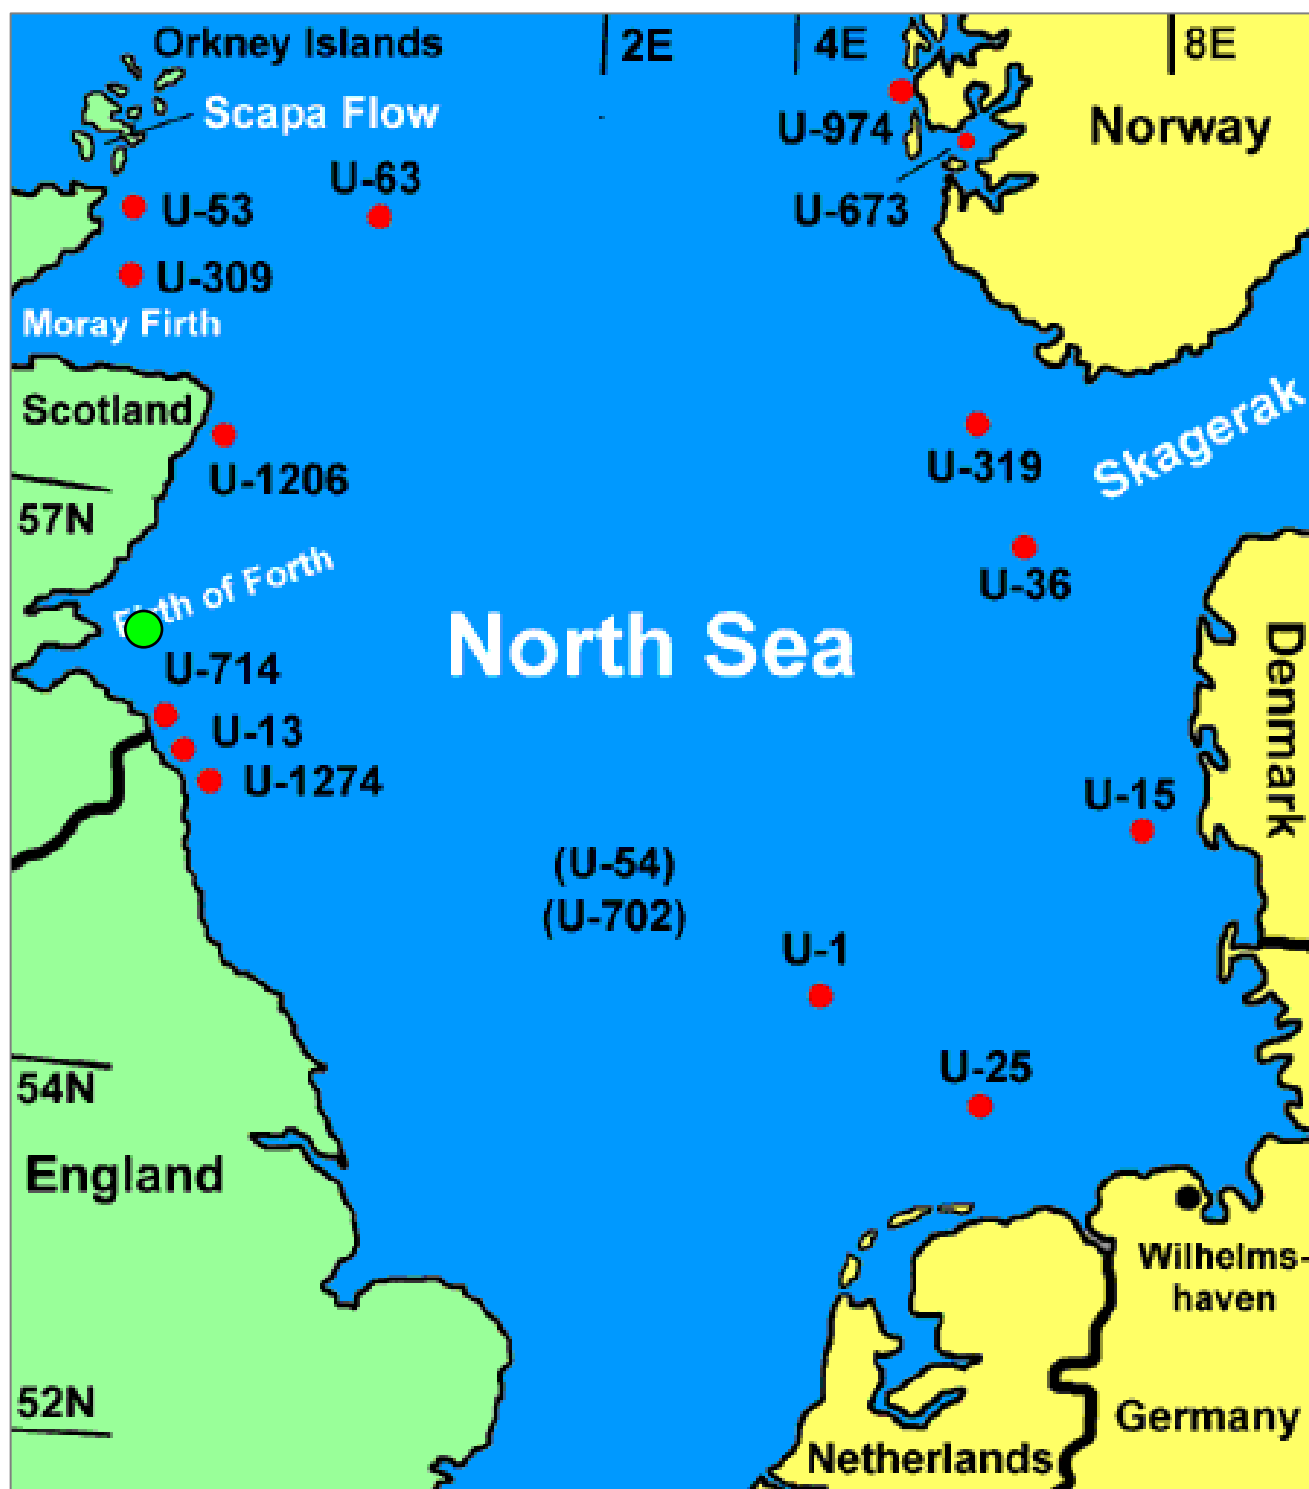
Annex F: Map of WWII U-Boat Losses in the North Sea

U-Boats listed in brackets are those known to have gone missing within the North Sea. Their exact locations are not known.

The mining of the area had some success with three U-boat losses in the region of the site (U-714, U-13 and U-1274) and two missing U-boats at unknown locations in the North Sea (U-54 and U-702). The locations of these losses are shown on a map in Annex F; however none are known to be within the area of the wind farm or cabling routes.

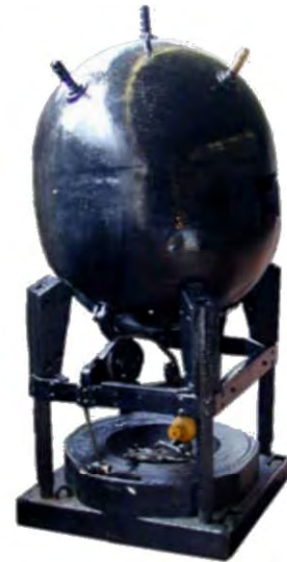
This photograph shows the base mooring unit and the mine

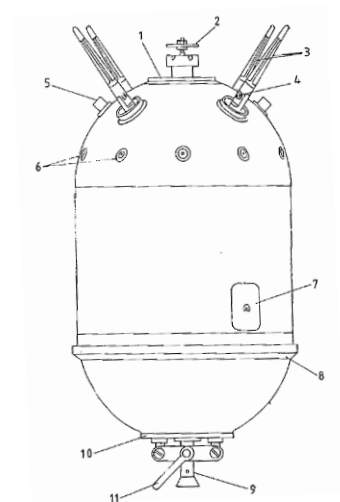
Contact Mine. Code BMC
British Designation: GM

Type: Moored contact
 Shape: Cylindrical with hemispherical top and bottom
 Dimensions: 1.0m high, 0.66m diameter
 Charge Weight: 50kg
 Delivered by: Aircraft (float planes?)
 First Deployed: 1943
 Remarks: Delivered without parachute. Equipped with four Hertz Horns.

1. Cover plate carrying master switch
2. Horn release plate
3. Four push-rod horns
4. Hinge
5. Tapped bosses
6. Welded projections
7. Plate covering detonator pocket
8. Seating band for sinker
9. Mechanism plate
10. Mooring shackle

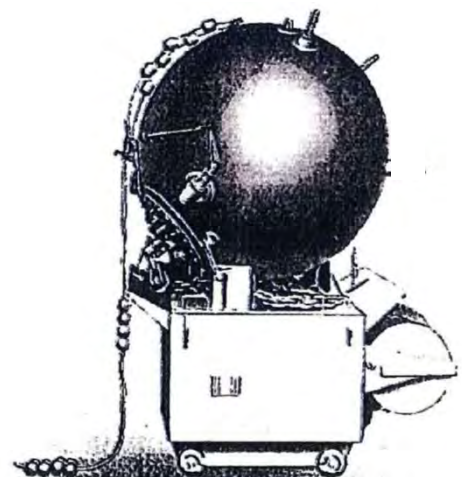
An example pictured on sea-bed in 2008

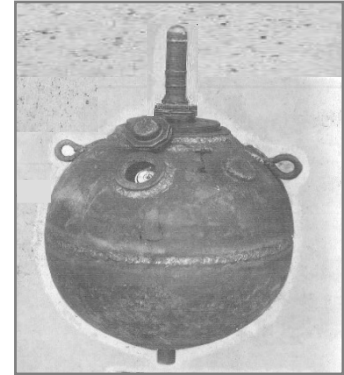
Contact Mine. Code KMA
British Designation: GJ

Type: Moored contact
 Shape: Spherical
 Dimensions: 0.38m diameter
 Charge Weight: 12kg
 Delivered by: Surface craft
 First deployed: September 1939.
 Remarks: Equipped with a single Hertz Horn.
 This is a beach mine

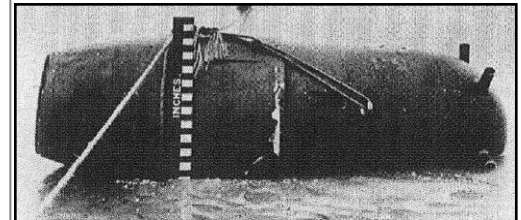
Influence Mine. Code KMA
British Designation: GA /GD

Type: Ground, Magnetic
 Dimensions: Cylindrical, with hemispherical nose and rear parachute housing
 1.8m long x 0.66m diameter
 Charge Weight: 300kg
 Delivered by: Aircraft, retarded by parachute.
 First deployed: September 1939
 Remarks: The mine had 6 anti-rolling (not Herz) horns
 A later version, designated GD in Britain, was later also equipped with acoustic detectors. It did not have anti-rolling horns

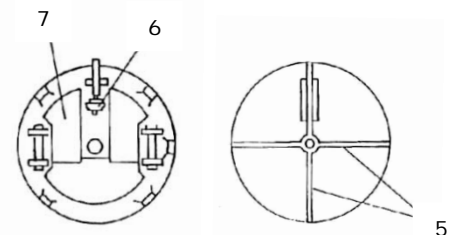
Influence Mine. Code LMF
British Designation: GT

Type: Moored magnetic
 Shape: Cylindrical, finned
 Dimensions: 0.53m diameter, 2.7m long
 Charge Weight: 230kg
 Delivered by: Surface craft, U-boats and float planes
 Deployment: Proved unreliable and was withdrawn in 1941
 Remarks: Used at 150m or 270m depths

- 1 Mooring rope
- 2 Buoyancy chamber
- 3 Charge
- 4 Bowden wire
- 5 Fins
- 6 Mooring shackle
- 7 Mechanism, covered by light casing
- 8 Anchor system, before deployment

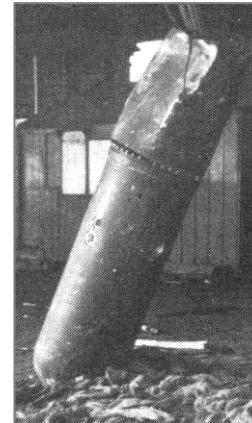
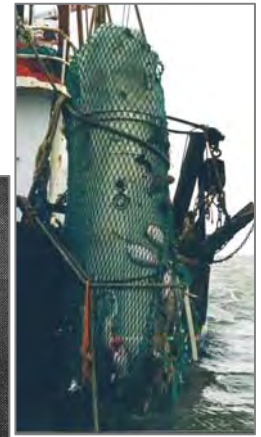
GC "land-mine" part of the parachute visible

GC mine caught in fishing gear. Note the parachute housing still intact

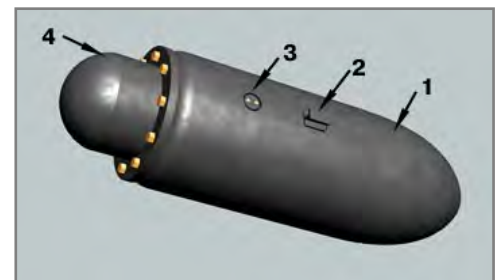
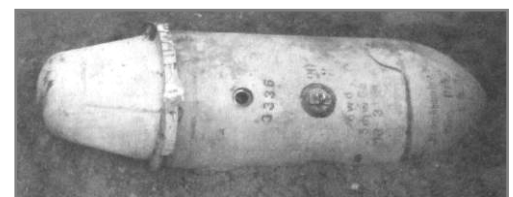
"Mine-bomb". Type BM1000
British Designation: GG

Type: Magnetic and acoustic (later also pressure) and impact
 Dimensions: Cylindrical 0.66m diameter, ~2.0m long, depending on tail unit
 Charge Weight: 725kg
 Delivered by: Aircraft
 First deployed: May 1941
 Remarks: Dropped as a conventional high explosive bomb normally without parachute. Unlike other mines designed by the German Navy this mine was designed by the Luftwaffe with the objective of allowing more accurate positioning than could be achieved with a parachute retarded mine. When deployed against shipping it could be used as an impact bomb or influence mine.
 Casing has low magnetic signature, manufactured from austenitic steel

1. Casing 2. Suspension lug
3. bomb fuse 4. Influence fuzing mechanism

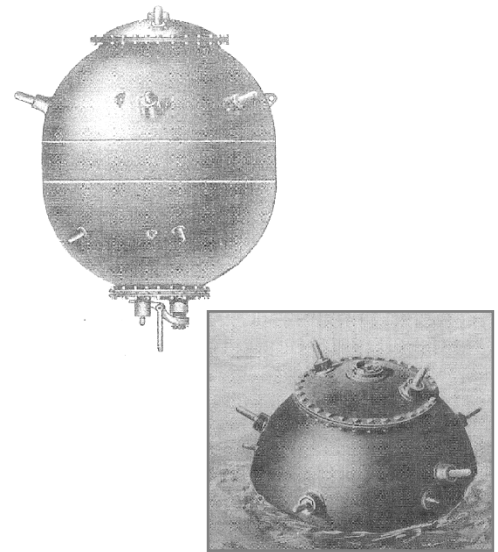
Contact Mine Mk XIV & XV

Type: Moored contact
 Shape: Ovoid
 Dimensions: Diameter 1016mm (40")
 Charge Weight: 145kg or 295kg
 Initiation: initially 11 Hertz horns, later switch horns
 Delivered by: Surface craft
 Dating from: 1920's
 Remarks: Designed for laying in 200 – 1000 fathoms (365 to 1830m) but also used as a general purpose mine in tidal waters

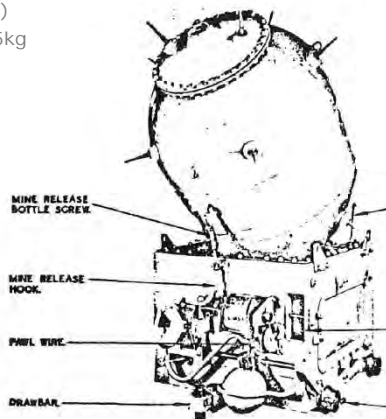
Contact Mine. Mk XVII

Type: Moored contact
 Shape: Ovoid
 Dimensions: Diameter 1016mm (40")
 Charge Weight: 145kg
 Initiation: 11 switch horns
 Delivered by: Surface craft
 Dating from: early 1940's
 Remarks: Designed for laying in 500 fathoms (925m)
 There was also an influence (acoustic) version

Mk XVII on sinker, before deployment

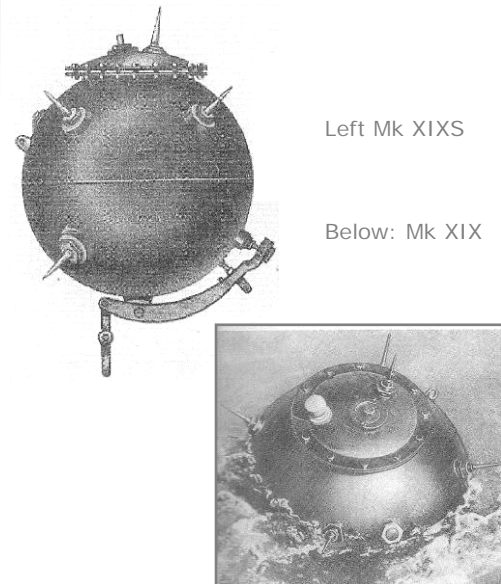
Contact Mine. Mk XIX & XIXS

Type: Moored contact
 Shape: Spherical
 Dimensions: 790mm (31") diameter
 Charge Weight: 45kg
 Initiation: initially 8 switch horns
 Delivered by: Surface vessel
 Remarks: Originally designed to be laid as anti-submarine barrage. The "S" variant was for use against shallow draft vessels

Left Mk XIXS

Below: Mk XIX

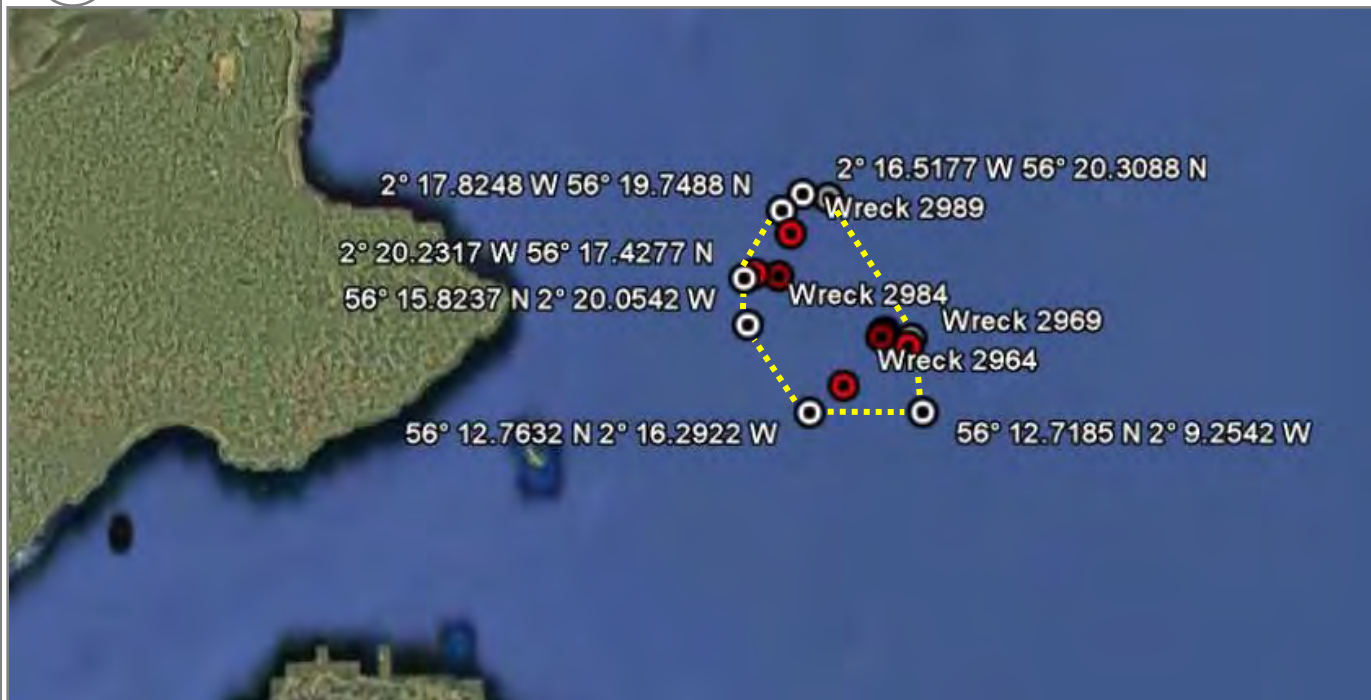
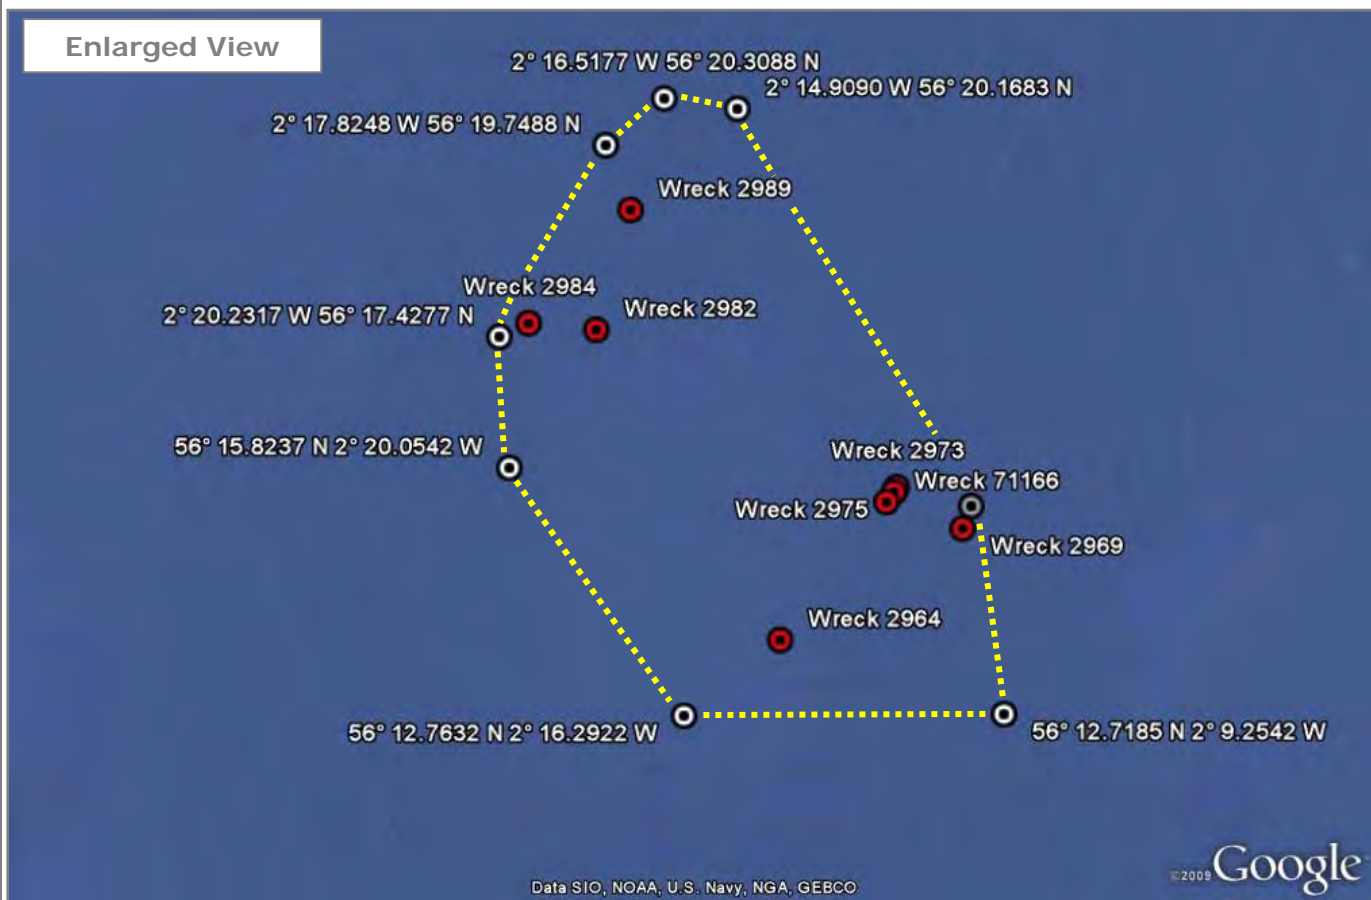
Annex J: Wreck Location Map & Data Information Sheets

— Approximate Windfarm Boundary ● Approximate Wreck Locations ○ Outlying Points

The data sheets document seven of the eight wrecks to be 'non-dangerous', however two of these are submarines, which may have contained various items of UXO. Also worthy of note is that one of the wrecks (number 2969) remains 'undefined'. The data sheet pertaining to this wreck provides minimal information regarding the nature and contents of the ship, however it should be noted that the wreck is neither detailed as historic, nor military related. As a result the possibility of UXO being contained within the vessel is considered to be low and it is considered unlikely to comprise anything more than a seabed feature.

It should be noted that whilst none of the listed wrecks are documented as dangerous or military vessels, five of the eight records date from the WWI or WWII-era and include references to two British submarines. Consequently, the likelihood of any such wrecks containing items of UXO cannot be entirely discounted, yet is considered to be minimal.

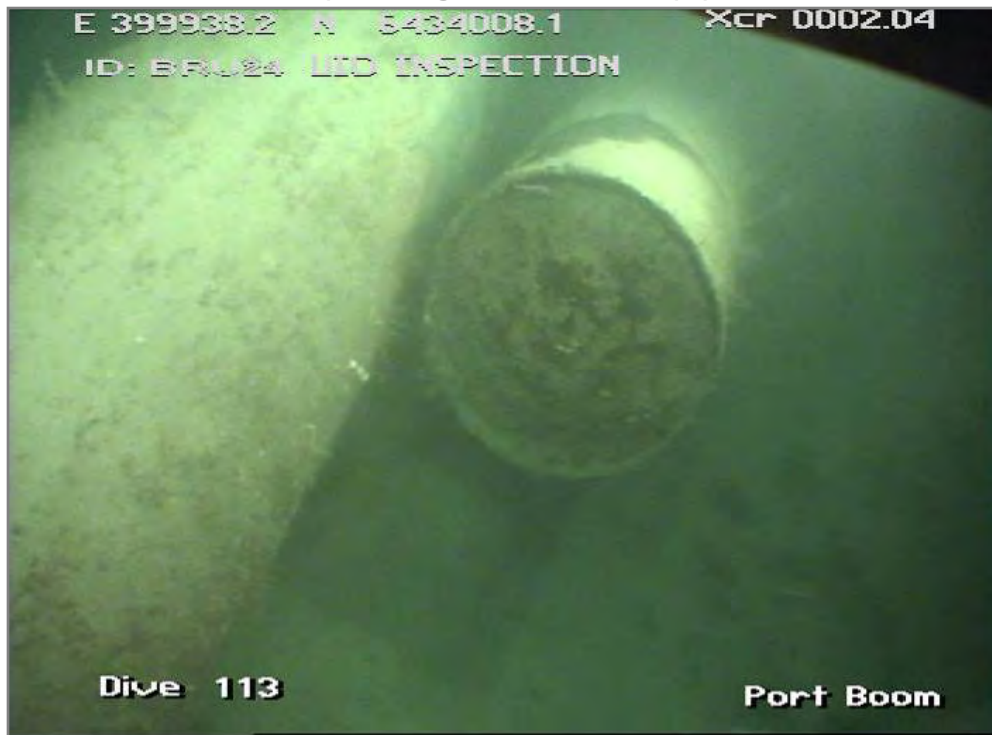
Torpedo against the 24" pipe

Failed torpedoes sink to the seabed with their warheads intact when they run out of fuel and several have been recovered from the waters around the UK in recent years (an example of a torpedo recovered by BACTEC in the North Sea is presented in Annex K-1). Such devices have the potential to be present within the proposed wind farm area. However, the risk of encountering unexploded torpedo warheads is not considered to be high as they were commonly deployed in relatively small numbers. Typically, the warheads would contain around 300-500kg of explosives; however taking into consideration the presence of the submarine exercise area to the south of the wind farm, there is an increased possibility of encountering dummy warheads which are free of such explosives. Photographs of WWII torpedoes are presented in Annex K-2.

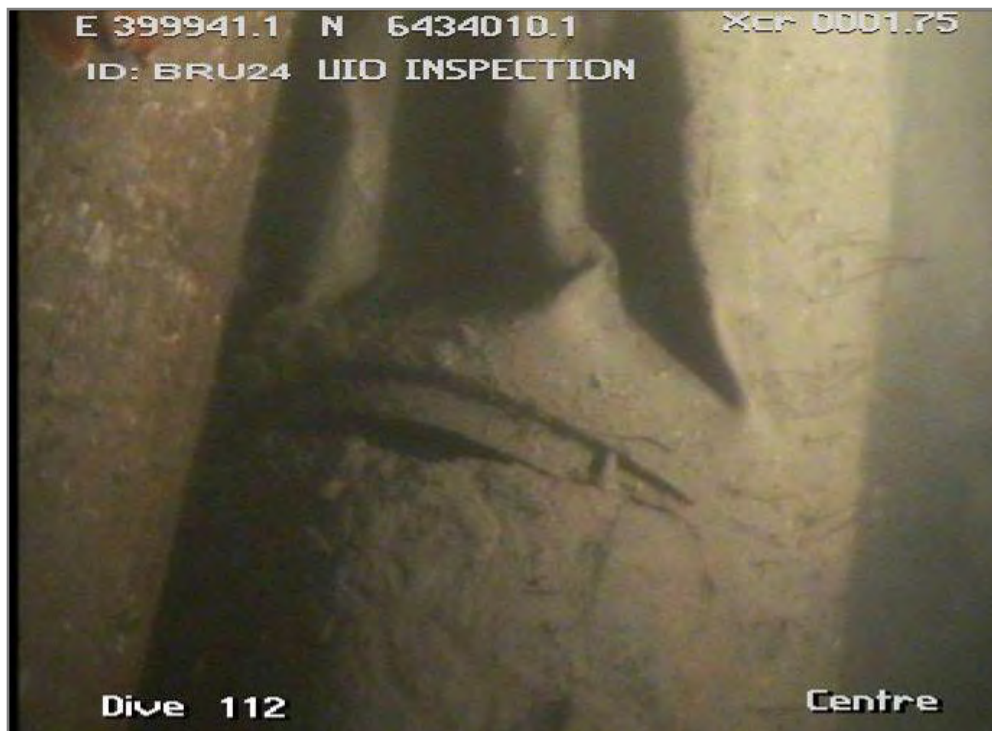
View of front of torpedo showing collapse of outer case and partial separation of warhead from pressure vessel

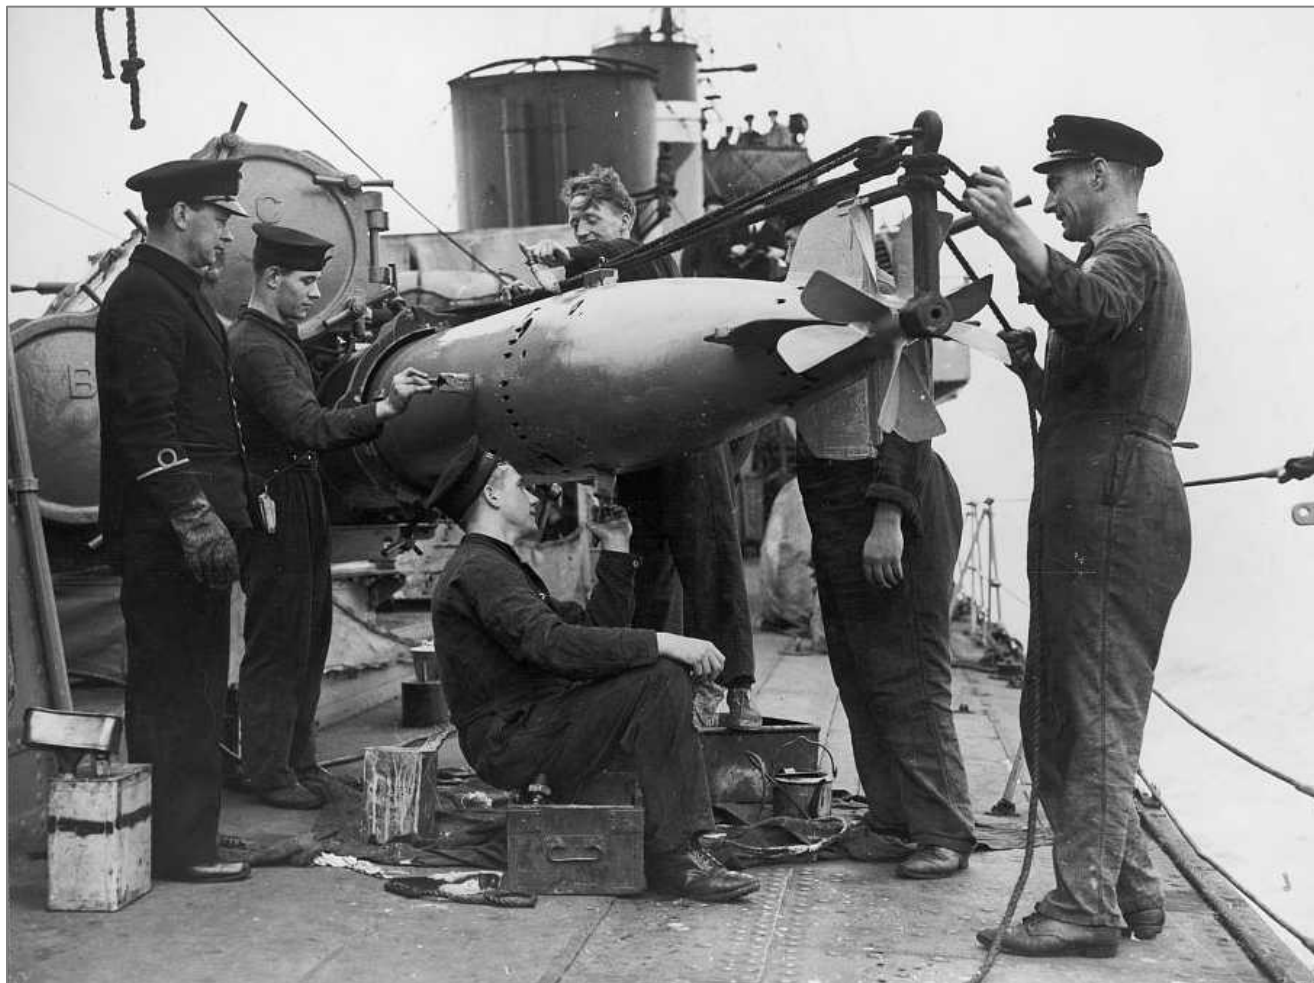
Preparing a torpedo aboard HMS Vanoc in August 1941
This is probably a Mark II or Mark IV torpedo

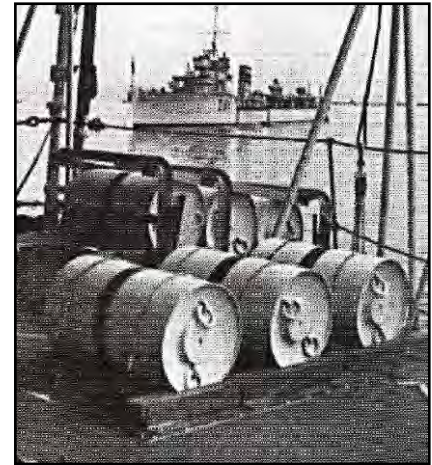
Type: Standard
 Shape: Cylindrical, drum shaped
 Dimensions: 700mm long, 450mm diameter
 Charge Weight: 132kg
 Delivered by: Surface vessel
 First Deployed: 1939
 Remarks: The Mk VII was little changed from the WWI Type D. Initially the depth charge was simply dropped from the attacking vessel but from late 1940 /early 1941 a launcher was used which projected the weapon some 35m

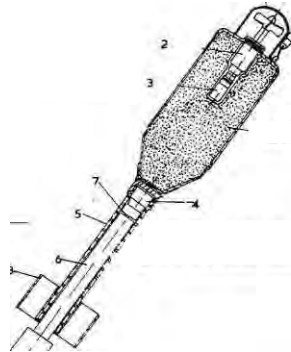
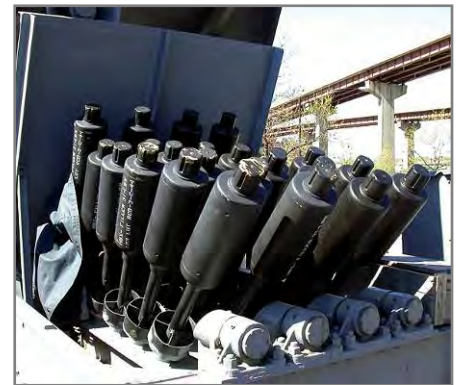
"Hedgehog" Spigot Mortar

Dimensions: Diameter 178mm (7") diameter
 Charge Weight: 16kg
 Initiation: Contact fuze
 Delivered by: Surface craft
 Dating from: 1942
 Remarks: Fired in 24 mortar barrages.
 The contact fuze was only activated if it struck a submarine

24 Mortar launcher

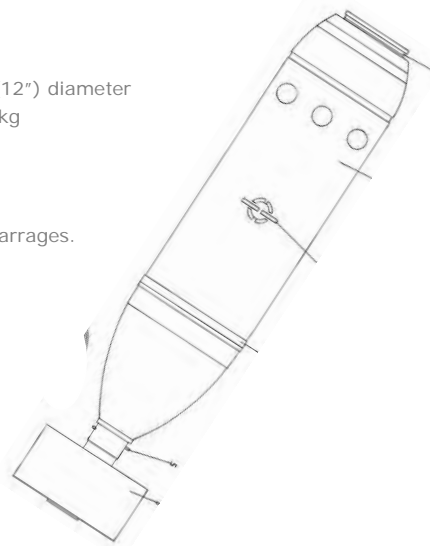
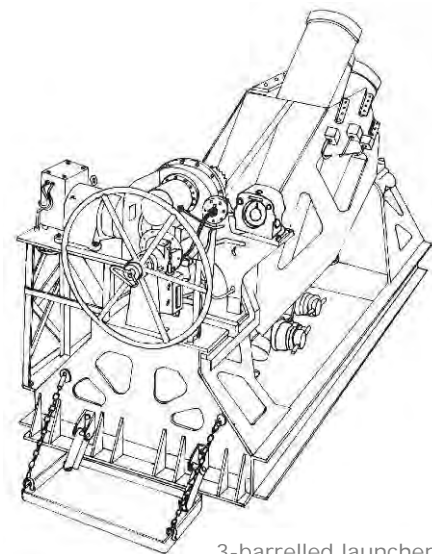
"Squid" Mortar

Dimensions: Diameter 305mm (12") diameter
 Charge Weight: 94kg
 Initiation: Timer fuze
 Delivered by: Surface craft
 Dating from: 1943
 Remarks: Fired in 3 mortar barrages.

3-barrelled launcher

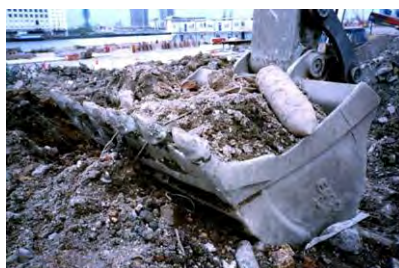
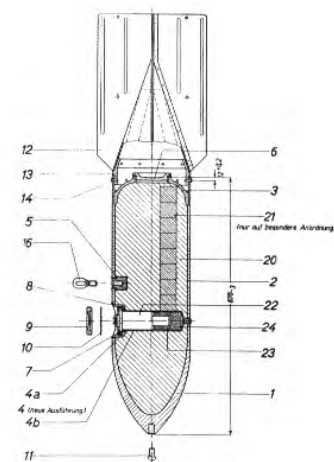
SC 50

Bomb Weight: 40-54kg (110-119lb)
 Explosive Weight: c25kg (55lb)
 Fuze Type: Impact fuze/electro-mechanical time delay fuze
 Bomb Dimensions: 1,090 x 280mm (42.9 x 11.0in)
 Body Diameter: 200mm (7.87in)
 Use: Against lightly damageable materials, hangars, railway rolling stock, ammunition depots, light bridges and buildings up to three stories.
 Remarks: The smallest and most common conventional German bomb. Nearly 70% of bombs dropped on the UK were 50kg.

50kg bomb, London Docklands

SC-50 JA (Güteklasse I)

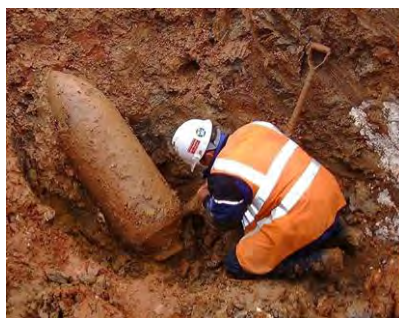
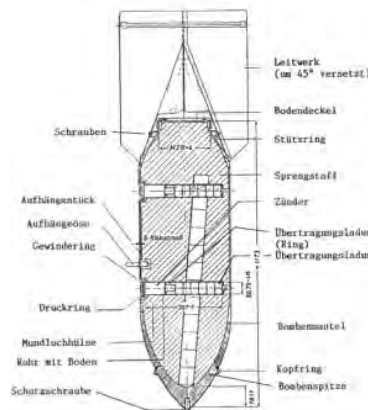
SC 250

Bomb weight: 245-256kg (540-564lb)
 Explosive weight: 125-130kg (276-287lb)
 Fuze type: Electrical impact/mechanical time delay fuze.
 Bomb dimensions: 1640 x 512mm (64.57 x 20.16in)
 Body diameter: 368mm (14.5in)
 Use: Against railway installations, embankments, flyovers, underpasses, large buildings and below-ground installations.

250kg bomb, Hawkinge

SC-250 JA (Güteklasse I)

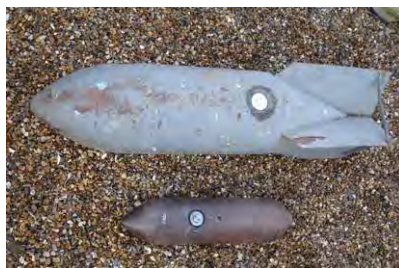
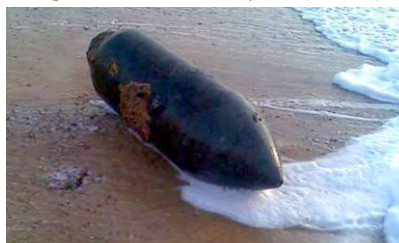
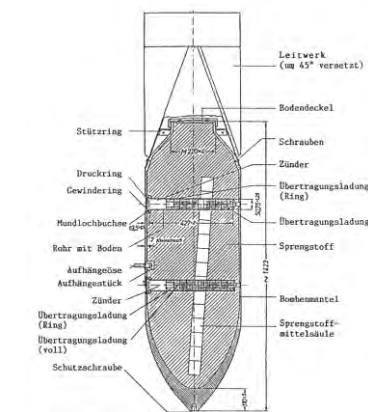
SC 500

Bomb weight: 480-520kg (1,058-1,146lb)
 Explosive weight: 250-260kg (551-573lb)
 Fuze type: Electrical impact/mechanical time delay fuze.
 Bomb dimensions: 1957 x 640mm (77 x 25.2in)
 Body Diameter: 470mm (18.5in)
 Use: Against fixed airfield installations, hangars, assembly halls, flyovers, underpasses, high-rise buildings and below-ground installations.

50kg bomb included for size comparison (see above)

500kg bomb, Felixstowe beach, April 2008

SC-500 J (Güteklasse I)

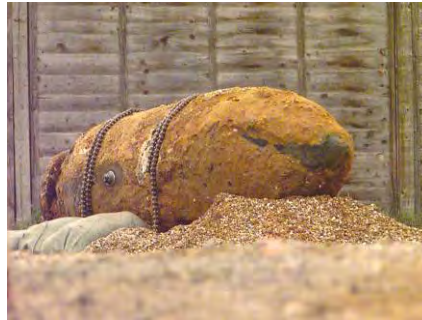
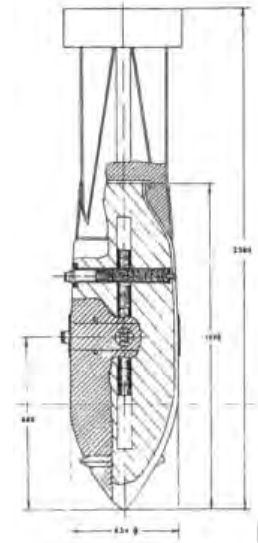
Bomb weight: 993-1,027kg (2189-2,264lb)
 Explosive weight: 530-590kg (1,168-1,300lb)
 Fuze type: Electrical impact fuze
 Bomb dimensions: 2,580 x 654mm (101.6 x 2.5in)
 Body diameter: 654mm (25.75in)
 Use: Against unarmoured sea and land targets
 Remarks: Known as the 'Hermann'

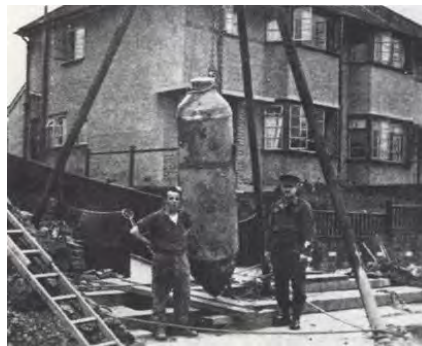
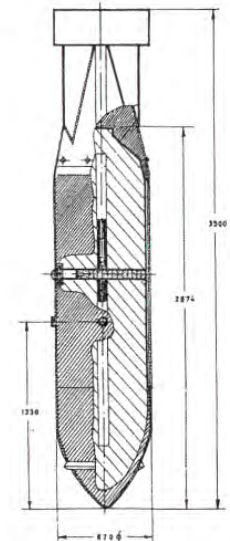
SC 1800

Bomb weight: 1,767-1,879kg (3,896-4,142lb)
 Explosive weight: 1,000kg (2,205lb)
 Fuze Type: Electrical impact fuze
 Bomb Dimensions: 3500 x 670mm (137 x 26in)
 Use: Against building complexes and large merchant vessels
 Remarks: Known as the 'Satan'

1800kg bomb, Bristol, 1941

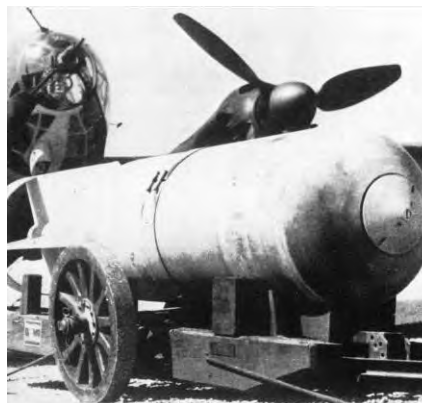
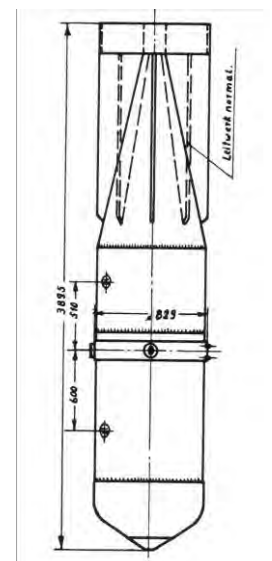
Bomb Weight: Bomb weights have been quoted as 1,950kg (4,300lb) and 2,500kg (5,512lb)
 Explosive Weight: 1,700kg (3,748lb)
 Fuze Type: Electrical impact fuze
 Bomb Dimensions: 3,895 x 829mm (153.3 x 32.6in)
 Body Diameter: 829mm (32.6in)
 Use: Against building complexes and merchant vessels.
 Remarks: The SC 2500 has an aluminium body with a welded head and tailpiece. Known as the 'Max'. Only a limited number were deployed.

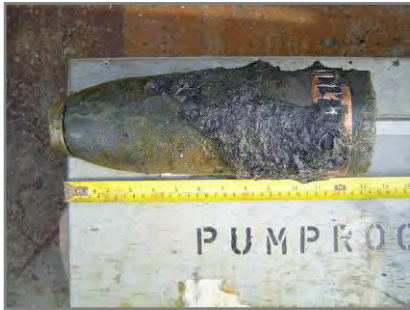
PROJECTILE 4"

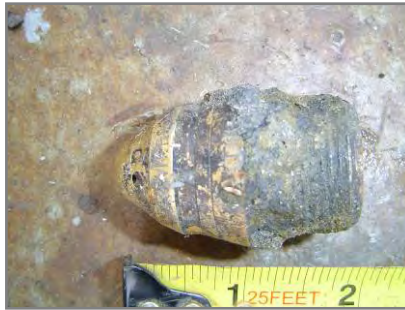
P.T.T.F LIVE FUZE

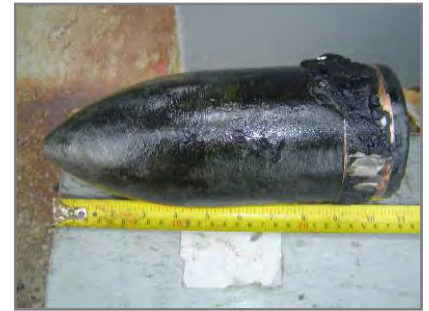
PROJECTILE 4" SOLID SHOT

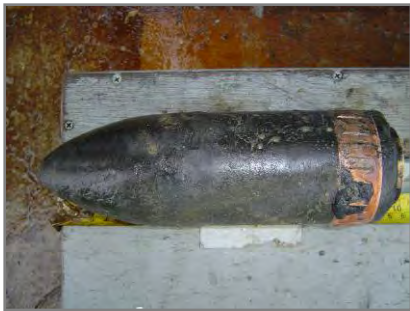
PROJECTILE 3" HE/BLACK POWDER

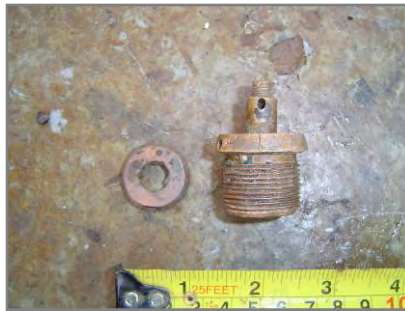
FUZE COMPONENTS

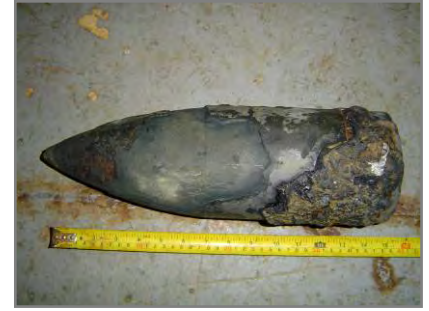
PROJECTILE 5" SOLID SHOT

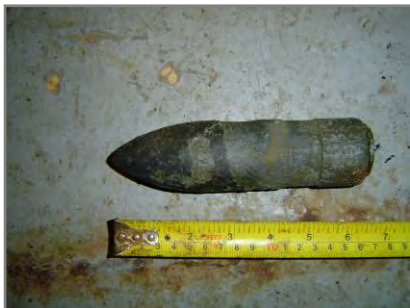
PROJECTILE 1 3/4" HE LIVE

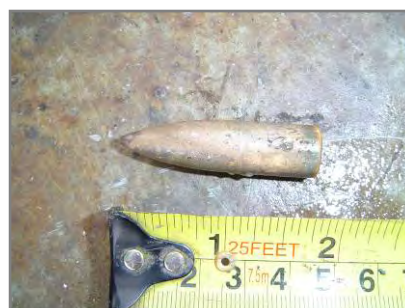
SAA

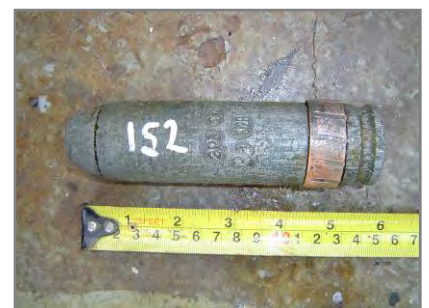
1 1/2" HE PROJECTILE

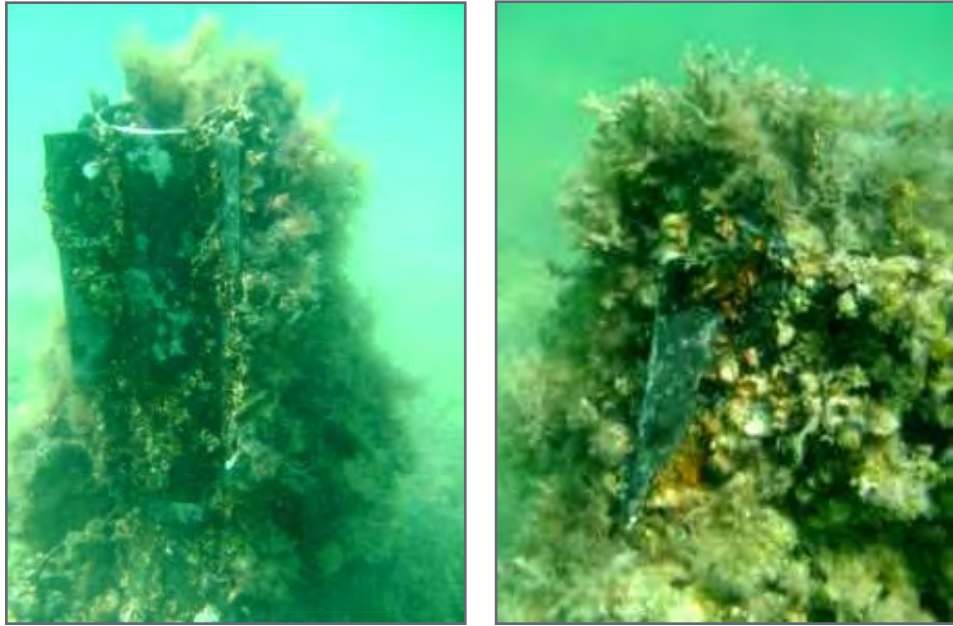
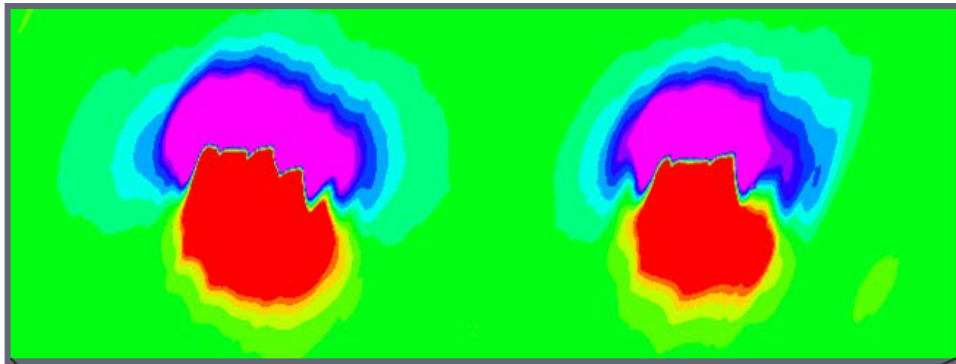
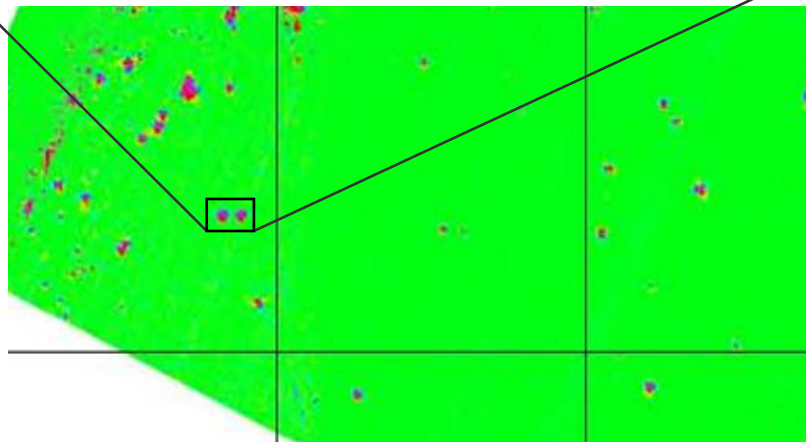
Annex R: Photos of HE Bombs Found in a Marine Environment

This Annex shows photographs of two unexploded US 1000lbs bombs believed to have been in the water for 20years
They were detected by BACTEC's AGS-1 magnetometry survey system and relocated by divers before being demolished
by controlled explosion

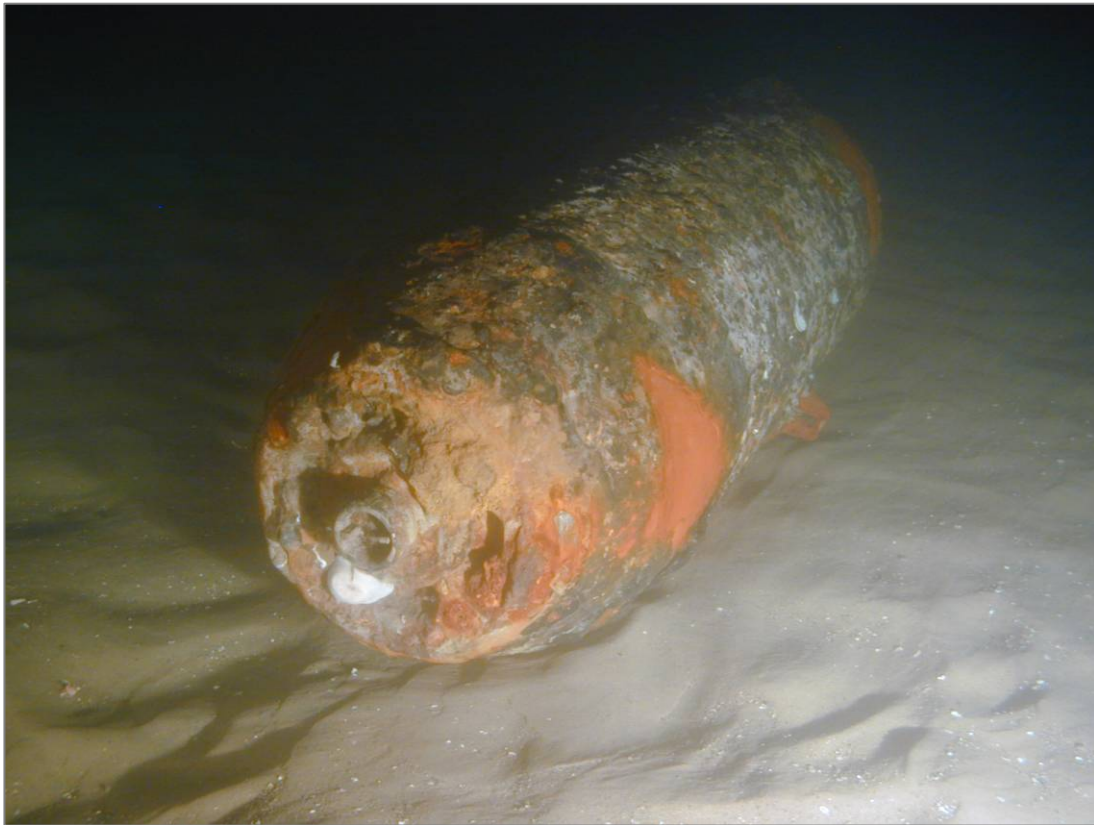
Annex S: Example of Ordnance in Transit, North Sea, 2006

1000lb British high explosive bomb recovered by BACTEC in the North Sea in 2006
