Figures

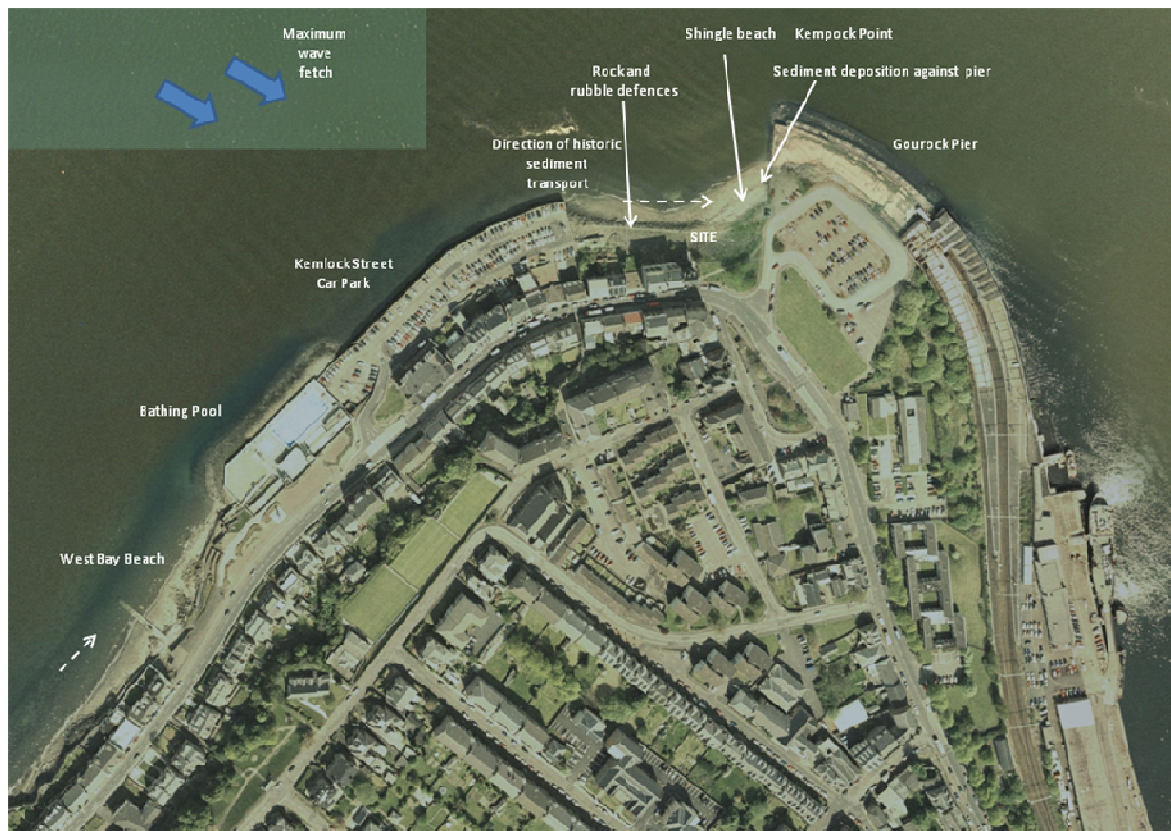
Figure 1: Coastal Processes at site, on annotated aerial photograph of Gourock

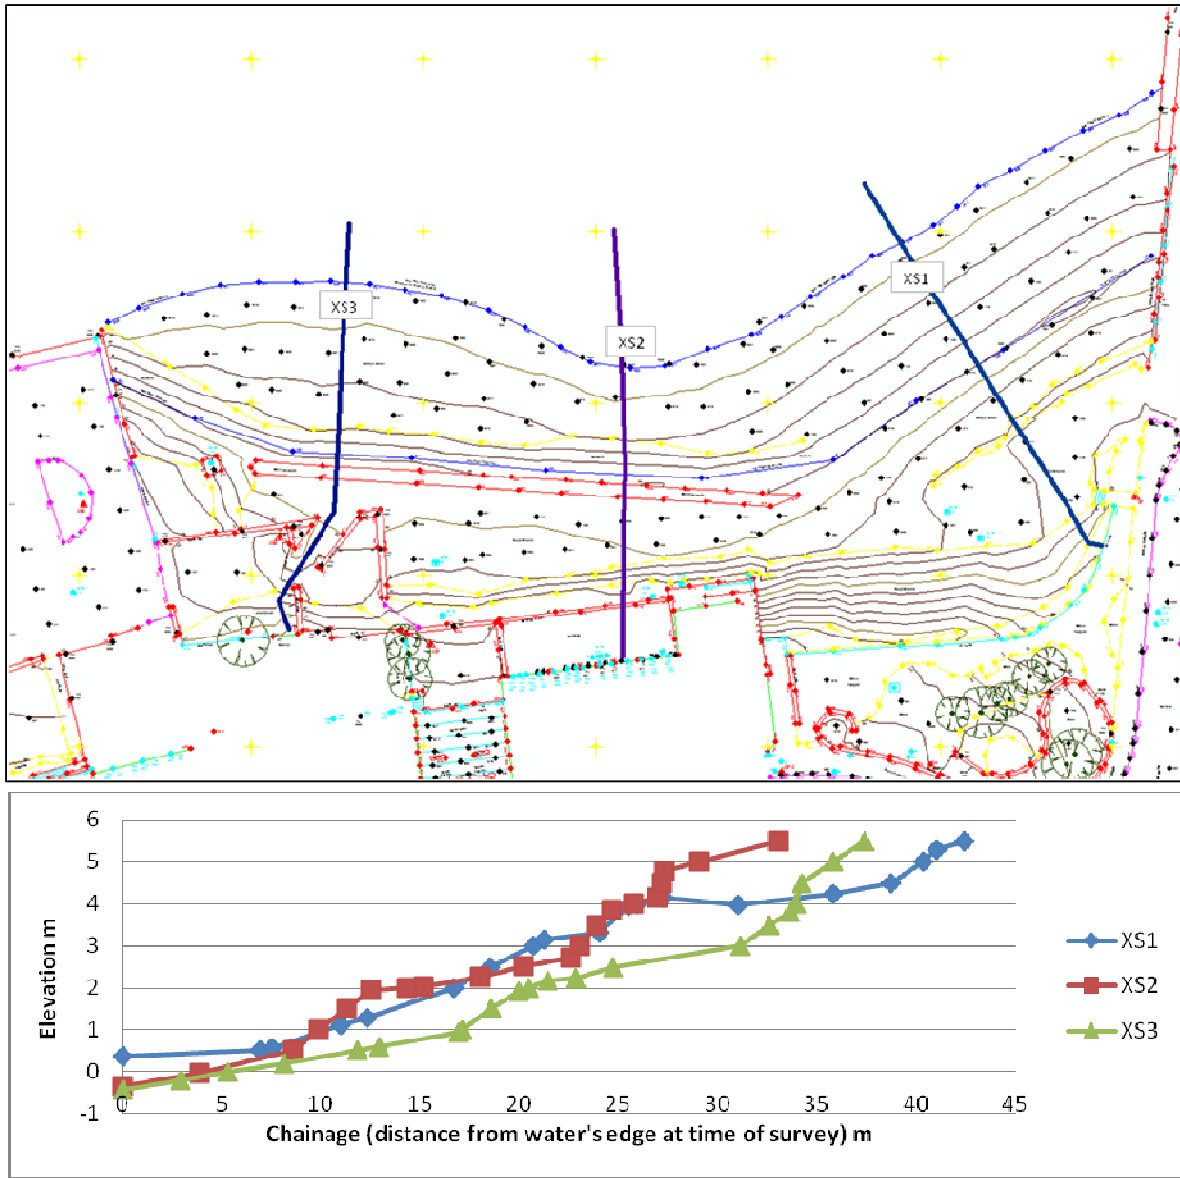
Figure 2: Cross-sections of the site, extracted from topographic survey

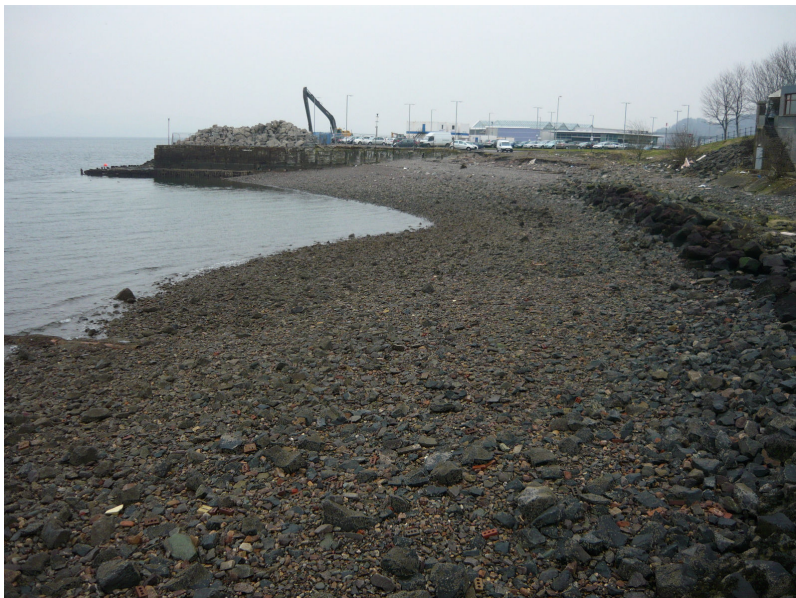
Photo 1: Proposed Development Site, looking to the east from Kempock Street car park

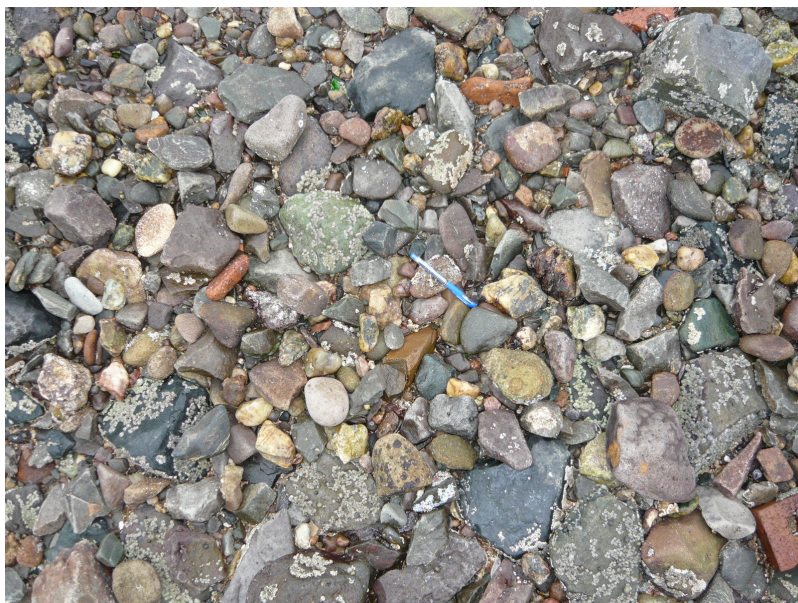
Photo 2: Beach sediment on western side of site (note the barnacle cover)

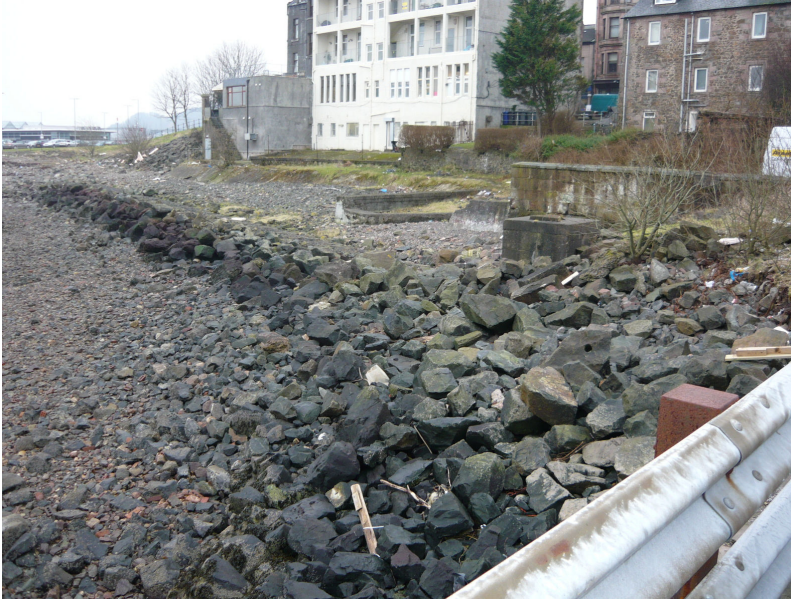
Photo 3: Rocks fronting the old concrete blocks along the western side of the site

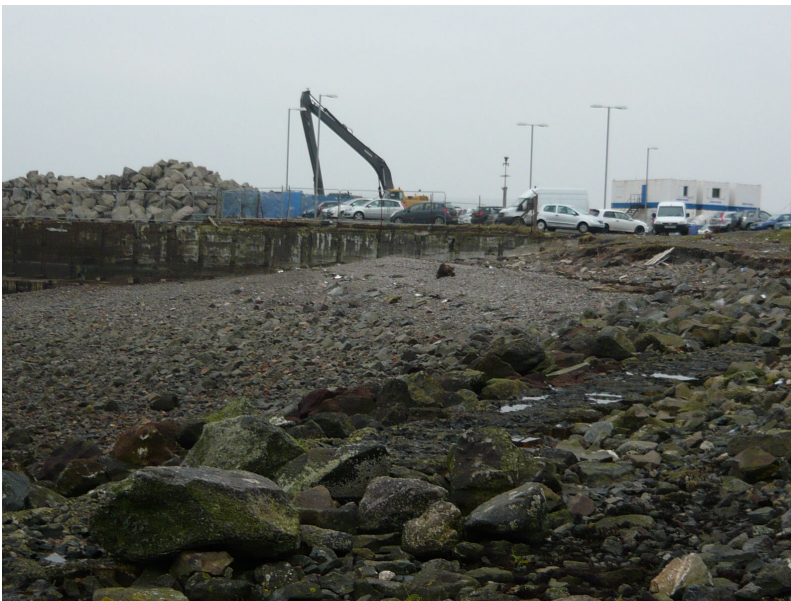
Photo 4: Short section of shingle beach at the eastern side of the site

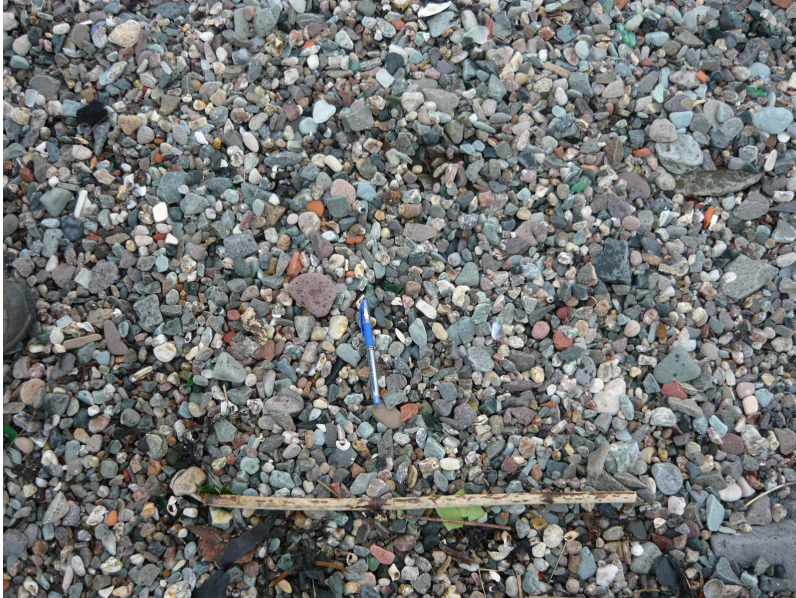
Photo 5: Finer shingle sediment on the lower part of the shingle beach at the eastern side of the site.
