Gourock Pierhead Regeneration Ground Investigation

Interpretative Report

January 2012

PROJECT TITLE: Gourock Pierhead Regeneration, Ground Investigation

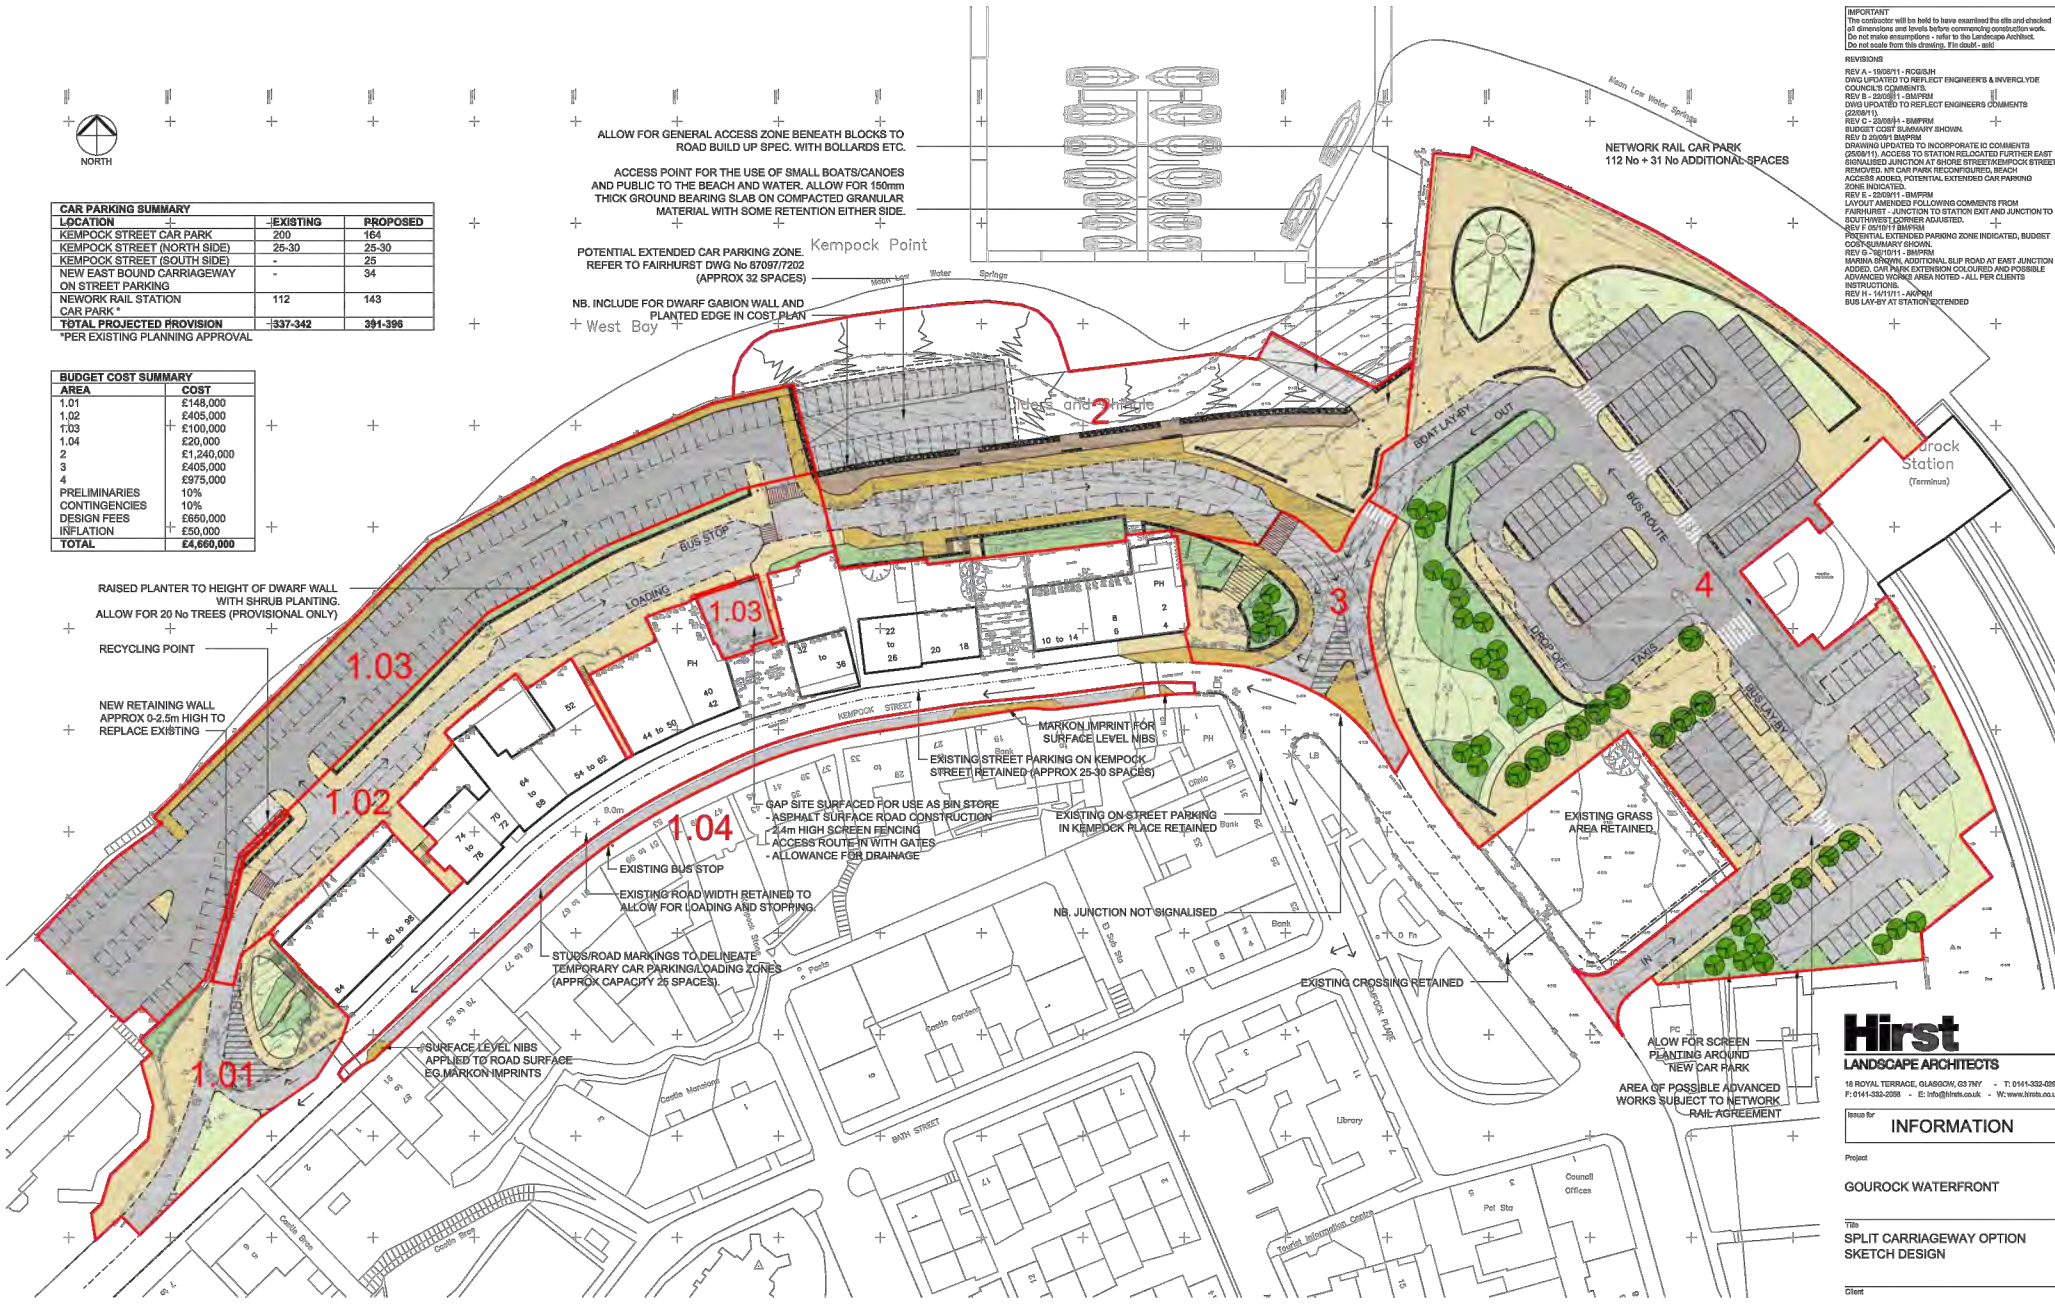
DRAWING UPDATED TO INCORPORATE IC COMMENTS (20/01/11). ACCESS TO STATION RELOCATED FURTHER EAST REORGANISED JUNCTION AT BRIDGE STREET/KEMPOCK STREET RECONFIGURED. NEW CAR PARK RECONFIGURED. BEACH ACCESS AND POTENTIAL NETWORKED CAR PARKING ZONE INDICATED.
REV E - 20/01/11 - SH/PM
LAYOUT AMENDMENTS FOLLOWING COMMENTS FROM FAIRHURST - JUNCTION TO STATION EXIT AND JUNCTION TO SOUTH WEST CORNER AMENDMENTS.
REV F - 16/01/11 - SH/PM
PROJECTAL EXTENDED PARKING ZONE INDICATED. BUDGET COST SUMMARY SHOWN.
REV G - 16/01/11 - SH/PM
MARRA OPENED. ADDITIONAL BLP ROAD AT EAST JUNCTION ADDED. CAR PARK EXTENSION COLOURED AND POSSIBLE ADVANCED WORKING AREA NOTED - ALL PER CLIENTS INSTRUCTIONS.
REV H - 16/01/11 - SH/PM
BUS LANE AT STATION EXTENDED

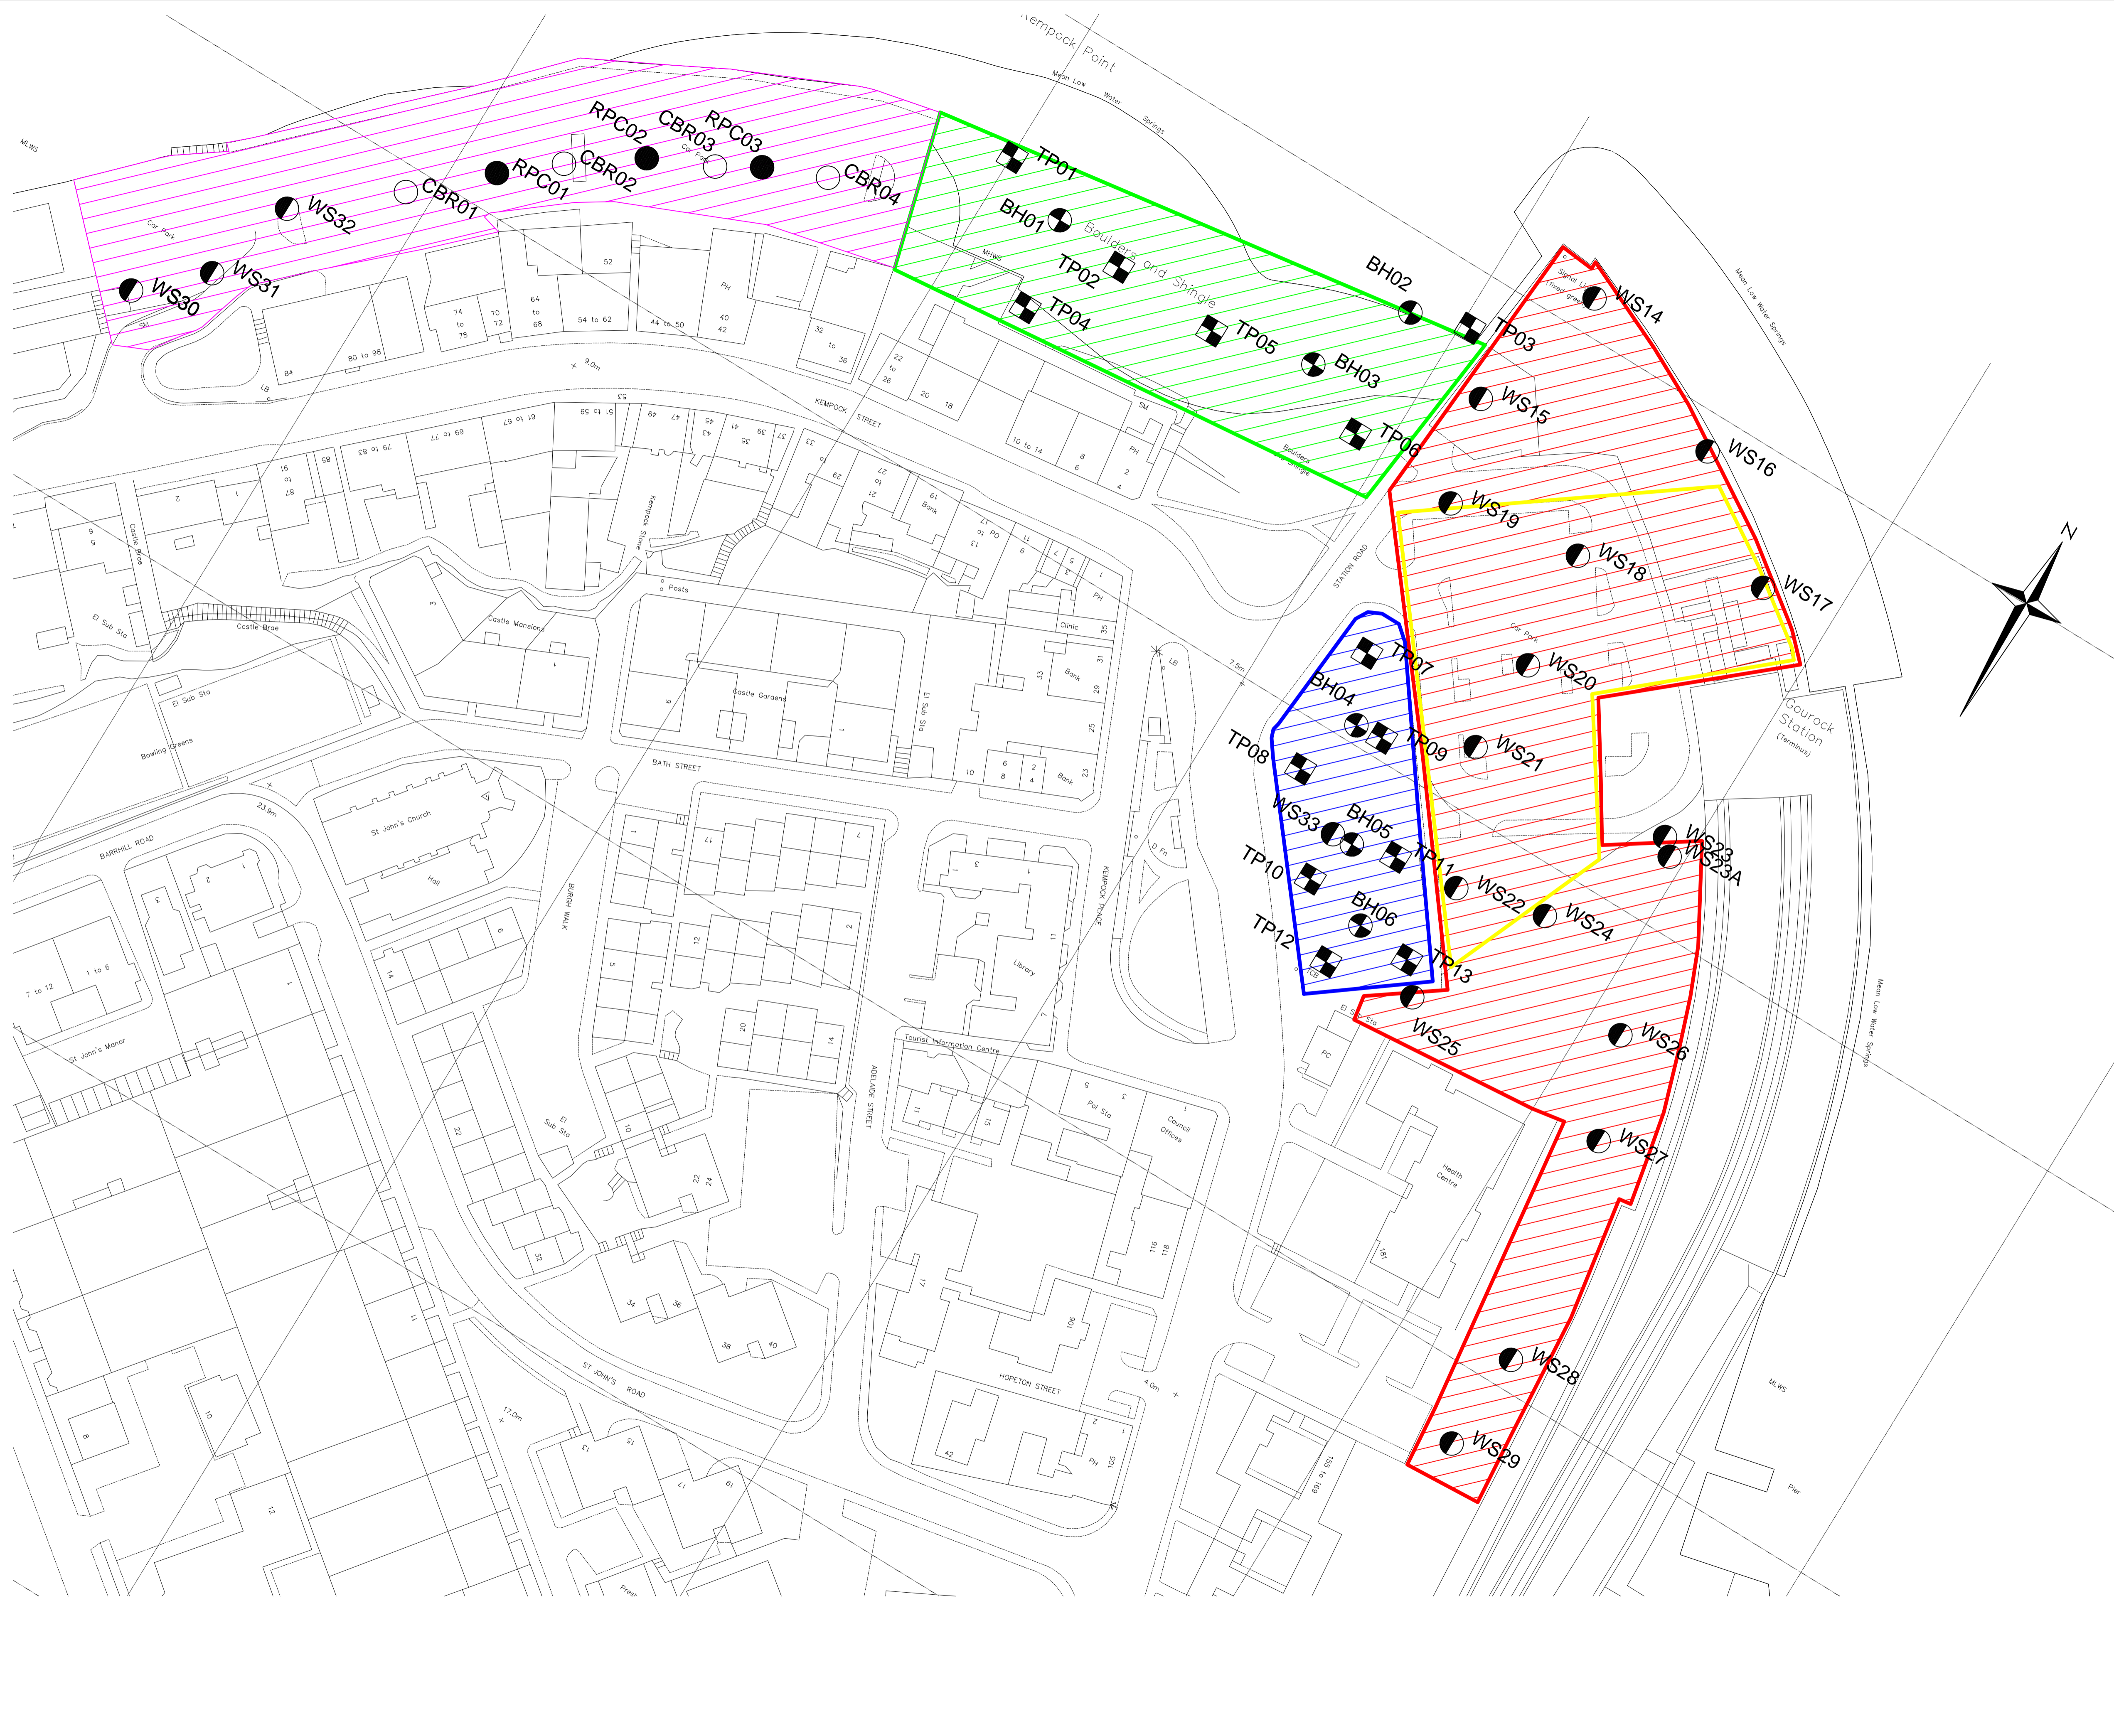
- BOREHOLE
- TRIAL PIT
- WINDOW SAMPLER
- ROAD PAVEMENT CORE
- CBR TEST
- AREA OF PROPOSED HARDSTANDING/CAR PARKING
- EXISTING CAR PARK
- AREA OF PROPOSED QUAY WALL/REVIEMENT
- AREA OF PROPOSED COMMERCIAL DEVELOPMENT
- AREA OF EXISTING CAR PARKING
