ABERDEEN HARBOUR
EXPANSION PROJECT
November 2015

APPENDIX 24-A HISTORIC ENVIRONMENT DESK-BASED ASSESSMENT

Aberdeen Harbour Expansion Project, Nigg Bay, Aberdeen

Historic Environment Desk-Based Assessment

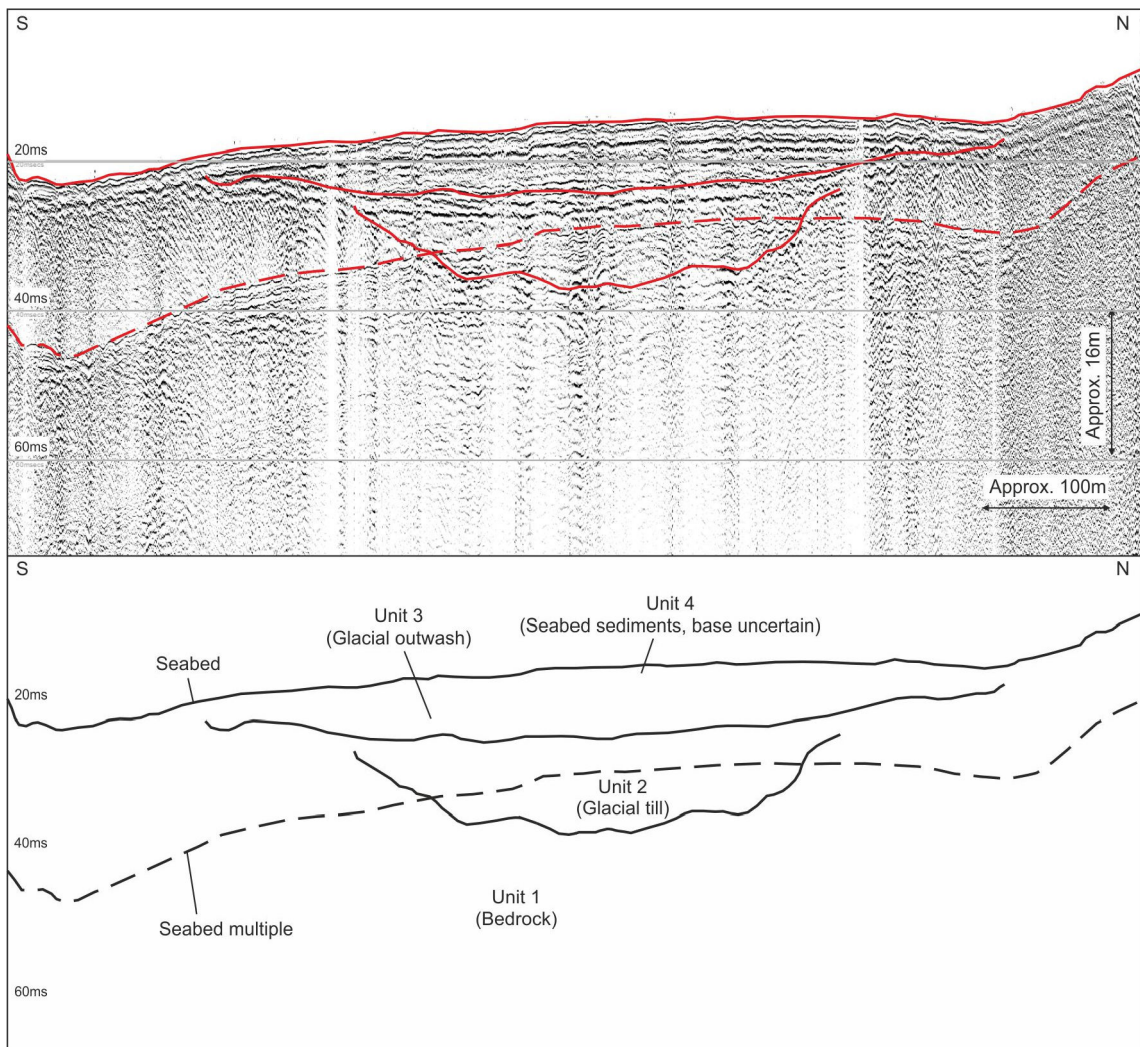
Figure 7

Sub-Bottom Profiler Data Example

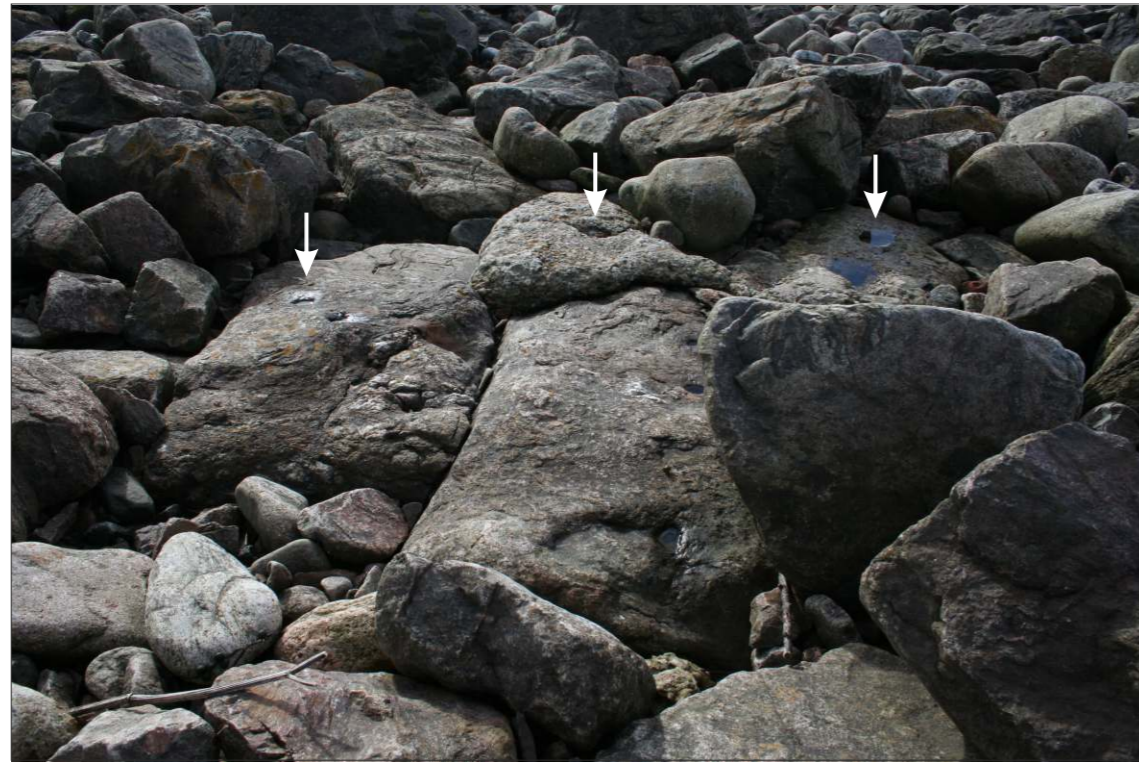
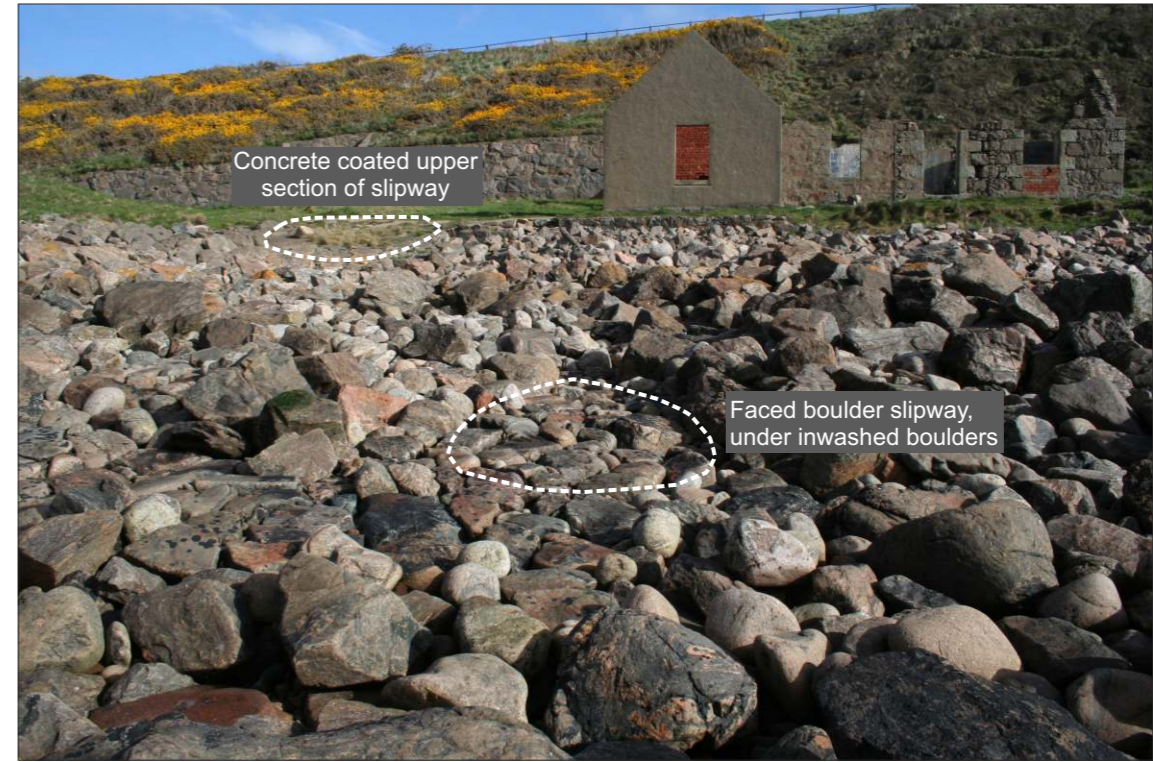
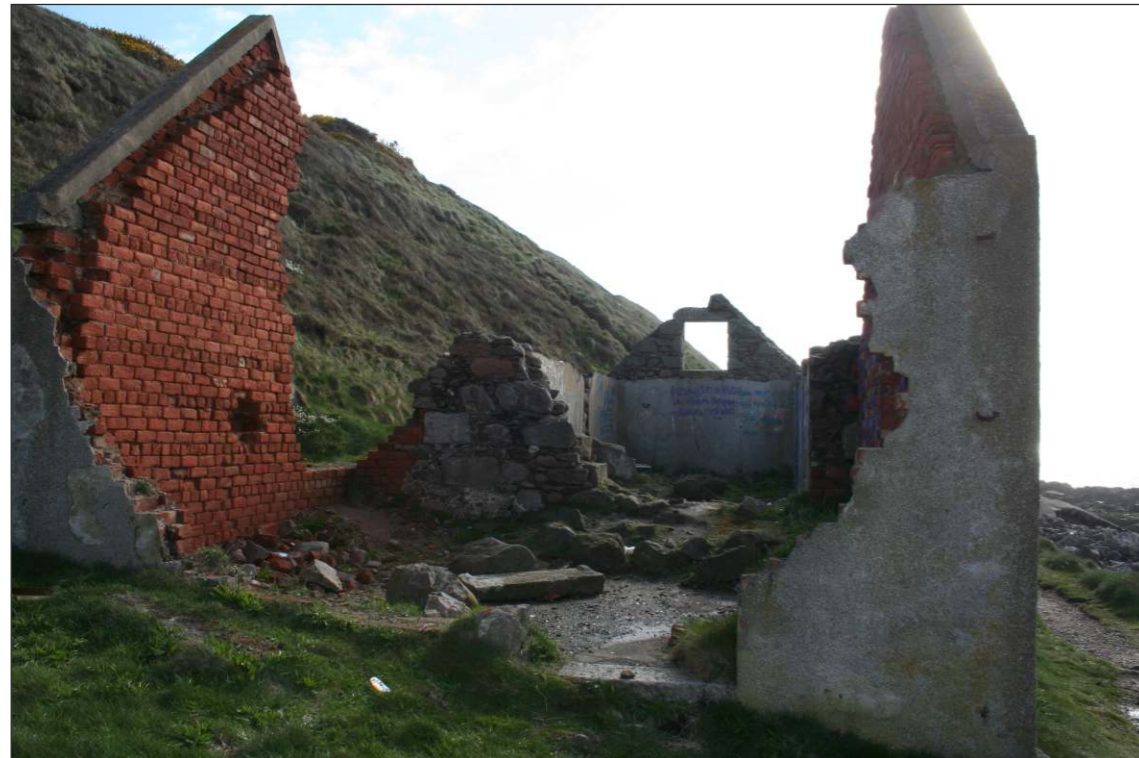
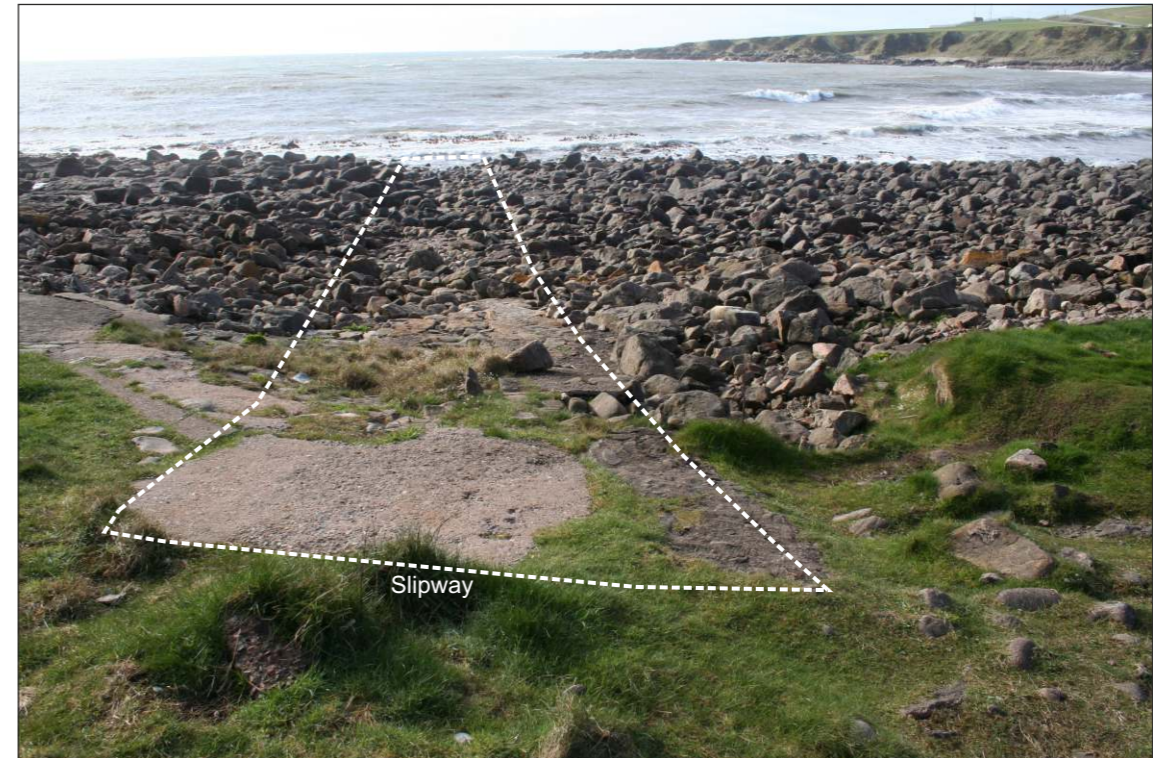
A. Slipway (fastenings highlighted by arrows)

B. Slipway and roofless building

C. Roofless building

D. Slipway and north coast of Nigg Bay

- 4.6.34 A vernacular slipway is located on the north side of Nigg Bay (**WA 1028**). The slipway is illustrated on 25" 1st Edition OS mapping as a cleared area of beach, surveyed in 1868. The slipway is located seaward of small building at the back of the beach above MHWS. During the Walkover Survey the slipway was observed as faced boulders embedded in the surface of beach extending at least 40m south and obscured partially by boulders and beach armouring. The upper sections near MHWS have been skimmed in concrete (presumably a later phase of use) (**Plate 9**). A number of iron fittings and holes for fittings are observed here. Anecdotally, the site is said to have been used by lobster fishermen until the 1960s (Cameron 2013). The western gable of the roofless, partly demolished building is a brick-built extension, perhaps early 20th century as depicted on 1901 25" 2nd edition

- 7.5.5 The historic vernacular slipway located on the north coast of Nigg Bay (**WA 1028**) and possibly the associated roofless building immediately to the north are likely to be buried or removed by the groundworks and construction of the north quay. It is recommended that the slipway be cleared of overlying boulders and detritus, surveyed and recorded *in situ* prior to site preparation works; forming the basis of a Historic Buildings Report and supplemental Heritage Statement. This may be achieved using a variety of high-resolution and rapid techniques such as photogrammetry, laser-scanning and hand-recorded plans.
