Beatrice Offshore Wind Farm

Cable Route Benthic Technical Report

February 2012

Document: J3151 Beatrice Cable Route Benthic Technical Report 2011

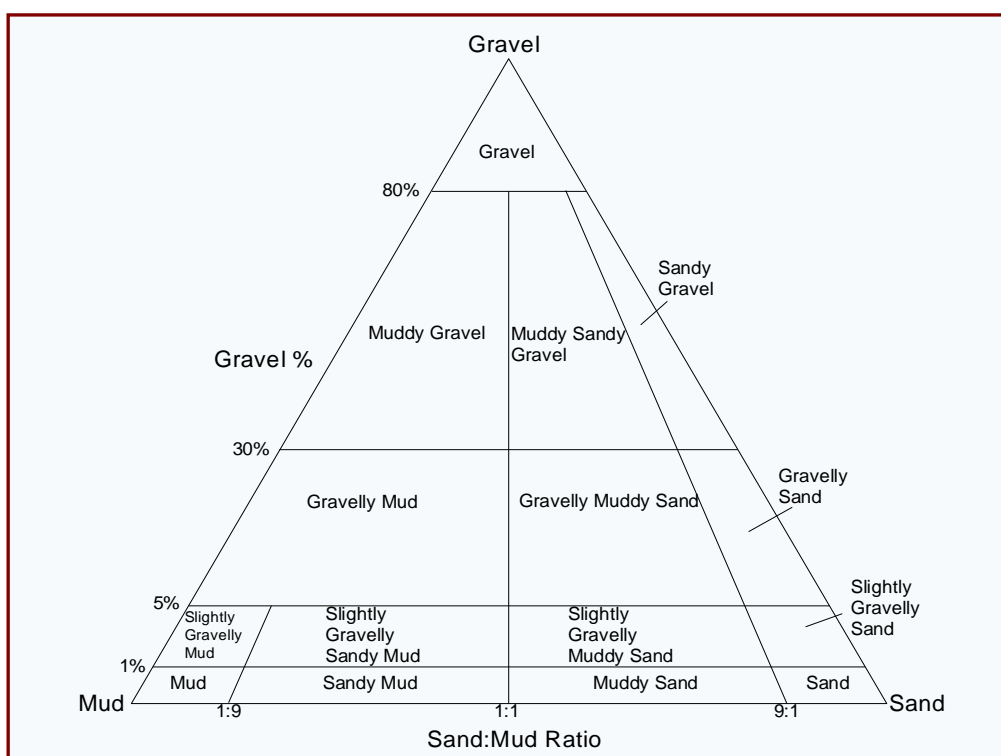
Figure 4: Sediment classifications after Folk (1954), where “gravel” refers to particles greater than 2mm and “mud” to particles less than 63µm; as used by the British Geological Society (BGS).

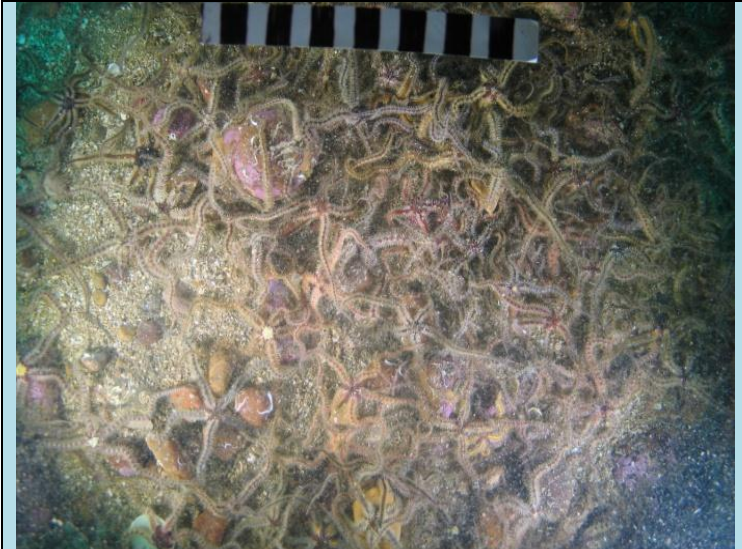
Time	11:09
		Position	5744.827°N 0251.734°W
		Depth (m)	26.2
		Description	Sandy gravel and pebbles. Brittle stars, <i>Ophiocomina nigra</i> and <i>Ophiothrix fragilis</i> . Encrusting pink algae, <i>Lithothamnion</i> sp. on pebbles. Small amount of <i>Pomatoceros triqueter</i> .

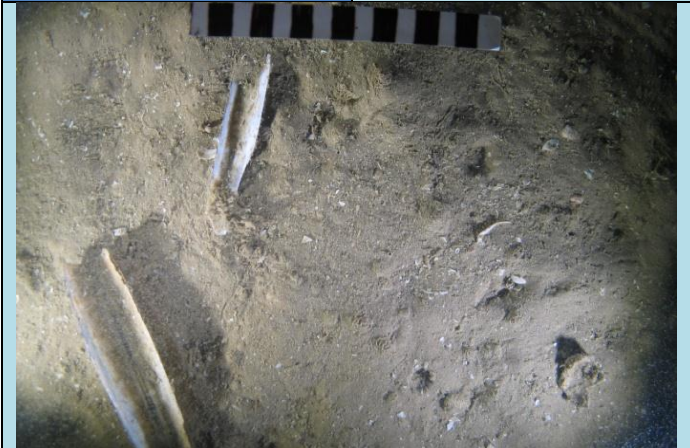
Time	15:00
		Position	5803.810°N 0303.063°W
		Depth (m)	46.1
		Description	Fine sand and shell with small amount of shell fragments. Empty <i>Ensis</i> sp. shells. Hydroid/bryozoa below scale bar and worm casts centre.

Figure 14: Fine sand with broken shell fragments and empty *Ensis* sp. shells.

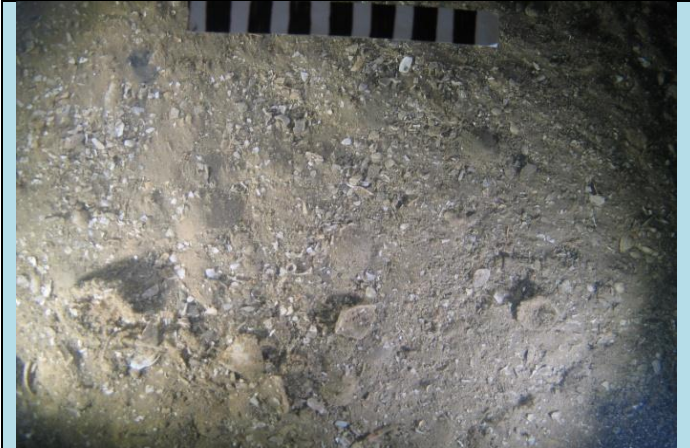
Time	11:43
		Position	5802.323°N 0302.571°W
		Depth (m)	42.4
		Description	Very shelly fine sand Small amount of hydroid bottom right.

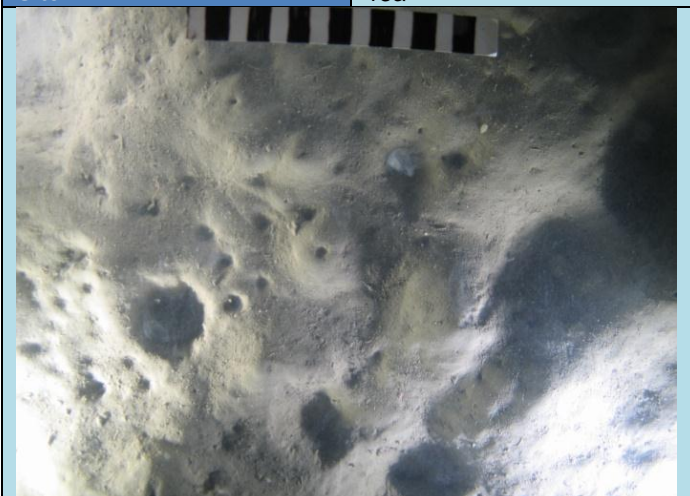
Time	10:42
		Position	5752.115°N 0302.126°W
		Depth (m)	82.3
		Description	Mud Numerous pits and burrows of varying size in sediment.

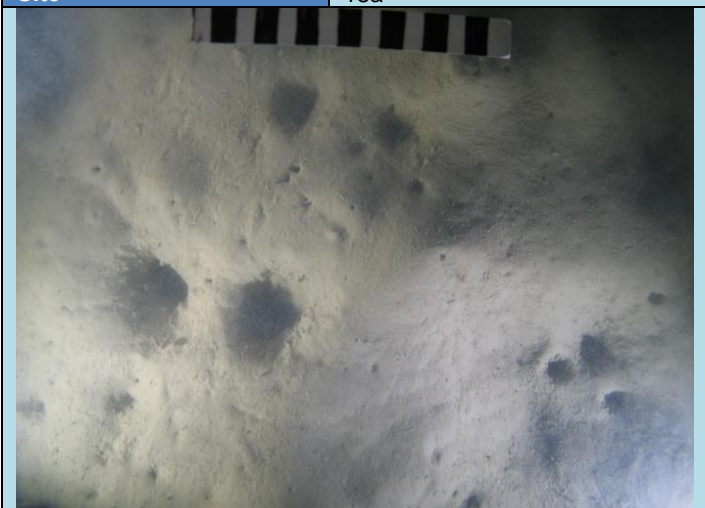
Time	12:40
		Position	5755.940°N 0302.223°W
		Depth (m)	81.7
		Description	Mud Large, deep burrows middle left likely from megafauna. Other smaller burrows in sediment.

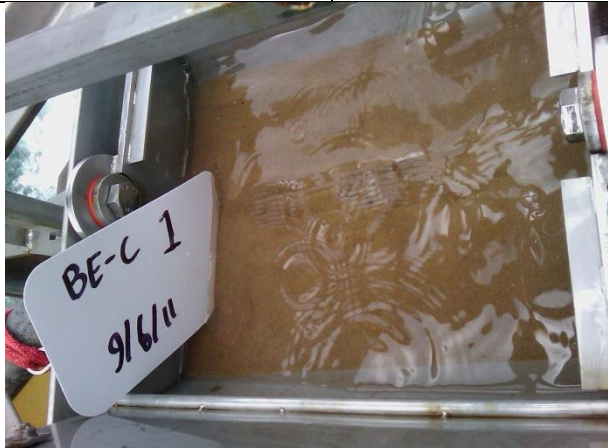
Site	1	Date	09/06/11

Time	09:45 Hrs
		Position	5740.740°N 0302.406°W
		Volume (l)	4
		Depth (m)	6.5
		Substratum	Hard packed fine sand.

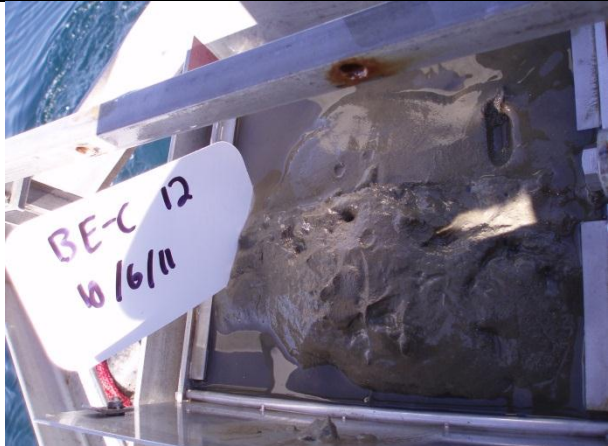
Site	12	Date	10/06/11

Time	10:17 Hrs
		Position	5750.778°N 0301.850°W
		Volume (l)	10
		Depth (m)	84
		Substratum	Sandy mud.

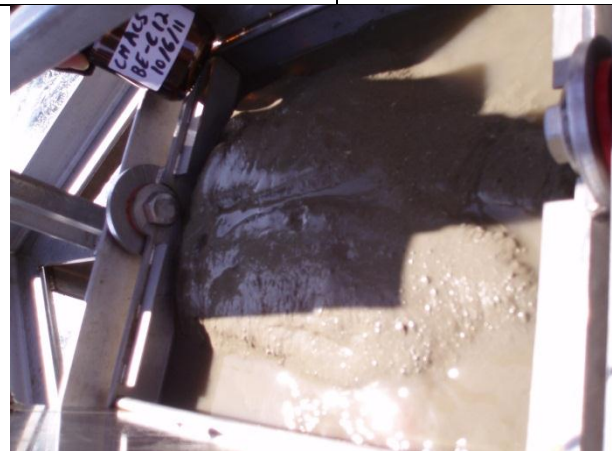
Site	12 contaminants	Date	10/06/11

Time	10:25 Hrs
		Position	5750.768°N 0301.831°W
		Volume (l)	10
		Depth (m)	84
		Substratum	Sandy mud.

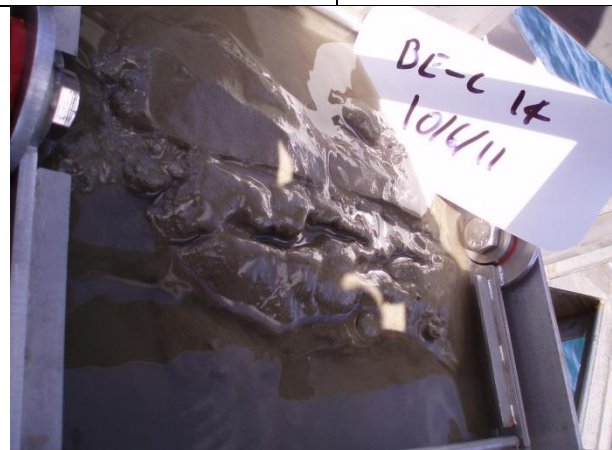
Site	14	Date	10/06/11

Time	11:22 Hrs
		Position	5753.530°N 0302.134°W
		Volume (l)	10
		Depth (m)	84.6
		Substratum	Sandy mud.

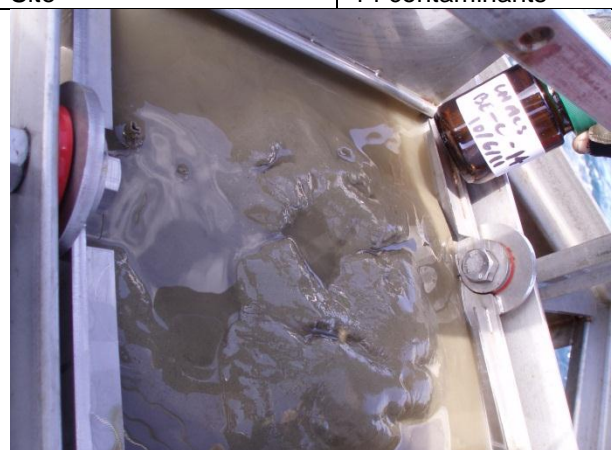
Site	14 contaminants	Date	10/06/11

Time	11:28 Hrs
		Position	5753.527°N 0302.139°W
		Volume (l)	10
		Depth (m)	84.5
		Substratum	Sandy mud.

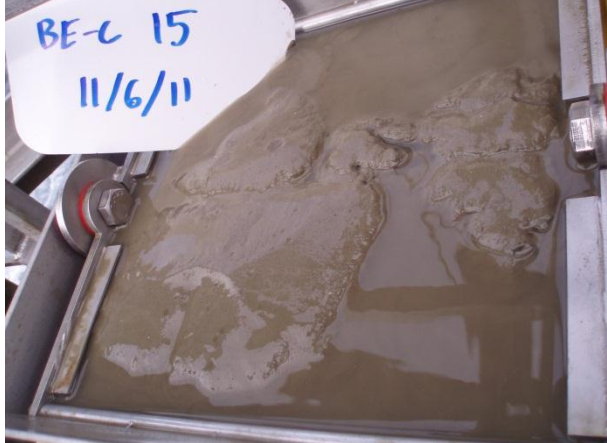
Site	15	Date	11/06/11

Time	19:21 Hrs
		Position	5752.419°N 0251.994°W
		Volume (l)	10
		Depth (m)	91.8
		Substratum	Muddy fine sand.

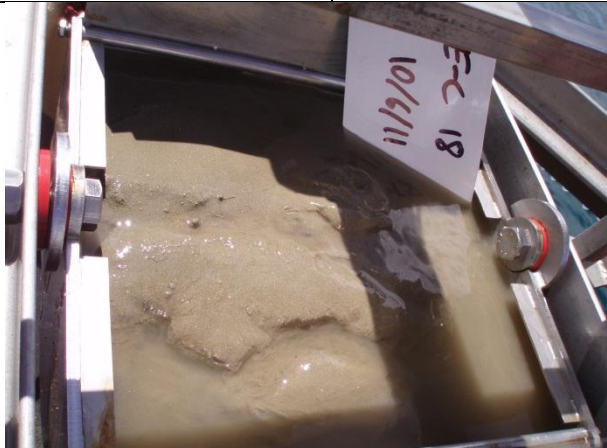
Site	18	Date	10/06/11

Time	12:59 Hrs
		Position	5755.931°N 0302.203°W
		Volume (l)	10
		Depth (m)	82.0
		Substratum	Sandy mud.

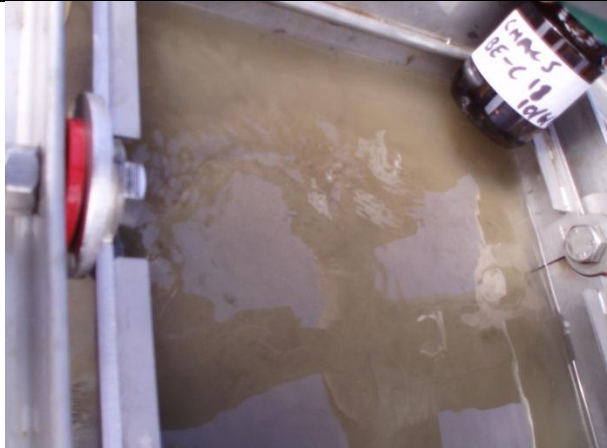
Site	18 contaminants	Date	10/06/11

Time	13:16 Hrs
		Position	5755.928°N 0302.230°W
		Volume (l)	8
		Depth (m)	81.8
		Substratum	Sandy mud.

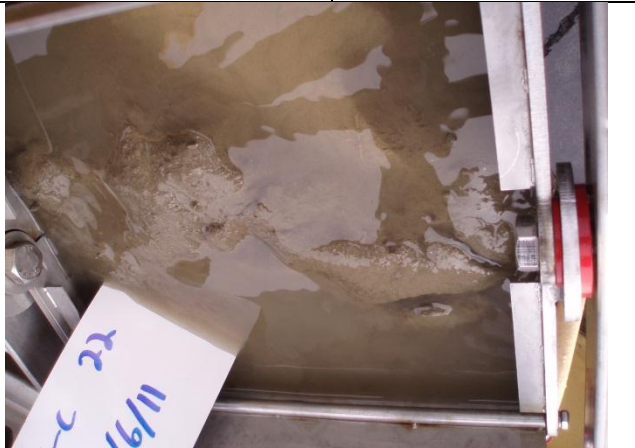
Time	18:12 Hrs
		Position	5757.425°N 0253.456°W
		Volume (l)	10
		Depth (m)	80.1
		Substratum	Fine sand & mud.

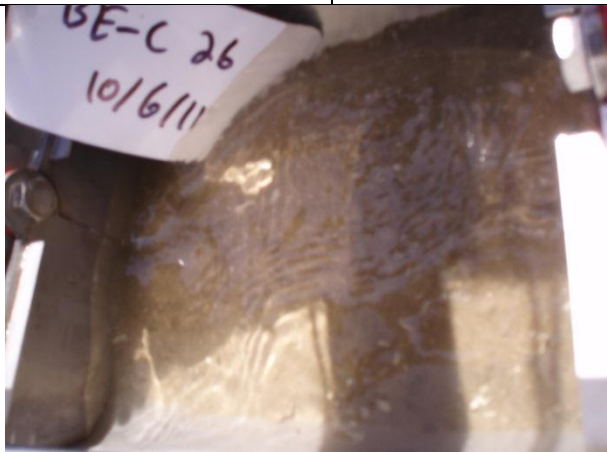
Site	26	Date	10/06/11

Time	14:39 Hrs
		Position	5802.461°N 0303.047°W
		Volume (l)	4
		Depth (m)	48.4
		Substratum	Fine sand with shell fragments.

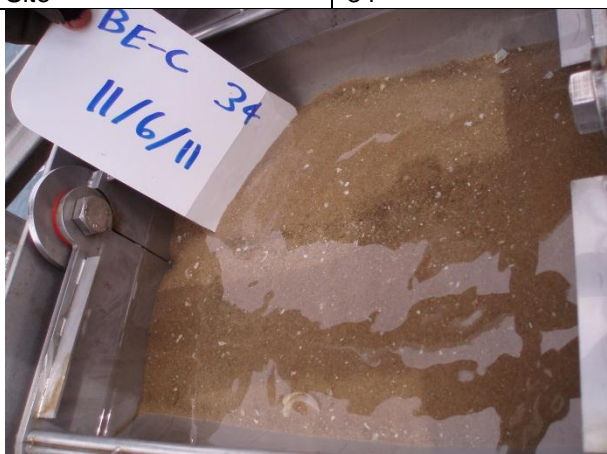
Site	34	Date	11/06/11

Time	13:03 Hrs
		Position	5808.418°N 0300.504°W
		Volume (l)	4
		Depth (m)	40.3
		Substratum	Sand with some shell.

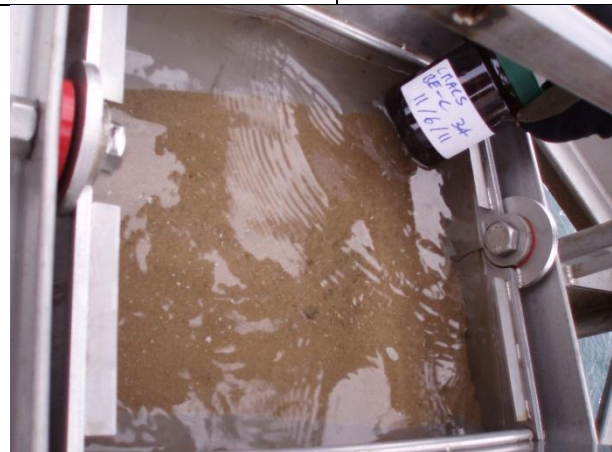
Site	34 contaminants	Date	11/06/11

Time	13:15 Hrs
		Position	5808.412°N 0300.504°W
		Volume (l)	3
		Depth (m)	40.4
		Substratum	Sand.

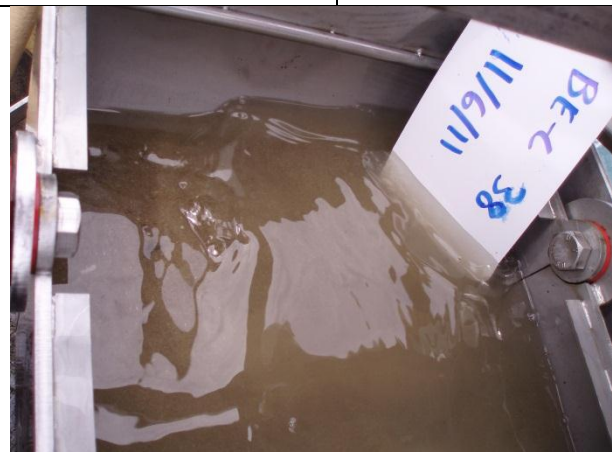
Site	38	Date	11/06/11

Time	13:53 Hrs
		Position	5809.635°N 0304.372°W
		Volume (l)	3
		Depth (m)	50.5
		Substratum	Fine sand with some shell.

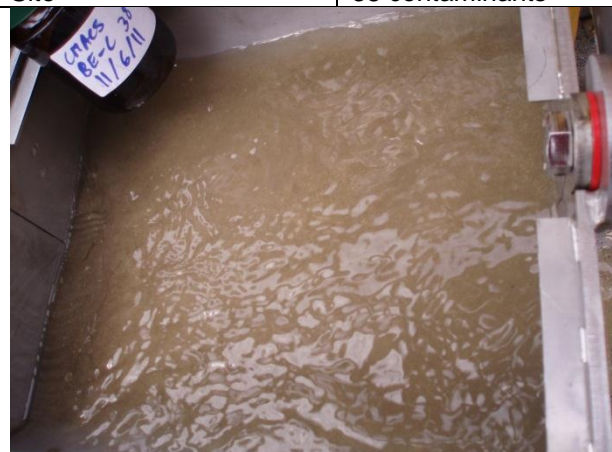
Site	38 contaminants	Date	11/06/11

Time	14:08 Hrs
		Position	5809.633°N 0304.374°W
		Volume (l)	4
		Depth (m)	50.5
		Substratum	Sand with some shell.

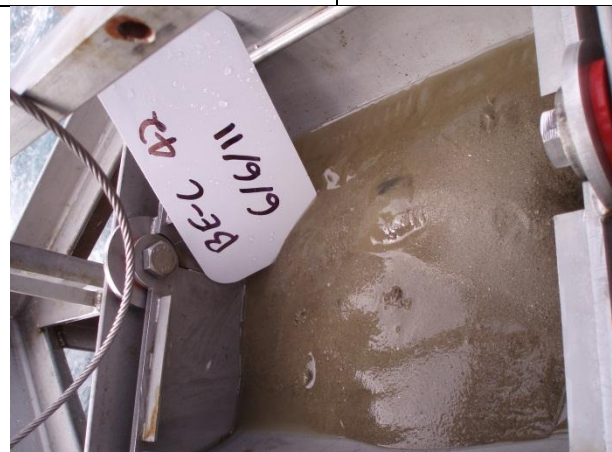
Site	42	Date	06/06/11

Time	18:15 Hrs
		Position	°N °W
		Volume (l)	6
		Depth (m)	53.0
		Substratum	Fine sand.

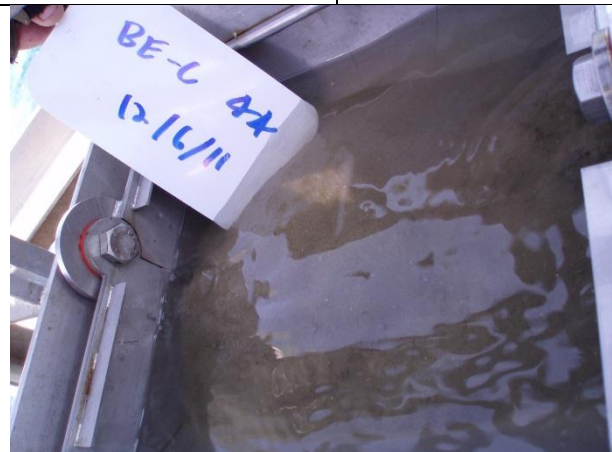
Site	44	Date	12/06/11

Time	10:53 Hrs
		Position	5753.997°N 0311.081°W
		Volume (l)	5
		Depth (m)	64.5
		Substratum	Fine sand & mud.

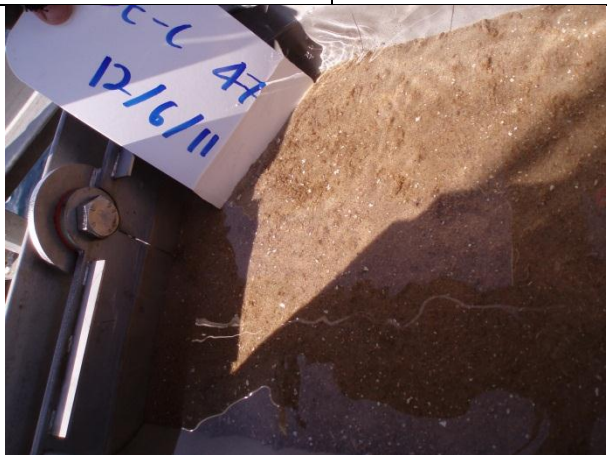
Site	47	Date	12/06/11

<p>A photograph showing a sediment sample in a metal container. A white label with blue handwriting is attached to the container, reading 'BE-C 47' and '12/6/11'. The sediment is a mix of light brown sand and dark brown mud.</p>	Time	09:22 Hrs	
	Position	5753.997°N 0311.081°W	
	Volume (l)	5	
	Depth (m)	64.5	
	Substratum	Fine sand & mud.

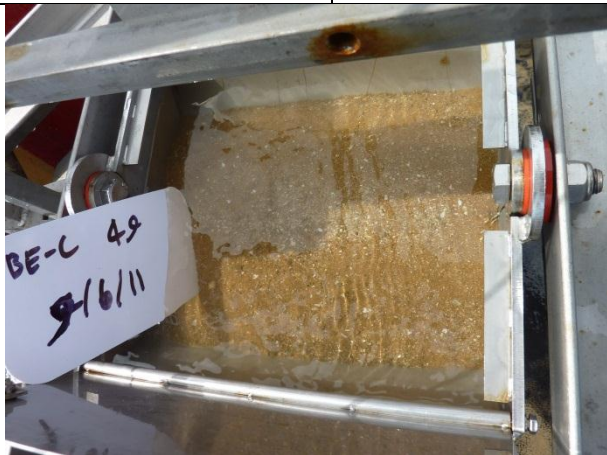
Site	49	Date	09/06/11

<p>A photograph showing a sediment sample in a metal container. A white label with black handwriting is attached to the container, reading 'BE-C 49' and '9/6/11'. The sediment is a mix of light brown sand and shell fragments.</p>	Time	11:47 Hrs	
	Position	5747.174°N 0317.760°W	
	Volume (l)	5	
	Depth (m)	40.1	
	Substratum	Coarse sand & shell.

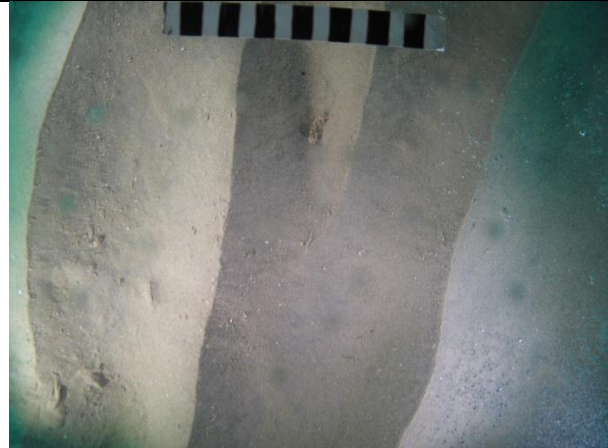
Site	1a	Date	09/06/11

Time	09:30 Hrs
		Position	5740.746°N 0302.418°W
		Depth (m)	6.5
		Description	Very fine sand with large distinct sand ripples. Tubeworm cast top centre.

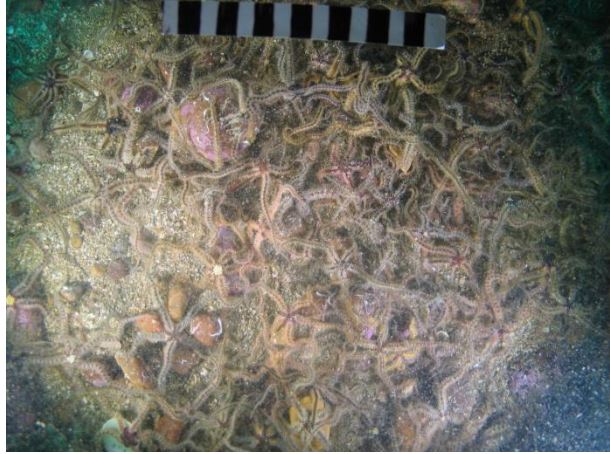
Site	3b	Date	09/06/11

Time	11:09 Hrs
		Position	5744.827°N 0251.734°W
		Depth (m)	26.2
		Description	Sandy gravel and pebbles. Brittle stars, <i>Ophiocomina nigra</i> and <i>Ophiothrix fragilis</i> Encrusting pink algae, <i>Lithothamnion sp.</i> on pebbles. Small amount of <i>Pomatoceros triqueter</i> .

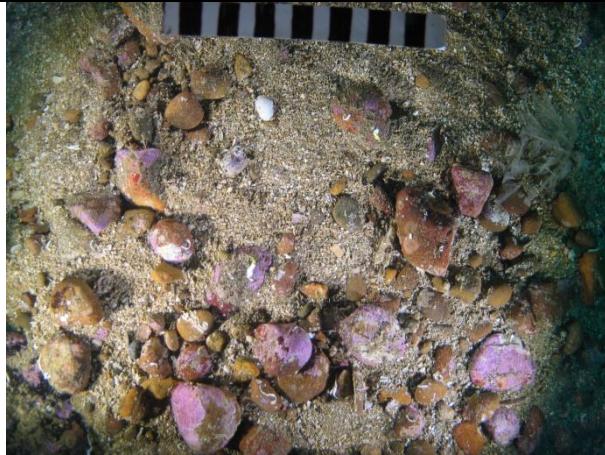
Site	3c	Date	09/06/11

Time	11:12 Hrs
		Position	5744.829°N 0251.754°W
		Depth (m)	26.2
		Description	Coarse sand/fine shell fragments, gravel and pebbles. Squat lobster, <i>Galathea</i> sp. bottom centre. Hydroid, <i>Kirchenpaueria pinnata</i> top right. Encrusting pink algae, <i>Lithothamnion</i> sp. on pebbles. Small amount of <i>Pomatoceros triqueter</i> . Indiscernible brittle star (legs protruding from under pebble) bottom right.

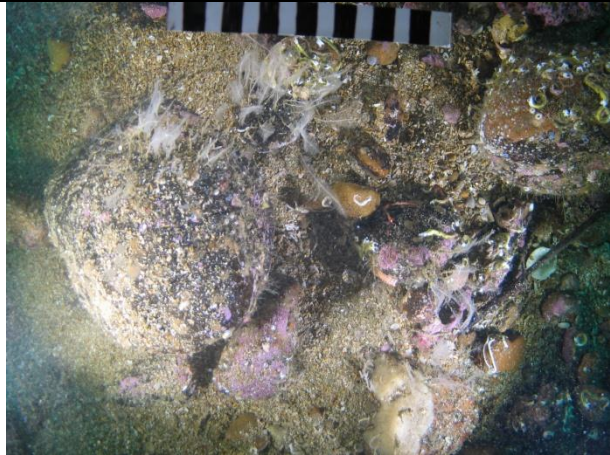
Site	5a	Date	06/06/11

Time	10:14 Hrs
		Position	5744.513°N 0301.817°W
		Depth (m)	22.2
		Description	Coarse sand/fine shell fragments, pebbles and cobble. Some encrusting <i>Pomatoceros triqueter</i> and unidentified barnacles.
			Squat lobster, <i>Munida rugosa</i> centre. Hydroid, <i>Kirchenpaueria pinnata</i> . Encrusting pink algae, <i>Lithothamnion sp.</i> Large white sponge on cobble bottom right. <i>Lanice conchilega</i> top left.

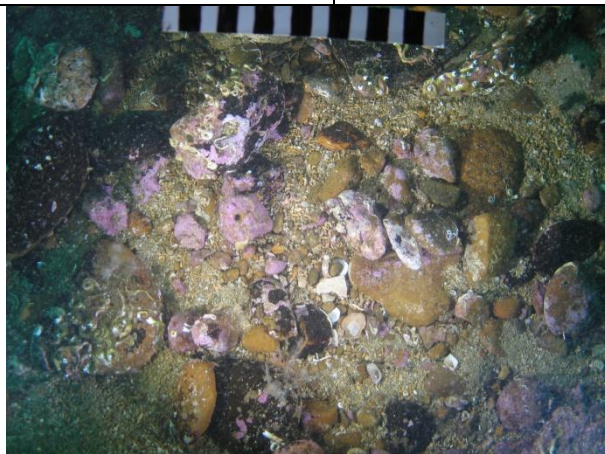
Site	5c	Date	06/06/11

Time	10:21 Hrs
		Position	5744.521°N 0301.838°W
		Depth (m)	22.1
		Description	Coarse sand/fine shell fragments, pebbles and cobble. Encrusting <i>Pomatoceros triqueter</i> . Hydroid, <i>Kirchenpaueria pinnata</i> bottom centre. Encrusting pink algae, <i>Lithothamnion sp.</i> <i>Lanice conchilega</i> centre right amongst pebbles.

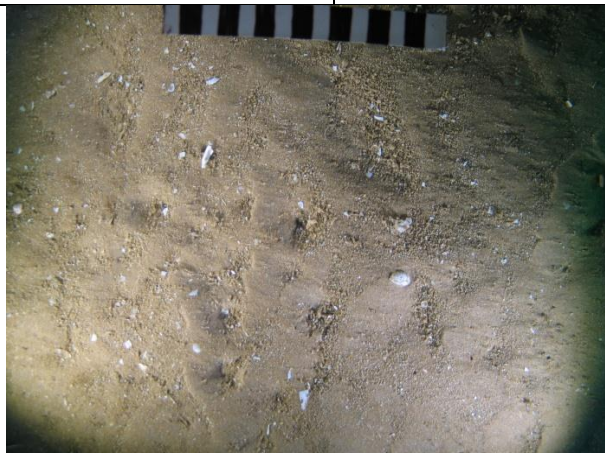
Site	6a	Date	06/06/11

Time	10:41 Hrs
		Position	5746.010°N 0301.627°W
		Depth (m)	30.1
		Description	Fine sand and shell fragments with some discernible ripples. No obvious epifauna

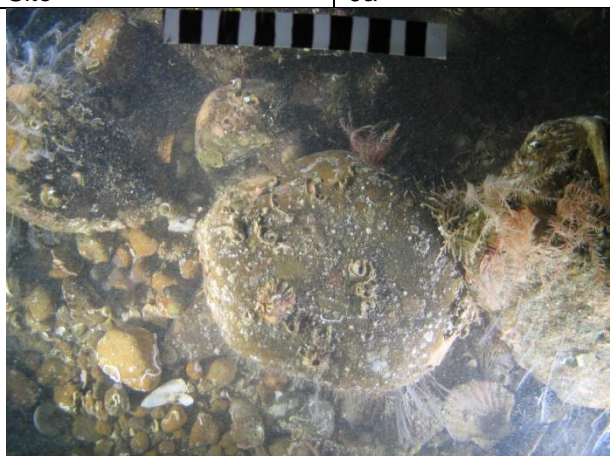
Site	9a	Date	07/06/11

Time	08:37 Hrs
		Position	5748.538°N 0256.203°W
		Depth (m)	55.8
		Description	Boulders, cobble and pebble. Some encrusting <i>Pomatoceros triqueter</i> . Feather stars, <i>Antedon bifida</i> . Hydroid, <i>Kirchenpaueria pinnata</i> and other <i>Plumulariidae</i> sp. on boulder top left and bottom right. <i>Scallop</i> sp. shells amongst substrate. Single large worm tube centre left.

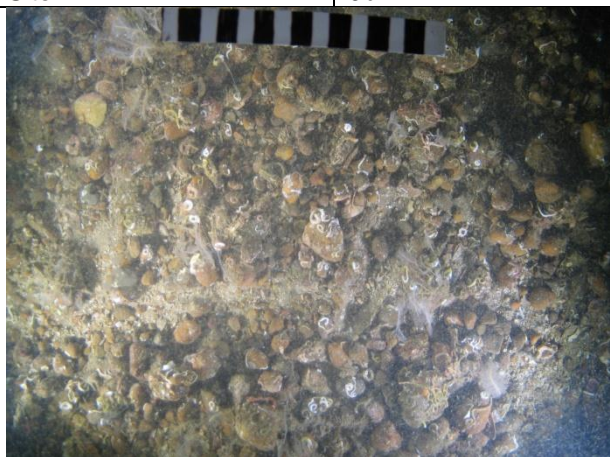
Time	08:41 Hrs
		Position	5748.538°N 0256.203°W
		Depth (m)	55.8
		Description	Pebbles and sandy gravel with encrusting <i>Pomatoceros triqueter</i> in places. Hydroid, <i>Kirchenpaueria pinnata</i> and other bottom centre. Possible squat lobster centre bottom. Cluster of worm tubes (likely <i>Serpulid</i> sp.) right centre.

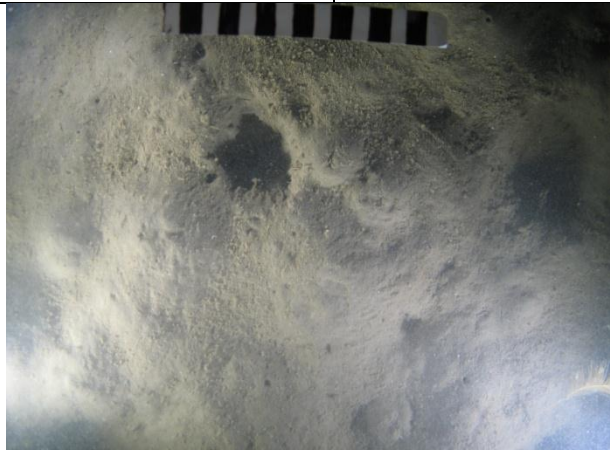
Site	11a	Date	10/06/11

Time	09:44 Hrs
		Position	5749.676°N 0301.692°W
		Depth (m)	80.1
		Description	Very fine sand/mud. Hydroid bottom right. Burrows in sediment.

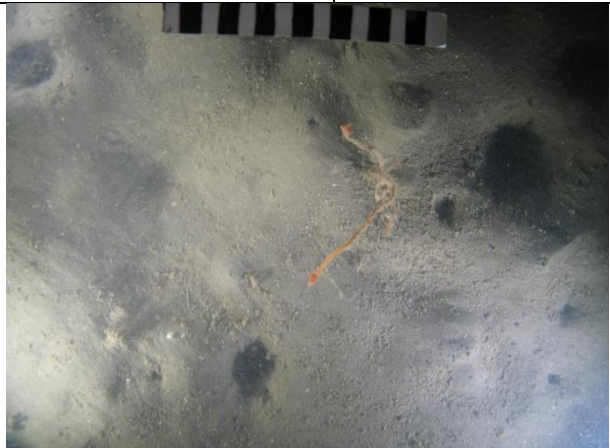
Site	11b	Date	10/06/11

Time	09:45 Hrs
		Position	5749.678°N 0301.680°W
		Depth (m)	80.3
		Description	Very fine sand/mud. Likely Maldanidae worm in centre of image. Burrows in sediment.

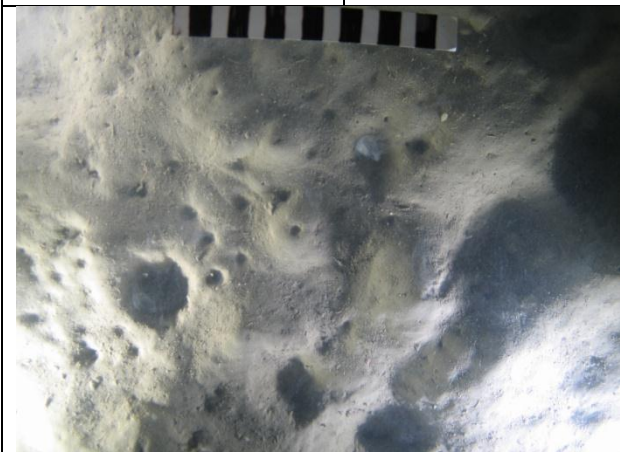
Time	10:42 Hrs
		Position	5752.115°N 0302.126°W
		Depth (m)	82.3
		Description	Mud Numerous pits and burrows of varying size in sediment. Possible Burrowing anemone below scale bar.

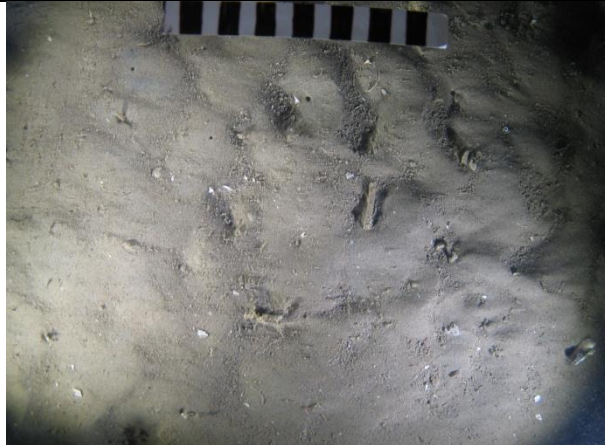
Site	19b	Date	10/06/11

Time	13:35 Hrs
		Position	5757.310°N 0302.434°W
		Depth (m)	54.4
		Description	Fine sand with ripples.
			Tubeworms protruding sediment surface. Some hydroids bottom centre and few small burrows below scale bar.

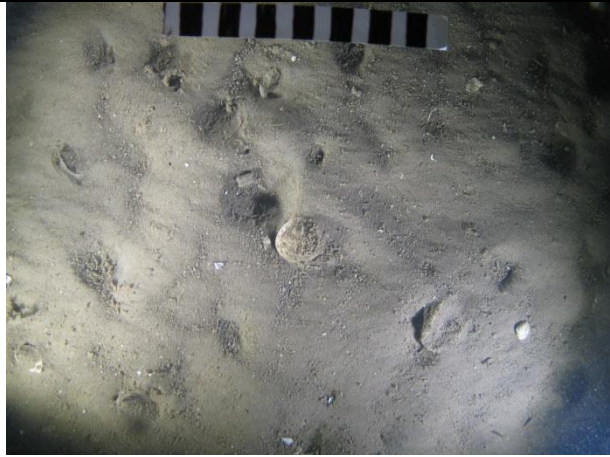
Time	13:37 Hrs
		Position	5757.308°N 0302.439°W
		Depth (m)	56.3
		Description	Fine sand with ripples. Tubeworms protruding sediment surface. Possible burrowing anemone below left of scale bar. Several deceased bivalve shells underlying veneer of sand.

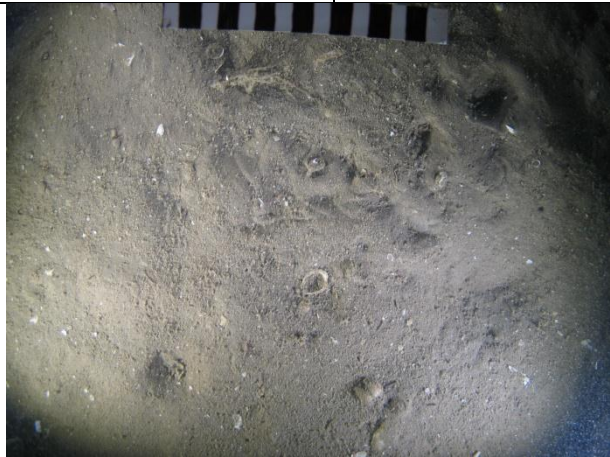
Time	13:12 Hrs
		Position	5758.451°N 0302.645°W
		Depth (m)	52.9
		Description	Very fine sand/mud. Some fine shell fragments and empty bivalve shells underlying. Mass of hydroid below scale bar.

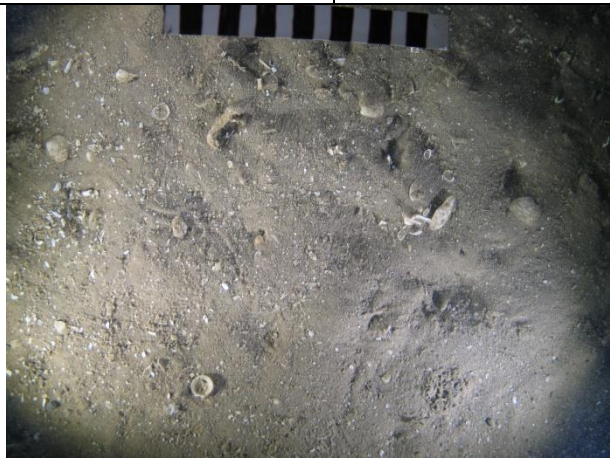
Time	13:17 Hrs
		Position	5758.462°N 0302.634°W
		Depth (m)	53.1
		Description	Fine sand and shell fragments (some large/intact). Protruding tubeworm/mass of hydroid below scale bar. Faunal track centre left.

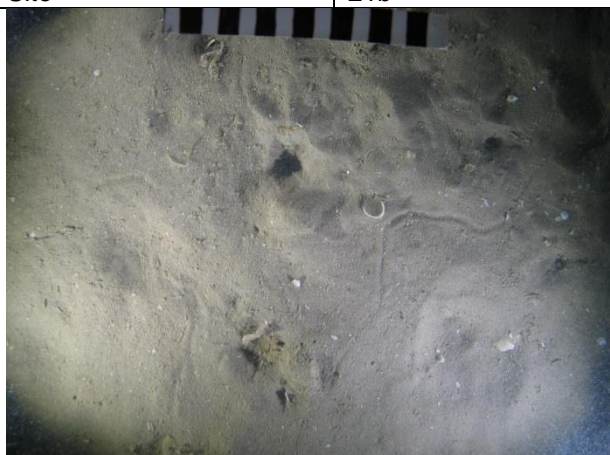
Time	14:15 Hrs
		Position	5759.788°N 0302.650°W
		Depth (m)	55.7
		Description	Very fine sand/mud. Few underlying shell fragments. Faunal tracks and burrows in sediment.

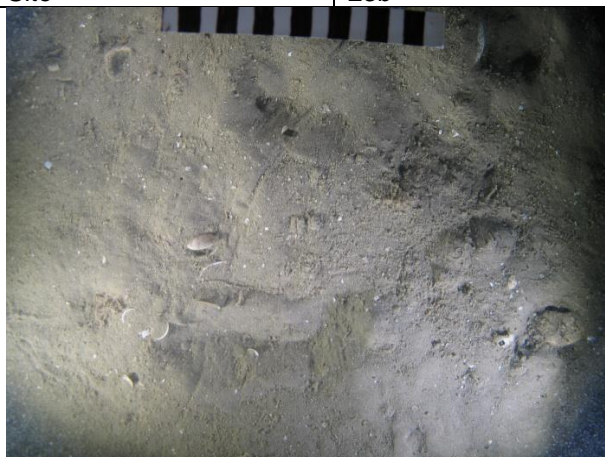
Site	23b	Date	06/06/11

Time	13:45 Hrs
		Position	5759.314°N 0259.320°W
		Depth (m)	55.9
		Description	Fine sand and some shell fragments (some whole/intact). Tubeworm protruding from sediment surface below scale bar. Faunal tracks. Possible small amount of bryozoa middle right.

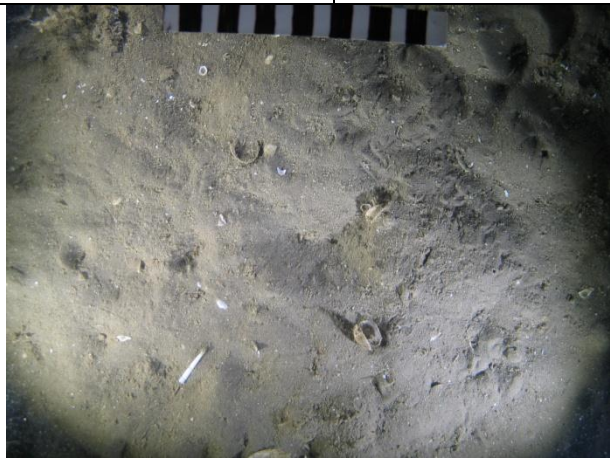
Time	13:47 Hrs
		Position	5759.321°N 0259.322°W
		Depth (m)	55.9
		Description	Fine sand and some shell fragments (some whole/intact). Mass of hydroid/bryozoa top left of scale bar. Fragments of worm tubes and faunal tracks/pits top right.

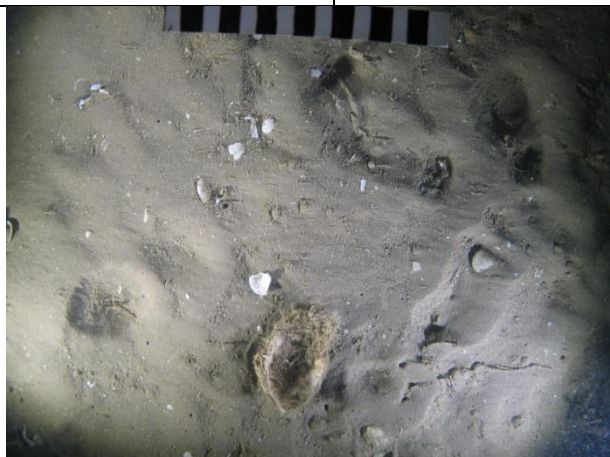
Site	24b	Date	06/06/11

Time	14:45 Hrs
		Position	5800.970°N 0302.870°W
		Depth (m)	52.7
		Description	Very fine sand and few shell fragments with ripples. Possible <i>Lanice conchilega</i> below scale bar. Empty bivalve shell covered in organic matter/weed. Burrows.

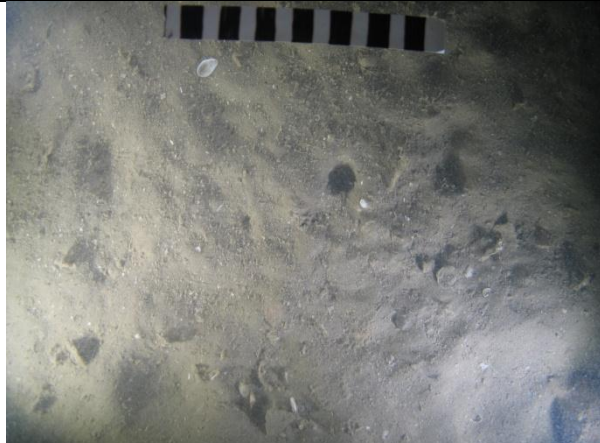
Site	25a	Date	11/06/11

Time	17:01 Hrs
		Position	5801.924°N 0254.579°W
		Depth (m)	52.5
		Description	Very fine sand/mud. Worm tubes and burrows in places.

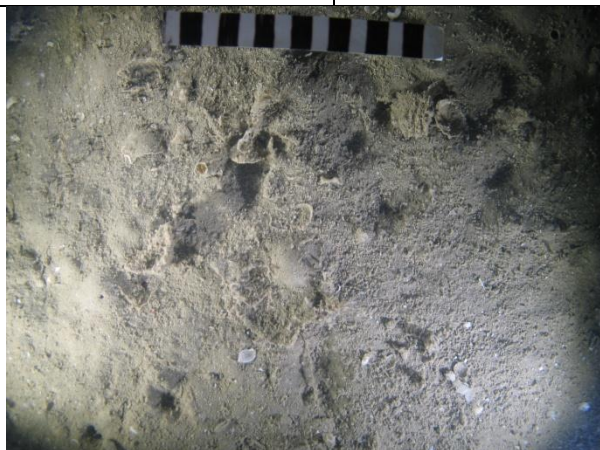
Site	25b	Date	11/06/11

Time	17:05 Hrs
		Position	5801.921°N 0254.566°W
		Depth (m)	52.7
		Description	Very fine sand/mud. Patches of hydroid/bryozoa covering shells. Tubeworm protruding from sediment surface centre and top right.

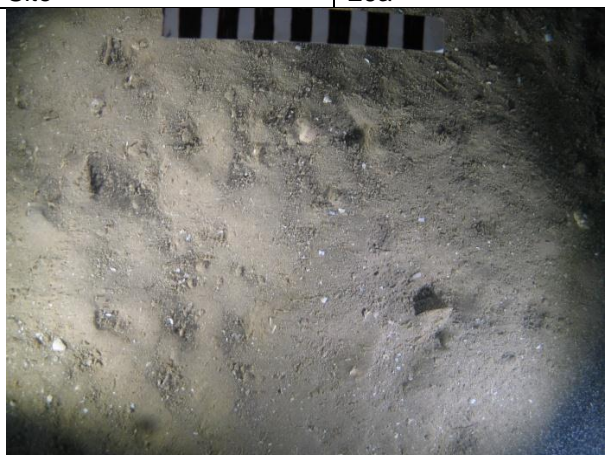
Site	26a	Date	10/06/11

Time	14:28 Hrs
		Position	5802.461°N 0303.029°W
		Depth (m)	48.4
		Description	Very fine sand and small amount of shell with small depressions (not rippled). No discernable fauna

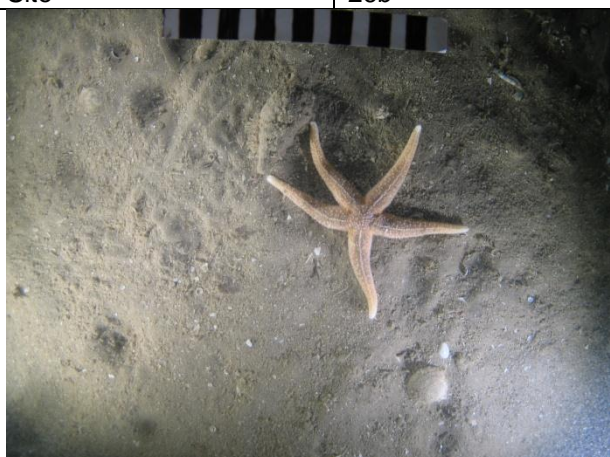
Site	26b	Date	10/06/11

Time	14:30 Hrs
		Position	5802.459°N 0303.046°W
		Depth (m)	48.2
		Description	Fine sand with shell fragments and dead bivalve shells. <i>Asterias rubens</i> and possible whelk with bryozoan growth on shell. <i>Lagis conchilega</i> present in sand.

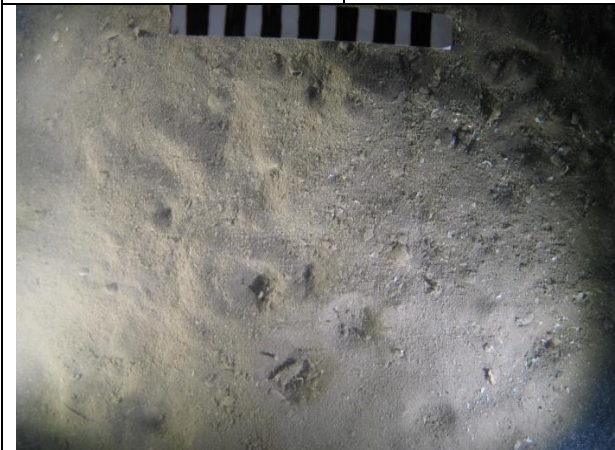
Site	26c	Date	10/06/11

Time	14:31 Hrs
		Position	5802.462°N 0303.054°W
		Depth (m)	48.5
		Description	Very fine sand/mud. Small amount of fine shell fragments. Protruding small tubeworm bottom centre. Burrows.

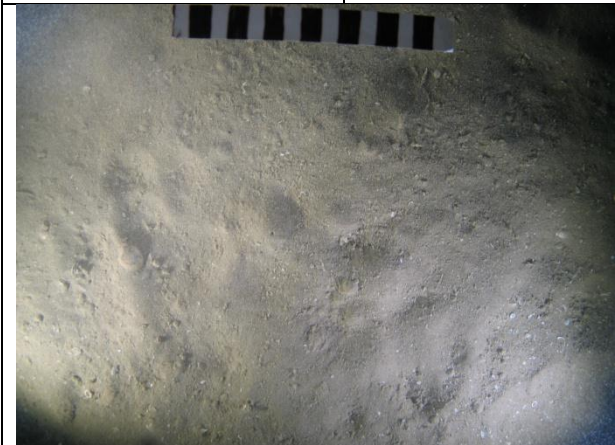
Site	27a	Date	10/06/11

Time	14:57 Hrs
		Position	5803.813°N 0303.033°W
		Depth (m)	46.2
		Description	Very fine sand/mud. Small amount of fine shell fragments. No discernible fauna.

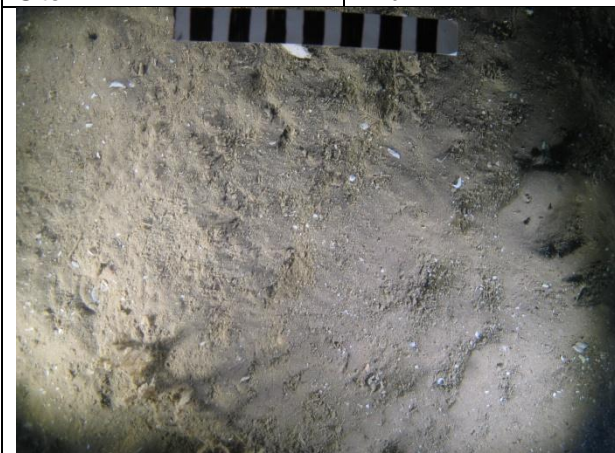
Site	27b	Date	10/06/11

Time	14:58 Hrs
		Position	5803.809°N 0303.054°W
		Depth (m)	45.8
		Description	Fine sand with shell fragments. Hydroids and burrows.

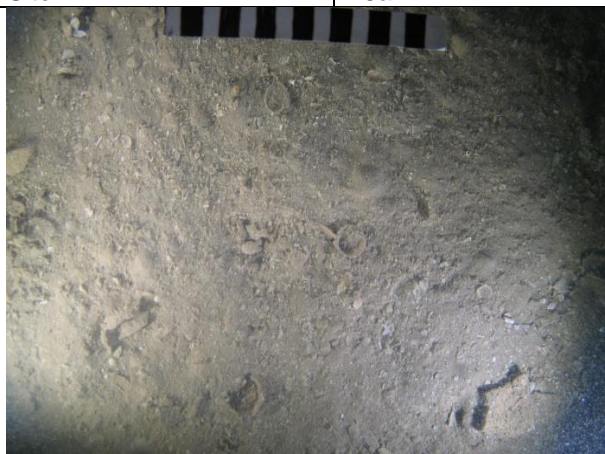
Site	28a	Date	10/06/11

Time	15:18 Hrs
		Position	5805.019°N 0302.954°W
		Depth (m)	43.3
		Description	Very fine sand/mud and shell fragments (some whole). No discernible fauna.

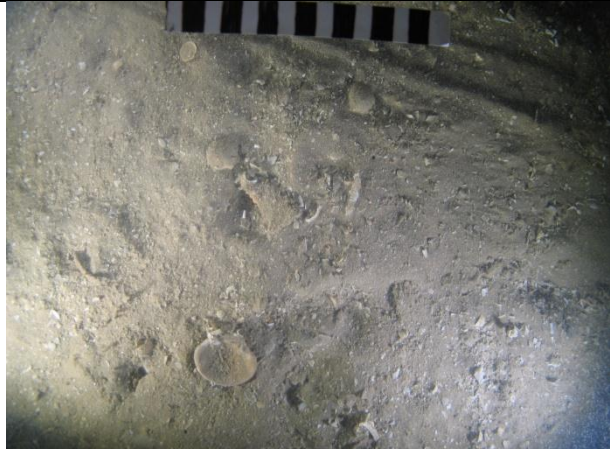
Site	28c	Date	10/06/11

Time	15:21 Hrs
		Position	5805.020°N 0302.969°W
		Depth (m)	43.6
		Description	Fine sand and shell. Some small tubeworms.

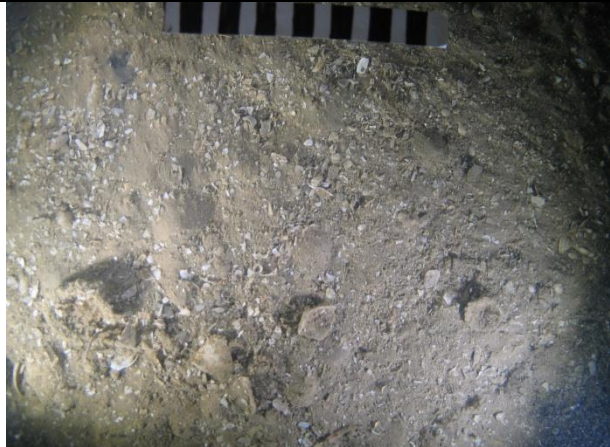
Site	29a	Date	11/06/11

Time	11:43 Hrs
		Position	5802.323°N 0302.571°W
		Depth (m)	42.4
		Description	Very shelly fine sand Small amount of hydroid bottom right.

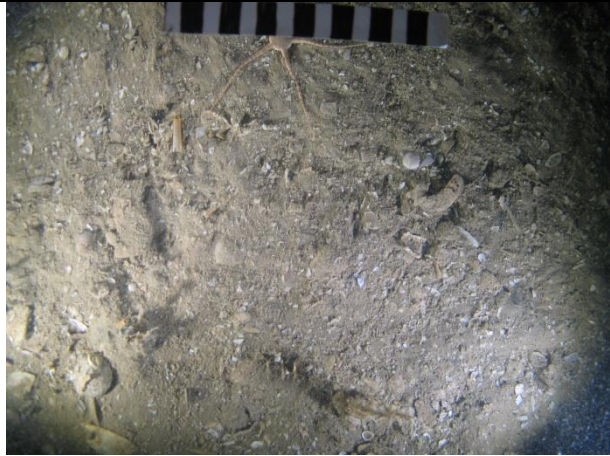
Site	29b	Date	11/06/11

Time	11:44 Hrs
		Position	5802.322°N 0302.577°W
		Depth (m)	41.4
		Description	Very shelly fine sand/mud. Brittlestar (<i>Ophiura ophiura</i>) below scale bar. Empty <i>Pectinaria</i> <i>sp.</i> shell. Hydroid/bryozoa bottom.

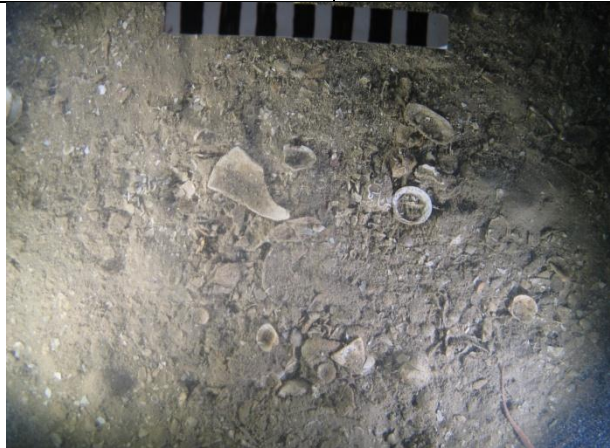
Site	29c	Date	11/06/11

Time	11:46 Hrs
		Position	5802.322°N 0302.588°W
		Depth (m)	42.5
		Description	Very shelly fine sand/mud. <i>Brittlestars, Ophiura sp.</i> <i>Pomatoceros triqueter</i> encrusting empty bivalve shell.

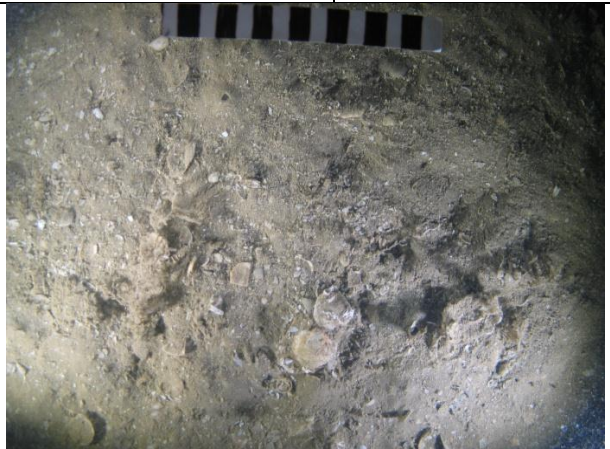
Site	30b	Date	11/06/11

Time	12:10 Hrs
		Position	5806.012°N 0259.768°W
		Depth (m)	45.1
		Description	Very shelly fine sand. <i>Pomatoceros triqueter</i> encrusting empty bivalve shells. Hydroid/bryozoa in clumps attached to shells left and right.

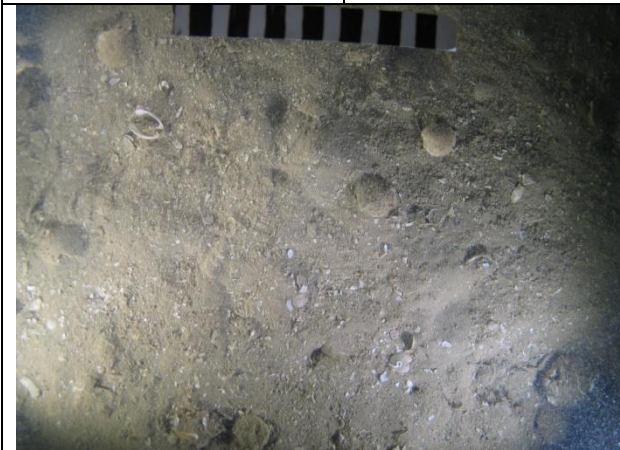
Time	12:12 Hrs
		Position	5806.012°N 0259.790°W
		Depth (m)	45.3
		Description	Very shelly fine sand. <i>Pomatoceros triqueter</i> encrusting some empty bivalve shells bottom right.

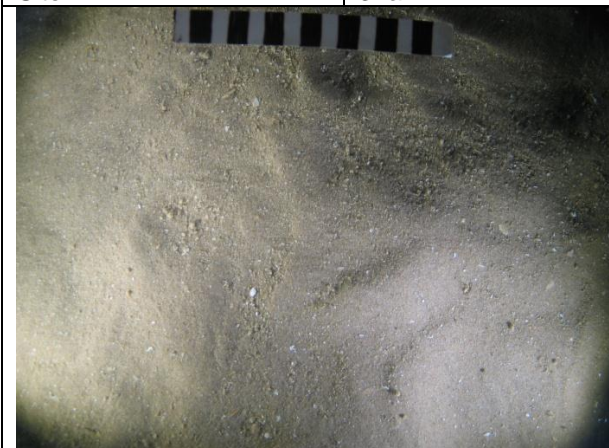
Site	32a	Date	11/06/11

Time	16:00 Hrs
		Position	5807.777°N 0251.652°W
		Depth (m)	38.9
		Description	Medium sand with few shell fragments. No discernible fauna, tracks or burrows.

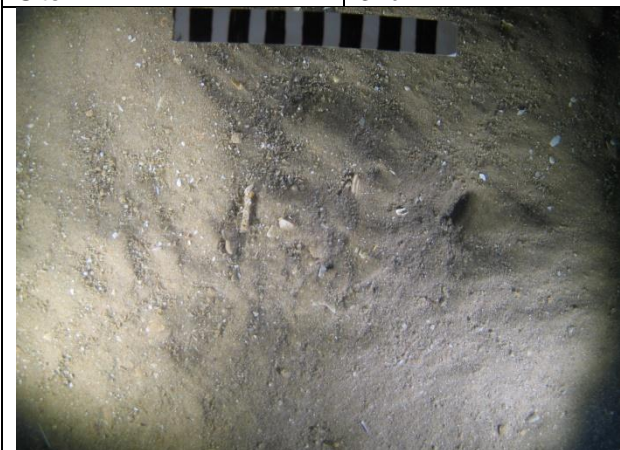
Time	16:02 Hrs
		Position	5807.773°N 0251.663°W
		Depth (m)	38.8
		Description	Medium sand and very fine shell fragments. <i>Lanice conchilega</i> tube on sediment surface. Single burrow. No other discernible fauna.

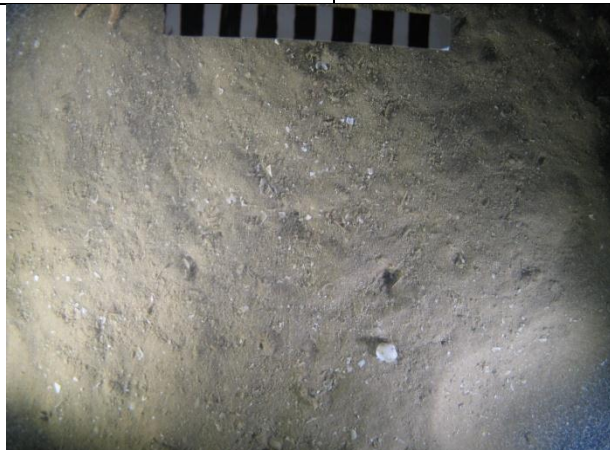
Site	33a	Date	11/06/11

Time	12:32 Hrs
		Position	5807.428°N 0301.564°W
		Depth (m)	43.3
		Description	Fine sand and very fine shell fragments. <i>Asterias rubens</i> (part of) top left. Possible <i>Lanice conchilega</i> below scale bar.

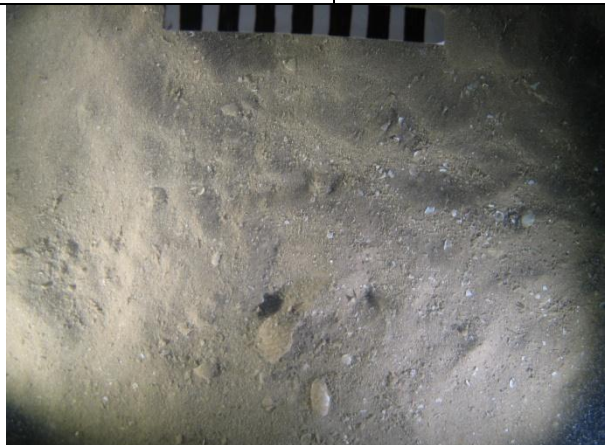
Site	33c	Date	11/06/11

Time	12:34 Hrs
		Position	5807.436°N 0301.569°W
		Depth (m)	43.7
		Description	Very fine sand/mud No discernible fauna.

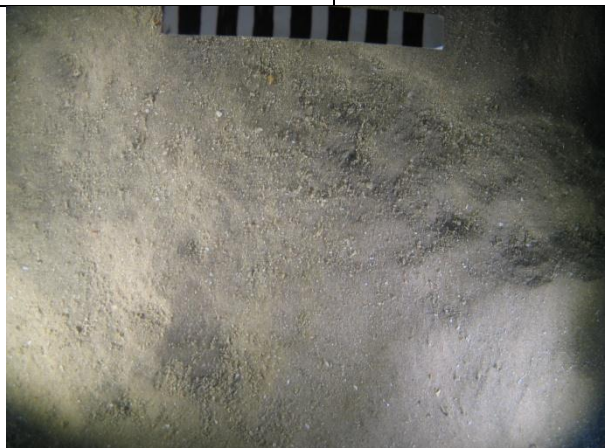
Site	35a	Date	11/06/11

Time	13:39 Hrs
		Position	5809.517°N 0258.999°W
		Depth (m)	34.6
		Description	Medium sand. No discernible fauna.

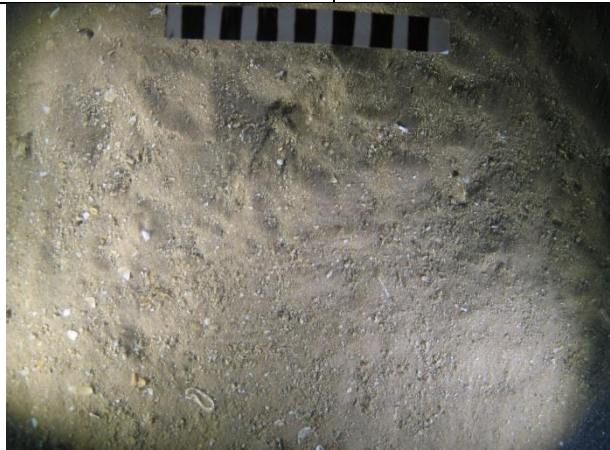
Site	36a	Date	11/06/11

Time	15:18 Hrs
		Position	5809.861°N 0257.224°W
		Depth (m)	34.6
		Description	Medium sand and fine shell fragments. No discernible fauna

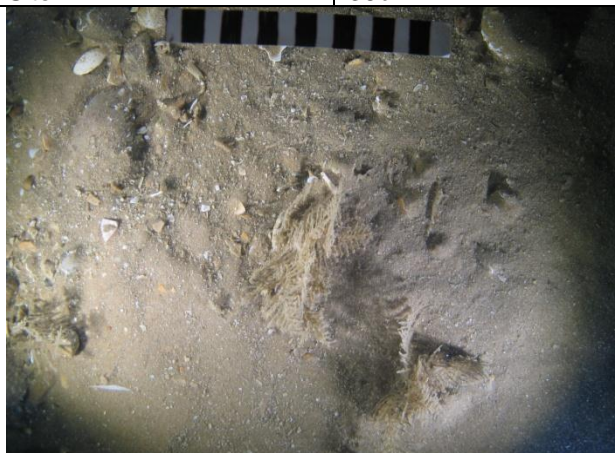
Site	36b	Date	11/06/11

Time	15:19 Hrs
		Position	5809.862°N 0257.239°W
		Depth (m)	34.9
		Description	Medium sand, fine shell fragments and coarse gravel/pebble. Hydroid, <i>Plumularia setacea</i> .

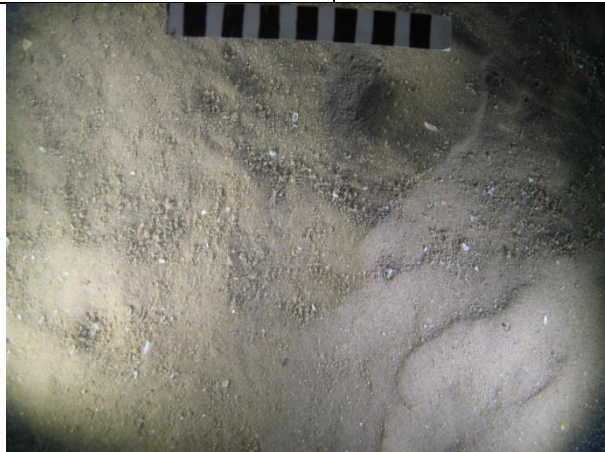
Site	37a	Date	11/06/11

Time	14:59 Hrs
		Position	5810.621°N 0258.346°W
		Depth (m)	34.3
		Description	Medium sand and fine shell fragments with ripples. No discernible fauna.

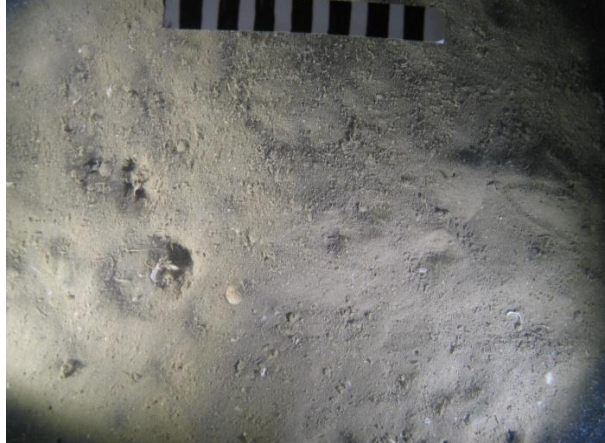
Site	38a	Date	11/06/11

Time	13:38 Hrs
		Position	5809.627°N 0304.396°W
		Depth (m)	50.5
		Description	Very fine sand/Mud. Burrows and possible faunal track centre right. No discernible fauna.
