Beatrice Offshore Wind Farm

Cable Route Benthic Technical Report

February 2012

Document: J3151 Beatrice Cable Route Benthic Technical Report 2011

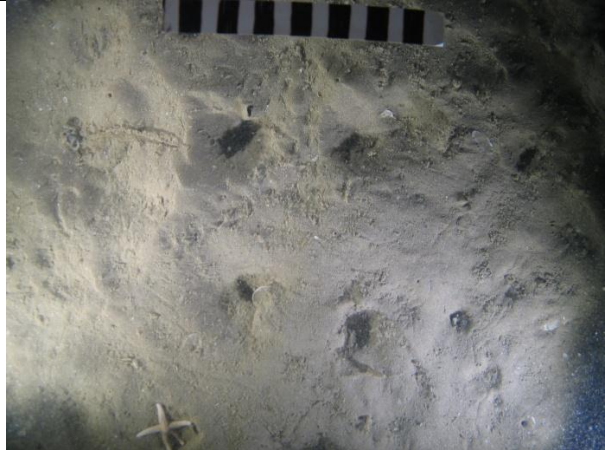
Site	38b	Date	11/06/11

Time	13:39 Hrs
		Position	5809.633°N 0304.395°W
		Depth (m)	50.6
		Description	Very fine sand/mud. <i>Asterias rubens</i> at bottom of image. Tubeworms protruding from sediment surface. Burrows and depressions.

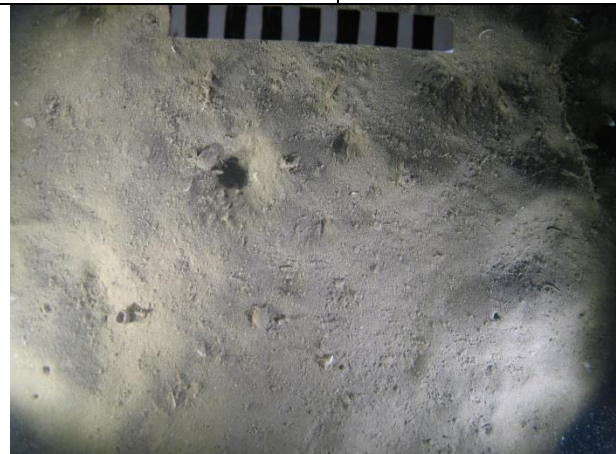
Time	13:41 Hrs
		Position	5809.640°N 0304.404°W
		Depth (m)	50.7
		Description	Very fine sand/mud. Tubeworms and burrows bottom left. Possible hydroid top right.

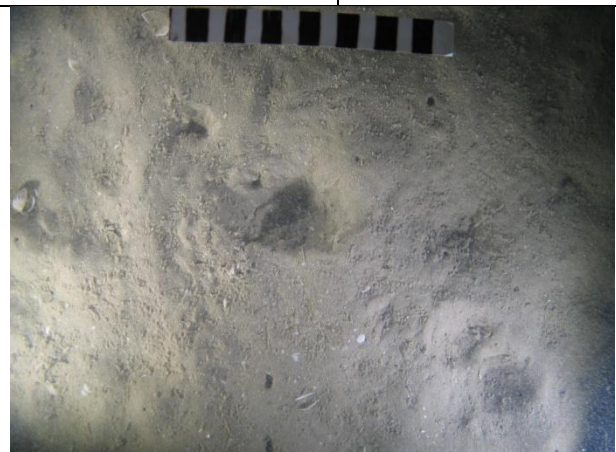
Site	39a	Date	10/06/11

Time	16:06 Hrs
		Position	5806.746°N 0306.915°W
		Depth (m)	48.0
		Description	Very fine sand/mud. Burrows and bioturbation. No discernable fauna.

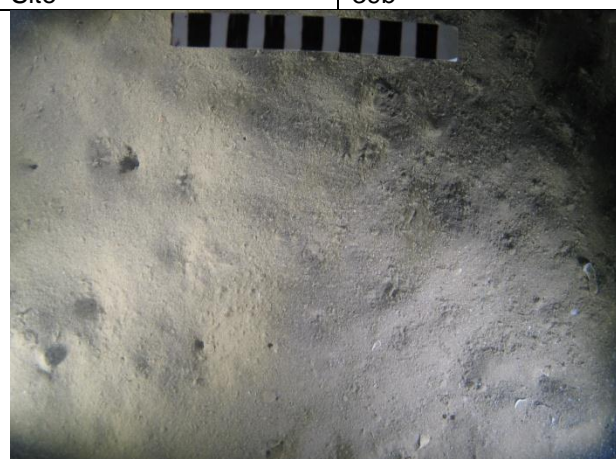
Time	16:08 Hrs
		Position	5806.747°N 0306.904°W
		Depth (m)	45.7
		Description	Very fine sand/mud. Possible tubeworm below scale bar. Burrows

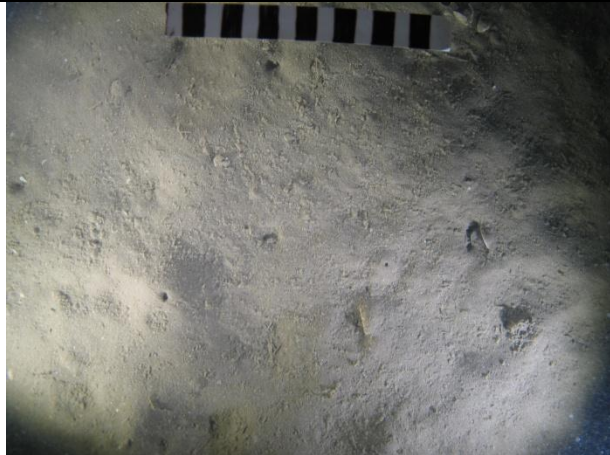
Site	39c	Date	10/06/11

Time	16:10 Hrs
		Position	5806.743°N 0306.921°W
		Depth (m)	48.1
		Description	Very fine sand/mud. Tubeworm (probably <i>Lanice conchilega</i>) middle and worm casts bottom right. Burrows.

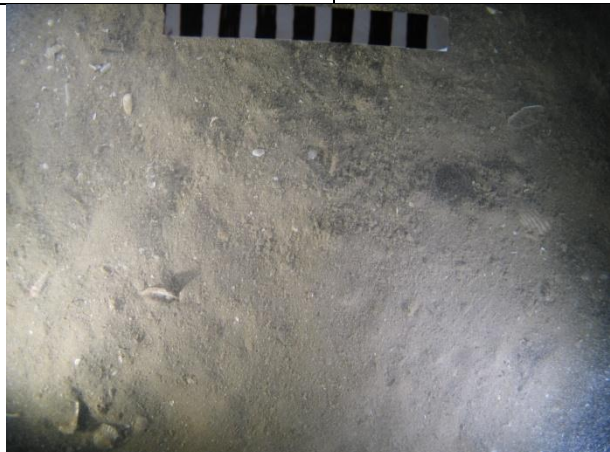
Site	40a	Date	10/06/11

Time	16:50 Hrs
		Position	5802.741°N 0305.756°W
		Depth (m)	47.6
		Description	Very fine sand/mud. Possible needle whelk/tower shell middle left.

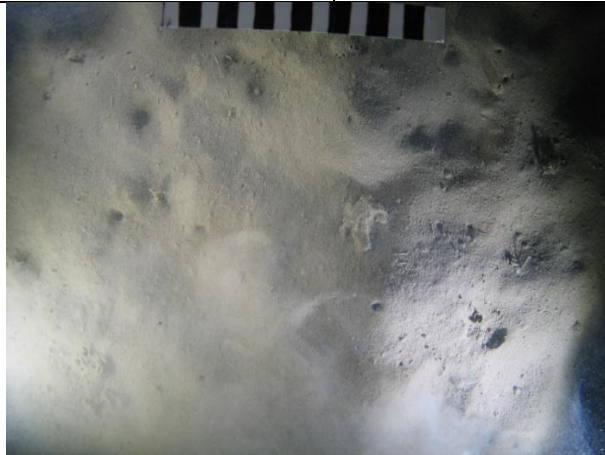
Site	41a	Date	06/06/11

Time	16:28 Hrs
		Position	5802.762°N 0322.320°W
		Depth (m)	52.0
		Description	Mud (Suspended sediment in field of view). Tubeworm protruding sediment surface middle right. Clump of material in centre – unknown. Hydroid/bryozoa middle left. Burrows.

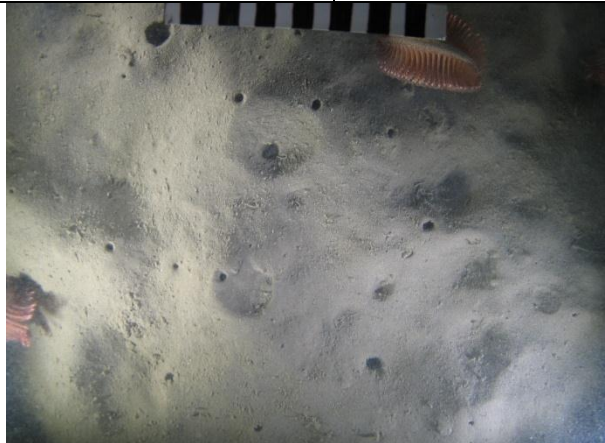
Site	41b	Date	06/06/11

Time	16:33 Hrs
		Position	5802.788°N 0322.349°W
		Depth (m)	51.3
		Description	Mud. Sea pens, <i>Pennatula phosphorea</i> . Burrows.

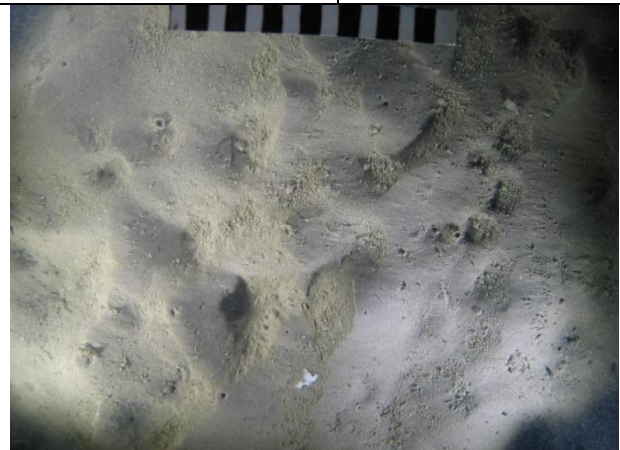
Time	16:35 Hrs
		Position	5802.784°N 0322.328°W
		Depth (m)	51.7
		Description	Very fine sand/mud with ripples and depressions. Some organic debris. Tubeworms and burrows.

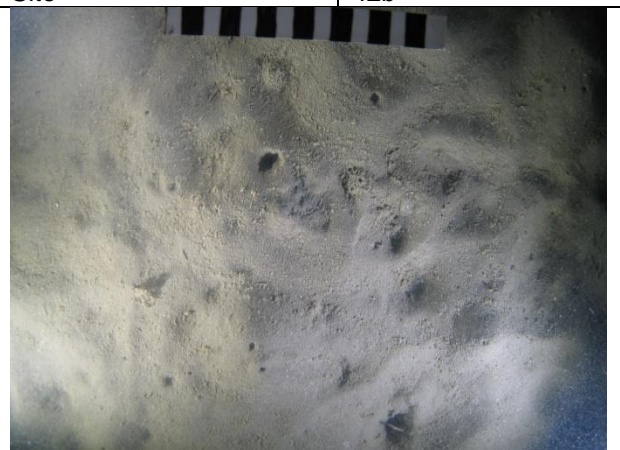
Time	18:00 Hrs
		Position	5757.165°N 0317.753°W
		Depth (m)	51.6
		Description	Mud. Small mass of bryozoa left middle. Possible worm cast below scale bar. Burrows.

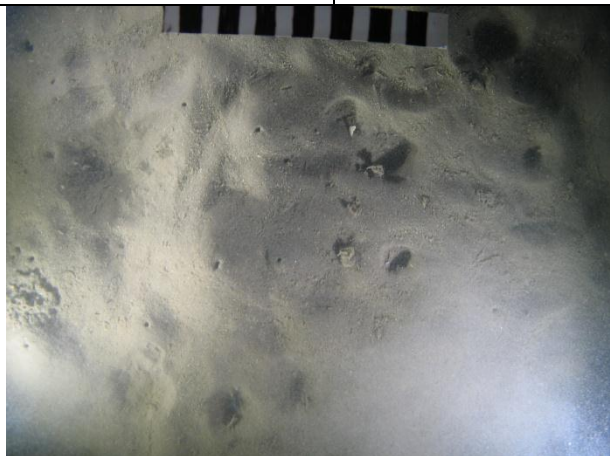
Site	42c	Date	06/06/11

Time	18:02 Hrs
		Position	5757.164°N 0317.760°W
		Depth (m)	51.3
		Description	Very fine sand/mud (Suspended sediment in field of view). Possible aggregation of tubeworms left middle. Larger tubeworms protruding from sediment surface in centre. Burrows.

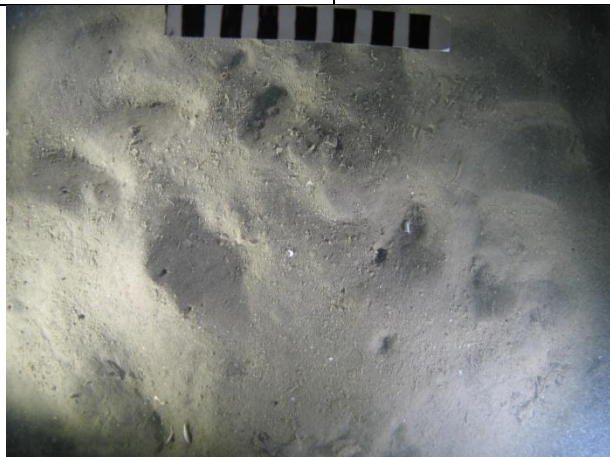
Site	43b	Date	10/06/11

Time	17:53 Hrs
		Position	5756.708°N 0306.055°W
		Depth (m)	58.5
		Description	Very fine sand/mud with ripples/depressions. Tubeworm slightly protruding from sediment surface below scale bar. Burrows. Possible strand of orange hydroid below right of scale bar.

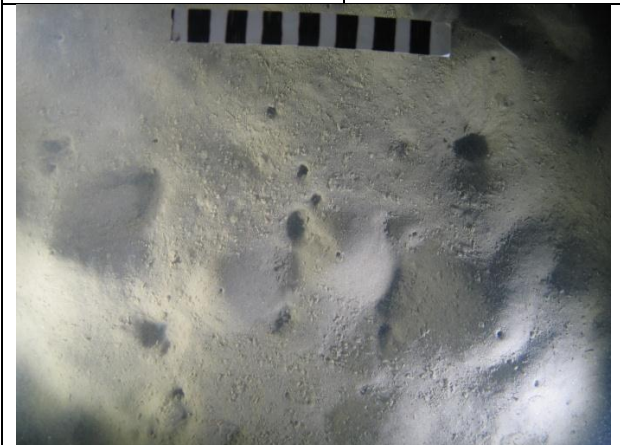
Site	44a	Date	12/06/11

Time	10:41 Hrs
		Position	5753.996°N 0311.085°W
		Depth (m)	65.2
		Description	Mud Burrows and bioturbation. No discernible fauna.

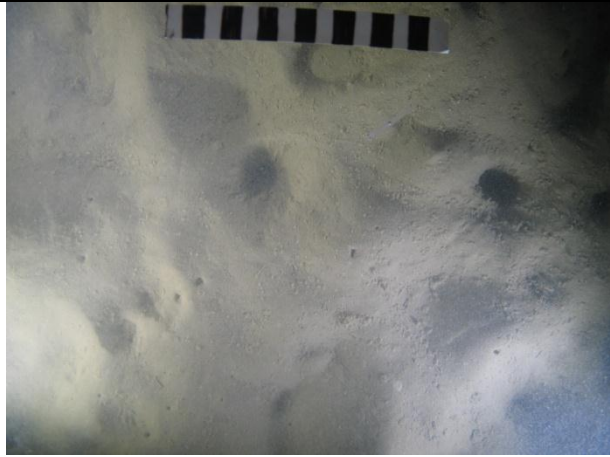
Site	44c	Date	12/06/11

Time	10:45 Hrs
		Position	5753.987°N 0311.069°W
		Depth (m)	64.9
		Description	Mud (Suspended sediment in field of view). Transparent goby, <i>Aphia minuta</i> below scale bar. Burrows and depressions.

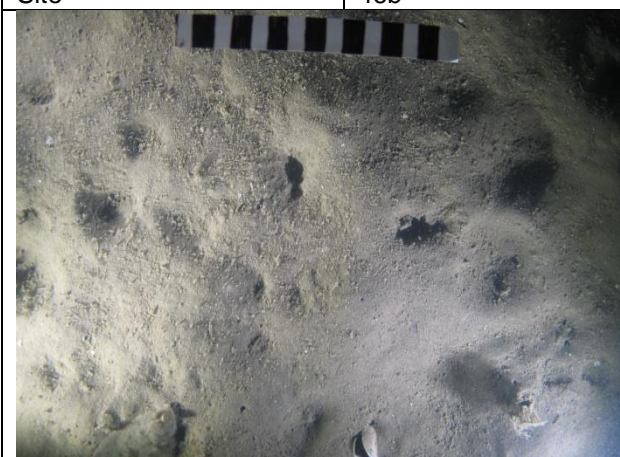
Time	12:11 Hrs
		Position	5748.929°N 0323.148°W
		Depth (m)	56.4
		Description	Very fine sand/mud. Plaice, <i>Pleuronectes platessa</i> bottom left. Hydroid/Bryozoa bottom right. Burrows.

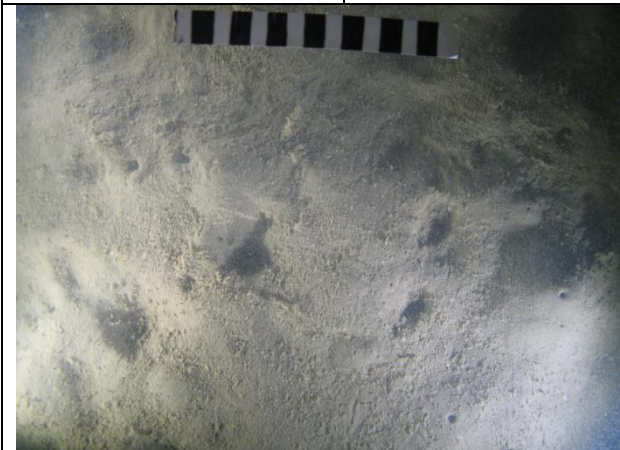
Time	12:13 Hrs
		Position	5748.932°N 0323.141°W
		Depth (m)	56.5
		Description	Very fine sand/mud. Small branch of hydroid/bryozoa below scale bar. Burrows and depressions.

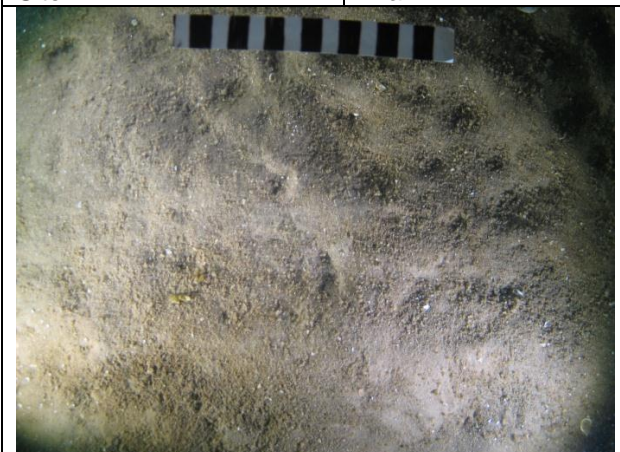
Time	09:10 Hrs
		Position	5745.523°N 0313.840°W
		Depth (m)	24.1
		Description	Medium sand. Small fragments of possible green algae middle left. Small depressions

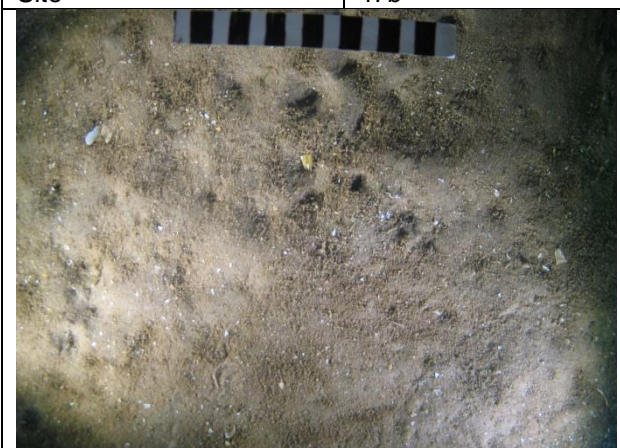
Site	47b	Date	12/06/11

Time	09:14 Hrs
		Position	5745.523°N 0313.824°W
		Depth (m)	24.2
		Description	Medium sand and some fine shell fragments. Burrows/small depressions. No discernible fauna.

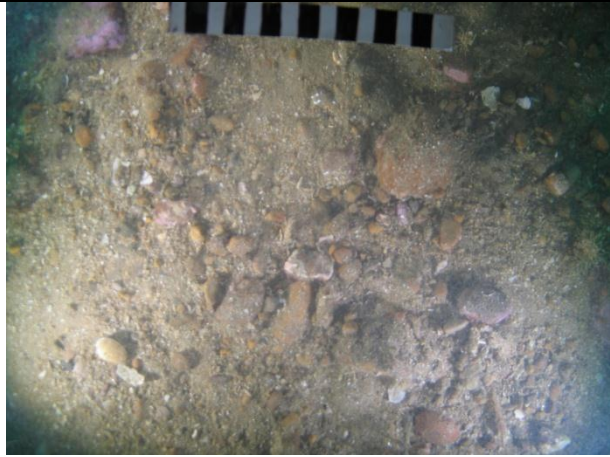
Site	50a	Date	06/06/11

Time	09:25 Hrs
		Position	5743.685°N 0309.141°W
		Depth (m)	18.0
		Description	Sand, gravel and pebbles with occasional cobble. <i>Lanice conchilega</i> right of scale bar and centre. Some hydroids and encrusting pink bryozoan, <i>Lithothamnion sp.</i> on pebble top left.

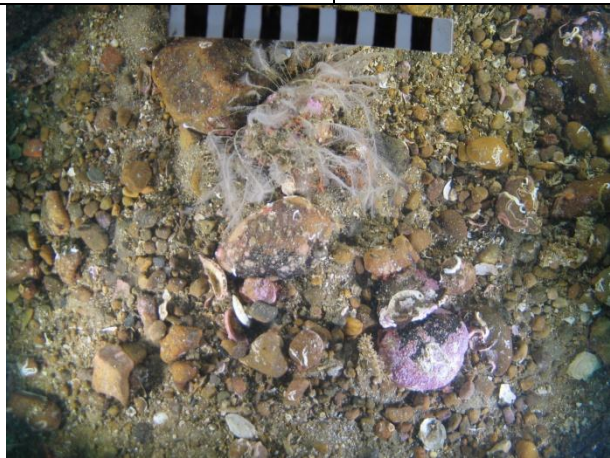
Time	09:31 Hrs
		Position	5743.693°N 0309.110°W
		Depth (m)	18.8
		Description	<p>Sand, gravel, pebble and some large cobble.</p> <p>Encrusting <i>Pomatoceros triqueter</i>. Pink <i>Lithothamnion sp.</i> bryozoa on pebble. White hydroid, <i>Kirchenpaueria pinnata</i>. <i>Lanice conchilega</i> amongst pebbles. <i>Galathea sp.</i> and <i>Munida rugosa</i>. Hermit crab <i>Pagurus prideauxi</i> with anemone <i>Carciniopados</i> top right. Edible crab, <i>C.pagurus</i> centre of image. Mass of hydroid/bryozoa bottom centre.</p> <p>Small orange sponges on cobble.</p>
