Neart na Gaoithe Proposed Offshore Wind Farm

Preliminary Assessment
of Coarse Sediment
Benthic Habitats

Document Release and Authorisation Record			
Job No:	J/1/03/1665	Version: 1	
Report No:		Status: Draft	
Date:	July 2011		
Client Name:	Neart na Gaoithe Offshore Wind Ltd		
Client Contact(s):	Zoe Crutchfield		
QA	Name	Signature	Date
Project Manager	Alison Duncan	 	14.07.2011
Report written by	Erin Pettifer	 	14.07.2011
	Dr. Simon Bray		
	Jo Weir	 	
	Paul English		
Report QA proof read by	Bev Forrow	 	14.07.2011
Report authorised by	Paul English	 	14.07.2011

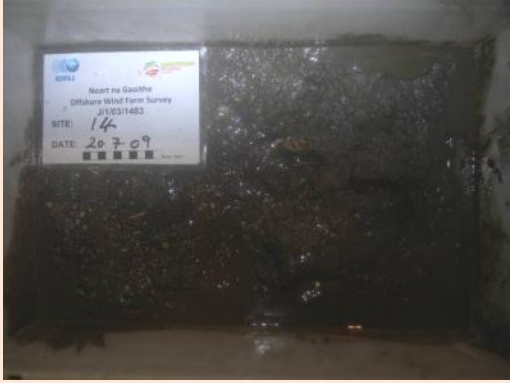
Station	Deck photo of grab sample	Grab data										
14

A photograph of a grab sample container for station 14. The container is dark and filled with sediment. A white label is attached to the top left, containing the following text: 'Nearit na Gaoithe Offshore Wind Farm Survey J1103/1483 SITE: 14 DATE: 20.7.09'.	<p>PSD Stats</p> <table border="1"> <tr> <td>% Gravel</td> <td>2.53</td> </tr> <tr> <td>%Sand</td> <td>91.16</td> </tr> <tr> <td>% Silt/Clay</td> <td>6.31</td> </tr> <tr> <td>Sorting coefficient</td> <td>1.24</td> </tr> <tr> <td>Folk sediment description</td> <td>Slightly Gravelly Sand</td> </tr> </table> <p>Faunal sample = 12% epifaunal species</p>	% Gravel	2.53	%Sand	91.16	% Silt/Clay	6.31	Sorting coefficient	1.24	Folk sediment description	Slightly Gravelly Sand
% Gravel	2.53											
%Sand	91.16											
% Silt/Clay	6.31											
Sorting coefficient	1.24											
Folk sediment description	Slightly Gravelly Sand

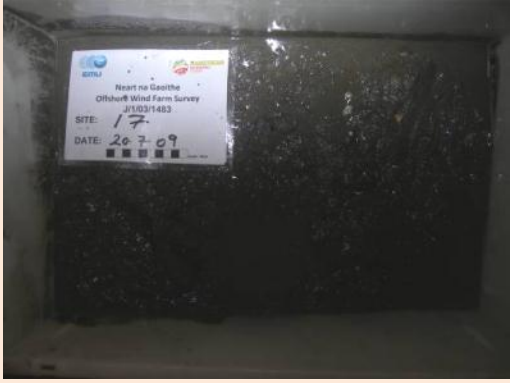
A photograph of a grab sample container for station 17. The container is dark and filled with sediment. A white label is attached to the top left, containing the following text: 'Nearit na Gaoithe Offshore Wind Farm Survey J1103/1483 SITE: 17 DATE: 20.7.09'.	<p>PSD Stats</p> <table border="1"> <tr> <td>% Gravel</td> <td>6.90</td> </tr> <tr> <td>%Sand</td> <td>85.57</td> </tr> <tr> <td>% Silt/Clay</td> <td>7.53</td> </tr> <tr> <td>Sorting coefficient</td> <td>1.55</td> </tr> <tr> <td>Folk sediment description</td> <td>Gravelly Sand</td> </tr> </table> <p>Faunal sample = 9% epifaunal species</p>	% Gravel	6.90	%Sand	85.57	% Silt/Clay	7.53	Sorting coefficient	1.55	Folk sediment description	Gravelly Sand
% Gravel	6.90											
%Sand	85.57											
% Silt/Clay	7.53											
Sorting coefficient	1.55											
Folk sediment description	Gravelly Sand											
18

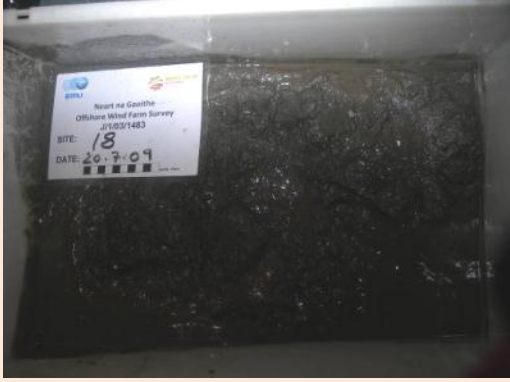
A photograph of a grab sample container for station 18. The container is dark and filled with sediment. A white label is attached to the top left, containing the following text: 'Nearit na Gaoithe Offshore Wind Farm Survey J1103/1483 SITE: 18 DATE: 20.7.09'.	<p>PSD Stats</p> <table border="1"> <tr> <td>% Gravel</td> <td>7.29</td> </tr> <tr> <td>%Sand</td> <td>85.83</td> </tr> <tr> <td>% Silt/Clay</td> <td>6.89</td> </tr> <tr> <td>Sorting coefficient</td> <td>1.58</td> </tr> <tr> <td>Folk sediment description</td> <td>Gravelly Sand</td> </tr> </table> <p>Faunal sample = 12% epifaunal species</p>	% Gravel	7.29	%Sand	85.83	% Silt/Clay	6.89	Sorting coefficient	1.58	Folk sediment description	Gravelly Sand

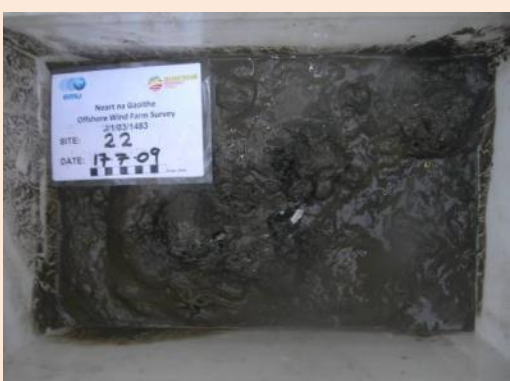
A photograph of a grab sample container for station 22. The container is dark and filled with sediment. A white label is attached to the top left, containing the following text: 'Nearit na Gaoithe Offshore Wind Farm Survey J1103/1483 SITE: 22 DATE: 17.7.09'.	<p>PSD Stats</p> <table border="1"> <tr> <td>% Gravel</td> <td>51.94</td> </tr> <tr> <td>%Sand</td> <td>43.06</td> </tr> <tr> <td>% Silt/Clay</td> <td>5.00</td> </tr> <tr> <td>Sorting coefficient</td> <td>3.80</td> </tr> <tr> <td>Folk sediment description</td> <td>Muddy Sandy Gravel</td> </tr> </table> <p>Faunal sample = 19% epifaunal species</p>	% Gravel	51.94	%Sand	43.06	% Silt/Clay	5.00	Sorting coefficient	3.80	Folk sediment description	Muddy Sandy Gravel
% Gravel	51.94

%Sand	43.06											
% Silt/Clay	5.00											
Sorting coefficient	3.80											
Folk sediment description	Muddy Sandy Gravel

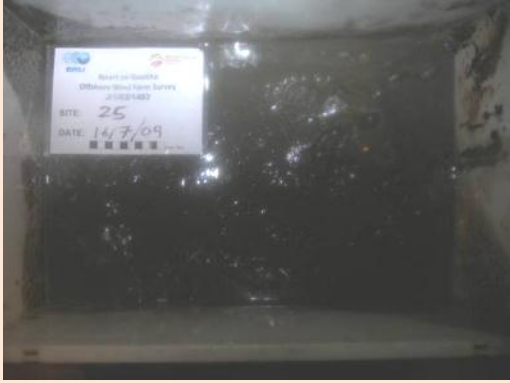
Station	Deck photo of grab sample	Grab data										
25

A photograph of a grab sample container for station 25. The container is dark and filled with sediment. A white label is attached to the top left, containing the following text: 'Nearst na Gaoithe Offshore Wind Farm Survey J10031483 SITE: 25 DATE: 14/7/09'. The label also features logos for EMU and other organizations.	<p>PSD Stats</p> <table border="1"> <tr> <td>% Gravel</td> <td>16.06</td> </tr> <tr> <td>%Sand</td> <td>79.85</td> </tr> <tr> <td>% Silt/Clay</td> <td>4.09</td> </tr> <tr> <td>Sorting coefficient</td> <td>2.57</td> </tr> <tr> <td>Folk sediment description</td> <td>Gravelly Sand</td> </tr> </table> <p>Faunal sample = 21% epifaunal species</p>	% Gravel	16.06	%Sand	79.85	% Silt/Clay	4.09	Sorting coefficient	2.57	Folk sediment description	Gravelly Sand
% Gravel	16.06											
%Sand	79.85											
% Silt/Clay	4.09

Sorting coefficient	2.57											
Folk sediment description	Gravelly Sand											
27

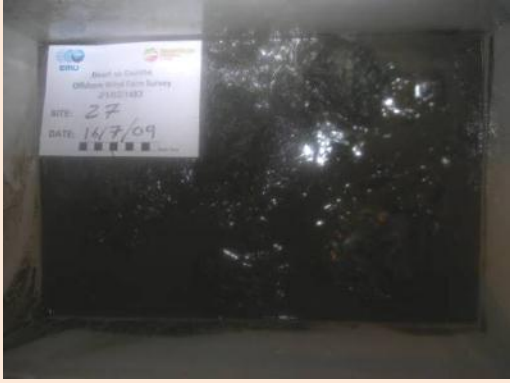
A photograph of a grab sample container for station 27. The container is dark and filled with sediment. A white label is attached to the top left, containing the following text: 'Nearst na Gaoithe Offshore Wind Farm Survey J10031483 SITE: 27 DATE: 14/7/09'. The label also features logos for EMU and other organizations.	<p>PSD Stats</p> <table border="1"> <tr> <td>% Gravel</td> <td>1.09</td> </tr> <tr> <td>%Sand</td> <td>94.38</td> </tr> <tr> <td>% Silt/Clay</td> <td>4.53</td> </tr> <tr> <td>Sorting coefficient</td> <td>1.18</td> </tr> <tr> <td>Folk sediment description</td> <td>Slightly Gravelly Sand</td> </tr> </table> <p>Faunal sample = 11% epifaunal species</p>	% Gravel	1.09	%Sand	94.38	% Silt/Clay	4.53	Sorting coefficient	1.18	Folk sediment description	Slightly Gravelly Sand
% Gravel	1.09

%Sand	94.38											
% Silt/Clay	4.53											
Sorting coefficient	1.18											
Folk sediment description	Slightly Gravelly Sand											
35

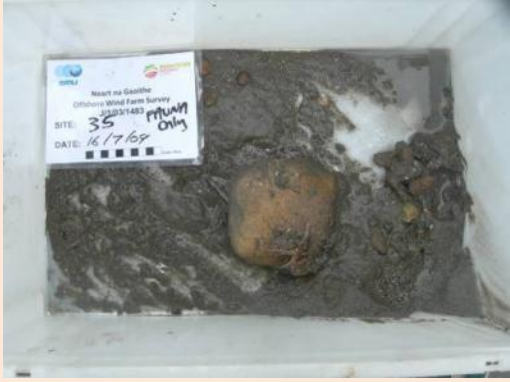
A photograph of a grab sample container for station 35. The container is filled with a mixture of sediment and a large, rounded, light-colored object. A white label is attached to the top left, containing the following text: 'Nearst na Gaoithe Offshore Wind Farm Survey J10031483 SITE: 35 DATE: 16/7/09'. The label also features logos for EMU and other organizations.	<p>PSD Stats</p> <table border="1"> <tr> <td>% Gravel</td> <td>41.63</td> </tr> <tr> <td>%Sand</td> <td>56.37</td> </tr> <tr> <td>% Silt/Clay</td> <td>2.00</td> </tr> <tr> <td>Sorting coefficient</td> <td>2.71</td> </tr> <tr> <td>Folk sediment description</td> <td>Sandy Gravel</td> </tr> </table> <p>Faunal sample = 49% epifaunal species</p>	% Gravel	41.63	%Sand	56.37	% Silt/Clay	2.00	Sorting coefficient	2.71	Folk sediment description	Sandy Gravel

% Gravel	41.63											
%Sand	56.37											
% Silt/Clay	2.00											
Sorting coefficient	2.71											
Folk sediment description	Sandy Gravel

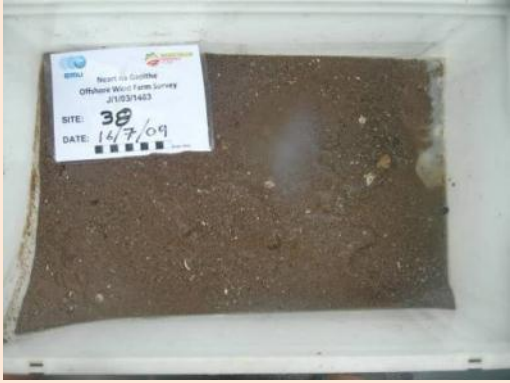
<p>PSD Stats</p> <table border="1"> <tr> <td>% Gravel</td> <td>11.34</td> </tr> <tr> <td>%Sand</td> <td>88.57</td> </tr> <tr> <td>% Silt/Clay</td> <td>0.08</td> </tr> <tr> <td>Sorting coefficient</td> <td>1.56</td> </tr> <tr> <td>Folk sediment description</td> <td>Gravelly Sand</td> </tr> </table> <p>Faunal sample = 3% epifaunal species</p>	% Gravel	11.34	%Sand	88.57	% Silt/Clay	0.08	Sorting coefficient	1.56	Folk sediment description	Gravelly Sand
% Gravel	11.34											
%Sand	88.57											
% Silt/Clay	0.08											
Sorting coefficient	1.56											
Folk sediment description	Gravelly Sand											
42

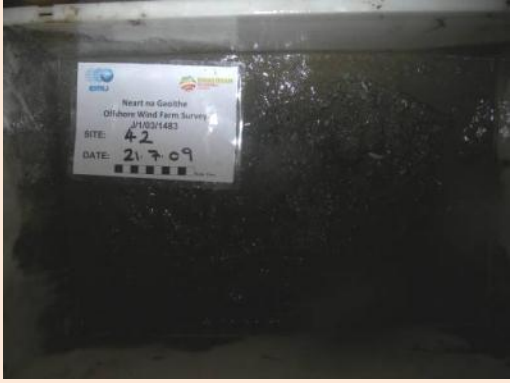
<p>PSD Stats</p> <table border="1"> <tr> <td>% Gravel</td> <td>31.60</td> </tr> <tr> <td>%Sand</td> <td>60.25</td> </tr> <tr> <td>% Silt/Clay</td> <td>8.15</td> </tr> <tr> <td>Sorting coefficient</td> <td>2.85</td> </tr> <tr> <td>Folk sediment description</td> <td>Muddy Sandy Gravel</td> </tr> </table> <p>Faunal sample = 5% epifaunal species</p>	% Gravel	31.60	%Sand	60.25	% Silt/Clay	8.15	Sorting coefficient	2.85	Folk sediment description	Muddy Sandy Gravel

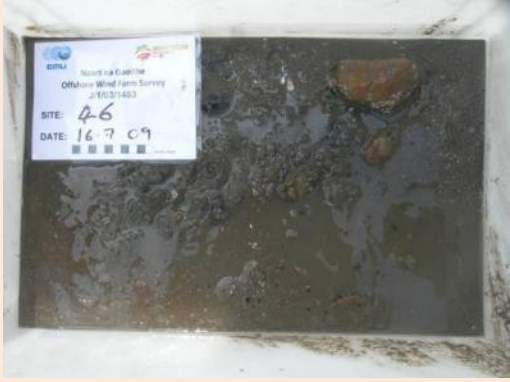
<p>PSD Stats</p> <table border="1"> <tr> <td>% Gravel</td> <td>25.74</td> </tr> <tr> <td>%Sand</td> <td>70.44</td> </tr> <tr> <td>% Silt/Clay</td> <td>3.83</td> </tr> <tr> <td>Sorting coefficient</td> <td>2.94</td> </tr> <tr> <td>Folk sediment description</td> <td>Gravelly Sand</td> </tr> </table> <p>Faunal sample = 26% epifaunal species</p>	% Gravel	25.74	%Sand	70.44	% Silt/Clay	3.83	Sorting coefficient	2.94	Folk sediment description	Gravelly Sand
% Gravel	25.74											
%Sand	70.44											
% Silt/Clay	3.83											
Sorting coefficient	2.94											
Folk sediment description	Gravelly Sand											
48

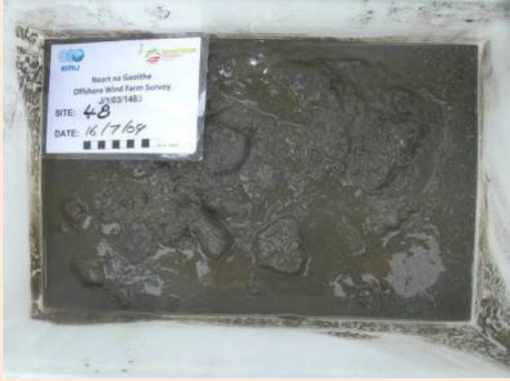
<p>PSD Stats</p> <table border="1"> <tr> <td>% Gravel</td> <td>12.32</td> </tr> <tr> <td>%Sand</td> <td>81.51</td> </tr> <tr> <td>% Silt/Clay</td> <td>6.17</td> </tr> <tr> <td>Sorting coefficient</td> <td>2.00</td> </tr> <tr> <td>Folk sediment description</td> <td>Gravelly Sand</td> </tr> </table> <p>Faunal sample = 17% epifaunal species</p>	% Gravel	12.32	%Sand	81.51	% Silt/Clay	6.17	Sorting coefficient	2.00	Folk sediment description	Gravelly Sand

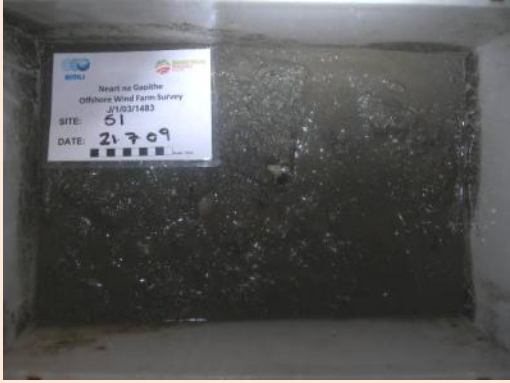
<p>PSD Stats</p> <table border="1"> <tr> <td>% Gravel</td> <td>29.00</td> </tr> <tr> <td>% Sand</td> <td>67.32</td> </tr> <tr> <td>% Silt/Clay</td> <td>3.68</td> </tr> <tr> <td>Sorting coefficient</td> <td>3.17</td> </tr> <tr> <td>Folk sediment description</td> <td>Gravelly Sand</td> </tr> </table> <p>Faunal sample = 38% epifaunal species</p>	% Gravel	29.00	% Sand	67.32	% Silt/Clay	3.68	Sorting coefficient	3.17	Folk sediment description	Gravelly Sand
% Gravel	29.00											
% Sand	67.32											
% Silt/Clay	3.68											
Sorting coefficient	3.17											
Folk sediment description	Gravelly Sand											
54

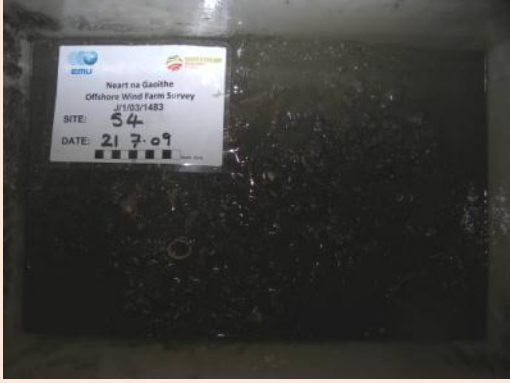
<p>PSD Stats</p> <table border="1"> <tr> <td>% Gravel</td> <td>4.94</td> </tr> <tr> <td>% Sand</td> <td>89.79</td> </tr> <tr> <td>% Silt/Clay</td> <td>5.27</td> </tr> <tr> <td>Sorting coefficient</td> <td>1.52</td> </tr> <tr> <td>Folk sediment description</td> <td>Slightly Gravelly Sand</td> </tr> </table> <p>Faunal sample = 9% epifaunal species</p>	% Gravel	4.94	% Sand	89.79	% Silt/Clay	5.27	Sorting coefficient	1.52	Folk sediment description	Slightly Gravelly Sand

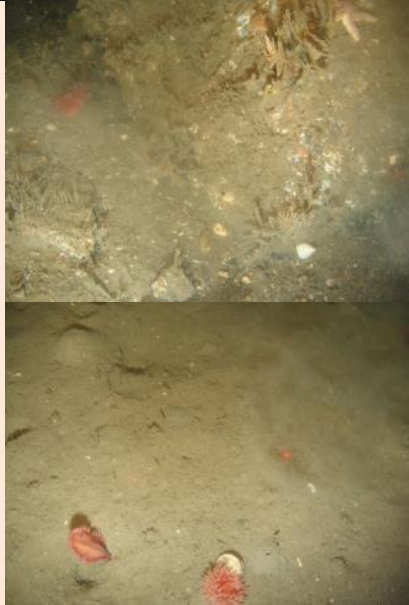
Site	General overall site description	Description of cobble and boulder component	Conspicuous species	Representative Photographs
14	<p>Video footage review: Muddy sand with burrows, mounds, soft polychaete tubes and casts. Very small patches of coarser grained sediments. Occasional cobbles and one small boulder.</p> <p>Static image review: Image 1 cobble/small boulder 4%/55% Image 2 - 11 cobble/small boulder 0%/0%</p> <p>Average cobbles and boulders = 5%</p>	<p>Elevation Cobbles and boulders, where present, where either embedded in sediment or on top of the soft sediment.</p> <p>Faunal community Muddy sand with seapens and burrows. Where cobbles were present these were colonised predominantly by <i>Alcyonium digitatum</i> and a hydroid turf.</p>	<p><i>Pennatula phosphorea</i> <i>Asterias rubens</i> Hydroid turf <i>Urticina eques</i> <i>Alcyonium digitatum</i> <i>Munida</i> sp. <i>Hydrallmania falcata</i> Nudibranch <i>Janolus</i> sp. <i>Abietinaria abietina</i> Paguridae Actinaria <i>Pomatoceros</i> sp. <i>Ophiothrix fragilis</i> <i>?Rhizocaulus</i> sp. <i>Bolocera tuediae</i> Cirripedia <i>?Limanda limanda</i> <i>Nephrops norvegicus</i> <i>Pecten maximus</i> <i>Nemertesia antennina</i></p>

Station	Composition Cobbles/boulders	Elevation	Extent	Biota * (% epifauna)	Resemblance
14	5%	<64 mm overall	>25 m ²	12%	Not reef
17	2%	<64 mm overall	>25 m ²	9%	Not reef
18	1%	<64 mm overall	>25 m ²	12%	Not reef
22	1%	<64 mm overall	>25 m ²	19%	Not reef
25	8%	<64 mm overall	>25 m ²	21%	Not reef
27	5%	<64 mm overall	>25 m ²	11%	Not reef
35	8%	<64 mm overall	>25 m ²	49%	Not reef
38	14%	<64 mm overall	>25 m ²	3%	Not reef
42	40%	64 mm - ~1 m in places	>25 m ²	5%	Low
46	6%	<64 mm overall	>25 m ²	26%	Not reef
48	8%	<64 mm overall	>25 m ²	17%	Not reef
51	4%	<64 mm overall	>25 m ²	38%	Not reef
54	4%	<64 mm overall	>25 m ²	9%	Not reef
VP2	38%	64 mm - ~1m in places	>25 m ²	No grab sample	Low
VP3	49%	64 mm - ~1m in places	>25 m ²	No grab sample	Low

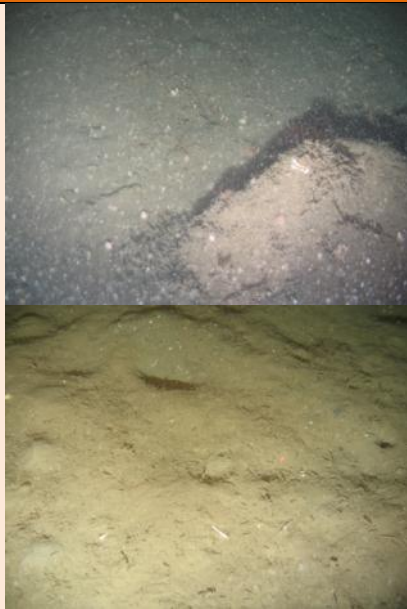
Site	General overall site description	Description of cobble and boulder component	Conspicuous species	Representative Photographs
17	<p>Video footage review: Muddy sand with burrows, soft polychaete tubes and mounds. Two very small patches (<25m²) of cobbles and boulders.</p> <p>Static image review: Image 1 - 6 cobble/small boulder 0%/0% Image 7 cobble/small boulder 0%/25% Image 8-12 cobble/small boulder 0%/0%</p> <p>Average cobbles and boulders = 2%</p>	<p>Elevation No significant elevation throughout the transect, only two small patches of cobbles and small boulders.</p> <p>Faunal community Muddy sand with seapens and burrows. Where cobbles were present these were colonised predominantly by <i>Alcyonium digitatum</i>, anemones and a hydroid turf.</p>	<p><i>Pennatula phosphorea</i> <i>Munida</i> sp. Hydroid/bryozoan turf Callionymidae <i>Cancer pagurus</i> <i>Bolocera tuediae</i> <i>Alcyonium digitatum</i> Setularidae Paguridae <i>Urticina</i> sp. Actinaria <i>Corystes cassivelaunus</i> Paguridae <i>Ebalia</i> sp. <i>Hydrallmania falcata</i> <i>Abietinaria abietina</i> <i>?Rhizocaulus</i> sp. Hexacorallia Serpulidae Gastropoda <i>Ophiothrix fragilis</i></p>

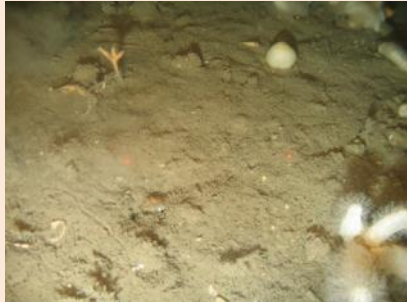
18	<p>Video footage review: Continuous gravelly sandy sediment (shelly gravelly sand), <i>Alcyonium digitatum</i> throughout, few scattered cobbles, and isolated small boulders.</p> <p>Video Image 1 cobbles: 0% Video Image 2 cobbles: 3% Video image 3 cobbles/small boulders: 10% / 15%</p> <p>Static image review: Image 1 cobbles: 3% Image 2 cobbles: 0% Image 3 cobbles: 0%</p> <p>Average cobbles and boulders = 1%</p>	<p>Elevation A few scattered cobbles with a veneer of sand over the surface.</p> <p>Faunal community Gravelly sand with mounds and burrows along transect. Associated with the coarser sediment is <i>Alcyonium digitatum</i>.</p>	<p>Gobiidae <i>Alcyonium digitatum</i> <i>Echinus esculentus</i> <i>Hyas/Inachus</i> sp. <i>Asterias rubens</i> Hydroid/Bryozoan turf <i>? Bolocera tuediae</i> <i>Pomatoceros</i> sp. <i>Munida</i> sp. <i>Metridium senile</i> Paguridae Porifera</p>

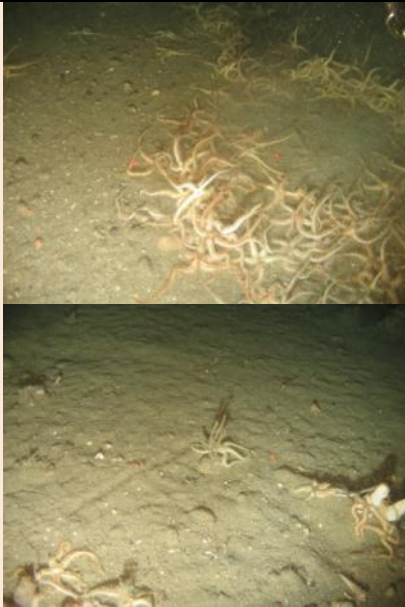
Site	General overall site description	Description of cobble and boulder component	Conspicuous species	Representative Photographs
22	<p>Video footage review: Slightly shelly sand with burrows, and soft polychaete tubes. Along the transect were occasional boulders and cobbles.</p> <p>Video image 1 – 6 cobbles : 0% Video image 7: small boulders: 10% Video image 8-10 cobbles: 0%</p> <p>Static image review: Image 1 cobbles: 0% Image 2 cobbles: 3% Image 3 cobbles: 0% Image 4 cobbles: 0% Image 5 cobbles: 0%</p> <p>Average cobbles and boulders = 1%</p>	<p>Elevation Occasional small boulders and cobbles. Cobbles were embedded within the sediment with a covering of sediment, whilst the boulders were on top of the sediment.</p> <p>Faunal community Patchy dense brittlestar bed on slightly shelly sand.</p>	<p><i>Asterias rubens</i> <i>Pagurus bernhardus</i> Hydroid/bryozoan turf <i>Alcyonium digitatum</i> <i>Ophiothrix fragilis</i> Callionymidae <i>Nemertesia antennina</i> <i>Astropecten irregularis</i> <i>?Rhizocaulus</i> sp. Paguridae <i>Chaetopterus variepedatus</i> tubes</p>

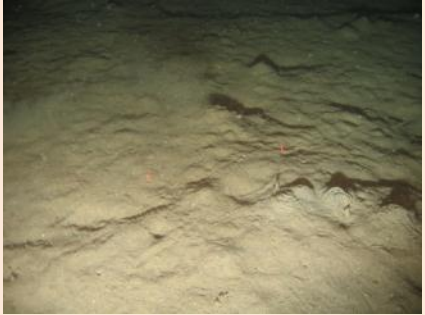
Site	General overall site description	Description of cobble and boulder component	Conspicuous species	Representative Photographs
27	<p>Video footage review: Slightly shelly muddy sand with burrows and worm casts. A small area with occasional cobbles.</p> <p>Video image 1 cobbles/small boulders: 0%/0% Video image 2 cobbles/small boulders: 5%/0% Video image 3 cobbles/small boulders: 8%/20% Video image 4 cobbles/small boulders: 5%/0%</p> <p>Static image review: Image 1 cobble/small boulder 0%/0% Image 2 cobble/small boulder 0%/0% Image 3 cobble/small boulder 0%/0% Image 4 cobble/small boulder:4%/0% Image 5 cobble/small boulder:0%/0%</p> <p>Average cobbles and boulders = 5%</p>	<p>Elevation Cobbles/ small boulders where present are embedded within sediment with a veneer of sediment overlying.</p> <p>Faunal community Muddy sand with seapens, where coarse sediments occur (pebbles/cobbles), <i>Alcyonium digitatum</i> is present.</p>	<p><i>Asterias rubens</i> <i>Alcyonium digitatum</i> <i>Pennatula phosphorea</i> <i>Cancer pagurus</i> Hydroid turf <i>Sertularia</i> sp. <i>Ophiothrix fragilis</i> <i>Ophiura ophiura</i></p>

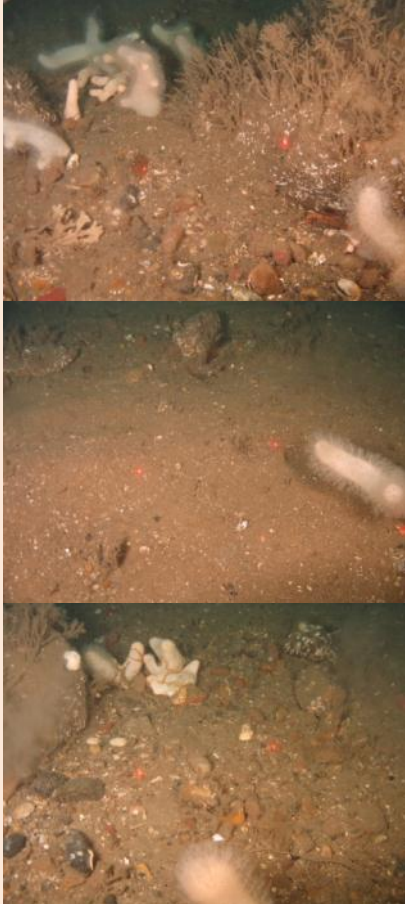
Site	General overall site description	Description of cobble and boulder component	Conspicuous species	Representative Photographs
35	<p>Video footage review: Shelly, gravelly, pebbly sand with occasional cobbles and small boulders, varying proportions of gravel and pebbles.</p> <p>Video Image 1 cobbles/small boulders: 5%/0% Video Image 2 cobbles/small boulders: 10%/0% Video Image 3 cobbles/small boulders: 0%/0% Video Image 4 cobbles/small boulders: 5%/5% Video Image 5 cobbles/small boulders:6%/0% Video Image 6 cobbles/small boulders:0%/0%</p> <p>Static image review: Image 1 cobble/small boulder 2%/25% Image 2 cobble/small boulder 3%/0% Image 3 cobble/small boulder 10%/5% Image 4 cobble/small boulder:2%/0% Image 5 cobble/small boulder:5%/0%</p> <p>Average cobbles and boulders = 8%</p>	<p>Elevation Occasional cobble and small boulder.</p> <p>Faunal community Abundant <i>Alcyonium digitatum</i> on shelly, gravelly, pebbly sand, <i>Pomatoceros</i> sp. present on coarser sediments.</p>	<p><i>Alcyonium digitatum</i> Hydroid/bryozoan turf <i>Pomatoceros</i> sp. Gobiidae <i>Pecten maximus</i> <i>Hydrallmania falcata</i> <i>Urticina</i> sp. <i>Metridium senile</i> Paguridae <i>Munida</i> sp. Bryozoan crusts <i>Asterias rubens</i> <i>Flustra foliacea</i> <i>Ophiothrix fragilis</i> <i>Asciidiella scabra</i> <i>Atelecyclus rotundatum</i> <i>Abietinaria abietina</i></p>

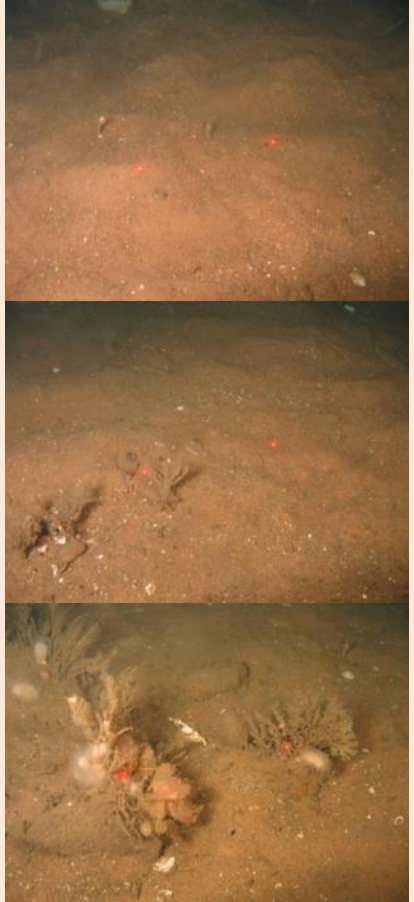
Site	General overall site description	Description of cobble and boulder component	Conspicuous species	Representative Photographs
38	<p>Video footage review: Sediment quite consistent throughout transect- Slightly shelly, gravelly, pebbly sand with slight variations in coarseness, scattered cobbles and small boulders on the sediment. At the start of the transect there is a denser cobble/boulder area. Towards the end of the transect there is rippled sand.</p> <p>Video Image 1 cobbles/small boulders/large boulders: 10%/20%/60% Video Image 2 cobbles: 0% Video Image 3 cobbles: 0% Video Image 4 cobbles: 3% Video Image 5 cobbles: 0% Video Image 6 cobbles/small boulders: 2%/20%</p> <p>Static image review: Image 1 cobbles: 0% Image 2 cobbles: 0% Image 3 cobbles: 0% Image 4 cobbles: 10% Image 5 cobbles/small boulders: 5%/25%</p> <p>Average cobbles and boulders = 14%</p>	<p>Elevation Cobbles and boulders are on the gravelly muddy sand rather than embedded within. most have a thin veneer of overlying sediment</p> <p>Faunal community <i>Alcyonium digitatum</i> present along most of the transect, possibly attached to coarser material such as gravel/pebbles/cobbles, coverage gets denser where cobbles/boulders are present.</p> <p>Sea squirts and Hydroid/bryozoan turf are present throughout.</p> <p><i>Ophiothrix fragilis</i> present where cobbles/boulders were found.</p>	<p><i>Munida rugosa</i> <i>Hydroid/bryozoan turf</i> <i>Alcyonium digitatum</i> <i>Asciadiella scabra</i> <i>Pomatoceros</i> sp. <i>Crossaster papposus</i> <i>Echinus esculentus</i> <i>Ophiothrix fragilis</i> <i>Asterias rubens</i> <i>Lanice conchilega</i> <i>Tubularia</i> sp. <i>Chaetopterus variepedatus</i> tubes Paguridae <i>?Securiflustra securifrons</i></p>

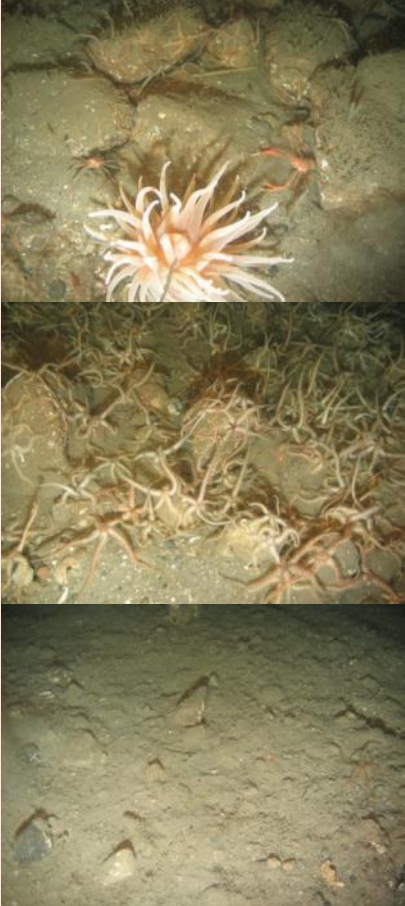
Site	General overall site description	Description of cobble and boulder component	Conspicuous species	Representative Photographs
42	<p>Video footage review:</p> <p>Along the transect the cobble / boulder habitat is interspersed with sand/ gravel and pebbles, with scattered cobbles/small boulders and occasional large boulders. Towards the end of the transect the percentage of cobbles and boulders increases.</p> <p>Video Image 1 cobbles/small boulders/large boulder: 20%/0%/5%</p> <p>Video Image 2 cobbles/small boulders: 0%/0%</p> <p>Video Image 3: cobbles/small boulders: 5%/60%</p> <p>Video Image 4 cobbles/small boulders: 0%/0%</p> <p>Video Image 5 cobbles/small boulders: 5%/40%</p> <p>Video Image 6 cobbles/small boulders: 10%/0%</p> <p>Video Image 7 cobbles/small boulders: 35%/0%</p> <p>Video Image 8 cobbles/small boulders: 10%/40%</p> <p>Video Image 9 cobbles/small boulders: 20%/20%</p> <p>Video Image 10 cobbles/small boulders: 10%/0%</p> <p>Video Image 11 cobbles/small boulders/large boulder: 5%/0%/90%</p> <p>Video Image 12 cobbles/small boulders: 20%/50%</p> <p>Video Image 13 cobbles/small boulders: 20%/65%</p> <p>Static image review:</p> <p>Image 1 cobbles/small boulders: 10%/0%</p> <p>Image 2 cobbles/small boulders: 0%/0%</p> <p>Image 3 cobbles/small boulders: 72%/0%</p> <p>Image 4 cobbles/small boulders: 10%/0%</p> <p>Image 5 cobbles/small boulders: 40%/25%</p> <p>Image 6 cobbles/small boulders: 0%/0%</p> <p>Image 7 cobbles/small boulders: 78%/5%</p> <p>Image 8 cobbles/small boulders: 60%/30%</p> <p>Average cobbles and boulders = 40%</p>	<p>Elevation:</p> <p>Cobbles and boulders are on the gravelly sand, with a thin veneer of sediment present on some cobbles/boulders.</p> <p>In localised areas, the cobbles and boulders are also on top of other cobbles.</p> <p>Faunal community:</p> <p>Dense <i>Ophiothrix fragilis</i> over cobble/boulder area and on soft sediment areas, along part of the transect.</p> <p>Soft sediment areas contain burrows, small burrowing anemones (<i>Cerianthus</i> sp.) and soft polychaete tubes.</p> <p>Squat lobsters (<i>Munida</i> sp.), large anemones (<i>Bolocera tuediae</i>), Hydroid/bryozoan turf and a crustose faunal community are associated with the dense cobble/boulder areas, where <i>Ophiothrix fragilis</i> are not present.</p>	<p><i>Alcyonium digitatum</i></p> <p>?<i>Cerianthus lloydii</i></p> <p><i>Asterias rubens</i></p> <p><i>Ophiura</i> sp.</p> <p>Hydroid/bryozoan turf</p> <p><i>Bolocera tuediae</i></p> <p><i>Munida</i> sp.</p> <p><i>Ophiothrix fragilis</i></p> <p><i>Pomatoceros</i> sp.</p> <p>Bryozoan crust</p> <p><i>Urticina</i> sp.</p> <p>Paguridae</p> <p><i>Nephrops norvegicus</i></p> <p><i>Ophiura albida</i></p> <p>Bryozoan crust</p> <p>Caridea</p> <p><i>Pomatoceros</i> sp.</p>

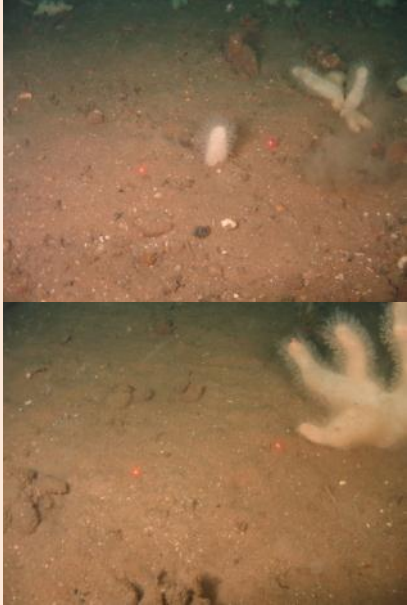
Site	General overall site description	Description of cobble and boulder component	Conspicuous species	Representative Photographs
46	<p>Video footage review: Consistent sediment type throughout site, abundant coarse material (pebbles/Gravel/shell) with scattered cobbles embedded in the sediment, partially covered in a layer of sand.</p> <p>Video Image 1 cobbles/small boulders: 5%/3% Video Image 2 cobbles/small boulders: 3%/0% Video Image 3 cobbles/small boulders: 5%/3% Video Image 4 cobbles/small boulders: 25%/0% Video Image 5 cobbles/small boulders: 15%/0% Video image 6 cobbles/small boulders: 0%/0%</p> <p>Static image review: Image 1 cobbles 2% Image 2 cobbles 0% Image 3 cobbles 3% Image 4 cobbles 2% Image 5 cobbles 2%</p> <p>Average cobbles and boulders = 6%</p>	<p>Elevation Few cobbles embedded within sediment. Most with a veneer of sediment.</p> <p>Faunal community <i>Alcyonium digitatum</i> on silt covered cobbles and pebbles throughout transect.</p> <p>Occasional clusters of sea squirts on exposed patches of cobble. Hydroid/Bryozoan turf present throughout.</p> <p><i>Pomatoceros</i> sp. were found on cobbles that were not covered in a veneer of silt/sand.</p>	<p><i>Alcyonium digitatum</i> <i>Urticina</i> sp. Hydroid/bryozoan turf <i>Asterias rubens</i> <i>Pecten maximus</i> <i>Asciella scabra</i> <i>?Securiflustra securifrons</i> Paguridae <i>Pomatoceros</i> sp. <i>Aequipecten opercularis</i> <i>Chaetopterus variepedatus</i> tubes</p>

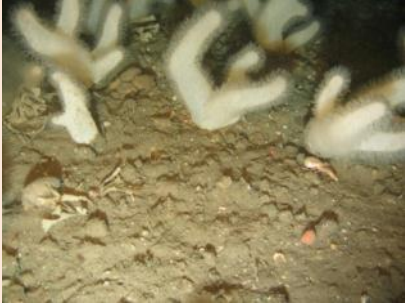
Site	General overall site description	Description of cobble and boulder component	Conspicuous species	Representative Photographs
51	<p>Video footage review: Consistent sediment composition along transect. Muddy gravel, shell, pebbles and small cobbles overlain with muddy sand.</p> <p>Video Image 1 cobbles/small boulders: 5%/0% Video Image 2 cobbles/small boulders: 5%/0% Video Image 3 cobbles/small boulders: 0%/0% Video image 4 cobbles/small boulders: 5%/0% Video image 5 cobbles/small boulders: 7%/0%</p> <p>Static image review: Image 1 cobbles 2% Image 2 cobbles 0% Image 3 cobbles 1% Image 4 cobbles 8% Image 5 cobbles 2%</p> <p>Average cobbles and boulders = 4%</p>	<p>Elevation No elevation from sediment along transect, no areas of larger cobbles and boulders, consistent coarse material embedded in sediment.</p> <p>Faunal community Large areas of <i>Alcyonium digitatum</i> on silt covered cobbles and pebbles.</p> <p>Soft Polychaete tubes present, associated with sediment composition along transect. <i>Munida</i> sp. and Hydroid/bryozoan turf abundant throughout most of the transect</p>	<p><i>Alcyonium digitatum</i> Hydroid/bryozoan turf Paguridae <i>Munida</i> sp. <i>Pagurus prideaux</i> <i>Adamsia carcinopados</i> Ascidiacea <i>Pomatoceros</i> sp. <i>Janolus</i> sp. <i>Flustra foliacea</i> <i>Ophiothrix fragilis</i> <i>Chaetopterus variepedatus</i> tubes</p>

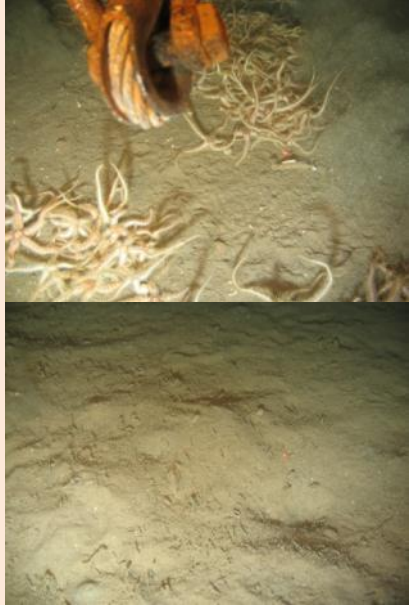
Site	General overall site description	Description of cobble and boulder component	Conspicuous species	Representative Photographs
54	<p>Video footage review: Scattered cobbles and small boulders on shelly, silty sand at the start of the transect. Further along transect the sediment becomes muddy sand with burrows.</p> <p>Video image 1 cobbles/small boulders: 5%/0% Video image 2 cobbles/small boulders: 10%/15% Video image 3 cobbles/small boulders: 10%/0% Video image 4 cobbles/small boulders: 0%/0% Video image 5 cobbles/small boulders: 0%/0%</p> <p>Static image review: Image 1 cobble/small boulder 0%/0% Image 2 cobble/small boulder 0%/0% Image 3 cobble/small boulder 0%/0% Image 4 cobble/small boulder 5%/0% Image 5 cobble/small boulder 0%/0%</p> <p>Average cobbles and boulders = 4%</p>	<p>Elevation Occasional scattered cobbles and small boulders on the sediment surface.</p> <p>Faunal community Dense <i>Ophiothrix fragilis</i> initially on soft sediment and cobbles with <i>Alcyonium digitatum</i>.</p> <p><i>Associated with the muddy sediment were the seapens, Pennatula phosphorea.</i></p>	<p><i>Ophiothrix fragilis</i> <i>Alcyonium digitatum</i> <i>Pennatula phosphorea</i> <i>Pomatoceros</i> sp. Bryozoan crust <i>Munida</i> sp. <i>Asterias rubens</i> <i>?Limanda limanda</i> <i>Paguridae</i> <i>Nephrops norvegicus</i> Hydroid/bryozoan turf <i>Virgularia mirabilis</i> <i>Chaetopterus variepedatus</i> tubes</p>

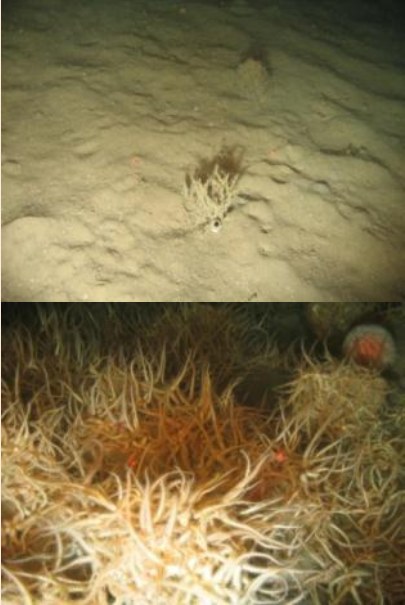
Site	General overall site description	Description of cobble and boulder component	Conspicuous species	Representative Photographs
VP2	<p>Video footage review: Patchy cobble/boulder area. The density varies along the transect, with localised areas of dense cobbles and boulders interspersed with soft sediment areas. Cobbles/boulders range from 10-90% in the densest areas, possible bedrock exposures, although covered in brittlestars, so difficult to ascertain. Between these areas, a muddy sand with sea pens habitat predominates.</p> <p>Video Image 1 cobbles/small boulders: 0%/0% Video Image 2 cobbles/small boulders: 0%/20% Video Image 3 cobbles/small boulders/large boulder: 5%/0%/45% Video Image 4 cobbles/small boulders: 15%/0% Video image 5 cobbles / small boulders: 40%/50% Video image 6 cobbles/small boulders: 60% / 15% Video image 7 cobbles/small boulders 0%/0%</p> <p>Static image review: Image 1 cobbles/small boulders: 0%/0% Image 2 cobbles/small boulders: 0%/0% Image 3 cobbles/small boulders: 1%/0% Image 4 cobbles/small boulders/large boulder/bedrock: 0%/0%/80%/20% Image 5 cobbles/small boulders/large boulder/bedrock: 20%/20%/40%/20%</p> <p>Average cobbles and boulders = 38%</p>	<p>Elevation: Cobbles/boulders are on the muddy sand and not embedded within the sediment. Some have a thin overlying sandy veneer.</p> <p>Faunal community: The cobble/boulder areas have a distinctly different associated fauna to the surrounding area, consisting of dense brittlestars (<i>Ophiothrix fragilis</i>), anemones and a crustose faunal community on the boulders.</p> <p>The muddy sand areas are associated with scattered sea pens (<i>Pennatula phosphorea</i>), soft worm tubes, burrows and a few scattered <i>Alcyonium digitatum</i>.</p>	<p><i>Ophiothrix fragilis</i> <i>Pomatoceros</i> sp. Anthozoa sp. <i>Munida</i> sp. <i>Asterias rubens</i> <i>Pennatula phosphorea</i> <i>Alcyonium digitatum</i> <i>Urticina</i> sp. <i>Pomatoceros</i> sp. <i>Bolocera tuediae</i> <i>Setularia</i> sp. <i>Nephrops norvegicus</i> <i>Pagurus bernhardus</i> <i>Flustra foliacea</i> <i>Ophiura albida</i> <i>Abietinaria abietina</i> <i>Echinus esculentus</i> <i>Cahetopterus variepedatus</i> tubes Cirripedia</p>

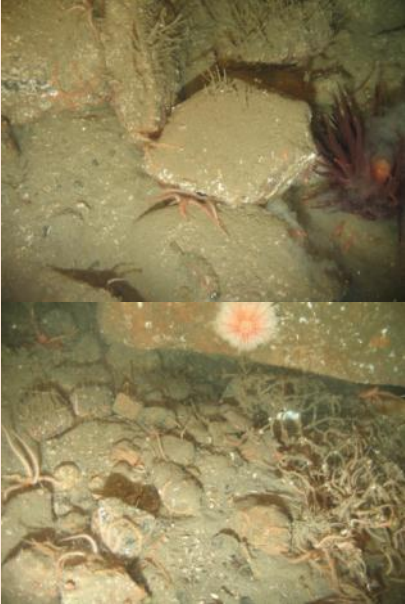
Site	General overall site description	Description of cobble and boulder component	Conspicuous species	Representative Photographs
VP3	<p>Video footage review: Patchy cobble/boulder area. Between the dense cobble/boulder areas, gravelly, pebbly, muddy sand is present.</p> <p>Video Image 1 cobbles/small boulders: 0%/0% Video Image 2 cobbles/small boulders: 35%/0% Video Image 3 cobbles/small boulders: 65%/15% Video Image 4 cobbles/small boulders: 0%/5% Video Image 5 cobbles/small boulders: 5%/20% Video Image 6 cobbles/small boulders: 5%/25% Video Image 7 cobbles/small boulders: 50%/0% Video Image 8 cobbles/small boulders: 5%/80% Video Image 9 cobbles/small boulders: 80%/0% Video Image 10 cobbles/small boulders: 90%/0% Video Image 11 cobbles/small boulders: 0%/0% Video Image 12 cobbles/small boulders: 50%/0%</p> <p>Static image review: Image 1 cobbles/small boulders: 0%/0% Image 2 cobbles/small boulders/large boulders: 63%/0%/20% Image 3 cobbles/small boulders: 91%/0% Image 4 cobbles/small boulders: 45%/20% Image 5 cobbles/small boulders: 60%/0%</p> <p>Average cobbles/boulders = 49%</p>	<p>Elevation: Cobbles and boulders are on the gravelly muddy sand rather than embedded within, and also on top of other cobbles.</p> <p>Veneer of sediment overlying many of the cobbles/boulders.</p> <p>Faunal community: Patches of dense <i>Ophiothrix fragilis</i> observed over the soft sediment and dense cobble/boulder areas.</p> <p><i>Echinus esculentus</i>, Hydroid/bryozoan turf, squat lobsters (<i>Munida</i> sp.) and a crustose faunal community observed associated with many of the dense cobble/boulder areas.</p>	<p><i>Urticina</i> sp. <i>Alcyonium digitatum</i> Hydroid/bryozoan turf <i>Munida</i> sp. <i>Ophiothrix fragilis</i> <i>Echinus esculentus</i> <i>Asterias rubens</i> <i>Bolocera tuediae</i> <i>Nephrops norvegicus</i> Paguroidea <i>Pomatoceros</i> sp. Bryozoan crust Cirripedia Porifera Caridea <i>Zeugopterus</i> sp. Nudibranch Pectinacea ?<i>Rhizocaulus</i> sp. <i>Chaetopterus variepedatus</i> tubes</p>

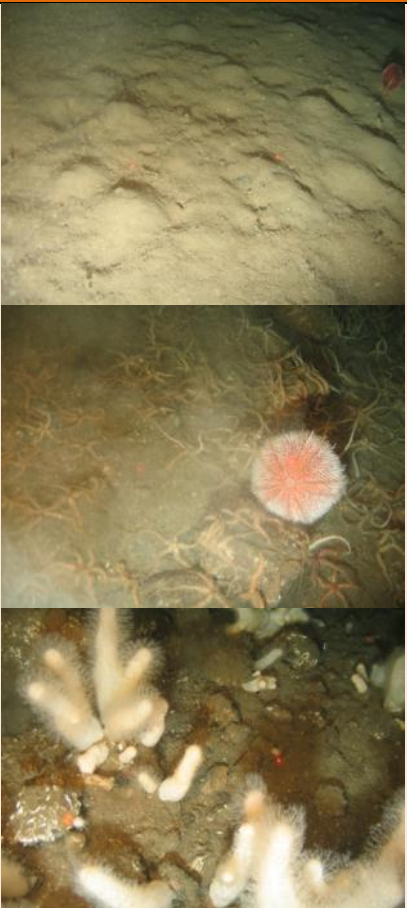
Site	General overall site description	Description of cobble and boulder component	Conspicuous species	Representative Photographs
VP4 (VT1)	<p>Video footage review: The sediment coarseness varies greatly along the transect. Initially the substrate comprises muddy sand, which then coarsens into shelly, gravelly, pebbly muddy sand with scattered cobbles embedded in the sediment. Next, a continuous long stretch of dense cobbles/small boulders with scattered large boulders is present, followed by another area of coarse sediment before reverting back to muddy sand.</p> <p>Video Image 1 cobbles/small boulders: 25%/0% Video Image 2 cobbles/small boulders: 60%/0% Video Image 3 cobbles/small boulders: 50%/20% Video Image 4 cobbles/small boulders: 40%/50% Video Image 5 cobbles/small boulders: 75%/10% Video Image 6 cobbles/small boulders: 0%/0% Video Image 7 cobbles/small boulders: 0%/0% Video Image 8 cobbles/small boulders: 15%/0%</p> <p>Static image review: Image 1 cobbles/small boulders: 0%/0% Image 2 cobbles/small boulders: 0%/0% Image 3 cobbles/small boulders: 63%/10% Image 4 cobbles/small boulders: 76%/0% Image 5 cobbles/small boulders: 68%/0% Image 6 cobbles/small boulders: 0%/0%</p> <p>Average cobbles and boulders = 40%</p>	<p>Elevation: Some cobbles/boulders are embedded within the sediment, others are on the sediment and many are covered with a veneer of sediment.</p> <p>Faunal community: Sea pens (<i>Pennatula phosphorea</i>), soft worm tubes and burrows were observed within the muddy sand areas.</p> <p>Dense brittlestars (<i>Ophiothrix fragilis</i>) occurred within the dense cobble/boulder area, together with occasional <i>Echinus esculentus</i>, <i>Bolocera tuediae</i>, <i>Alcyonium digitatum</i>, Bryozoan/Hydrozoan turf and, in places, a crustose faunal community.</p> <p>Abundant <i>Alcyonium digitatum</i> were present on cobbles at the end of the dense cobble/boulder area and on the coarse sediment following this.</p>	<p><i>Pennatula phosphorea</i> <i>Echinus esculentus</i> <i>Bolocera tuediae</i> <i>Alcyonium digitatum</i> <i>Ophiothrix fragilis</i> <i>Pecten maximus</i> Paguroidea Hydroid/bryozoan turf Galatheididae <i>Caridea</i> Pectinacea Cirripedia <i>Pomatoceros</i> sp. <i>Asciadiella scabra</i> Bryozoan crust</p>

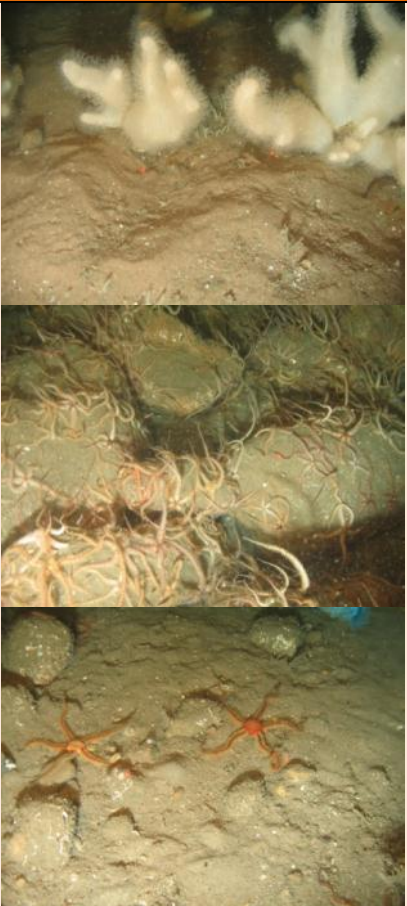
Site	General overall site description	Description of cobble and boulder component	Conspicuous species	Representative Photographs
VP5 (VT2)	<p>Video footage review: Initially, shelly, gravelly, muddy sand with scattered cobbles. Then, a small dense cobble/boulder patch is present, becoming less dense towards the end of the transect.</p> <p>Video Image 1 cobbles/small boulders: 5%/0% Video Image 2 cobbles/small boulders: 15%/0% Video Image 3 cobbles/small boulders: 0%/0% Video Image 4 cobbles/small boulders: 0%/0% Video Image 5 cobbles/large boulders: 0%/20% Video Image 6 cobbles/small boulders: 55%/25% Video Image 7 cobbles/small boulders: 70%/30% Video image 8 cobbles/small boulders: 40%/60% Video Image 9 cobbles/small boulders: 10%/0%</p> <p>Static image review: Image 1 cobbles/small boulders: 2%/0% Image 2 cobbles/small boulders: 4%/0% Image 3 cobbles/small boulders: 10%/0% Image 4 cobbles/small boulders: 67%/30% Image 5 cobbles/small boulders: 6%/0% Image 6 cobbles/small boulders: 20%/0%</p> <p>Average cobbles and boulders = 31%</p>	<p>Elevation: Cobbles and boulders are on the gravelly muddy sand rather than embedded within. Some have a thin veneer of overlying sediment. The cobble/boulder area is distinctly different to the proceeding substrate.</p> <p>Faunal community: Scattered <i>Alcyonium digitatum</i> are associated with scattered cobbles on the gravelly, muddy sand.</p> <p>Dense cobble/boulder area covered in abundant brittlestars (<i>Ophiothrix fragilis</i>) whose quantities reduce when the cobbles/boulders become less dense.</p>	<p><i>Alcyonium digitatum</i> <i>Ophiothrix fragilis</i> Paguroidea Hydroid/bryozoan turf <i>Crossaster papposus</i> <i>Pomatoceros</i> sp. <i>Ciocalypta penicillus</i> <i>Asterias rubens</i> Bryozoan crust <i>Munida</i> sp. <i>Nemertesia antennina</i></p>

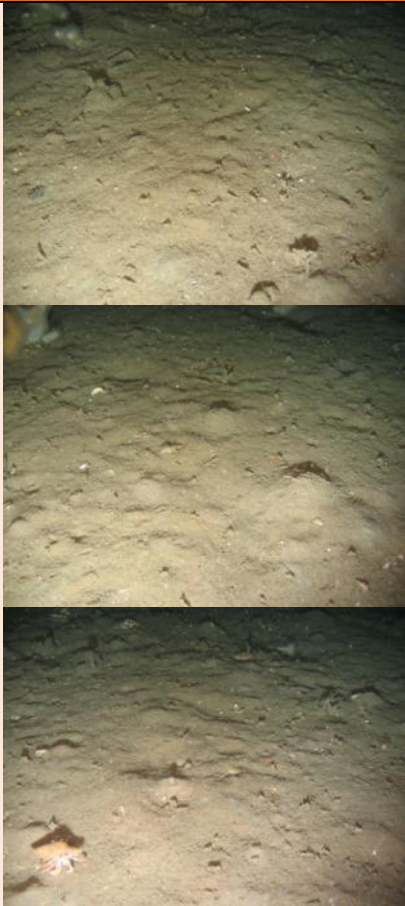
Site	General overall site description	Description of cobble and boulder component	Conspicuous species	Representative Photographs
VP6 (VT3)	<p>Video footage review: Lots of mounds formed from coarse sediment covered in a layer of sand, also scattered cobbles (not covered). Later on in the transect rippled sand can be seen.</p> <p>Video Image 1 cobbles: 2% Video Image 2 cobbles: 0% Video Image 3 cobbles: 5% Video Image 4 cobbles/large boulder: 10%/ 50% Video Image 5 cobbles: 0%</p> <p>Static image review: Image 1 cobbles: 0% Image 2 cobbles: 0% Image 3 cobbles: 0% Image 4 cobbles: 0% Image 5 cobbles: 0%</p> <p>Average cobbles and boulders = 7%</p>	<p>Elevation Lots of mounds (made up of coarser sediment covered in a veneer of sand), also a few scattered cobbles were found in the earlier part of the transect.</p> <p>Faunal community Lots of fish scattered throughout the transect; flatfish, gobies and possibly Callionymidae.</p> <p><i>Alcyonium digitatum</i>, sometimes attached to cobbles. Soft polychaete tubes also present in the sediment.</p>	<p>Paguridae Pisces (flatfish, gobies and possibly dragonets) Hydroid/Bryozoan turf <i>Bolocera tuediae</i> <i>Urticina</i> sp. <i>Flustra foliacea</i> <i>Callionymus lyra</i> <i>Ophiura</i> sp. Gurnard <i>Asterias rubens</i> <i>Pennatula phosphorea</i></p>

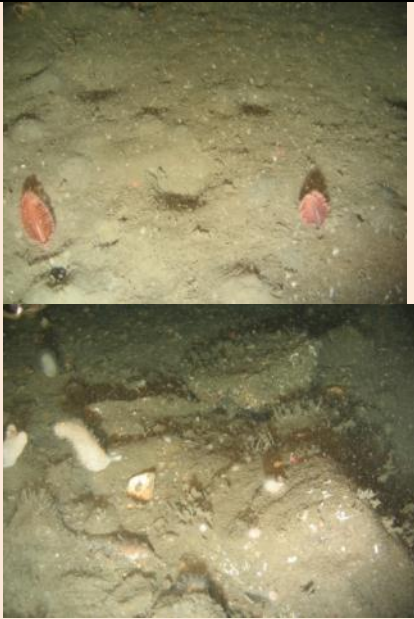
Site	General overall site description	Description of cobble and boulder component	Conspicuous species	Representative Photographs
VCT4	<p>Video footage review: Largely muddy sand with burrows with varying proportions of gravel, shell and pebbles. Along the transect are patches of cobbles and small boulders. Areas of coarser substrate are present along transect with occasional cobbles.</p> <p>Video image 1 cobbles/small boulders: 0%/0% Video image 2 cobbles/small boulders: 0%/0% Video image 3 cobbles/small boulders: 20%/30% Video image 4 cobbles/small boulders: 0%/0% Video image 5 cobbles/small boulders: 0%/0% Video image 6 cobbles/small boulders: 20%/40% Video image 7 cobbles/small boulders: 0%/0% Video image 8 cobbles/small boulders: 0%/0% Video image 9 cobbles/small boulders: 0%/0% Video image 10 cobbles/small boulders: 0%/0%</p> <p>Static image review: Image 1 cobbles/small boulders 0%/0% Image 2 cobbles/small boulders 0%/0% Image 3 cobbles/small boulders 10%/25% Image 4 cobbles/small boulders 0%/0% Image 5 cobbles/small boulders 30%/10% Image 6 cobbles/small boulders 0%/0%</p> <p>Average cobbles and boulders = 11%</p>	<p>Elevation A few scattered boulders and cobbles but largely covered in a veneer of sediment.</p> <p>Faunal community <i>Alcyonium digitatum</i> abundance is distinctly increased at the areas of the transect where the substrate is coarser.</p> <p>The areas of muddy sand are populated by sea pens (<i>Pennatula phosphorea</i>) soft polychaete tubes, burrows and mounds. Along the transect there are patches of dense <i>Ophiothrix fragilis</i>.</p>	<p><i>Ophiothrix fragilis</i> <i>Pennatula phosphorea</i> <i>Alcyonium digitatum</i> Callionymidae Hydroid/bryozoan turf Bryozoan crust <i>Pomatoceros</i> sp. <i>Liocarcinus</i> sp. <i>Munida rugosa</i> <i>Asterias rubens</i> <i>Urticina</i> sp. <i>Abietinaria abietina</i> <i>Bolocera tuediae</i></p>

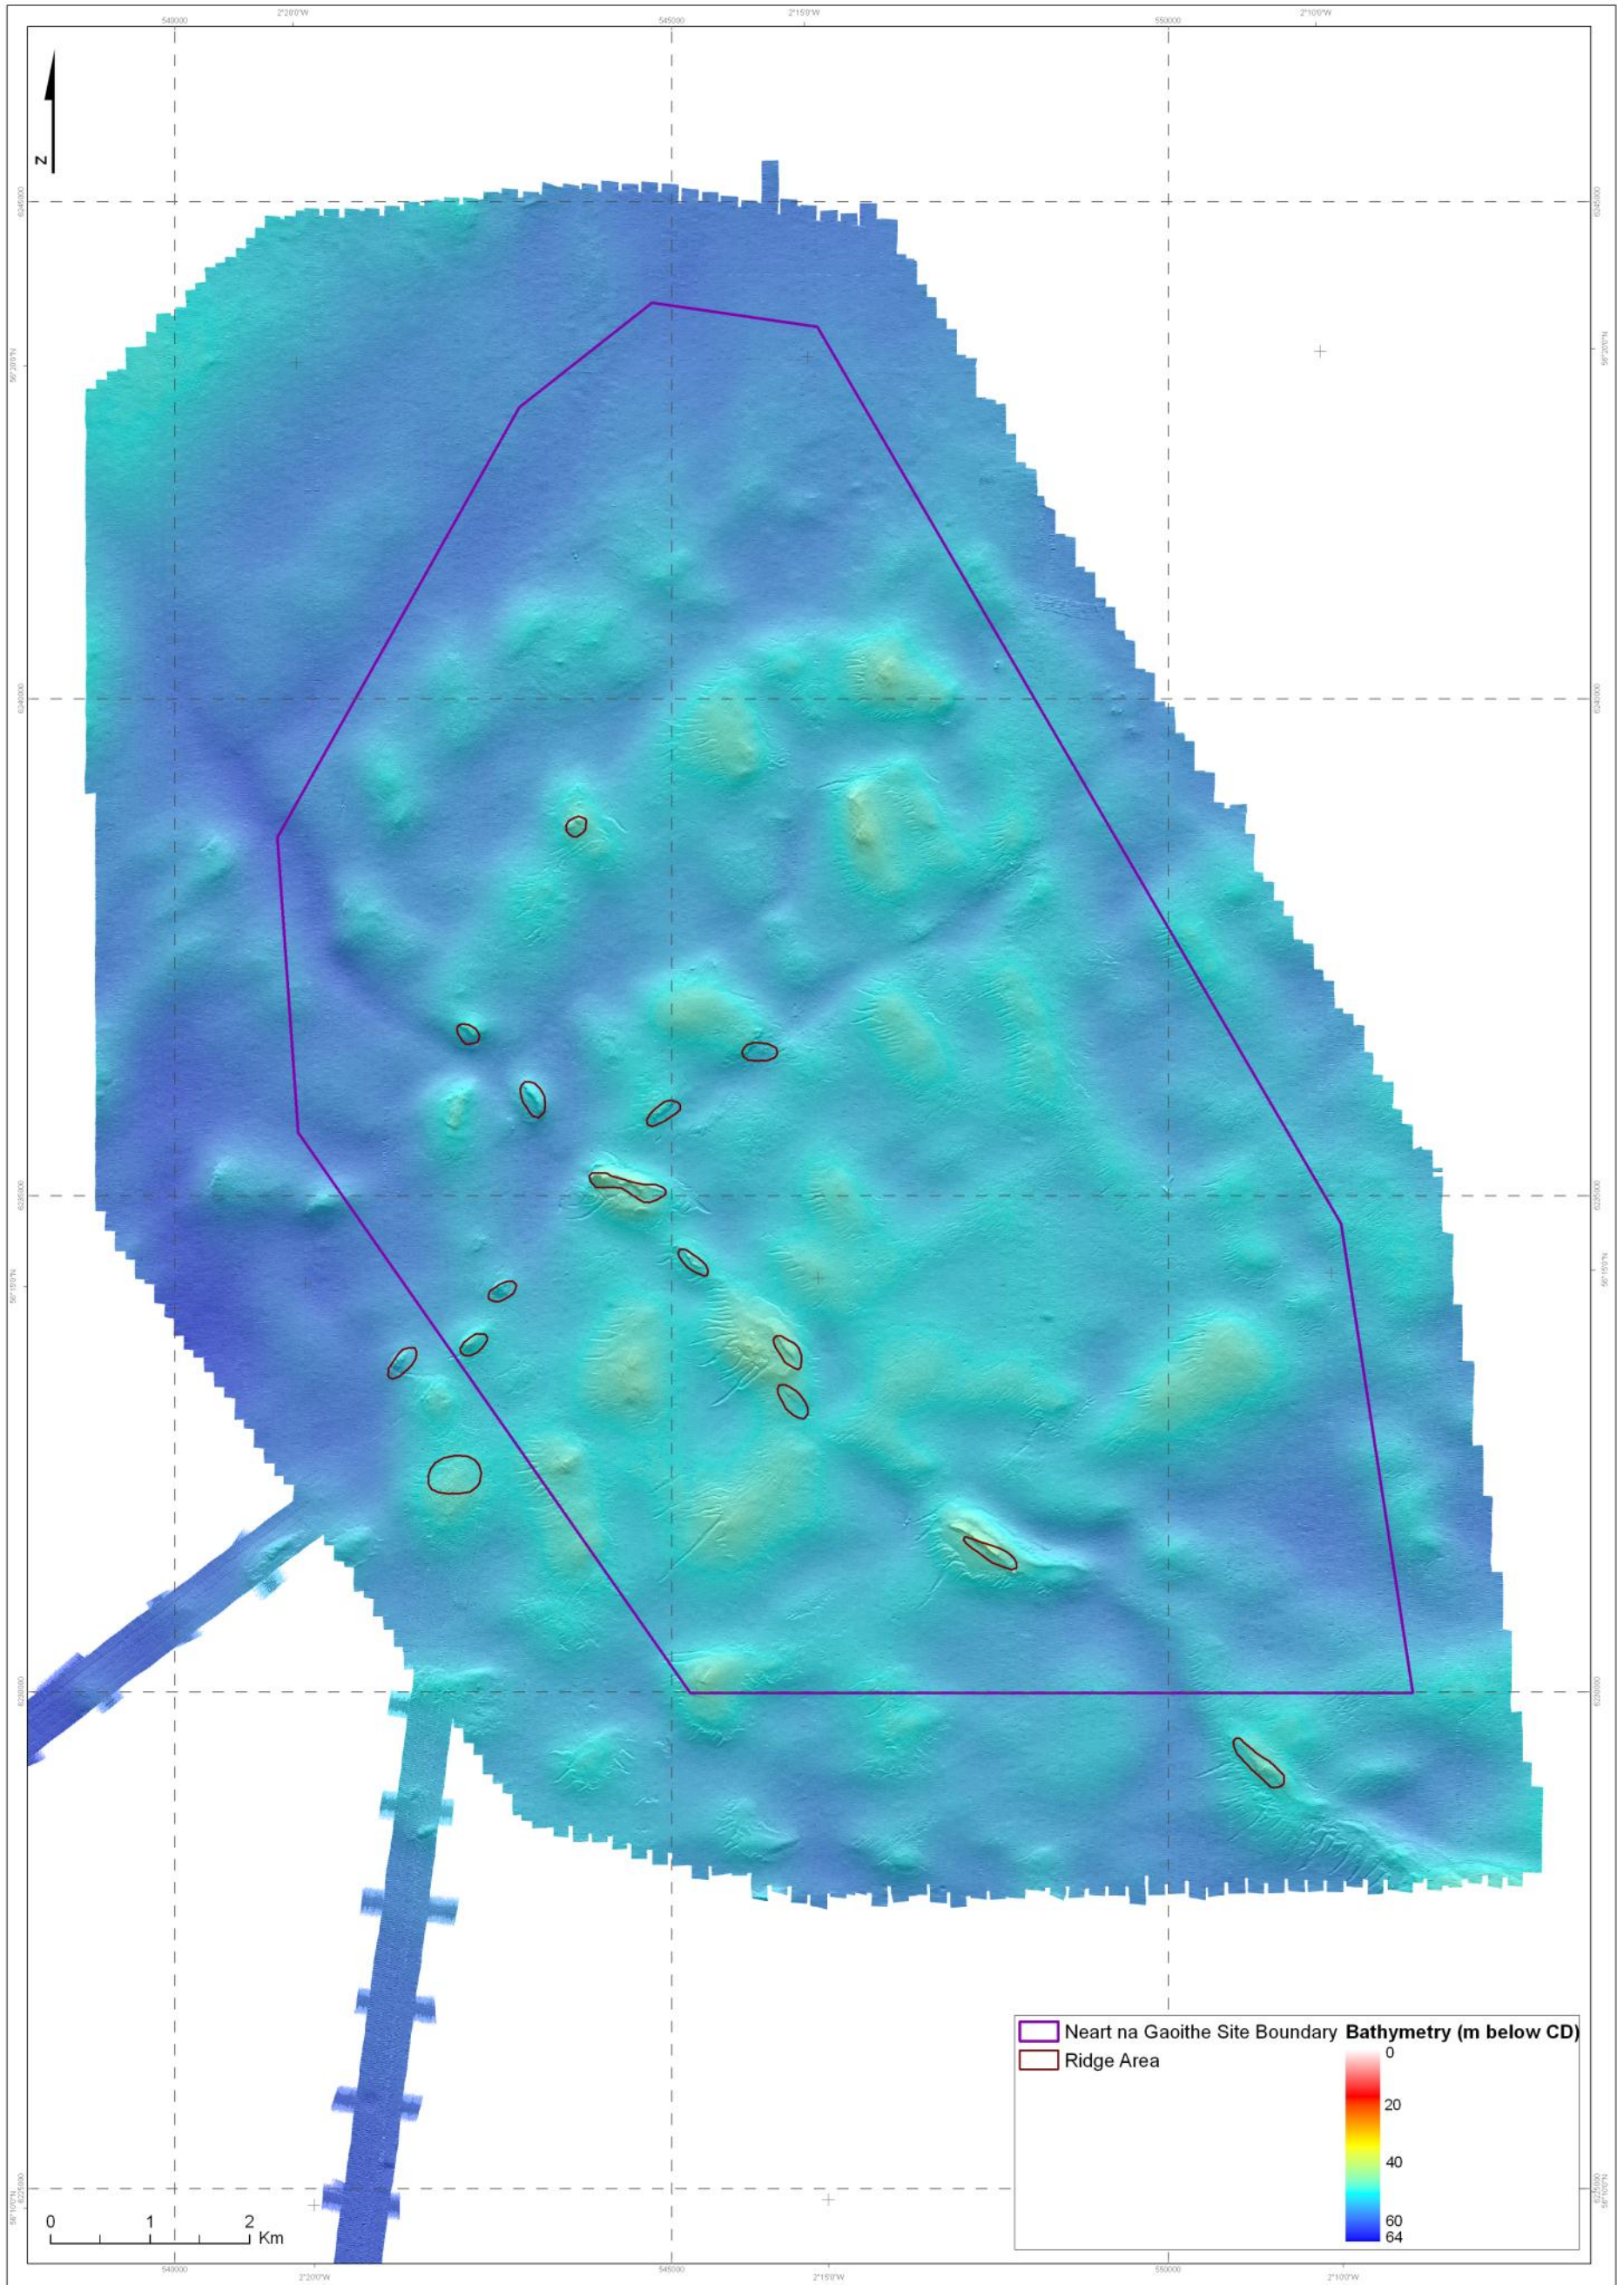
APPENDIX C: Mapping of Potential Annex I Stony Reef

From the GIS mapping presented in Appendix C, it can be determined that the total area of potential Annex I stony reef present with the boundaries of the development site is 0.953 km². The known extent of this habitat will be used to quantify the proportion predicted to be lost as a result of the placement of turbines on the seabed within the context of the total extent of habitat available at the appropriate geographical scale. Given the small footprint of wind turbines and associated infrastructure then only a very small amount of habitat is forecast to be lost as a result of the construction of the wind farm. At this stage, therefore, the impact of potential loss of coarse sediment habitats is considered to be of **minor significance** although the ES will refine assessments based on final design. Depending upon the material used, the placement of scour protection together with the turbine foundations themselves may mitigate for loss of stony reef habitat as a substrate for attachment of epibenthic communities.
