Scapa Deep Water Quay Environmental Impact Assessment Report:

SCAPA DEEP WATER QUAY EIAR

VOLUME 3

TECHNICAL APPENDIX 2

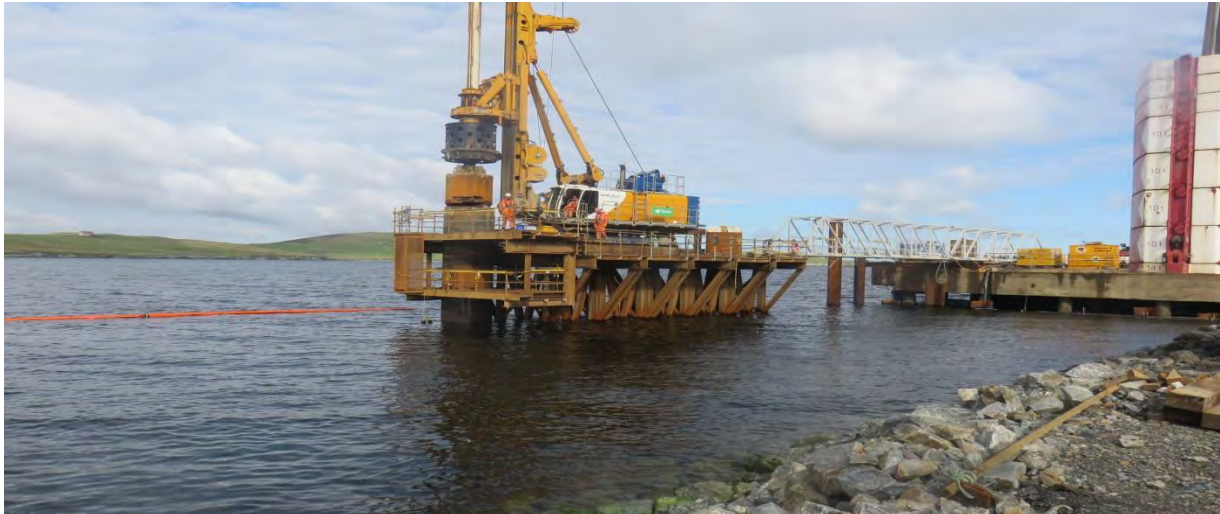
The anticipated tubular steel piles (approx. 2.1m dia.) for the quay wall require drilled rock sockets to provide suitable pile toe fixity below -15m CD dredge level. Bauer BG41 Drill rigs or similar will work over water from temporary piling platforms from the reclamation bund or a jack up barge with silt booms placed to seaward side.

Drill cuttings would be directed to temporary filter and silt beds on land with no discharge of cuttings to sea or watercourse. Tubular piles and sheet piles are expected to be vibro hammered to required depth (20 to 40 minutes /day) with no impact hammers anticipated at this stage. Piles will then be filled with tremie concrete.

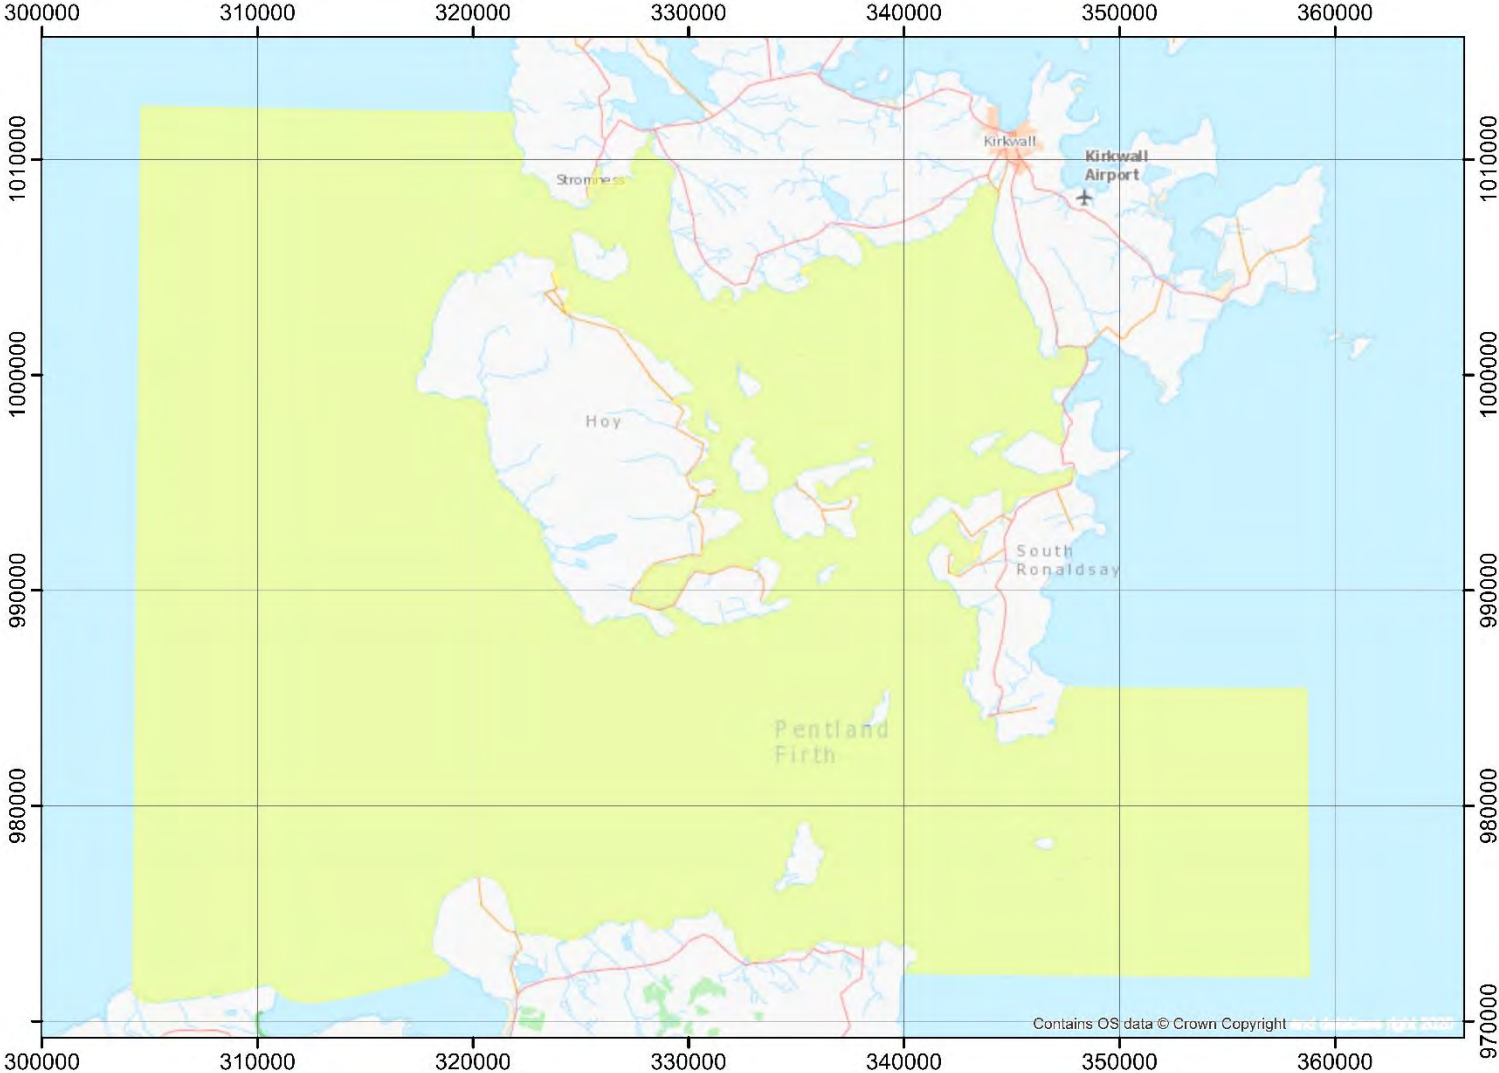
Figure 3-1: MIKE HD model extent (yellow polygon)

Initially the model extent included only the central channel of the Pentland Firth between Orkney and mainland Scotland. However, during the model validation process it was found that this did not sufficiently represent the complex inflow mechanisms into Scapa Flow through the Hoy Sound and the Sound of Hoxa. Expanding the model extents further to the west and east improved the accuracy of the model.

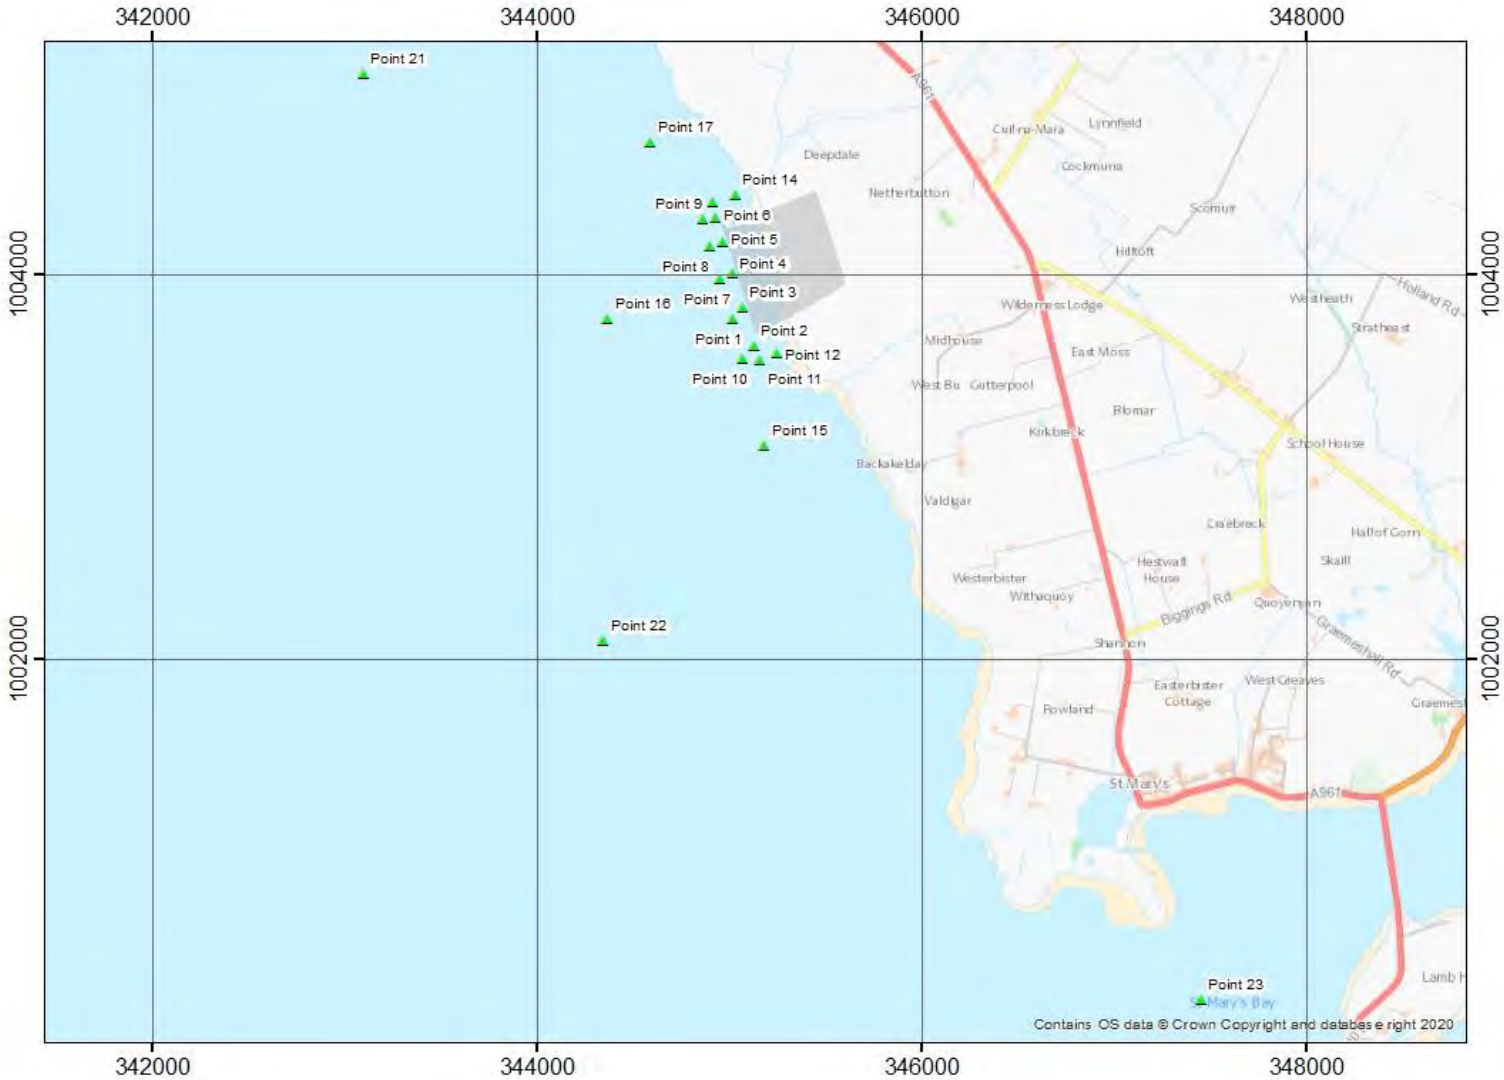
Figure 3-9: HD model point output locations

The area outputs are generated for the whole model extent, whilst point outputs have been generated at 20 identified locations within the model extent as detailed in Table 3-2. The locations of point outputs are situated within the immediate vicinity of Deepdale bay and the proposed development including the capital dredge pockets. Points are also situated out into the wider Scapa flow Area with a point at St Marys Bay to provide reference with Admiralty tide predictions. Point output locations are shown in Figure 3-9 and Figure 3-10.

A summary of the results from the existing (baseline) model run (FM HD 16) are presented in Section 4.1, whilst a summary of results from the post-development model run (FM HD 18) are presented in Section 4.2, along with comparative analysis versus the baseline model results. Appendix B contains tabulated model results under existing and post-development conditions for key tidal states, with relative change between both scenarios also tabulated. Appendix C contains graphical comparisons between existing and post-development results for the point output locations identified in Figure 3-9.

Tidal water surface elevation predictions relative to chart datum at point output locations 4 and 16 (see Figure 3-9) are presented in Figure 4-16 for the spring and neap tidal cycle. Review of these figures highlights that the same levels are predicted at both point output locations, as per the results for FM HD 16 under existing conditions.

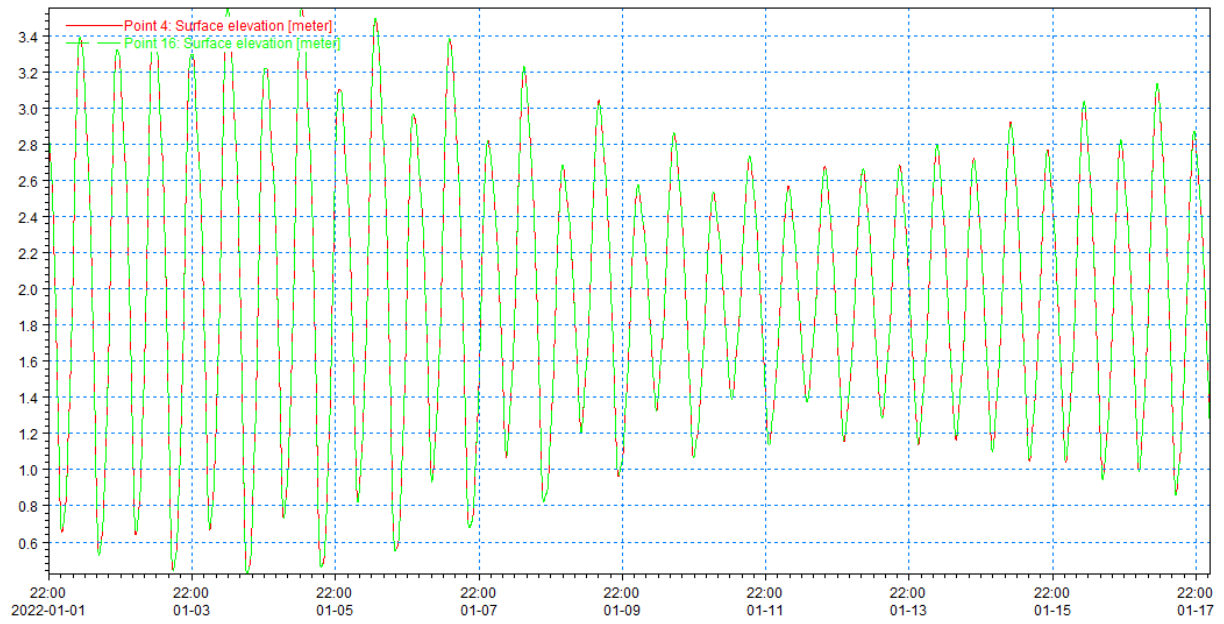
Figure 4-16: FM HD 19 water surface elevation predictions at points 4 and 16 for spring and neap tidal cycle

Figure 4-17 presents a comparison of the full model run tidal curves for existing (FM HD 16) and post-development (FM HD 19) conditions at point output location 4. This highlights that no significant change is observed in surface elevation predictions between the two model runs. Further comparative analysis presented in Table 2, Appendix B, and within figures in Appendix C, confirms this to be the case across the study area.

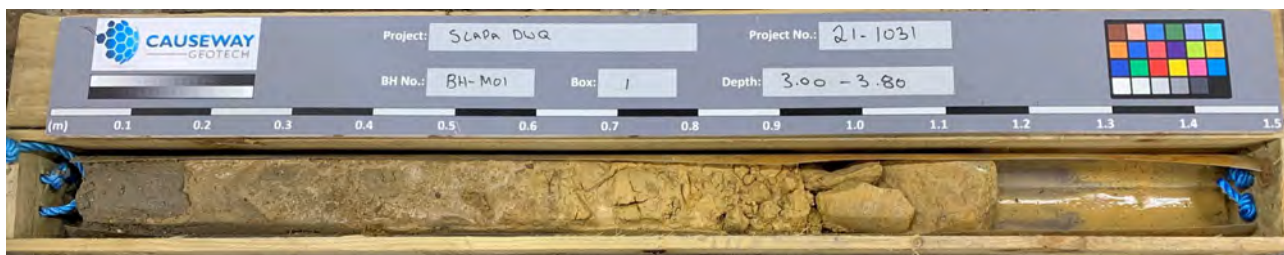
BH-M01 Box 1 3.00-3.80m

3.70	C1					(0.30)				
3.80	C2					3.70		Weak (locally medium strong) indistinctly thinly laminated fine grained light brownish orange and whitish grey SANDSTONE. Partially weathered: reduced strength and much closer fracture spacing. Discontinuities: 1. 0 to 20 degree joints closely spaced (50/110/250) planar, rough, unstained and clean. 2. 55 to 75 degree joints from 4.50m to 4.80m, 5.10m to 5.20m, 5.20m to 5.30m and 6.90m tom 7.00m, planar, rough, unstained and clean.

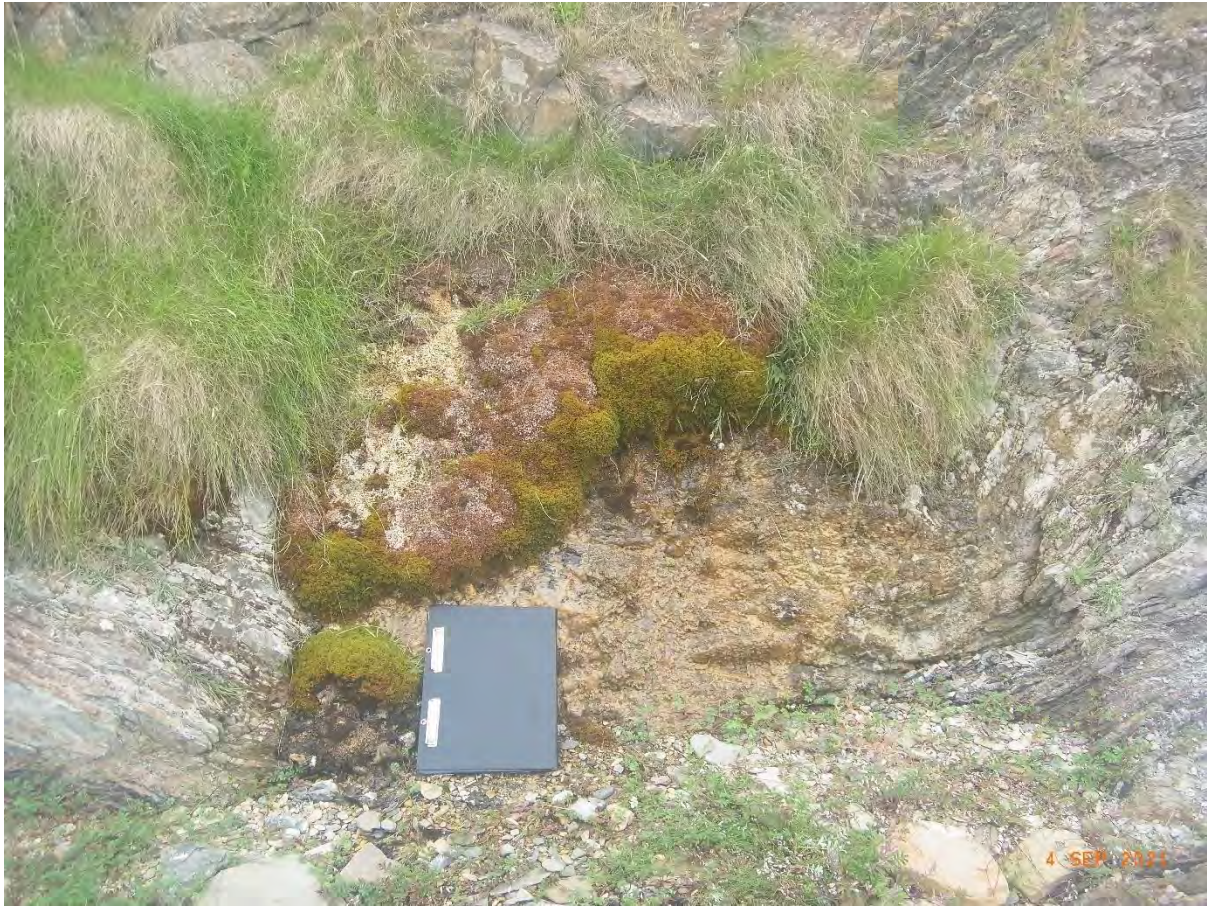
Figure 5. *Tufa-forming spring at the south end of the site; just above the shingle here.*

More than 20 tufa-forming springs or seepages arise directly from the cliffs or sea-banks, along the full length of the shore where the development is proposed, with an outlying location along the lower course of the burn. These are rather species-poor and variable in their amount of vegetation cover, but include characteristic mosses which can thrive in the calcareous water. No NVC category covers lowland springs of this type, but recent work in Ireland¹⁰ has proposed eight groupings, of which two appear to be present here. These are the Group 1 *Eucladium verticillatum-Pellia endiviifolia* Tufa cascades and Group 4 *Palustriella commutata-Agrostis stolonifera* Springheads. **Figure 5** shows one of these springs at the southern end of the site and four more examples from the centre and north of the site are shown in section **1.5**, Additional Photographs, below.

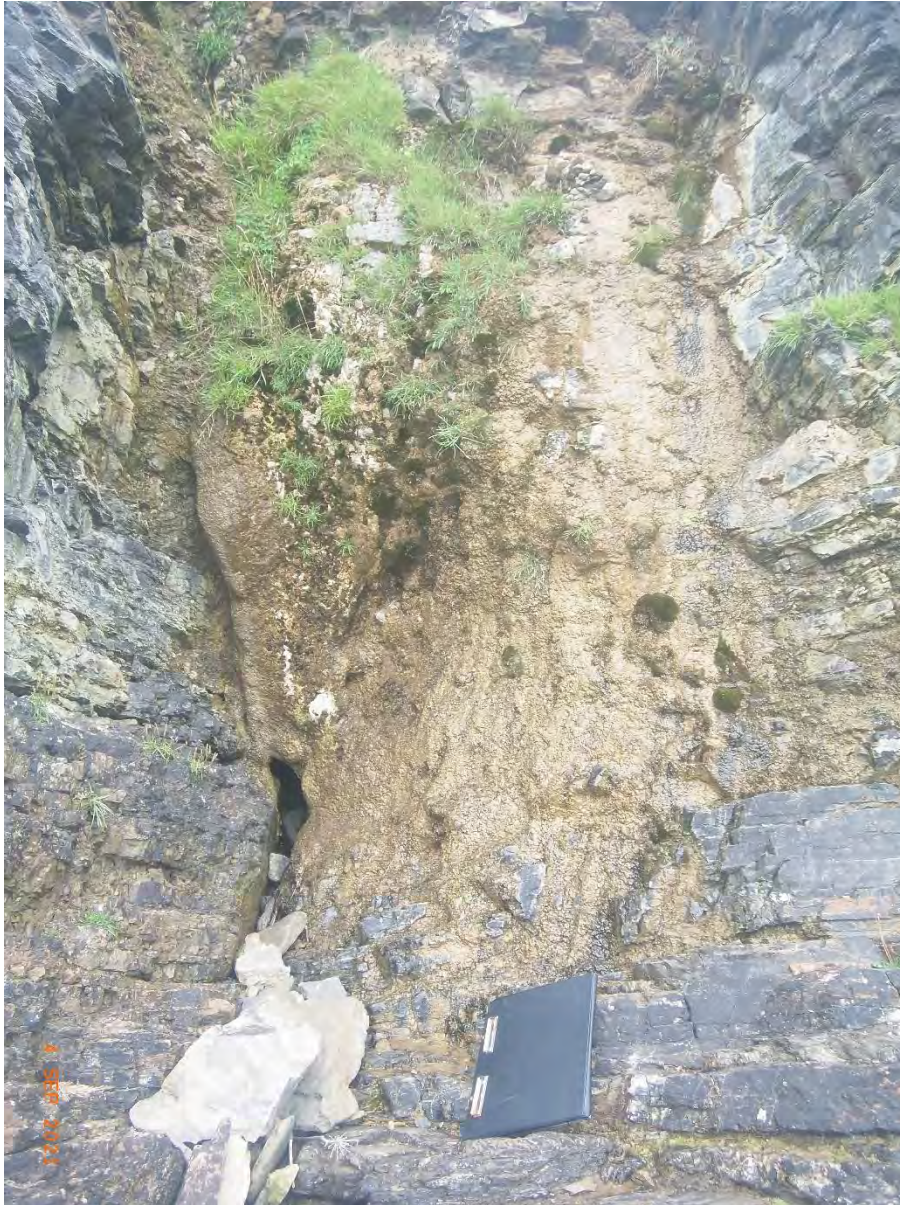
Figure 6. *Tufa cascade from the top part of the cliff, near the centre of the site. This example with low vegetation cover.*

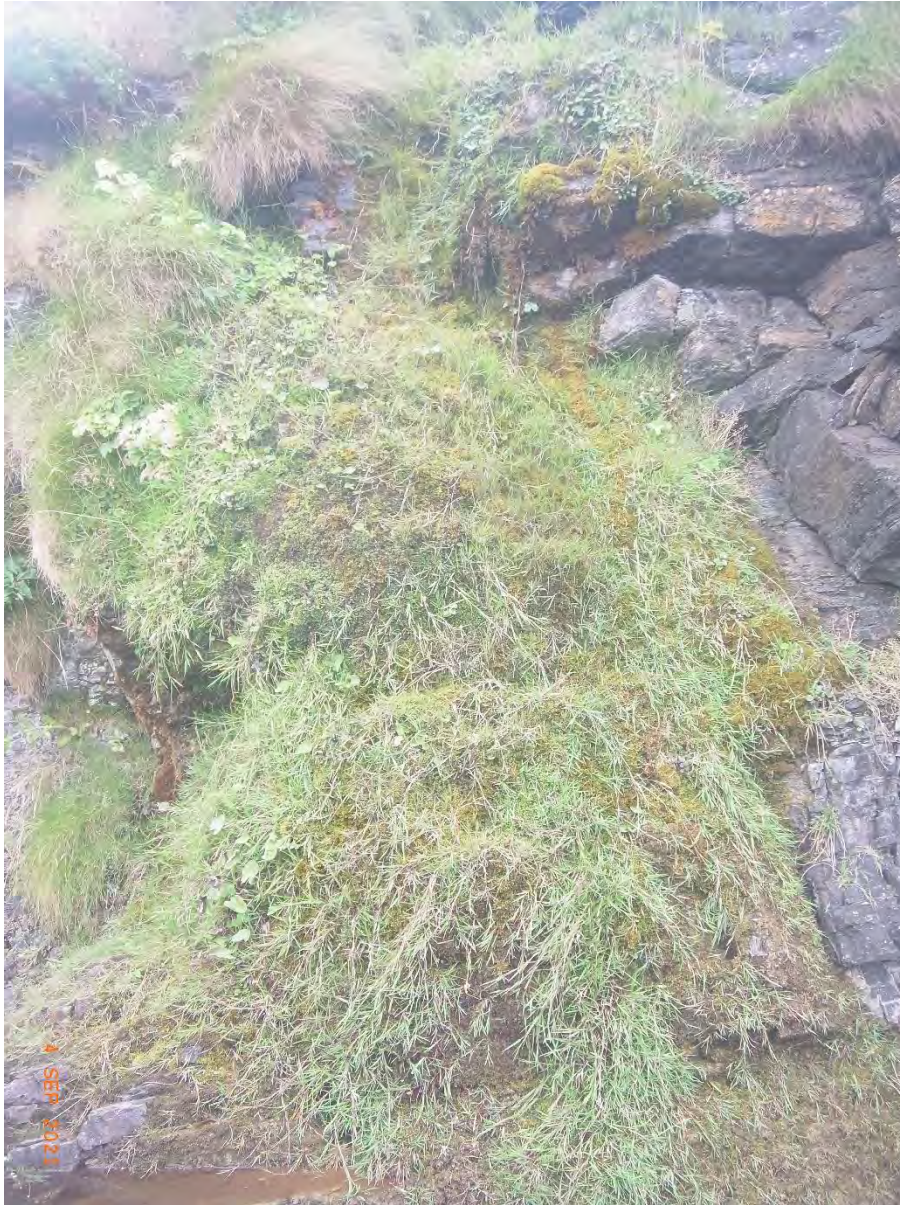
Figure 7. *Well-vegetated tufa spring near the centre of the site, with much Creeping Bent *Agrostis stolonifera*.*

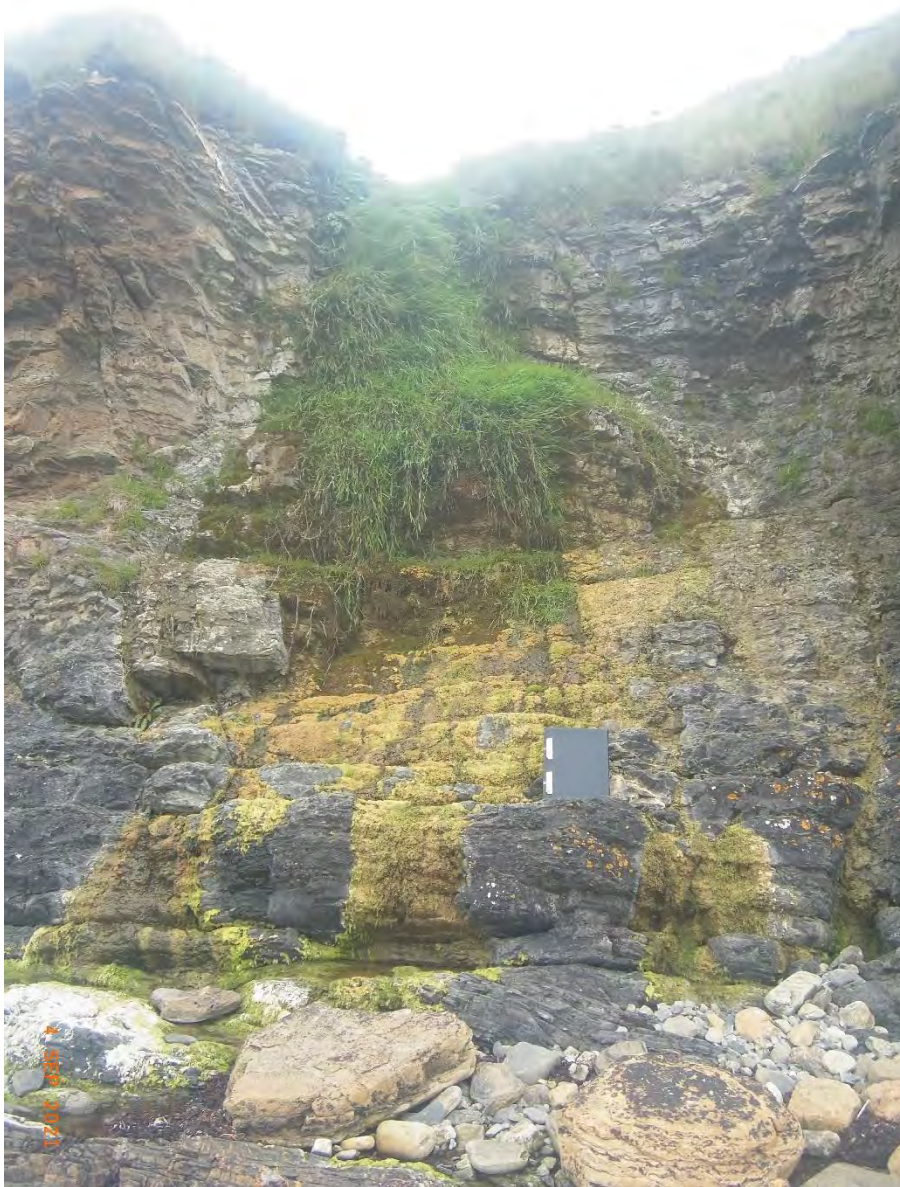
Figure 8. Tufa-forming spring with an algal layer on the rock beneath the mosses – possibly indicating nutrient enrichment.

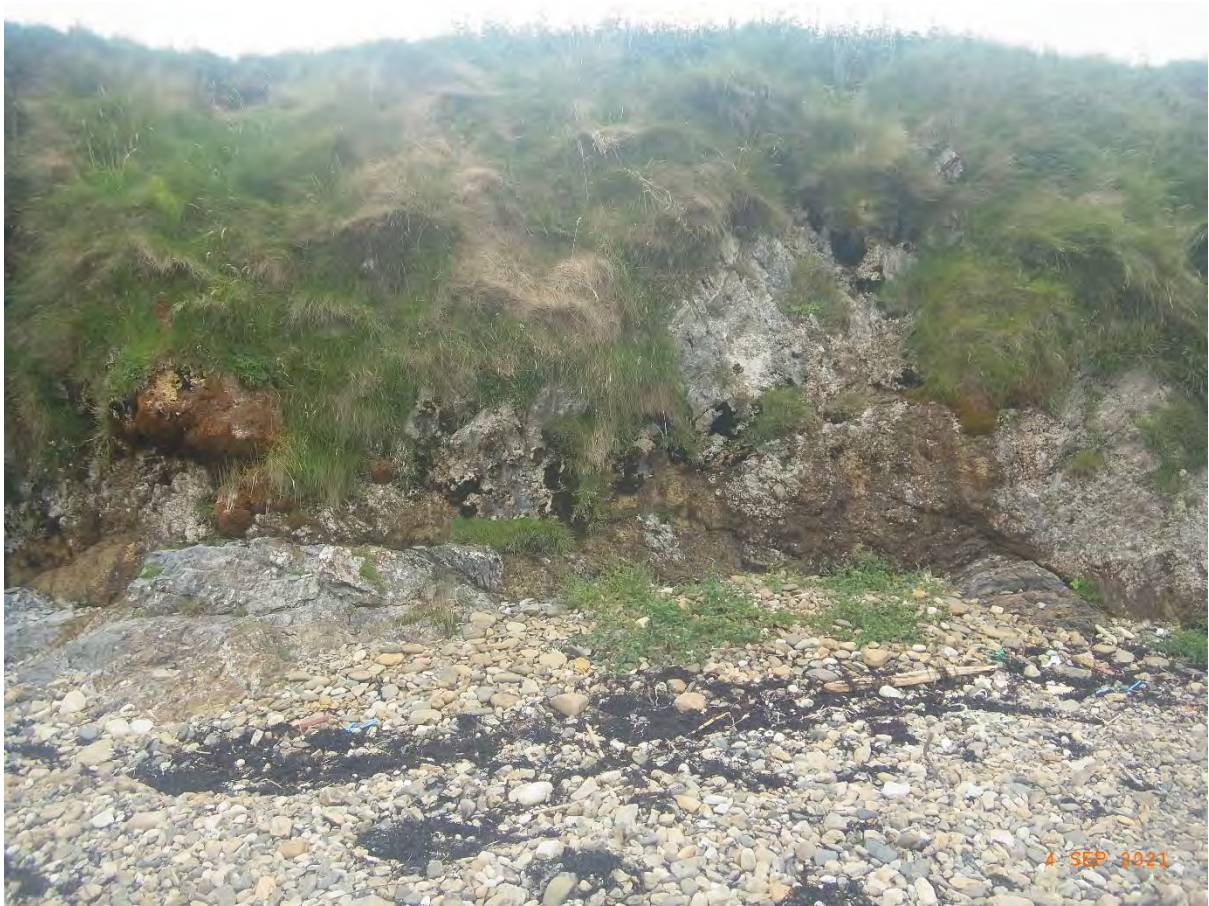
Figure 9. *Tufa-forming springs emerging at the base of the low sea-banks at the north end of the site; two moss cushions are visible below the edge of the grass at either side of the picture.*

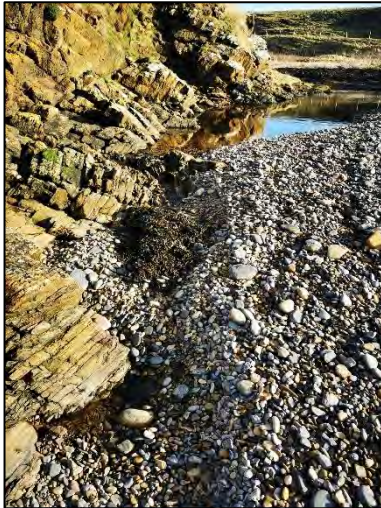
Photograph 1: Burn of Deepdale, with underground flow between watercourse mouth and sea during low tide in February 2023.

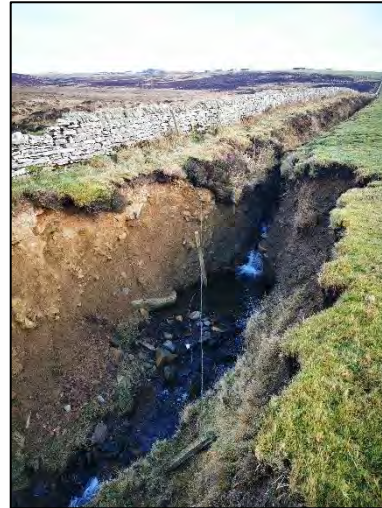
Photograph 2: Impassable fall in Burn of Button, approximately 15m upstream of confluence with Burn of Deepdale. Further upstream the burn is canalised, lacking suitable bed substrate for salmonid spawning and relatively shallow, with signs of agricultural enrichment, during low tide in February 2023.

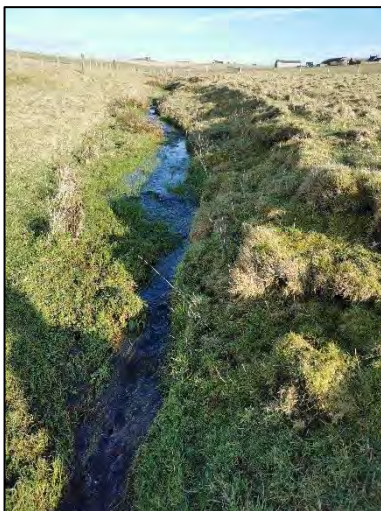
Photograph 3: Low water levels, lack of suitable bed substrate for salmonid spawning and exposed nature of Burn of Gangsta, with signs of agricultural enrichment, during low tide in February 2023.

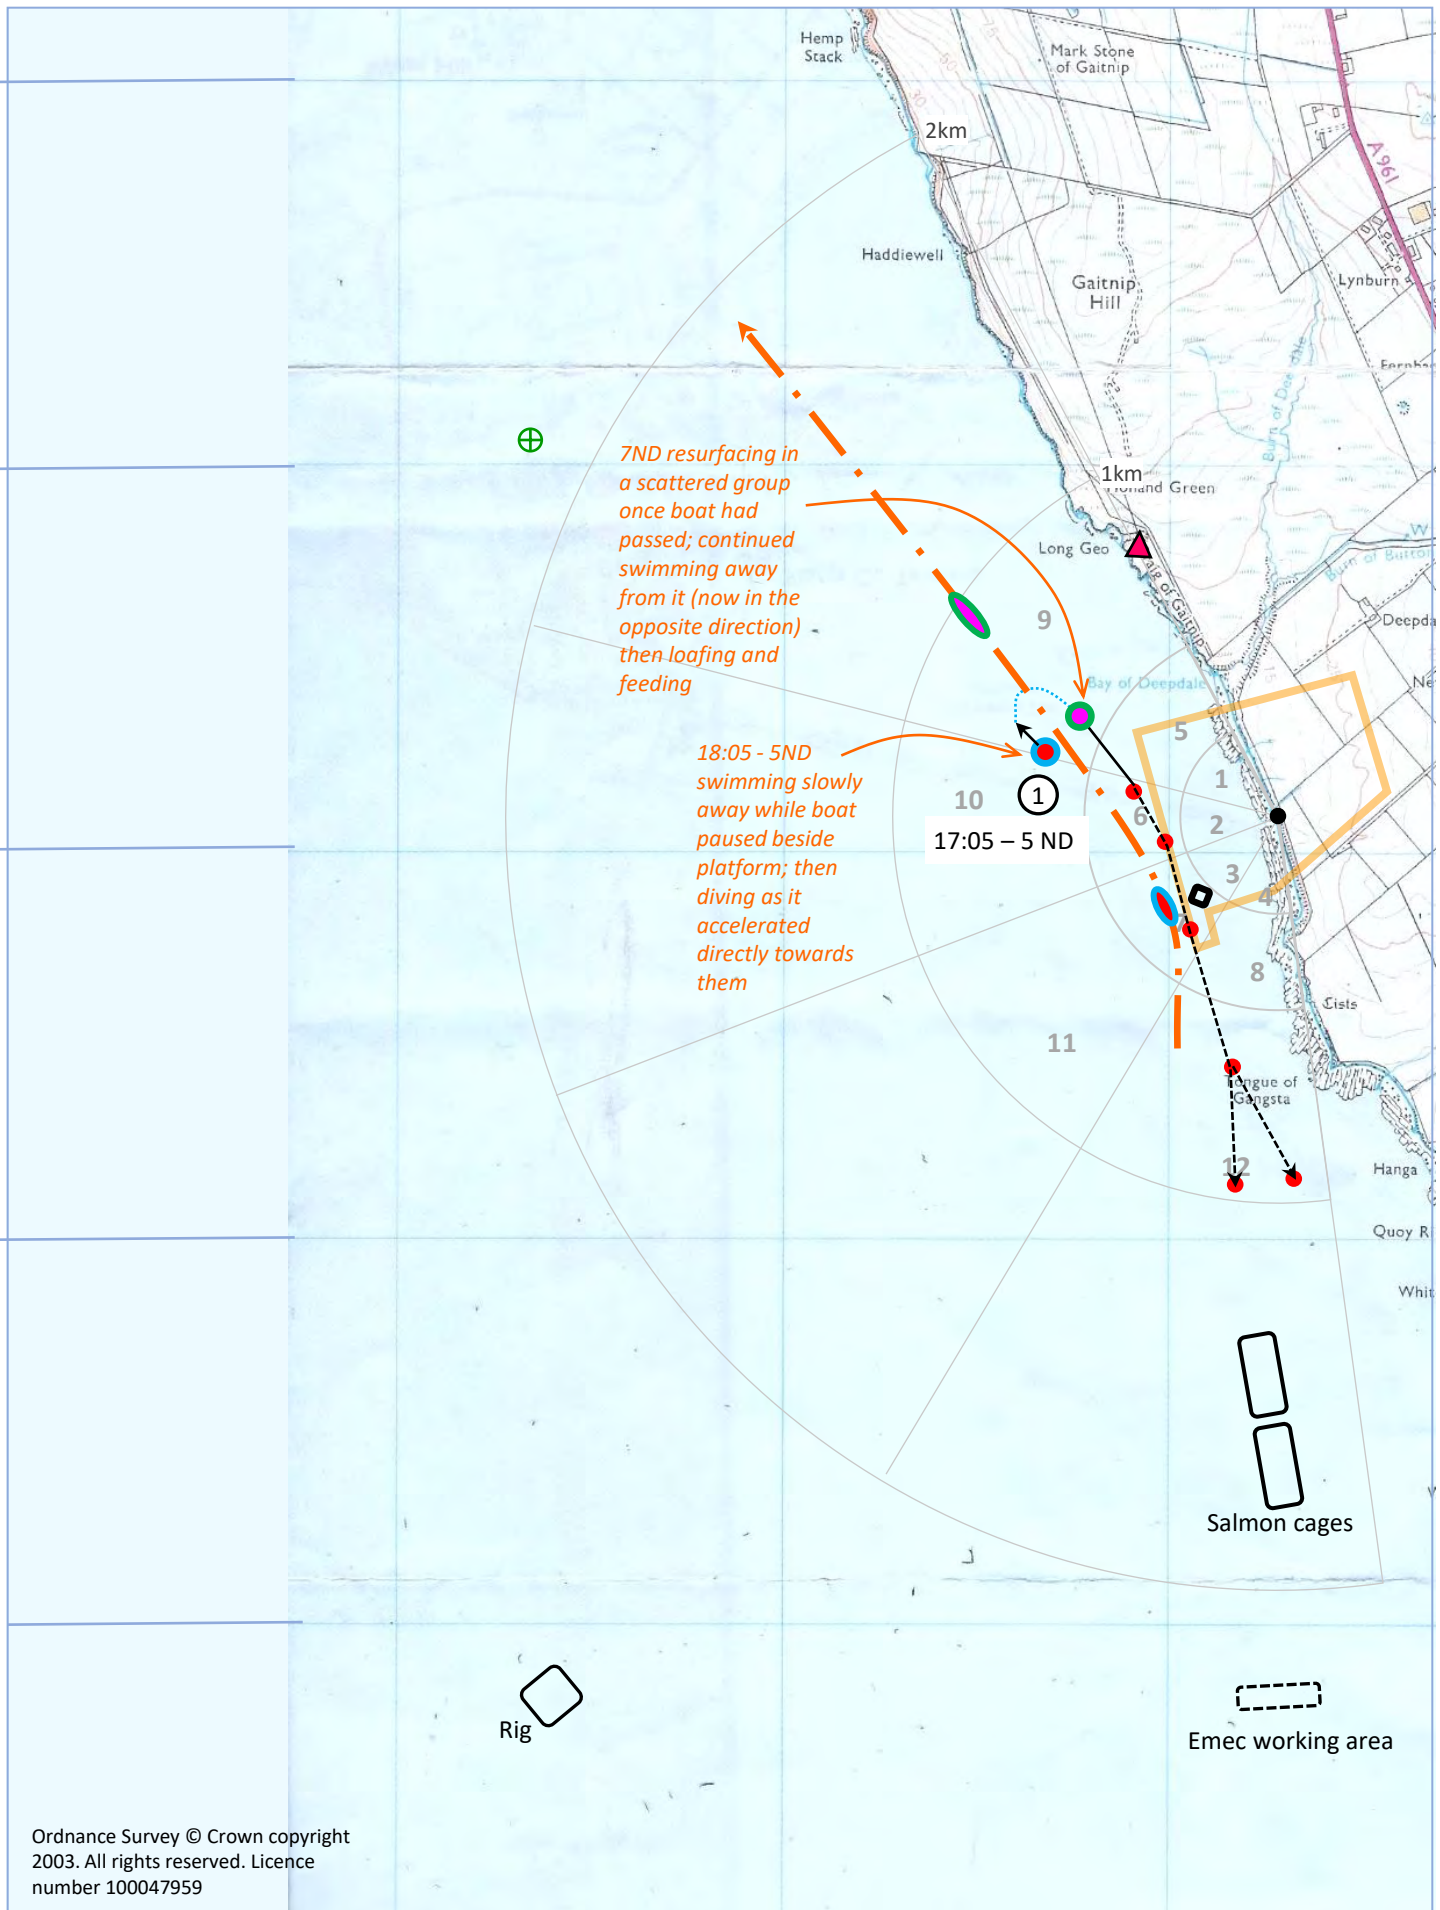
16th March 2022 – Great Northern Diver movement /boat interaction (1)

Circles represent locations at approximate 5-minute intervals). Dotted lines indicate where birds were missed at an interval(s), i.e. two or more intervals between dots.

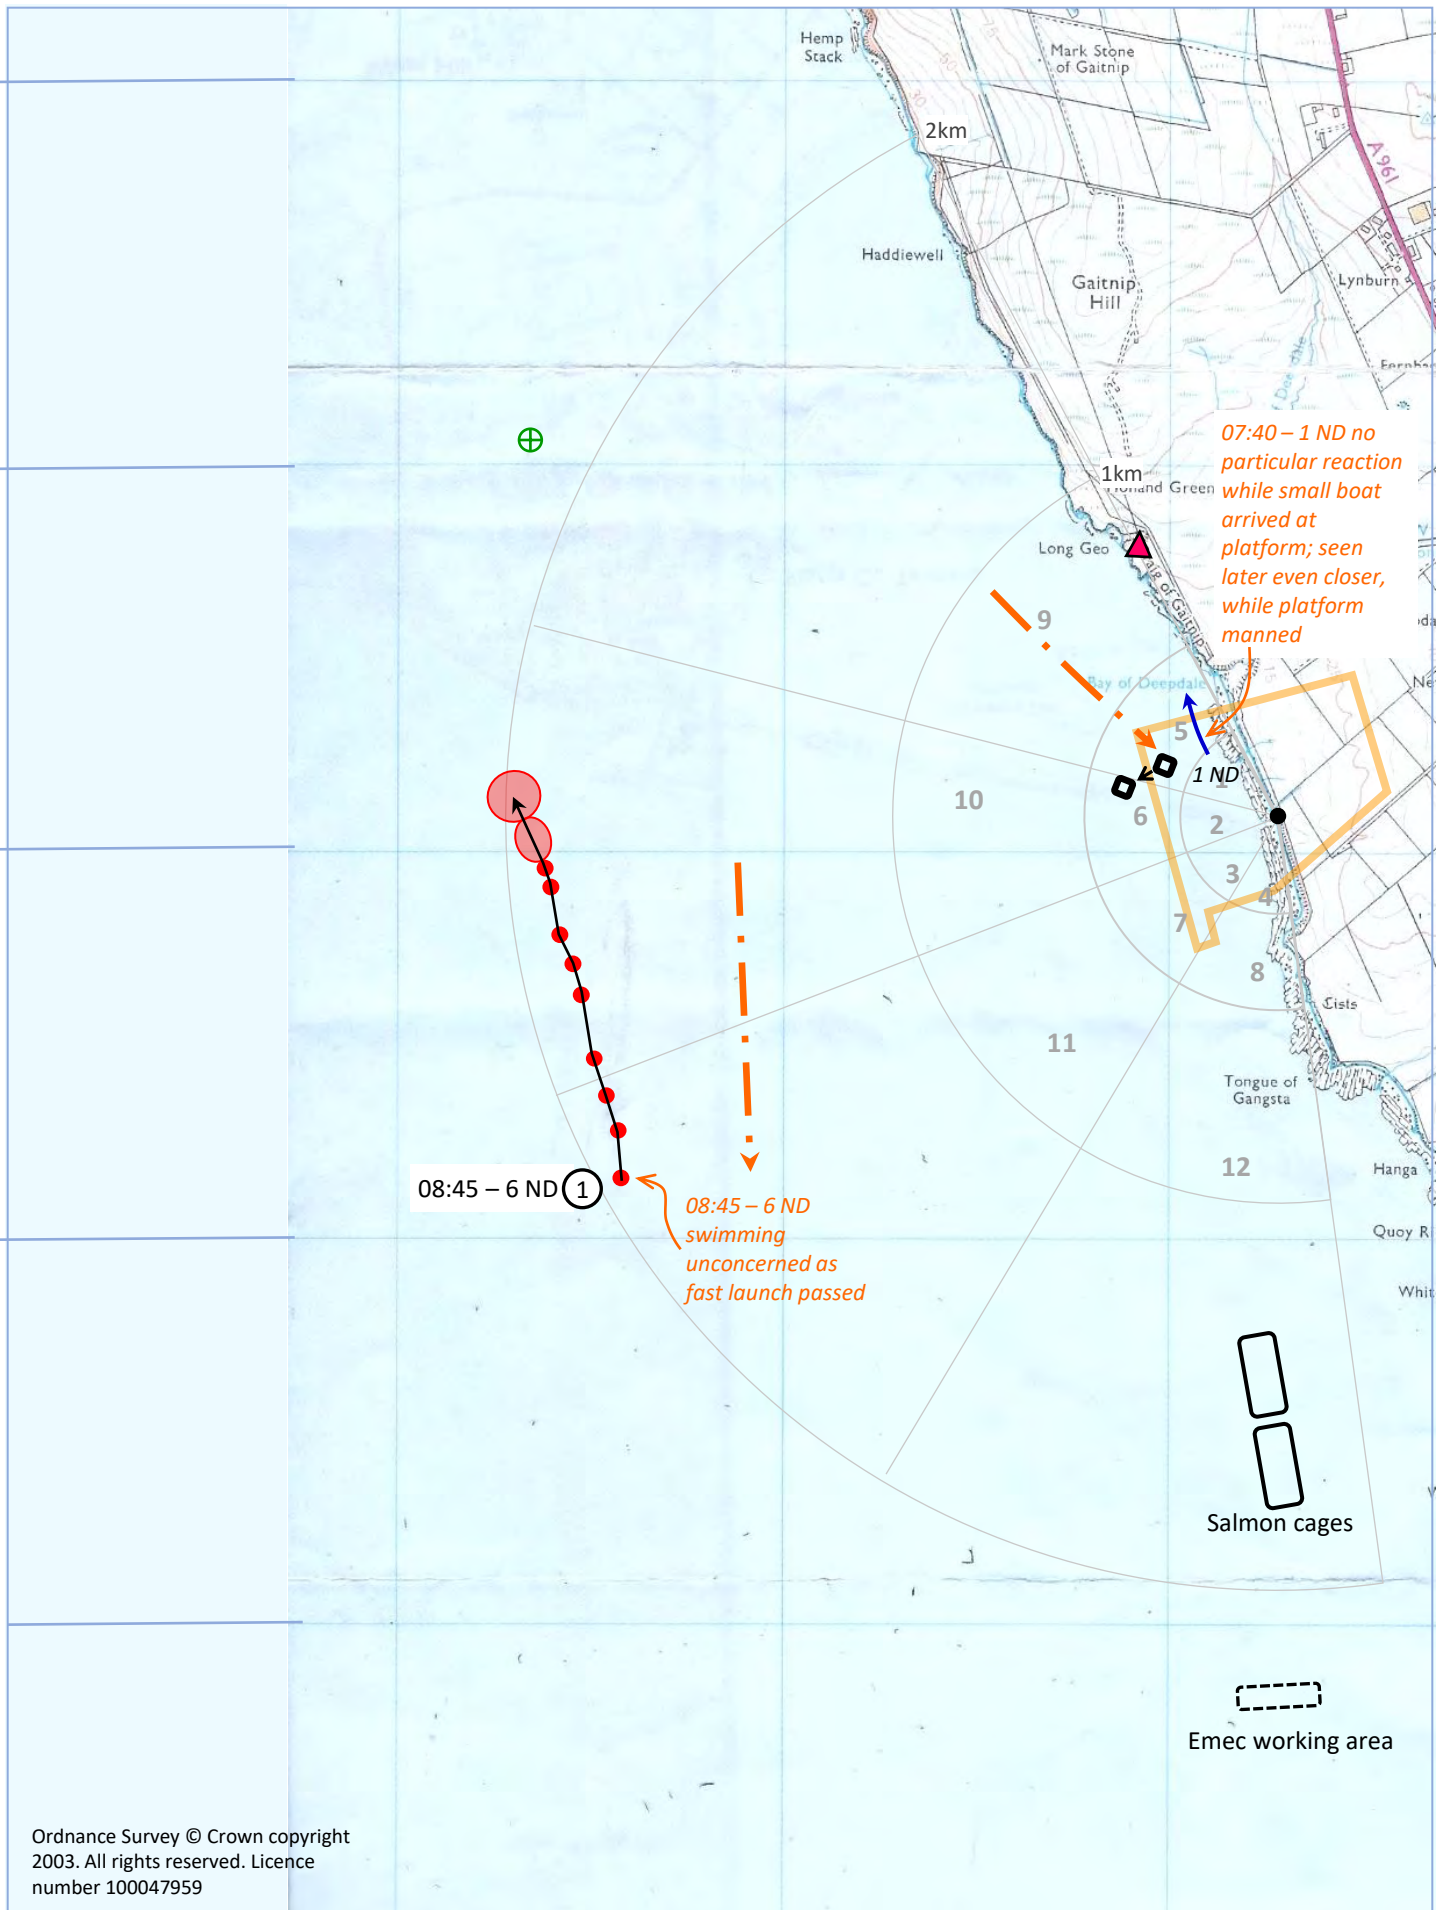
29th March 2022 – Great Northern Diver movements/boat interactions (2)

Circles represent locations at approximate 5-minute intervals). Dotted lines indicate where birds were missed at an interval(s), i.e. two or more intervals between dots.

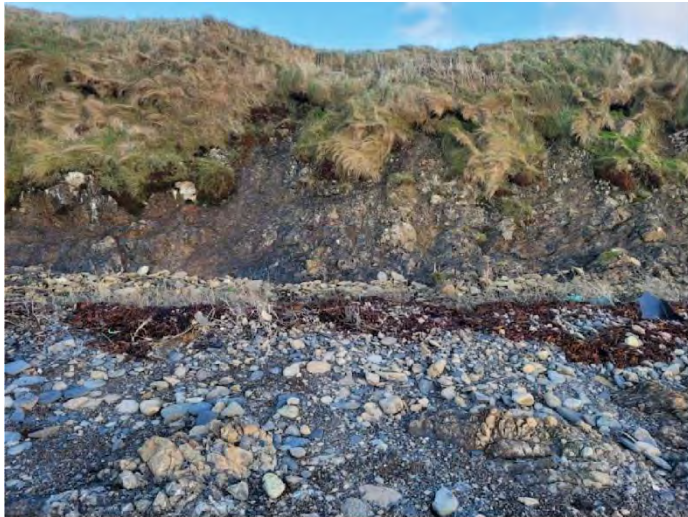
Plate 1a. Scapa Deep Water Quay intertidal survey Transect 1 (SB_1), upper shore.

Transect 1 was located approximately 160 m south of the mouth of the Burn of Deepdale (see Figure 2.1). The central transect line extended 27 m from the upper shore cliff to the low water mark on the day of the survey (low water was 1.33 m above CD).

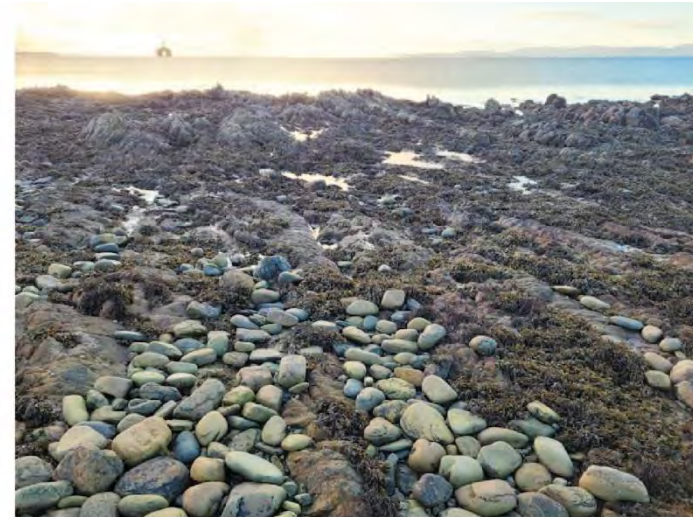
Plate 1b. Scapa Deep Water Quay intertidal survey Transect 1 (SB_1), mid and lower shore.

SB_1 Zone 2. The substrate in Zone 2 was more coarse than that present in Zone 1, with cobbles overlying the shingle. Beneath the cobbles, low densities of gammarid amphipods (occasional) were recorded. Sparse individuals of the small periwinkle *Melarhappe neritoides* (rare) were also observed on the cobble surfaces. However, as no other taxa were recorded, this zone was also assigned the biotope **LS.LCS.Sh.BarSh**.

The biological communities present in this zone were variable, with vertical zonation apparent on the individual bedrock ridges and gullies. On the tops of the ridges, egg wrack, *Ascophyllum nodosum*, (rare) was dominant. Below this, and covering the majority of the rock, was the same biological community observed in zone 4, with dense *F. vesiculosus* (abundant) and *O. pinnatifida* (common) present together with *P. vulgata* (abundant) and the barnacle *Semibalanus balanoides* (frequent). Other faunal taxa recorded in this zone included *N. lapillus* (common), *L. obtusata* (common), *L. littorea* (rare), *S. umbilicalis* (rare) and *A. equina* (occasional). In the gullies, *F. serratus* (abundant) was the dominant taxa, with encrusting red algae (rare to occasional) present on the rock beneath.

The abundances of the taxa *F. vesiculosus*, *O. pinnatifida* and *S. balanoides* recorded are highly indicative of the biotope **LR.MLR.BF.FvesB** ('*Fucus vesiculosus* and barnacle mosaics on moderately exposed mid eulittoral rock'). While this community was the dominant one within zone 5 and was therefore assigned to the observed habitat, the presence of *F. serratus* in gullies may suggest that this zone could be best described as a mosaic habitat together with **LR.LLR.F.Fserr.FS** ('*Fucus serratus* on full salinity sheltered lower eulittoral rock').

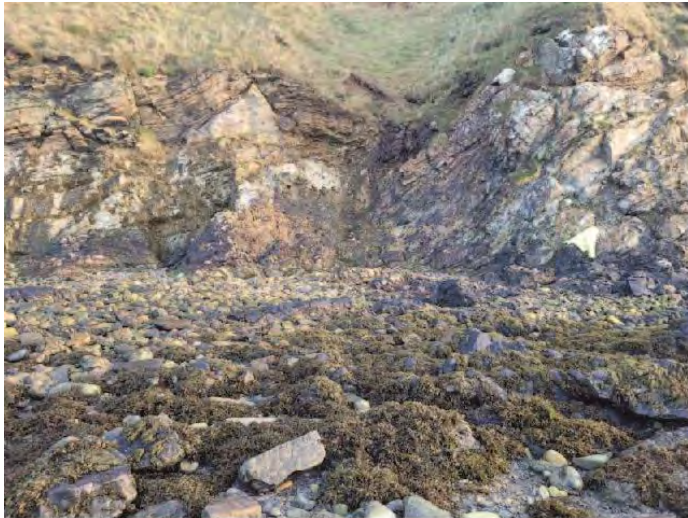
Plate 2a. Scapa Deep Water Quay intertidal survey Transect 2 (SB_2), upper shore.

Transect 2 was located approximately 470 m south of the Burn of Deepdale. The upper shore was backed by a steeply sloping cliff approximately 8 m in height. The top of the cliff supported a thin soil strata and coarse terrestrial grasses. Occasional clumps of grasses occurred in the crevices of the main rock face (see Appendix III). The rock surface supported the lichens *Hydropunctaria maura* (previously *Verrucaria maura*), *O. parella*, *Caloplaca* sp. and *R. siliquosa*. Freshwater was observed percolating from the soil at the top of the cliff causing an area of cliff rock at the centre of the transect to support a brown algal biofilm.

In addition to the lichens, a range of fauna was present in this zone. On the rock surface, *L. saxatilis* (occasional), *L. littorea* (rare) and *P. vulgata* (rare) were all observed, while underneath the less stable cobbles highly abundant talitrid amphipods (abundant) and the sea slater *Ligia oceanica* (frequent) were also recorded.

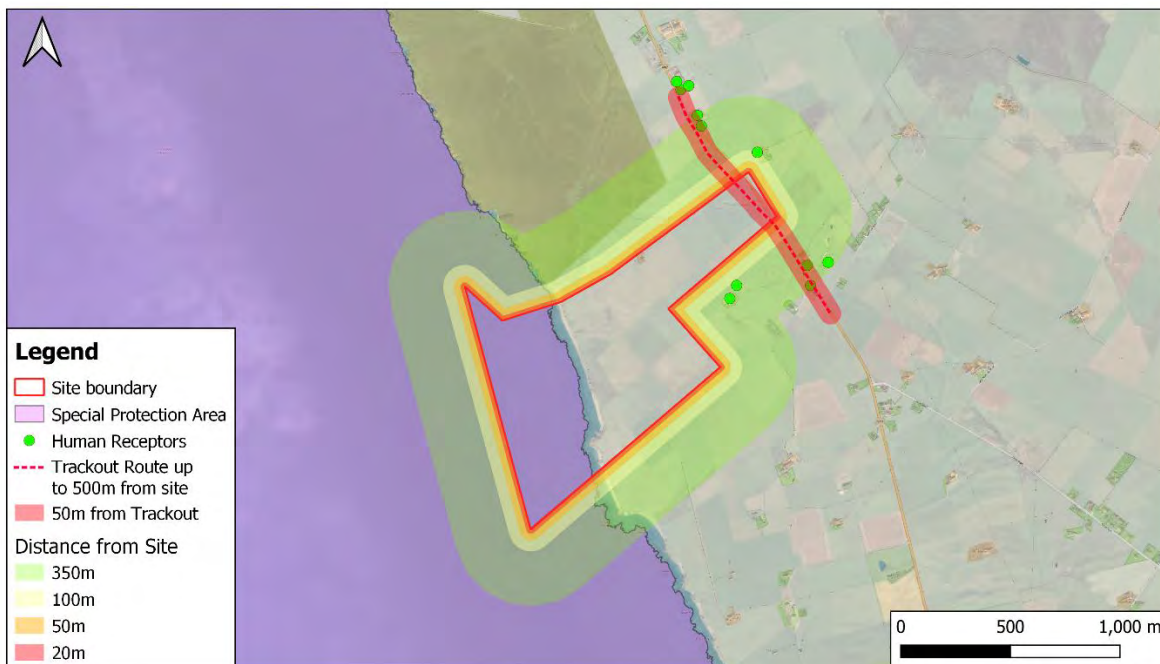
Figure 2 Identified sensitive receptors within defined distance buffers from the Proposed Development site boundary

Figure 2 presents the location of nearby sensitive receptors and distance buffers from the Proposed Development.

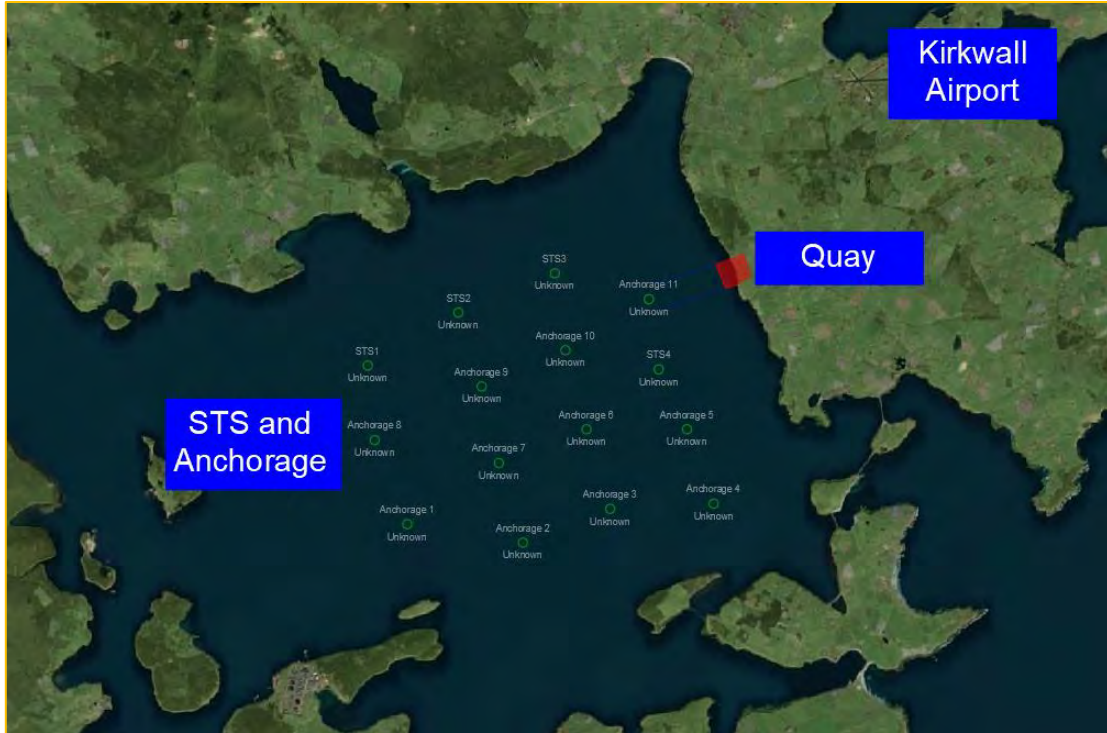
Figure 5 – STS and Turbine Location (Image © Google Earth Pro)

The obstacle positions were entered into Autodesk AutoCAD:

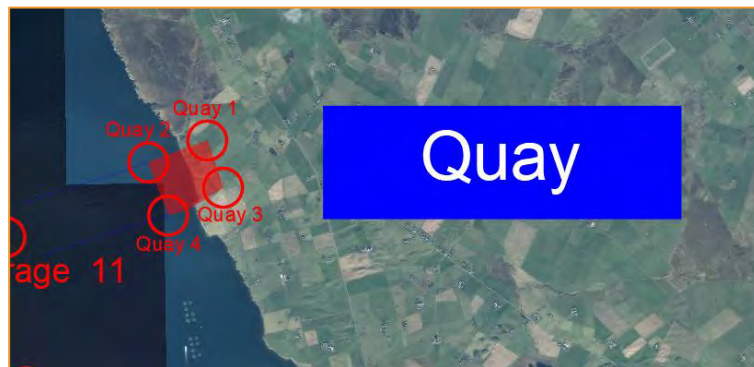
Figure 6 - Quay Location and 4 Points (Image © Google Earth Pro)

4 points were plotted at each corner of the proposed quay. Highest ground elevation was determined to be 31m. The elevation of the corners was set to a conservate 331m which would be the max turbine tip on the highest point of the site.

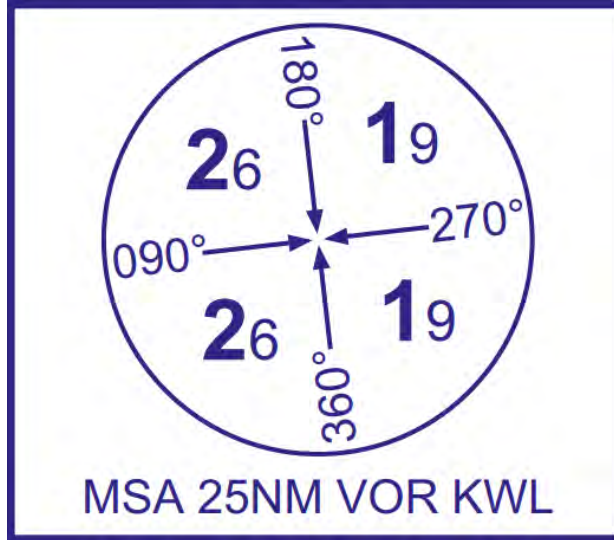
Figure 24 – MSA VOR KWL

The proposed development lies within the MSA 25NM VOR KWL South West, South East (Buffer) and North West (Buffer) Quadrants:

With a MOC of 300m, using a max obstacle elevation of 331m the proposed development would require the MSA Quadrant to be **2100ft**:
