# Habitats Regulations Assessment: Appropriate Assessment

Perth Harbour Phase 1 Dredging

February 2022

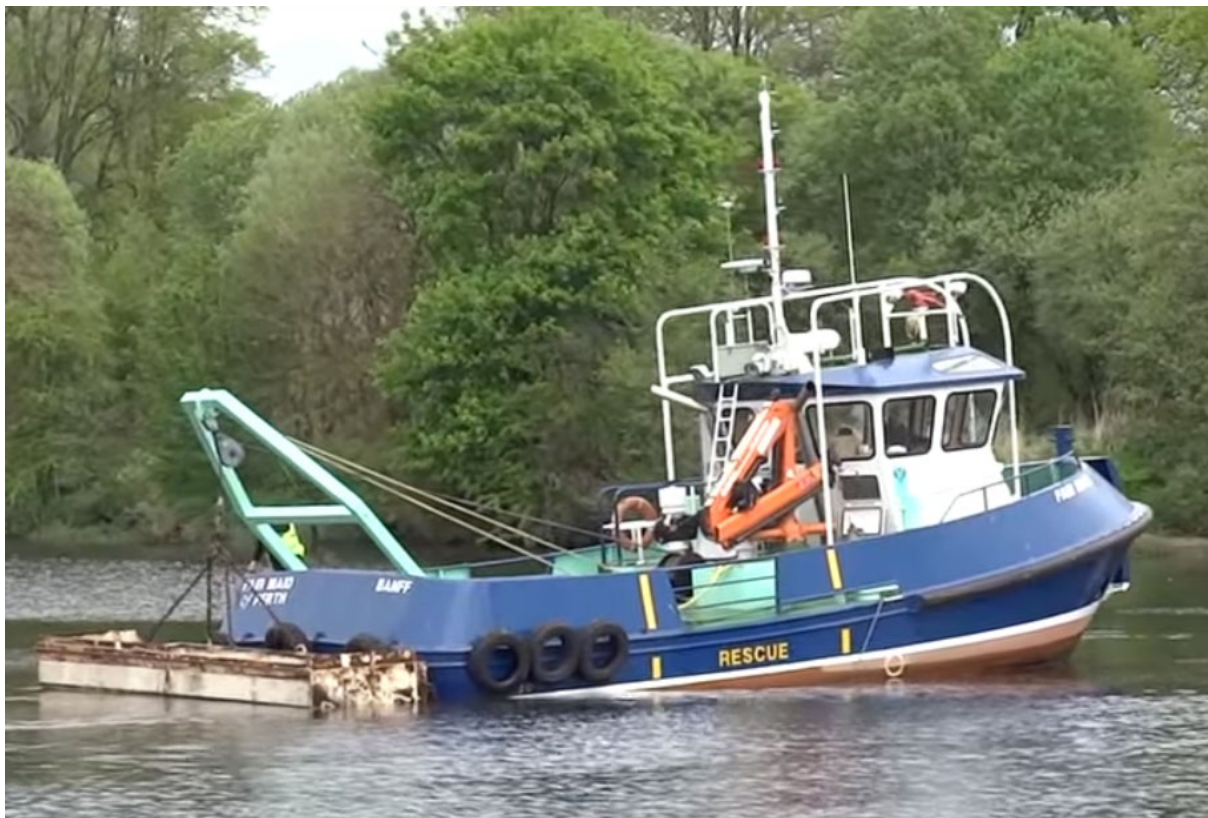
It is proposed to carry out the dredging by relocating material from the bar into the deeper areas of the harbour. This will be achieved using a plough (see figures 2 and 3).

Figure 2. Plough fitted to the back of a suitable tug. The plough is lowered and raised by a winch running over the 'A' frame.

This dredging method works by capturing the sediment to be dredged in an open bottom box that is pulled over the area to be dredged. The plough is lowered down to a specific depth on winch wires and is then directed towards the area to be dredged by the tug on which the plough is mounted. As the plough encounters an area that is shallower than the set height of the plough, the cutting blade, on the front of the plough, separates the shallower material from the bed and it accumulates within the plough box. When the plough passes out of the area to be dredged and into deeper water, the material accumulated in the plough box drops out. The plough is then raised and the tug is re-positioned on the outer side of the bar to repeat the process. By repeating this process many times the available depth, over the bar, will be gradually increased and the deeper water immediately inside the harbour will be progressively filled. The process is repeated until the required depth (-1.5mCD) is achieved, at which point the dredging process will be completed.

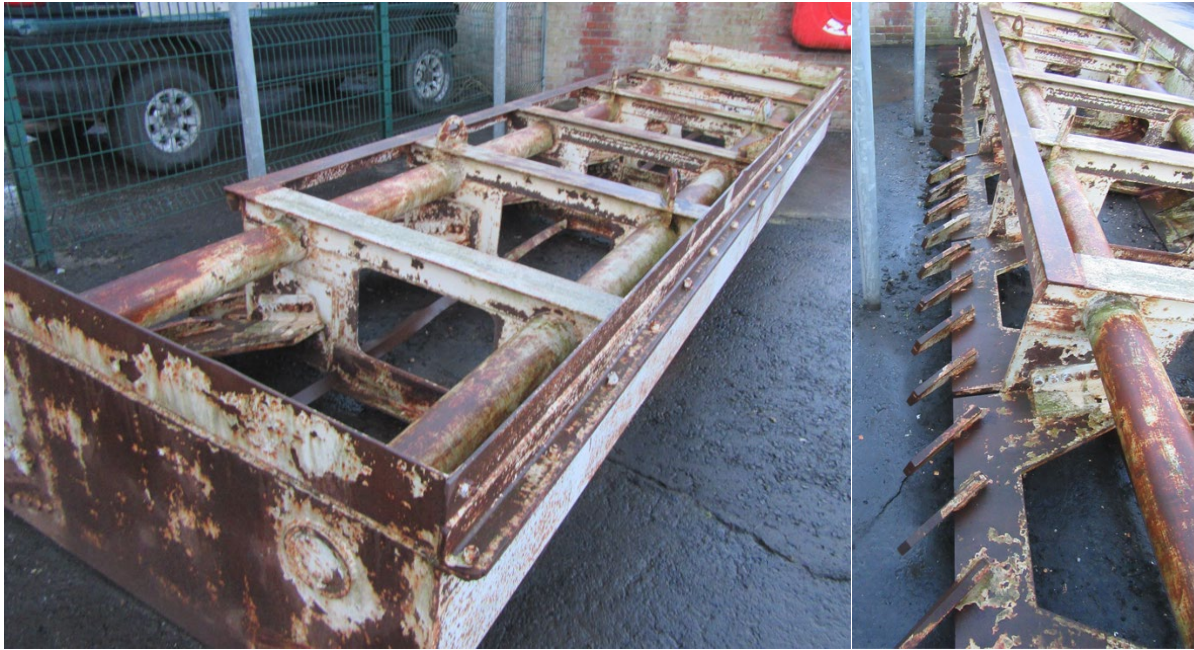
Figure 3. Close up images of the Plough.

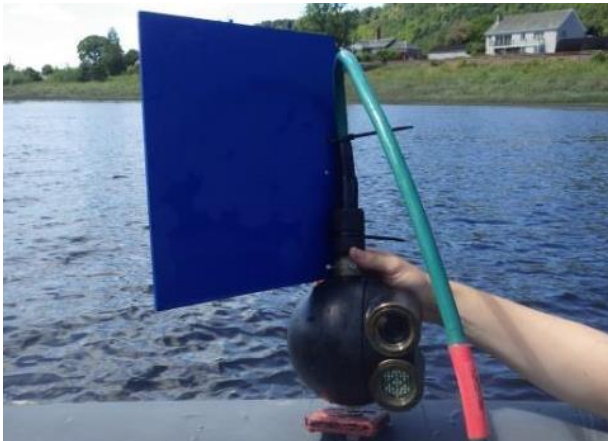
For the survey an underwater Spyball™ camera and control unit supplied by Submertec Ltd was used as recommended by NatureScot (Cosgrove *et al.* 2007). This camera unit is mounted to an umbilical cord (Photos 3, 4) connecting it to a control unit with a large screen which allows users to view the riverbed, control the camera angle, zoom, focus and capture video and stills. The control unit also automatically records the footage and stills to an external USB drive for export to a computer for later analysis. The camera is able to rotate a full 360 degrees on two axes and is also equipped with a light to illuminate the riverbed that aids survey in darker conditions. This system was powered by a 110v supply from a small suitcase style generator suitable for use on board a boat. A stabilising weight attached to the bottom of the camera along with a fin was also employed for the survey. The boat was operated by John Kettles, arranged through Perth and Kinross Council.

Photo 3: Submertec Spyball Camera Unit

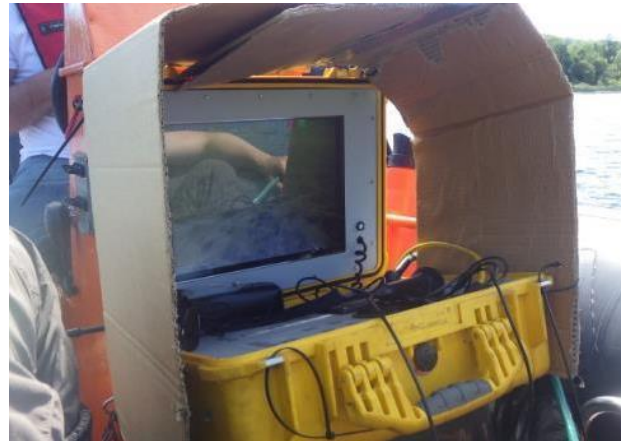
Photo 4: Submertec Spyball control unit in use

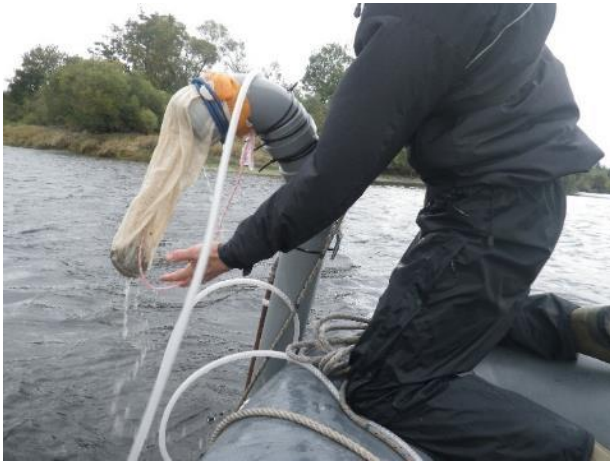
*Photo 5: The pipe equipment with mesh bag*

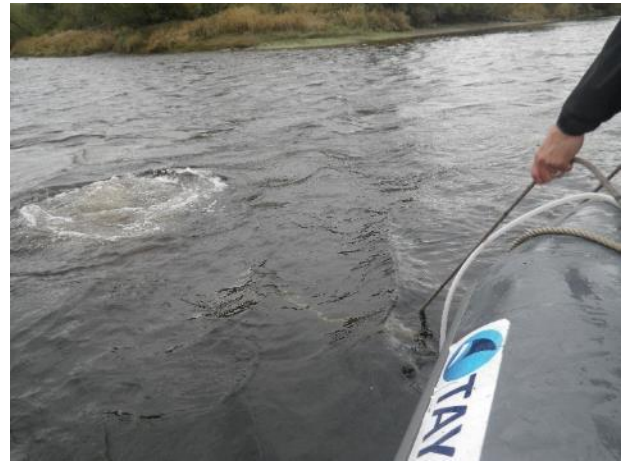
*Photo 6: The submerged equipment with air bubbles in the background*

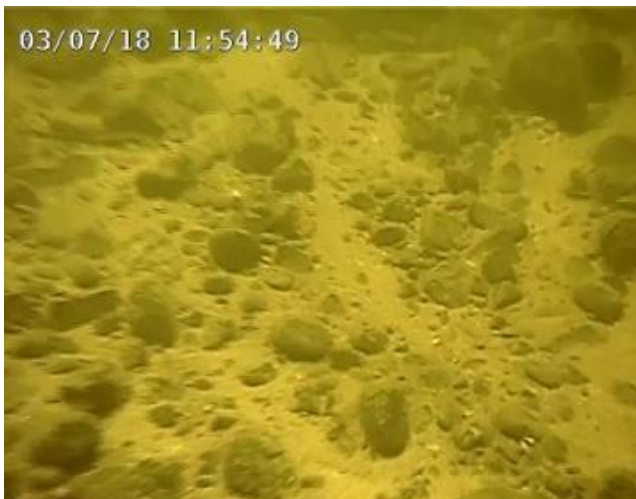
Downstream of the Harbour, as the river bends (and there is a faster flow), is an area of good quality habitat consisting of a fairly even percentage of the substrate covered by silt, pebbles, cobbles and boulders; this alternates between patches which are more dominated by silt and patches consisting of cobbles and boulders. Frequent mussels were recorded here. 28 live mussels were recorded on one transect and 10 mussels were recorded on another (see Figure 4). This is also the area where frequent mussels were found in 2021 (see below). In a lot of areas further downstream, the habitat was considered sub-optimal for freshwater pearl mussel due to the high percentage cover of silt.

*Photo 9: Typical riverbed habitat along south shore of Moncreiffe Island.*
