404000000 - Dunnet WwTW Outfall- Ecology walkover			
Autocode / Project title: 4040000000 - Dunnet WwTW outfall and PAA Dosing de-commissioning			
Survey Type: Ecology walkover	Redacted		
Survey Date: 06 September 2018	Weather conditions: At start – 5/8 cloud, 13° C,NW 1(G2)		
Location: West Dunnet, Thurso KW14 8YD (Grid Reference: ND 21259 71068)

In support of Scottish Water's proposal to extend the existing outfall at Dunnet Waste water Treatment Works (WwTW), on 06 September 2018 an ecological walkover survey was conducted of the area surrounding the site at Dunnet Head, Caithness.

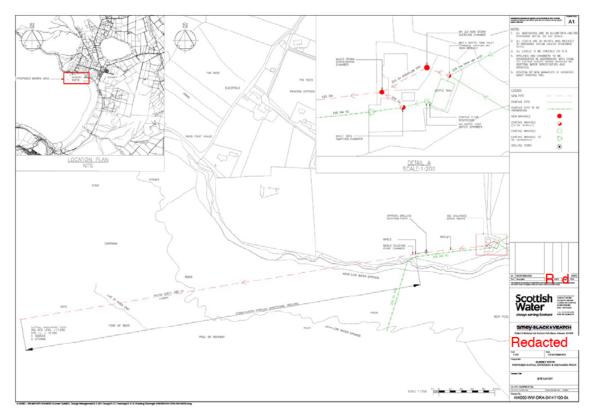
Map 1: Location and proposed layout of the site at Dunnet, Caithness

The proposed HDD pit will be located approximately 100 metres to the west of Dunnet WwTW at grid reference ND 21259 71068. The proposed new outfall will be located approximately 700 metres west south west at grid reference ND 20533 70948 (Map 1).

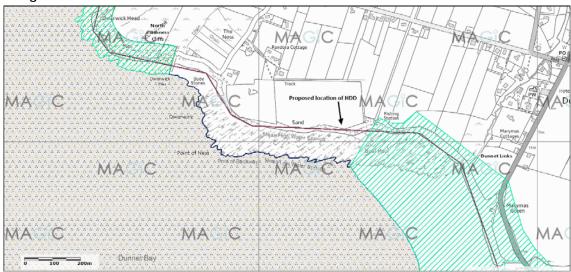
Map 2: Location of the proposed HDD site sandwiched between designated sites

Dunnet head is designated a Site of Special Scientific Interest (SSSI) as are the Dunnet links to the east. The peninsula forms part of the *North Caithness Cliffs* Specially Protected Area (SPA), qualifying under Article 4.1 of the Birds Directive (79/409/EEC) by supporting populations of European importance of peregrine falcon (*Falco peregrinus*).

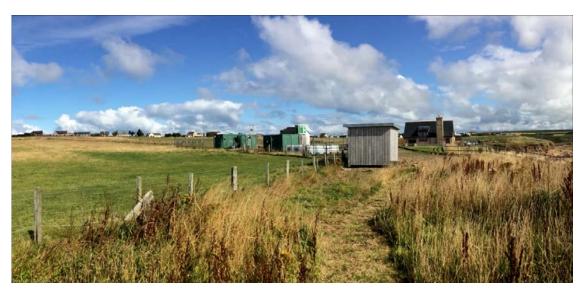
Photo 1: Location of the existing Dunnet WwTW (centre) and Salmon Bothy (right)

The existing Dunnet WwTW (Photo 1) is accessed by a rough farm track leading to a converted fishing station now residential property called 'Salmon Bothy'.

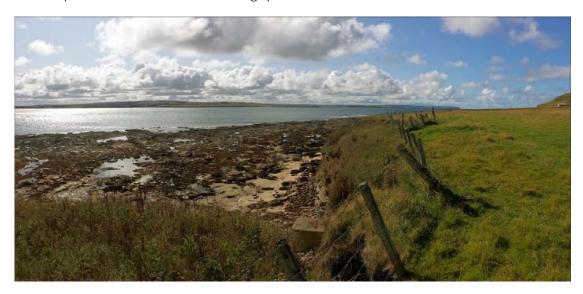
Photo 2: Location of existing outfall infrastructure at the base of the sandstone cliffs

The proposed location of the HDD drilling pit is found in a field of improved grassland adjacent the WwTW, currently occupied by sheep. The field is enclosed by a post and wire fence that protects an un-grazed strip of wildflower grassland and coastal path that lines the top of the cliffs (Photo 2).

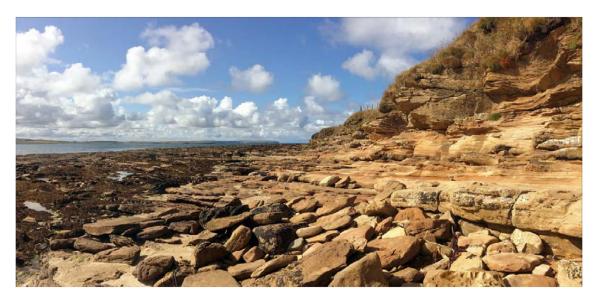
Photo 3: Wave cut platform and eroded cliff ledges

The old red sandstone cliffs that form the base rock of Dunnet head vary in slope and aspect but are predominantly steep, south facing and between 3 and 4 meters in height. The cliff base sits on a wave cut platform with small areas of sand and shingle along the foreshore (Photo 3), this area offers potential for nesting waders such as ringed plover and oystercatcher.

The soft composition of sandstone rock, has resulted in the erosion of undercuts and horizontal ledges along the length of the cliffs, which could provide nesting opportunities for birds, in particular cliff or crevice nesting species such as fulmar and rock dove.

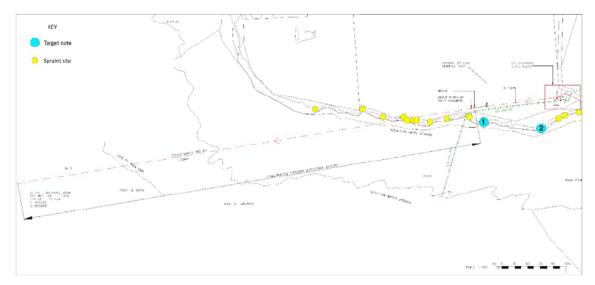
Map 3: Location of spraint marked sites within the survey area

The following Map (Map 3) and Table (Table 1) give details of the otter activity recorded during the survey. Apart from one potential couch found within licensable distance of the works, these findings should not have an impact on the proposals.

Target Note (TN)	Ordnance Survey Grid Reference Locations	Details	Approximate Distance from proposed drill pit location (m)
01	ND 21269 71039	Spraint marked couch	<mark>30</mark>
02	ND 21338 71033	Spraint marked couch	80

A disturbance licence should be sought ahead of works for the spraint marked couch highlighted as TN 1.

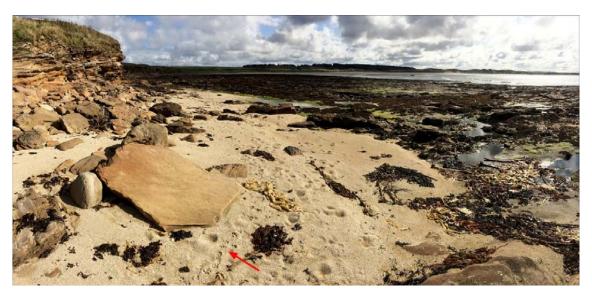
Photo 4: Dog, human and fresh otter tracks in the sand and shingle at the base of the cliffs

Signs of recent otter activity were found throughout the survey area, initially highlighted by a fresh trail of otter footprints found in the sand above the high tide line (Photo 4). These prints wound in and out of the undercut sandstone cliffs, visiting the regularly used spraint sites found beneath (Photo 5 and 6).

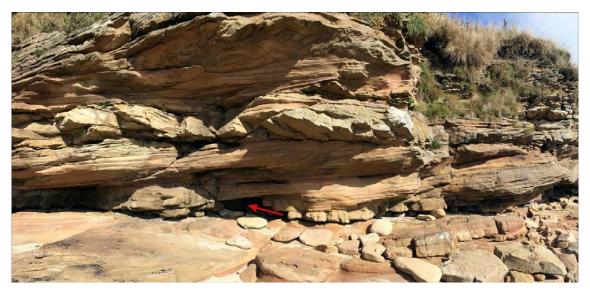
Photo 9: Location of Spraint marked couch - Target Note 1

One of the more significant spraint sites was found approximately 30 metres from the proposed location of the HDD drill pit (Photo 9), this site is highlighted as Target Note 1 (Map 3).

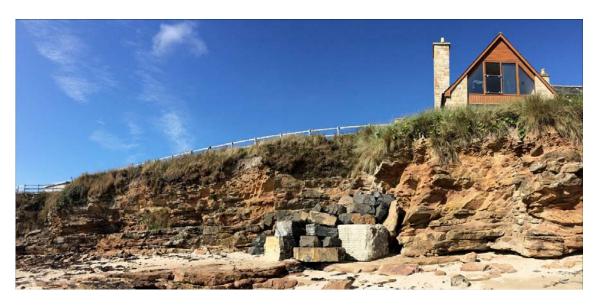
Photo 10: Spraint marked site in rock armour beneath the Salmon Bothy

Another potential couch site, highlighted as Target Note 2 (Map 3) was found approximately 80 metres to the east (Map 3), and another (although unlikely) in rock armour beneath the 'Salmon Bothy' residence (Photo 10).
